Development at West Kowloon Cultural District

Monthly Environmental Monitoring and Audit
(EM&A) Report for October 2018

November 2018

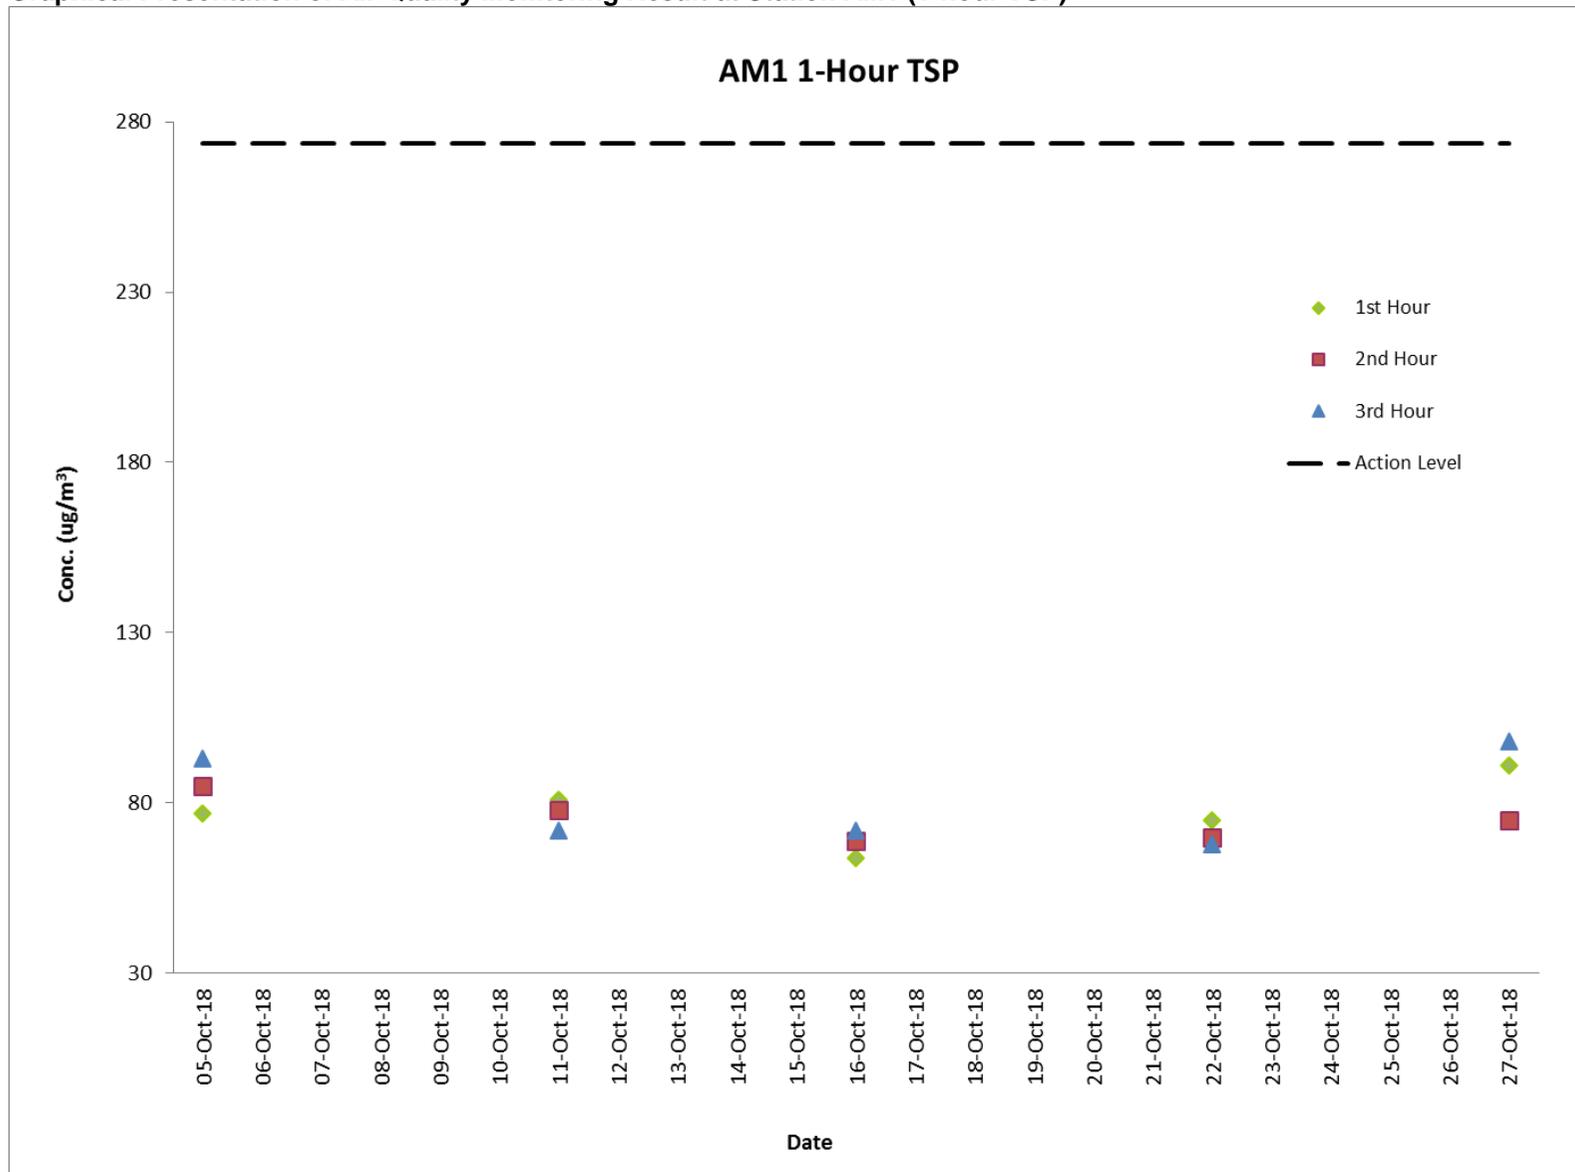
Graphical Presentation of Air Quality Monitoring Result at Station AM1 (1-hour TSP)

Date	Weather Condition	Time	Conc. ($\mu\text{g}/\text{m}^3$)			Action Level ($\mu\text{g}/\text{m}^3$)	Limit Level ($\mu\text{g}/\text{m}^3$)
			1 st Hour	2 nd Hour	3 rd Hour		
05-Oct-18	Sunny	8:12 - 11:12	77	85	93	273.7	500
11-Oct-18	Cloudy	10:55 - 13:55	81	78	72	273.7	500
16-Oct-18	Cloudy	8:02 - 11:02	64	69	72	273.7	500
22-Oct-18	Sunny	7:50 - 10:50	75	70	68	273.7	500
27-Oct-18	Fine	8:12 - 11:12	91	75	98	273.7	500

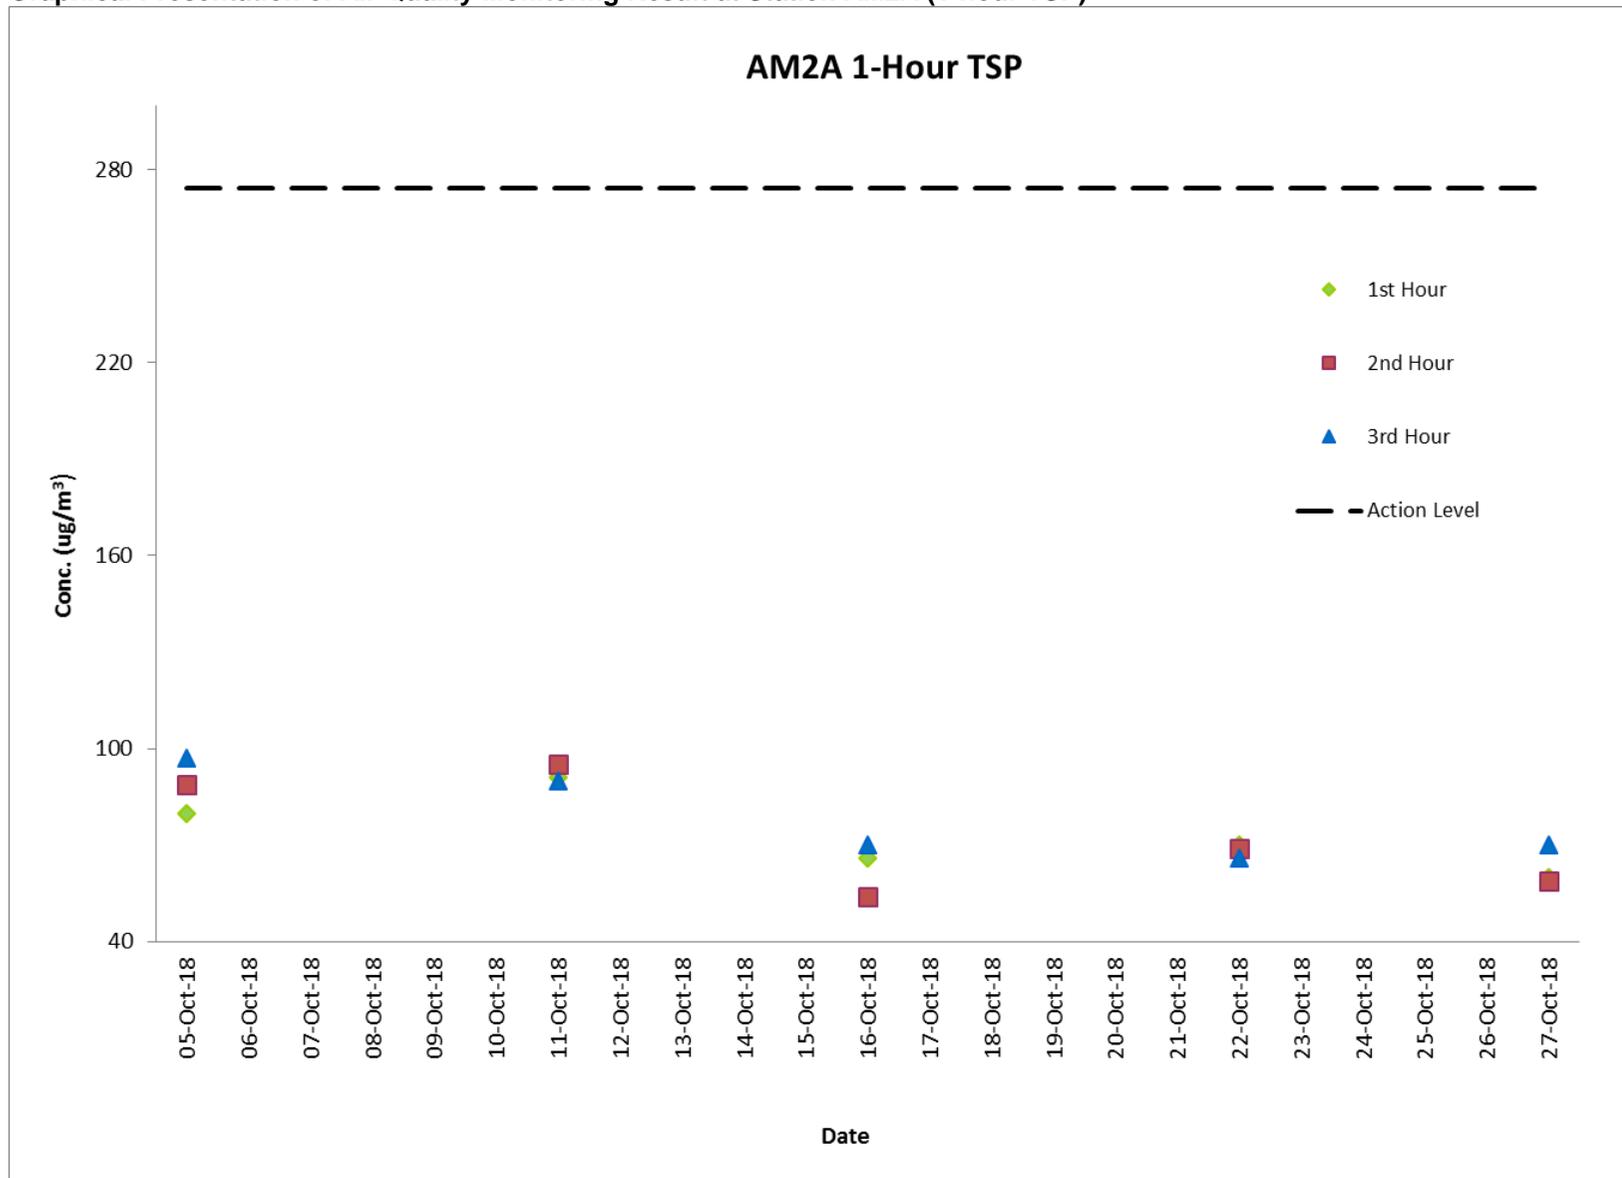
Graphical Presentation of Air Quality Monitoring Result at Station AM2A (1-hour TSP)

Date	Weather Condition	Time	Conc. ($\mu\text{g}/\text{m}^3$)			Action Level ($\mu\text{g}/\text{m}^3$)	Limit Level ($\mu\text{g}/\text{m}^3$)
			1 st Hour	2 nd Hour	3 rd Hour		
05-Oct-18	Sunny	8:25 - 11:25	80	89	97	274.2	500
11-Oct-18	Cloudy	10:22 - 13:22	91	95	90	274.2	500
16-Oct-18	Cloudy	8:18 - 11:18	66	54	70	274.2	500
22-Oct-18	Sunny	8:06 - 11:06	70	69	66	274.2	500
27-Oct-18	Fine	8:25 - 11:25	60	59	70	274.2	500

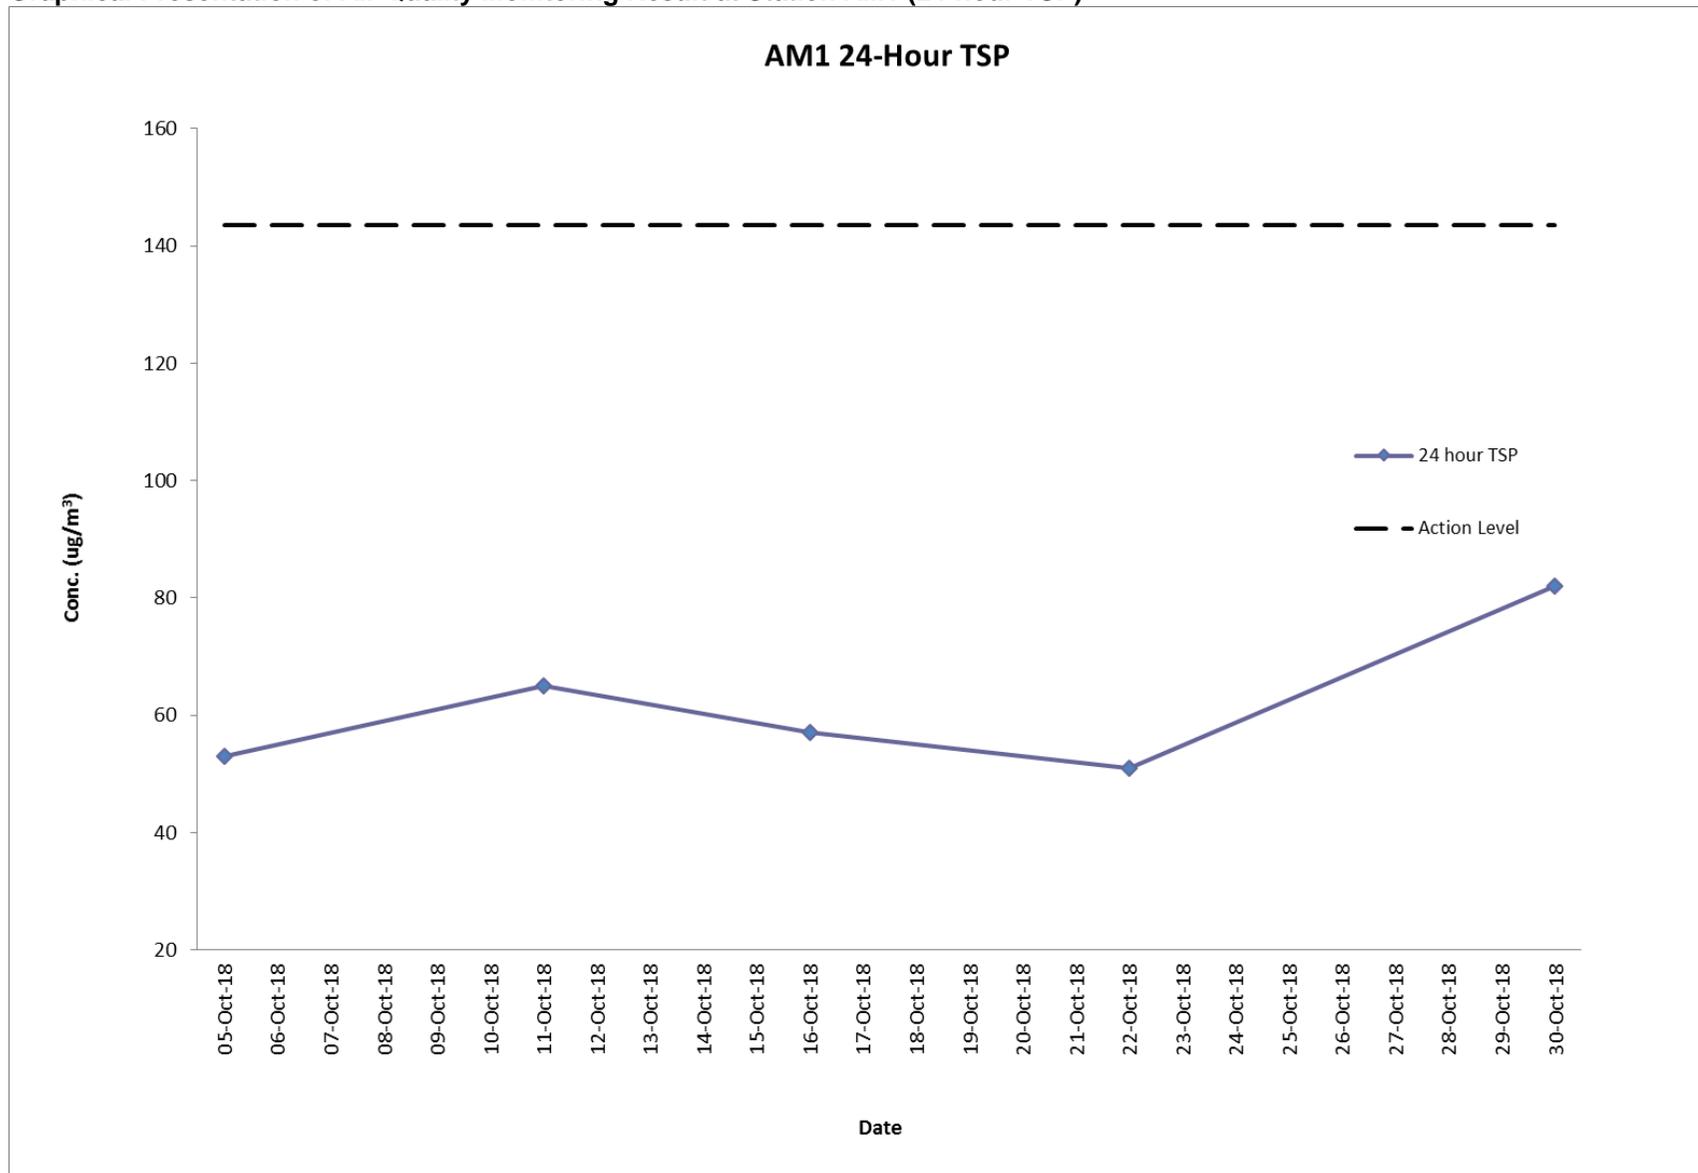
Graphical Presentation of Air Quality Monitoring Result at Station AM1 (24-hour TSP)

Start		Finish		Filter Weight (g)		Elapsed Time Reading		Sampling Time (hrs)	Flow Rate (m ³ /min)			Conc. (µg/m ³)	Weather Condition	Action Level	Limit Level
Date	Time	Date	Time	Initial	Final	Initial	Final		Initial	Final	Average				
05-Oct-18	08:10	06-Oct-18	08:10	2.7101	2.8024	23256.38	23280.38	24	1.22	1.22	1.22	53	Sunny	143.6	260
11-Oct-18	10:53	12-Oct-18	10:53	2.6753	2.7889	23280.38	23304.38	24	1.22	1.22	1.22	65	Cloudy	143.6	260
16-Oct-18	08:00	17-Oct-18	08:00	2.7006	2.8006	23304.38	23328.38	24	1.22	1.22	1.22	57	Cloudy	143.6	260
22-Oct-18	07:52	23-Oct-18	07:52	2.6906	2.7805	23328.38	23352.38	24	1.22	1.22	1.22	51	Sunny	143.6	260
30-Oct-18	08:10	31-Oct-18	08:10	2.6824	2.8271	23352.38	23376.38	24	1.22	1.22	1.22	82	Fine	143.6	260

Remarks: The 24hr TSP impact monitoring at AM1 station scheduled on 27/10/2018 was suspended due to electricity issue, the monitoring was rescheduled to 30/10/2018.

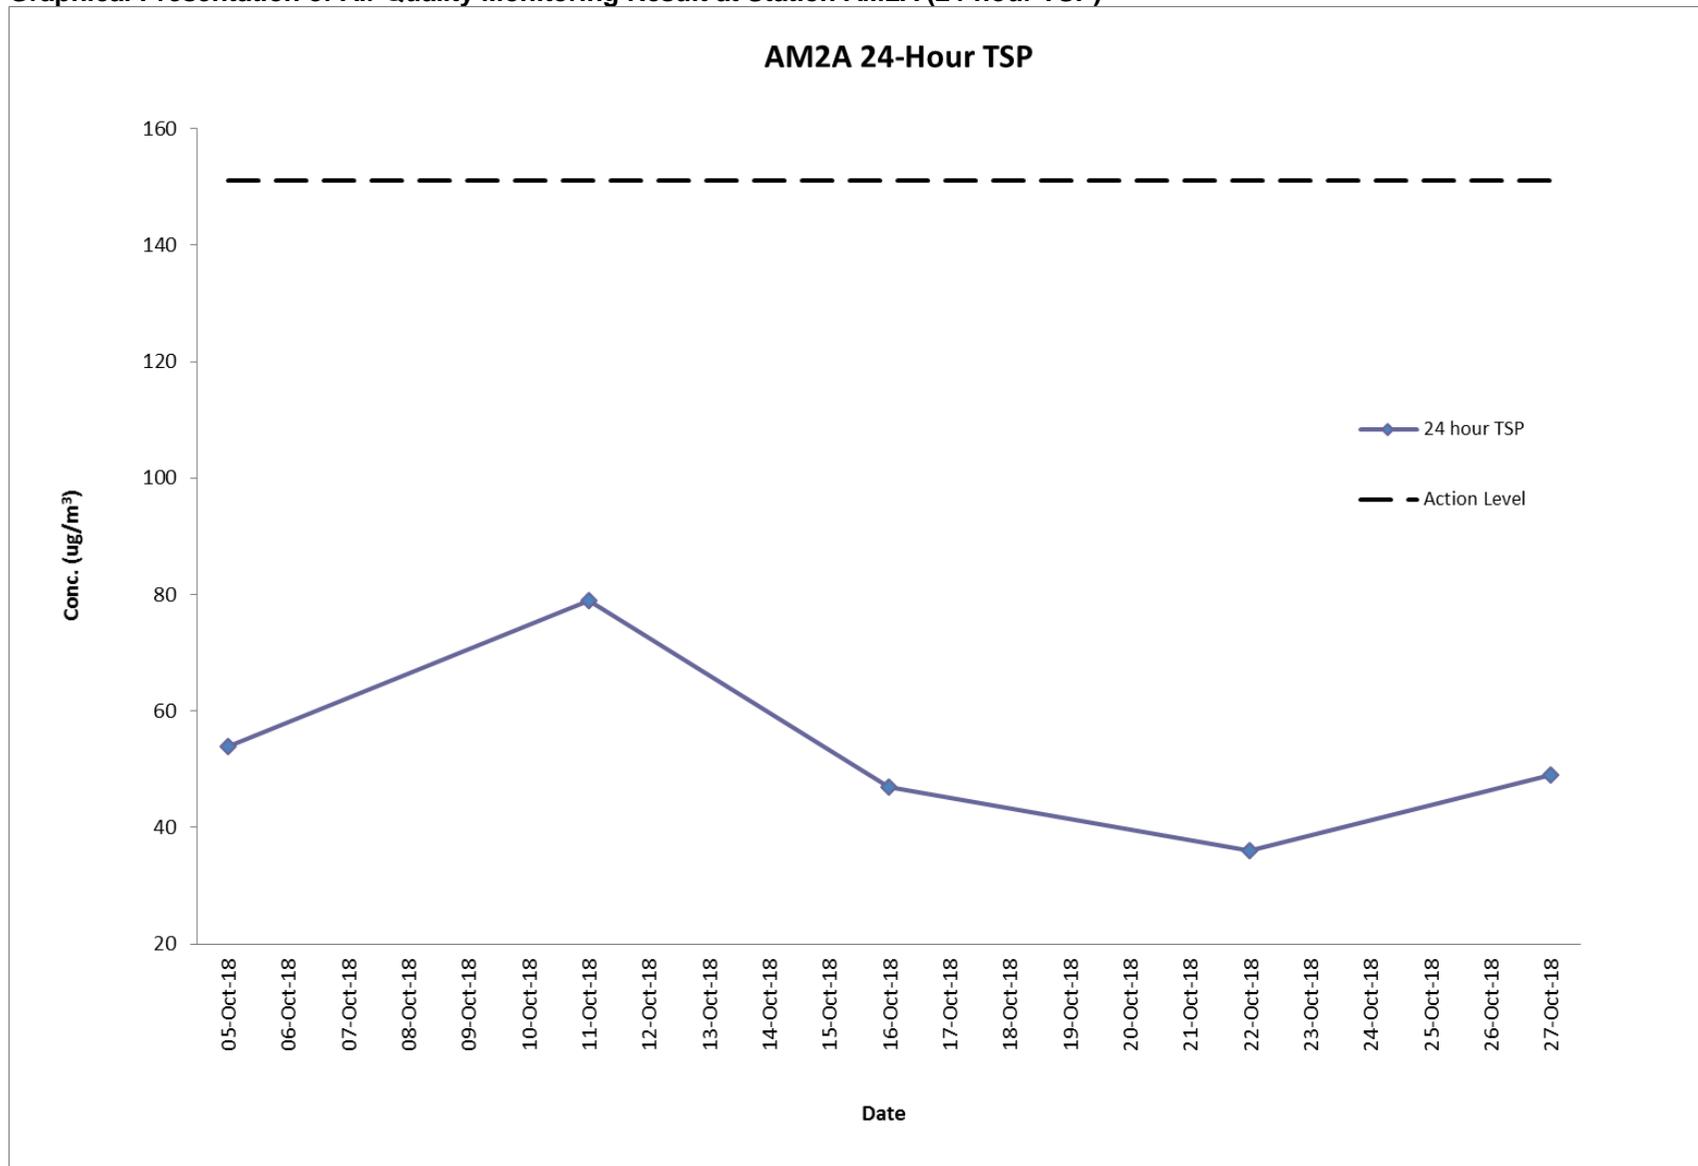
Graphical Presentation of Air Quality Monitoring Result at Station AM2A (24-hour TSP)

Start		Finish		Filter Weight (g)		Elapsed Time Reading		Sampling Time (hrs)	Flow Rate (m ³ /min)			Conc. (µg/m ³)	Weather Condition	Action Level	Limit Level
Date	Time	Date	Time	Initial	Final	Initial	Final		Initial	Final	Average				
05-Oct-18	08:22	06-Oct-18	08:22	2.6822	2.7819	18911.59	18935.59	24	1.29	1.29	1.29	54	Sunny	151.1	260
11-Oct-18	10:20	12-Oct-18	10:20	2.6707	2.8180	18935.59	18959.59	24	1.29	1.29	1.29	79	Cloudy	151.1	260
16-Oct-18	08:15	17-Oct-18	08:15	2.6911	2.7780	18959.59	18983.59	24	1.29	1.29	1.29	47	Cloudy	151.1	260
22-Oct-18	08:03	23-Oct-18	08:03	2.6962	2.7623	18983.59	19007.59	24	1.29	1.29	1.29	36	Sunny	151.1	260
27-Oct-18	08:22	28-Oct-18	08:22	2.6874	2.7793	19007.59	19031.59	24	1.29	1.29	1.29	49	Fine	151.1	260

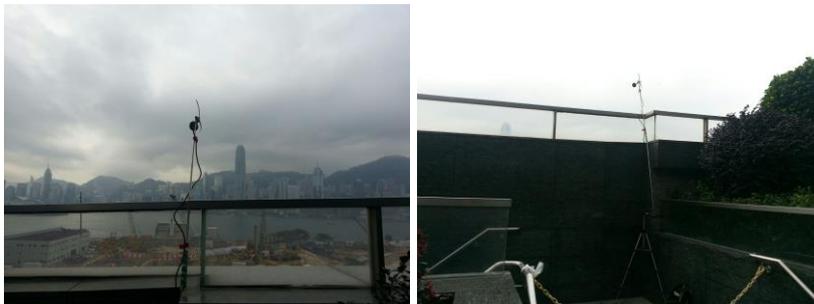
* +3dB (A) correction was applied to free-field measurement.

The station set-up of a free-field measurement at Station NM1A.

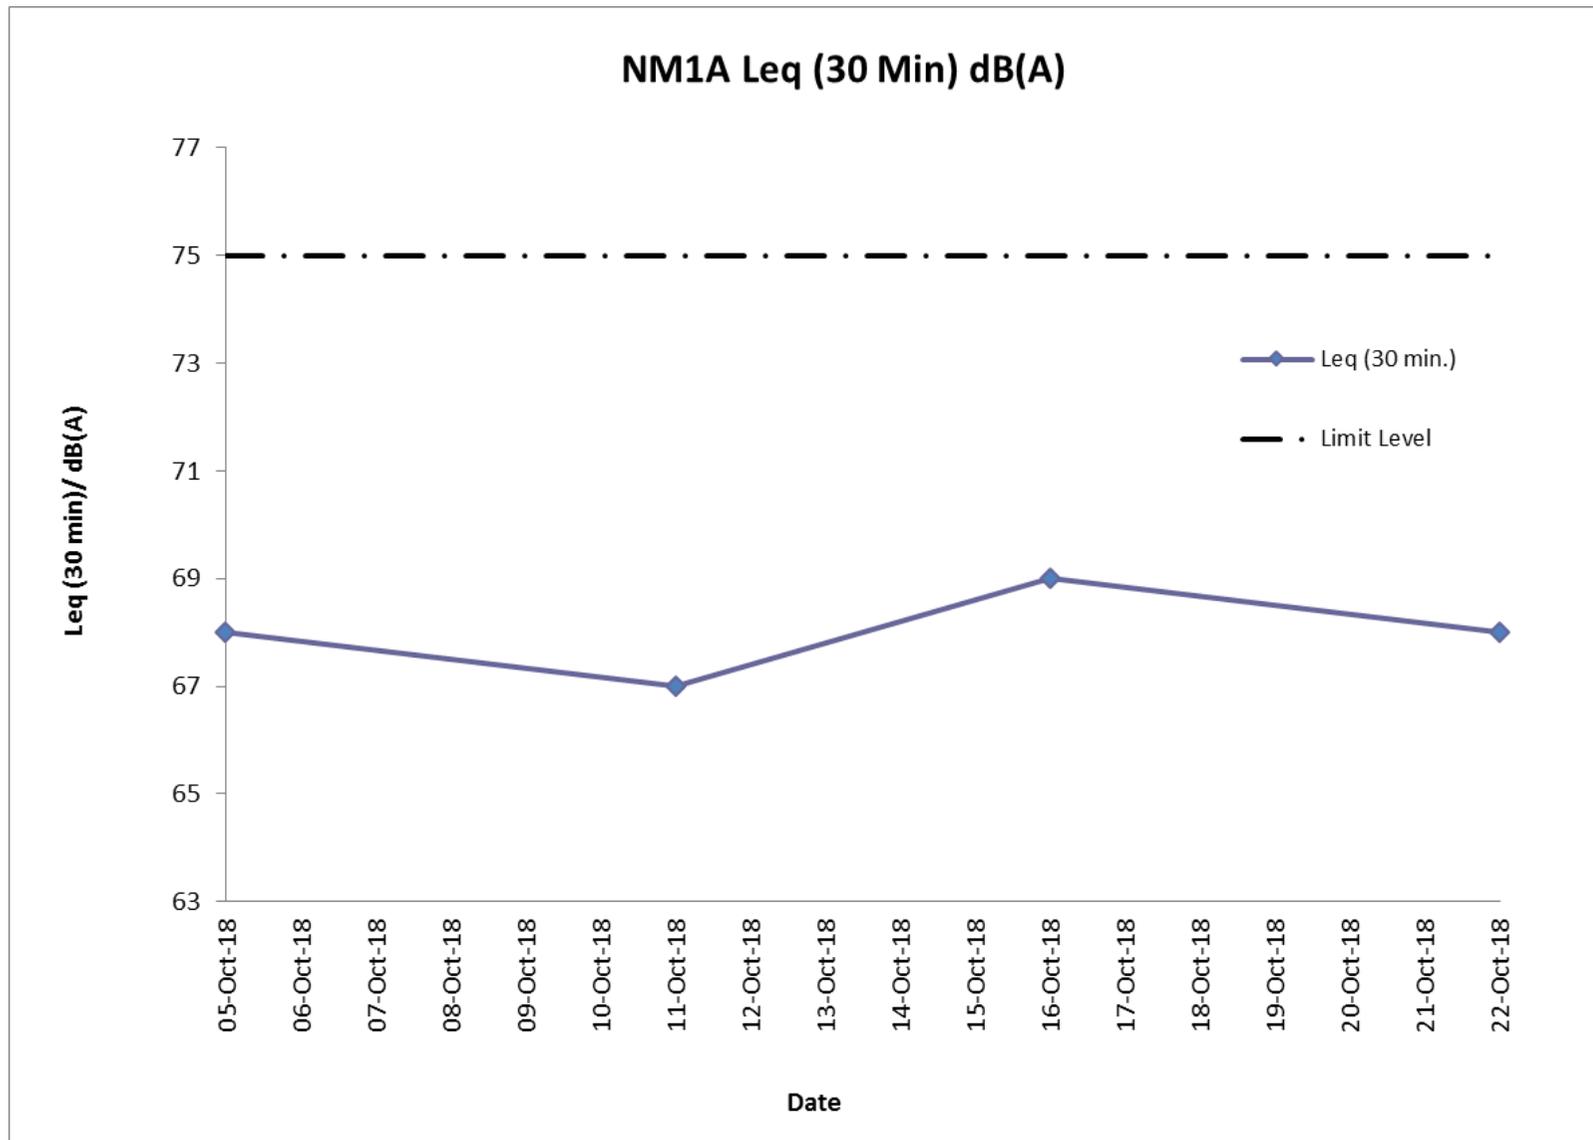
Graphical Presentation Noise Monitoring Result at Station NM1A

Date	Time	Measured L ₁₀ , dB(A)	Measured L ₉₀ , dB(A)	L _{eq} (30 min.)*, dB(A)
05-Oct-18	10:30	66.4	62.4	68
05-Oct-18	10:35	65.8	61.7	
05-Oct-18	10:40	67.9	63.9	
05-Oct-18	10:45	67.7	63.4	
05-Oct-18	10:50	65.8	61.5	
05-Oct-18	10:55	66.0	61.7	
11-Oct-18	10:58	66.0	62.7	67
11-Oct-18	11:03	67.1	63.4	
11-Oct-18	11:08	65.8	61.5	
11-Oct-18	11:13	66.5	62.4	
11-Oct-18	11:18	65.4	61.7	
11-Oct-18	11:23	65.7	61.5	
16-Oct-18	10:25	68.4	64.7	69
16-Oct-18	10:30	67.9	63.4	
16-Oct-18	10:35	66.7	62.5	
16-Oct-18	10:40	67.0	63.4	
16-Oct-18	10:45	67.8	63.5	
16-Oct-18	10:50	68.4	64.1	
22-Oct-18	10:15	67.4	63.4	68
22-Oct-18	10:20	68.5	64.7	
22-Oct-18	10:25	66.7	62.5	
22-Oct-18	10:30	67.9	63.4	
22-Oct-18	10:35	66.5	62.7	
22-Oct-18	10:40	68.0	64.9
