Development at West Kowloon Cultural District

Monthly Environmental Monitoring and Audit
(EM&A) Report for November 2018

December 2018

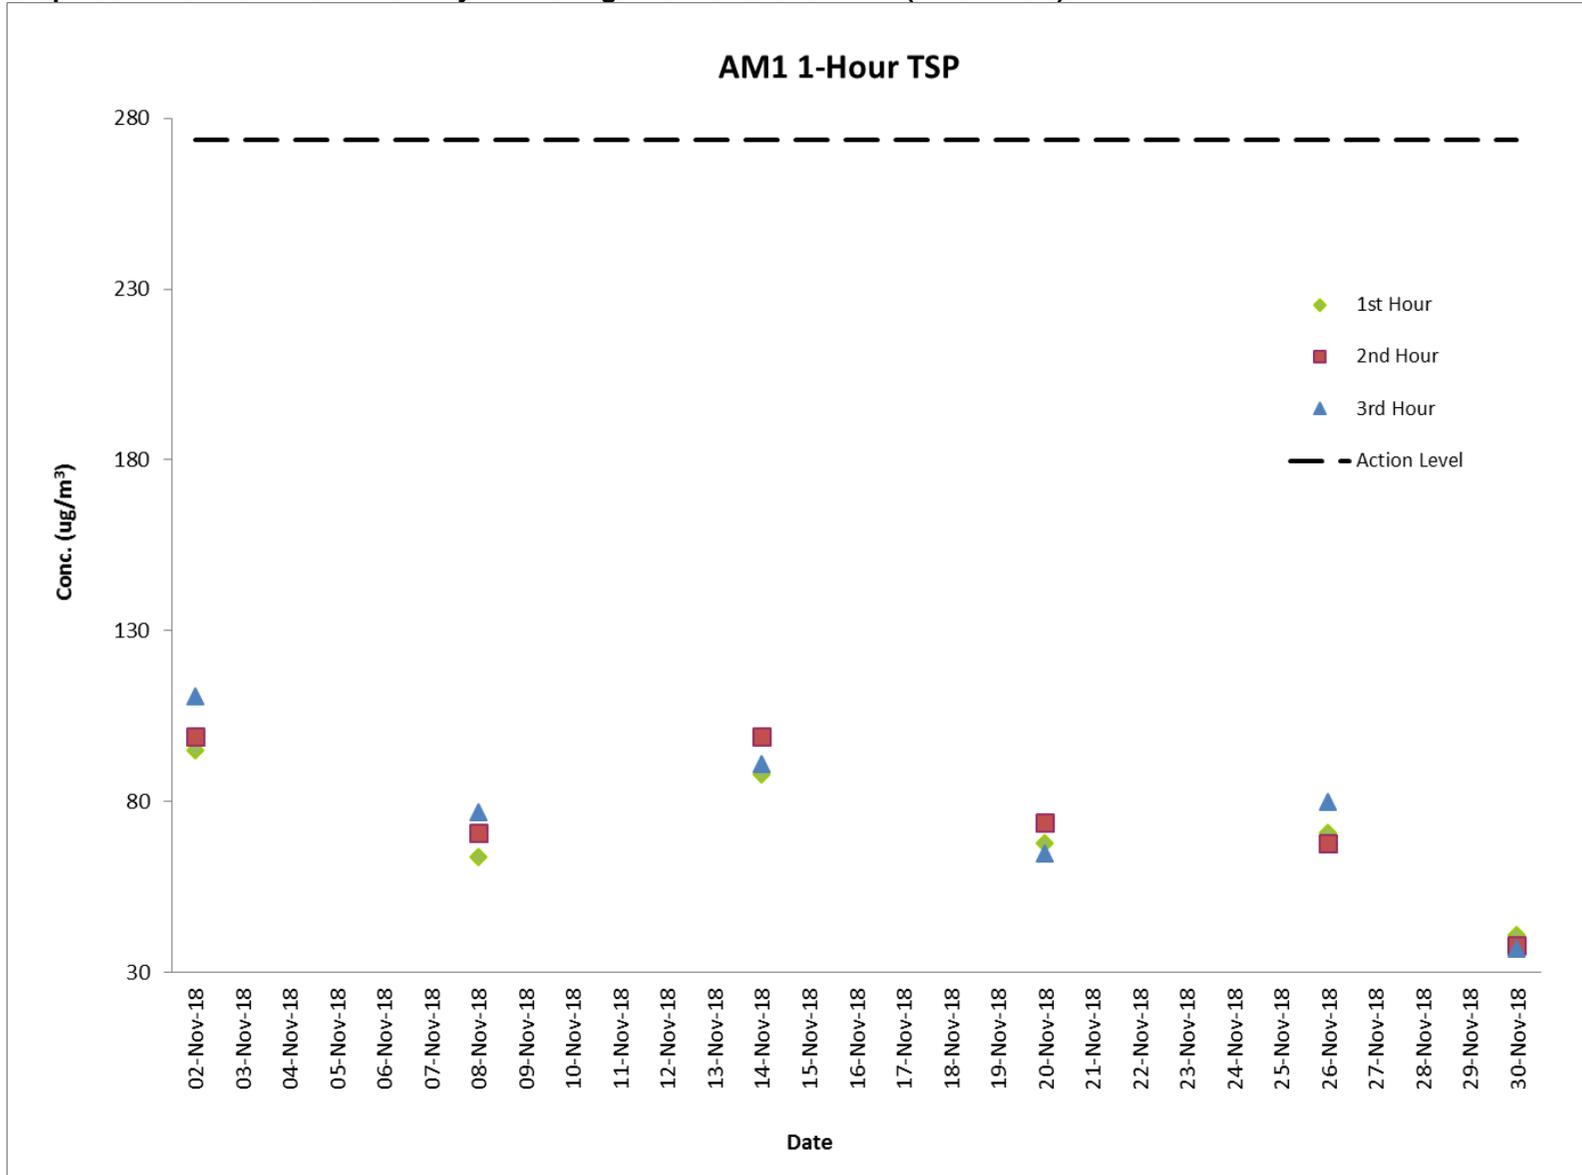
Graphical Presentation of Air Quality Monitoring Result at Station AM1 (1-hour TSP)

Date	Weather Condition	Time	Conc. ($\mu\text{g}/\text{m}^3$)			Action Level ($\mu\text{g}/\text{m}^3$)	Limit Level ($\mu\text{g}/\text{m}^3$)
			1 st Hour	2 nd Hour	3 rd Hour		
02-Nov-18	Cloudy	8:04 - 11:04	95	99	111	273.7	500
08-Nov-18	Fine	7:58 - 10:58	64	71	77	273.7	500
14-Nov-18	Fine	7:50 - 10:50	88	99	91	273.7	500
20-Nov-18	Cloudy	7:50 - 10:50	68	74	65	273.7	500
26-Nov-18	Cloudy	7:52 - 10:52	71	68	80	273.7	500
30-Nov-18	Sunny	8:02 - 11:02	41	38	37	273.7	500

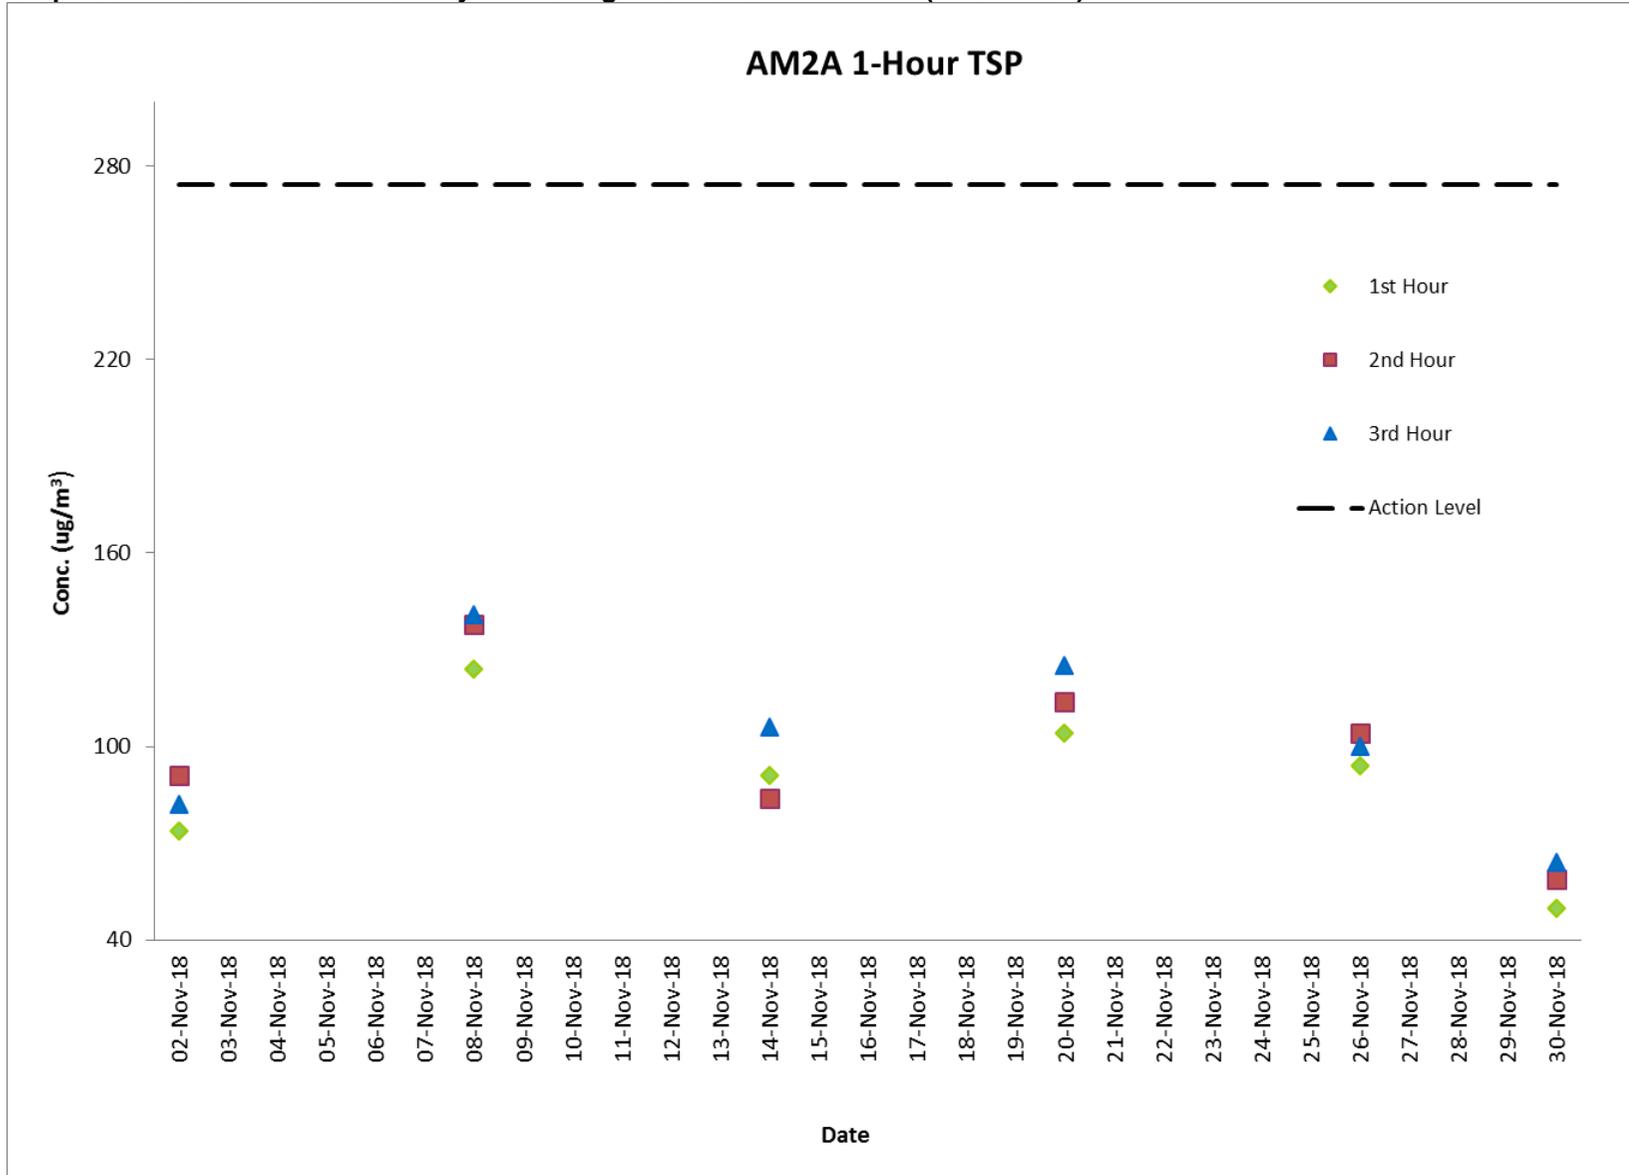
Graphical Presentation of Air Quality Monitoring Result at Station AM2A (1-hour TSP)

Date	Weather Condition	Time	Conc. ($\mu\text{g}/\text{m}^3$)			Action Level ($\mu\text{g}/\text{m}^3$)	Limit Level ($\mu\text{g}/\text{m}^3$)
			1 st Hour	2 nd Hour	3 rd Hour		
02-Nov-18	Cloudy	8:18 - 11:18	74	91	82	274.2	500
08-Nov-18	Fine	8:10 - 11:10	124	138	141	274.2	500
14-Nov-18	Fine	8:05 - 11:05	91	84	106	274.2	500
20-Nov-18	Cloudy	8:05 - 11:05	104	114	125	274.2	500
26-Nov-18	Cloudy	8:05 - 11:05	94	104	100	274.2	500
30-Nov-18	Sunny	8:14 - 11:14	50	59	64	274.2	500

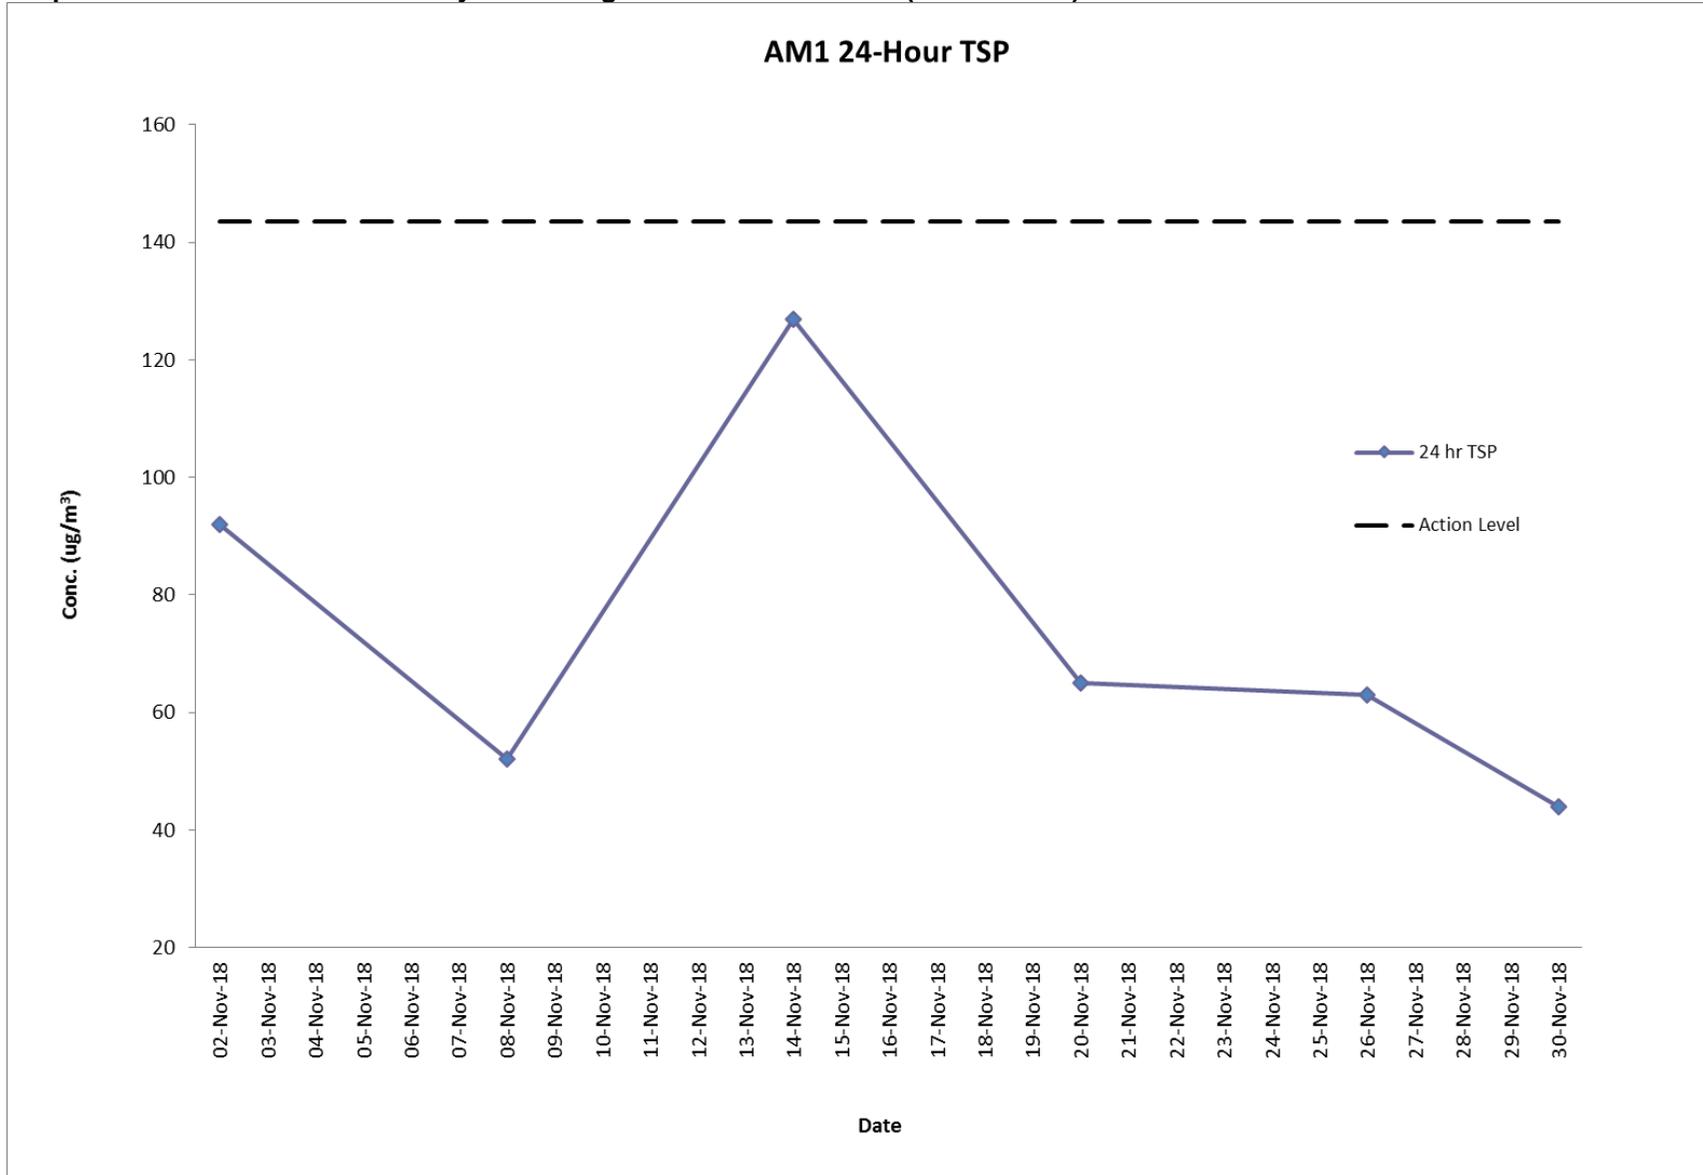
Graphical Presentation of Air Quality Monitoring Result at Station AM1 (24-hour TSP)

Start		Finish		Filter Weight (g)		Elapsed Time Reading		Sampling Time (hrs)	Flow Rate (m ³ /min)			Conc. (µg/m ³)	Weather Condition	Action Level	Limit Level
Date	Time	Date	Time	Initial	Final	Initial	Final		Initial	Final	Average				
02-Nov-18	08:02	03-Nov-18	08:02	2.6613	2.8223	23376.38	23400.38	24	1.22	1.22	1.22	92	Cloudy	143.6	260
08-Nov-18	07:56	09-Nov-18	07:56	2.6933	2.7871	23400.38	23424.38	24	1.26	1.26	1.26	52	Fine	143.6	260
14-Nov-18	07:52	15-Nov-18	07:52	2.6719	2.8957	23424.38	23448.38	24	1.22	1.22	1.22	127	Fine	143.6	260
20-Nov-18	07:48	21-Nov-18	07:48	2.664	2.7798	23448.38	23472.38	24	1.24	1.24	1.24	65	Cloudy	143.6	260
26-Nov-18	07:50	27-Nov-18	07:50	2.6534	2.7642	23472.38	23496.38	24	1.22	1.22	1.22	63	Cloudy	143.6	260
30-Nov-18	08:00	01-Dec-18	08:00	2.644	2.7209	23496.38	23520.38	24	1.22	1.22	1.22	44	Sunny	143.6	260

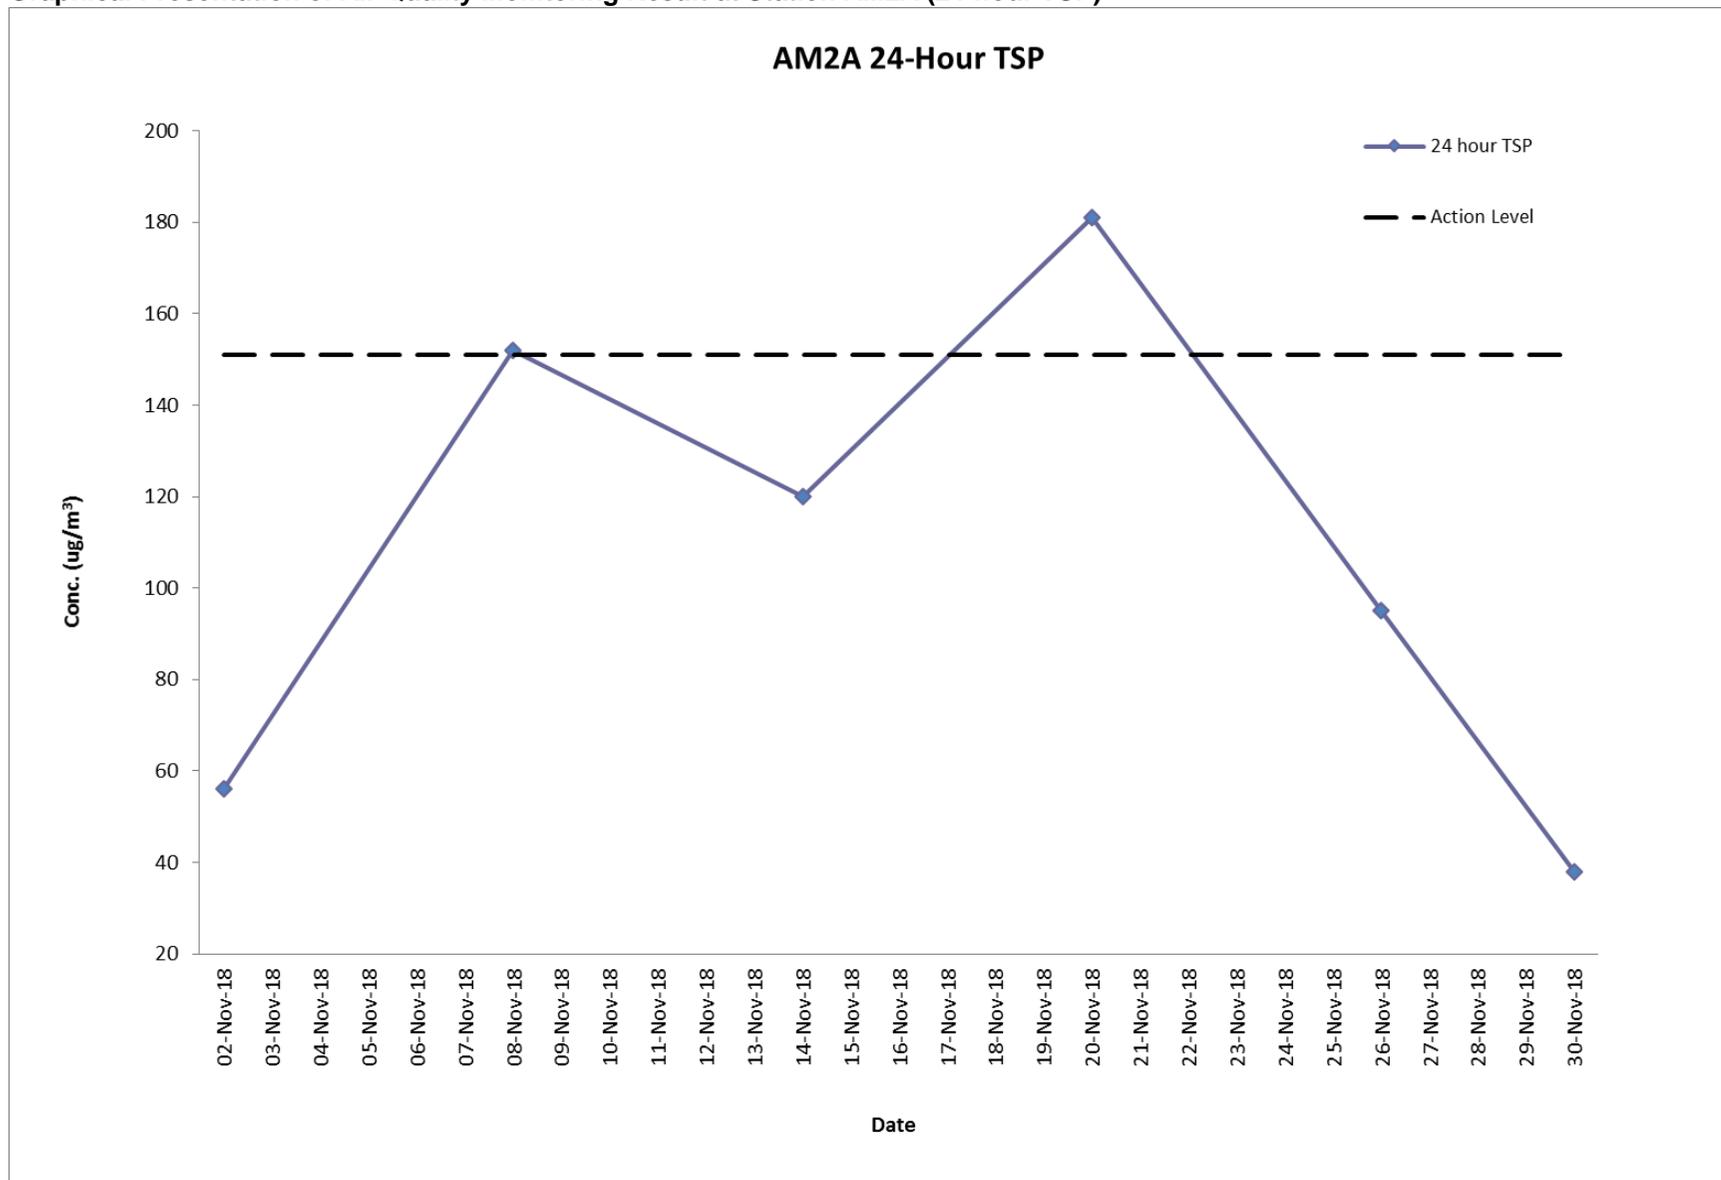
Graphical Presentation of Air Quality Monitoring Result at Station AM2A (24-hour TSP)

Start		Finish		Filter Weight (g)		Elapsed Time Reading		Sampling Time (hrs)	Flow Rate (m ³ /min)			Conc. (µg/m ³)	Weather Condition	Action Level	Limit Level
Date	Time	Date	Time	Initial	Final	Initial	Final		Initial	Final	Average				
02-Nov-18	08:15	03-Nov-18	08:15	2.6846	2.7895	19031.59	19055.59	24	1.29	1.29	1.29	56	Cloudy	151.1	260
08-Nov-18	08:08	09-Nov-18	08:08	2.6924	2.9701	19055.59	19079.59	24	1.27	1.27	1.27	152	Fine	151.1	260
14-Nov-18	08:03	15-Nov-18	08:03	2.6749	2.8950	19079.59	19103.59	24	1.27	1.27	1.27	120	Fine	151.1	260
20-Nov-18	08:02	21-Nov-18	08:02	2.6708	3.0077	19103.59	19127.59	24	1.29	1.29	1.29	181	Cloudy	151.1	260
26-Nov-18	08:02	27-Nov-18	08:02	2.6881	2.8623	19127.05	19151.05	24	1.27	1.27	1.27	95	Cloudy	151.1	260
30-Nov-18	08:12	01-Dec-18	08:12	2.6610	2.7297	19151.05	19175.05	24	1.27	1.27	1.27	38	Sunny	151.1	260

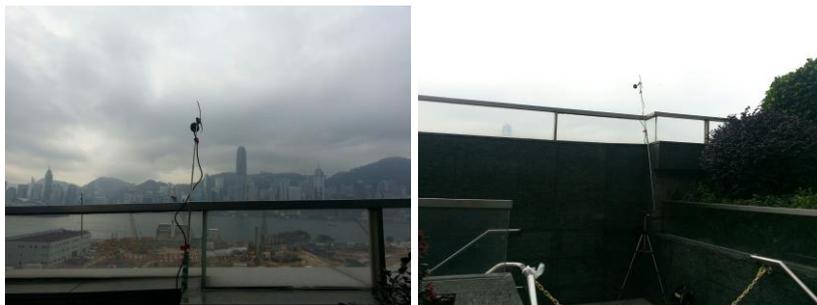
The station set-up of a free-field measurement at Station NM1A.

- The microphone of the Sound Level Meter was set at least 1.2 m above the ground.
- Free Field measurement was made at the monitoring locations.
- The battery condition was checked to ensure the correct functioning of the meter.

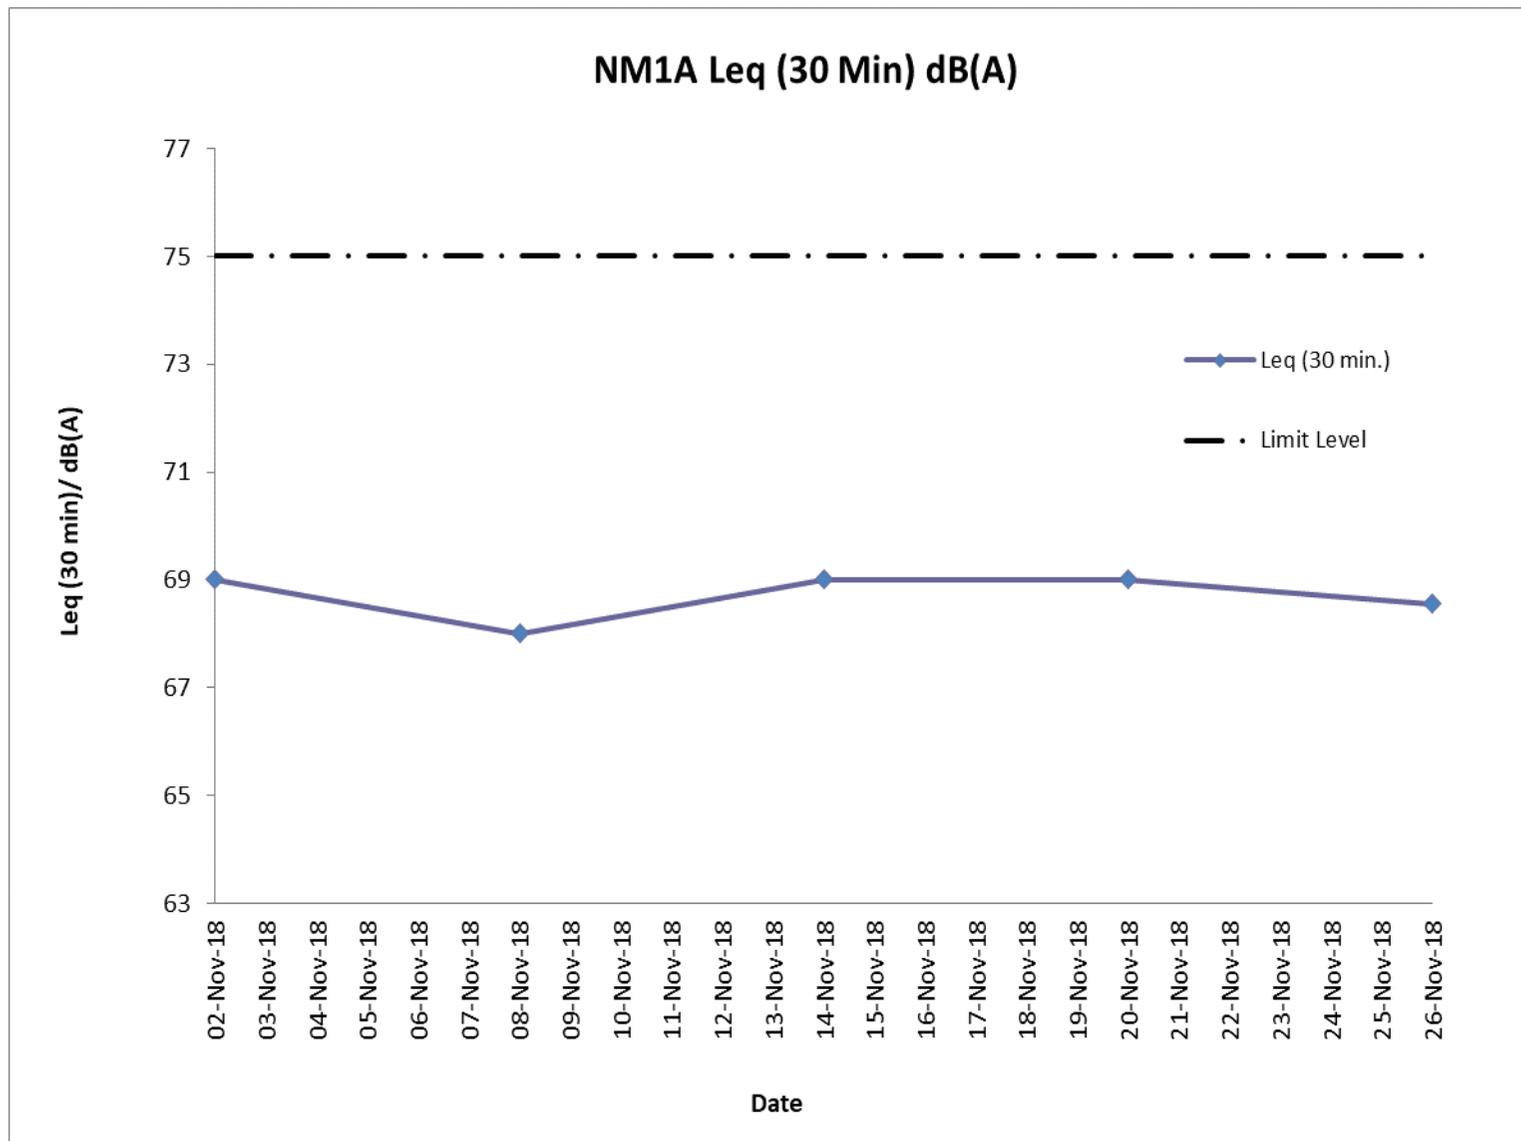
Graphical Presentation Noise Monitoring Result at Station NM1A

Date	Time	Measured L ₁₀ , dB(A)	Measured L ₉₀ , dB(A)	L _{eq} (30 min.)*, dB(A)
2-Nov-18	10:28	68.4	64.7	69
2-Nov-18	10:33	67.9	63.5	
2-Nov-18	10:38	68.5	64.7	
2-Nov-18	10:43	67.4	63.2	
2-Nov-18	10:48	66.7	62.6	
2-Nov-18	10:53	67.5	63.7	
8-Nov-18	10:18	68.7	64.5	68
8-Nov-18	10:23	66.9	62.4	
8-Nov-18	10:28	67.4	63.2	
8-Nov-18	10:33	66.2	62.7	
8-Nov-18	10:38	67.9	63.0	
8-Nov-18	10:43	66.2	62.5	
14-Nov-18	10:15	67.1	63.4	69
14-Nov-18	10:20	66.4	62.5	
14-Nov-18	10:25	68.4	64.1	
14-Nov-18	10:30	67.9	63.5	
14-Nov-18	10:35	68.0	63.6	
14-Nov-18	10:40	68.2	64.2	
20-Nov-18	10:14	68.4	64.7	69
20-Nov-18	10:19	66.5	62.5	
20-Nov-18	10:24	67.4	63.0	
20-Nov-18	10:29	68.5	64.2	
20-Nov-18	10:34	67.6	63.8	
20-Nov-18	10:39	66.7	62.7	
26-Nov-18	10:10	67.2	63.4	69
26-Nov-18	10:15	68.4	64.1	
26-Nov-18	10:20	67.4	63.9	
26-Nov-18	10:25	66.5	62.7	
26-Nov-18	10:30	66.7	62.5	
26-Nov-18	10:35	68.0	64.2
