Development at West Kowloon Cultural District

Monthly Environmental Monitoring and Audit
(EM&A) Report for December 2018

March 2019

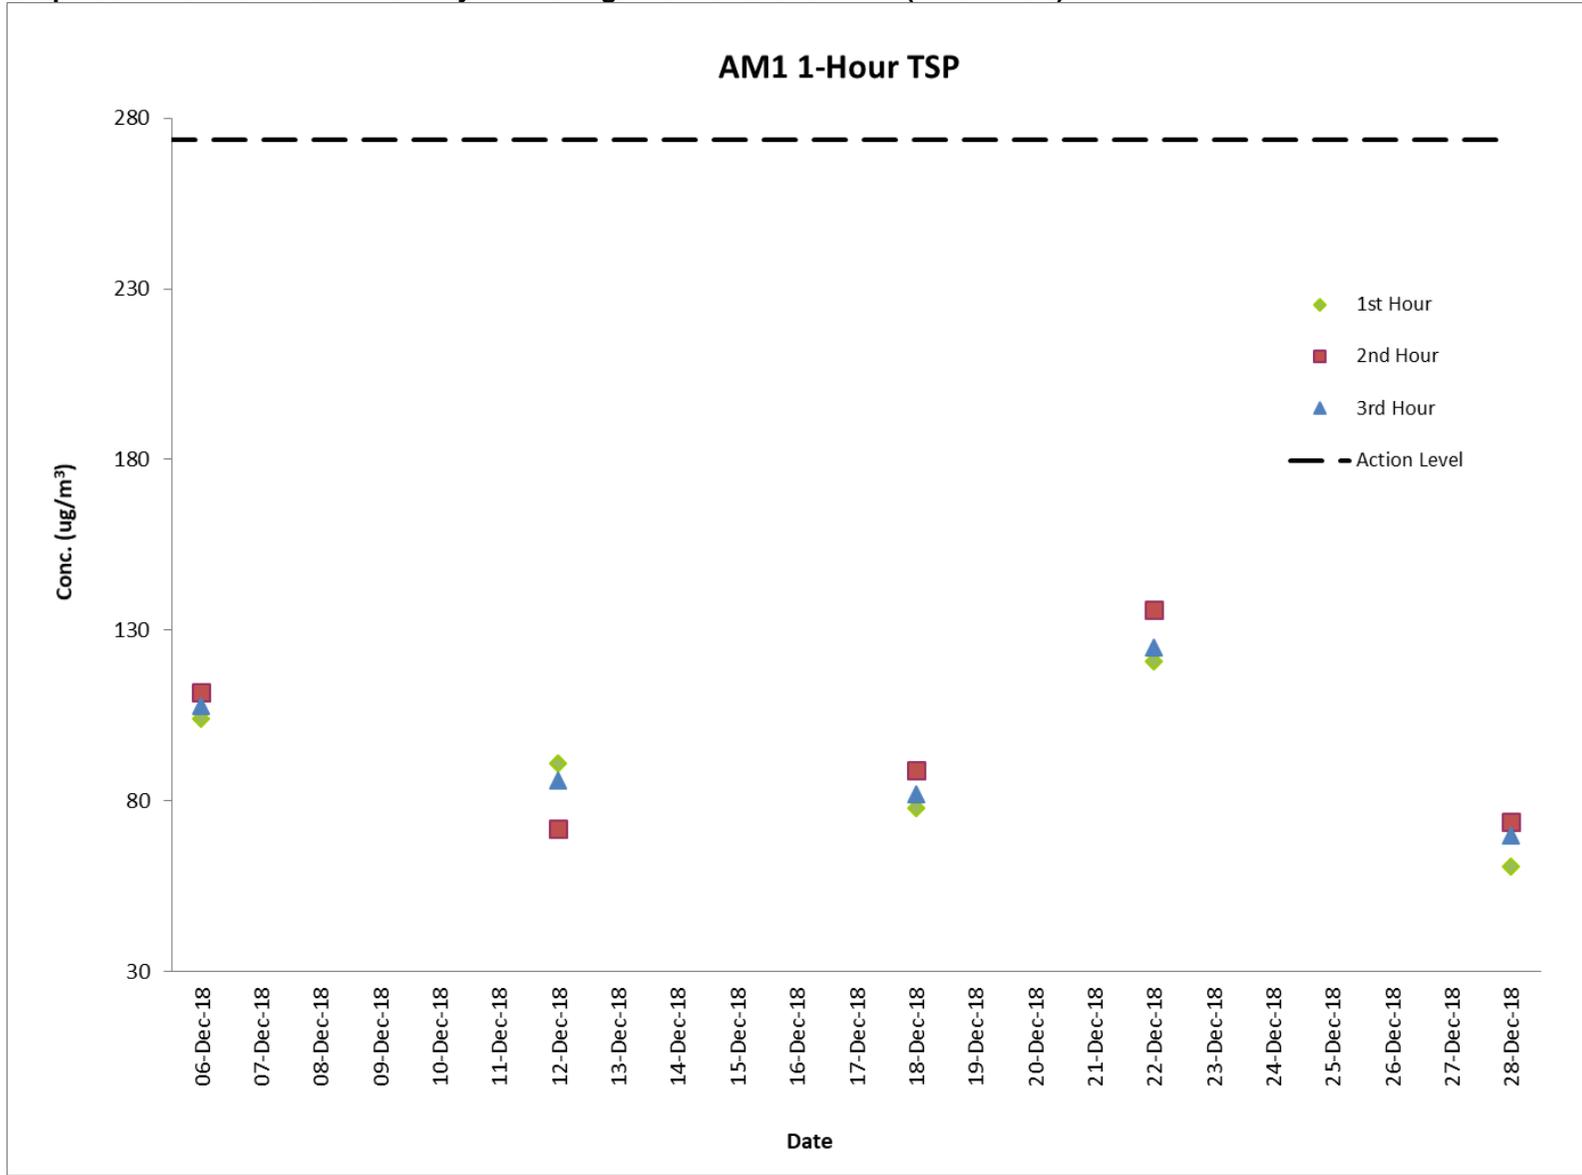
Graphical Presentation of Air Quality Monitoring Result at Station AM1 (1-hour TSP)

Date	Weather Condition	Time	Conc. ($\mu\text{g}/\text{m}^3$)			Action Level ($\mu\text{g}/\text{m}^3$)	Limit Level ($\mu\text{g}/\text{m}^3$)
			1 st Hour	2 nd Hour	3 rd Hour		
6-Dec-18	Cloudy	8:03 - 11:03	104	112	108	273.7	500
12-Dec-18	Cloudy	7:52 - 10:52	91	72	86	273.7	500
18-Dec-18	Sunny	7:50 - 10:50	78	89	82	273.7	500
22-Dec-18	Sunny	8:02 - 11:02	121	136	125	273.7	500
28-Dec-18	Sunny	7:50 - 10:50	61	74	70	273.7	500

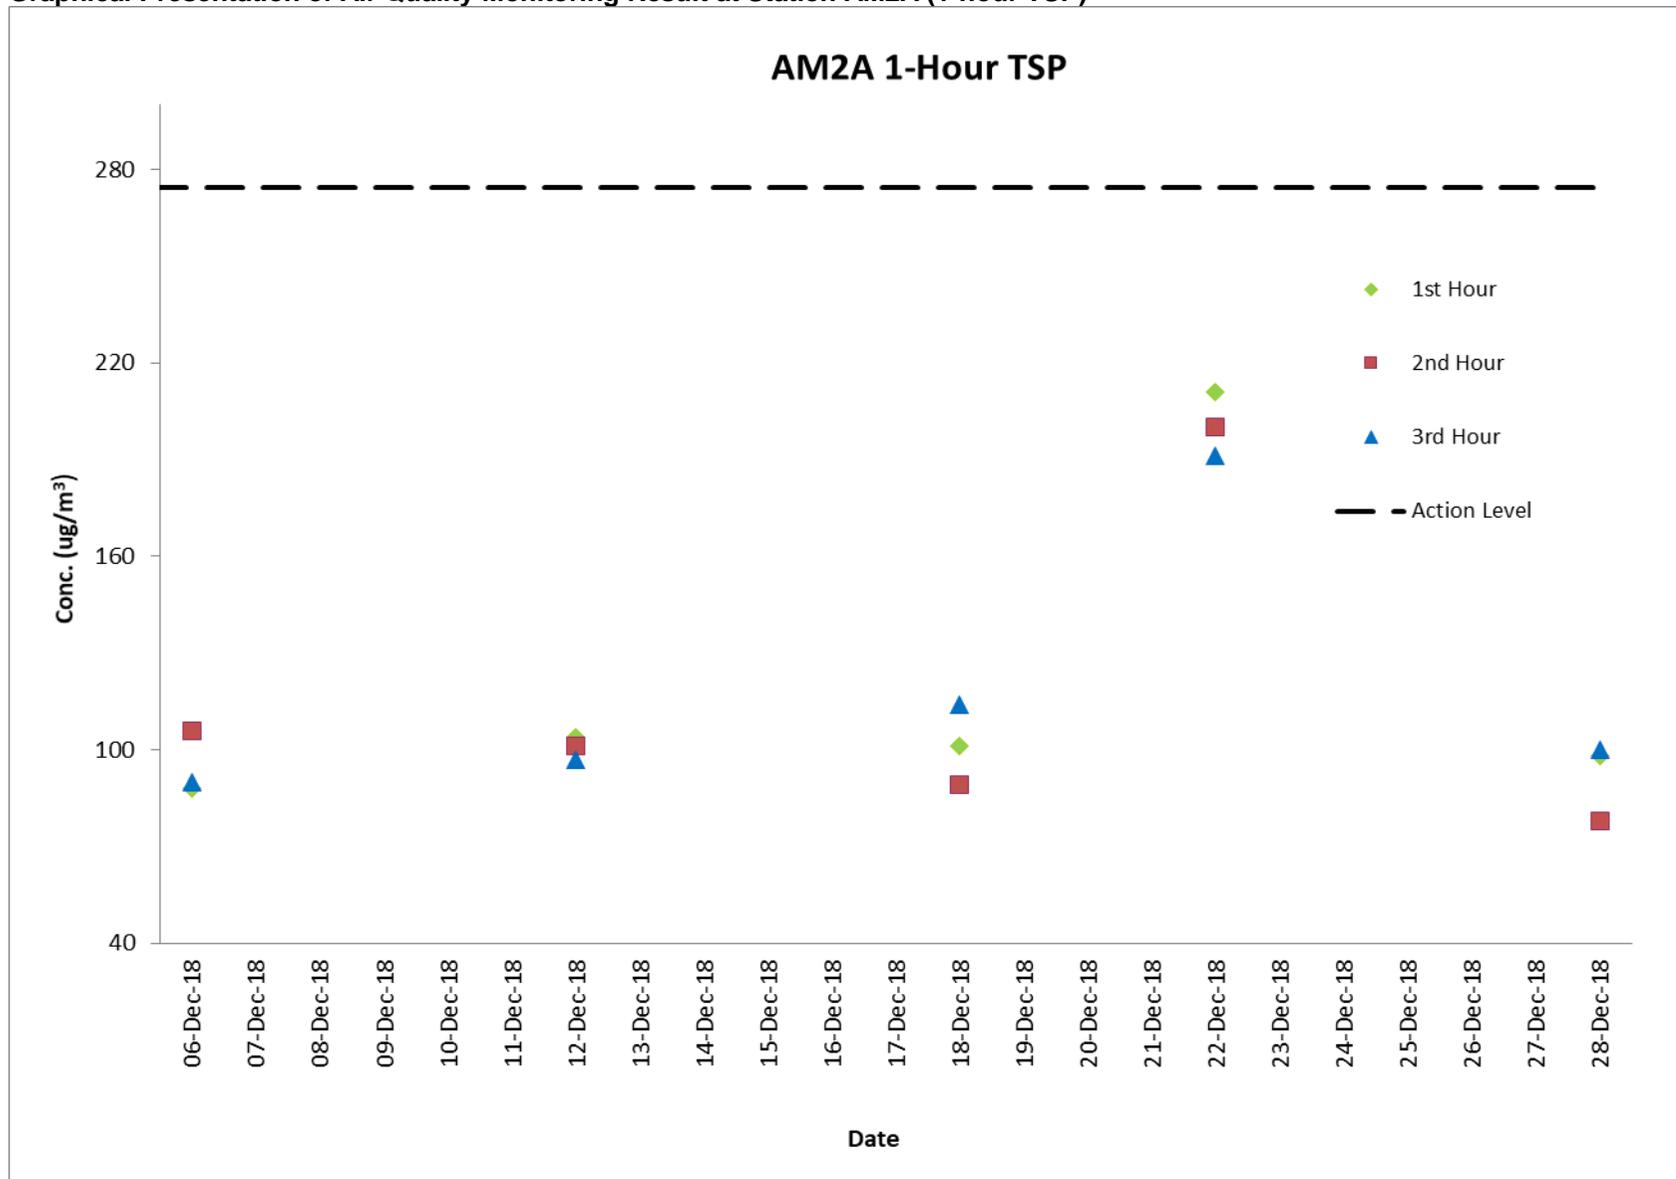
Graphical Presentation of Air Quality Monitoring Result at Station AM2A (1-hour TSP)

Date	Weather Condition	Time	Conc. ($\mu\text{g}/\text{m}^3$)			Action Level ($\mu\text{g}/\text{m}^3$)	Limit Level ($\mu\text{g}/\text{m}^3$)
			1 st Hour	2 nd Hour	3 rd Hour		
6-Dec-18	Cloudy	8:15 - 11:15	88	106	90	274.2	500
12-Dec-18	Cloudy	8:05 - 11:05	104	101	97	274.2	500
18-Dec-18	Sunny	8:04 - 11:04	101	89	114	274.2	500
22-Dec-18	Sunny	8:14 - 11:14	211	200	191	274.2	500
28-Dec-18	Sunny	8:05 - 11:05	98	78	100	274.2	500

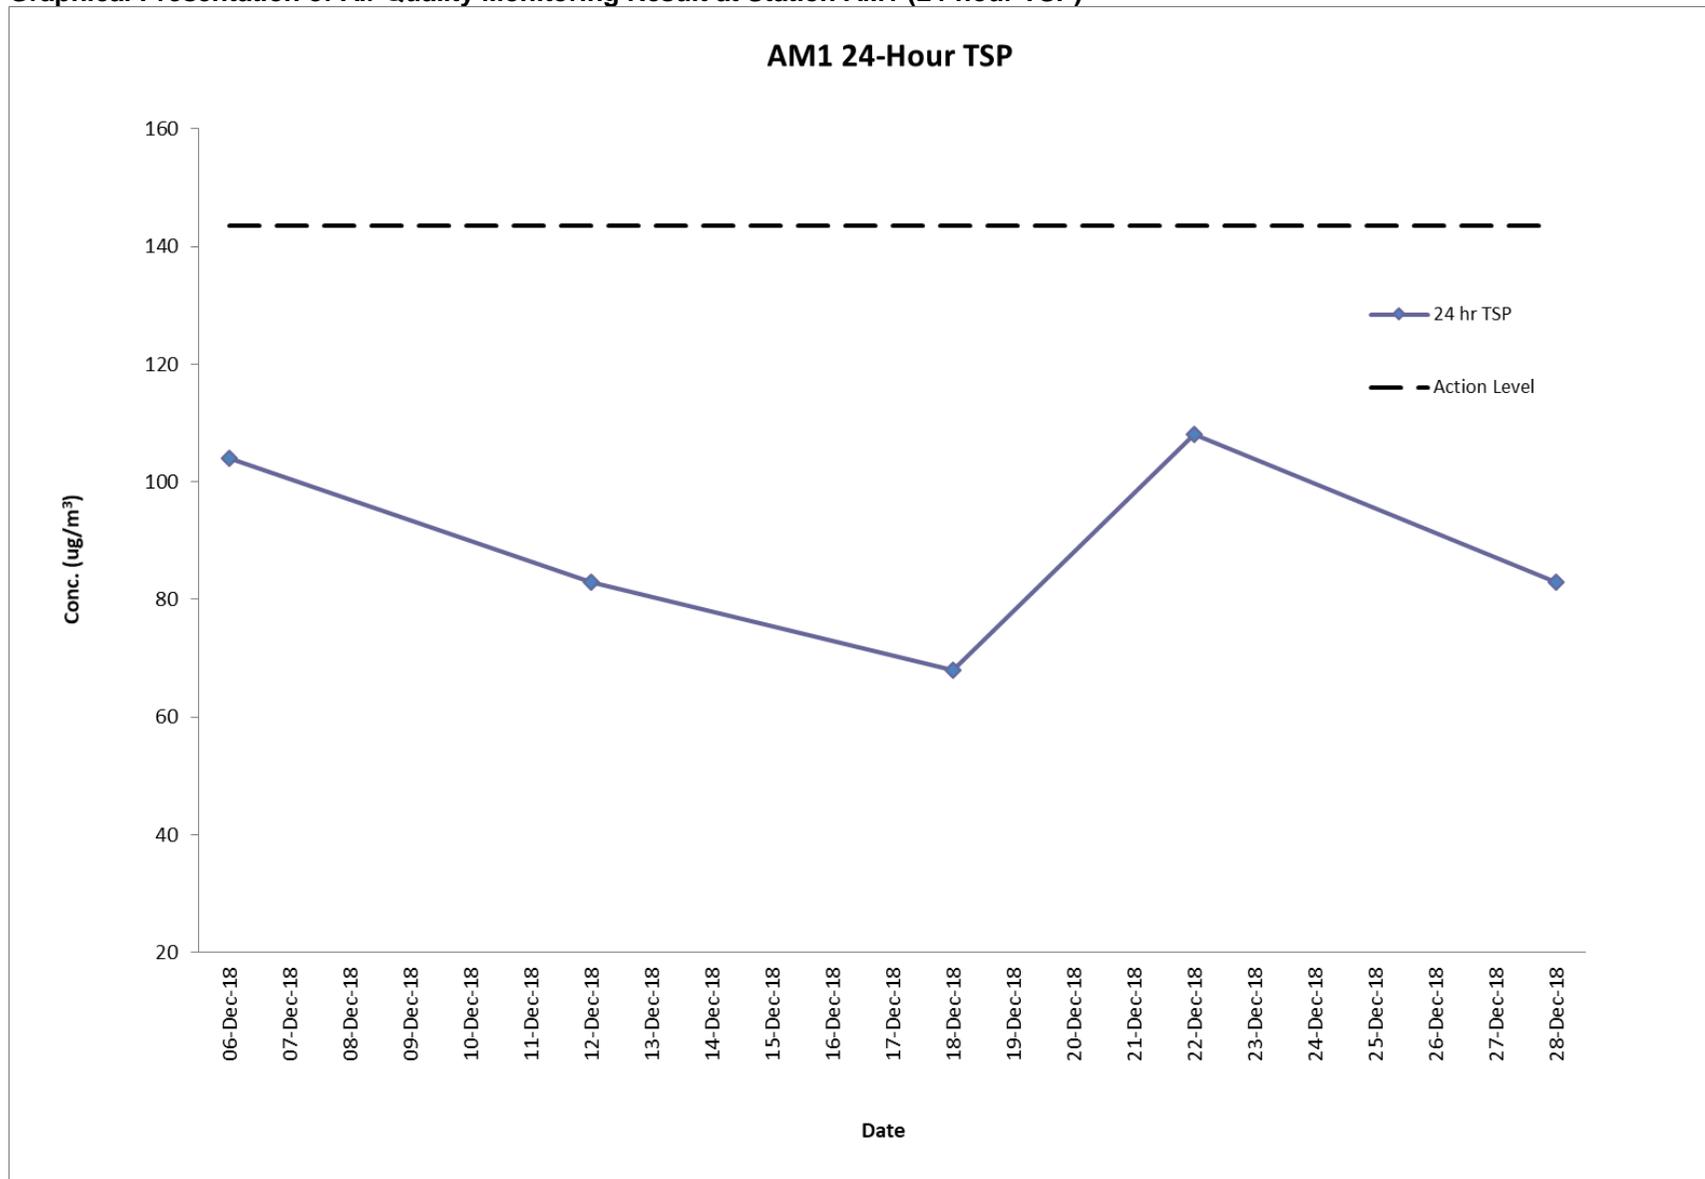
Graphical Presentation of Air Quality Monitoring Result at Station AM1 (24-hour TSP)

Start		Finish		Filter Weight (g)		Elapsed Time Reading		Sampling Time (hrs)	Flow Rate (m ³ /min)			Conc. (µg/m ³)	Weather Condition	Action Level	Limit Level
Date	Time	Date	Time	Initial	Final	Initial	Final		Initial	Final	Average				
6-Dec-18	8:05	7-Dec-18	8:05	2.7015	2.8939	23520.38	23544.38	24	1.28	1.28	1.28	104	Cloudy	143.6	260
12-Dec-18	7:50	13-Dec-18	7:50	2.6809	2.8337	23544.38	23568.38	24	1.28	1.28	1.28	83	Cloudy	143.6	260
18-Dec-18	7:52	19-Dec-18	7:52	2.6950	2.8207	23568.38	23592.38	24	1.28	1.28	1.28	68	Sunny	143.6	260
22-Dec-18	8:00	23-Dec-18	8:00	2.6787	2.8777	23592.38	23616.38	24	1.28	1.28	1.28	108	Sunny	143.6	260
28-Dec-18	7:52	29-Dec-18	7:52	2.6697	2.8226	23616.38	23640.38	24	1.28	1.28	1.28	83	Sunny	143.6	260

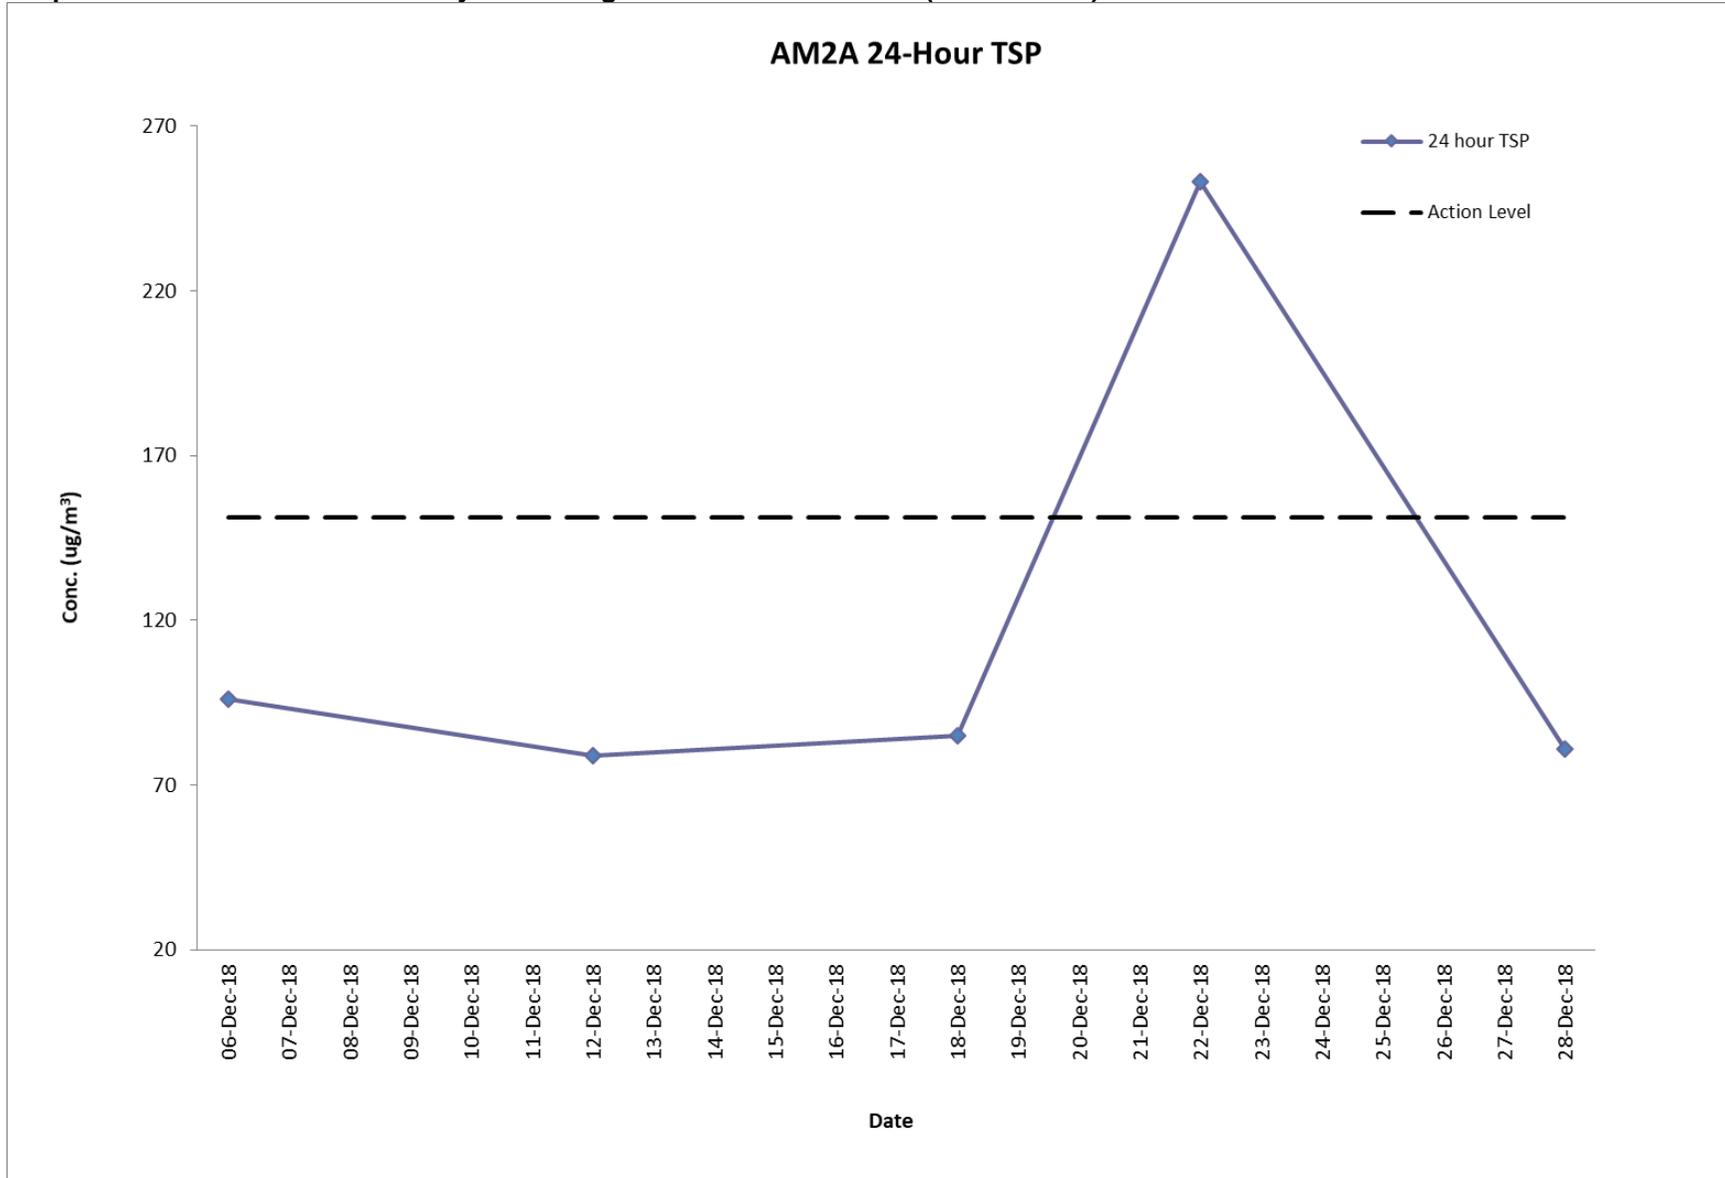
Graphical Presentation of Air Quality Monitoring Result at Station AM2A (24-hour TSP)

On 22 December 2018, an exceedance of 24-hr TSP was recorded at monitoring station AM2A. The measured level was at 253 $\mu\text{g}/\text{m}^3$ while the action level is at 151.1 $\mu\text{g}/\text{m}^3$. The contractors, IEC and ER were informed of the exceedance. Investigation has been carried out and it is revealed that the contractors of M+ Museum and Lyric Theatre Complex have already implemented dust mitigation measures to reduce the dust impact from their construction works. Uncovered debris was found on 19 Dec 2018 during weekly site inspection, but it was no longer found on site on 22 Dec 2018. Therefore, it is deemed that the contribution from the uncovered debris to the exceedance was minor. Moreover, it should be noted that there have been construction works carried out by another contractor at Austin Road West, which may also have contributed to the 24-hr TSP exceedance during the concerned monitoring period. Nonetheless, the contractors were reminded to strengthen the implementation of dust control measures including providing regular water spraying for dust generating construction work, such as excavation and breaking works; fully covering all dusty materials with impervious sheeting; provide wheel washing for vehicles to remove any dusty material before leaving the site; ensuring the mechanical cover of dump trucks are properly closed for transportation of dusty material; and keeping the haul road and site entrances wet by spraying water with hose.

Start		Finish		Filter Weight (g)		Elapsed Time Reading		Sampling Time (hrs)	Flow Rate (m ³ /min)			Conc. (µg/m ³)	Weather Condition	Action Level	Limit Level
Date	Time	Date	Time	Initial	Final	Initial	Final		Initial	Final	Average				
6-Dec-18	8:13	7-Dec-18	8:13	2.6569	2.8310	19175.05	19199.05	24	1.26	1.26	1.26	96	Cloudy	151.1	260
12-Dec-18	8:02	13-Dec-18	8:02	2.6758	2.8219	19199.05	19223.05	24	1.28	1.28	1.28	79	Cloudy	151.1	260
18-Dec-18	8:02	19-Dec-18	8:02	2.7072	2.8683	19223.05	19247.05	24	1.31	1.31	1.31	85	Sunny	151.1	260
22-Dec-18	8:12	23-Dec-18	8:12	2.695	3.1721	19247.05	19271.05	24	1.31	1.31	1.31	253	Sunny	151.1	260
28-Dec-18	8:02	29-Dec-18	8:02	2.6816	2.8306	19271.05	19295.05	24	1.28	1.28	1.28	81	Sunny	151.1	260

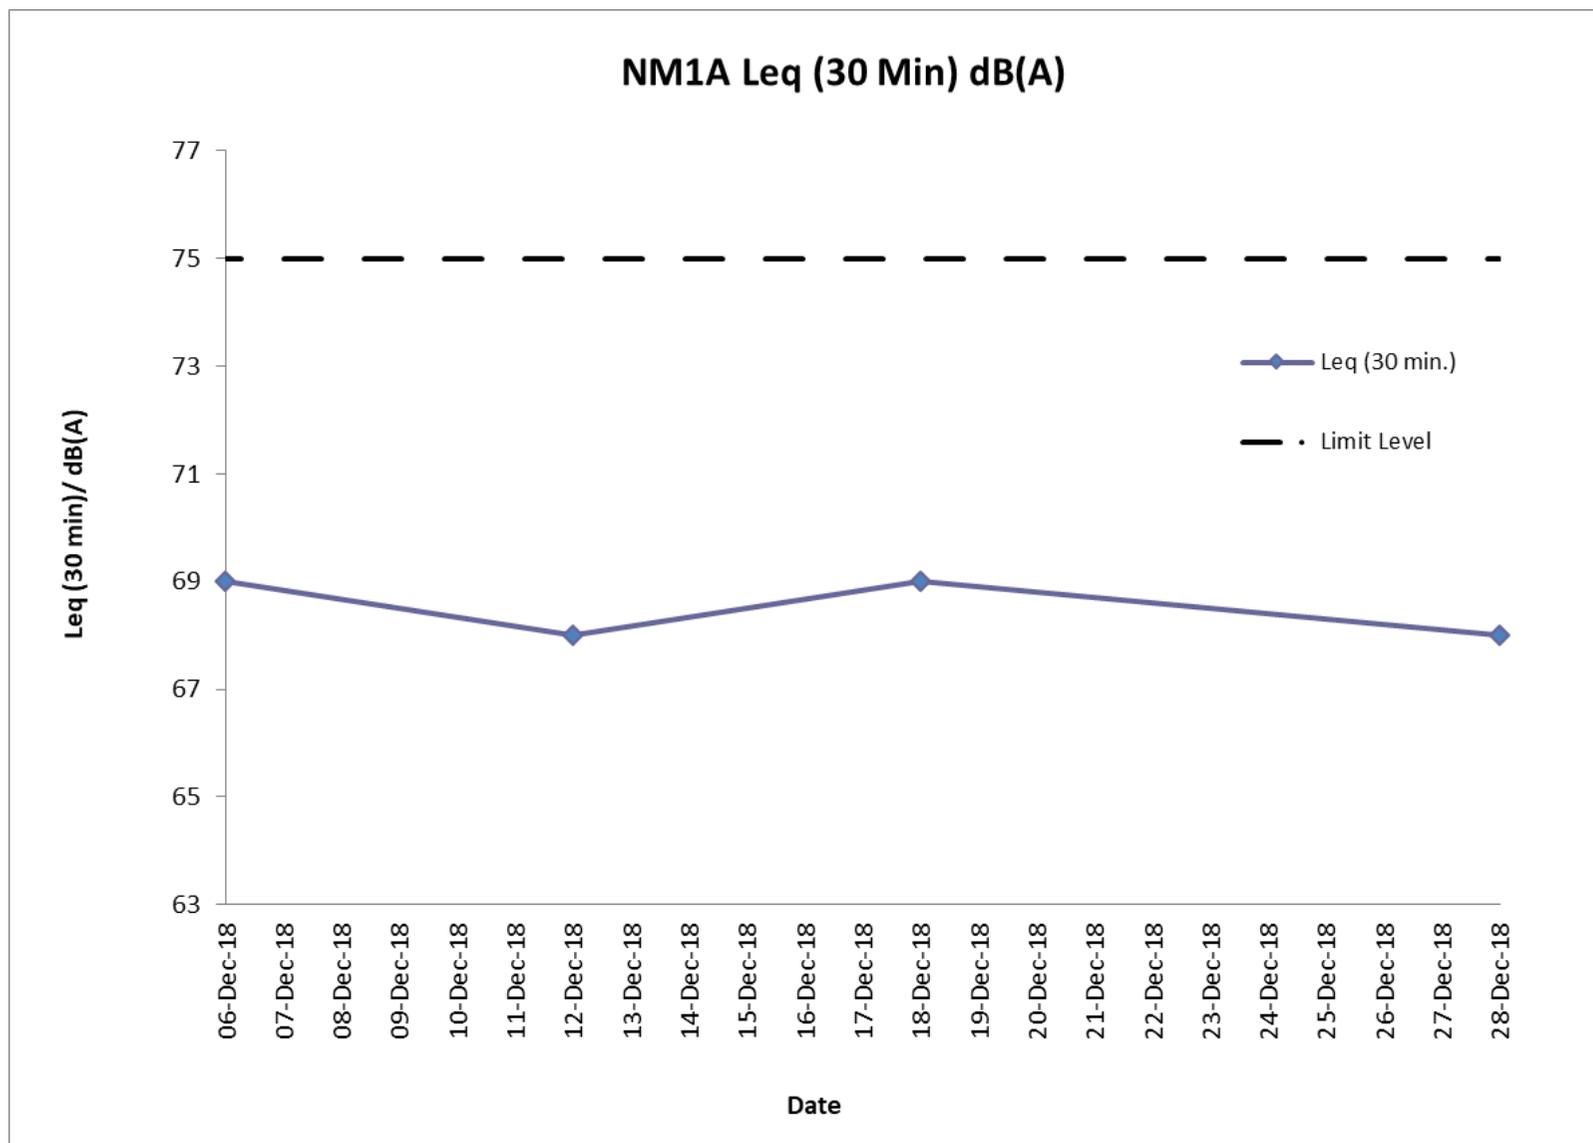
Graphical Presentation Noise Monitoring Result at Station NM1A

Date	Time	Measured L ₁₀ , dB(A)	Measured L ₉₀ , dB(A)	L _{eq} (30 min.)*, dB(A)
6-Dec-18	10:20	67.5	63.4	69
6-Dec-18	10:25	66.7	62.5	
6-Dec-18	10:30	68.4	64.7	
6-Dec-18	10:35	67.5	63.2	
6-Dec-18	10:40	66.7	62.5	
6-Dec-18	10:45	68.4	64.7	
12-Dec-18	10:10	67.4	63.1	68
12-Dec-18	10:15	68.5	64.0	
12-Dec-18	10:20	66.7	62.4	
12-Dec-18	10:25	66.9	62.7	
12-Dec-18	10:30	67.5	63.4	
12-Dec-18	10:35	66.4	62.7	
18-Dec-18	10:15	68.1	64.4	69
18-Dec-18	10:20	67.9	63.5	
18-Dec-18	10:25	66.4	62.6	
18-Dec-18	10:30	67.0	63.7	
18-Dec-18	10:35	68.2	64.7	
18-Dec-18	10:40	67.9	63.5	
28-Dec-18	10:10	67.2	63.4	68
28-Dec-18	10:15	66.8	62.6	
28-Dec-18	10:20	68.7	64.3	
28-Dec-18	10:25	68.9	64.7	
28-Dec-18	10:30	66.7	62.5	
28-Dec-18	10:35	66.5	62.6

* +3dB (A) correction was applied to free-field measurement.
