Development at West Kowloon Cultural District

Monthly Environmental Monitoring and Audit
(EM&A) Report for May 2019

June 2019

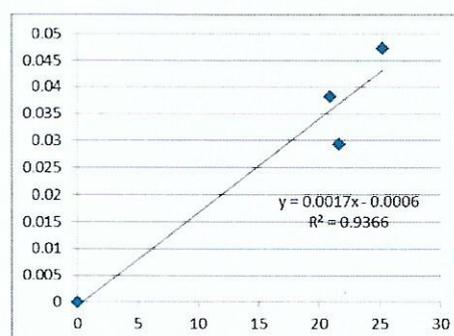
Linear Regression of Y or X

Slope (K-factor): 0.0017
 Correlation Coefficient 0.9678
 Date of Issue 28 December 2018

- Strong** Correlation ($R > 0.8$)
 - Factor 0.0017 should be applied for TSP monitoring
- *if $R < 0.5$, repair or re-verification is required for the equipment

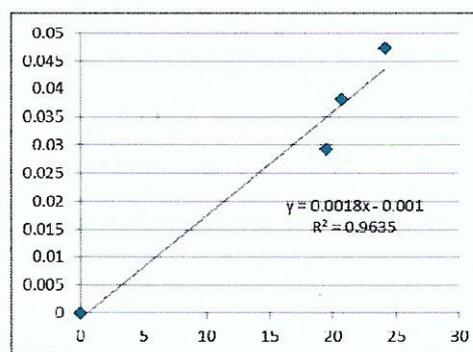
Linear Regression of Y or X

Slope (K-factor): 0.0018
 Correlation Coefficient 0.9816
 Date of Issue 28 December 2018

- Strong** Correlation ($R > 0.8$)
 - Factor 0.0018 should be applied for TSP monitoring
- *If $R < 0.5$, repair or re-verification is required for the equipment

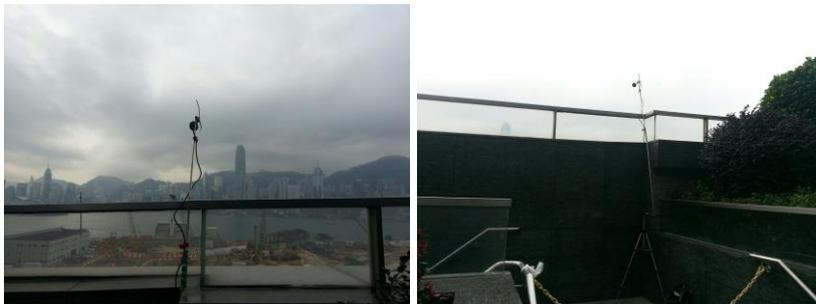
The station set-up of a free-field measurement at Station NM1A
