Development at West Kowloon Cultural District

Monthly Environmental Monitoring and Audit
(EM&A) Report for August 2019

September 2019

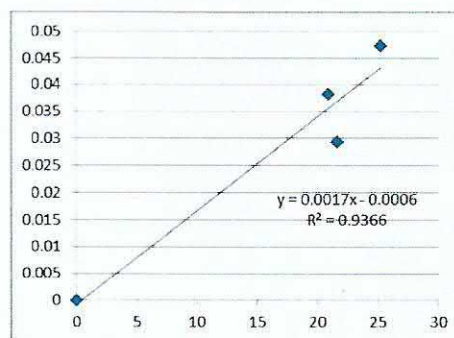
Linear Regression of Y or X

Slope (K-factor): 0.0017
Correlation Coefficient 0.9678
Date of Issue 28 December 2018

1. **Strong** Correlation ($R > 0.8$)
2. Factor 0.0017 should be applied for TSP monitoring

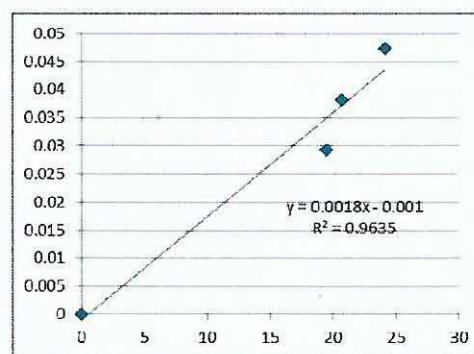
Linear Regression of Y or X

Slope (K-factor): 0.0018
Correlation Coefficient 0.9816
Date of Issue 28 December 2018

1. **Strong** Correlation ($R > 0.8$)
2. Factor 0.0018 should be applied for TSP monitoring

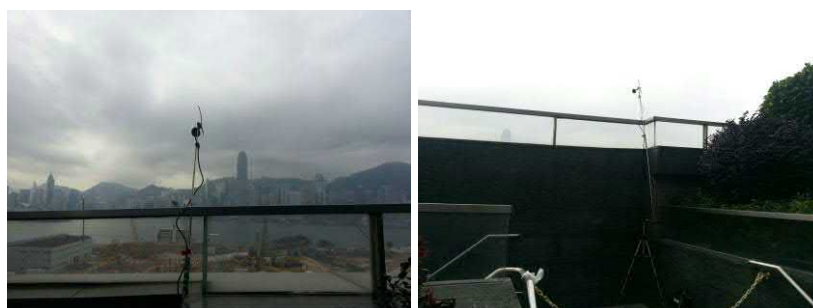
* +3dB (A) correction was applied to free-field measurement.

The station set-up of a free-field measurement at Station NM1A
