Development at West Kowloon Cultural District

Monthly Environmental Monitoring and Audit
(EM&A) Report for February 2020

3 March 2020

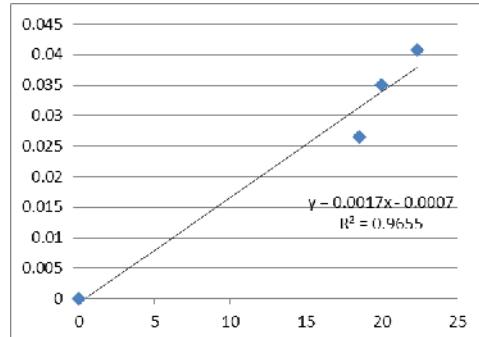
Linear Regression of Y or X

Slope (K-factor): 0.0017
Correlation Coefficient: 0.9826
Date of Issue: 7 March 2019

- Strong Correlation ($R>0.8$)
- Factor 0.0017 should be applied for TSP monitoring

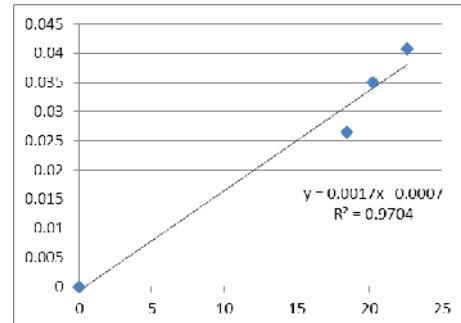
Linear Regression of Y or X

Slope (K-factor): 0.0017
Correlation Coefficient 0.9851
Date of Issue 7 March 2019

- Strong Correlation ($R>0.8$)
- Factor 0.0017 should be applied for TSP monitoring

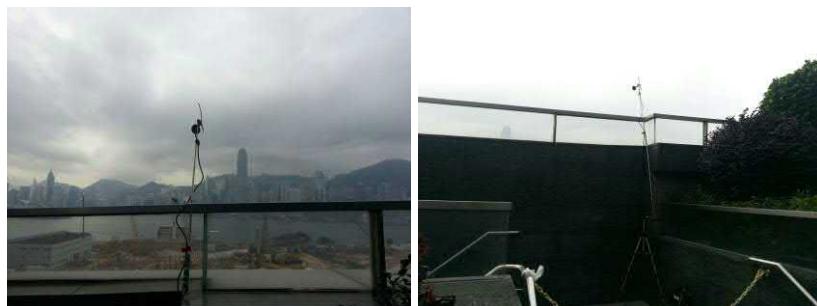
The station set-up of a free-field measurement at Station NM1A.
