# **Development at West Kowloon Cultural District**

Monthly Environmental Monitoring and Audit  
(EM&A) Report for June 2020

6 July 2020

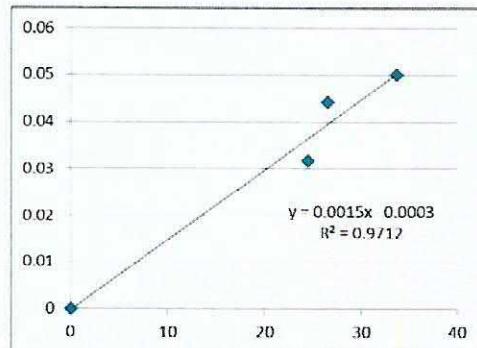
### **Linear Regression of Y or X**

Slope (K-factor): 0.0015  
 Correlation Coefficient 0.9855  
 Date of Issue 13 December 2019

1. Strong Correlation ( $R>0.8$ )
2. Factor 0.0015 should be applied for TSP monitoring

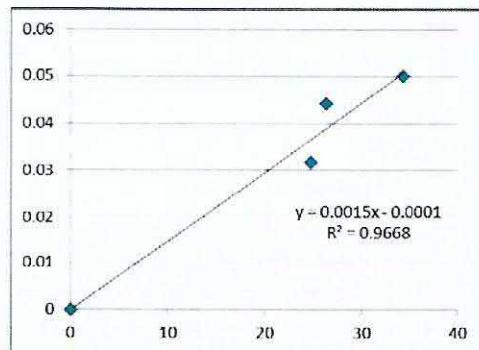
### Linear Regression of Y or X

Slope (K-factor): 0.0015  
Correlation Coefficient 0.9833  
Date of Issue 13 December 2019

- Strong Correlation ( $R>0.8$ )
- Factor 0.0015 should be applied for TSP monitoring

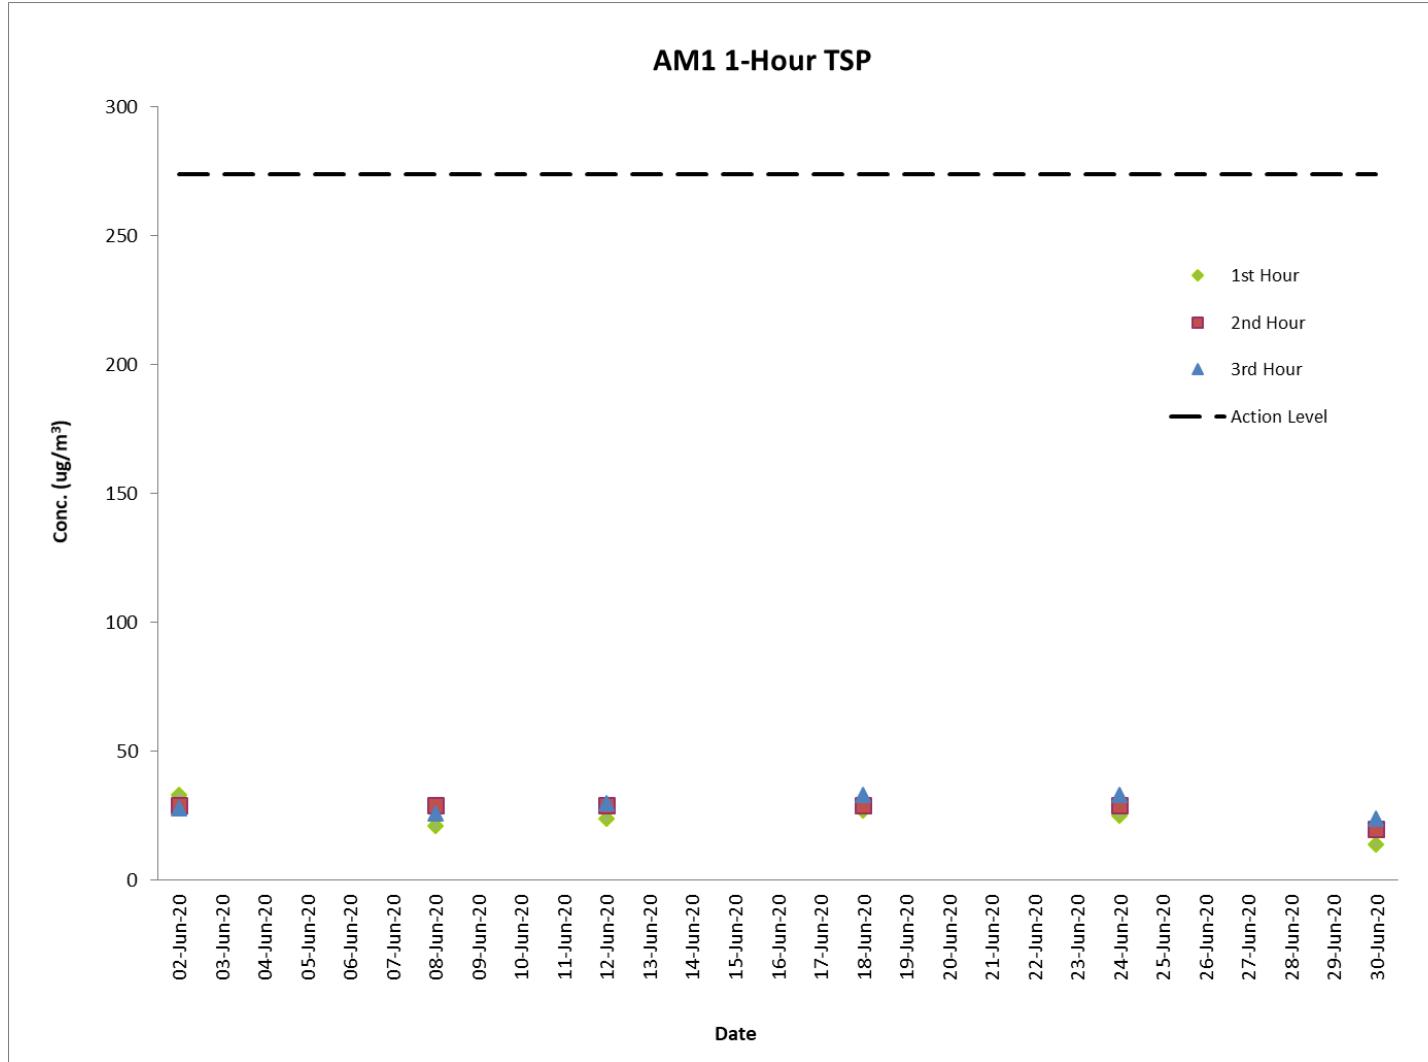
### Graphical Presentation of Air Quality Monitoring Result at Station AM1 (1-hour TSP)

Date	Weather Condition	Time	Conc. ( $\mu\text{g}/\text{m}^3$ )			Action Level ( $\mu\text{g}/\text{m}^3$ )	Limit Level ( $\mu\text{g}/\text{m}^3$ )
			1 <sup>st</sup> Hour	2 <sup>nd</sup> Hour	3 <sup>rd</sup> Hour		
02-Jun-20	Fine	8:12 - 11:12	33	29	28	273.7	500
08-Jun-20	Rainy	13:22 - 16:22	21	29	26	273.7	500
12-Jun-20	Sunny	13:27 - 16:27	24	29	30	273.7	500
18-Jun-20	Fine	13:15 - 16:15	27	29	33	273.7	500
24-Jun-20	Cloudy	8:14 - 11:14	25	29	33	273.7	500
30-Jun-20	Fine	8:17 - 11:17	14	20	24	273.7	500

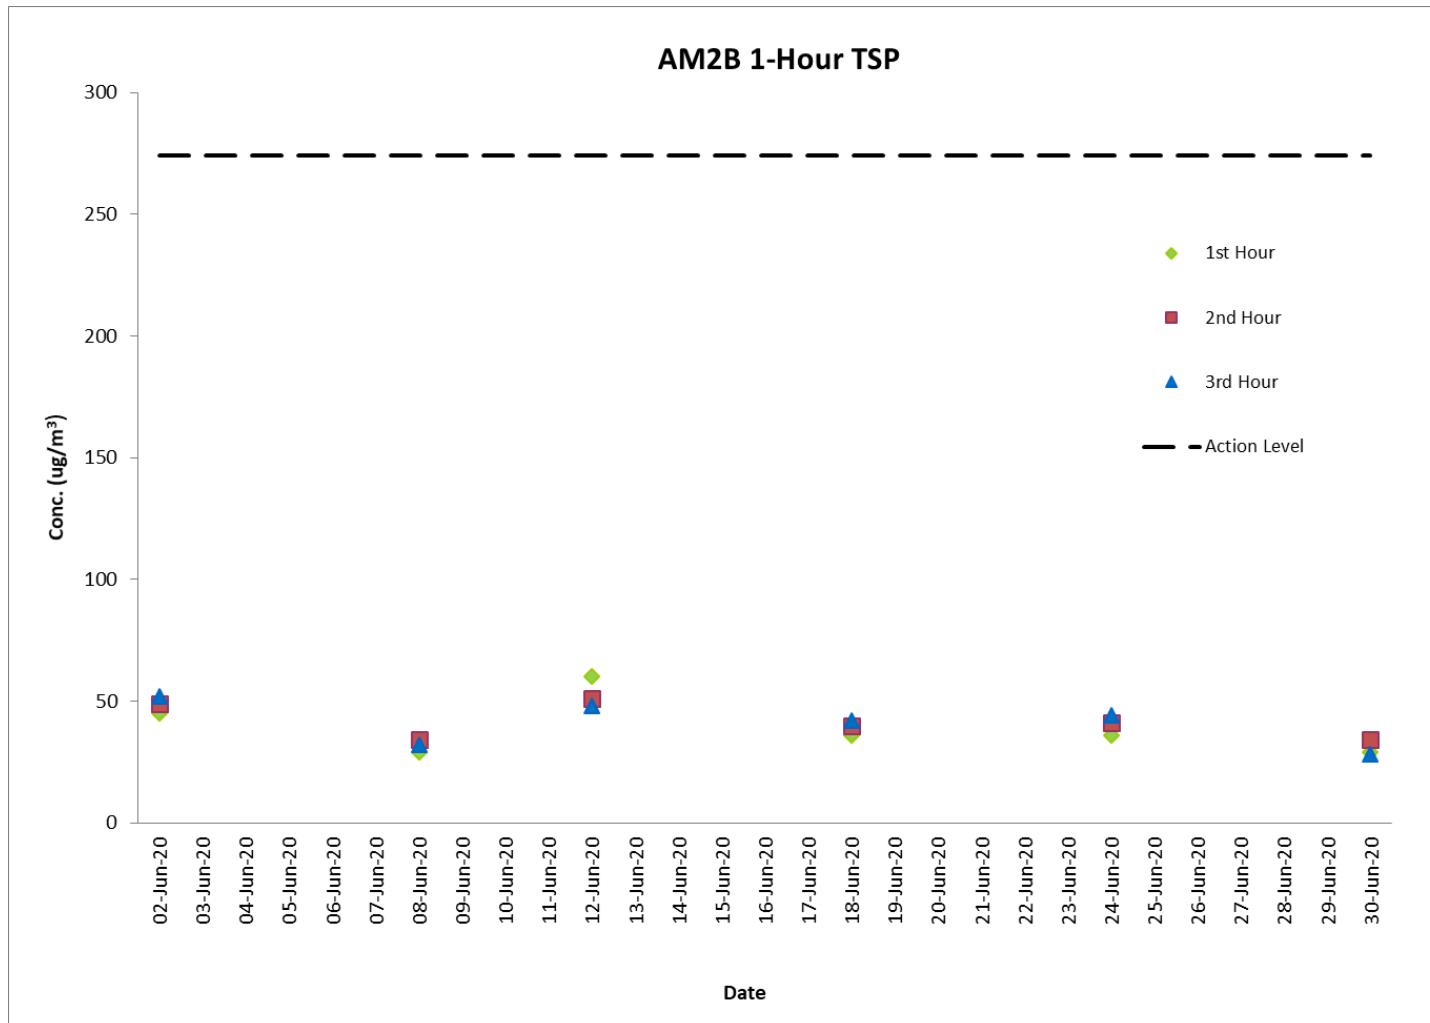
### Graphical Presentation of Air Quality Monitoring Result at Station AM2B (1-hour TSP)

Date	Weather Condition	Time	Conc. ( $\mu\text{g}/\text{m}^3$ )			Action Level ( $\mu\text{g}/\text{m}^3$ )	Limit Level ( $\mu\text{g}/\text{m}^3$ )
			1 <sup>st</sup> Hour	2 <sup>nd</sup> Hour	3 <sup>rd</sup> Hour		
02-Jun-20	Fine	8:26 - 11:26	45	49	52	274.2	500
08-Jun-20	Rainy	13:37 - 16:37	29	34	32	274.2	500
12-Jun-20	Sunny	13:42 - 16:42	60	51	48	274.2	500
18-Jun-20	Fine	13:30 - 16:30	36	40	42	274.2	500
24-Jun-20	Cloudy	8:30 - 11:30	36	41	44	274.2	500
30-Jun-20	Fine	8:32 - 11:32	29	34	28	274.2	500

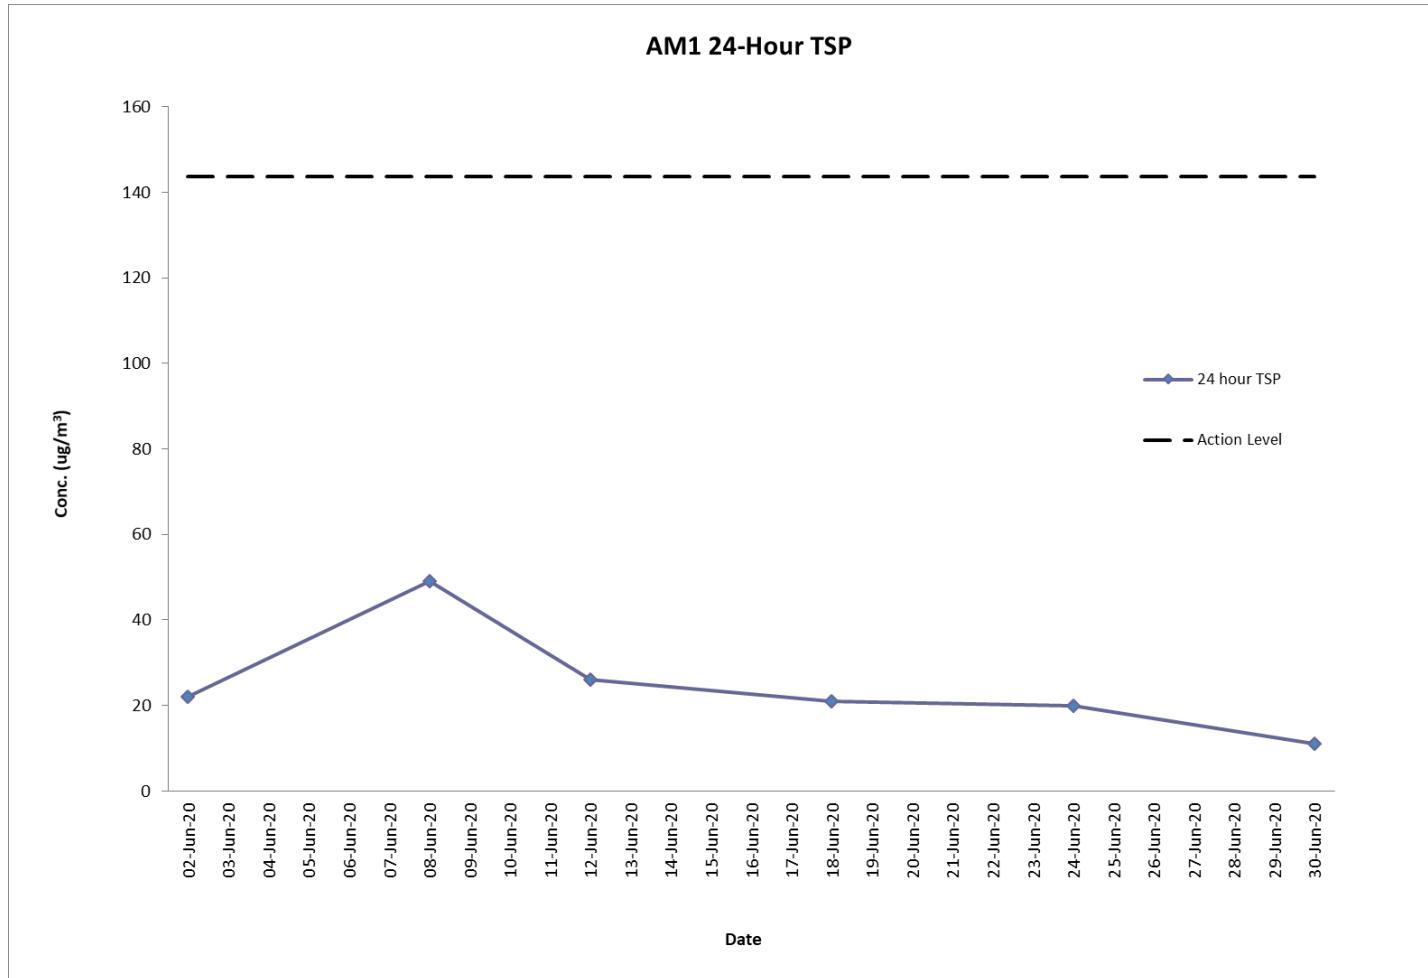
### Graphical Presentation of Air Quality Monitoring Result at Station AM1 (24-hour TSP)

Start		Finish		Filter Weight (g)		Elapsed Time Reading		Sampling Time (hrs)	Flow Rate (m <sup>3</sup> /min)			Conc. (µg/m <sup>3</sup> )	Weather Condition	Action Level	Limit Level
Date	Time	Date	Time	Initial	Final	Initial	Final		Initial	Final	Average				
02-Jun-20	8:10	03-Jun-20	8:10	2.713	2.7508	21872.38	21896.38	24	1.19	1.19	1.19	22	Fine	143.6	260
08-Jun-20	8:20	09-Jun-20	8:20	2.7022	2.7857	21451.05	21475.05	24	1.19	1.19	1.19	49	Rainy	143.6	260
12-Jun-20	8:25	13-Jun-20	8:25	2.7049	2.7497	21920.38	21944.38	24	1.19	1.19	1.19	26	Sunny	143.6	260
18-Jun-20	8:12	19-Jun-20	8:12	2.7807	2.8167	21944.38	21968.38	24	1.19	1.19	1.19	21	Fine	143.6	260
24-Jun-20	8:12	25-Jun-20	8:12	2.7764	2.8101	21968.38	21992.38	24	1.19	1.19	1.19	20	Cloudy	143.6	260
30-Jun-20	8:15	01-Jul-20	8:15	2.7052	2.7233	21992.38	22016.38	24	1.19	1.19	1.19	11	Fine	143.6	260

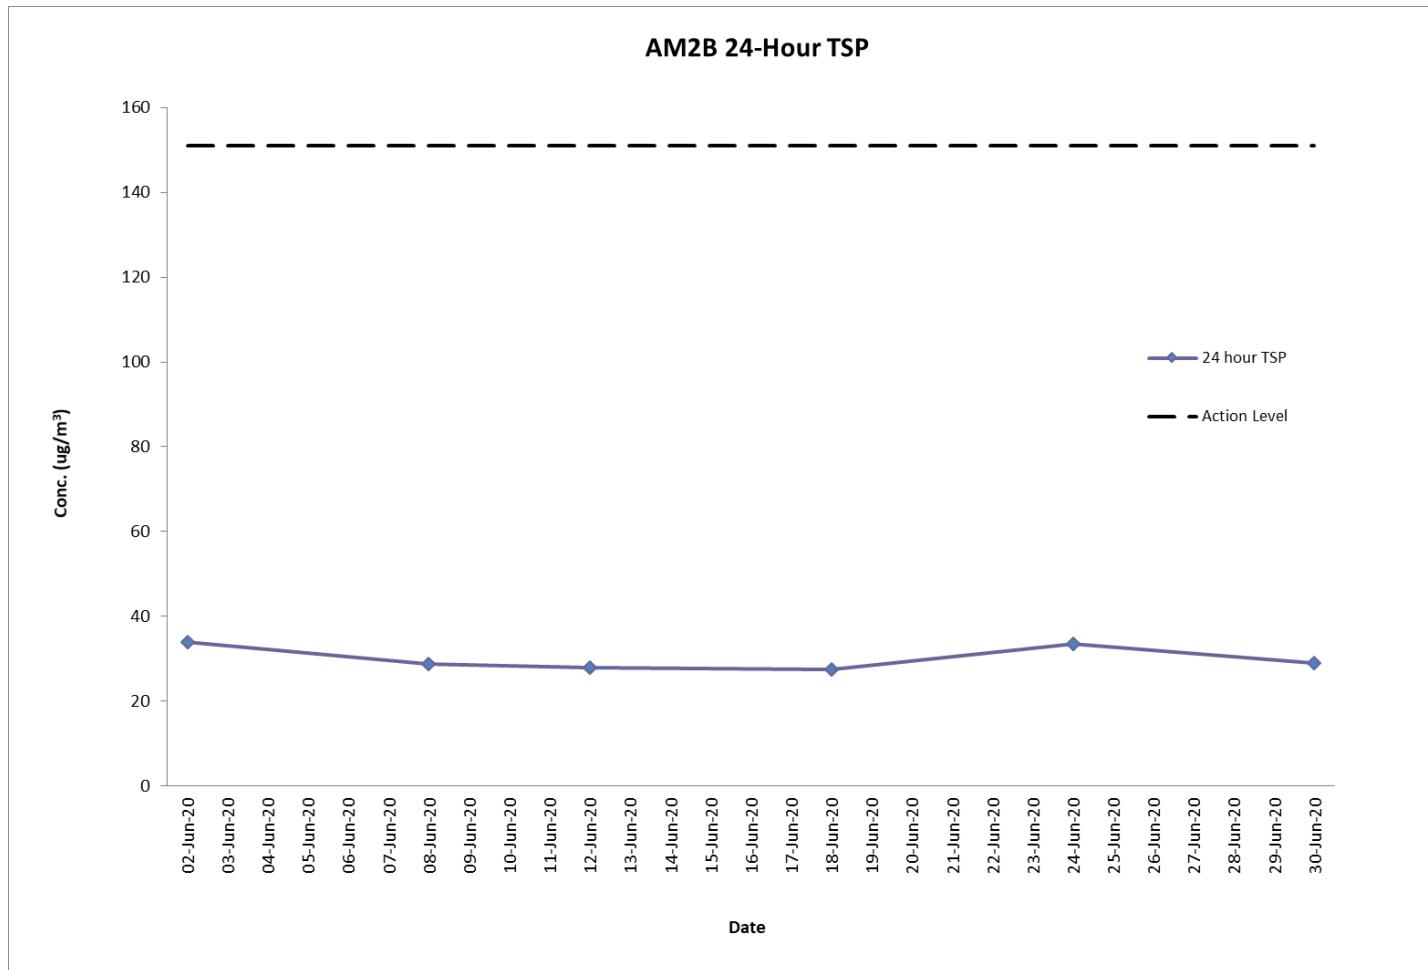
### Graphical Presentation of Air Quality Monitoring Result at Station AM2B (24-hour TSP)

Start		Finish		Filter Weight (g)		Elapsed Time Reading		Sampling Time (hrs)	Flow Rate (m <sup>3</sup> /min)			Conc. (µg/m <sup>3</sup> )	Weather Condition	Action Level	Limit Level
Date	Time	Date	Time	Initial	Final	Initial	Final		Initial	Final	Average				
02-Jun-20	8:24	03-Jun-20	8:24	2.7092	2.7687	21427.05	21451.05	24	1.22	1.22	1.22	34	Fine	151.1	260
08-Jun-20	8:35	09-Jun-20	8:35	2.6862	2.7367	21896.38	21920.38	24	1.22	1.22	1.22	29	Rainy	151.1	260
12-Jun-20	8:40	13-Jun-20	8:40	2.7068	2.7558	21475.05	21499.05	24	1.22	1.22	1.22	28	Sunny	151.1	260
18-Jun-20	8:27	19-Jun-20	8:27	2.8027	2.8511	21499.05	21523.05	24	1.22	1.22	1.22	28	Fine	151.1	260
24-Jun-20	8:27	25-Jun-20	8:27	2.7260	2.7849	21523.05	21547.05	24	1.22	1.22	1.22	34	Cloudy	151.1	260
30-Jun-20	8:30	01-Jul-20	8:30	2.6983	2.7486	21547.05	21571.05	24	1.22	1.22	1.22	29	Fine	151.1	260

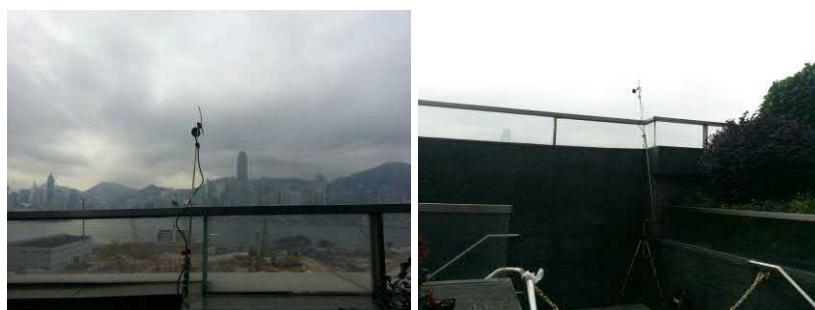
\* +3dB (A) correction was applied to free-field measurement.

The station set-up of a free-field measurement at Station NM1A.

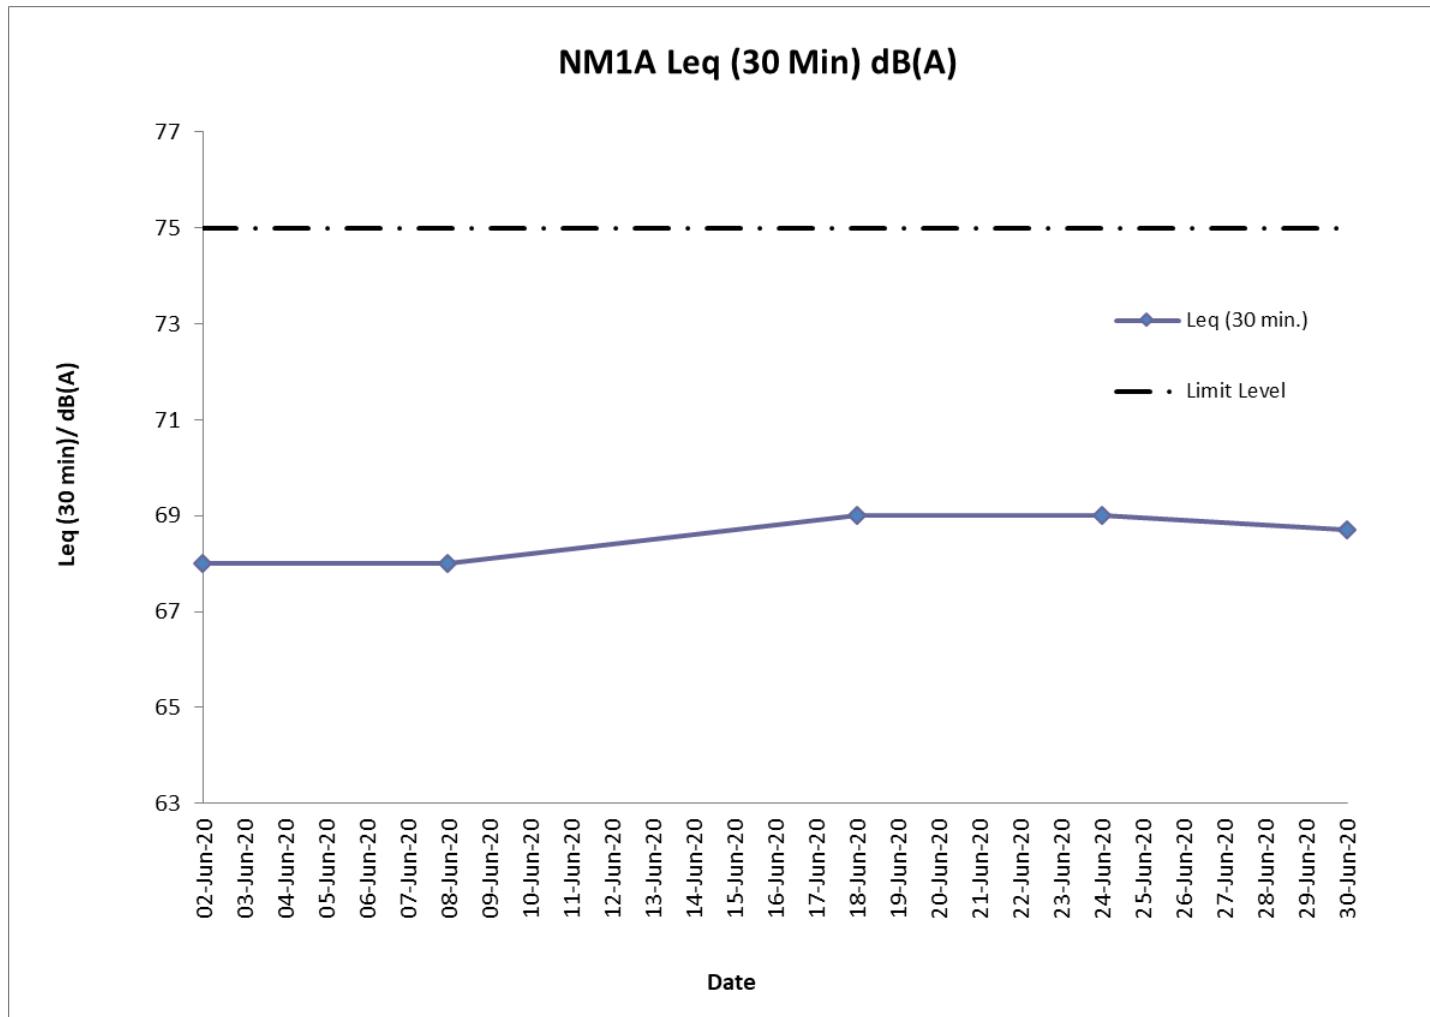
**Graphical Presentation Noise Monitoring Result at Station NM1A**

Date	Time	Measured L <sub>10</sub> , dB(A)	Measured L <sub>90</sub> , dB(A)	L <sub>eq</sub> (30 min.)*, dB(A)
02-Jun-20	10:30	67.0	63.4	68
02-Jun-20	10:35	68.6	64.1	
02-Jun-20	10:40	66.3	62.1	
02-Jun-20	10:45	67.1	63.6	
02-Jun-20	10:50	67.5	63.7	
02-Jun-20	10:55	66.7	62.9	
08-Jun-20	10:02	66.0	62.3	68
08-Jun-20	10:07	68.3	64.2	
08-Jun-20	10:12	67.3	63.6	
08-Jun-20	10:17	68.7	64.8	
08-Jun-20	10:22	66.8	62.1	
08-Jun-20	10:27	67.5	63.4	
18-Jun-20	10:35	67.4	63.1	69
18-Jun-20	10:40	66.8	62.7	
18-Jun-20	10:45	68.6	64.5	
18-Jun-20	10:50	67.5	63.1	
18-Jun-20	10:55	68.3	64.2	
18-Jun-20	11:00	67.1	63.4	
24-Jun-20	10:35	66.0	62.3	69
24-Jun-20	10:40	67.3	63.1	
24-Jun-20	10:45	68.4	64.2	
24-Jun-20	10:50	66.2	62.6	
24-Jun-20	10:55	67.5	63.1	
24-Jun-20	11:00	67.6	63.4	
30-Jun-20	10:38	66.3	62.0	69
30-Jun-20	10:43	67.4	63.1	
30-Jun-20	10:48	68.3	64.1	
30-Jun-20	10:53	68.2	64.9	
30-Jun-20	10:58	66.1	62.7	
30-Jun-20	11:03	67.5	63.1
