# **Development at West Kowloon Cultural District**

Monthly Environmental Monitoring and Audit  
(EM&A) Report for September 2020

9 October 2020

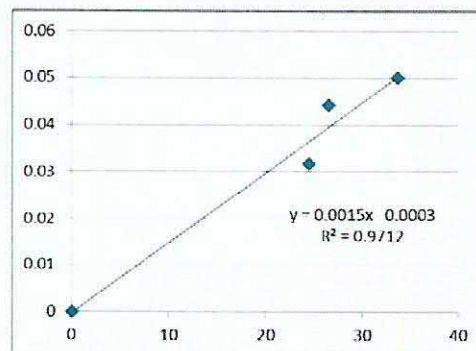
### Linear Regression of Y or X

Slope (K-factor): 0.0015  
Correlation Coefficient 0.9855  
Date of Issue 13 December 2019

1. Strong Correlation ( $R > 0.8$ )
2. Factor 0.0015 should be applied for TSP monitoring

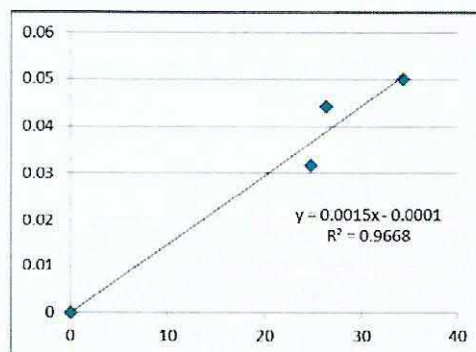
### Linear Regression of Y or X

Slope (K-factor): 0.0015  
Correlation Coefficient 0.9833  
Date of Issue 13 December 2019

1. **Strong** Correlation ( $R > 0.8$ )
2. Factor 0.0015 should be applied for TSP monitoring

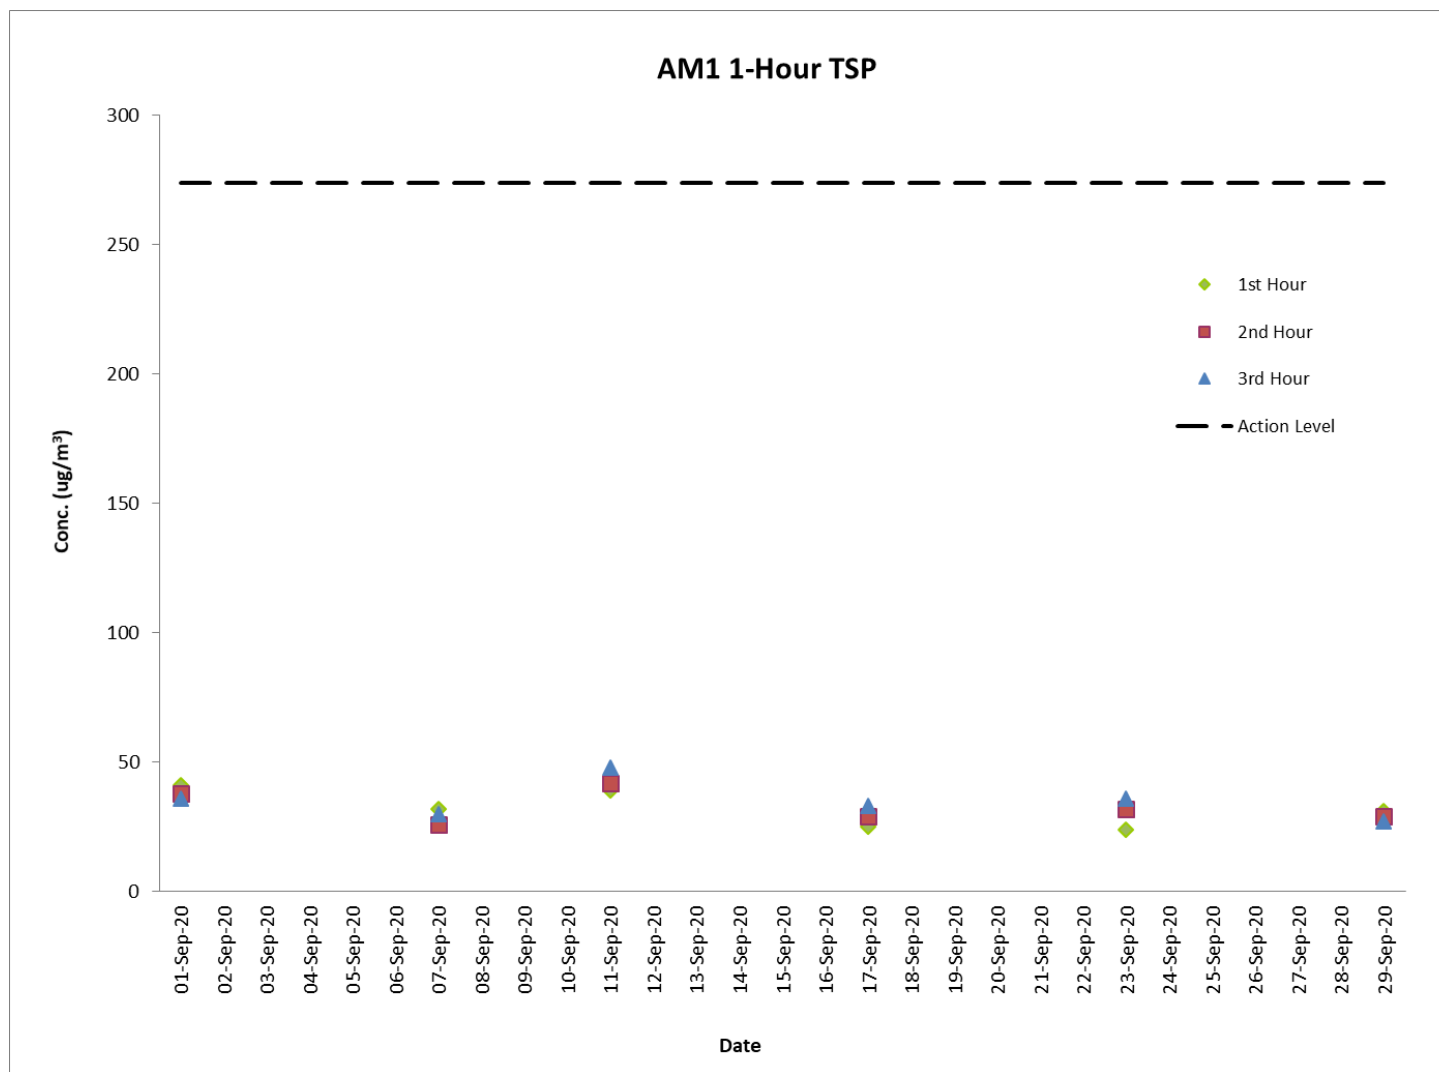
### Graphical Presentation of Air Quality Monitoring Result at Station AM1 (1-hour TSP)

Date	Weather Condition	Time	Conc. (µg/m³)			Action Level (µg/m³)	Limit Level (µg/m³)
			1 <sup>st</sup> Hour	2 <sup>nd</sup> Hour	3 <sup>rd</sup> Hour		
01-Sep-20	Sunny	8:14 - 11:14	41	38	36	273.7	500
07-Sep-20	Cloudy	8:20 - 11:20	32	26	30	273.7	500
11-Sep-20	Fine	13:22 - 16:22	39	42	48	273.7	500
17-Sep-20	Cloudy	8:20 - 11:20	25	29	33	273.7	500
23-Sep-20	Sunny	13:17 - 16:17	24	32	36	273.7	500
29-Sep-20	Cloudy	8:14 - 11:14	31	29	27	273.7	500

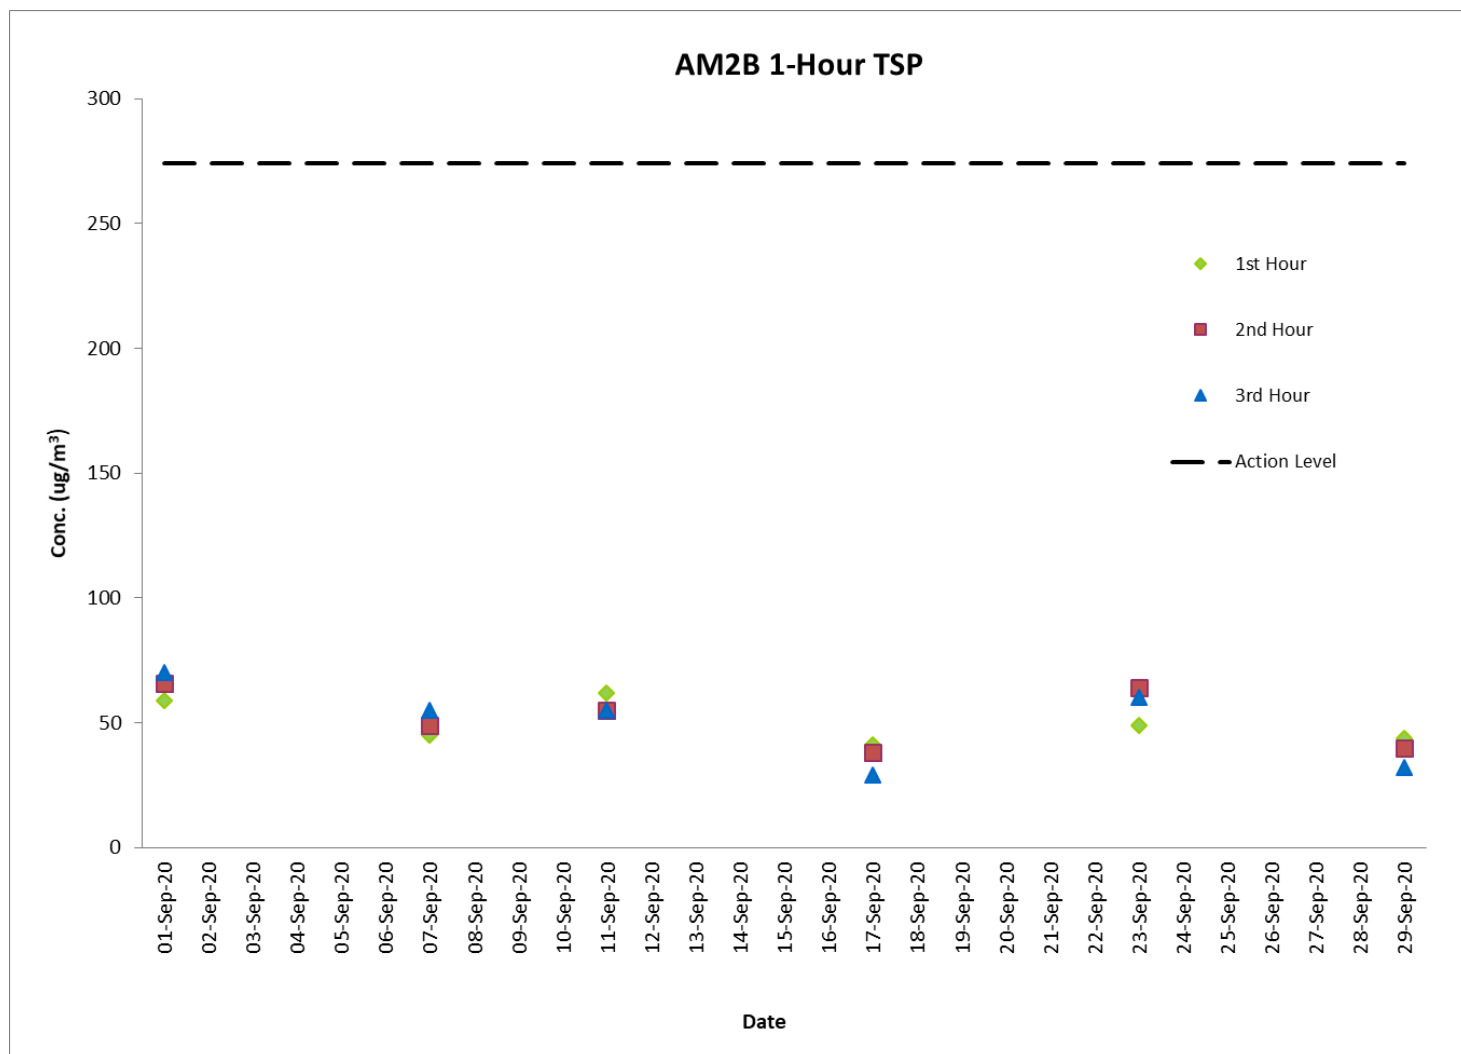
Graphical Presentation of Air Quality Monitoring Result at Station AM2B (1-hour TSP)

Date	Weather Condition	Time		Conc. ( $\mu\text{g}/\text{m}^3$ )			Action Level ( $\mu\text{g}/\text{m}^3$ )	Limit Level ( $\mu\text{g}/\text{m}^3$ )
				1 <sup>st</sup> Hour	2 <sup>nd</sup> Hour	3 <sup>rd</sup> Hour		
01-Sep-20	Sunny	8:29	- 11:29	59	66	70	274.2	500
07-Sep-20	Cloudy	8:37	- 11:37	45	49	55	274.2	500
11-Sep-20	Fine	13:36	- 16:36	62	55	55	274.2	500
17-Sep-20	Cloudy	8:35	- 11:35	41	38	29	274.2	500
23-Sep-20	Sunny	13:32	- 16:32	49	64	60	274.2	500
29-Sep-20	Cloudy	8:28	- 11:28	44	40	32	274.2	500

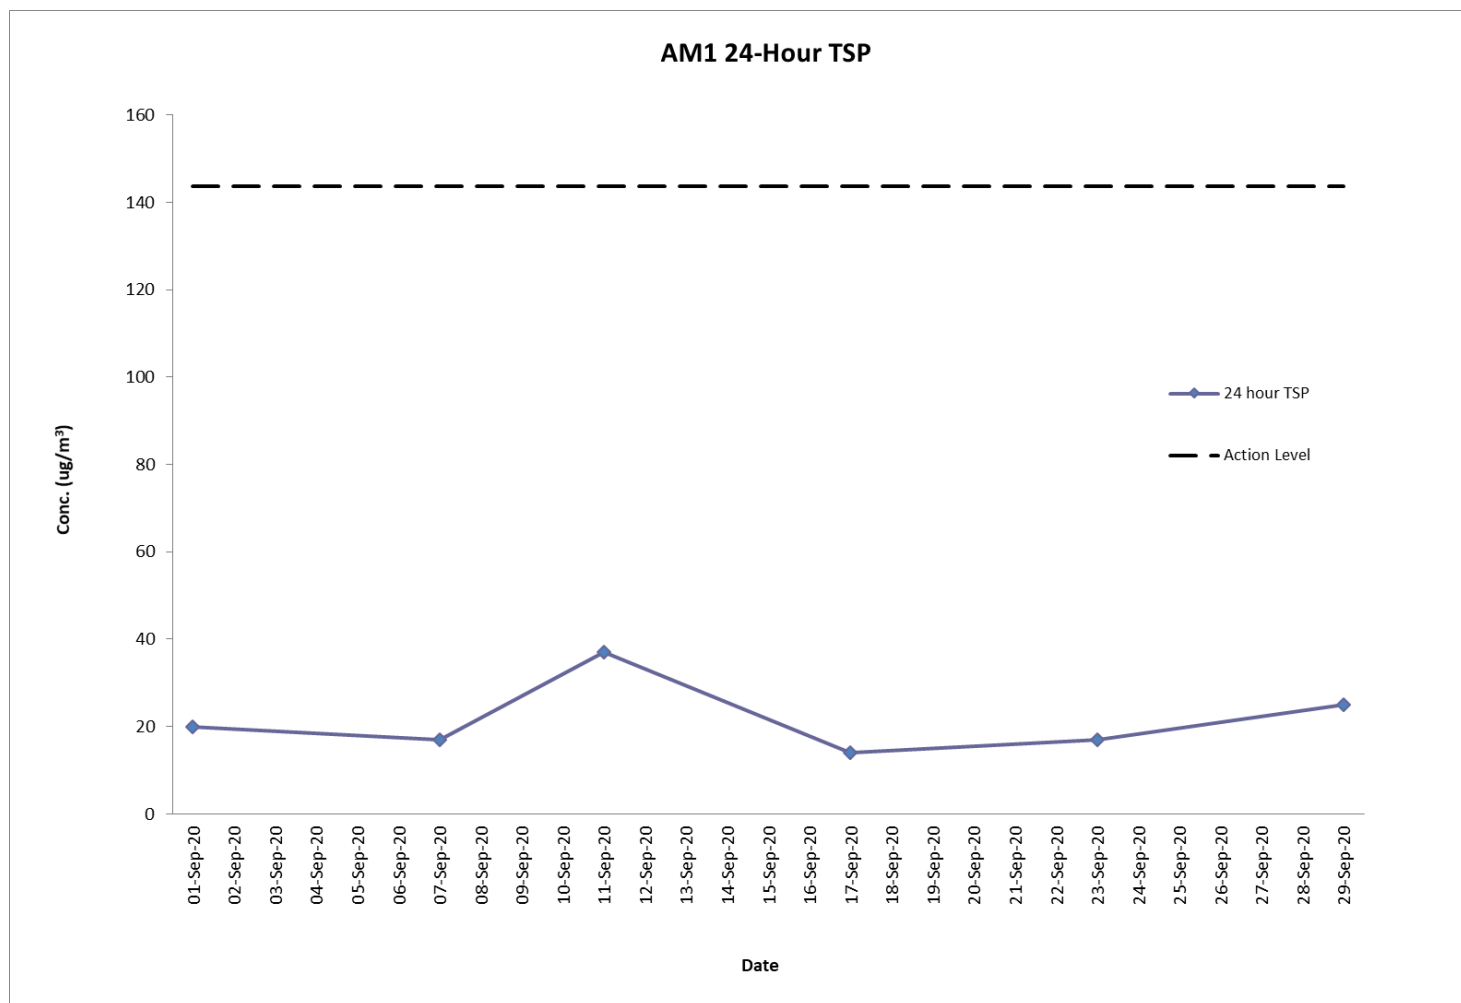
### Graphical Presentation of Air Quality Monitoring Result at Station AM1 (24-hour TSP)

Start		Finish		Filter Weight (g)		Elapsed Time Reading		Sampling Time (hrs)	Flow Rate (m <sup>3</sup> /min)			Conc. (µg/m <sup>3</sup> )	Weather Condition	Action Level	Limit Level
Date	Time	Date	Time	Initial	Final	Initial	Final		Initial	Final	Average				
01-Sep-20	08:12	02-Sep-20	08:12	2.6716	2.7082	22256.38	22280.38	24	1.27	1.27	1.27	20	Sunny	143.6	260
07-Sep-20	08:18	08-Sep-20	08:18	2.6778	2.7082	22280.38	22304.38	24	1.27	1.27	1.27	17	Cloudy	143.6	260
11-Sep-20	08:20	12-Sep-20	08:20	2.6802	2.7480	22304.38	22328.38	24	1.27	1.27	1.27	37	Fine	143.6	260
17-Sep-20	08:18	18-Sep-20	08:18	2.6887	2.7148	22328.38	22352.38	24	1.27	1.27	1.27	14	Cloudy	143.6	260
23-Sep-20	08:15	24-Sep-20	08:15	2.7080	2.7385	22352.38	22376.38	24	1.22	1.22	1.22	17	Cloudy	143.6	260
29-Sep-20	08:12	30-Sep-20	08:12	2.6959	2.7394	22376.38	22400.38	24	1.22	1.22	1.22	25	Cloudy	143.6	260

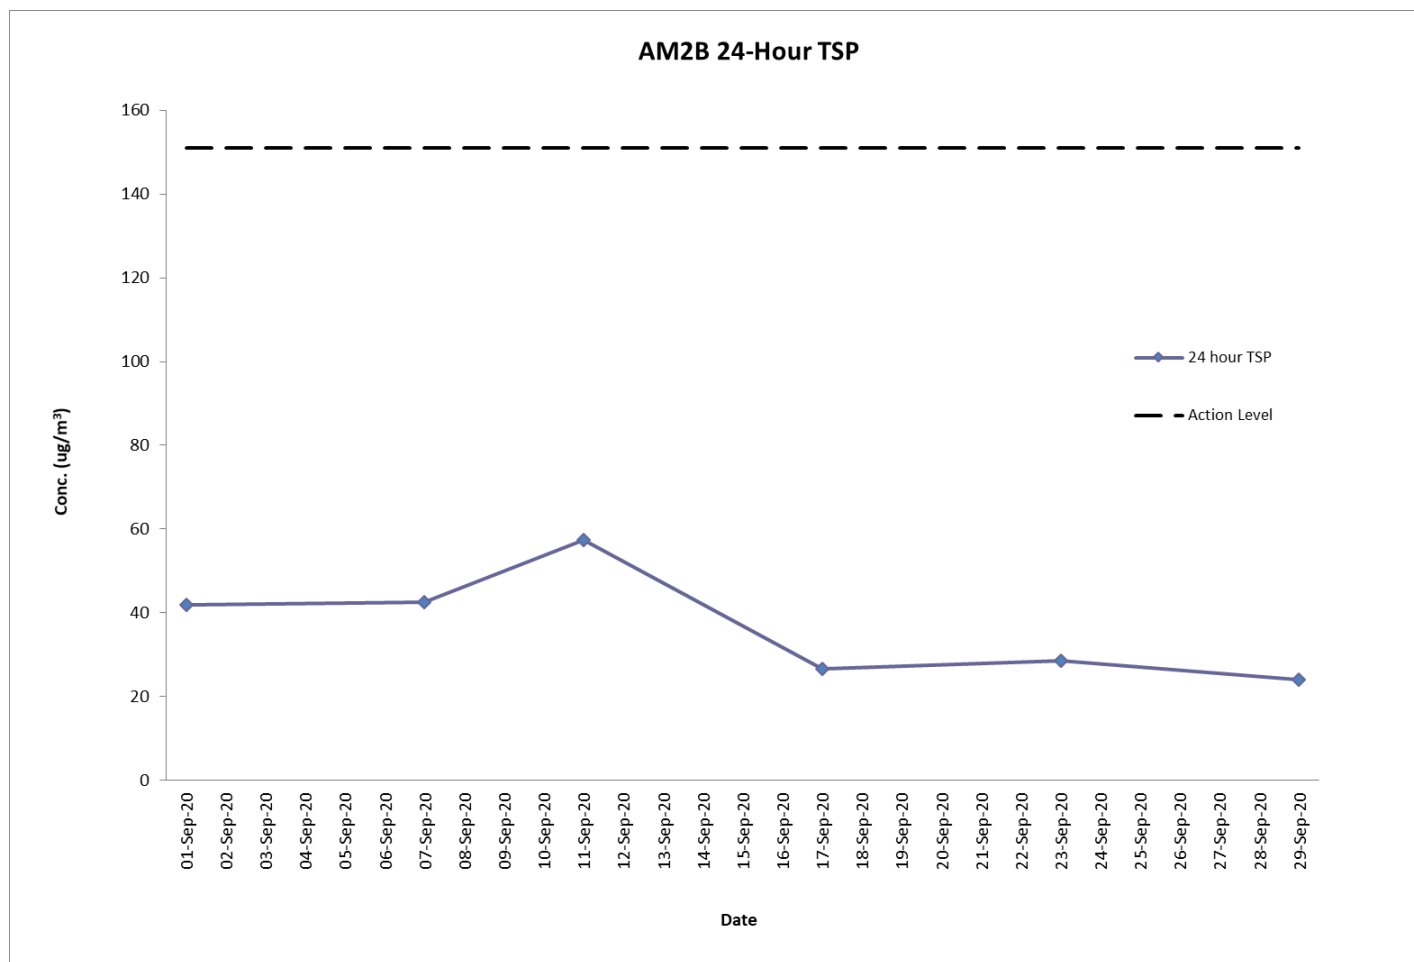
### Graphical Presentation of Air Quality Monitoring Result at Station AM2B (24-hour TSP)

Start		Finish		Filter Weight (g)		Elapsed Time Reading		Sampling Time (hrs)	Flow Rate (m <sup>3</sup> /min)			Conc. (µg/m <sup>3</sup> )	Weather Condition	Action Level	Limit Level
Date	Time	Date	Time	Initial	Final	Initial	Final		Initial	Final	Average				
01-Sep-20	08:27	02-Sep-20	08:27	2.6803	2.7563	21811.05	21835.05	24	1.26	1.26	1.26	42	Sunny	151.1	260
07-Sep-20	08:35	08-Sep-20	08:35	2.6982	2.7755	21835.05	21859.05	24	1.26	1.26	1.26	43	Cloudy	151.1	260
11-Sep-20	08:34	12-Sep-20	08:34	2.6870	2.7913	21859.05	21883.05	24	1.26	1.26	1.26	57	Fine	151.1	260
17-Sep-20	08:33	18-Sep-20	08:33	2.6976	2.7458	21883.05	21907.05	24	1.26	1.26	1.26	27	Cloudy	151.1	260
23-Sep-20	08:30	24-Sep-20	08:30	2.7084	2.7597	21907.05	21931.05	24	1.25	1.25	1.25	28	Sunny	151.1	260
29-Sep-20	08:26	30-Sep-20	08:26	2.7031	2.7472	21931.05	21955.05	24	1.25	1.25	1.25	24	Cloudy	151.1	260

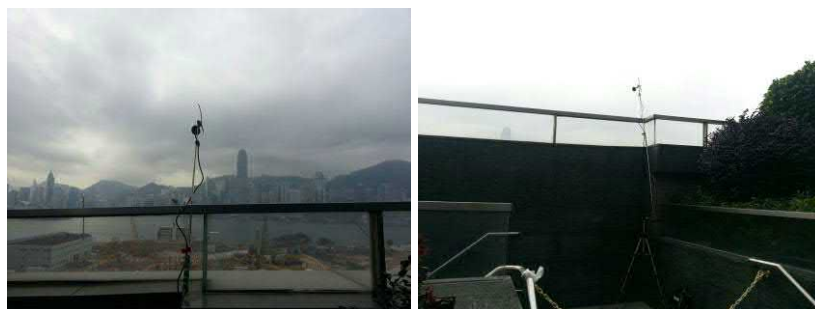
The station set-up of a free-field measurement at Station NM1A.

- The microphone of the Sound Level Meter was set at least 1.2 m above the ground.
- Free Field measurement was made at the monitoring locations.
- The battery condition was checked to ensure the correct functioning of the meter.

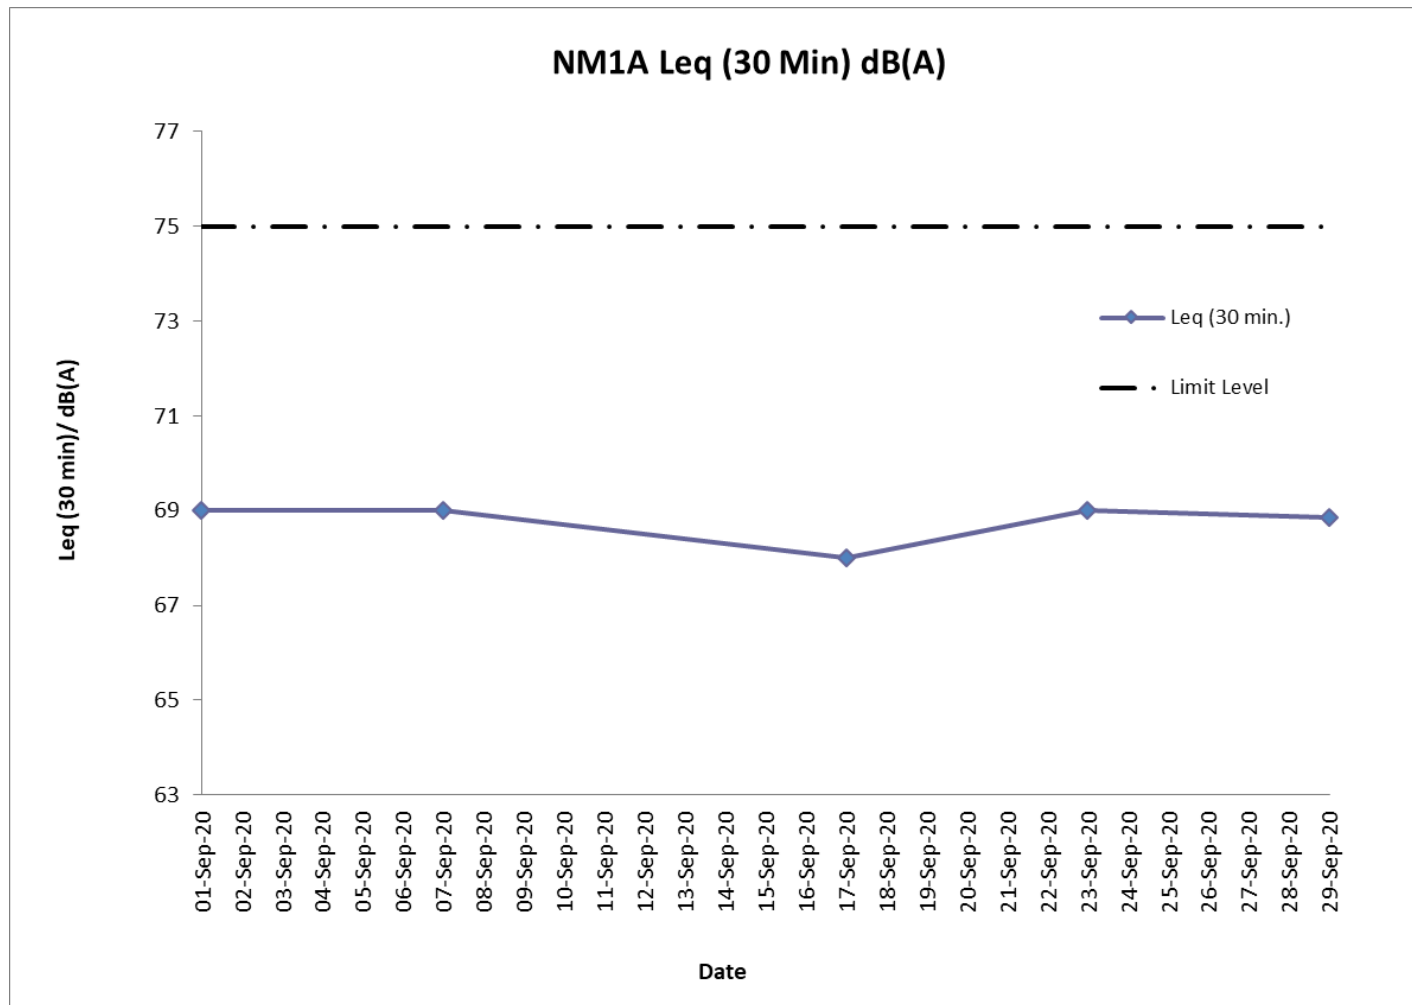
# Graphical Presentation Noise Monitoring Result at Station NM1A

Date	Time	Measured $L_{10}$ , dB(A)	Measured $L_{90}$ , dB(A)	$L_{eq}$ (30 min.)*, dB(A)
01-Sep-20	10:38	66.5	62.6	69
01-Sep-20	10:43	67.2	63.0	
01-Sep-20	10:48	68.1	64.7	
01-Sep-20	10:53	66.8	62.1	
01-Sep-20	10:58	67.3	63.4	
01-Sep-20	11:03	68.4	64.2	
07-Sep-20	10:45	68.3	64.5	69
07-Sep-20	10:50	66.8	62.7	
07-Sep-20	10:55	67.6	63.5	
07-Sep-20	11:00	68.2	64.1	
07-Sep-20	11:05	67.4	67.3	
07-Sep-20	11:10	68.5	64.6	
17-Sep-20	10:41	68.3	64.5	68
17-Sep-20	10:46	67.5	63.6	
17-Sep-20	10:51	66.8	62.6	
17-Sep-20	10:56	67.6	63.3	
17-Sep-20	11:01	68.0	64.1	
17-Sep-20	11:06	66.7	62.5	
23-Sep-20	10:39	66.3	62.5	69
23-Sep-20	10:44	67.5	63.1	
23-Sep-20	10:49	68.2	64.4	
23-Sep-20	10:54	68.6	64.3	
23-Sep-20	10:59	67.0	63.1	
23-Sep-20	11:04	66.4	62.9	
29-Sep-20	10:35	68.0	64.1	69
29-Sep-20	10:40	67.3	63.5	
29-Sep-20	10:45	67.8	63.7	
29-Sep-20	10:50	66.6	62.8	
29-Sep-20	10:55	68.1	64.0	
29-Sep-20	11:00	68.5	64.3

\* +3dB (A) correction was applied to free-field measurement.
