Development at West Kowloon Cultural District

**Monthly Environmental Monitoring and Audit (EM&A) Report
for December 2020**

**Part-1: EM&A at M+ Museum and
Lyric Theatre Complex**

**Part-2: EM&A for Foundation, Excavation
and Lateral Works for Integrated
Basement and Underground Road in
Zone 2A**

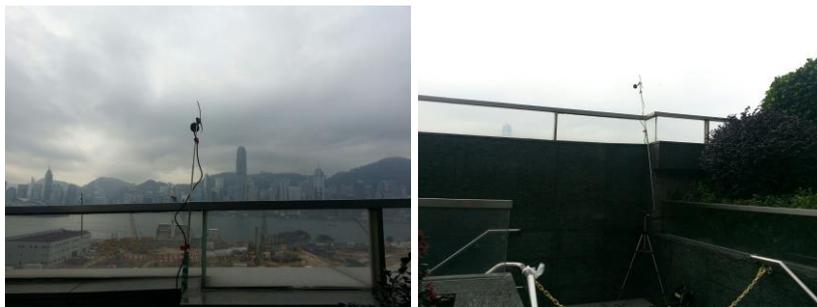
Graphical Presentation Noise Monitoring Result at Station NM1A

The station set-up of a free-field measurement at Station NM1A.

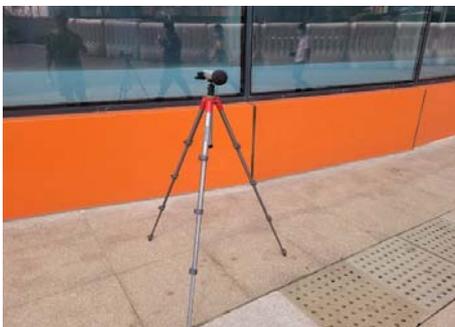
Graphical Presentation of Noise Monitoring Result at Station NM2A

The station set-up of a façade measurement at station NM2A.

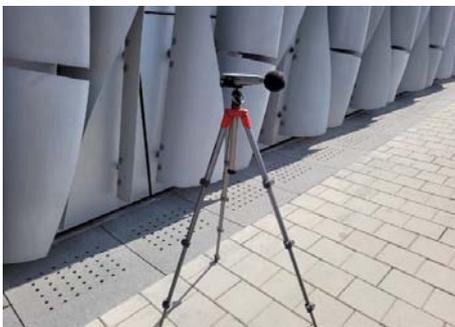
Graphical Presentation of Noise Monitoring Result at Station NM3A

The station set-up of a façade measurement at station NM3A.

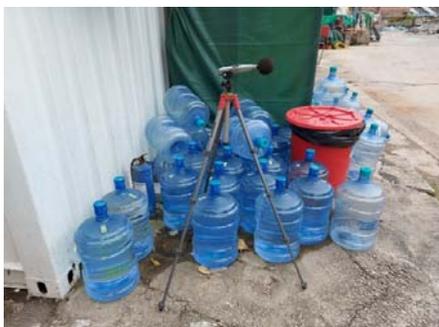
Graphical Presentation of Noise Monitoring Result at Station NM4A

The station set-up of a façade measurement at station NM4A.

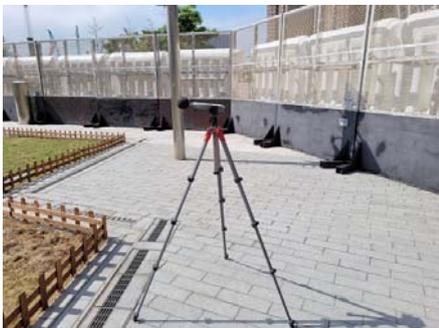
Graphical Presentation of Noise Monitoring Result at Station NM5A

The station set-up of a free-field measurement at station NM5A.
