# **Development at West Kowloon Cultural District**

**Monthly Environmental Monitoring and Audit (EM&A) Report  
for January 2021**

**Part-1: EM&A at M+ Museum and  
Lyric Theatre Complex**

**Part-2: EM&A for Foundation, Excavation  
and Lateral Works for Integrated  
Basement and Underground Road  
in Zone 2A**

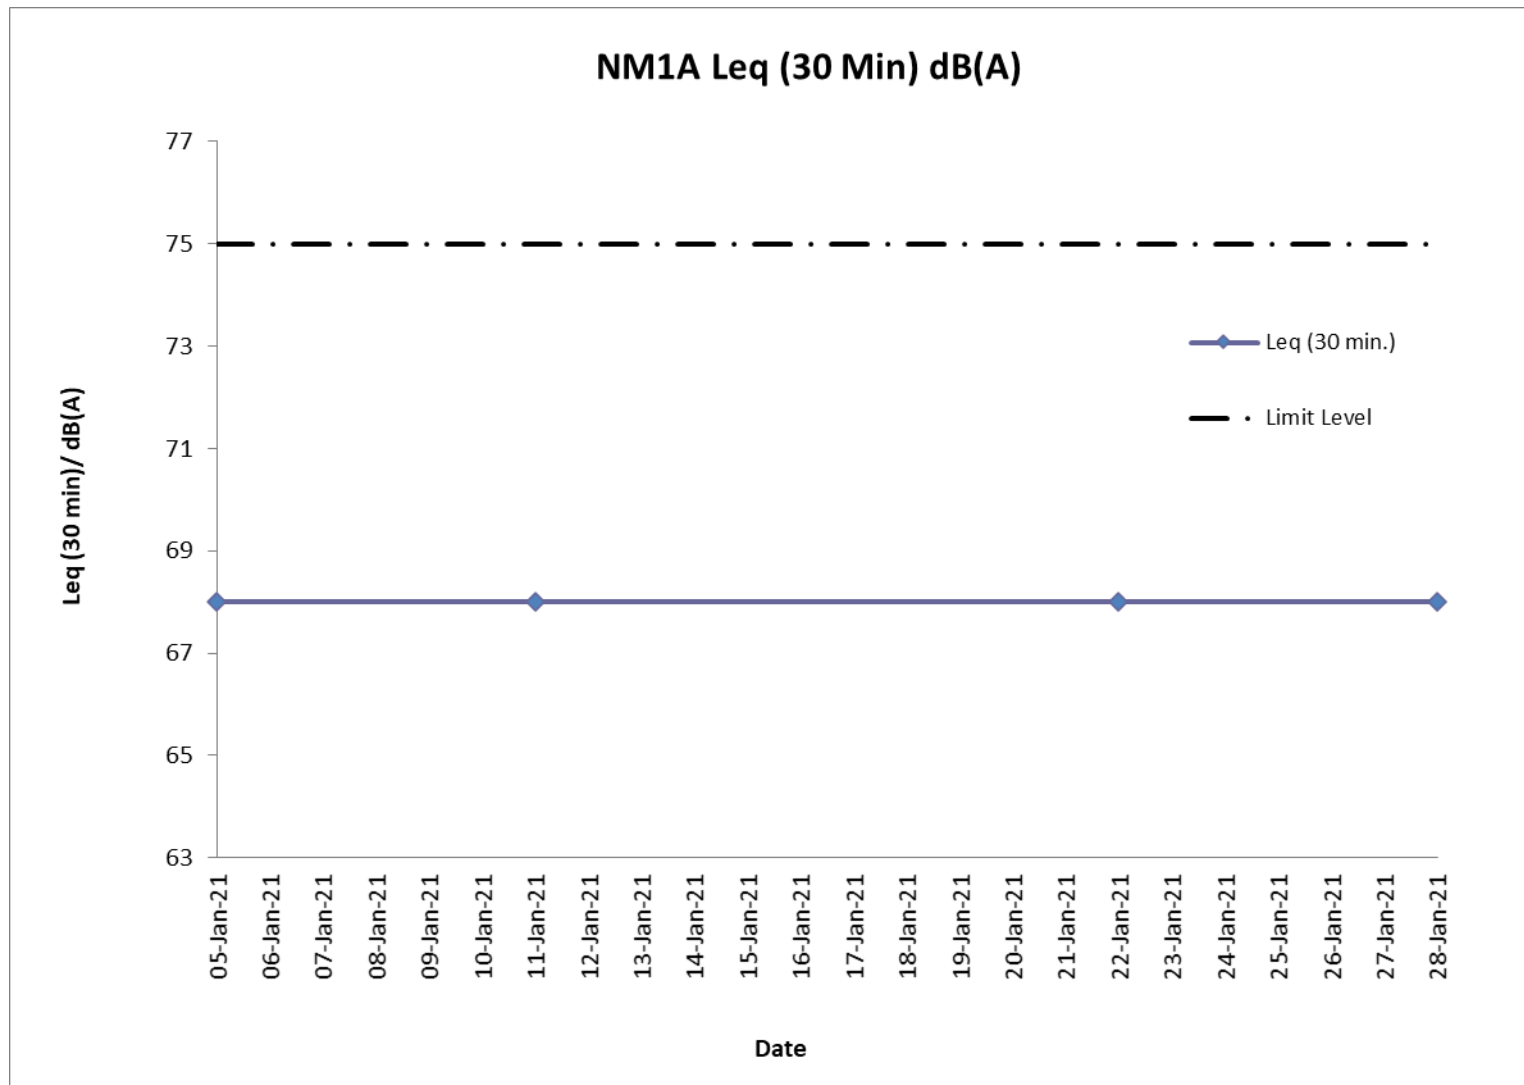
# Graphical Presentation Noise Monitoring Result at Station NM1A

The station set-up of a free-field measurement at Station NM1A.

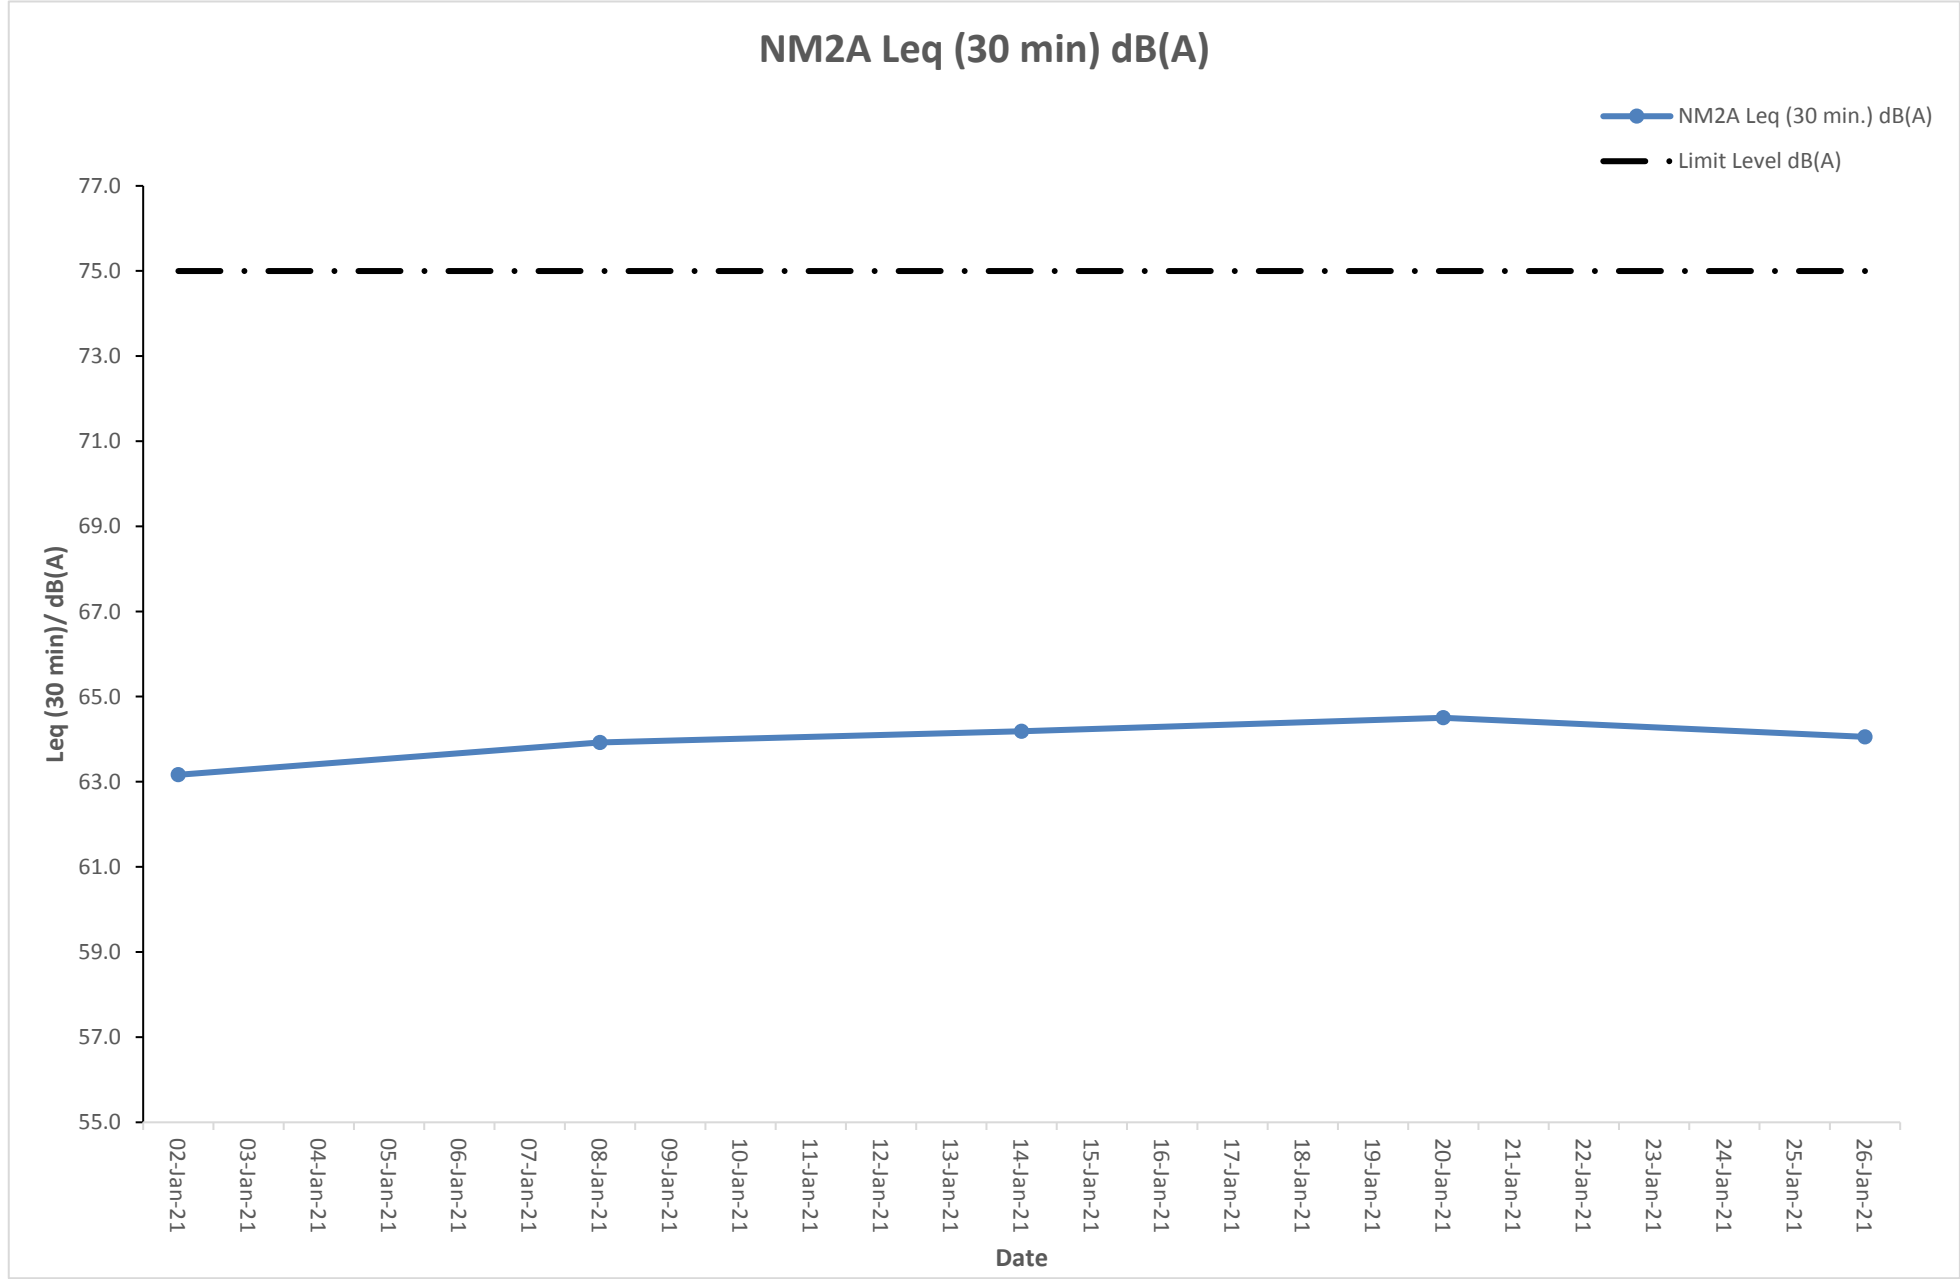
Graphical Presentation of Noise Monitoring Result at Station NM2A

The station set-up of a façade measurement at station NM2A.

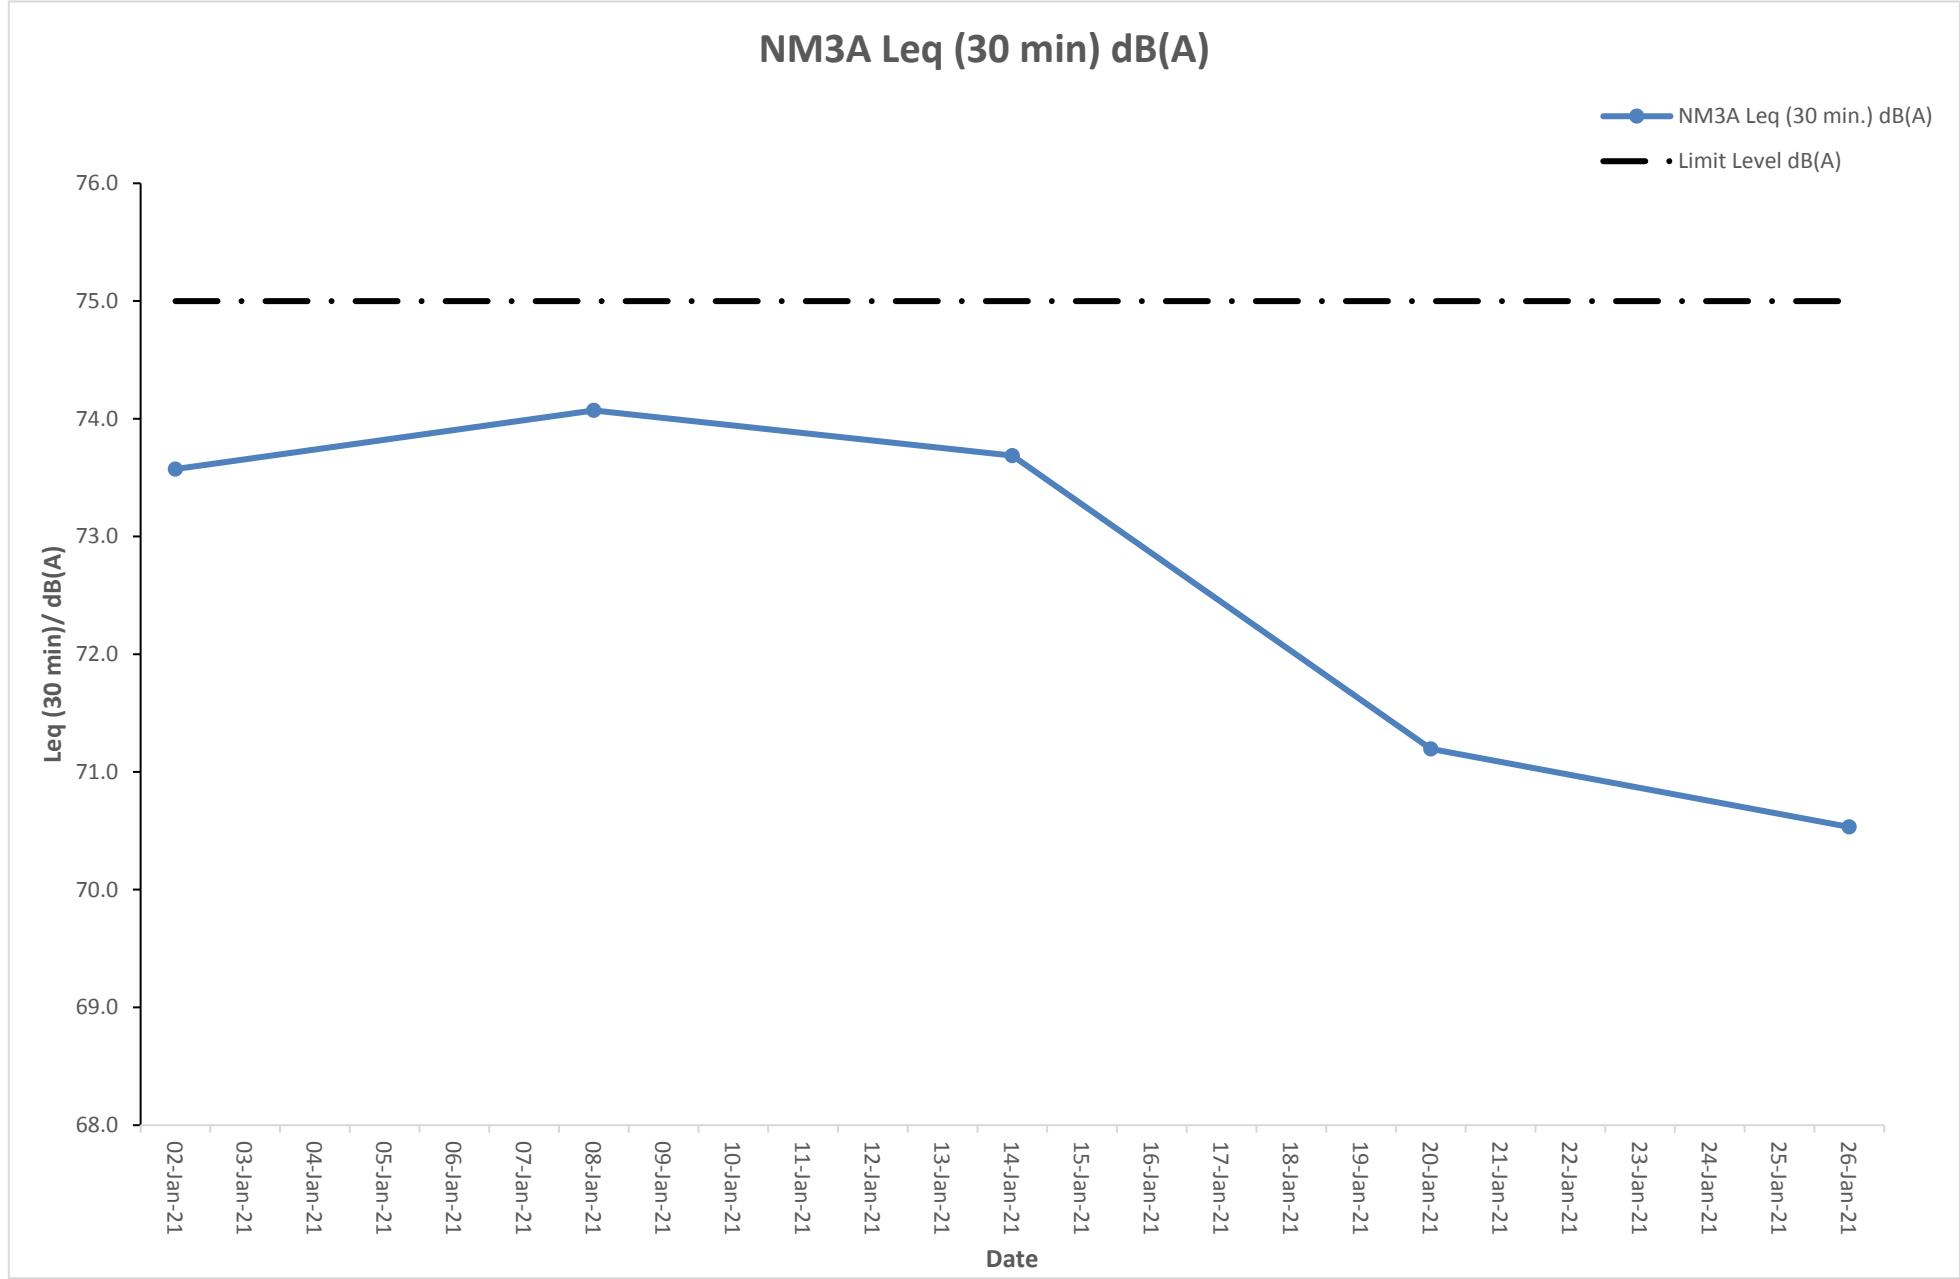
Graphical Presentation of Noise Monitoring Result at Station NM3A

The station set-up of a façade measurement at station NM3A.

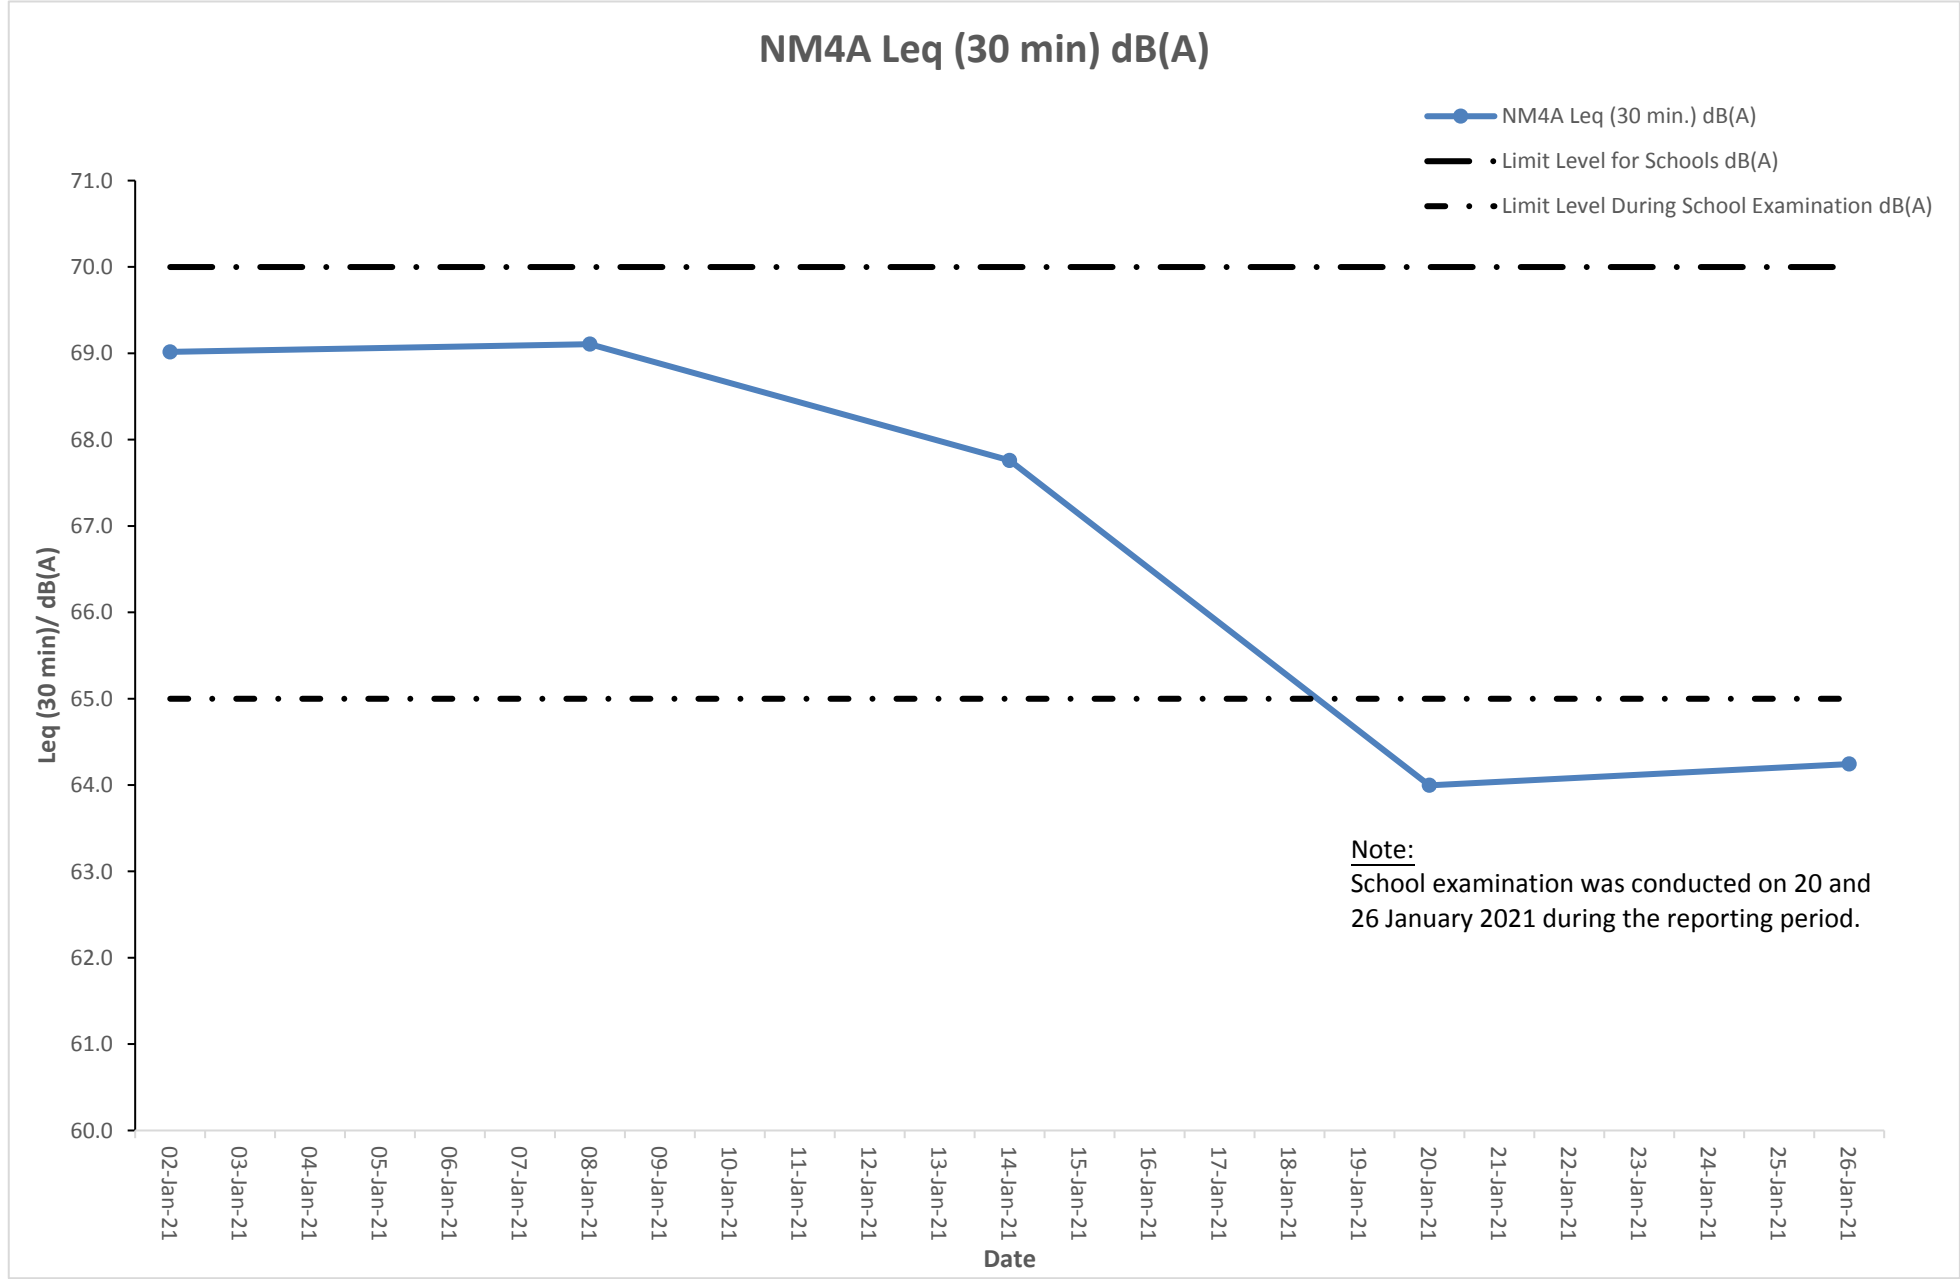
Graphical Presentation of Noise Monitoring Result at Station NM4A

The station set-up of a façade measurement at station NM4A.

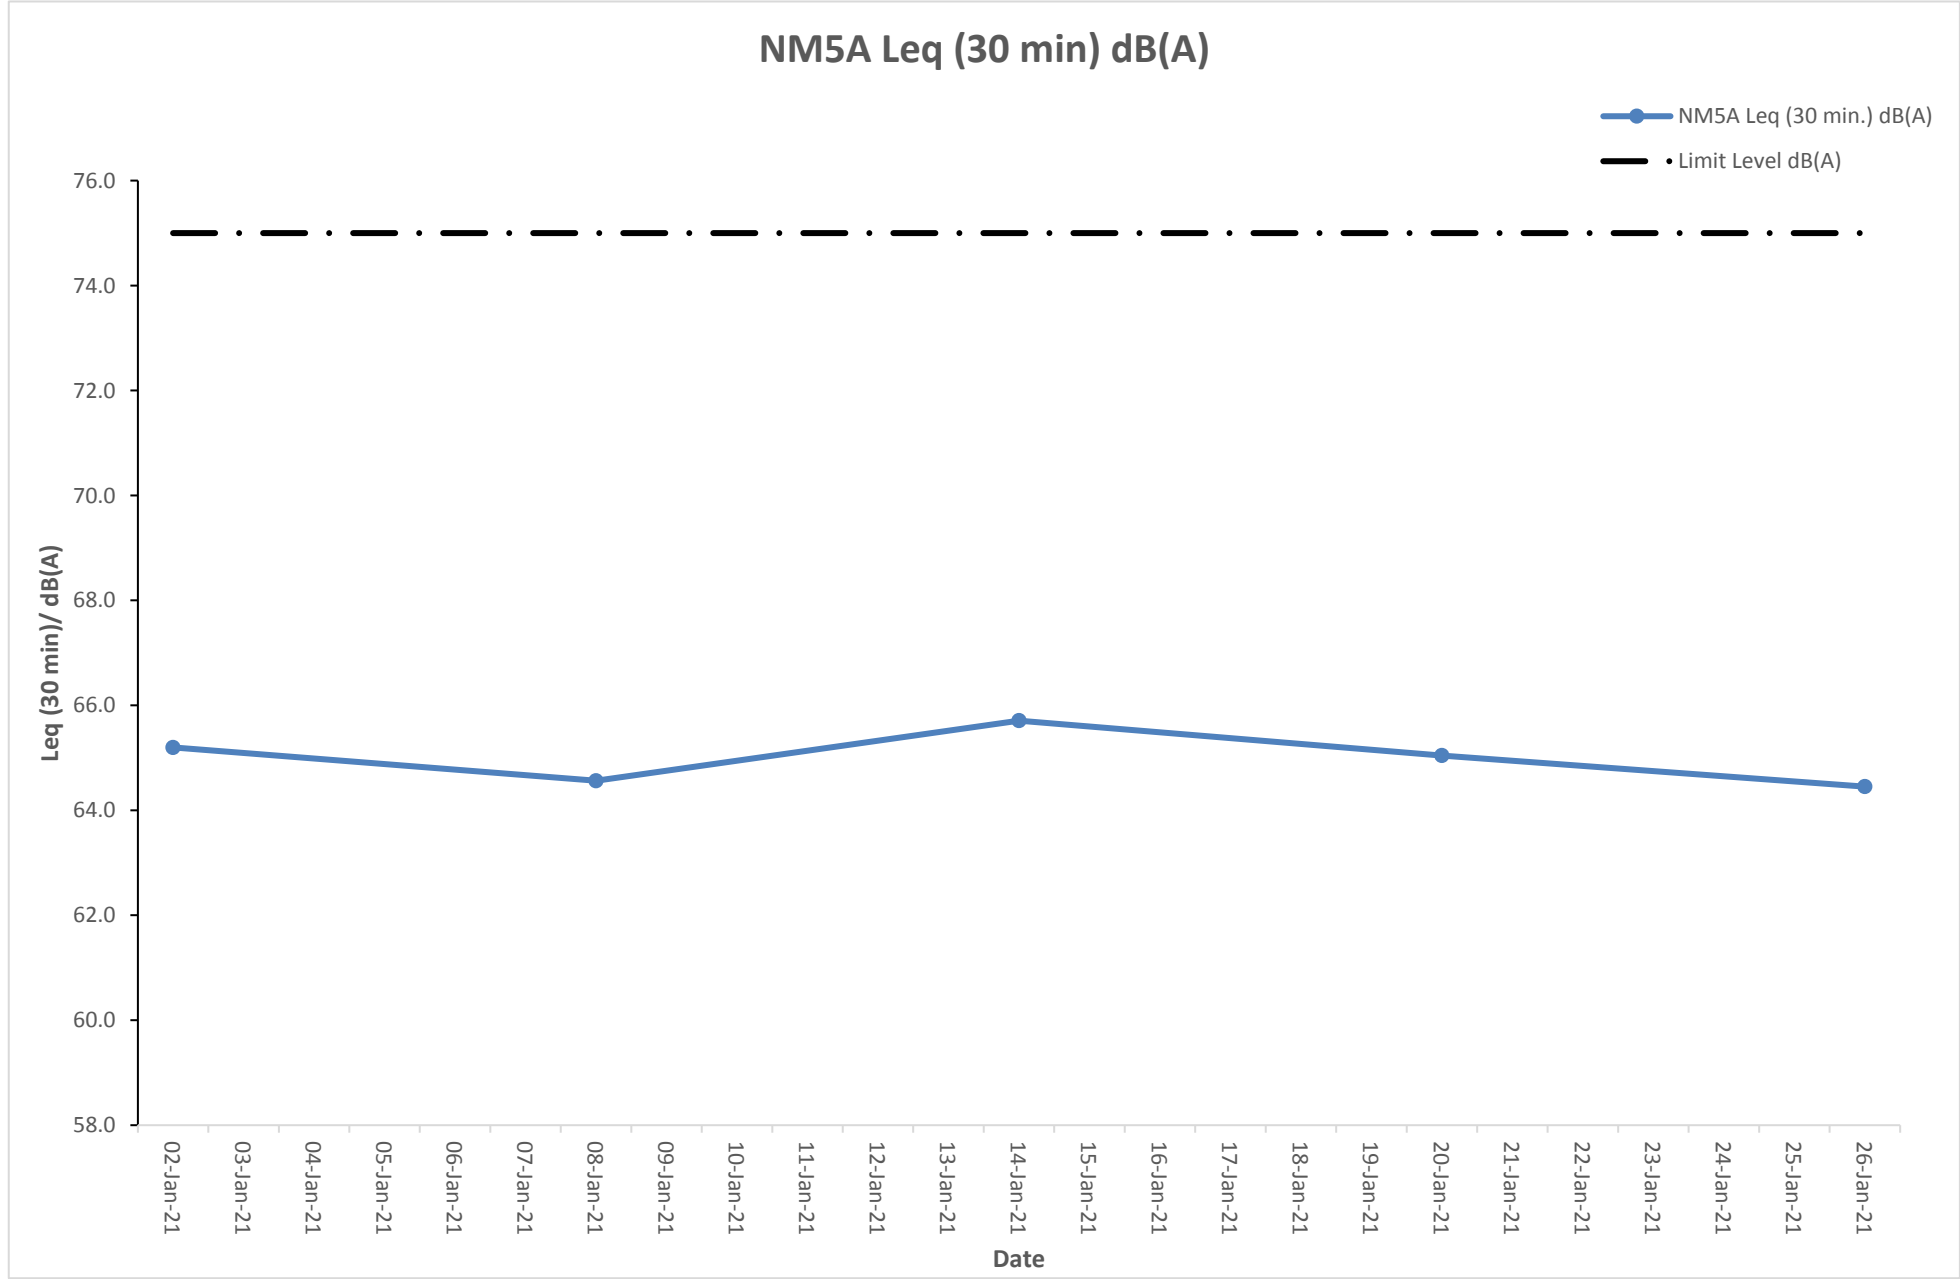
Graphical Presentation of Noise Monitoring Result at Station NM5A

The station set-up of a free-field measurement at station NM5A.
