# **Development at West Kowloon Cultural District**

**Monthly Environmental Monitoring and Audit (EM&A) Report  
for June 2021**

**12 July 2021**

# Part-1: EM&A at Lyric Theatre Complex

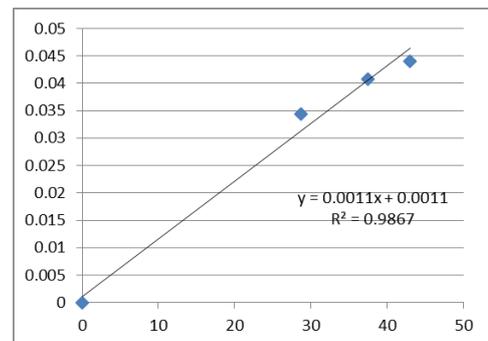
### Linear Regression of Y or X

Slope (K-factor): 0.0011  
Correlation Coefficient 0.9933  
Date of Issue 30 November 2020

1. **Strong** Correlation ( $R > 0.8$ )
  2. Factor 0.0011 should be applied for TSP monitoring
- \*If  $R < 0.5$ , repair or re-verification is required for the equipment

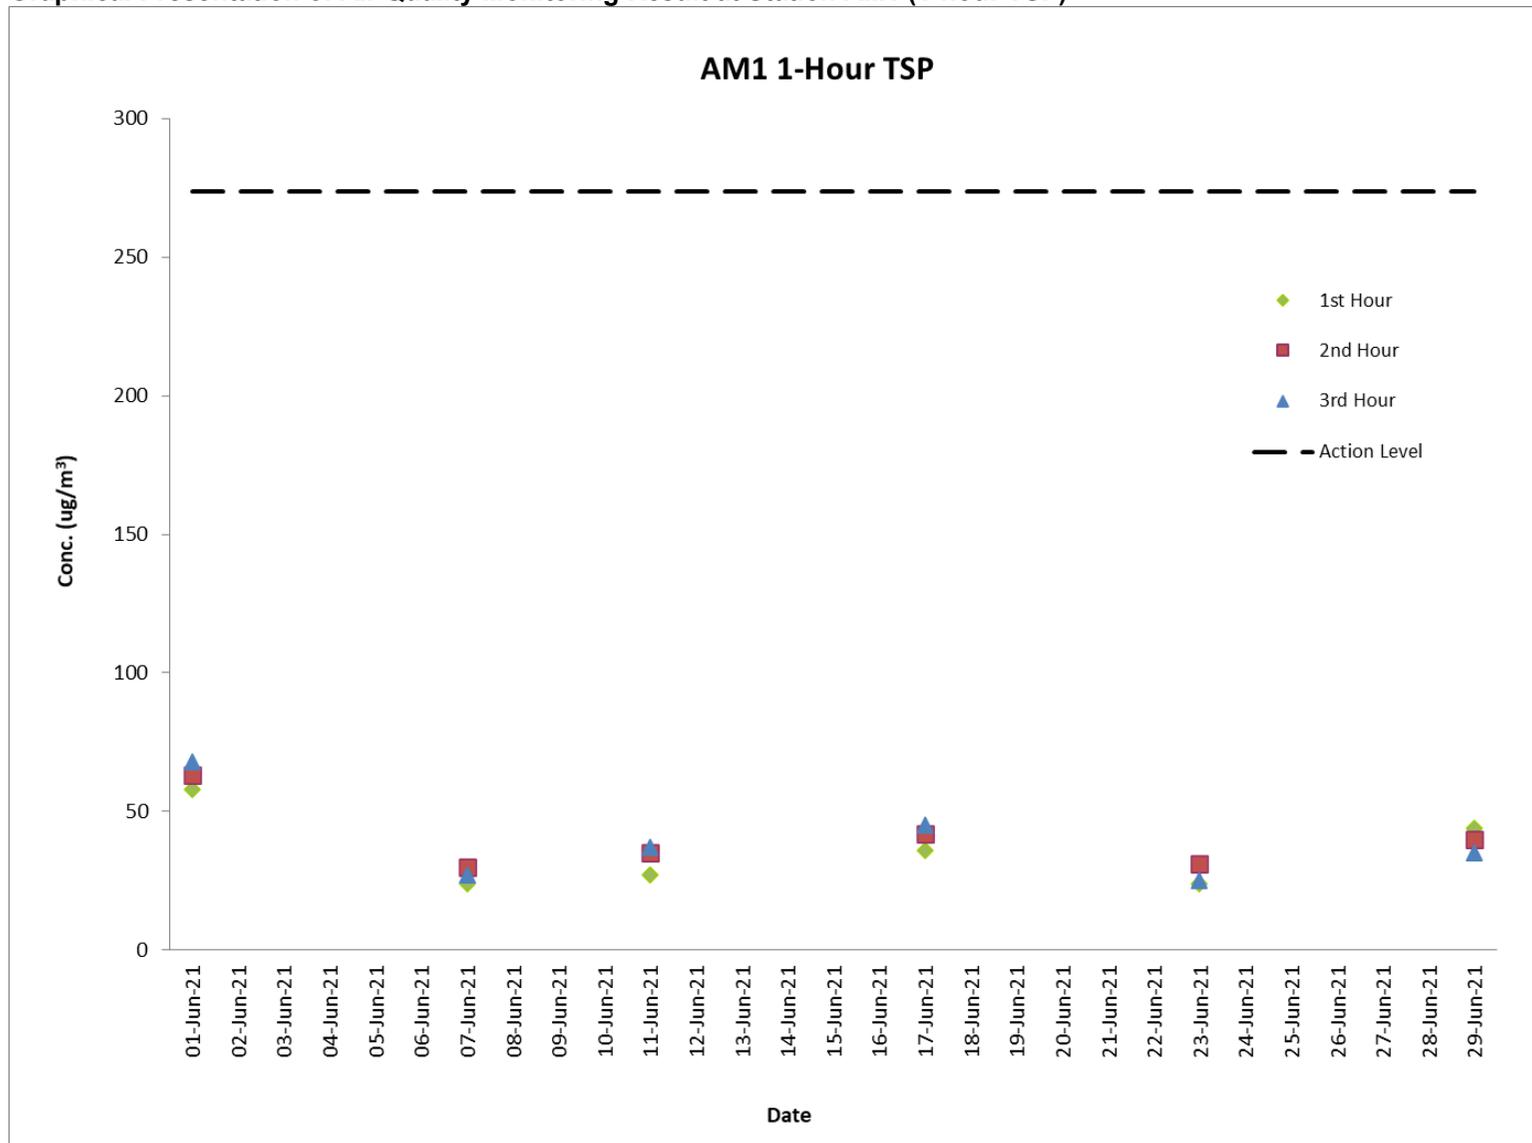
### Graphical Presentation of Air Quality Monitoring Result at Station AM1 (1-hour TSP)

Date	Weather Condition	Time	Conc. ( $\mu\text{g}/\text{m}^3$ )			Action Level ( $\mu\text{g}/\text{m}^3$ )	Limit Level ( $\mu\text{g}/\text{m}^3$ )
			1 <sup>st</sup> Hour	2 <sup>nd</sup> Hour	3 <sup>rd</sup> Hour		
01-Jun-21	Cloudy	8:32 - 11:32	58	63	68	273.7	500
07-Jun-21	Cloudy	8:34 - 11:34	24	30	27	273.7	500
11-Jun-21	Fine	8:22 - 11:22	27	35	37	273.7	500
17-Jun-21	Fine	8:32 - 11:32	36	42	45	273.7	500
23-Jun-21	Cloudy	8:22 - 11:22	24	31	25	273.7	500
29-Jun-21	Cloudy	8:32 - 11:32	44	40	35	273.7	500

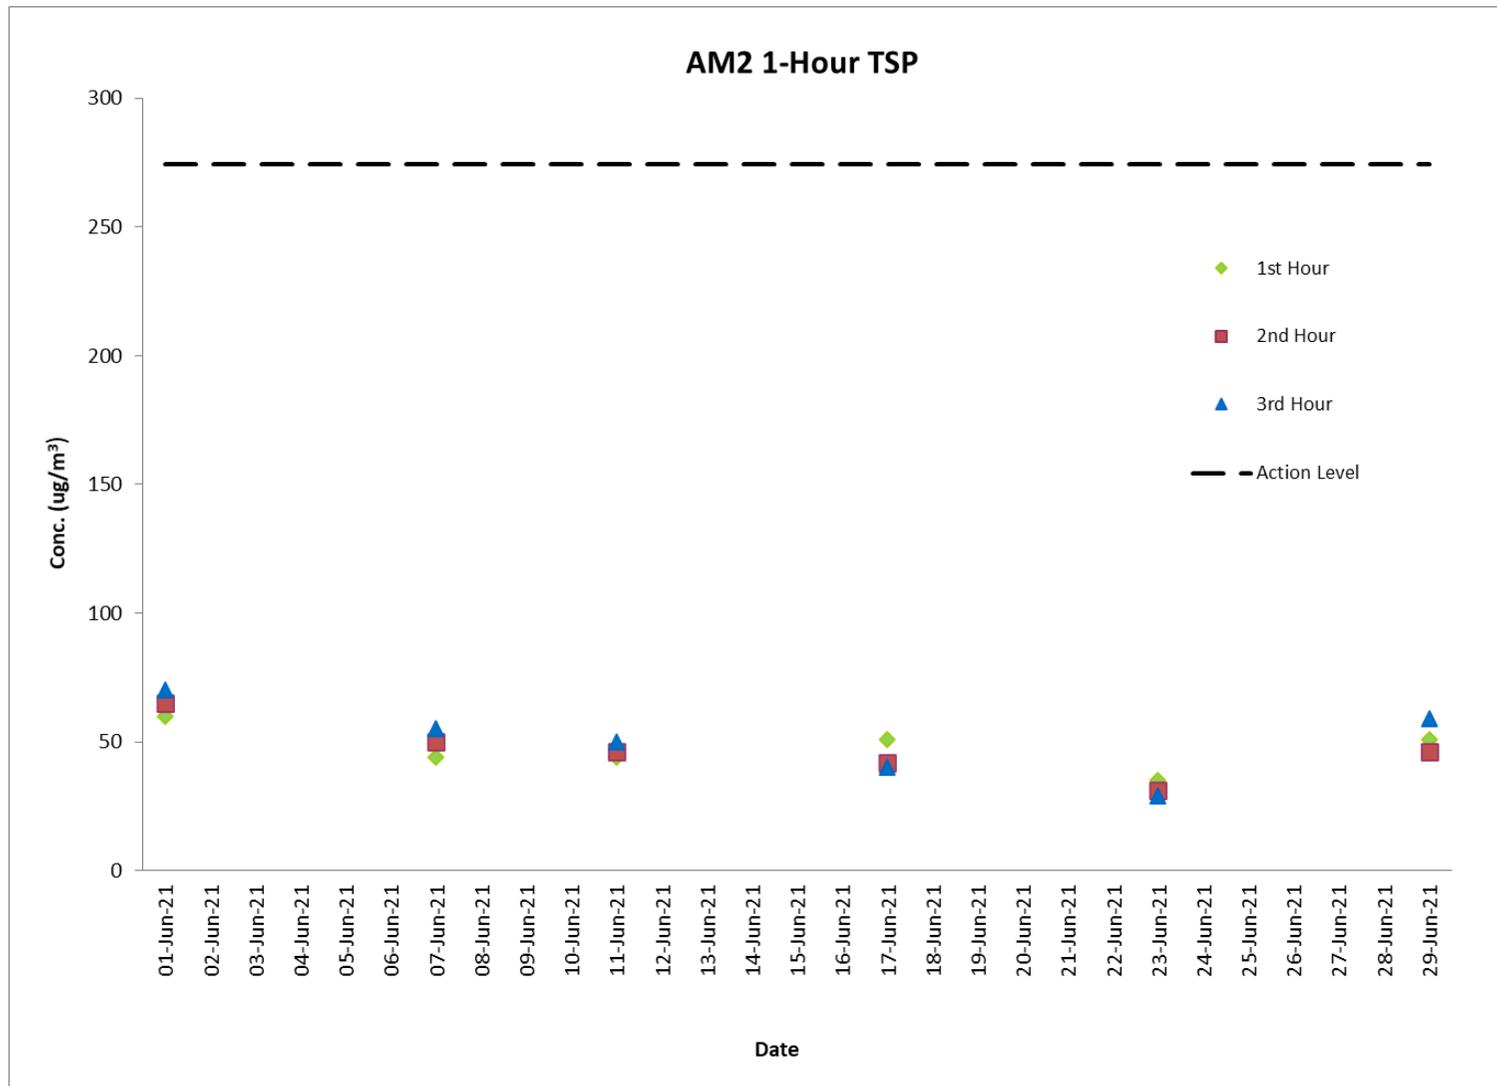
### Graphical Presentation of Air Quality Monitoring Result at Station AM2 (1-hour TSP)

Date	Weather Condition	Time	Conc. ( $\mu\text{g}/\text{m}^3$ )			Action Level ( $\mu\text{g}/\text{m}^3$ )	Limit Level ( $\mu\text{g}/\text{m}^3$ )
			1 <sup>st</sup> Hour	2 <sup>nd</sup> Hour	3 <sup>rd</sup> Hour		
01-Jun-21	Cloudy	9:00 - 12:00	60	65	70	274.2	500
07-Jun-21	Cloudy	8:55 - 11:55	44	50	55	274.2	500
11-Jun-21	Fine	8:33 - 11:33	44	46	50	274.2	500
17-Jun-21	Fine	8:33 - 11:33	51	42	40	274.2	500
23-Jun-21	Cloudy	9:15 - 12:15	35	31	29	274.2	500
29-Jun-21	Cloudy	8:43 - 11:43	51	46	59	274.2	500

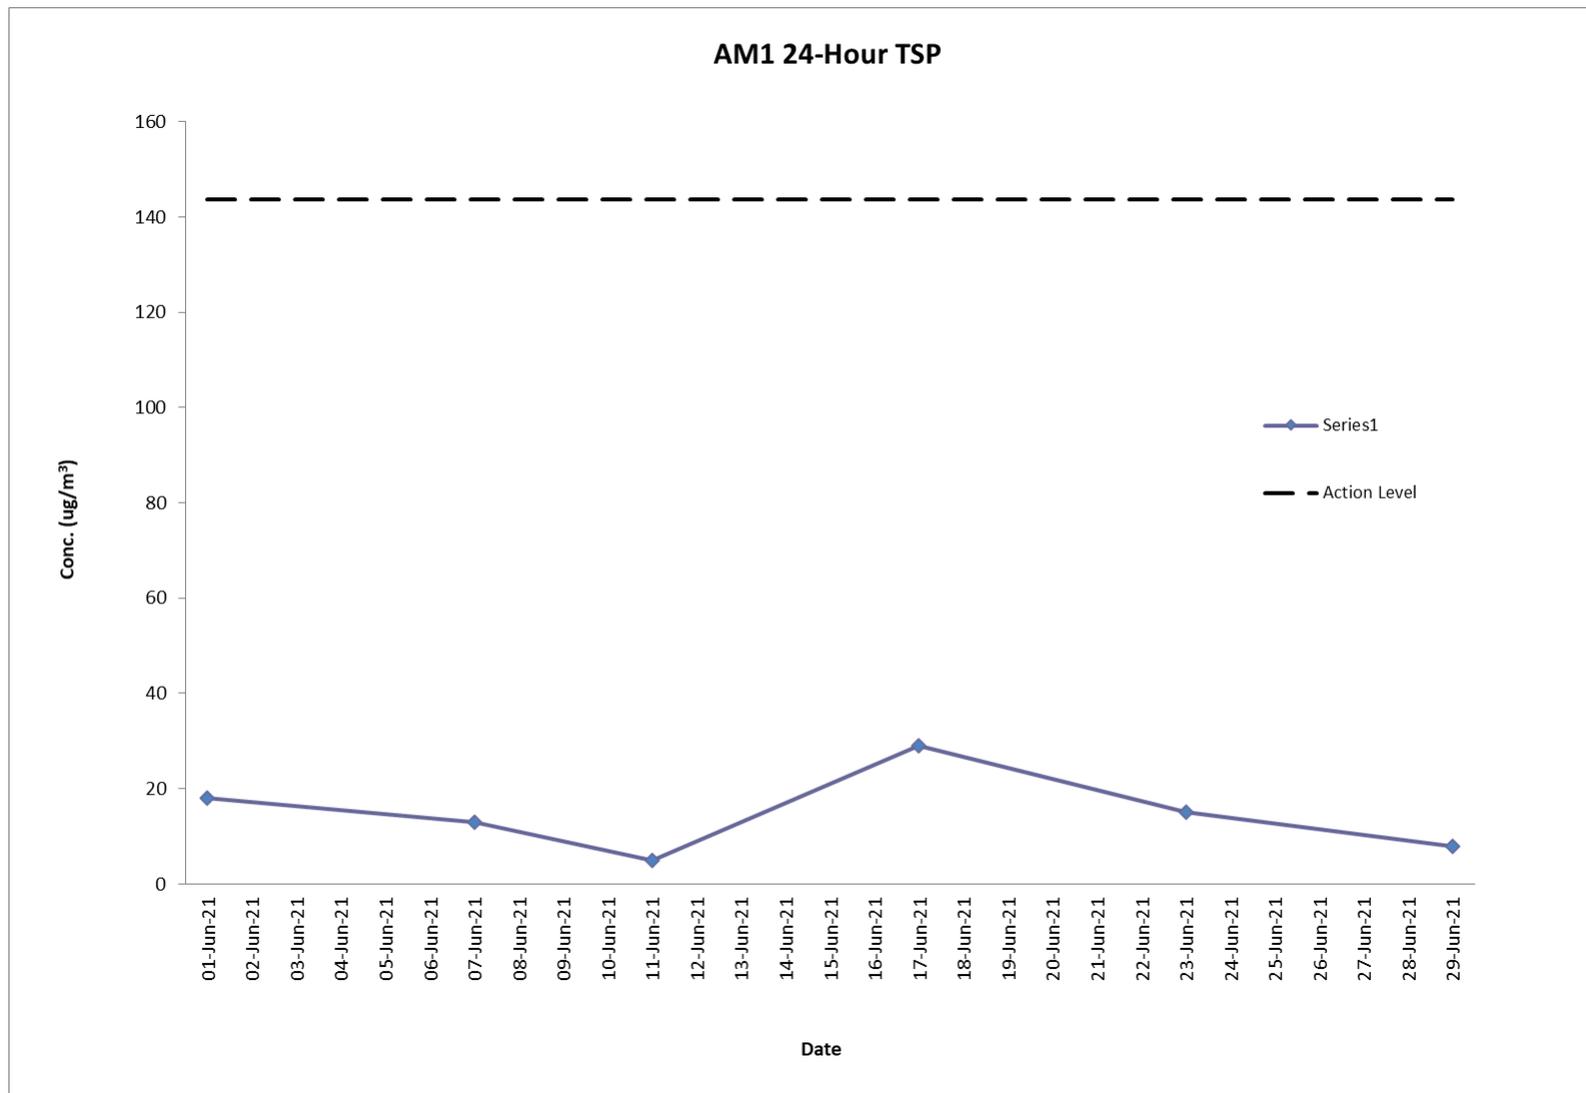
### Graphical Presentation of Air Quality Monitoring Result at Station AM1 (24-hour TSP)

Start		Finish		Filter Weight (g)		Elapsed Time Reading		Sampling Time (hrs)	Flow Rate (m <sup>3</sup> /min)			Conc. (µg/m <sup>3</sup> )	Weather Condition	Action Level	Limit Level
Date	Time	Date	Time	Initial	Final	Initial	Final		Initial	Final	Average				
01-Jun-21	08:30	02-Jun-21	08:30	2.6643	2.6944	23432.38	23456.38		24	1.17	1.17				
07-Jun-21	08:32	08-Jun-21	08:32	2.7363	2.7578	23456.38	23480.38	24	1.17	1.17	1.17	13	Cloudy	143.6	260
11-Jun-21	08:20	12-Jun-21	08:20	2.7484	2.7566	23480.38	23504.38	24	1.17	1.17	1.17	5	Fine	143.6	260
17-Jun-21	08:30	18-Jun-21	08:30	2.7487	2.7983	23504.38	23528.38	24	1.17	1.17	1.17	29	Fine	143.6	260
23-Jun-21	08:20	24-Jun-21	08:20	2.7345	2.7605	23528.38	23552.38	24	1.17	1.17	1.17	15	Cloudy	143.6	260
29-Jun-21	08:30	30-Jun-21	08:30	2.7297	2.7426	23552.38	23576.38	24	1.17	1.17	1.17	8	Cloudy	143.6	260

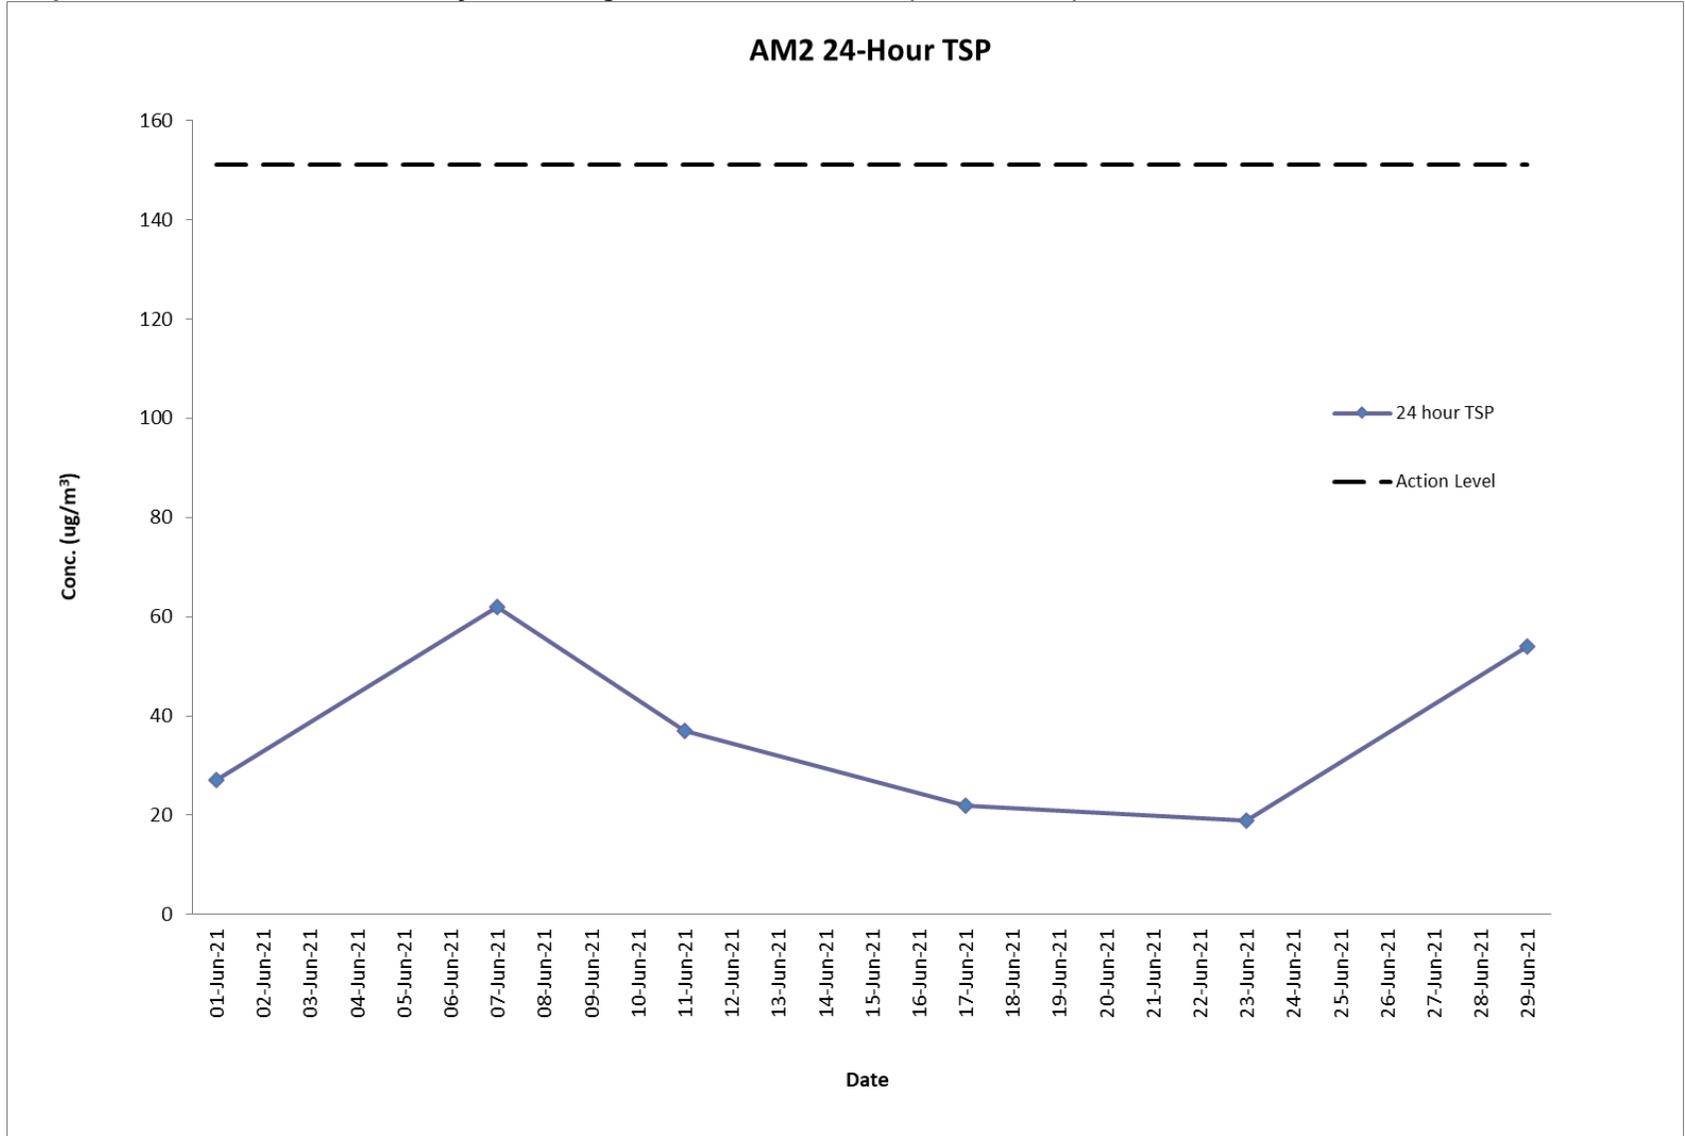
**Graphical Presentation of Air Quality Monitoring Result at Station AM2 (24-hour TSP)**

Start		Finish		Sampling Time (hrs)	Conc. ( $\mu\text{g}/\text{m}^3$ )	Weather Condition	Action Level	Limit Level
Date	Time	Date	Time					
01-Jun-21	08:47	02-Jun-21	08:47	24	27	Rainy	151.1	260
07-Jun-21	08:56	08-Jun-21	08:56	24	62	Cloudy	151.1	260
11-Jun-21	08:40	12-Jun-21	08:40	24	37	Fine	151.1	260
17-Jun-21	08:40	18-Jun-21	08:40	24	22	Fine	151.1	260
23-Jun-21	09:53	24-Jun-21	09:53	24	19	Cloudy	151.1	260
29-Jun-21	08:36	30-Jun-21	08:36	24	54	Cloudy	151.1	260

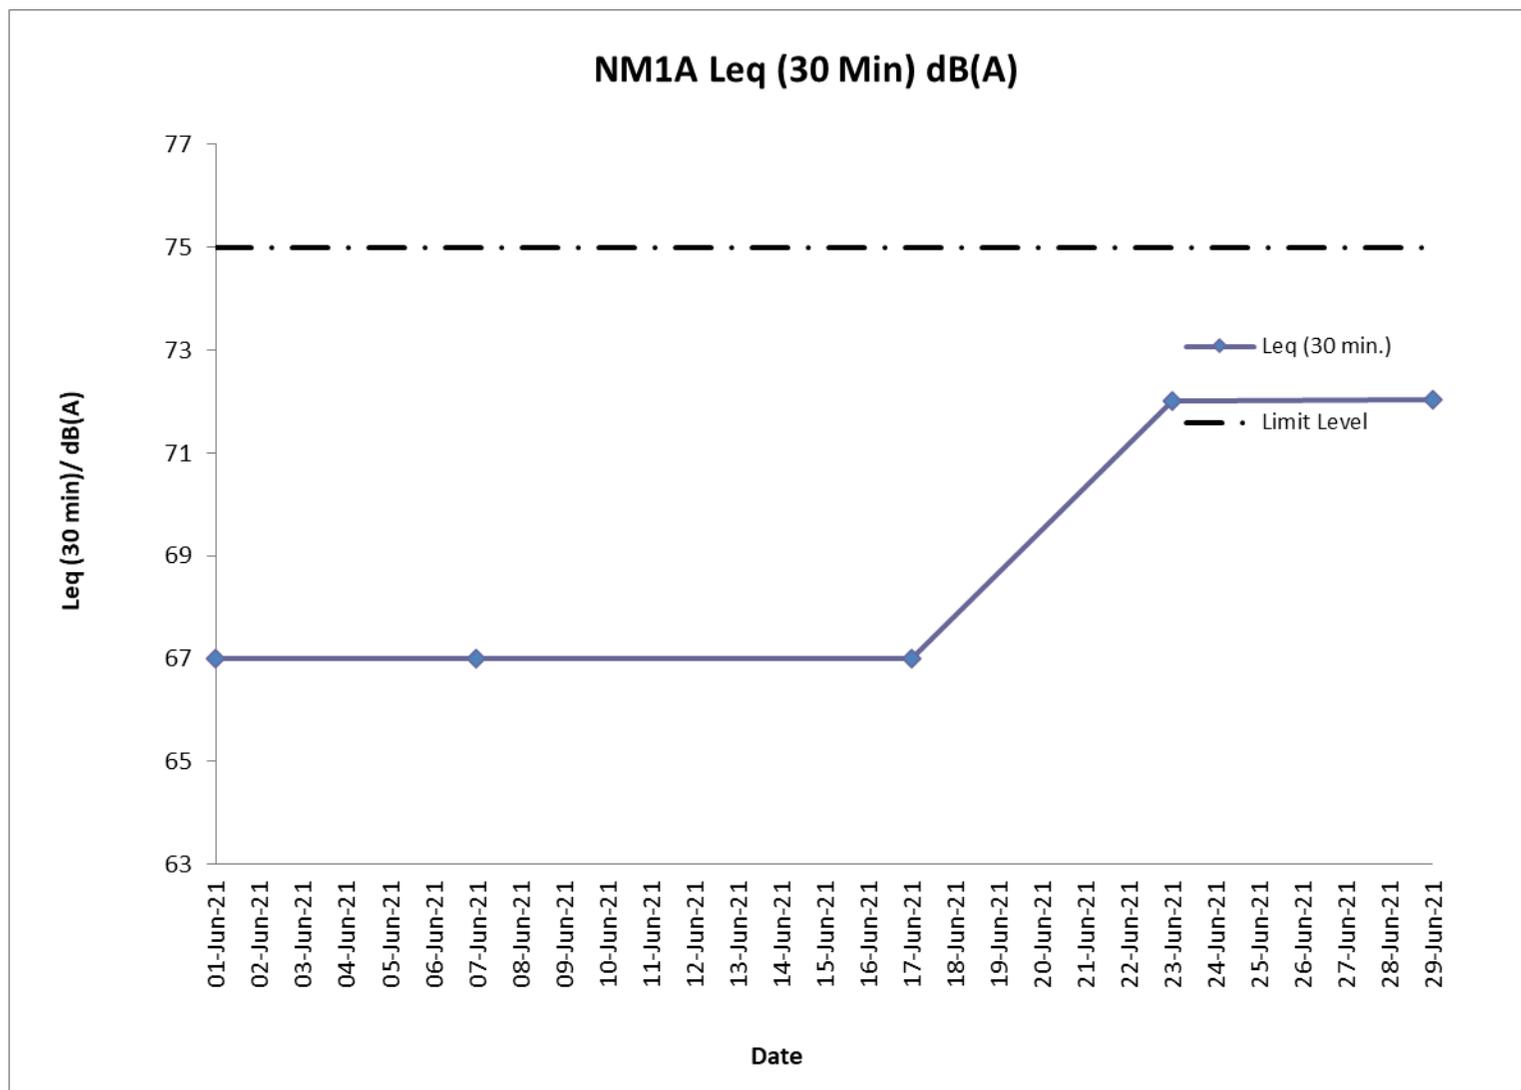
### Graphical Presentation Noise Monitoring Result at Station NM1A

Date	Time	Measured L <sub>10</sub> , dB(A)	Measured L <sub>90</sub> , dB(A)	L <sub>eq</sub> (30 min.)*, dB(A)
01-Jun-21	10:30	65.2	61.9	67
01-Jun-21	10:35	66.0	62.1	
01-Jun-21	10:40	66.5	62.3	
01-Jun-21	10:45	65.4	61.6	
01-Jun-21	10:50	65.6	61.7	
01-Jun-21	10:55	66.6	62.7	
07-Jun-21	09:39	66.6	62.9	67
07-Jun-21	09:44	65.1	61.8	
07-Jun-21	09:49	65.5	61.7	
07-Jun-21	09:54	66.3	62.5	
07-Jun-21	09:59	65.6	61.5	
07-Jun-21	10:04	65.6	61.7	
17-Jun-21	09:27	65.4	61.5	67
17-Jun-21	09:32	66.3	62.2	
17-Jun-21	09:37	65.1	61.2	
17-Jun-21	09:42	65.5	61.8	
17-Jun-21	09:47	66.0	62.9	
17-Jun-21	09:52	65.6	61.8	
23-Jun-21	08:30	70.6	67.3	72
23-Jun-21	08:35	70.9	67.6	
23-Jun-21	08:40	70.2	66.4	
23-Jun-21	08:45	71.7	67.1	
23-Jun-21	08:50	69.4	65.9	
23-Jun-21	08:55	70.6	66.3	
29-Jun-21	09:26	70.2	66.4	72
29-Jun-21	09:31	71.5	67.4	
29-Jun-21	09:36	69.2	65.9	
29-Jun-21	09:41	71.2	67.3	
29-Jun-21	09:46	71.7	67.0	
29-Jun-21	09:51	71.5	67.4

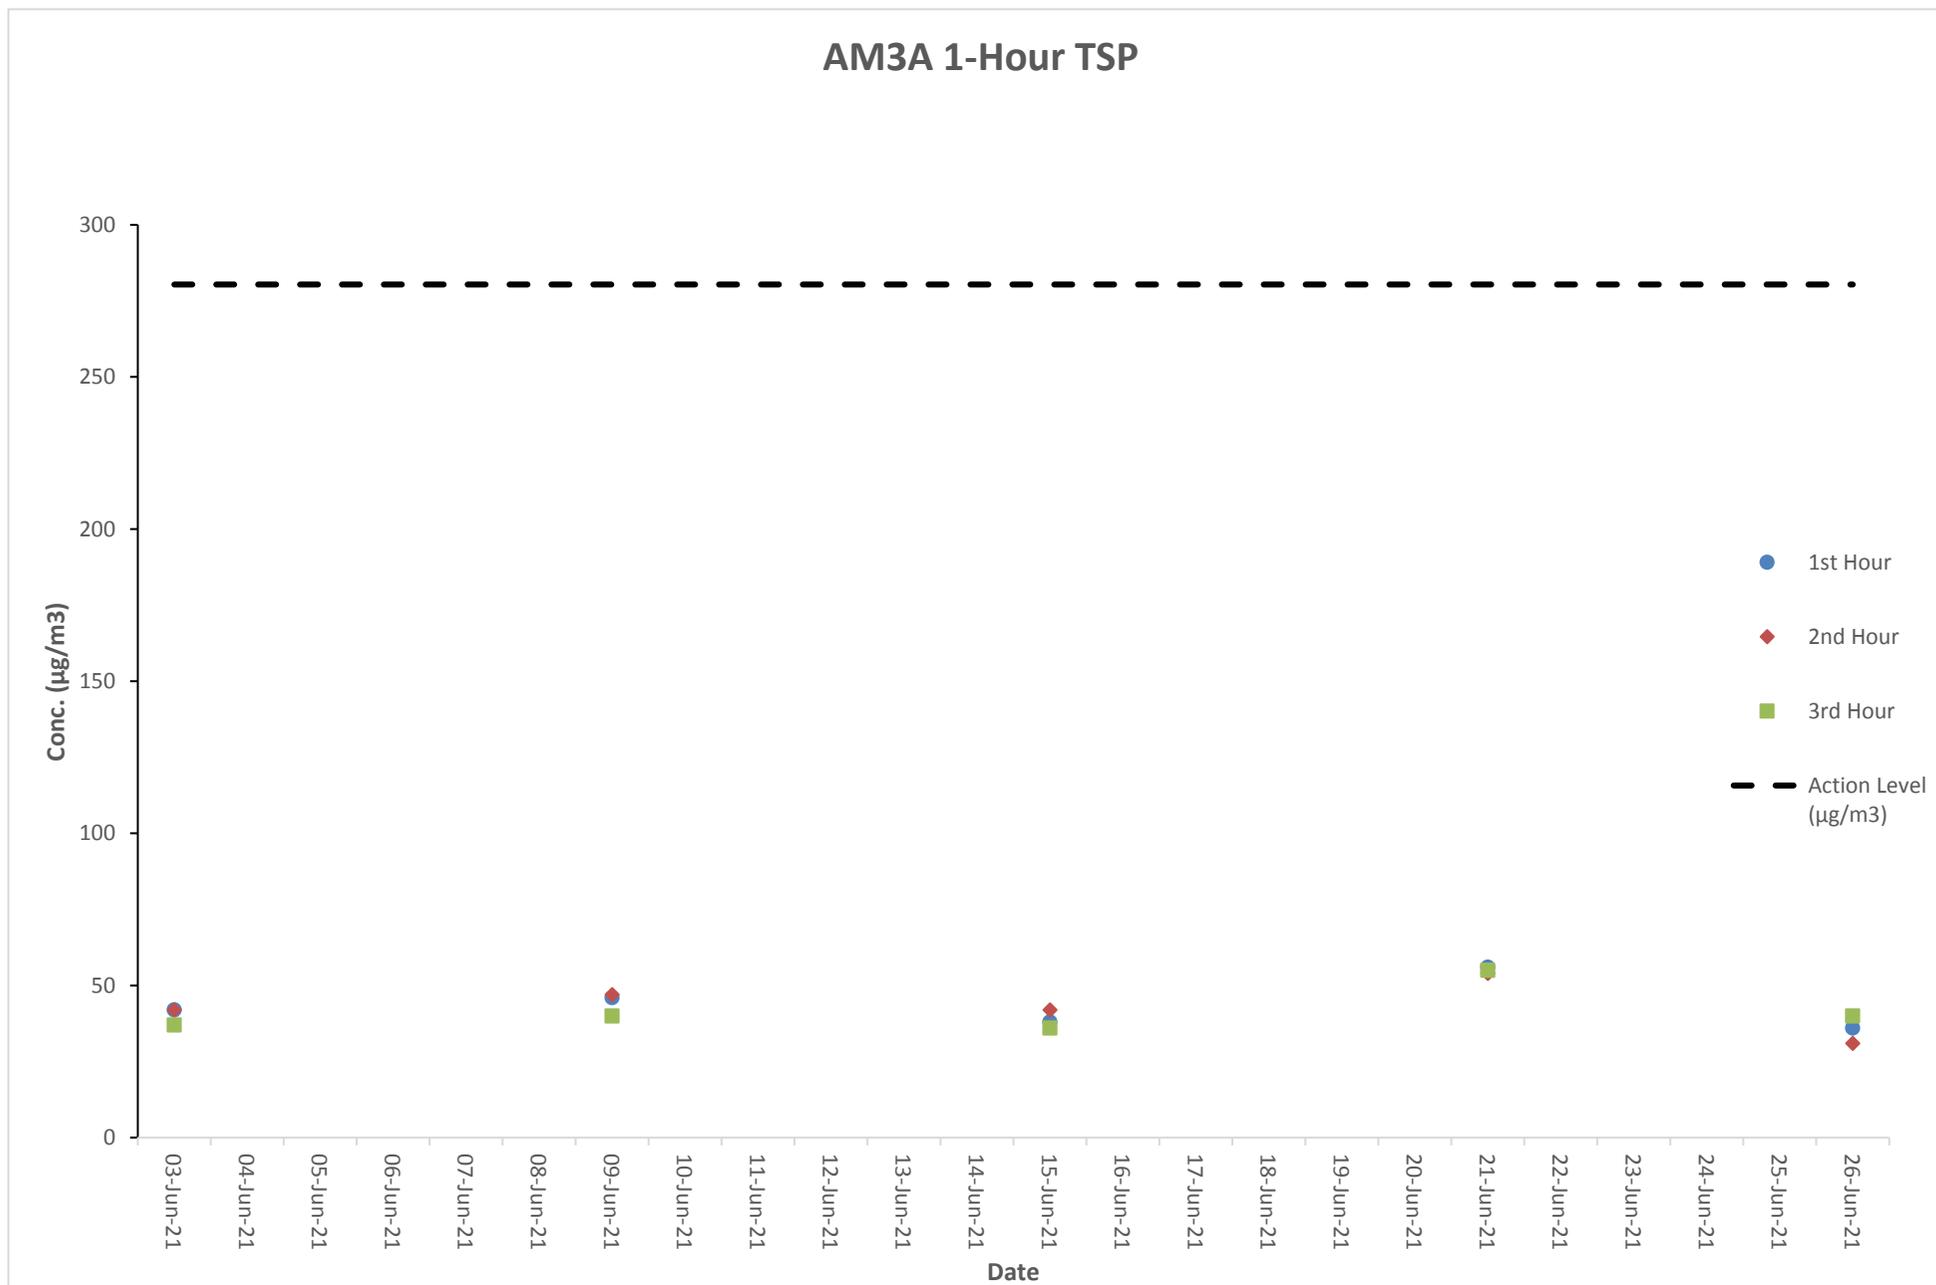
# Graphical Presentation of Air Quality Monitoring Result at Station AM3A (1-hour TSP)

Date	Weather Condition	Time		Conc. ( $\mu\text{g}/\text{m}^3$ )			Action Level	Limit Level
		Start	Finish	1st Hour	2nd Hour	3rd Hour		
03-Jun-21	Fine	14:02	17:02	42	42	37	280.4	500
09-Jun-21	Cloudy	8:01	11:01	46	47	40	280.4	500
15-Jun-21	Cloudy	14:01	17:01	38	42	36	280.4	500
21-Jun-21	Cloudy	8:03	11:03	56	54	55	280.4	500
26-Jun-21	Cloudy	14:00	17:00	36	31	40	280.4	500

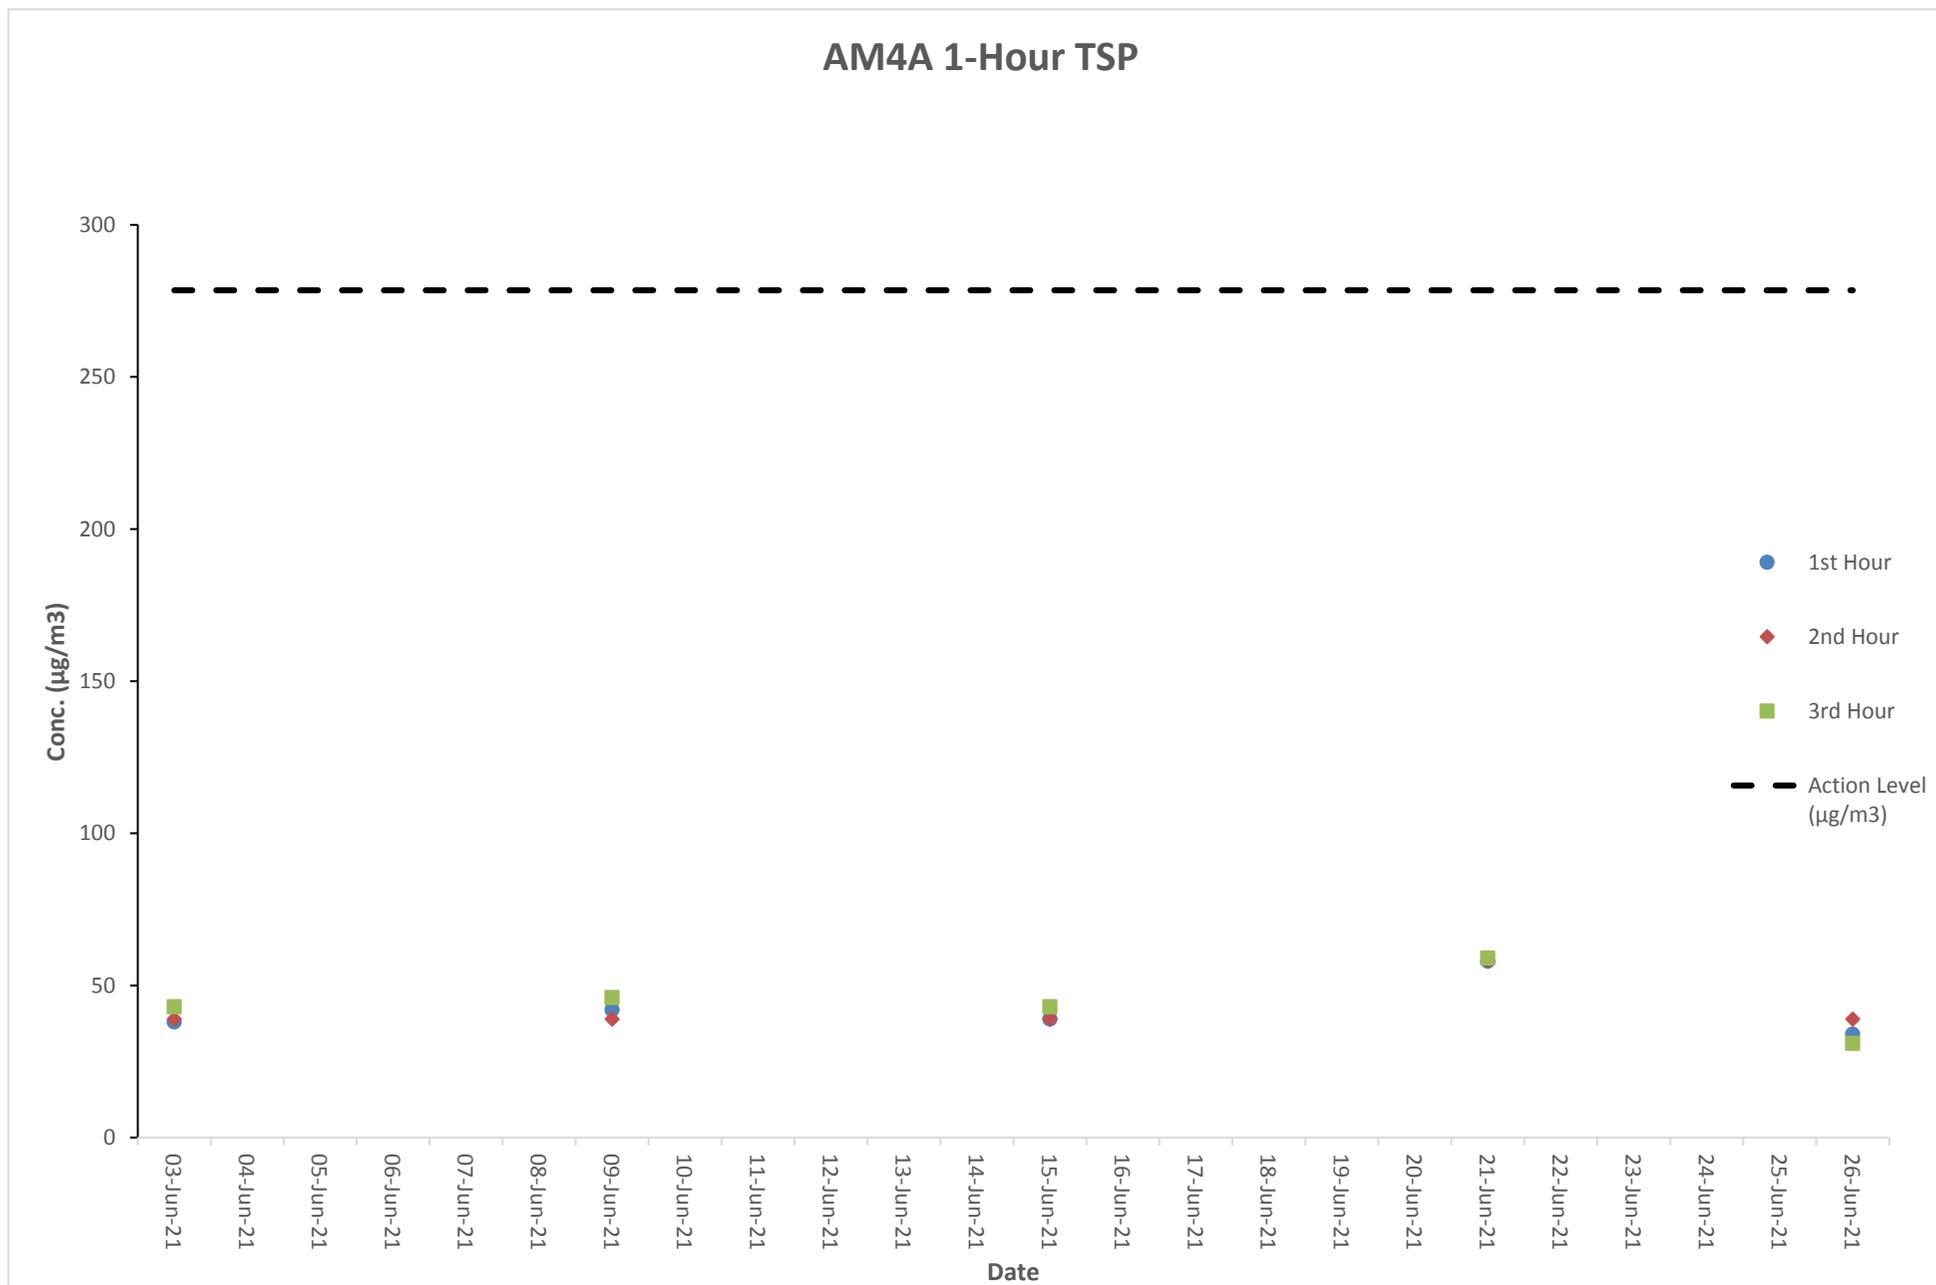
# Graphical Presentation of Air Quality Monitoring Result at Station AM4A (1-hour TSP)

Date	Weather Condition	Time		Conc. ( $\mu\text{g}/\text{m}^3$ )			Action Level	Limit Level
		Start	Finish	1st Hour	2nd Hour	3rd Hour		
03-Jun-21	Fine	14:10	17:10	38	39	43	278.5	500
09-Jun-21	Cloudy	8:09	11:09	42	39	46	278.5	500
15-Jun-21	Cloudy	14:09	17:09	39	39	43	278.5	500
21-Jun-21	Cloudy	8:11	11:11	58	58	59	278.5	500
26-Jun-21	Cloudy	14:08	17:08	34	39	31	278.5	500

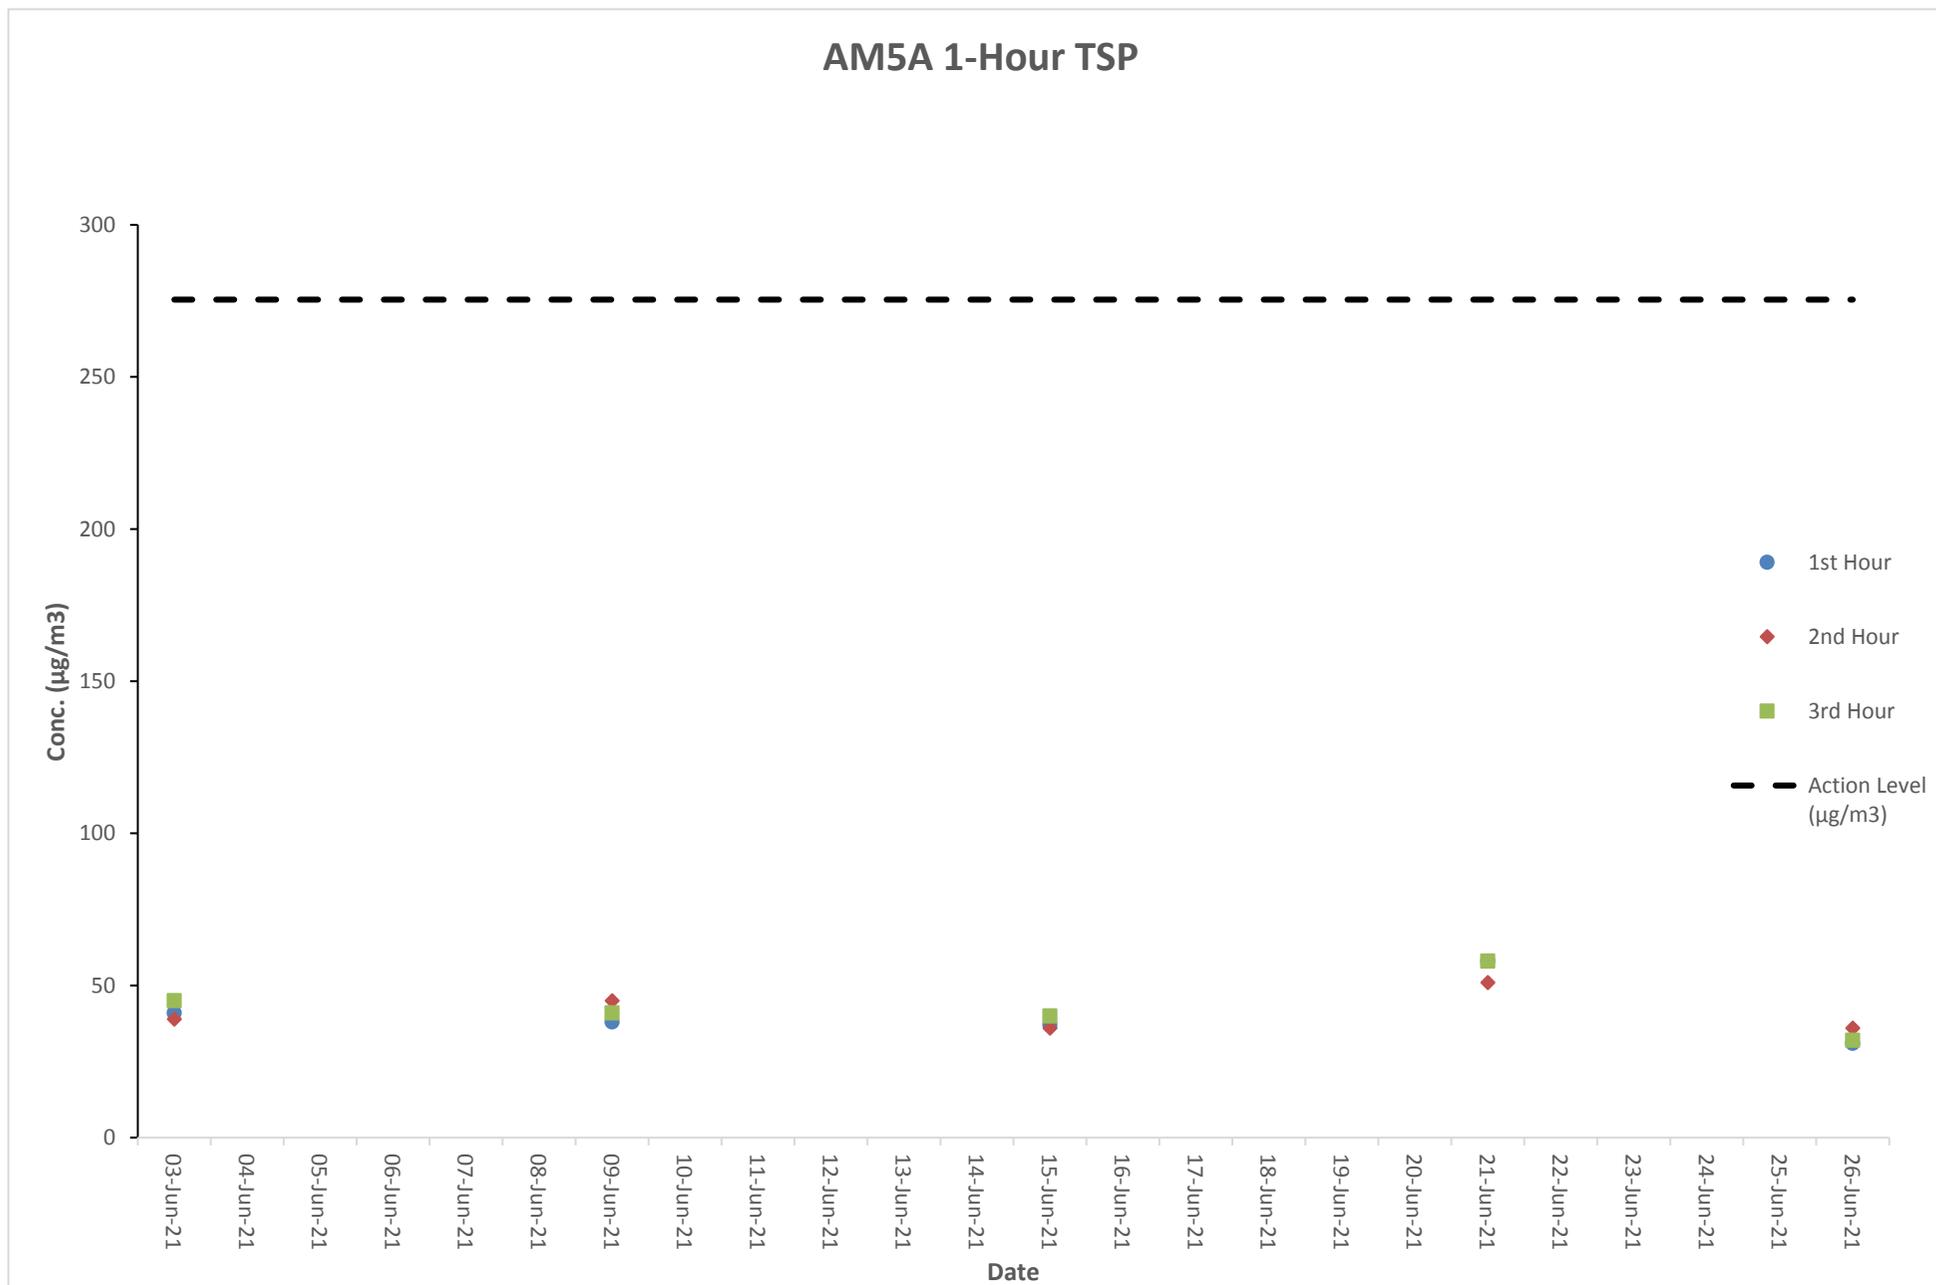
# Graphical Presentation of Air Quality Monitoring Result at Station AM5A (1-hour TSP)

Date	Weather Condition	Time		Conc. ( $\mu\text{g}/\text{m}^3$ )			Action Level	Limit Level
		Start	Finish	1st Hour	2nd Hour	3rd Hour		
03-Jun-21	Fine	14:25	17:25	41	39	45	275.4	500
09-Jun-21	Cloudy	8:26	11:26	38	45	41	275.4	500
15-Jun-21	Cloudy	14:24	17:24	37	36	40	275.4	500
21-Jun-21	Cloudy	8:28	11:28	58	51	58	275.4	500
26-Jun-21	Cloudy	14:23	17:23	31	36	32	275.4	500

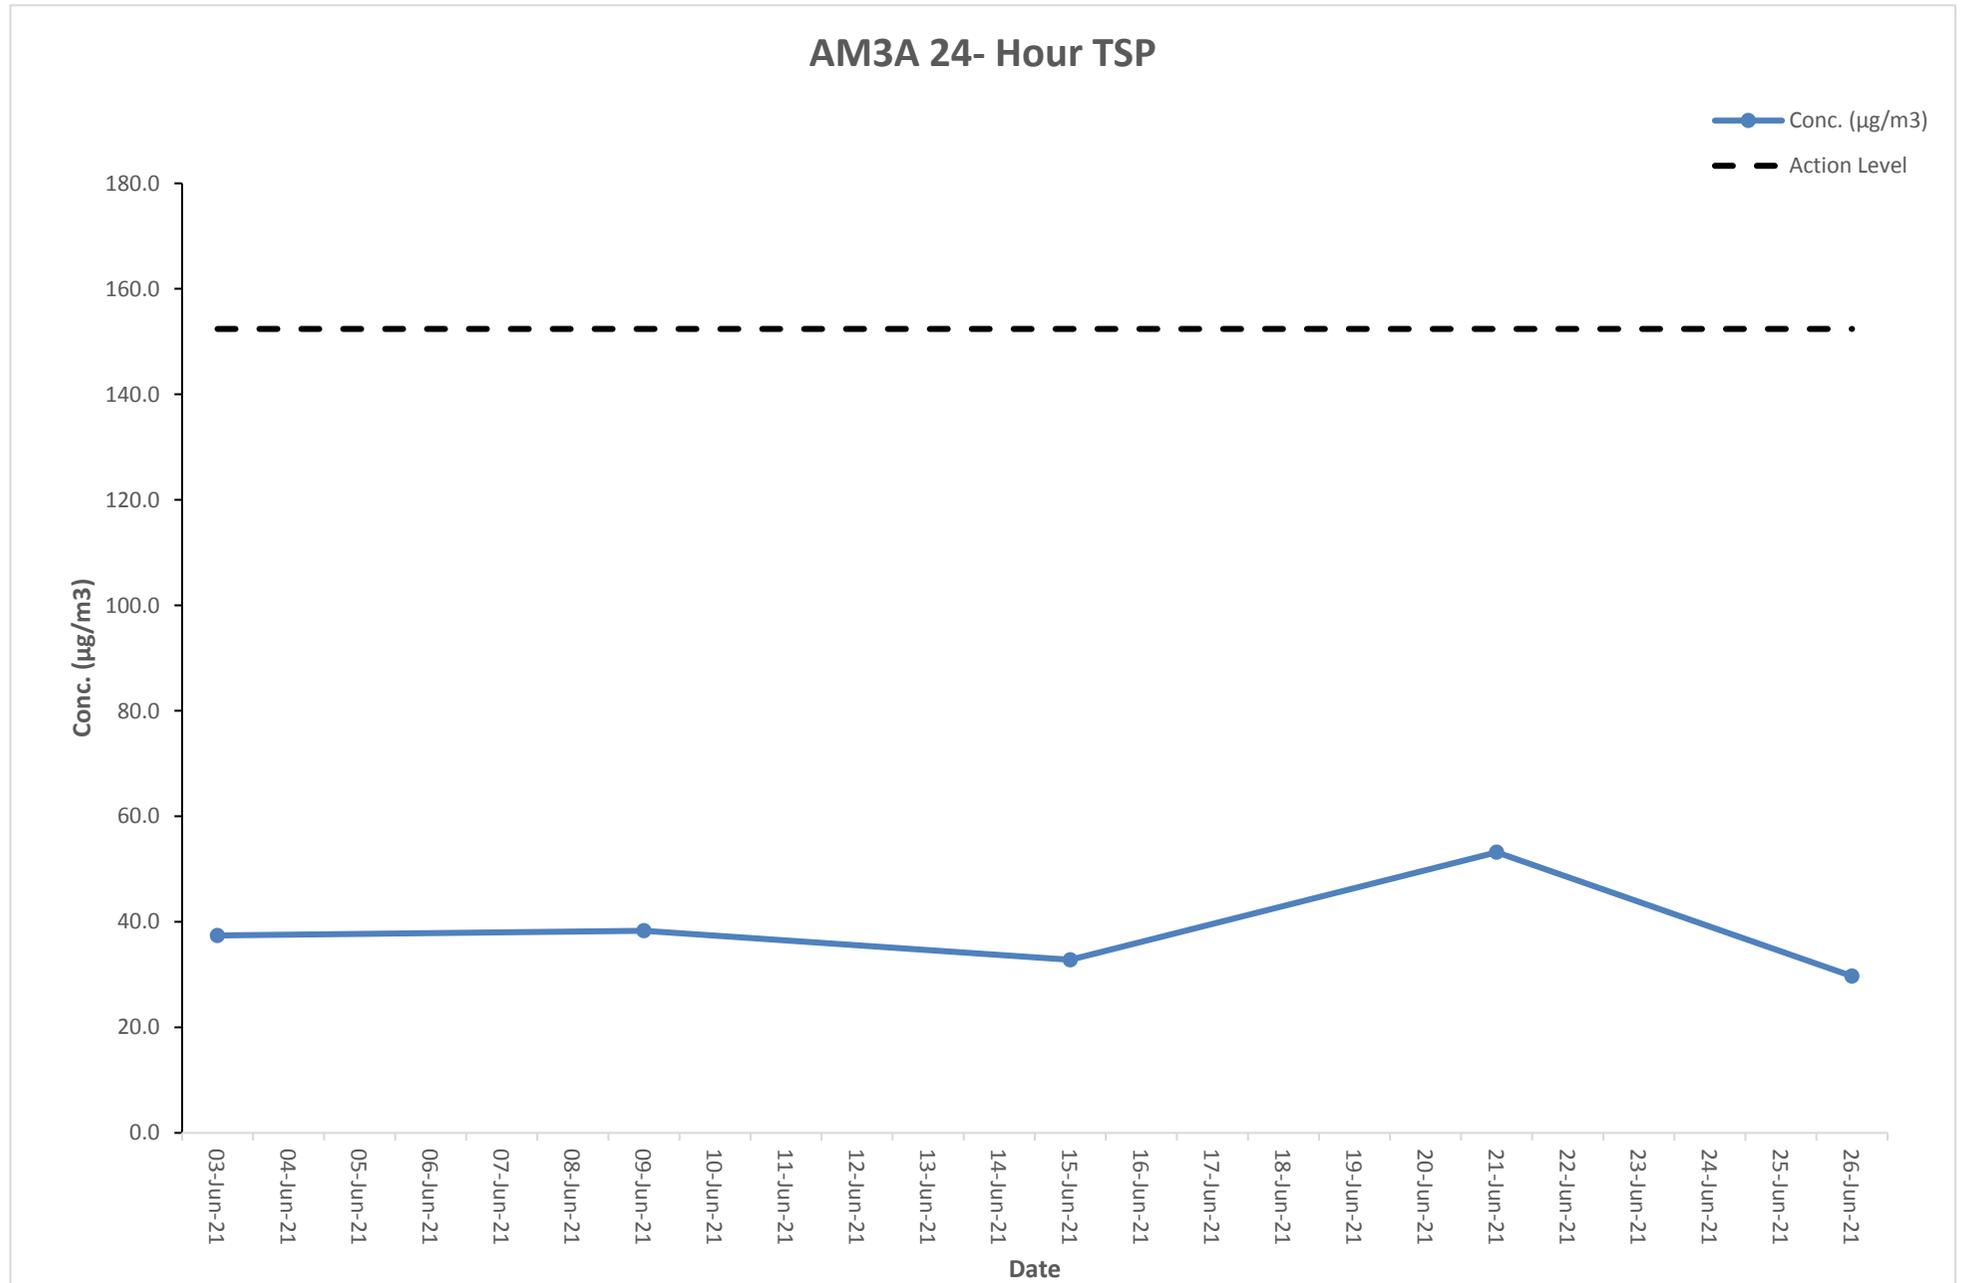
# Graphical Presentation of Air Quality Monitoring Result at Station AM3A (24-hour TSP)

Start		Finish		Filter Weight (g)		Elapsed Time Reading		Sampling Time (hrs)	Flow Rate (m <sup>3</sup> /min)			Conc. (µg/m <sup>3</sup> )	Weather Condition	Action Level	Limit Level
Date	Time	Date	Time	Initial	Final	Initial	Final		Initial	Final	Average				
03-Jun-21	10:00AM	04-Jun-21	10:00AM	2.8077	2.8679	2060.8	2084.8	24	1.12	1.12	1.12	37.4	Sunny	152.4	260
09-Jun-21	10:00AM	10-Jun-21	10:00AM	2.8075	2.8691	2084.8	2108.8	24	1.12	1.12	1.12	38.3	Rainy	152.4	260
15-Jun-21	10:00AM	16-Jun-21	10:00AM	2.8090	2.8617	2108.8	2132.8	24	1.12	1.12	1.12	32.8	Rainy	152.4	260
21-Jun-21	10:00AM	22-Jun-21	10:00AM	2.8069	2.8926	2132.8	2156.8	24	1.12	1.12	1.12	53.2	Cloudy	152.4	260
26-Jun-21	10:00AM	27-Jun-21	10:00AM	2.8051	2.8528	2156.8	2180.8	24	1.12	1.12	1.12	29.7	Rainy	152.4	260
