# **Development at West Kowloon Cultural District**

**Monthly Environmental Monitoring and Audit (EM&A) Report  
for June 2021**

**12 July 2021**

# Part-1: EM&A at Lyric Theatre Complex

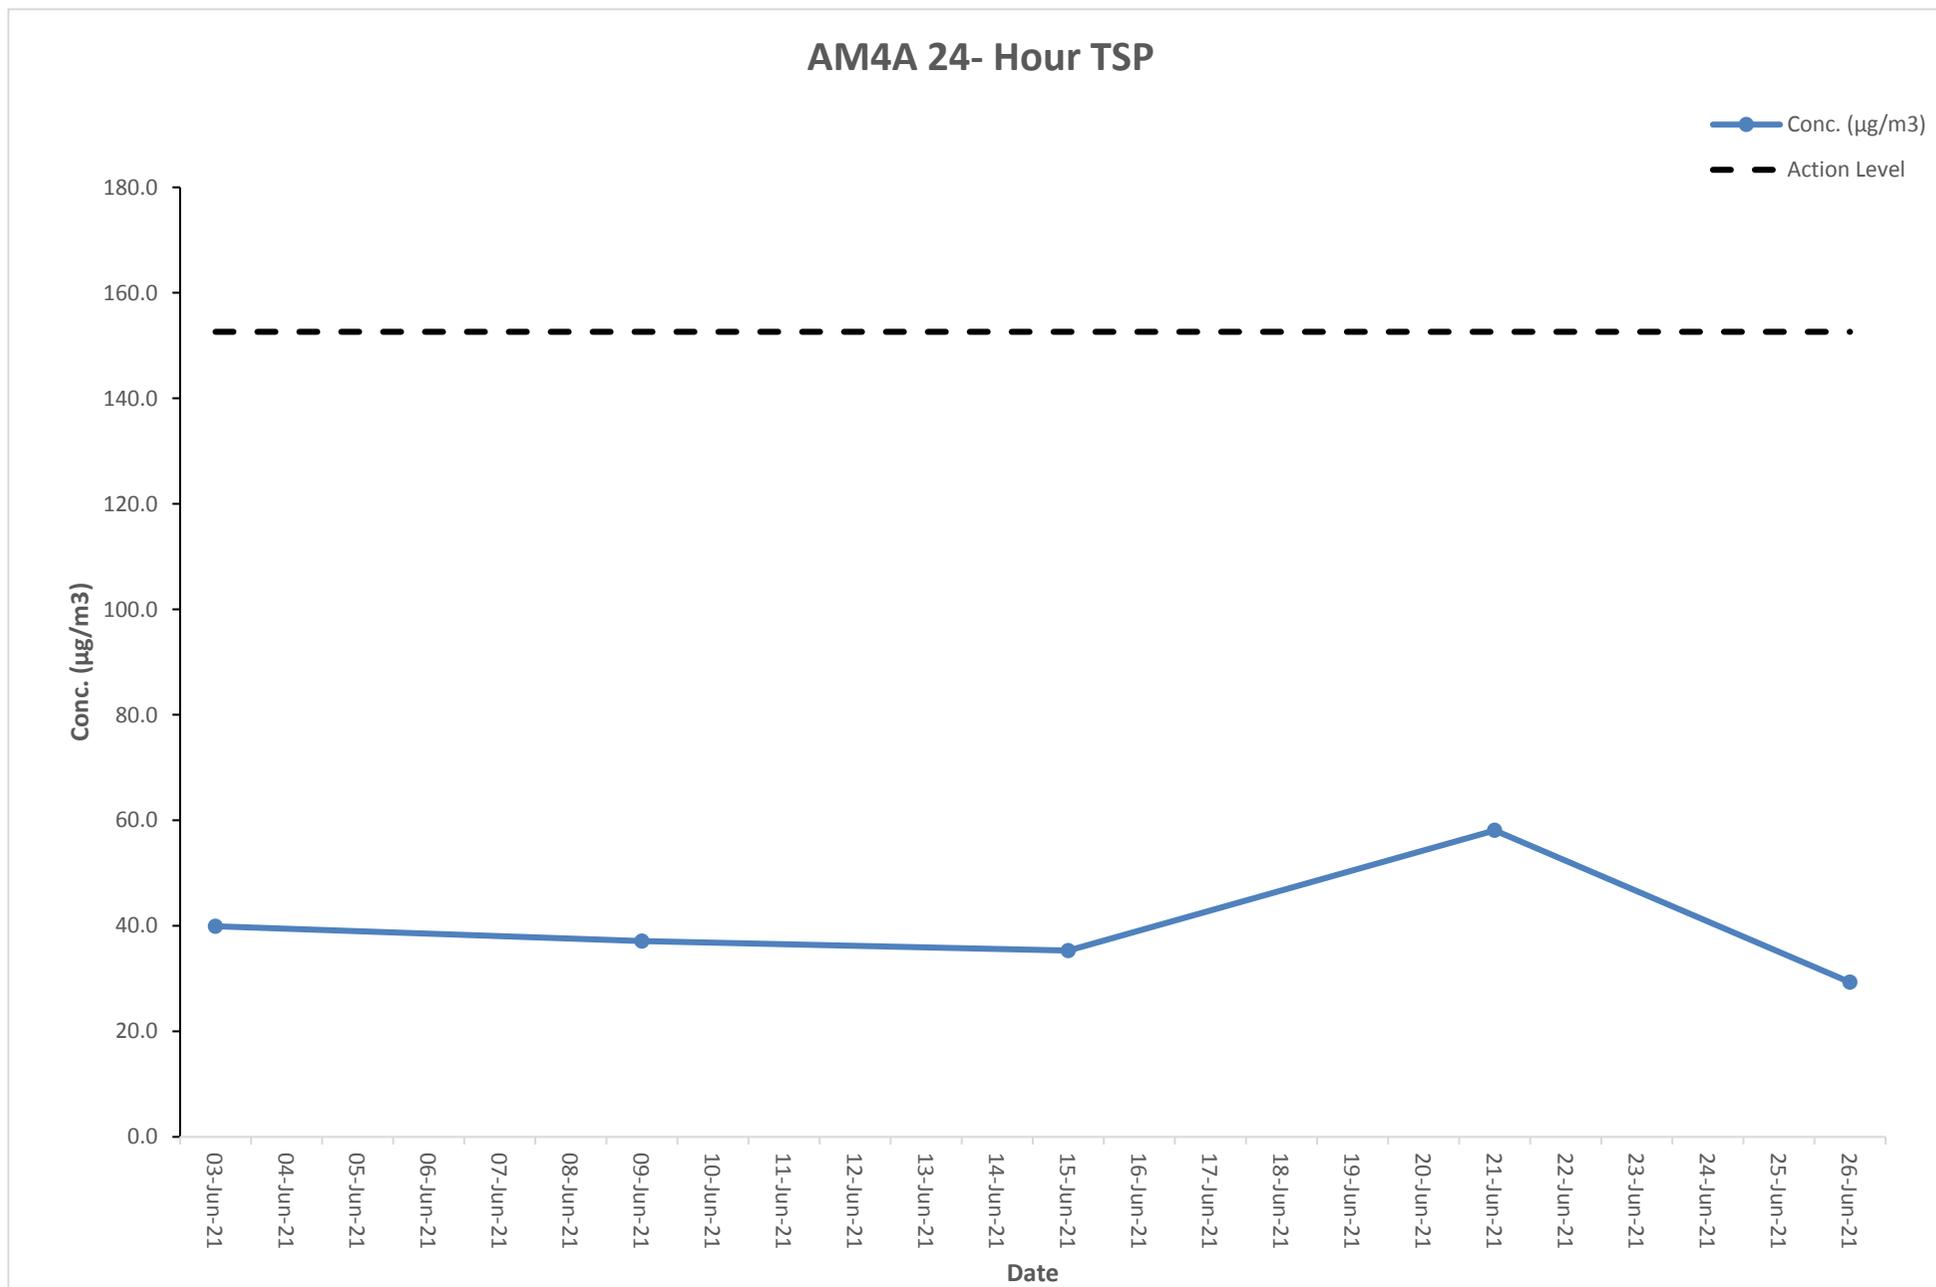
# Graphical Presentation of Air Quality Monitoring Result at Station AM4A (24-hour TSP)

Start		Finish		Filter Weight (g)		Elapsed Time Reading		Sampling Time (hrs)	Flow Rate (m <sup>3</sup> /min)			Conc. (µg/m <sup>3</sup> )	Weather Condition	Action Level	Limit Level
Date	Time	Date	Time	Initial	Final	Initial	Final		Initial	Final	Average				
03-Jun-21	10:00AM	04-Jun-21	10:00AM	2.8054	2.8696	2480.4	2504.4	24	1.12	1.12	1.12	39.9	Sunny	152.6	260
09-Jun-21	10:00AM	10-Jun-21	10:00AM	2.8038	2.8636	2504.4	2528.4	24	1.12	1.12	1.12	37.1	Rainy	152.6	260
15-Jun-21	10:00AM	16-Jun-21	10:00AM	2.8016	2.8584	2528.4	2552.4	24	1.12	1.12	1.12	35.3	Rainy	152.6	260
21-Jun-21	10:00AM	22-Jun-21	10:00AM	2.8040	2.8975	2552.4	2576.4	24	1.12	1.12	1.12	58.1	Cloudy	152.6	260
26-Jun-21	10:00AM	27-Jun-21	10:00AM	2.8037	2.8508	2576.4	2600.4	24	1.12	1.12	1.12	29.3	Rainy	152.6	260

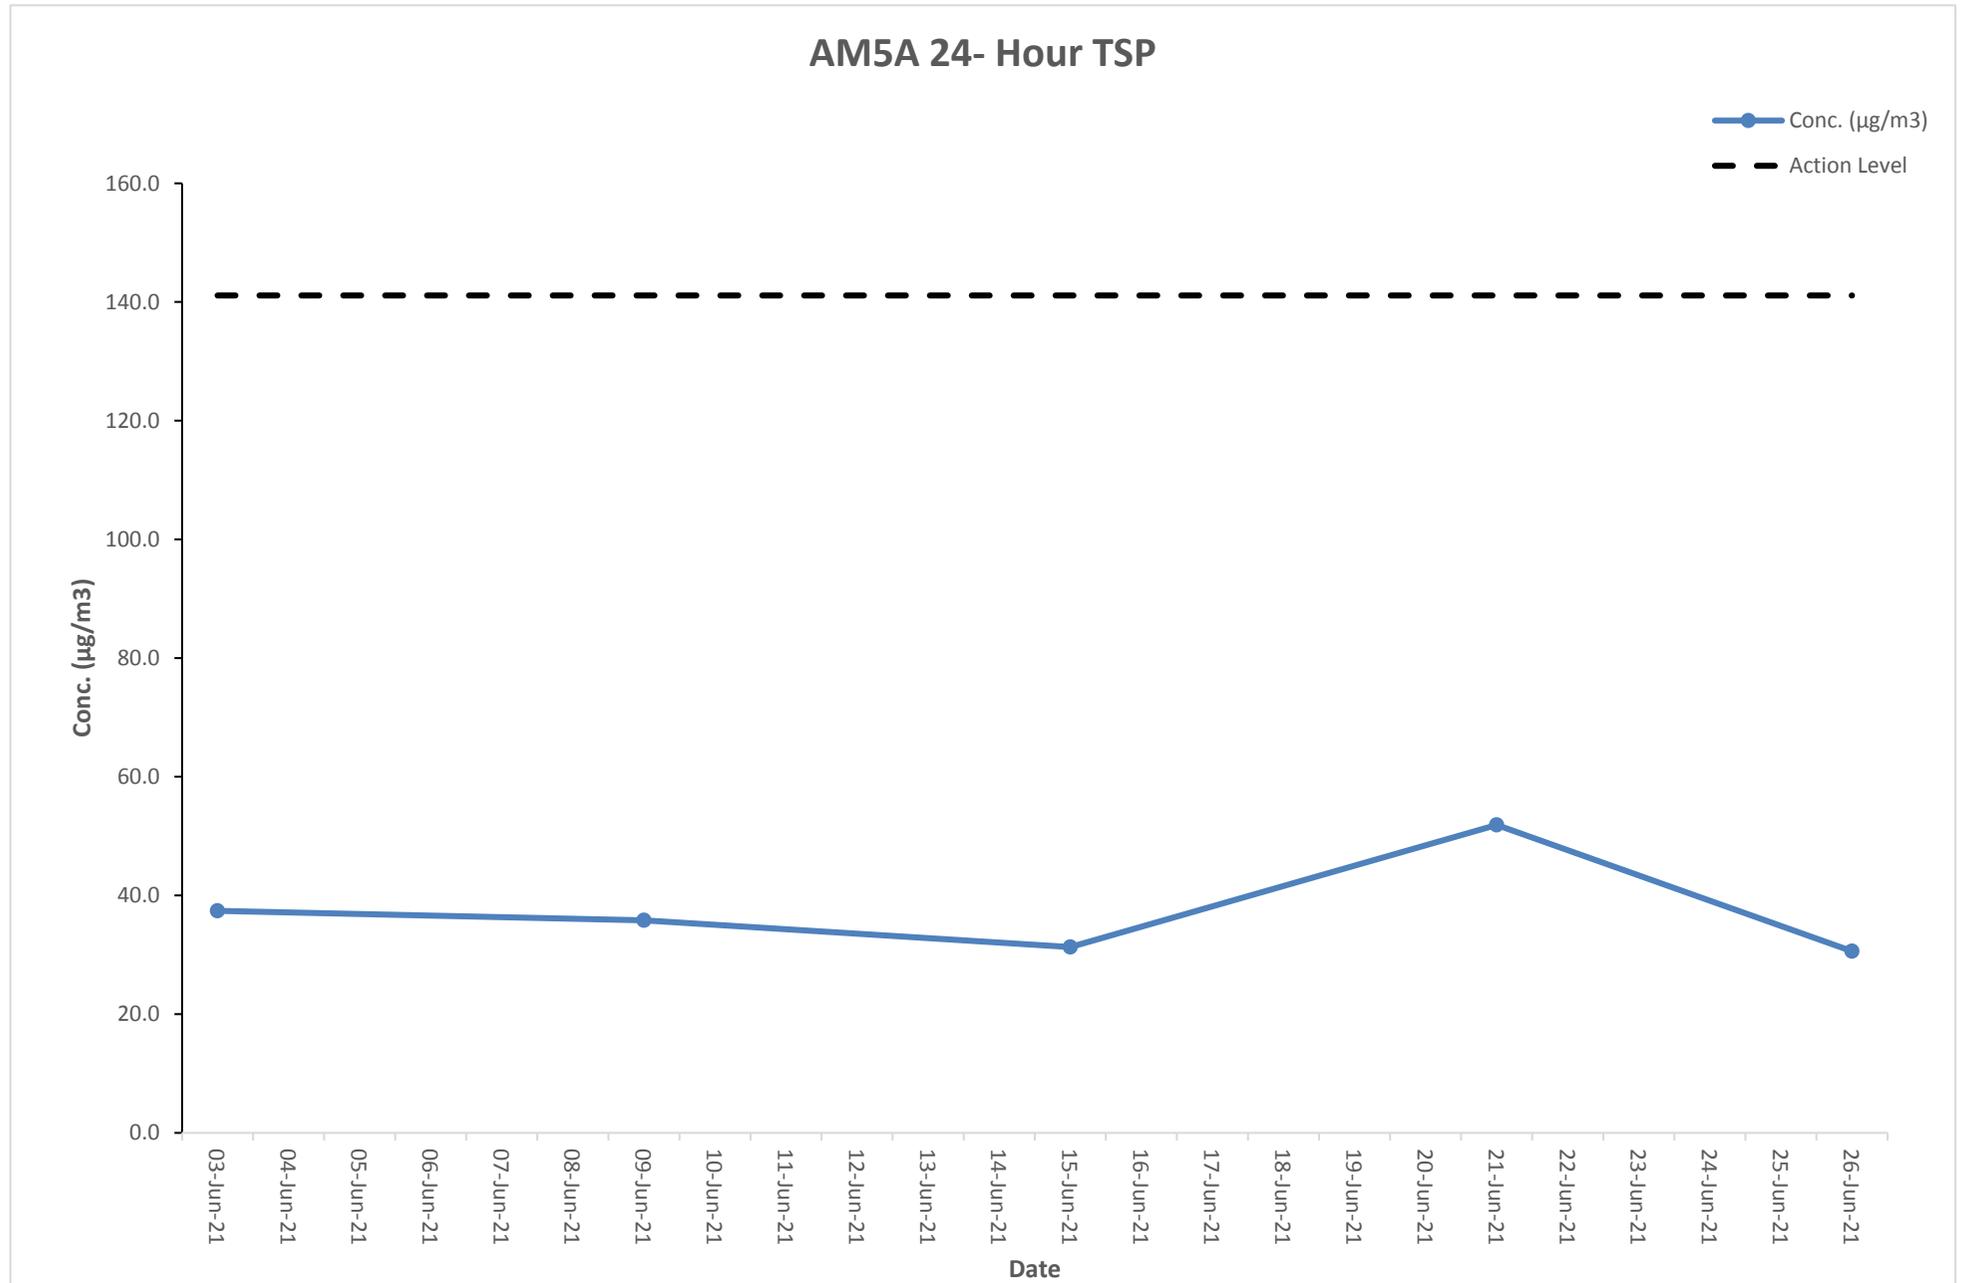
# Graphical Presentation of Air Quality Monitoring Result at Station AM5A (24-hour TSP)

Start		Finish		Filter Weight (g)		Elapsed Time Reading		Sampling Time (hrs)	Flow Rate (m <sup>3</sup> /min)			Conc. (µg/m <sup>3</sup> )	Weather Condition	Action Level	Limit Level
Date	Time	Date	Time	Initial	Final	Initial	Final		Initial	Final	Average				
03-Jun-21	10:00AM	04-Jun-21	10:00AM	2.8074	2.8676	2620.6	2644.6	24	1.12	1.12	1.12	37.4	Sunny	141.1	260
09-Jun-21	10:00AM	10-Jun-21	10:00AM	2.8052	2.8628	2644.6	2668.6	24	1.12	1.12	1.12	35.8	Rainy	141.1	260
15-Jun-21	10:00AM	16-Jun-21	10:00AM	2.8042	2.8545	2668.6	2692.6	24	1.12	1.12	1.12	31.3	Rainy	141.1	260
21-Jun-21	10:00AM	22-Jun-21	10:00AM	2.8028	2.8863	2692.6	2716.6	24	1.12	1.12	1.12	51.9	Cloudy	141.1	260
26-Jun-21	10:00AM	27-Jun-21	10:00AM	2.8013	2.8506	2716.6	2740.6	24	1.12	1.12	1.12	30.6	Rainy	141.1	260

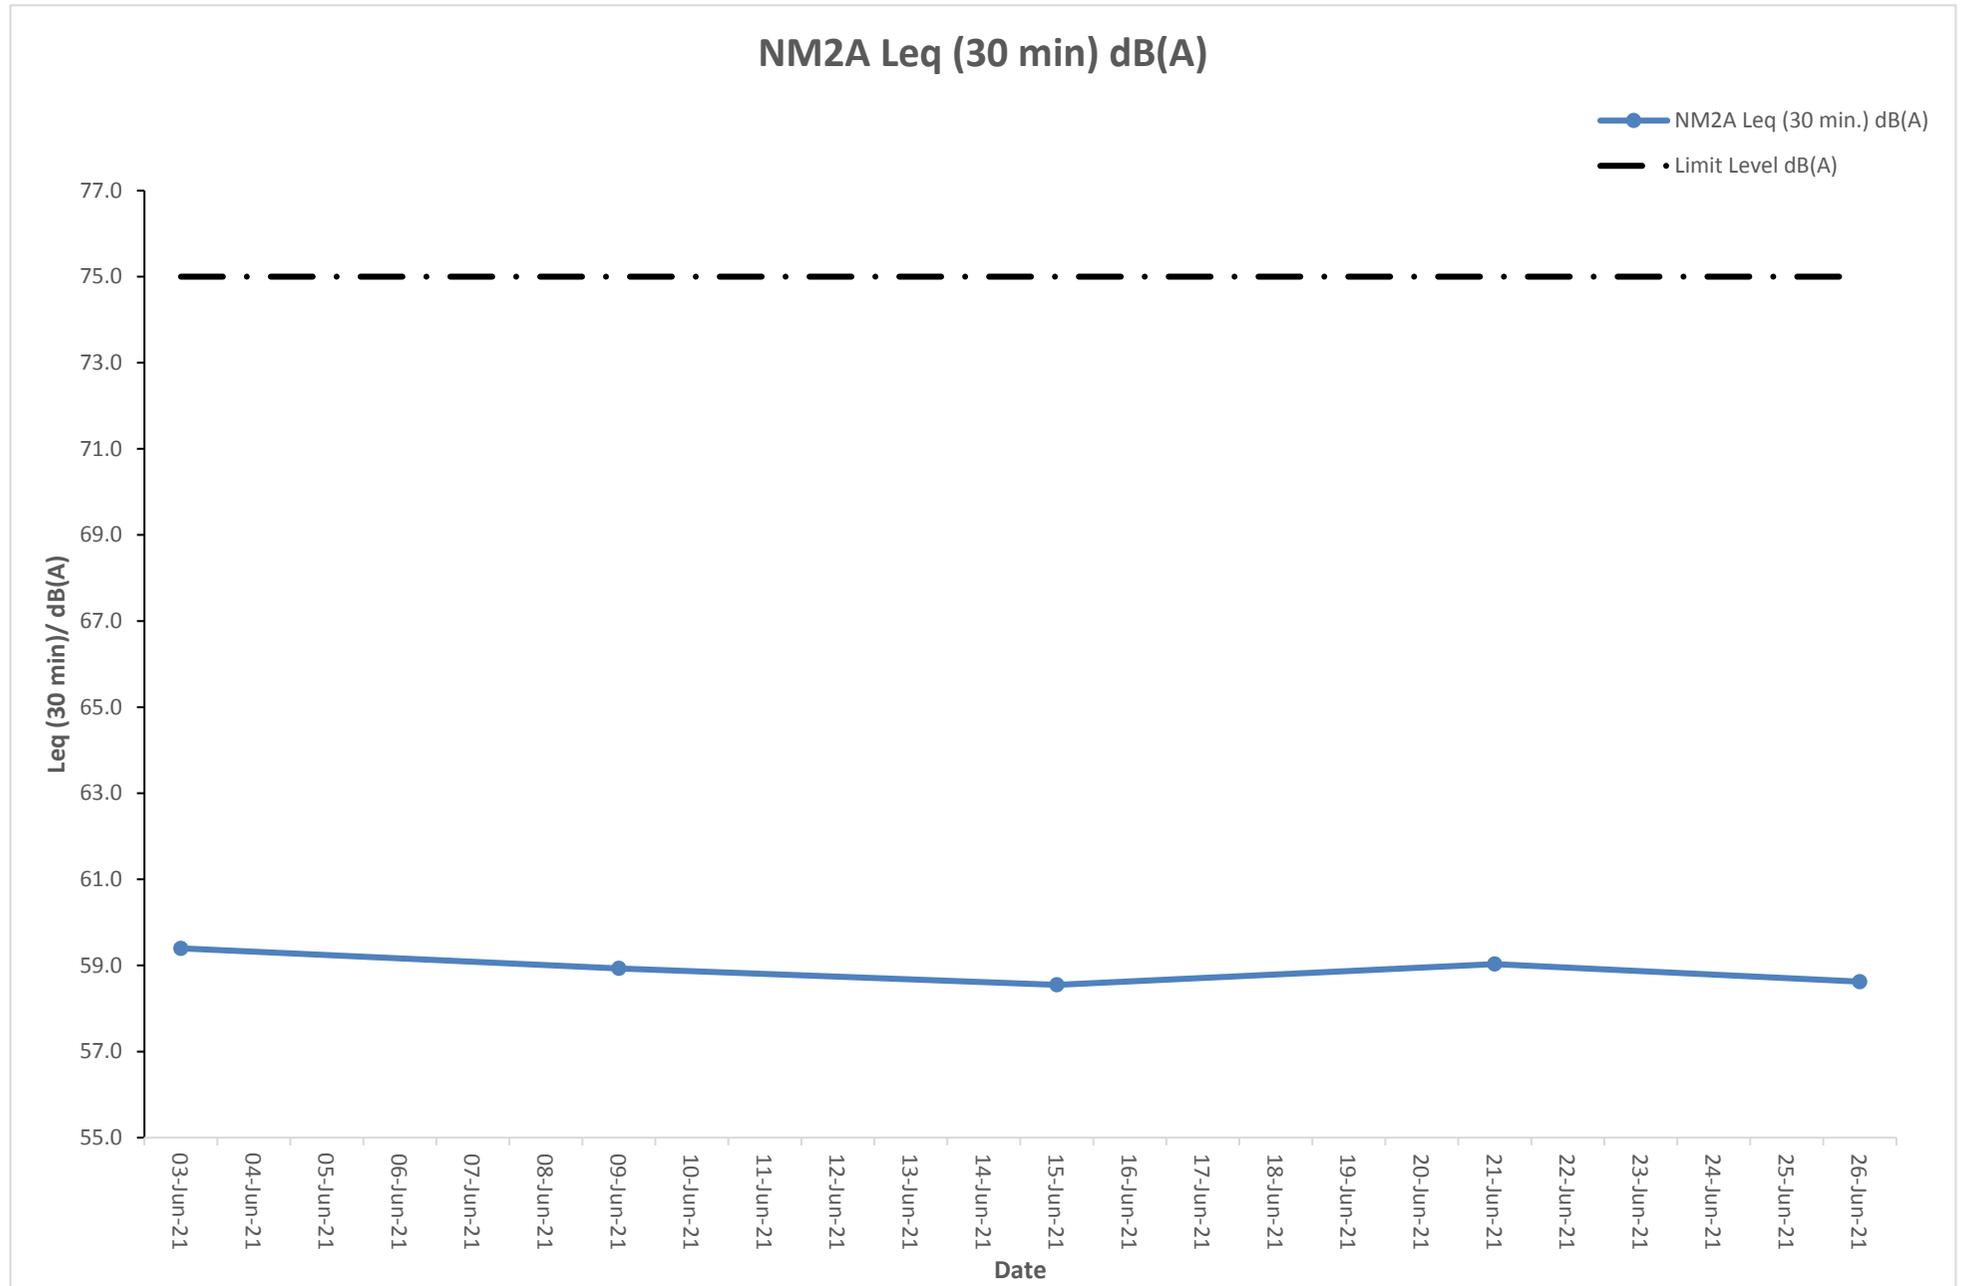
# Graphical Presentation of Noise Monitoring Result at Station NM2A

Date	Time	Measured L10 dB(A)	Measured L90 dB(A)	Leq (30 min.) dB(A)
03-Jun-21	14:32	62.3	56.5	59.4
03-Jun-21	14:37	64.4	55.9	
03-Jun-21	14:42	64.0	55.3	
03-Jun-21	14:47	64.1	55.0	
03-Jun-21	14:52	62.6	54.1	
03-Jun-21	14:57	64.2	54.6	
09-Jun-21	8:31	63.4	54.2	58.9
09-Jun-21	8:36	64.3	55.4	
09-Jun-21	8:41	62.4	56.1	
09-Jun-21	8:46	64.5	56.3	
09-Jun-21	8:51	62.5	55.9	
09-Jun-21	8:56	62.9	54.5	
15-Jun-21	14:31	63.7	55.7	58.6
15-Jun-21	14:36	64.4	56.0	
15-Jun-21	14:41	64.0	56.8	
15-Jun-21	14:46	64.0	56.8	
15-Jun-21	14:51	64.3	54.5	
15-Jun-21	14:56	62.6	55.3	
21-Jun-21	8:33	62.1	54.1	59.0
21-Jun-21	8:38	62.6	54.6	
21-Jun-21	8:43	62.7	55.4	
21-Jun-21	8:48	64.1	54.8	
21-Jun-21	8:53	63.4	56.0	
21-Jun-21	8:58	63.0	54.7	
26-Jun-21	14:30	63.1	55.3	58.6
26-Jun-21	14:35	63.8	56.1	
26-Jun-21	14:40	63.9	55.9	
26-Jun-21	14:45	64.5	56.6	
26-Jun-21	14:50	62.7	56.7	
26-Jun-21	14:55	64.0	54.3

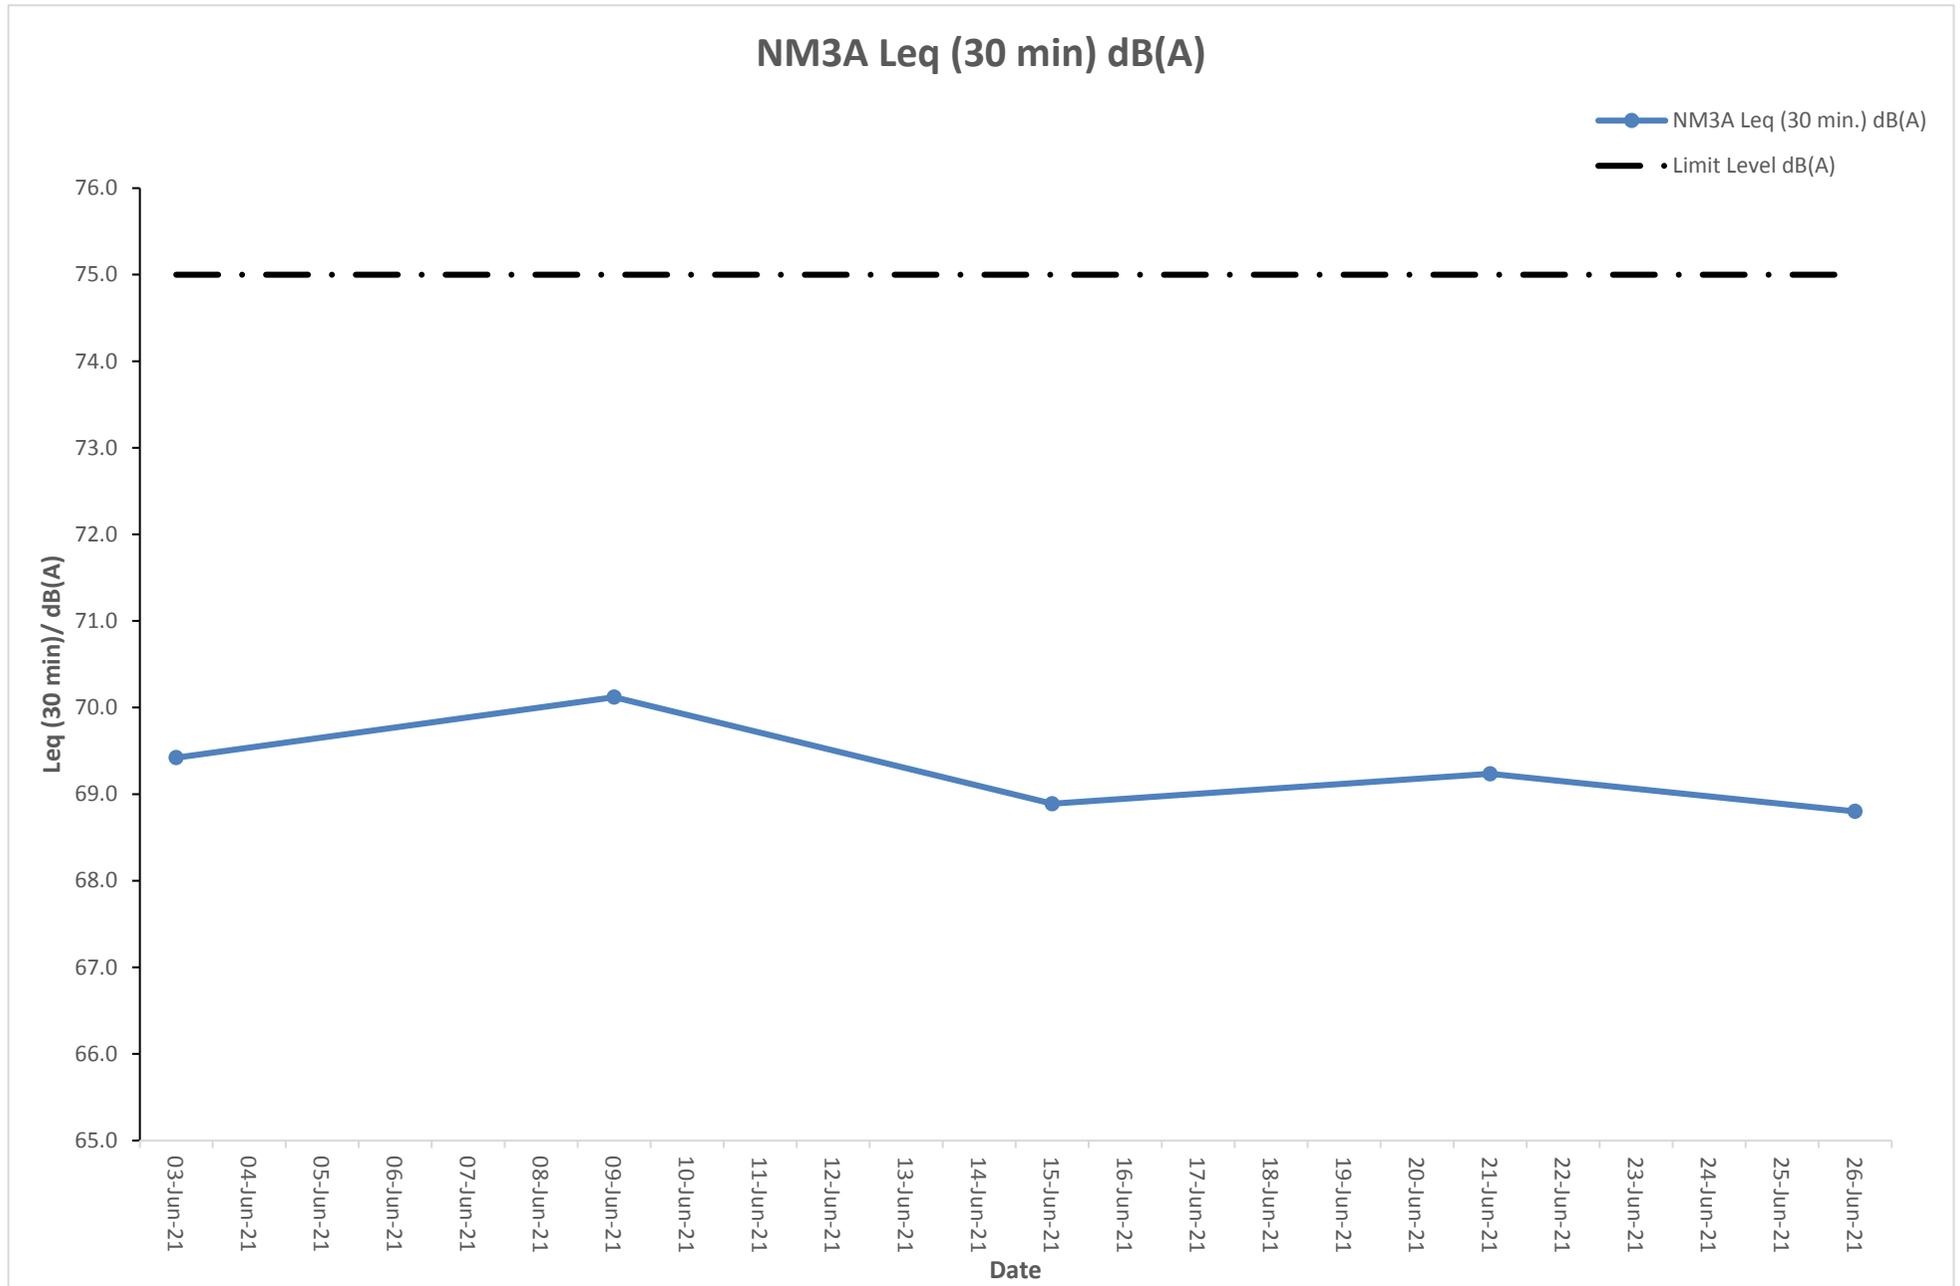
# Graphical Presentation of Noise Monitoring Result at Station NM3A

Date	Time	Measured L10 dB(A)	Measured L90 dB(A)	Leq (30 min.) dB(A)
03-Jun-21	16:02	73.0	66.7	69.4
03-Jun-21	16:07	73.1	67.3	
03-Jun-21	16:12	74.1	66.6	
03-Jun-21	16:17	73.2	67.4	
03-Jun-21	16:22	73.5	66.5	
03-Jun-21	16:27	72.7	66.7	
09-Jun-21	10:04	72.2	65.2	70.1
09-Jun-21	10:09	73.5	66.9	
09-Jun-21	10:14	72.0	66.6	
09-Jun-21	10:19	72.4	66.6	
09-Jun-21	10:24	72.0	67.9	
09-Jun-21	10:29	72.1	65.0	
15-Jun-21	16:01	72.6	65.5	68.9
15-Jun-21	16:06	72.8	67.7	
15-Jun-21	16:11	71.7	65.1	
15-Jun-21	16:16	71.4	65.5	
15-Jun-21	16:21	73.1	66.3	
15-Jun-21	16:26	73.2	66.5	
21-Jun-21	10:06	71.6	65.0	69.2
21-Jun-21	10:11	73.3	66.8	
21-Jun-21	10:16	74.0	65.0	
21-Jun-21	10:21	73.6	65.0	
21-Jun-21	10:26	72.2	66.4	
21-Jun-21	10:31	71.6	66.9	
26-Jun-21	16:00	72.8	66.5	68.8
26-Jun-21	16:05	73.5	65.0	
26-Jun-21	16:10	73.4	65.9	
26-Jun-21	16:15	73.5	67.7	
26-Jun-21	16:20	73.4	67.9	
26-Jun-21	16:25	72.0	65.3

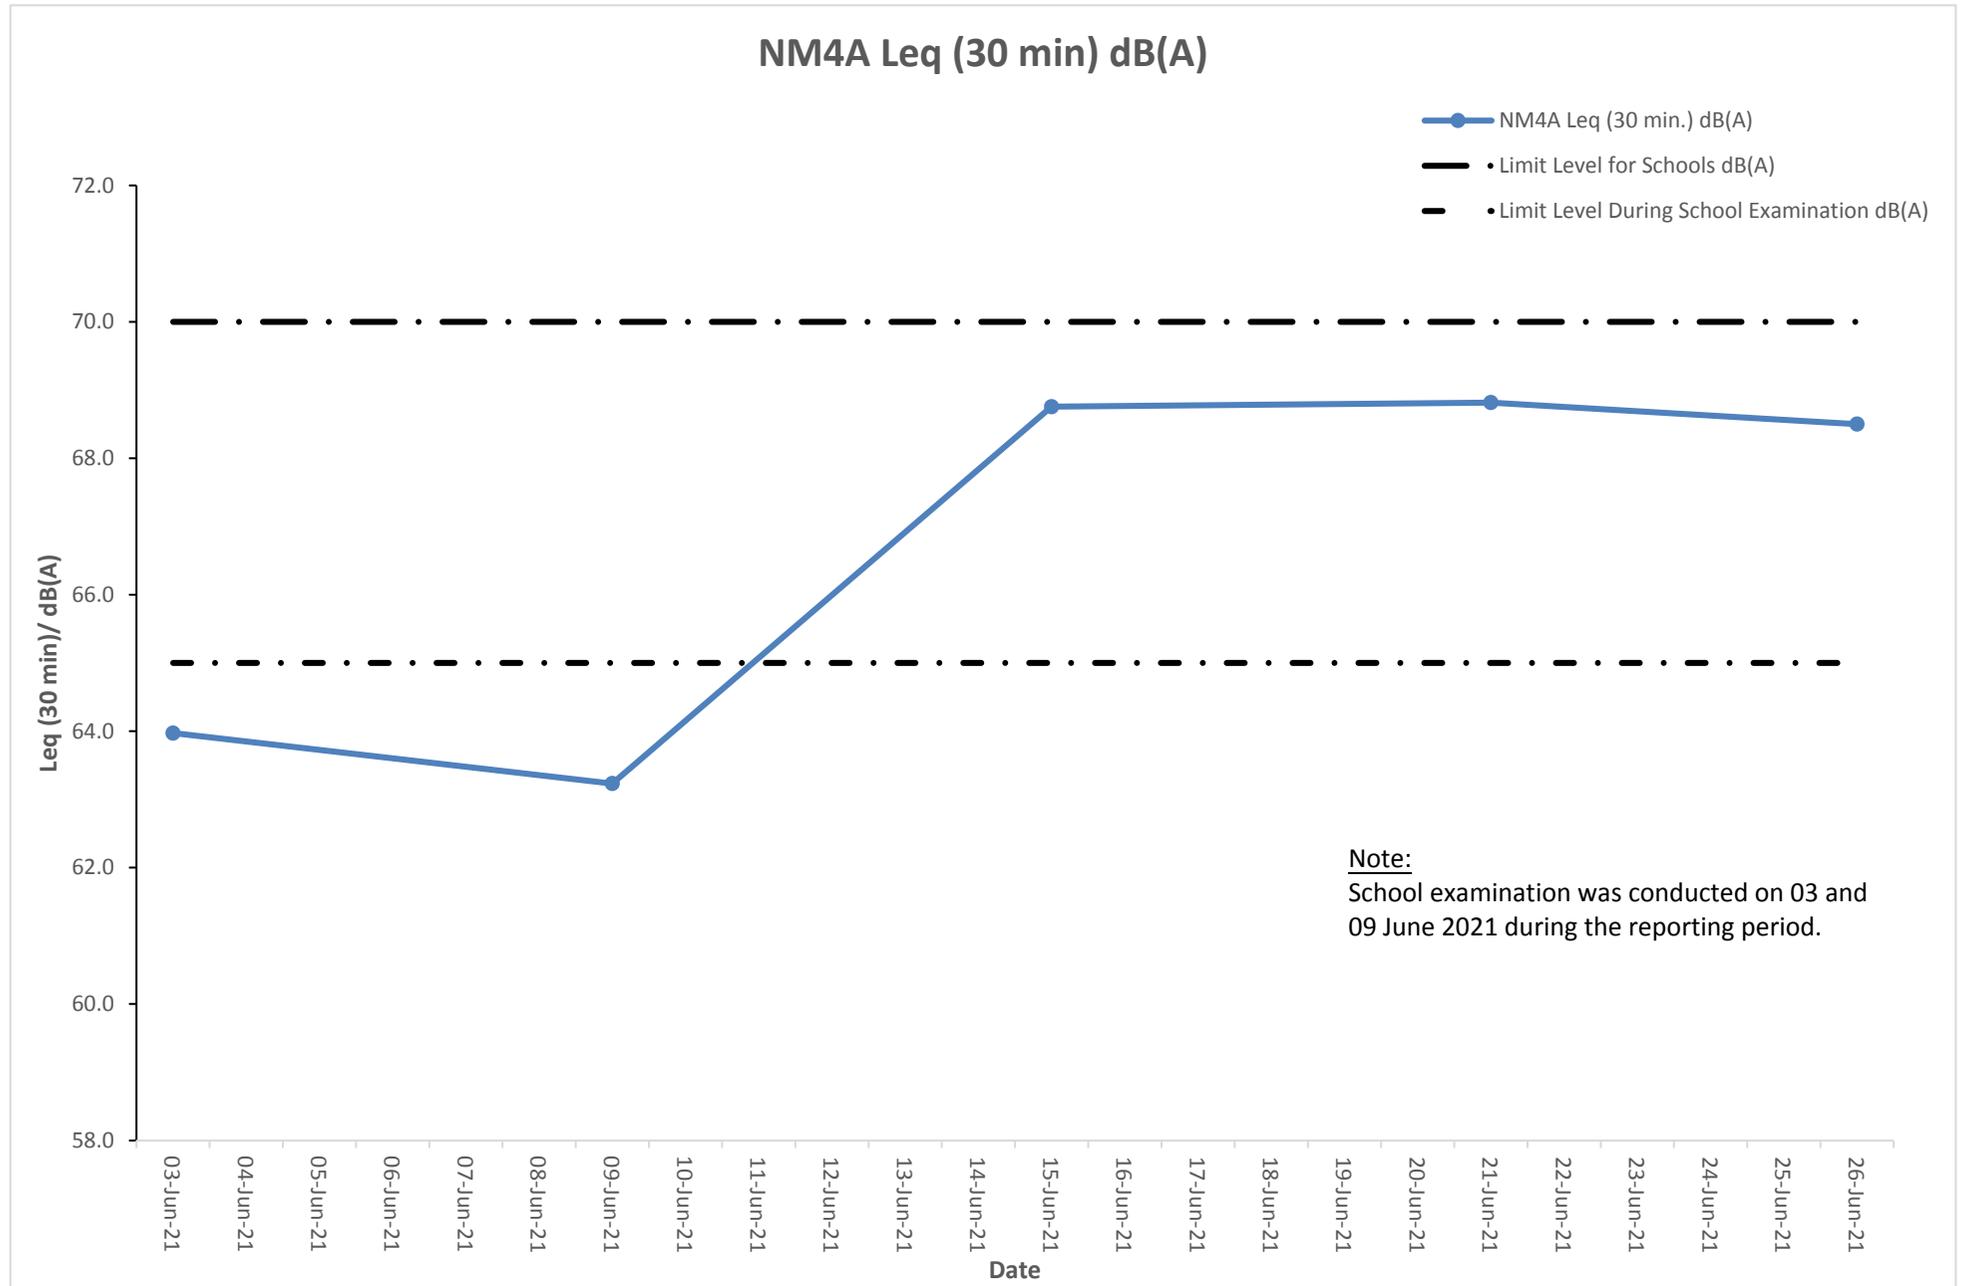
# Graphical Presentation of Noise Monitoring Result at Station NM4A

Date	Time	Measured L10 dB(A)	Measured L90 dB(A)	Leq (30 min.) dB(A)
03-Jun-21	16:37	70.3	61.5	64.0
03-Jun-21	16:42	69.8	62.7	
03-Jun-21	16:47	70.5	61.2	
03-Jun-21	16:52	69.3	61.4	
03-Jun-21	16:57	71.8	62.4	
03-Jun-21	17:02	71.1	63.9	
09-Jun-21	10:39	69.9	63.0	63.2
09-Jun-21	10:44	69.9	61.9	
09-Jun-21	10:49	70.1	60.4	
09-Jun-21	10:54	69.4	62.5	
09-Jun-21	10:59	69.5	63.2	
09-Jun-21	11:04	70.9	63.7	
15-Jun-21	16:36	69.9	64.1	68.8
15-Jun-21	16:41	71.3	66.3	
15-Jun-21	16:46	70.5	65.8	
15-Jun-21	16:51	70.2	64.7	
15-Jun-21	16:56	70.5	65.0	
15-Jun-21	17:01	71.2	66.6	
21-Jun-21	10:41	70.0	66.1	68.8
21-Jun-21	10:46	69.8	64.4	
21-Jun-21	10:51	71.5	65.8	
21-Jun-21	10:56	71.2	64.6	
21-Jun-21	11:01	69.3	64.2	
21-Jun-21	11:06	71.6	64.5	
26-Jun-21	16:35	71.0	66.4	68.5
26-Jun-21	16:40	71.7	64.4	
26-Jun-21	16:45	70.3	65.0	
26-Jun-21	16:50	69.2	65.5	
26-Jun-21	16:55	69.6	66.5	
26-Jun-21	17:00	71.3	65.5

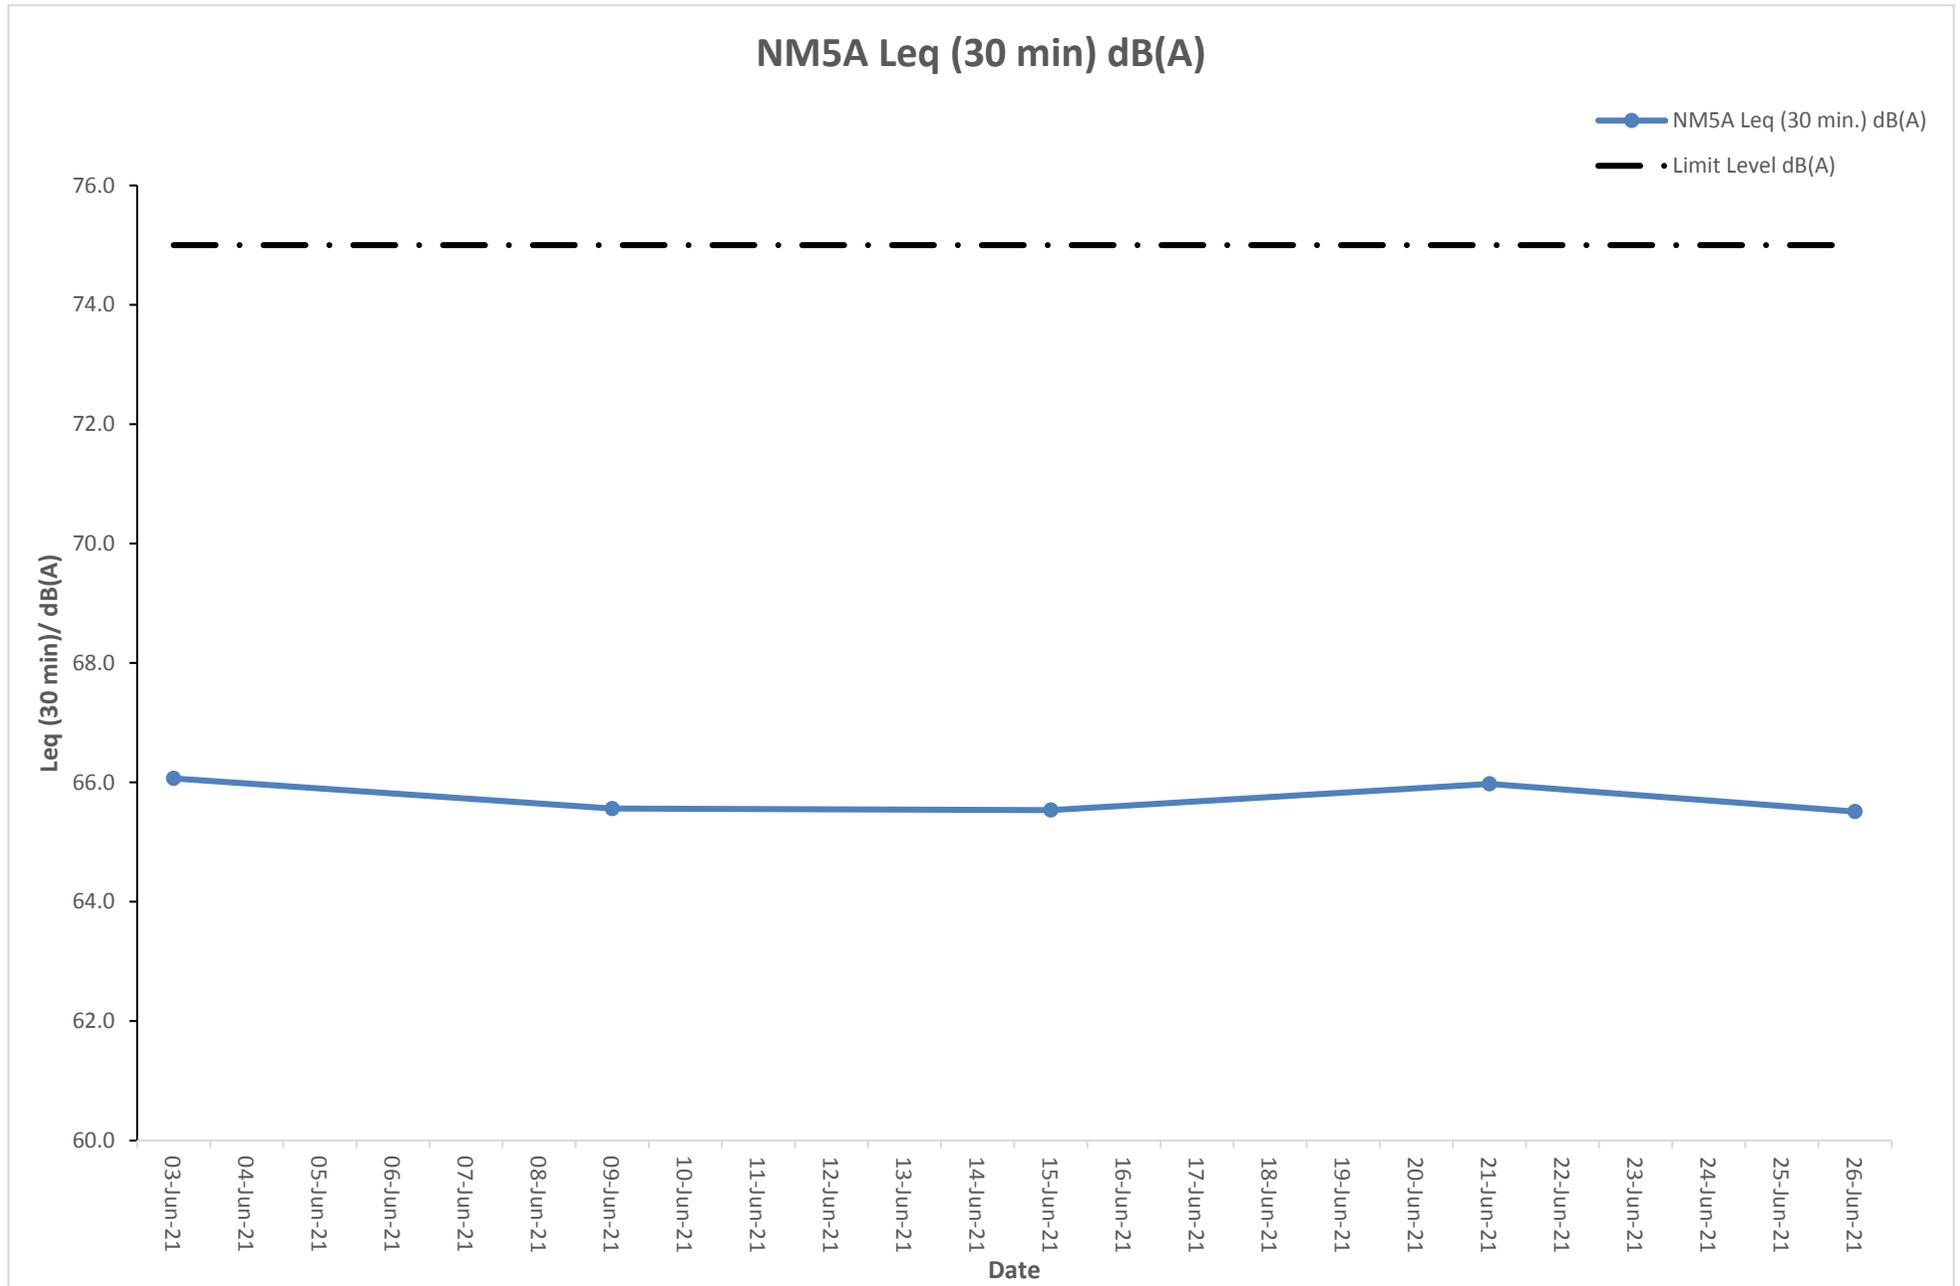
# Graphical Presentation of Noise Monitoring Result at Station NM5A

Date	Time	Measured L10 dB(A)	Measured L90 dB(A)	Leq (30 min.) dB(A)	Leq (30 min.) +3 dB(A)
03-Jun-21	15:22	66.1	59.9	63.1	66.1
03-Jun-21	15:27	64.5	59.7		
03-Jun-21	15:32	66.4	60.1		
03-Jun-21	15:37	66.6	60.4		
03-Jun-21	15:42	64.4	59.8		
03-Jun-21	15:47	64.9	59.4		
09-Jun-21	9:23	66.8	59.7	62.6	65.6
09-Jun-21	9:28	67.0	60.4		
09-Jun-21	9:33	64.5	58.6		
09-Jun-21	9:38	65.9	58.3		
09-Jun-21	9:43	66.8	58.9		
09-Jun-21	9:48	65.6	60.1		
15-Jun-21	15:21	64.2	60.8	62.5	65.5
15-Jun-21	15:26	65.9	58.0		
15-Jun-21	15:31	64.5	59.4		
15-Jun-21	15:36	66.7	59.8		
15-Jun-21	15:41	65.2	59.1		
15-Jun-21	15:46	66.2	58.0		
21-Jun-21	9:25	67.0	60.8	63.0	66.0
21-Jun-21	9:30	65.5	59.3		
21-Jun-21	9:35	67.1	59.4		
21-Jun-21	9:40	64.3	58.2		
21-Jun-21	9:45	66.7	59.1		
21-Jun-21	9:50	66.7	59.8		
26-Jun-21	15:20	65.8	59.7	62.5	65.5
26-Jun-21	15:25	64.5	60.9		
26-Jun-21	15:30	65.5	59.2		
26-Jun-21	15:35	66.4	59.3		
26-Jun-21	15:40	65.5	58.8
