Development at West Kowloon Cultural District

**Monthly Environmental Monitoring and Audit (EM&A) Report
for July 2021**

**Part-2: EM&A for Foundation, Excavation
and Lateral Works for Integrated
Basement and Underground Road
in Zone 2A**

Part-1: EM&A at Lyric Theatre Complex

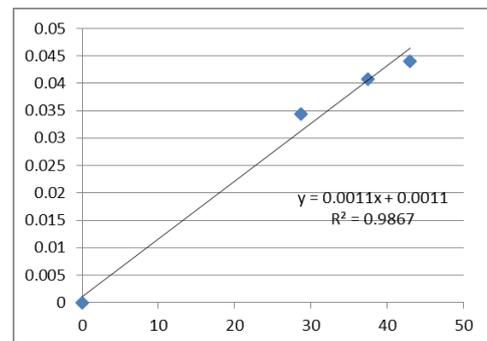
Slope (K-factor): 0.0011
Correlation Coefficient 0.9933
Date of Issue 30 November 2020

1. **Strong** Correlation ($R > 0.8$)
 2. Factor 0.0011 should be applied for TSP monitoring
- *If $R < 0.5$, repair or re-verification is required for the equipment

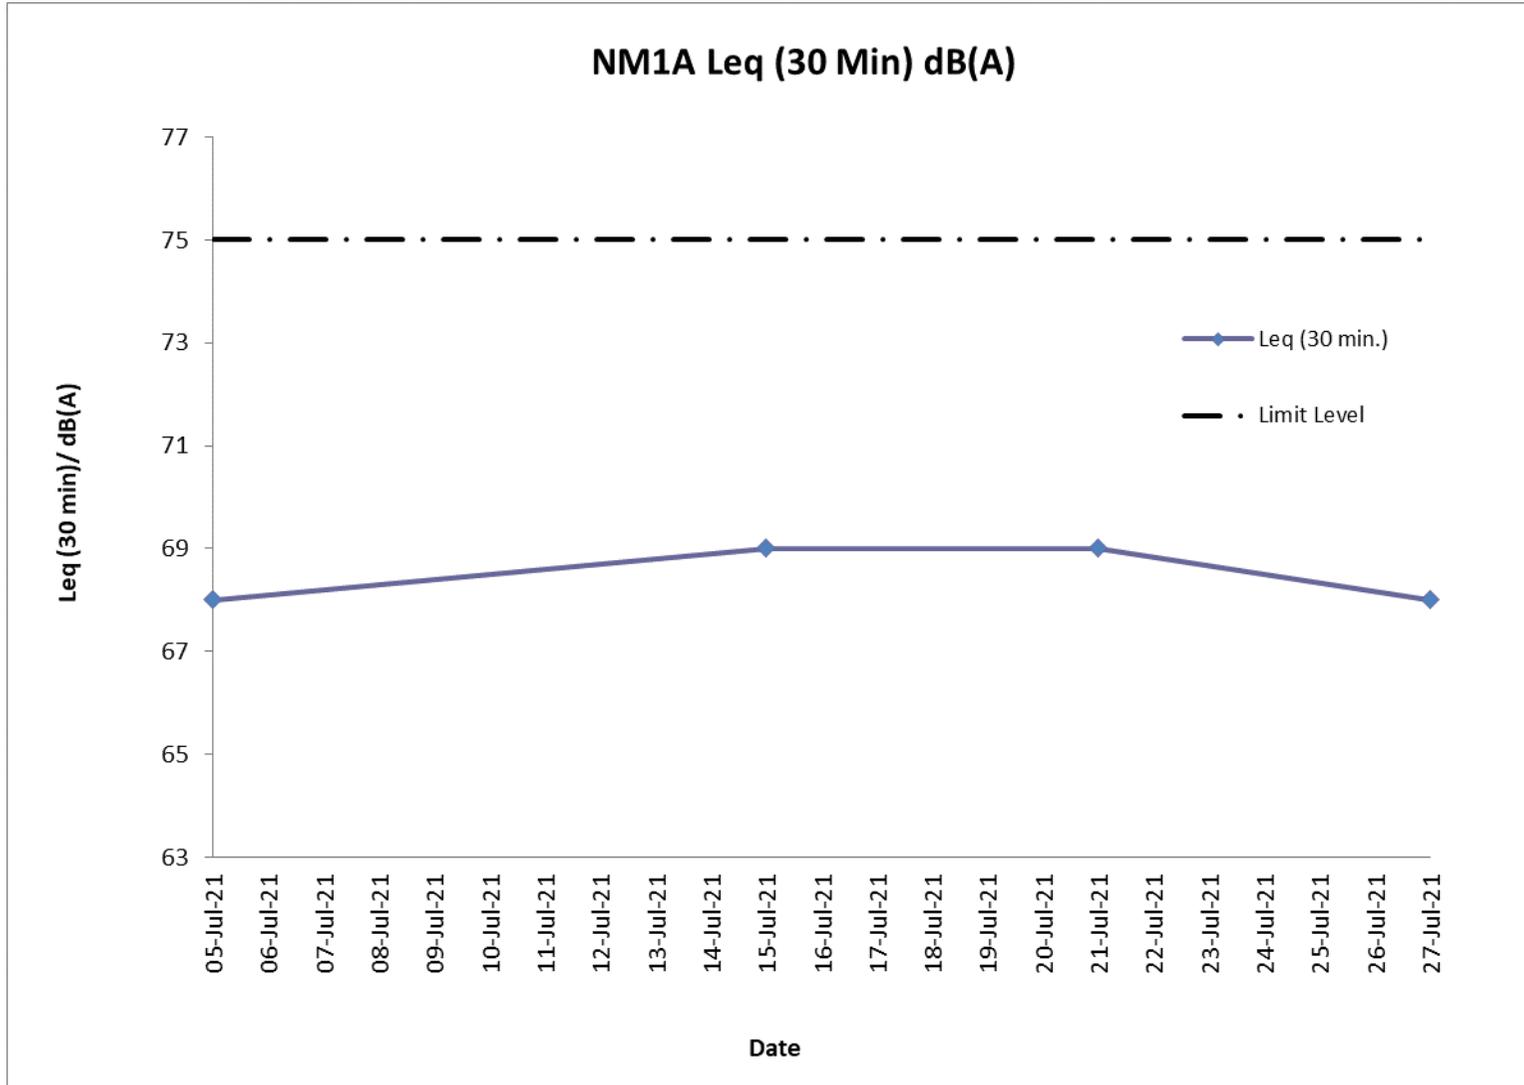
Graphical Presentation Noise Monitoring Result at Station NM1A

The station set-up of a free-field measurement at Station NM1A.

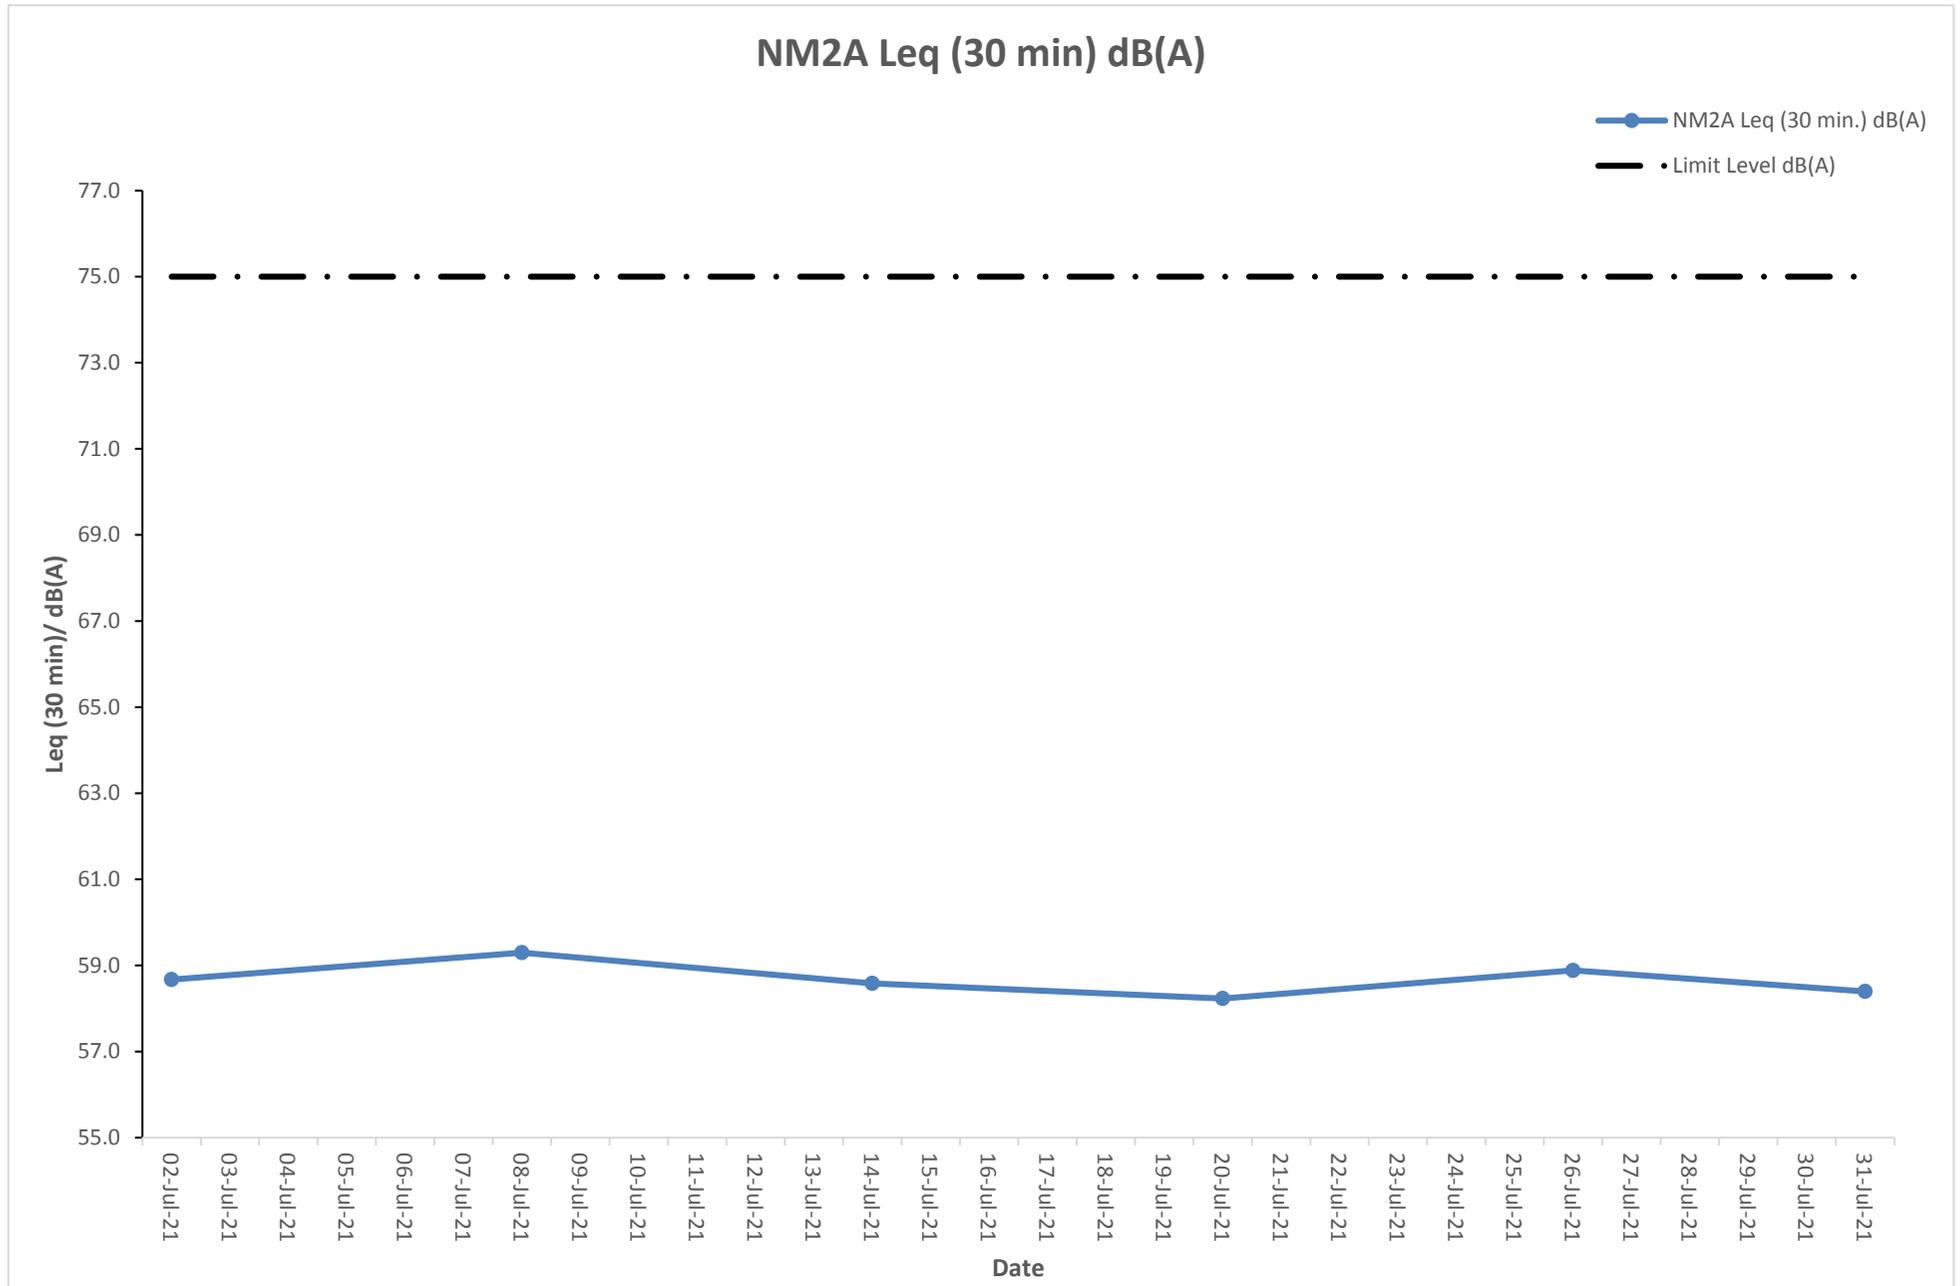
Graphical Presentation of Noise Monitoring Result at Station NM2A

The station set-up of a façade measurement at station NM2A.

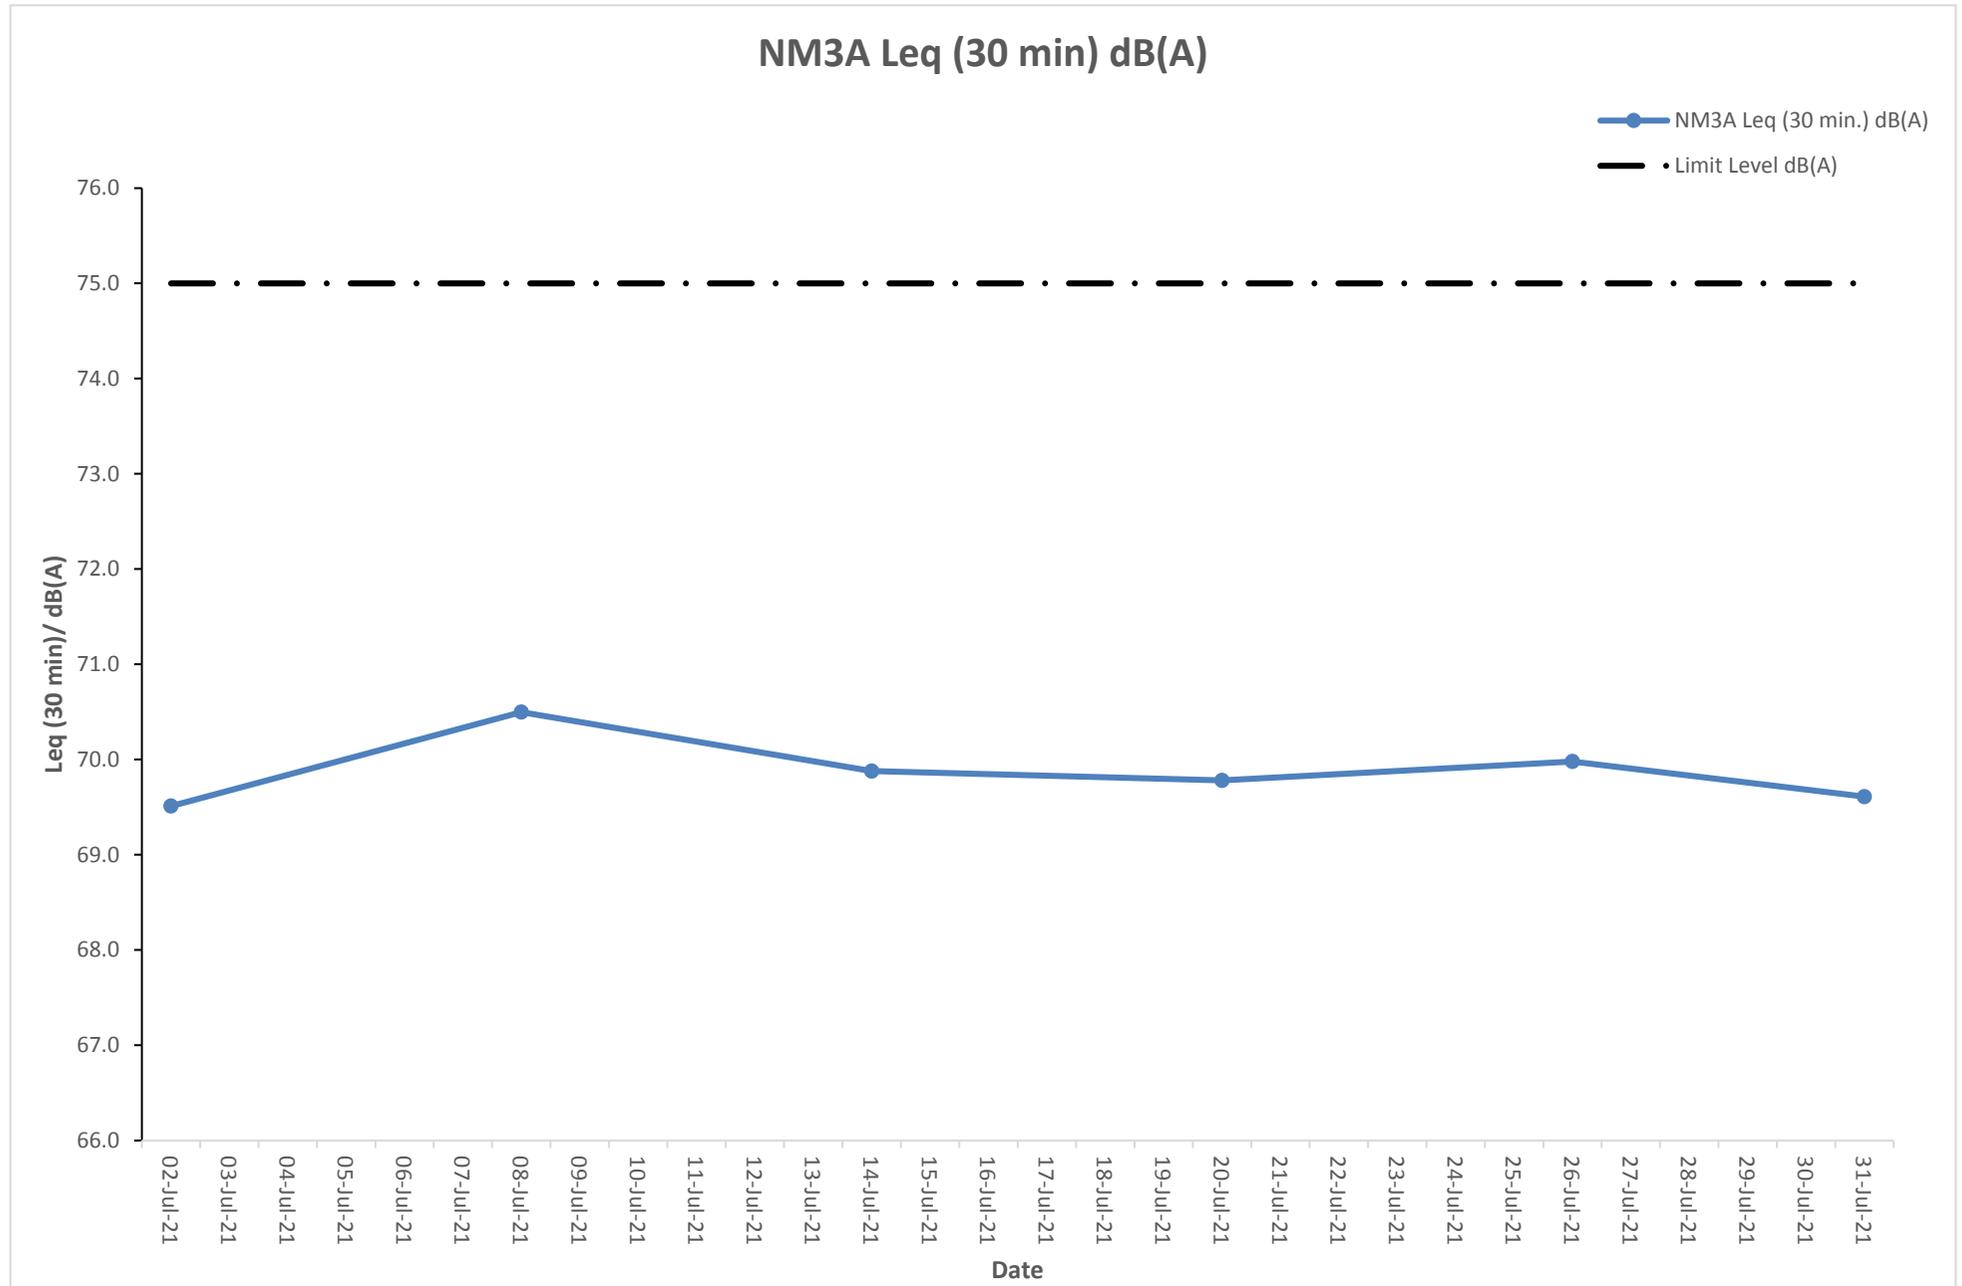
Graphical Presentation of Noise Monitoring Result at Station NM3A

The station set-up of a façade measurement at station NM3A.

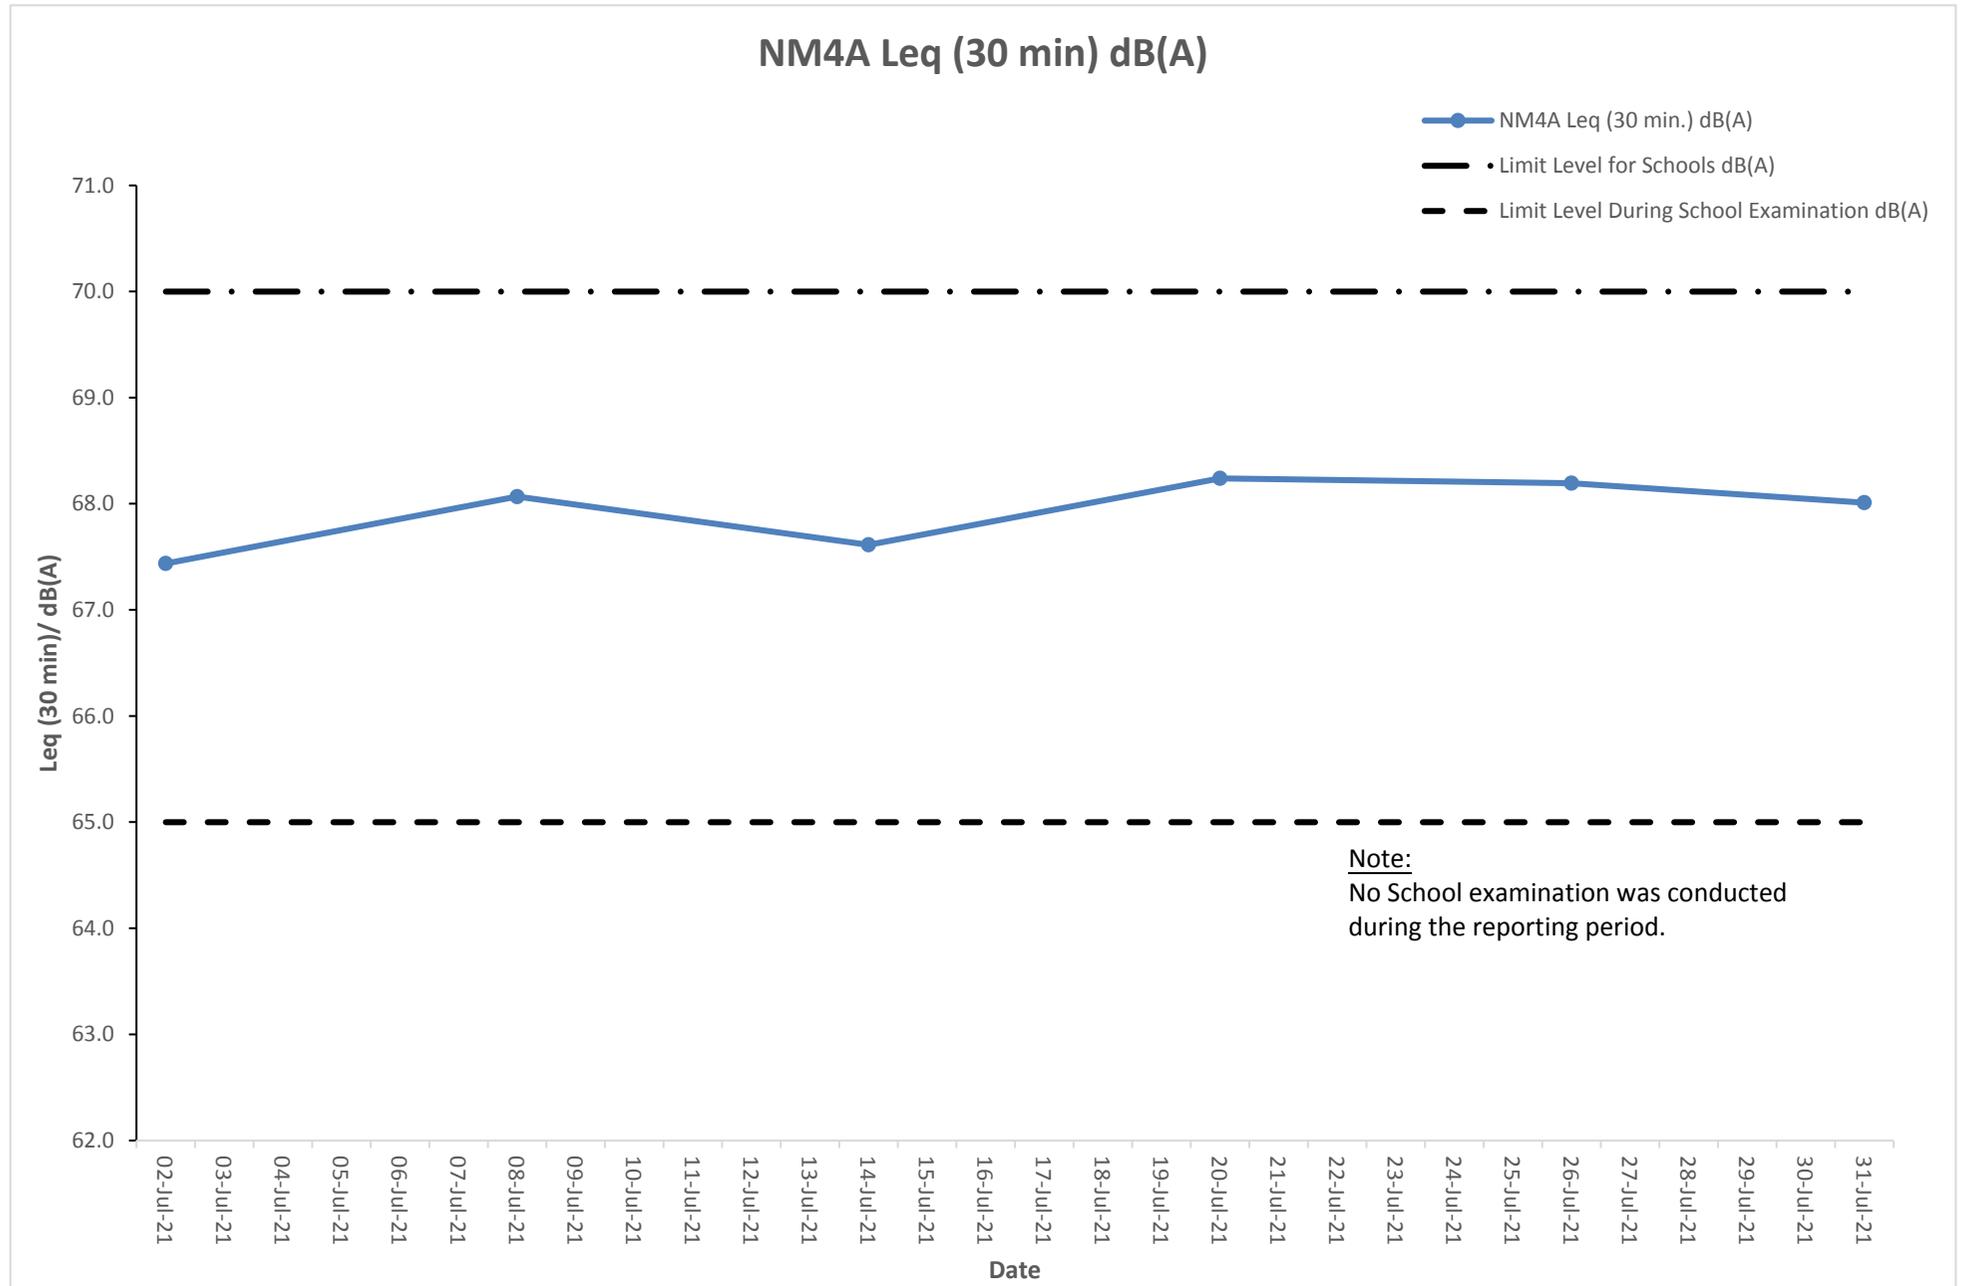
Graphical Presentation of Noise Monitoring Result at Station NM4A

The station set-up of a façade measurement at station NM4A.

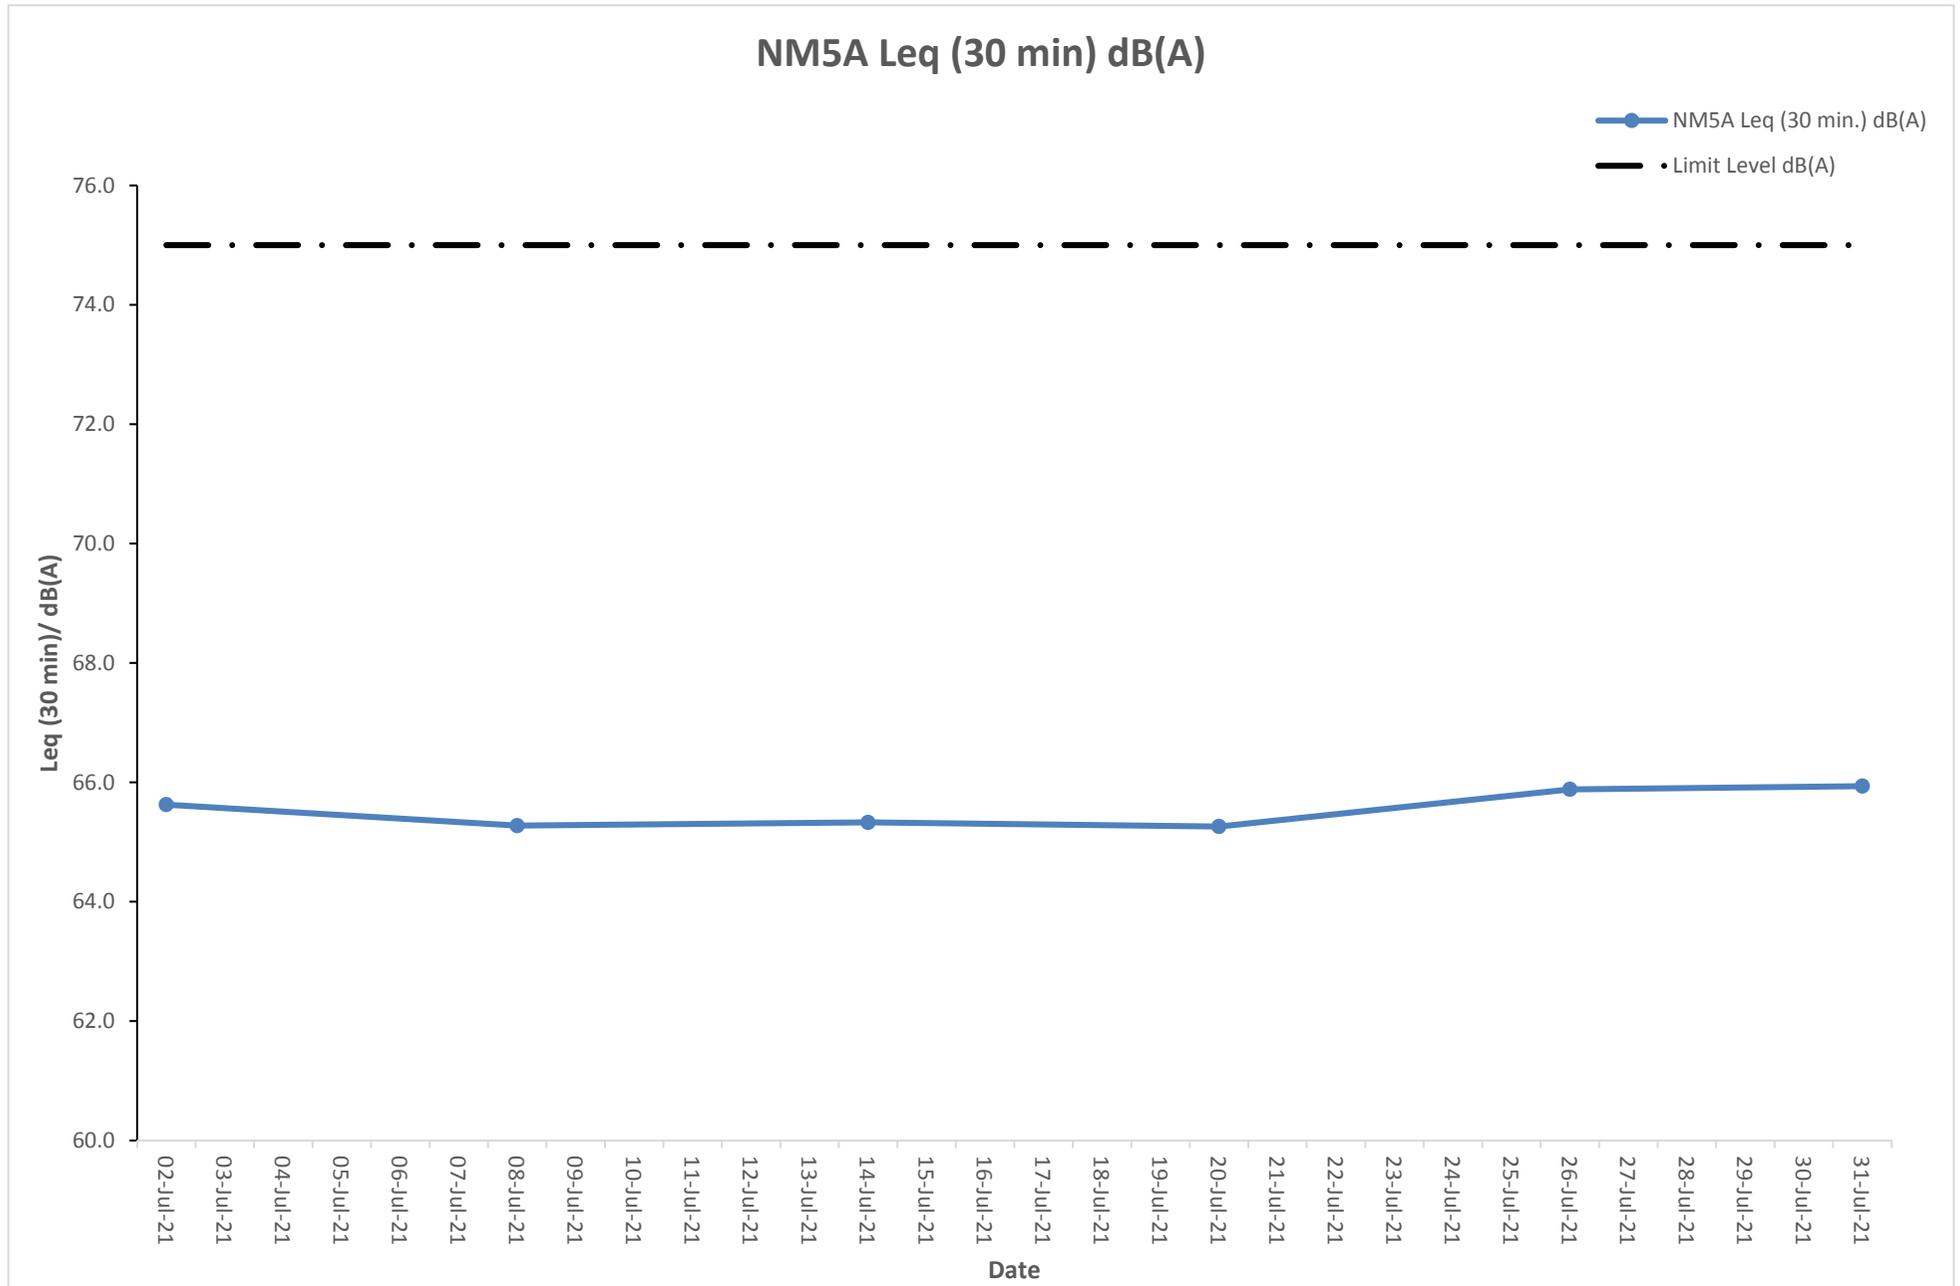
Graphical Presentation of Noise Monitoring Result at Station NM5A

The station set-up of a free-field measurement at station NM5A.
