Development at West Kowloon Cultural District

**Monthly Environmental Monitoring and Audit (EM&A) Report
for October 2021**

**Part-2: EM&A for Foundation Works in
Zones 2A, 2B & 2C**

Part-1: EM&A at Lyric Theatre Complex

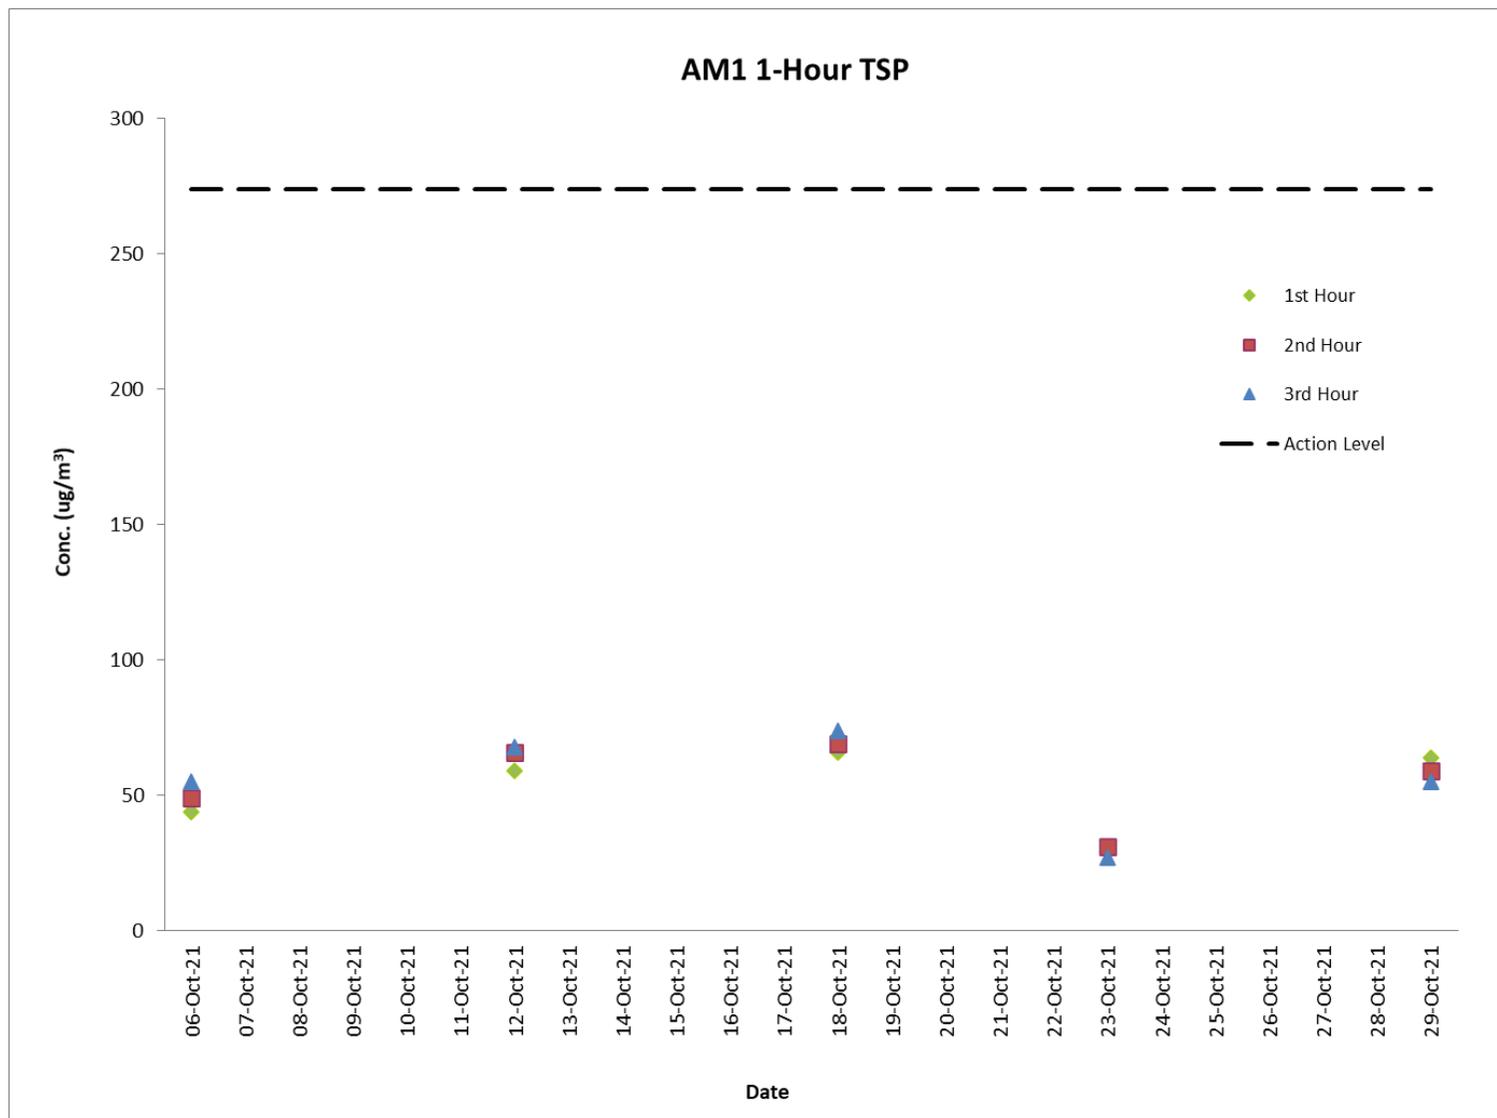
Graphical Presentation of Air Quality Monitoring Result at Station AM1 (1-hour TSP)

Date	Weather Condition	Time	Conc. ($\mu\text{g}/\text{m}^3$)			Action Level ($\mu\text{g}/\text{m}^3$)	Limit Level ($\mu\text{g}/\text{m}^3$)
			1 st Hour	2 nd Hour	3 rd Hour		
06-Oct-21	Sunny	8:22 - 11:22	44	49	55	273.7	500
12-Oct-21	Fine	8:31 - 11:31	59	66	68	273.7	500
18-Oct-21	Cloudy	8:24 - 11:24	66	69	74	273.7	500
23-Oct-21	Cloudy	8:23 - 11:23	29	31	27	273.7	500
29-Oct-21	Cloudy	8:18 - 11:18	64	59	55	273.7	500

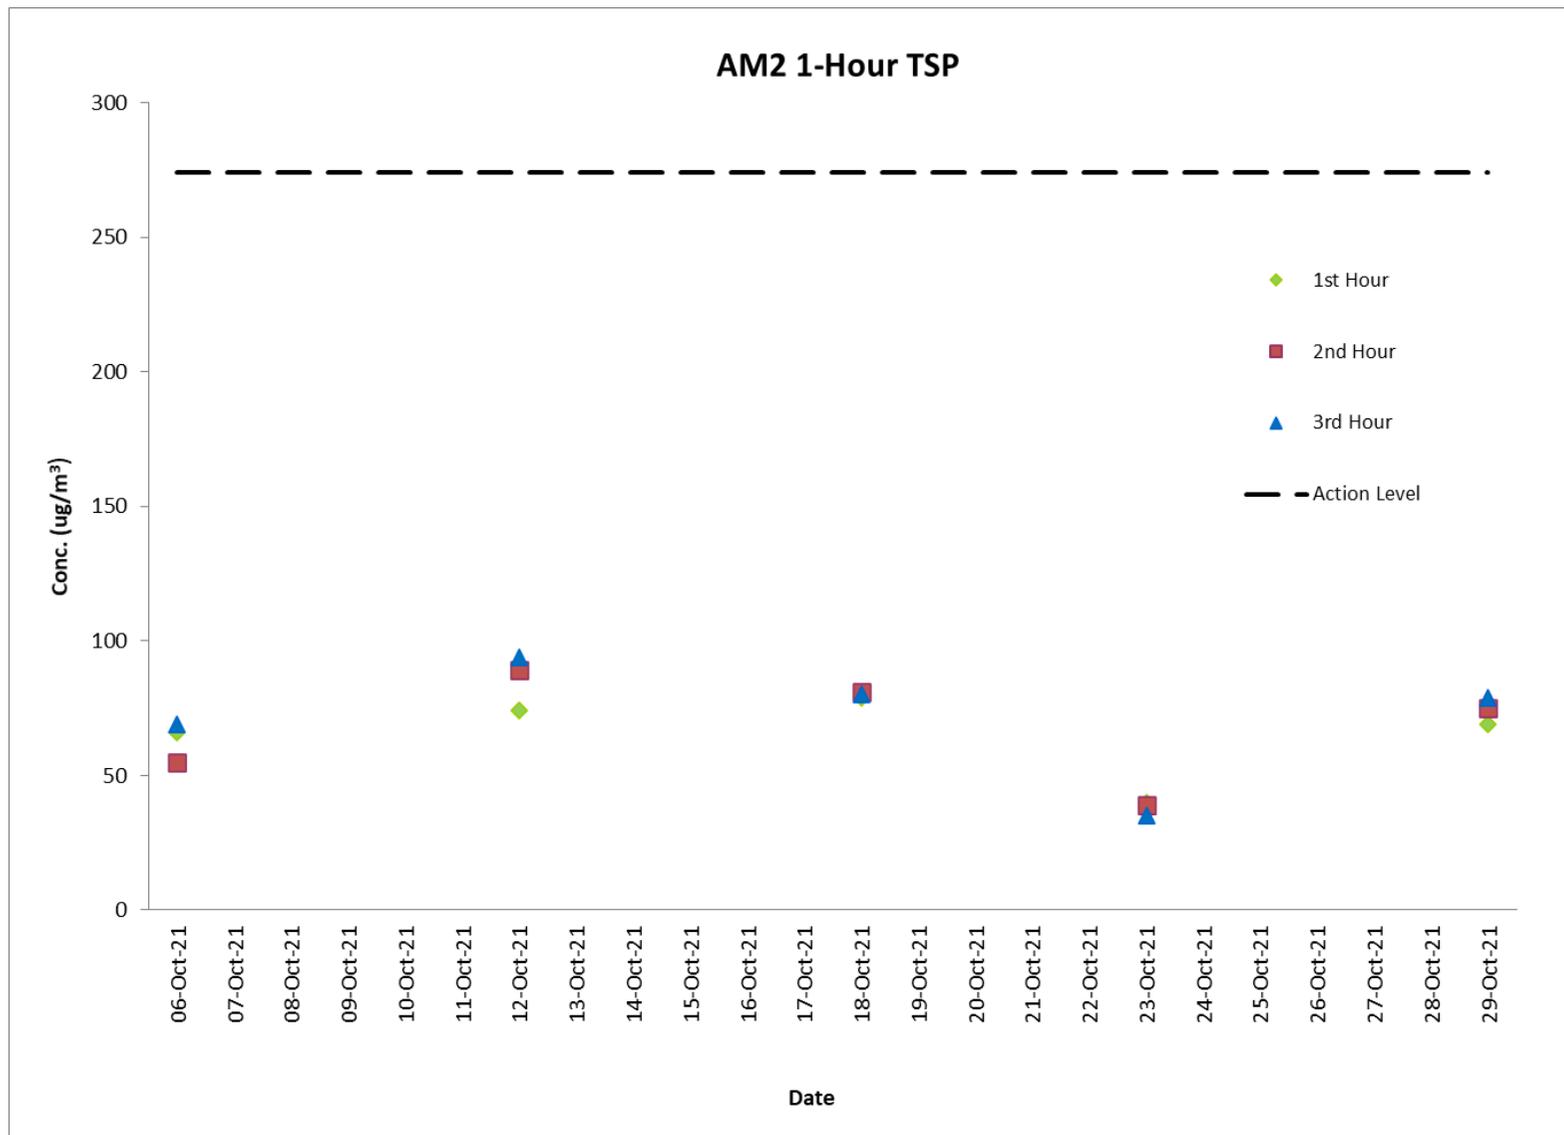
Graphical Presentation of Air Quality Monitoring Result at Station AM2 (1-hour TSP)

Date	Weather Condition	Time	Conc. ($\mu\text{g}/\text{m}^3$)			Action Level ($\mu\text{g}/\text{m}^3$)	Limit Level ($\mu\text{g}/\text{m}^3$)
			1 st Hour	2 nd Hour	3 rd Hour		
06-Oct-21	Sunny	8:37 - 11:37	66	55	69	274.2	500
12-Oct-21	Fine	8:48 - 11:48	74	89	94	274.2	500
18-Oct-21	Cloudy	8:39 - 11:39	79	81	80	274.2	500
23-Oct-21	Cloudy	8:38 - 11:38	40	39	35	274.2	500
29-Oct-21	Cloudy	8:33 - 11:33	69	75	79	274.2	500

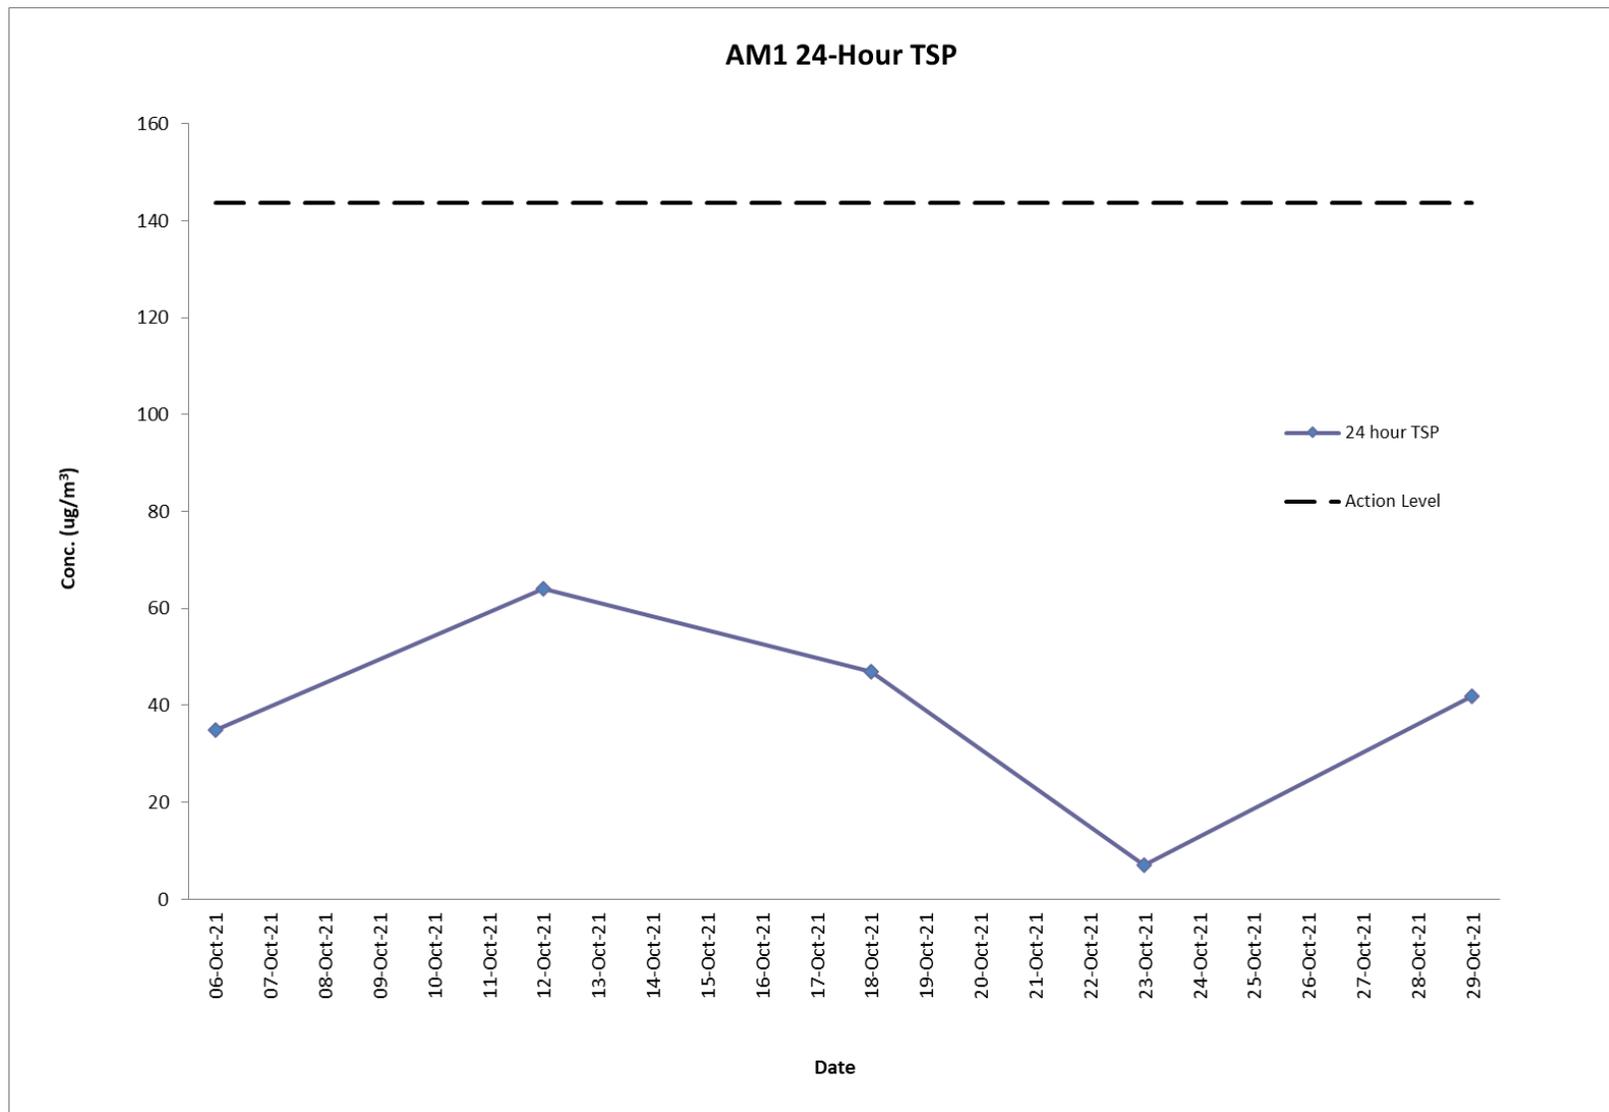
Graphical Presentation of Air Quality Monitoring Result at Station AM1 (24-hour TSP)

Start		Finish		Filter Weight (g)		Elapsed Time Reading		Sampling Time (hrs)	Flow Rate (m ³ /min)			Conc. (µg/m ³)	Weather Condition	Action Level	Limit Level
Date	Time	Date	Time	Initial	Final	Initial	Final		Initial	Final	Average				
06-Oct-21	08:20	07-Oct-21	08:20	2.7737	2.8357	23984.38	24008.38	24	1.22	1.22	1.22	35	Sunny	143.6	260
12-Oct-21	08:29	13-Oct-21	08:29	2.7770	2.8890	24008.38	24032.38	24	1.22	1.22	1.22	64	Fine	143.6	260
18-Oct-21	08:22	19-Oct-21	08:22	2.7767	2.8590	24032.38	24056.38	24	1.22	1.22	1.22	47	Cloudy	143.6	260
23-Oct-21	08:20	24-Oct-21	08:20	2.7620	2.7736	24056.38	24080.38	24	1.22	1.22	1.22	7	Cloudy	143.6	260
29-Oct-21	08:15	30-Oct-21	08:15	2.7480	2.8217	24080.38	24104.38	24	1.22	1.22	1.22	42	Cloudy	143.6	260

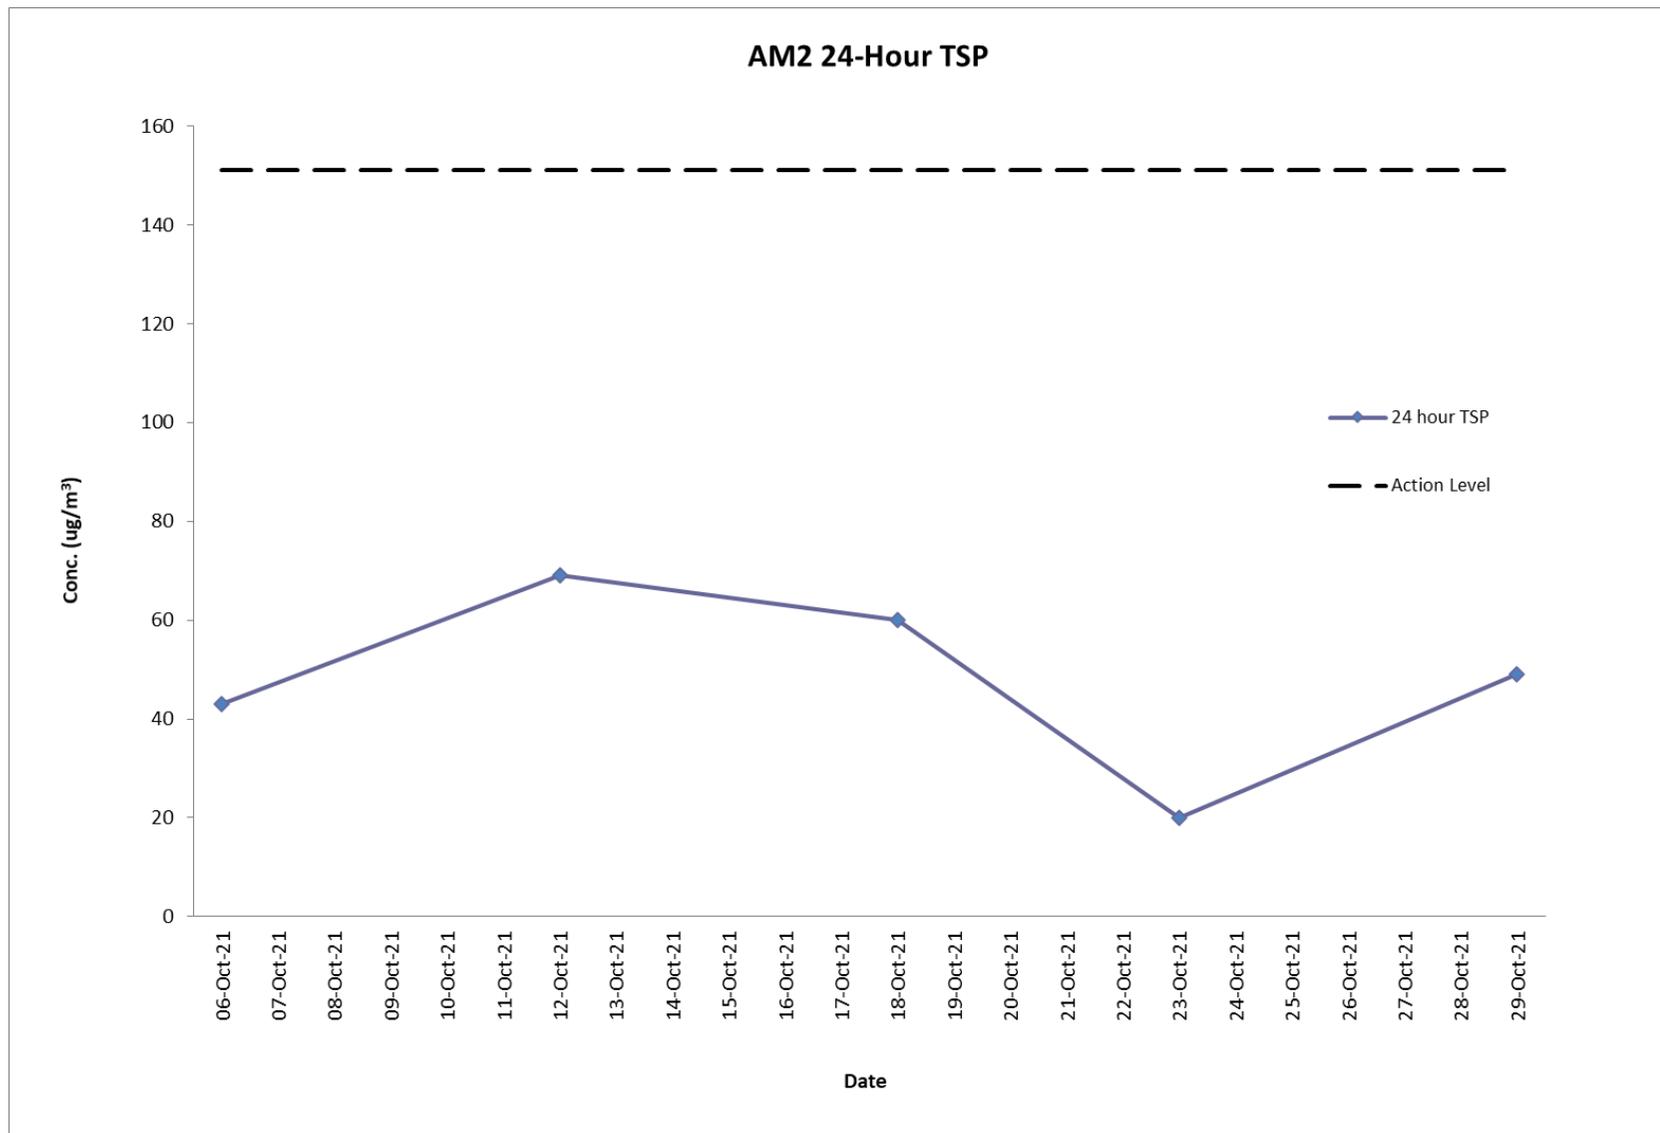
Graphical Presentation of Air Quality Monitoring Result at Station AM2 (24-hour TSP)

Start		Finish		Sampling Time (hrs)	Conc. ($\mu\text{g}/\text{m}^3$)	Weather Condition	Action Level	Limit Level
Date	Time	Date	Time					
06-Oct-21	08:34	07-Oct-21	08:34	24	43	Sunny	151.1	260
12-Oct-21	08:44	13-Oct-21	08:44	24	69	Fine	151.1	260
18-Oct-21	08:36	19-Oct-21	08:36	24	60	Cloudy	151.1	260
23-Oct-21	08:35	24-Oct-21	08:35	24	20	Cloudy	151.1	260
29-Oct-21	08:29	30-Oct-21	08:29	24	49	Cloudy	151.1	260

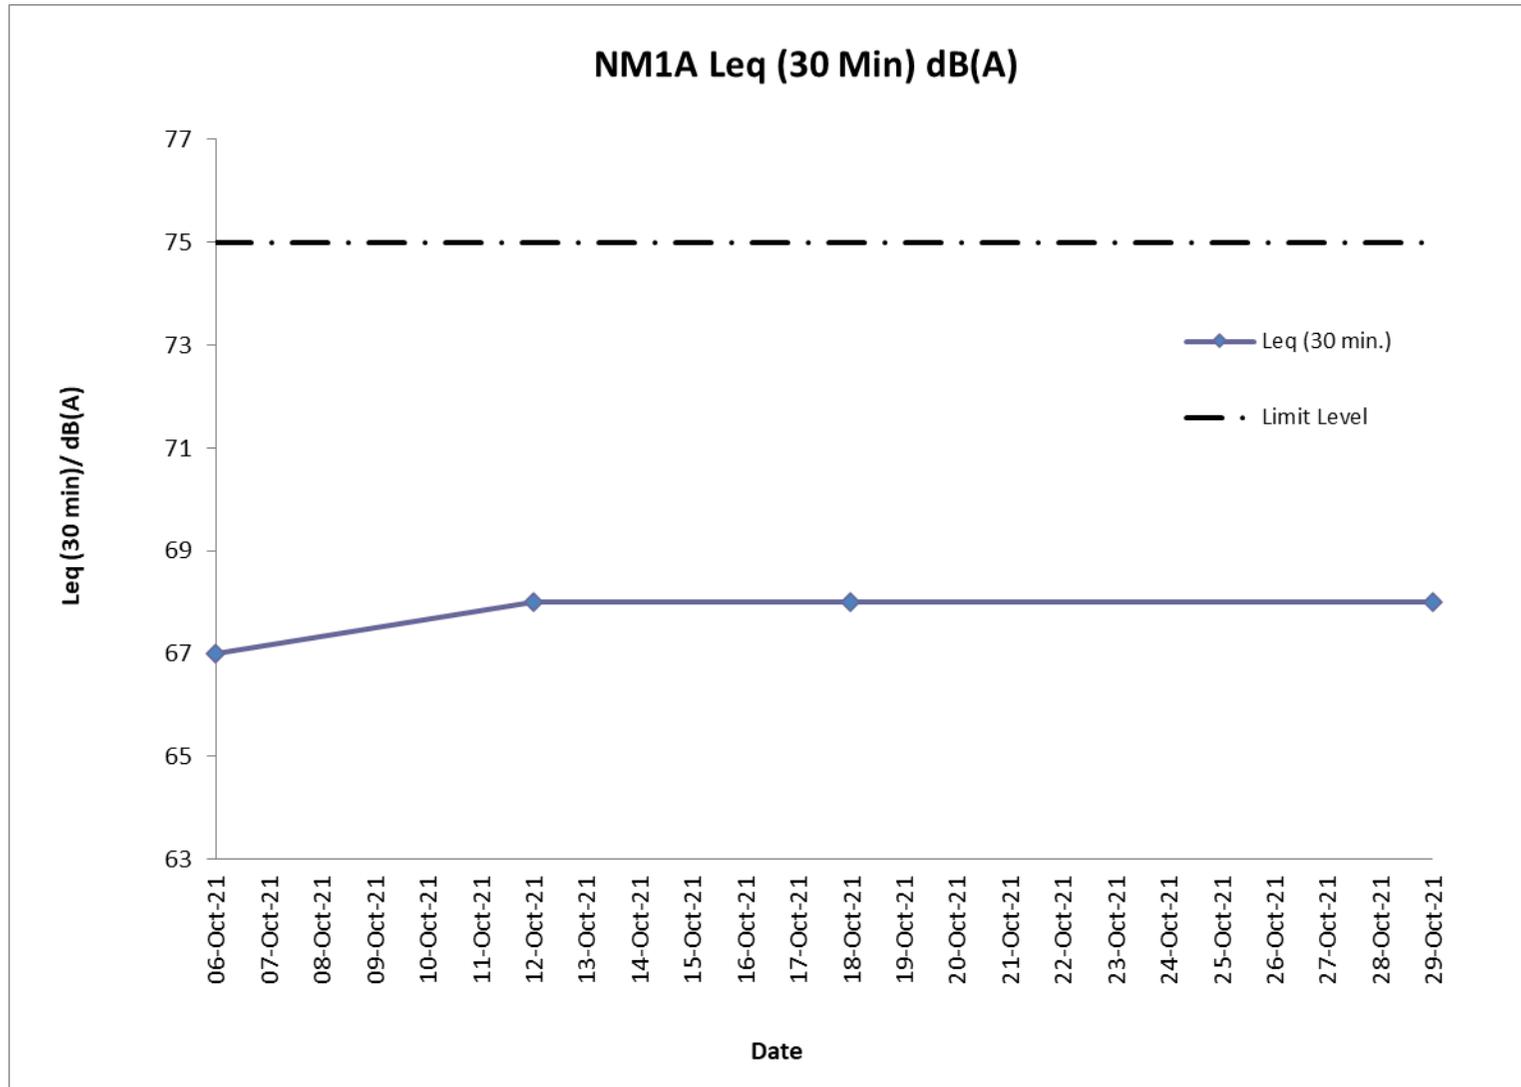
Graphical Presentation Noise Monitoring Result at Station NM1A

Date	Time	Measured L ₁₀ , dB(A)	Measured L ₉₀ , dB(A)	L _{eq} (30 min.)*, dB(A)
06-Oct-21	09:22	65.0	61.9	67
06-Oct-21	09:27	66.4	62.8	
06-Oct-21	09:32	65.2	61.5	
06-Oct-21	09:37	66.3	62.7	
06-Oct-21	09:42	66.6	62.8	
06-Oct-21	09:47	65.5	61.3	
12-Oct-21	09:32	66.0	62.9	68
12-Oct-21	09:37	67.2	63.8	
12-Oct-21	09:42	68.3	64.7	
12-Oct-21	09:47	67.2	63.6	
12-Oct-21	09:52	66.5	62.1	
12-Oct-21	09:57	66.8	62.6	
18-Oct-21	09:22	67.6	63.5	68
18-Oct-21	09:27	68.6	64.5	
18-Oct-21	09:32	66.4	62.8	
18-Oct-21	09:37	66.9	62.6	
18-Oct-21	09:42	66.0	62.1	
18-Oct-21	09:47	67.2	63.1	
29-Oct-21	09:17	66.0	62.5	68
29-Oct-21	09:22	65.2	61.4	
29-Oct-21	09:27	65.6	61.7	
29-Oct-21	09:32	67.4	63.1	
29-Oct-21	09:37	67.8	63.6	
29-Oct-21	09:42	66.7	62.6

The station set-up of a free-field measurement at Station NM1A.

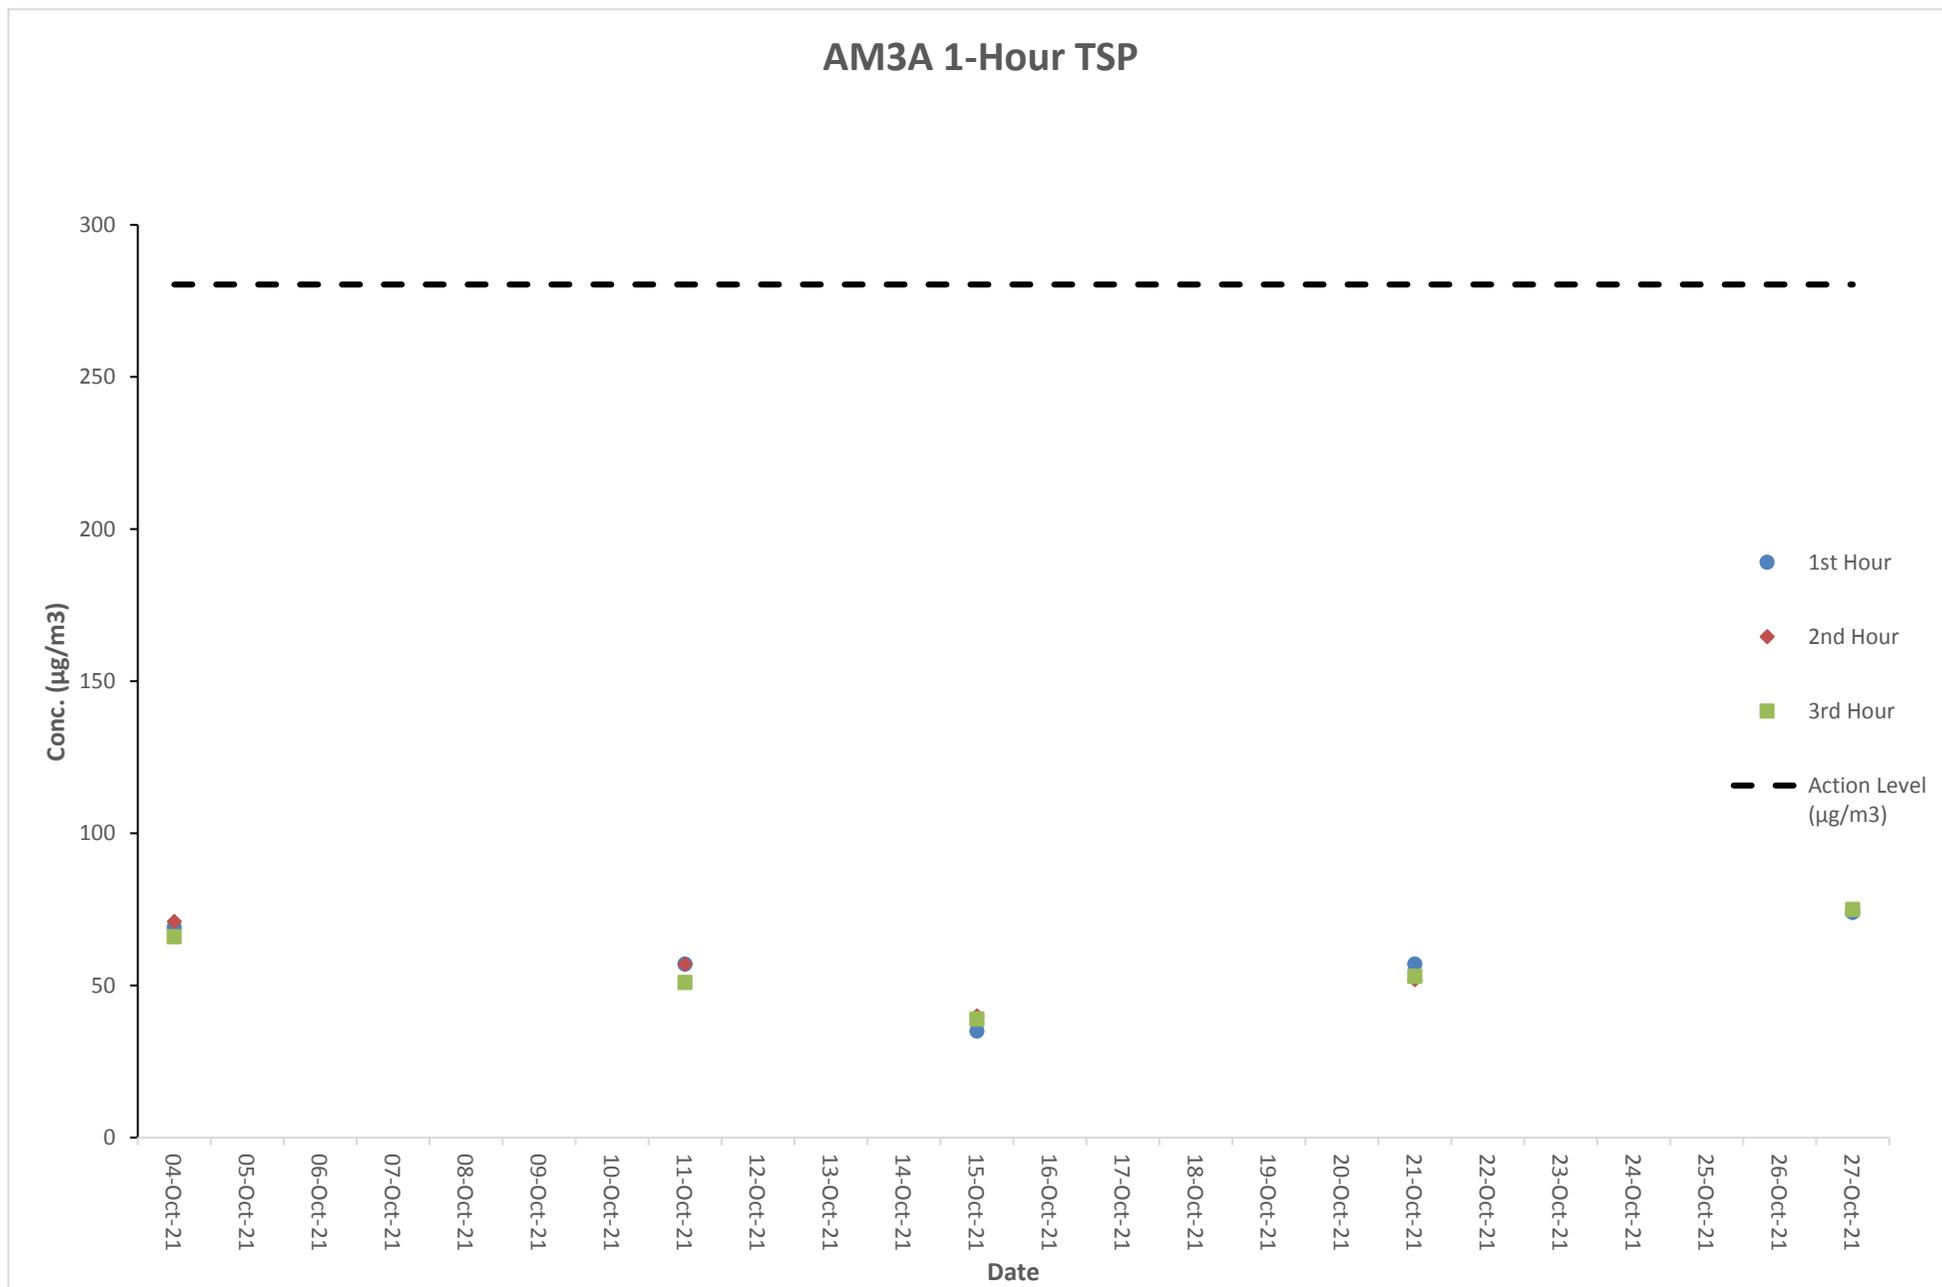
Graphical Presentation of Air Quality Monitoring Result at Station AM3A (1-hour TSP)

Note: Impact monitoring on 9 Oct has rescheduled to 11 Oct due to Tropical Cyclone Warning Signal No.8

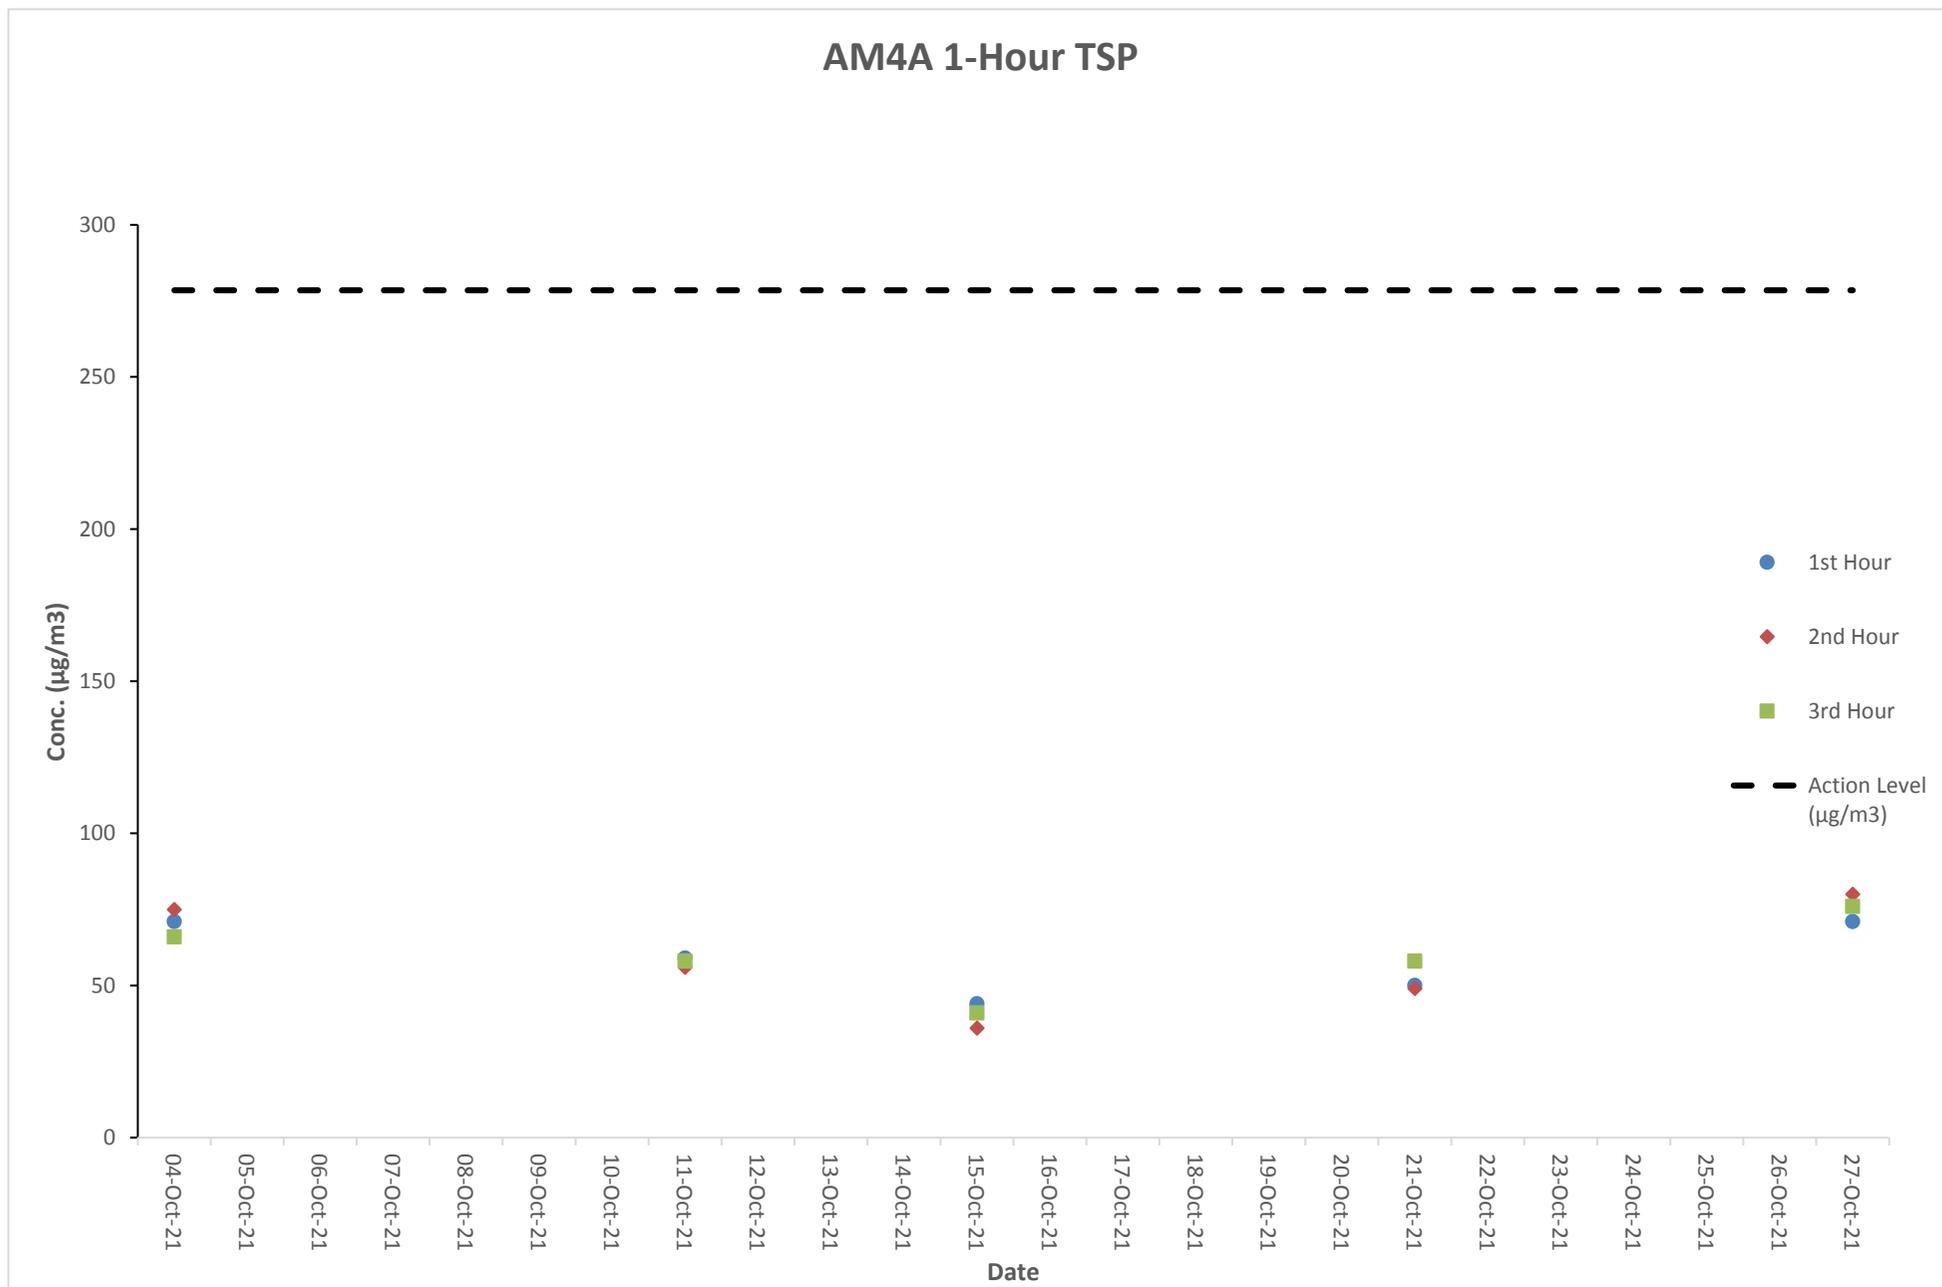
Graphical Presentation of Air Quality Monitoring Result at Station AM4A (1-hour TSP)

Date	Weather Condition	Time		Conc. ($\mu\text{g}/\text{m}^3$)			Action Level	Limit Level
		Start	Finish	1st Hour	2nd Hour	3rd Hour		
04-Oct-21	Fine	8:09	11:09	71	75	66	278.5	500
11-Oct-21	Fine	14:10	17:10	59	56	58	278.5	500
15-Oct-21	Cloudy	8:11	11:11	44	36	41	278.5	500
21-Oct-21	Cloudy	14:13	17:13	50	49	58	278.5	500
27-Oct-21	Fine	8:12	11:12	71	80	76	278.5	500

Note: Impact monitoring on 9 Oct has rescheduled to 11 Oct due to Tropical Cyclone Warning Signal No.8

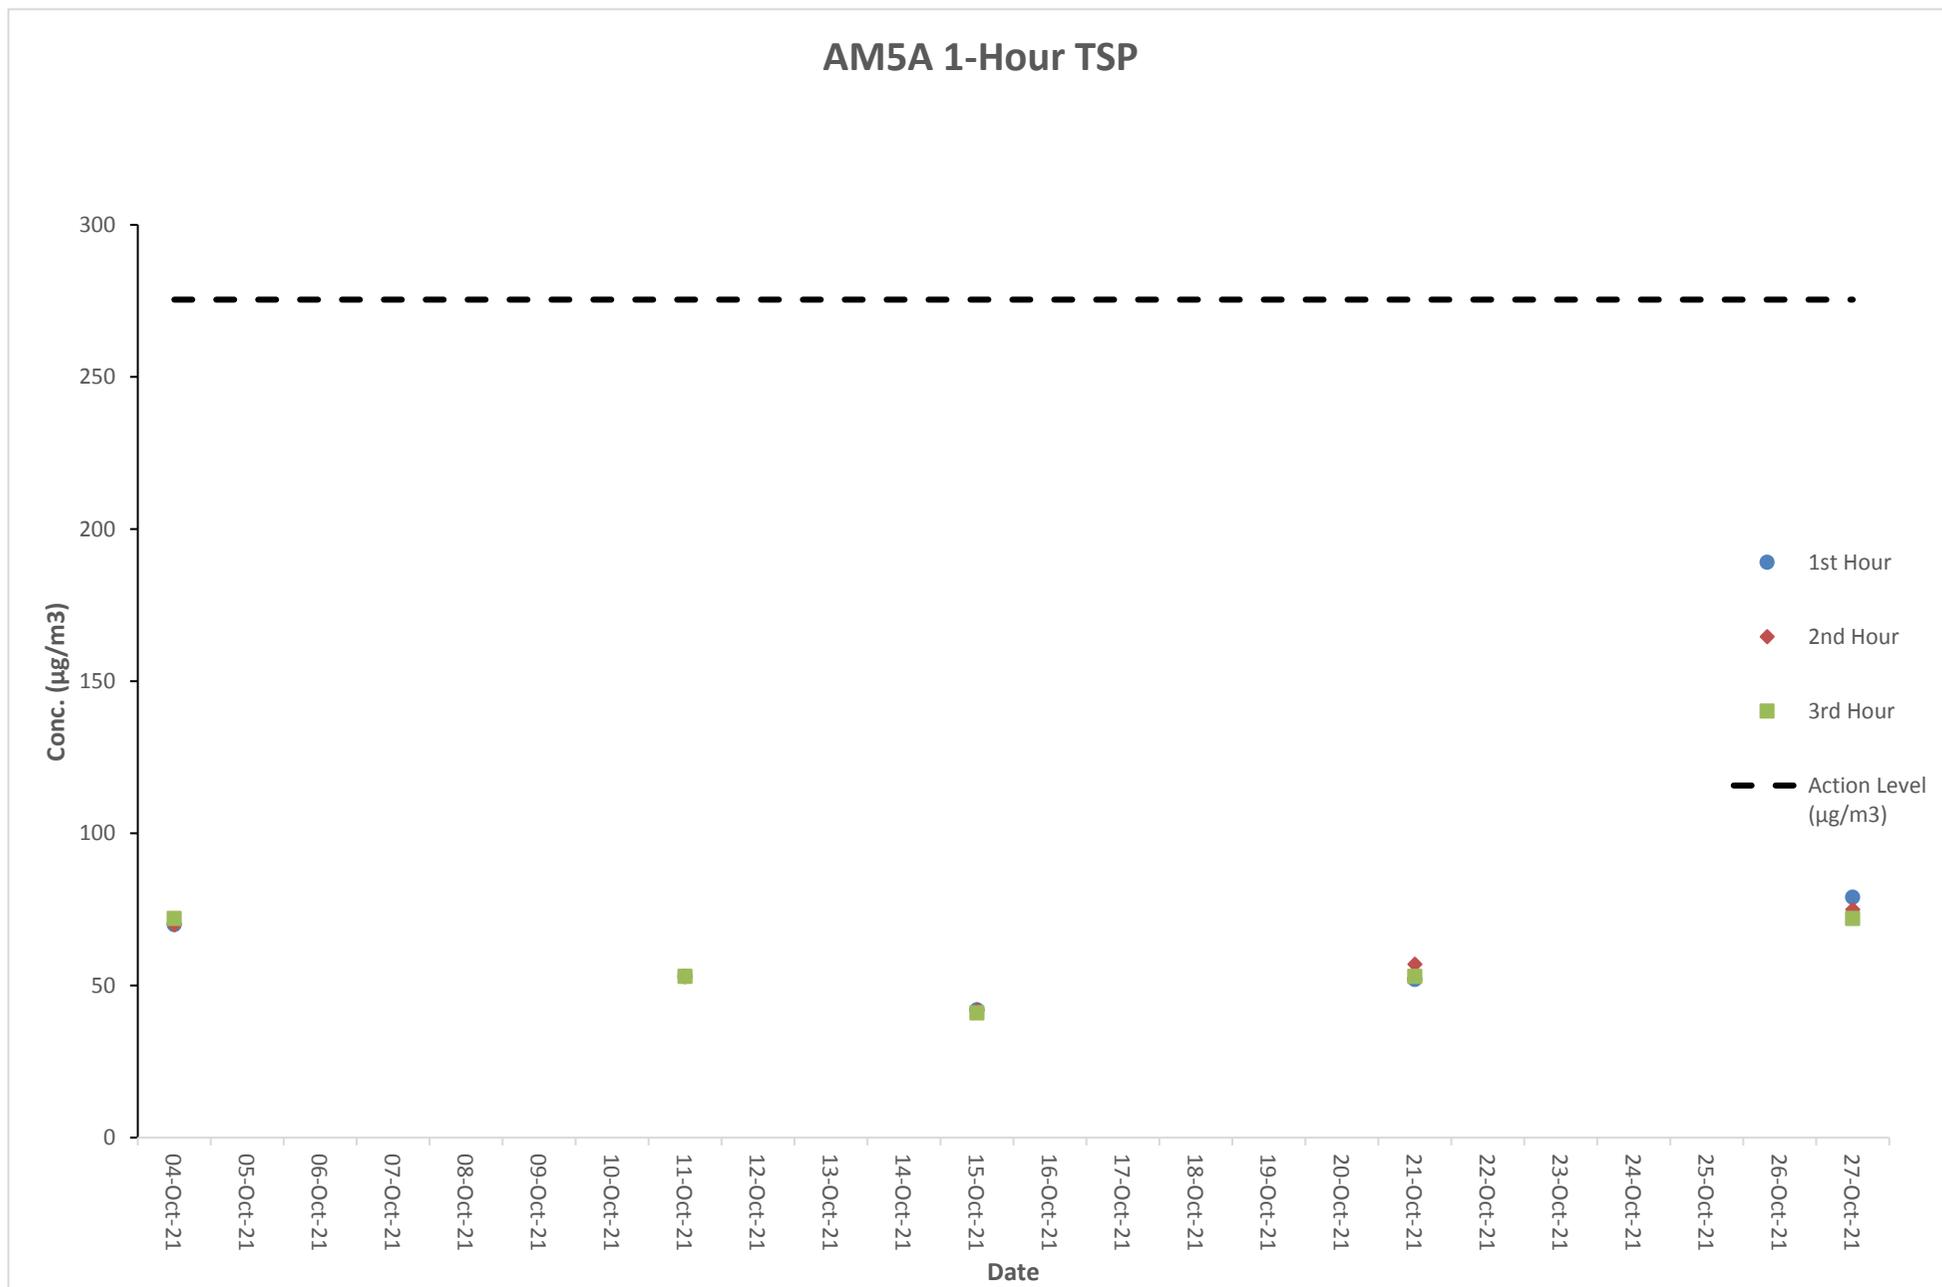
Graphical Presentation of Air Quality Monitoring Result at Station AM5A (1-hour TSP)

Date	Weather Condition	Time		Conc. ($\mu\text{g}/\text{m}^3$)			Action Level	Limit Level
		Start	Finish	1st Hour	2nd Hour	3rd Hour		
04-Oct-21	Fine	8:24	11:24	70	70	72	275.4	500
11-Oct-21	Fine	14:27	17:27	53	53	53	275.4	500
15-Oct-21	Cloudy	8:26	11:26	42	42	41	275.4	500
21-Oct-21	Cloudy	14:30	17:30	52	57	53	275.4	500
27-Oct-21	Fine	8:27	11:27	79	75	72	275.4	500

Note: Impact monitoring on 9 Oct has rescheduled to 11 Oct due to Tropical Cyclone Warning Signal No.8

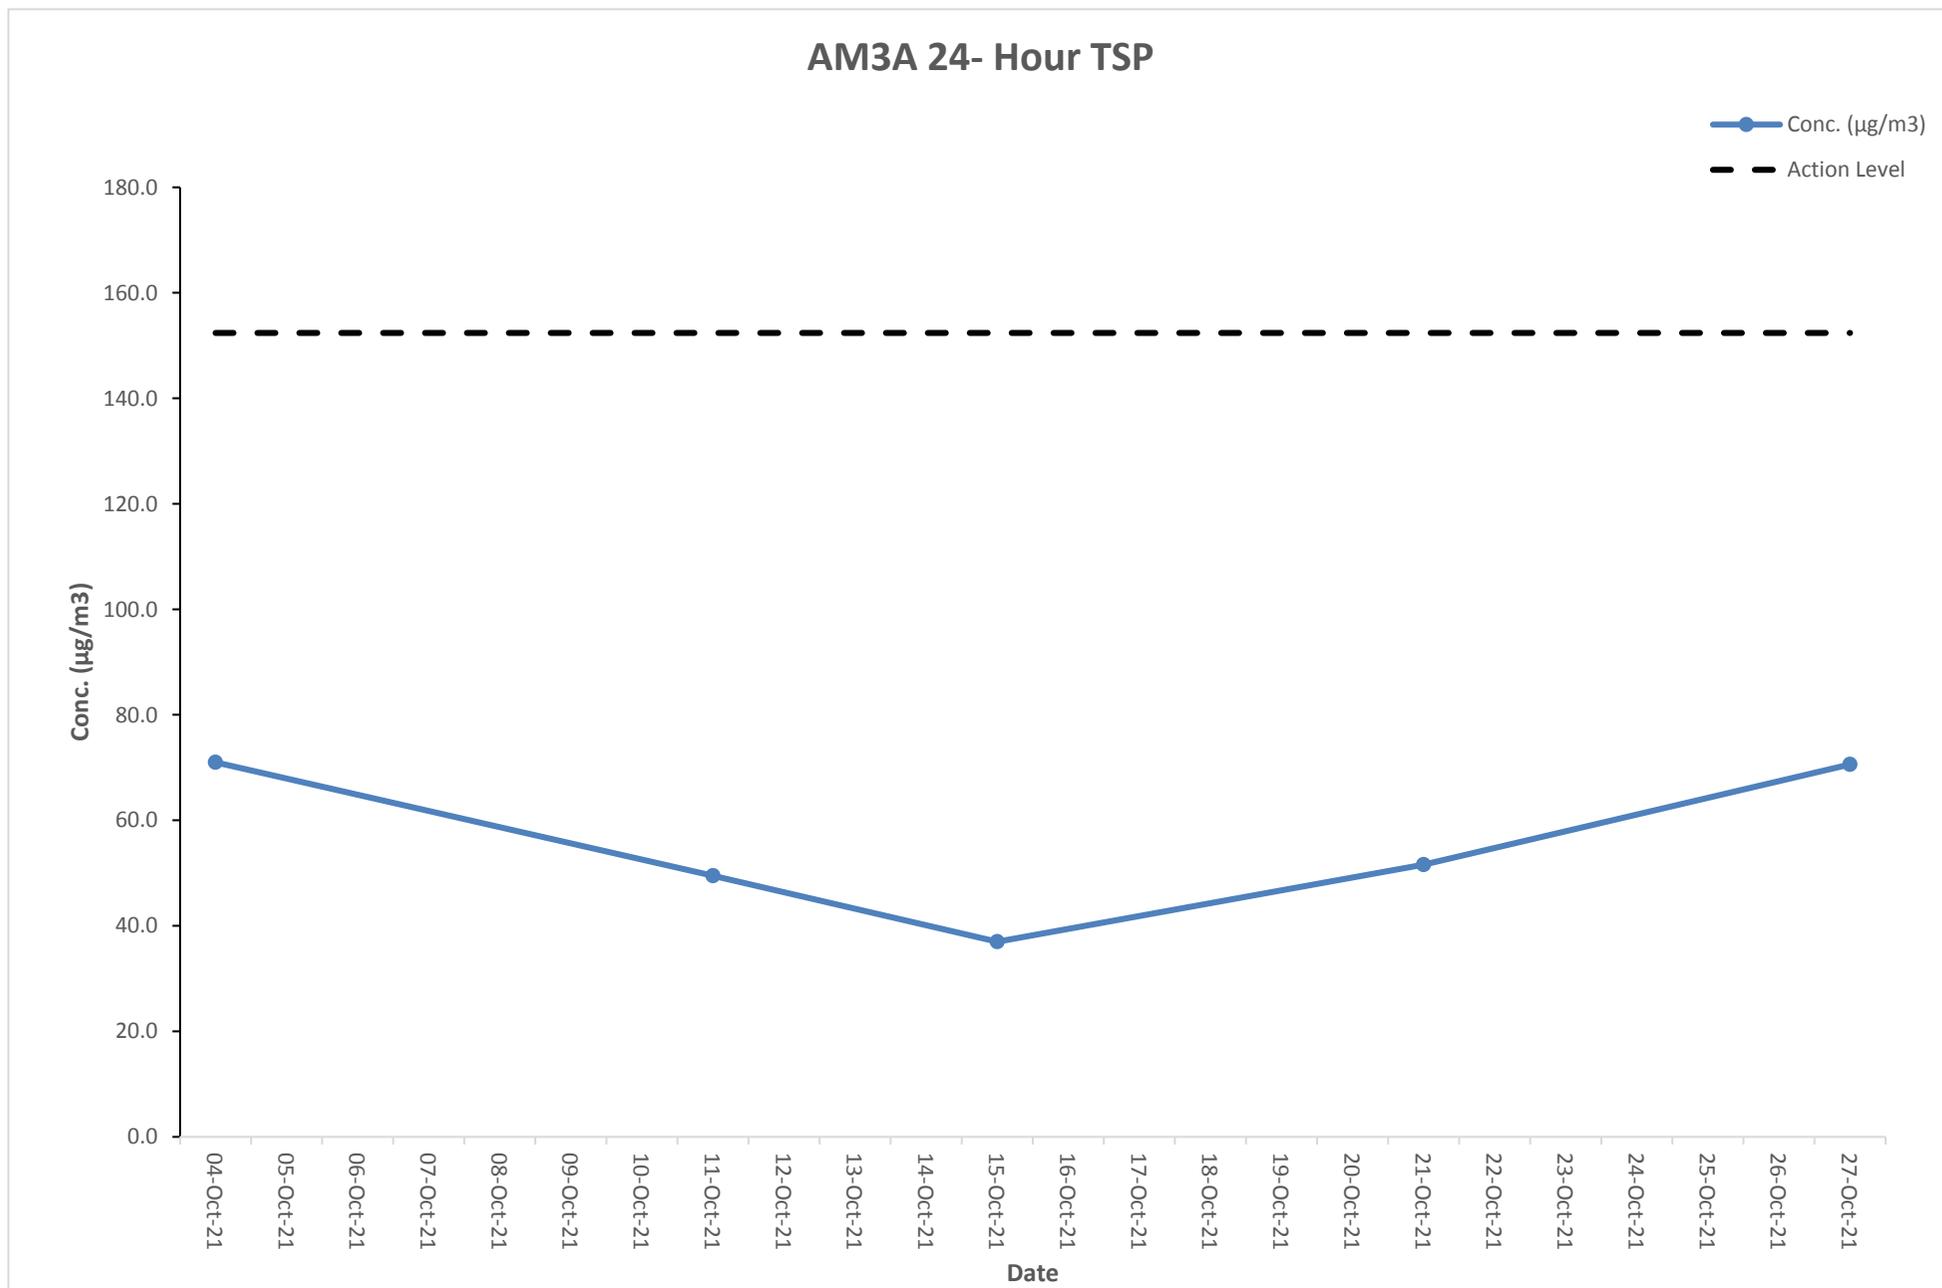
Graphical Presentation of Air Quality Monitoring Result at Station AM3A (24-hour TSP)

Start		Finish		Filter Weight (g)		Elapsed Time Reading		Sampling Time (hrs)	Flow Rate (m ³ /min)			Conc. (µg/m ³)	Weather Condition	Action Level	Limit Level
Date	Time	Date	Time	Initial	Final	Initial	Final		Initial	Final	Average				
04-Oct-21	10:00AM	05-Oct-21	10:00AM	2.8051	2.9194	2590.8	2614.8	24	1.12	1.12	1.12	71.0	Sunny	152.4	260
11-Oct-21	10:00AM	12-Oct-21	10:00AM	2.8046	2.8843	2614.8	2638.8	24	1.12	1.12	1.12	49.5	Sunny	152.4	260
15-Oct-21	10:00AM	16-Oct-21	10:00AM	2.8080	2.8675	2638.8	2662.8	24	1.12	1.12	1.12	37.0	Rainy	152.4	260
21-Oct-21	10:00AM	22-Oct-21	10:00AM	2.8083	2.8914	2662.8	2686.8	24	1.12	1.12	1.12	51.6	Cloudy	152.4	260
27-Oct-21	10:00AM	28-Oct-21	10:00AM	2.8017	2.9152	2686.8	2710.8	24	1.12	1.12	1.12	70.6	Sunny	152.4	260

Note: Impact monitoring on 9 Oct has rescheduled to 11 Oct due to Tropical Cyclone Warning Signal No.8

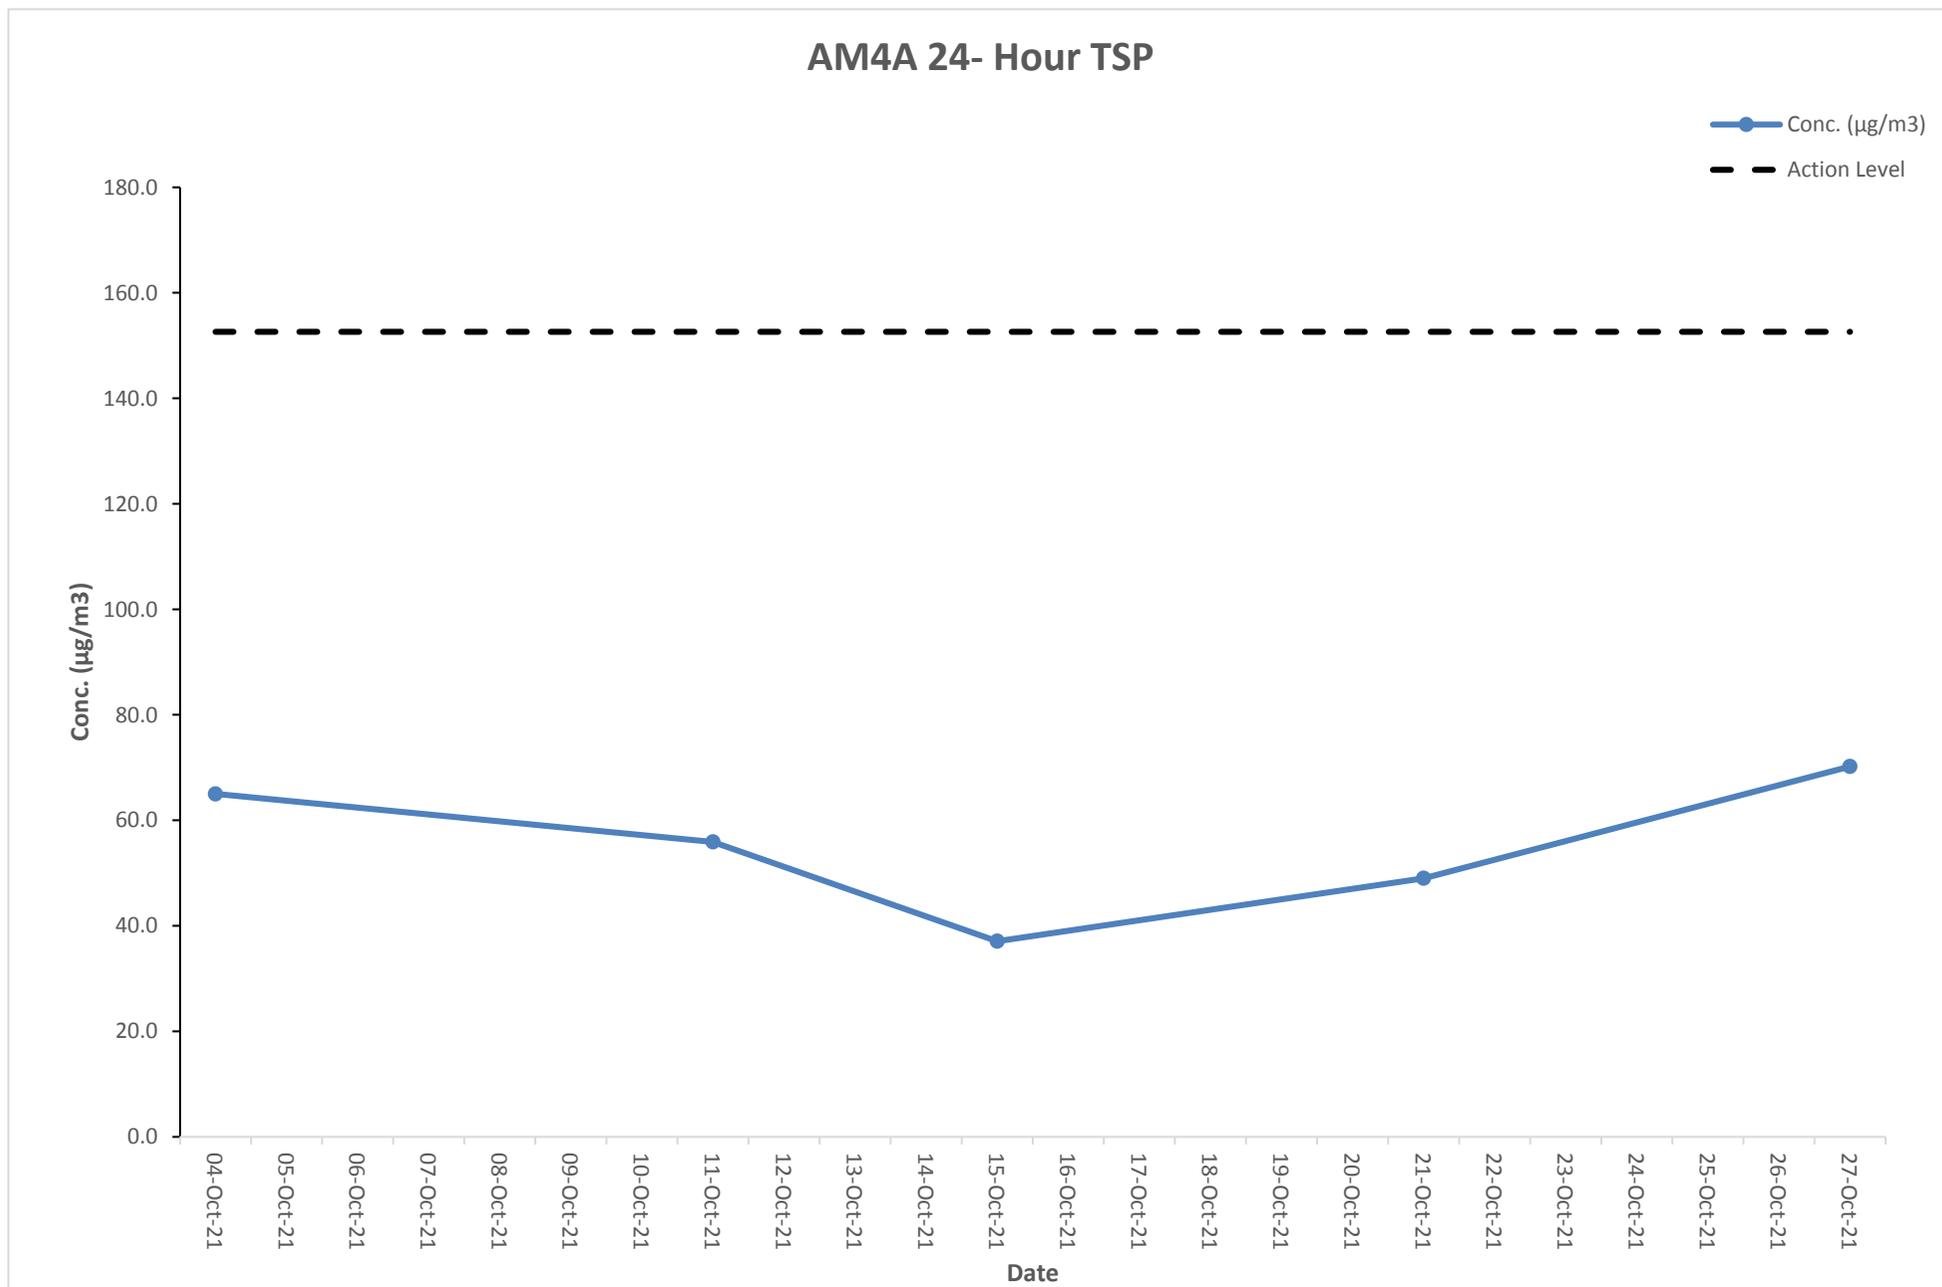
Graphical Presentation of Air Quality Monitoring Result at Station AM4A (24-hour TSP)

Start		Finish		Filter Weight (g)		Elapsed Time Reading		Sampling Time (hrs)	Flow Rate (m ³ /min)			Conc. (µg/m ³)	Weather Condition	Action Level	Limit Level
Date	Time	Date	Time	Initial	Final	Initial	Final		Initial	Final	Average				
04-Oct-21	10:00AM	05-Oct-21	10:00AM	2.8070	2.9116	3010.4	3034.4	24	1.12	1.12	1.12	65.0	Sunny	152.6	260
11-Oct-21	10:00AM	12-Oct-21	10:00AM	2.8030	2.8930	3034.4	3058.4	24	1.12	1.12	1.12	55.9	Sunny	152.6	260
15-Oct-21	10:00AM	16-Oct-21	10:00AM	2.8022	2.8619	3058.4	3082.4	24	1.12	1.12	1.12	37.1	Rainy	152.6	260
21-Oct-21	10:00AM	22-Oct-21	10:00AM	2.8035	2.8824	3082.4	3106.4	24	1.12	1.12	1.12	49.0	Cloudy	152.6	260
27-Oct-21	10:00AM	28-Oct-21	10:00AM	2.8072	2.9202	3106.4	3130.4	24	1.12	1.12	1.12	70.2	Sunny	152.6	260

Note: Impact monitoring on 9 Oct has rescheduled to 11 Oct due to Tropical Cyclone Warning Signal No.8
