Development at West Kowloon Cultural District

**Monthly Environmental Monitoring and Audit (EM&A) Report
for October 2021**

**Part-2: EM&A for Foundation Works in
Zones 2A, 2B & 2C**

Part-1: EM&A at Lyric Theatre Complex

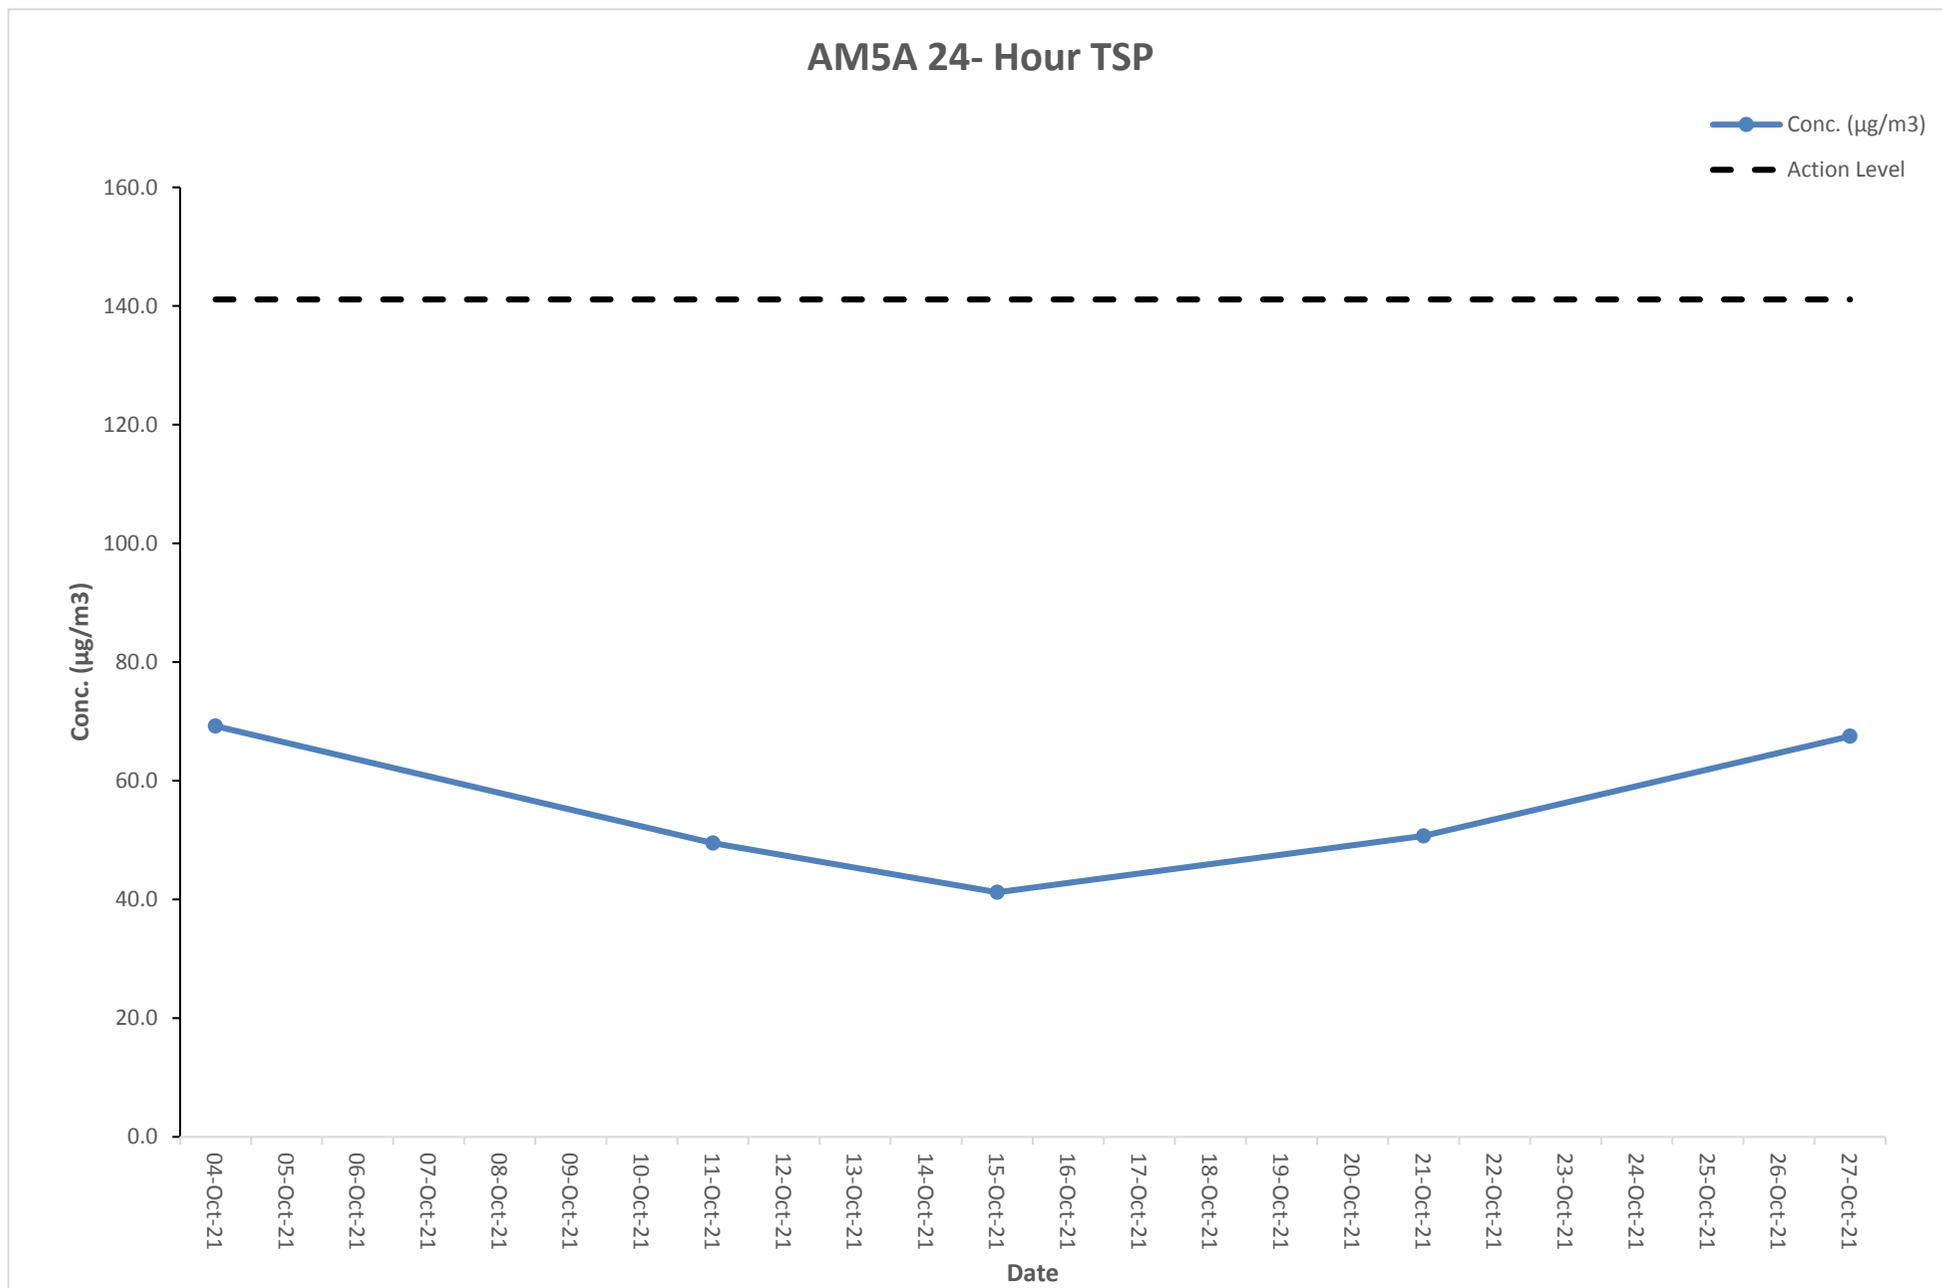
Graphical Presentation of Air Quality Monitoring Result at Station AM5A (24-hour TSP)

Start		Finish		Filter Weight (g)		Elapsed Time Reading		Sampling Time (hrs)	Flow Rate (m ³ /min)			Conc. (µg/m ³)	Weather Condition	Action Level	Limit Level
Date	Time	Date	Time	Initial	Final	Initial	Final		Initial	Final	Average				
04-Oct-21	10:00AM	05-Oct-21	10:00AM	2.8030	2.9144	3150.6	3174.6	24	1.12	1.12	1.12	69.2	Sunny	141.1	260
11-Oct-21	10:00AM	12-Oct-21	10:00AM	2.8016	2.8813	3174.6	3198.6	24	1.12	1.12	1.12	49.5	Sunny	141.1	260
15-Oct-21	10:00AM	16-Oct-21	10:00AM	2.8068	2.8732	3198.6	3222.6	24	1.12	1.12	1.12	41.2	Rainy	141.1	260
21-Oct-21	10:00AM	22-Oct-21	10:00AM	2.8089	2.8905	3222.6	3246.6	24	1.12	1.12	1.12	50.7	Cloudy	141.1	260
27-Oct-21	10:00AM	28-Oct-21	10:00AM	2.8012	2.9099	3246.6	3270.6	24	1.12	1.12	1.12	67.5	Sunny	141.1	260

Note: Impact monitoring on 9 Oct has rescheduled to 11 Oct due to Tropical Cyclone Warning Signal No.8

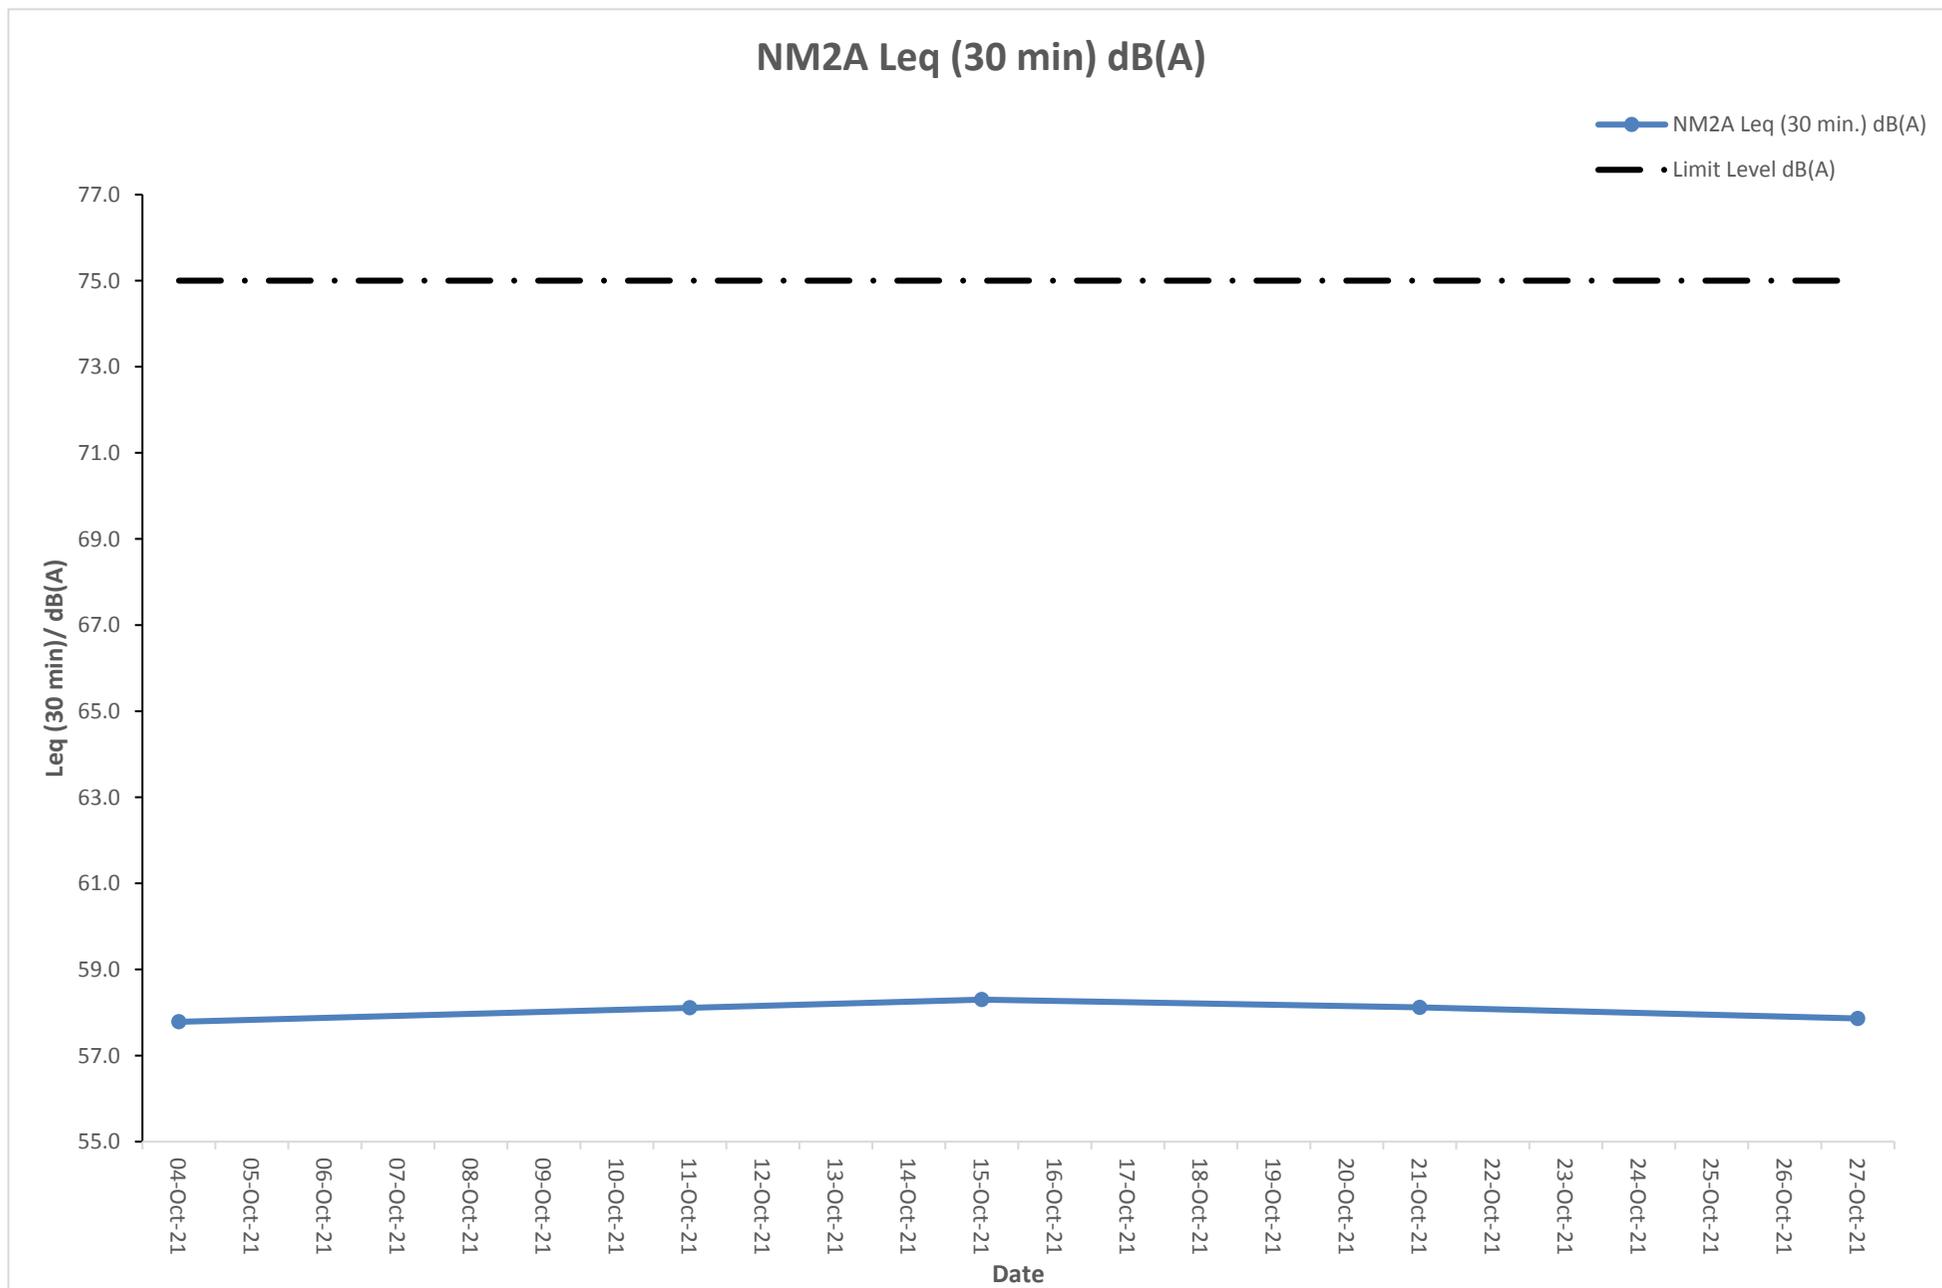
Graphical Presentation of Noise Monitoring Result at Station NM2A

Date	Time	Measured L10 dB(A)	Measured L90 dB(A)	Leq (30 min.) dB(A)
04-Oct-21	8:31	65.9	54.9	57.8
04-Oct-21	8:36	66.0	55.6	
04-Oct-21	8:41	64.1	55.8	
04-Oct-21	8:46	64.3	55.0	
04-Oct-21	8:51	65.7	54.7	
04-Oct-21	8:56	63.9	55.5	
11-Oct-21	14:32	64.0	55.9	58.1
11-Oct-21	14:37	64.9	54.3	
11-Oct-21	14:42	64.9	55.9	
11-Oct-21	14:47	63.1	54.4	
11-Oct-21	14:52	63.2	55.9	
11-Oct-21	14:57	64.2	54.9	
15-Oct-21	8:33	63.5	55.0	58.3
15-Oct-21	8:38	64.5	54.9	
15-Oct-21	8:43	64.8	55.7	
15-Oct-21	8:48	63.7	55.7	
15-Oct-21	8:53	64.4	54.6	
15-Oct-21	8:58	65.9	54.3	
21-Oct-21	14:35	64.3	55.9	58.1
21-Oct-21	14:40	63.3	55.9	
21-Oct-21	14:45	63.3	55.0	
21-Oct-21	14:50	66.0	55.1	
21-Oct-21	14:55	65.4	55.5	
21-Oct-21	15:00	63.9	55.8	
27-Oct-21	8:34	64.5	55.9	57.9
27-Oct-21	8:39	63.5	55.5	
27-Oct-21	8:44	64.4	54.5	
27-Oct-21	8:49	63.8	54.8	
27-Oct-21	8:54	65.5	56.0	
27-Oct-21	8:59	64.8	55.3

The station set-up of a façade measurement at station NM2A.

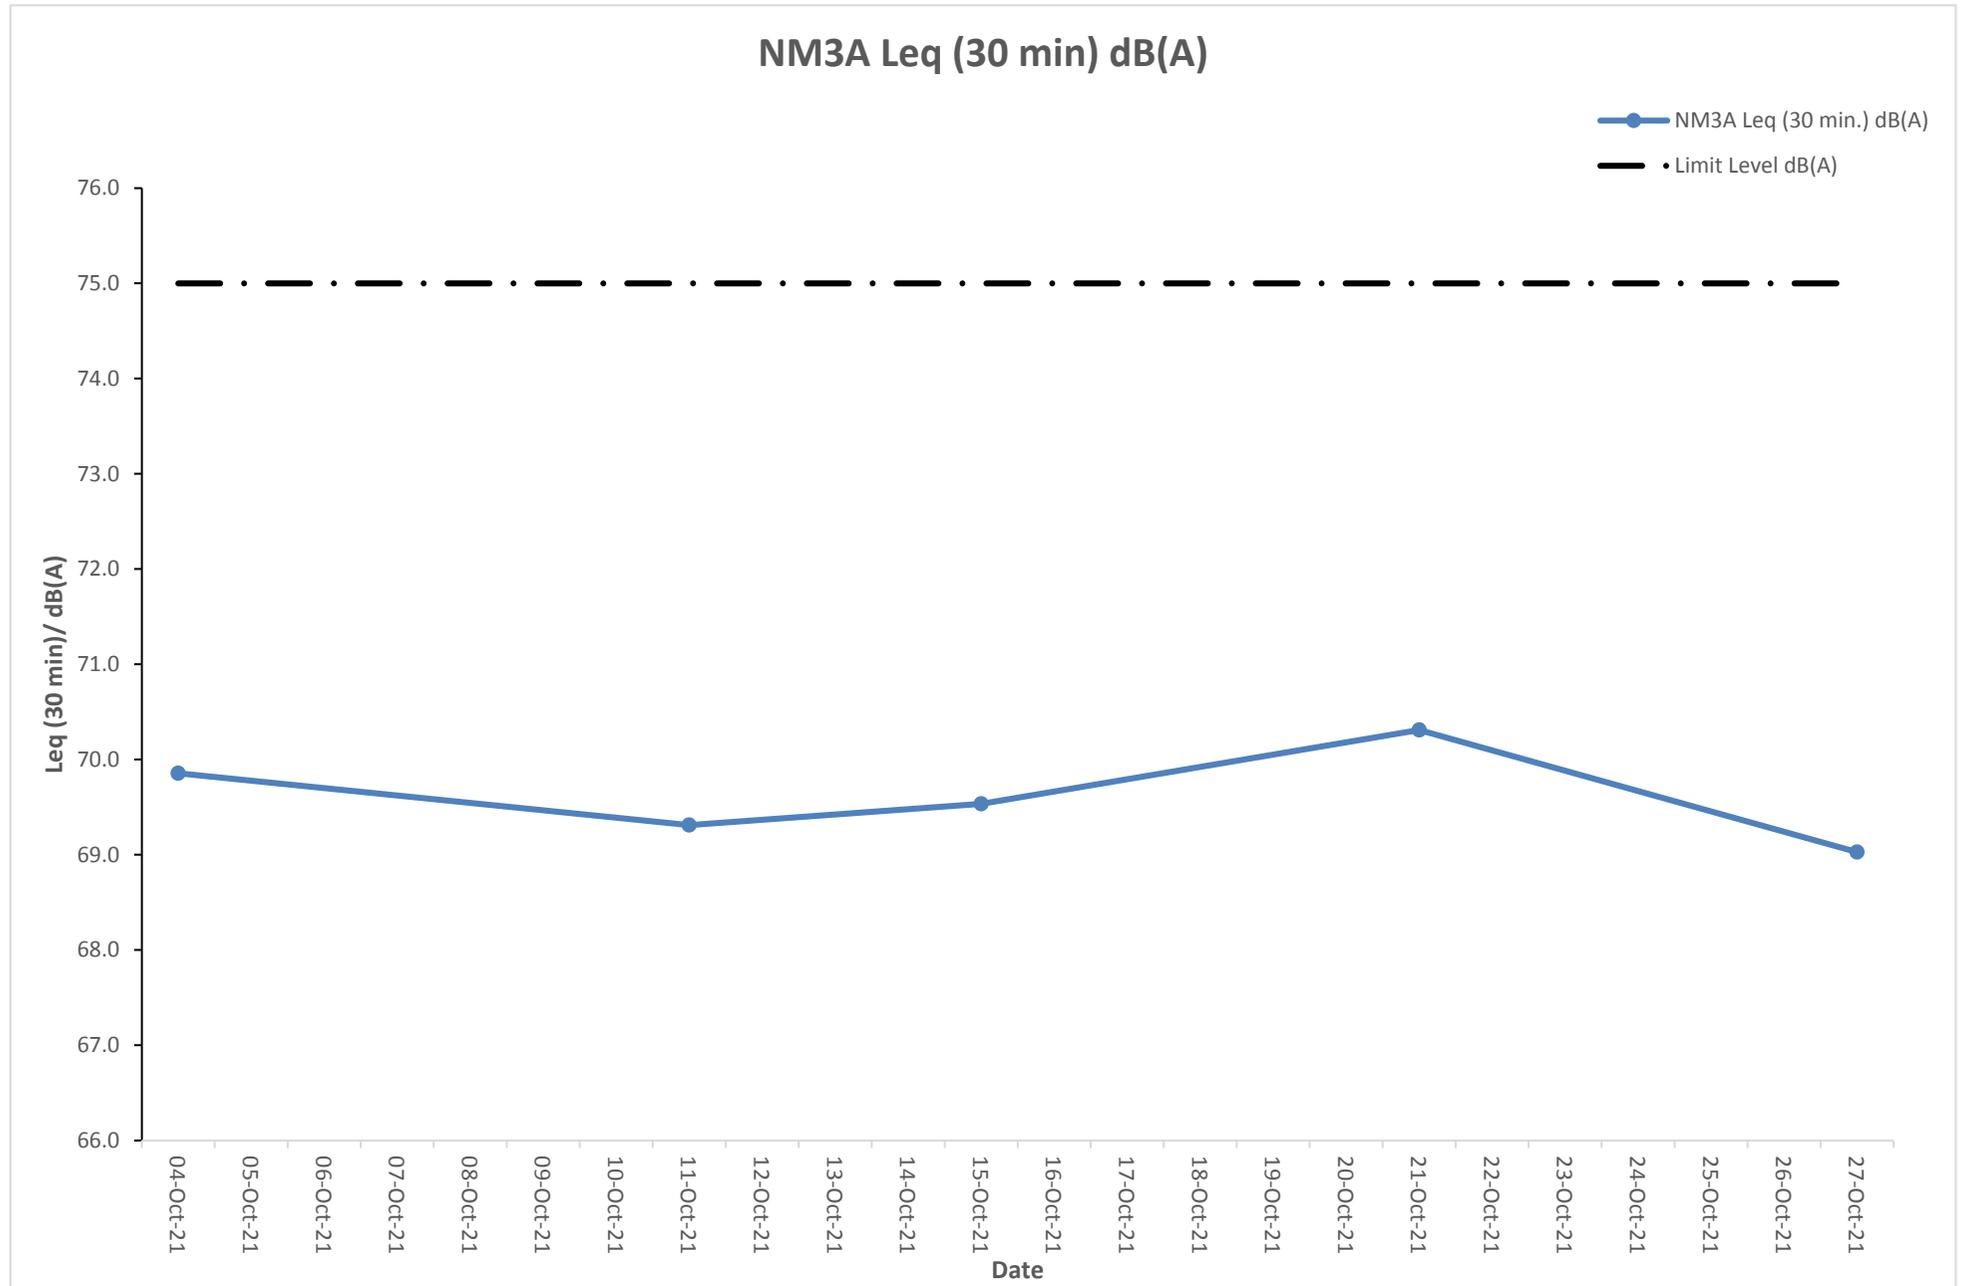
Graphical Presentation of Noise Monitoring Result at Station NM3A

Date	Time	Measured L10 dB(A)	Measured L90 dB(A)	Leq (30 min.) dB(A)
04-Oct-21	10:01	74.0	66.2	69.9
04-Oct-21	10:06	73.5	66.7	
04-Oct-21	10:11	73.9	66.8	
04-Oct-21	10:16	72.8	64.5	
04-Oct-21	10:21	73.7	66.3	
04-Oct-21	10:26	73.3	64.4	
11-Oct-21	16:05	73.2	64.3	69.3
11-Oct-21	16:10	73.5	64.3	
11-Oct-21	16:15	73.0	65.1	
11-Oct-21	16:20	74.5	65.5	
11-Oct-21	16:25	72.8	65.8	
11-Oct-21	16:30	73.7	65.2	69.5
15-Oct-21	10:03	73.1	64.7	
15-Oct-21	10:08	74.5	66.7	
15-Oct-21	10:13	74.2	64.4	
15-Oct-21	10:18	73.3	66.3	
15-Oct-21	10:23	73.4	66.4	
15-Oct-21	10:28	74.1	64.2	70.3
21-Oct-21	16:08	73.5	65.4	
21-Oct-21	16:13	73.7	64.3	
21-Oct-21	16:18	73.9	66.2	
21-Oct-21	16:23	74.4	64.3	
21-Oct-21	16:28	73.8	64.8	
21-Oct-21	16:33	74.5	64.6	69.0
27-Oct-21	10:04	73.6	65.7	
27-Oct-21	10:09	72.8	66.6	
27-Oct-21	10:14	73.6	66.4	
27-Oct-21	10:19	73.2	65.2	
27-Oct-21	10:24	74.2	65.5	
27-Oct-21	10:29	74.3	66.1

The station set-up of a façade measurement at station NM3A.

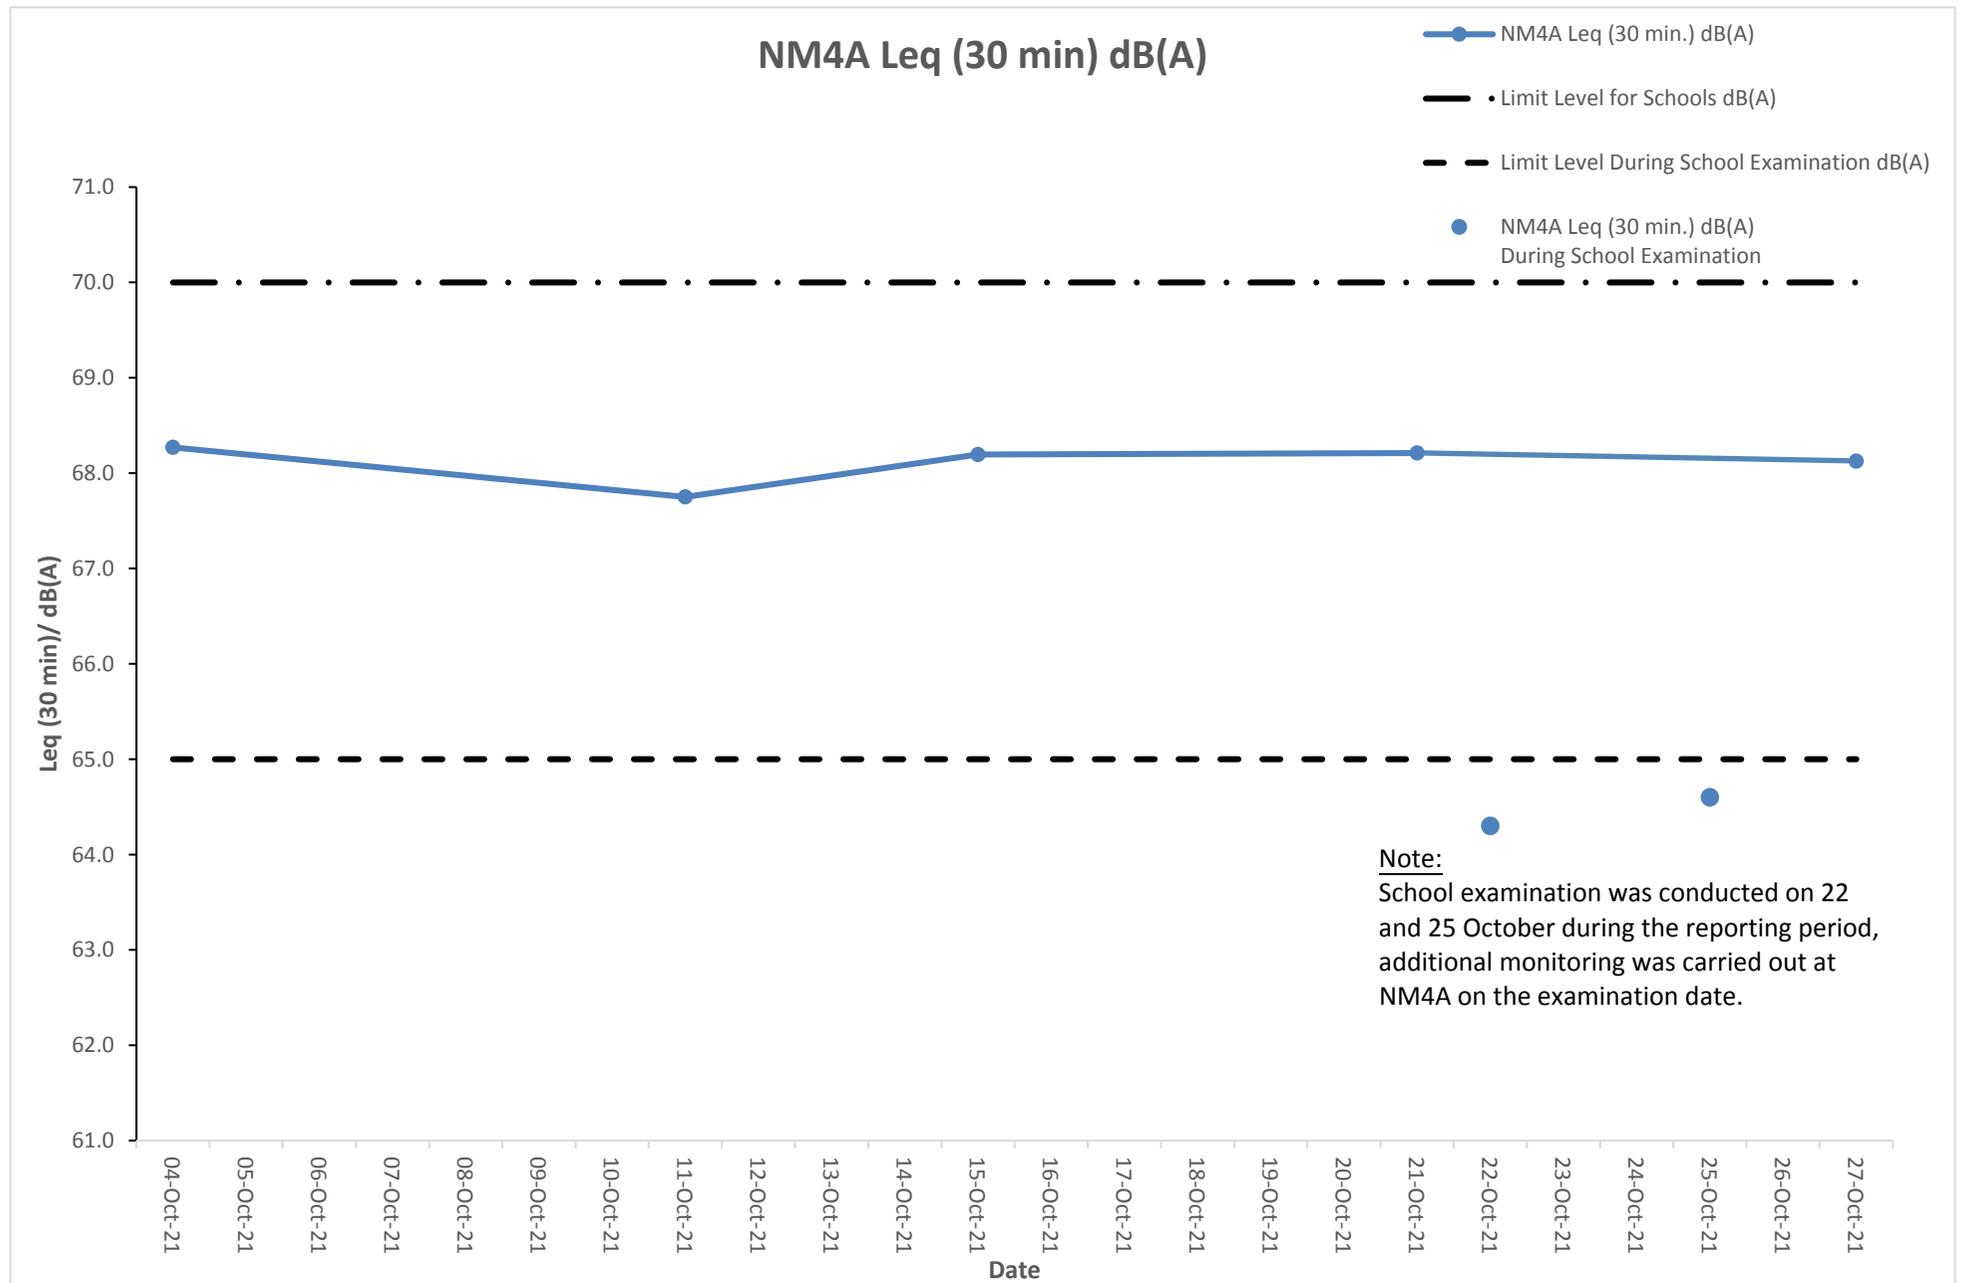
Graphical Presentation of Noise Monitoring Result at Station NM4A

Date	Time	Measured L10 dB(A)	Measured L90 dB(A)	Leq (30 min.) dB(A)
04-Oct-21	10:36	70.2	65.2	68.3
04-Oct-21	10:41	69.7	65.5	
04-Oct-21	10:46	69.8	63.4	
04-Oct-21	10:51	72.0	63.7	
04-Oct-21	10:56	69.7	64.9	
04-Oct-21	11:01	69.7	66.0	
11-Oct-21	16:40	69.2	63.5	67.8
11-Oct-21	16:45	69.2	65.4	
11-Oct-21	16:50	70.6	63.9	
11-Oct-21	16:55	70.6	65.6	
11-Oct-21	17:00	69.4	63.3	
11-Oct-21	17:05	70.5	64.5	
15-Oct-21	10:38	69.5	63.8	68.2
15-Oct-21	10:43	69.3	64.8	
15-Oct-21	10:48	71.0	64.5	
15-Oct-21	10:53	70.9	64.6	
15-Oct-21	10:58	69.2	63.1	
15-Oct-21	11:03	71.1	63.2	
21-Oct-21	16:43	71.2	65.4	68.2
21-Oct-21	16:48	72.0	65.3	
21-Oct-21	16:53	70.4	65.5	
21-Oct-21	16:58	69.3	63.2	
21-Oct-21	17:03	69.4	64.1	
21-Oct-21	17:08	71.4	65.1	
27-Oct-21	10:39	71.6	64.2	68.1
27-Oct-21	10:44	71.9	64.8	
27-Oct-21	10:49	71.2	65.8	
27-Oct-21	10:54	71.1	65.6	
27-Oct-21	10:59	70.8	64.2	
27-Oct-21	11:04	71.6	64.4

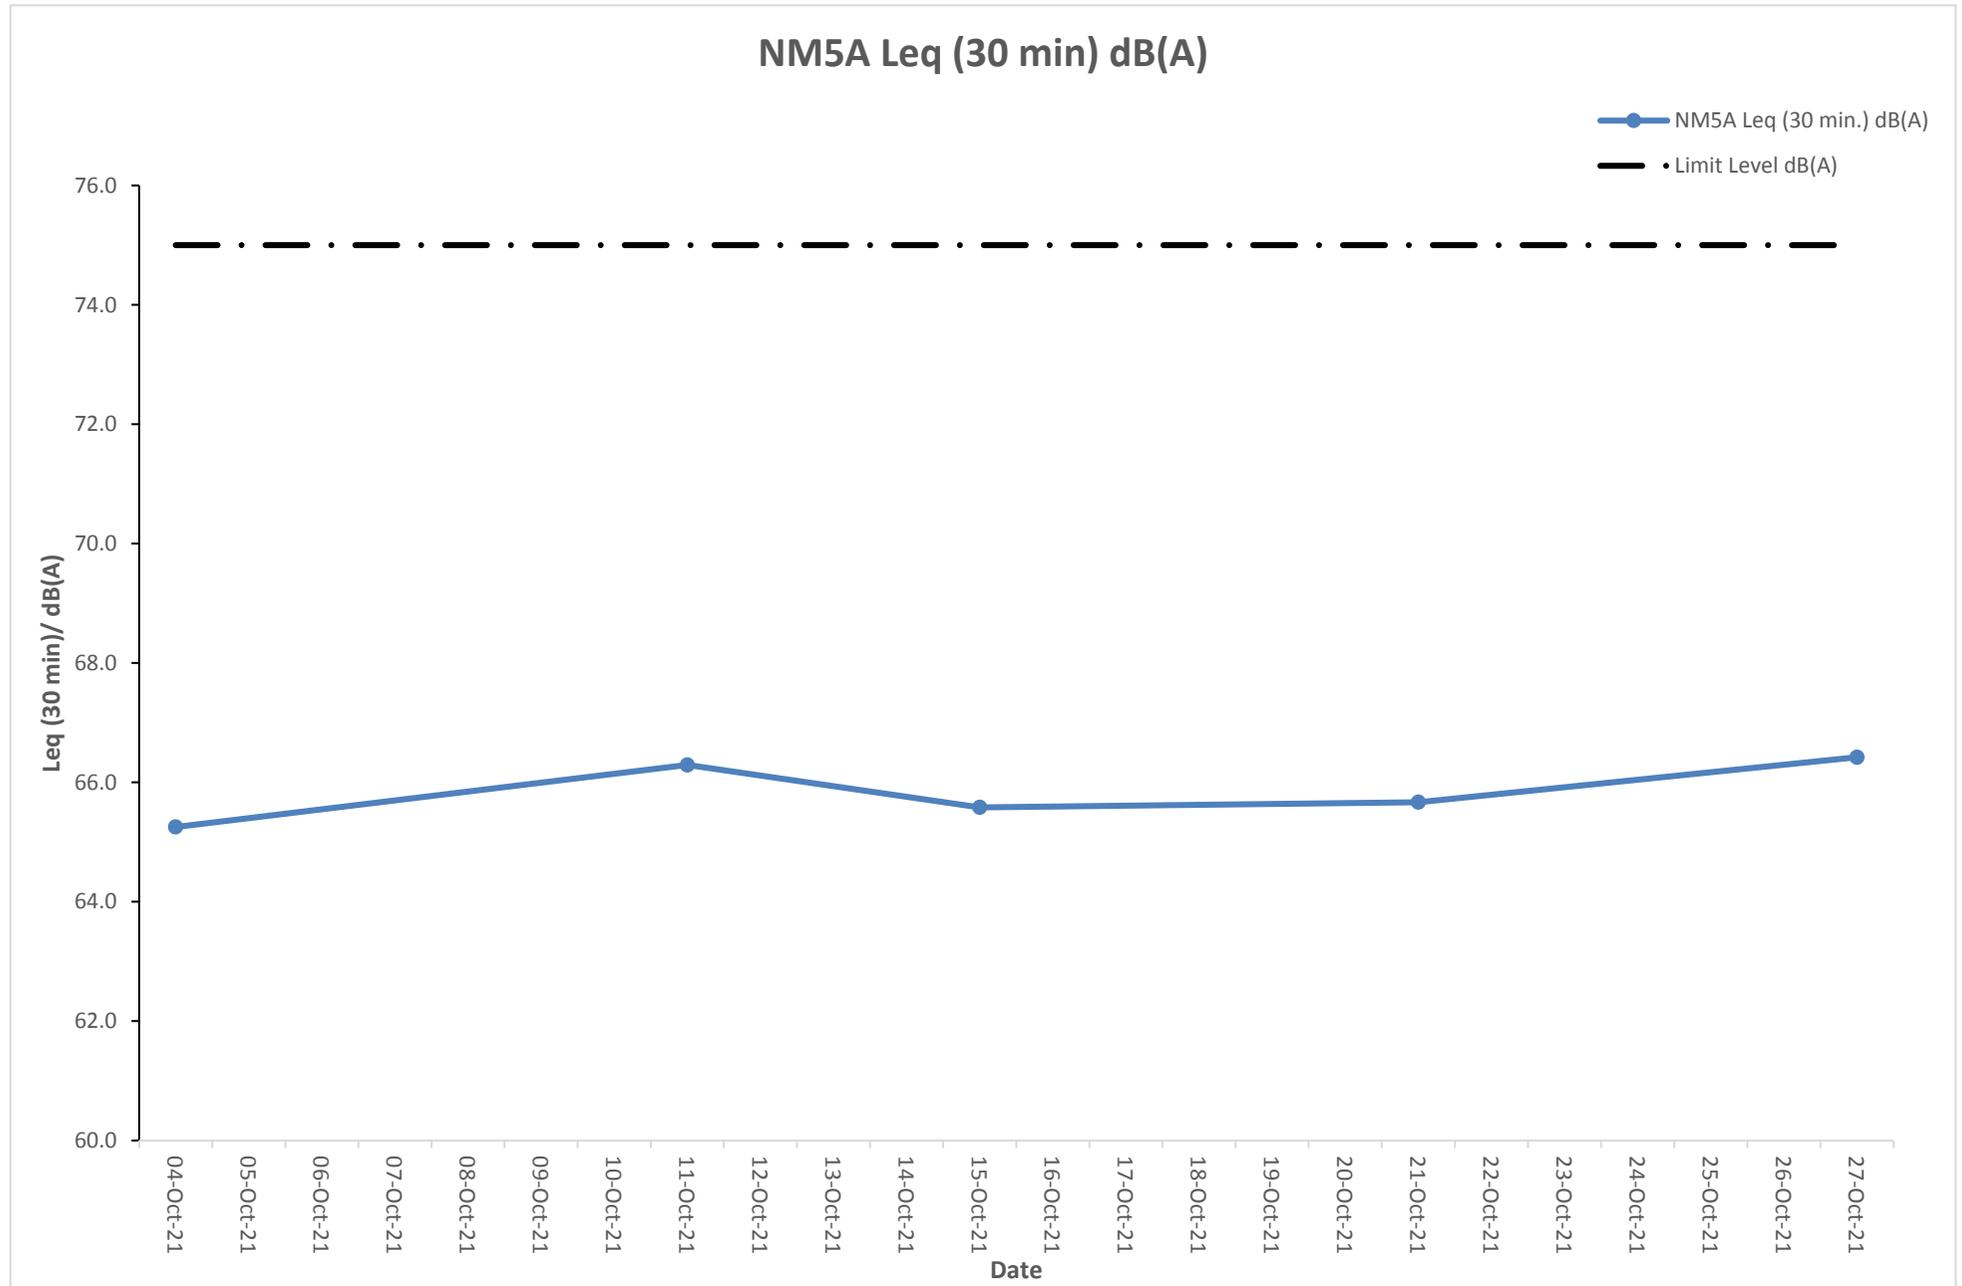
Graphical Presentation of Noise Monitoring Result at Station NM5A

Date	Time	Measured L10 dB(A)	Measured L90 dB(A)	Leq (30 min.) dB(A)	Leq (30 min.) +3 dB(A)
04-Oct-21	9:21	64.5	57.1	62.3	65.3
04-Oct-21	9:26	66.7	57.6		
04-Oct-21	9:31	65.3	57.7		
04-Oct-21	9:36	65.5	58.8		
04-Oct-21	9:41	65.8	57.0		
04-Oct-21	9:46	65.4	56.2		
11-Oct-21	15:24	66.1	56.4	63.3	66.3
11-Oct-21	15:29	64.9	58.9		
11-Oct-21	15:34	64.3	58.1		
11-Oct-21	15:39	66.4	57.2		
11-Oct-21	15:44	64.3	58.2		
11-Oct-21	15:49	66.5	59.0	62.6	65.6
15-Oct-21	9:23	64.9	56.6		
15-Oct-21	9:28	66.6	57.0		
15-Oct-21	9:33	67.1	58.4		
15-Oct-21	9:38	65.6	57.9		
15-Oct-21	9:43	66.8	58.6		
15-Oct-21	9:48	66.9	56.4	62.7	65.7
21-Oct-21	15:27	67.0	58.2		
21-Oct-21	15:32	66.9	56.4		
21-Oct-21	15:37	64.3	57.9		
21-Oct-21	15:42	64.2	58.0		
21-Oct-21	15:47	66.5	56.2		
21-Oct-21	15:52	64.9	57.4	63.4	66.4
27-Oct-21	9:24	65.9	58.0		
27-Oct-21	9:29	66.5	58.9		
27-Oct-21	9:34	67.1	57.1		
27-Oct-21	9:39	66.4	56.3		
27-Oct-21	9:44	66.2	58.4		
27-Oct-21	9:49	65.7	56.7
