# Development at West Kowloon Cultural District

Monthly Environmental Monitoring and Audit (EM&A) Report  
for December 2021

# Part-1: EM&A at Lyric Theatre Complex

# Lyric Theatre Complex

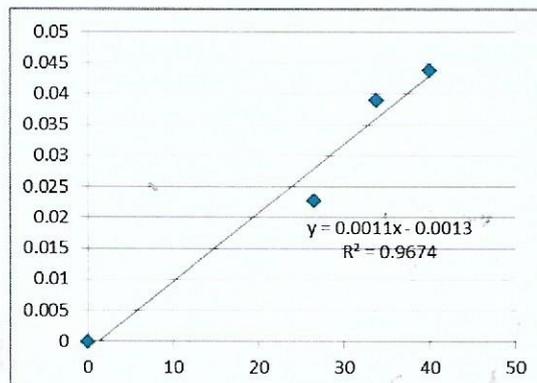
1. **Strong** Correlation ( $R > 0.8$ )
2. Factor 0.0011 should be applied for TSP monitoring

\*If  $R < 0.5$ , repair or re-verification is required for the equipment

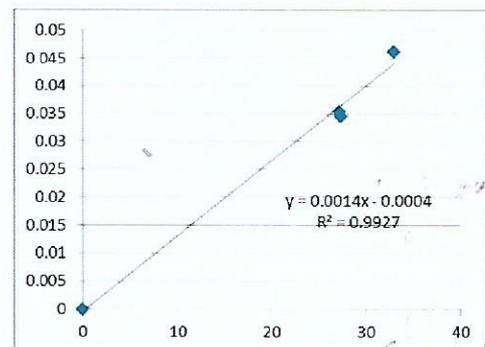
Slope (K-factor): 0.0014  
Correlation Coefficient 0.9963  
Date of Issue 10 May 2021

1. **Strong Correlation (R>0.8)**
  2. Factor 0.0014 should be applied for TSP monitoring
- \*if R<0.5, repair or re-verification is required for the equipment

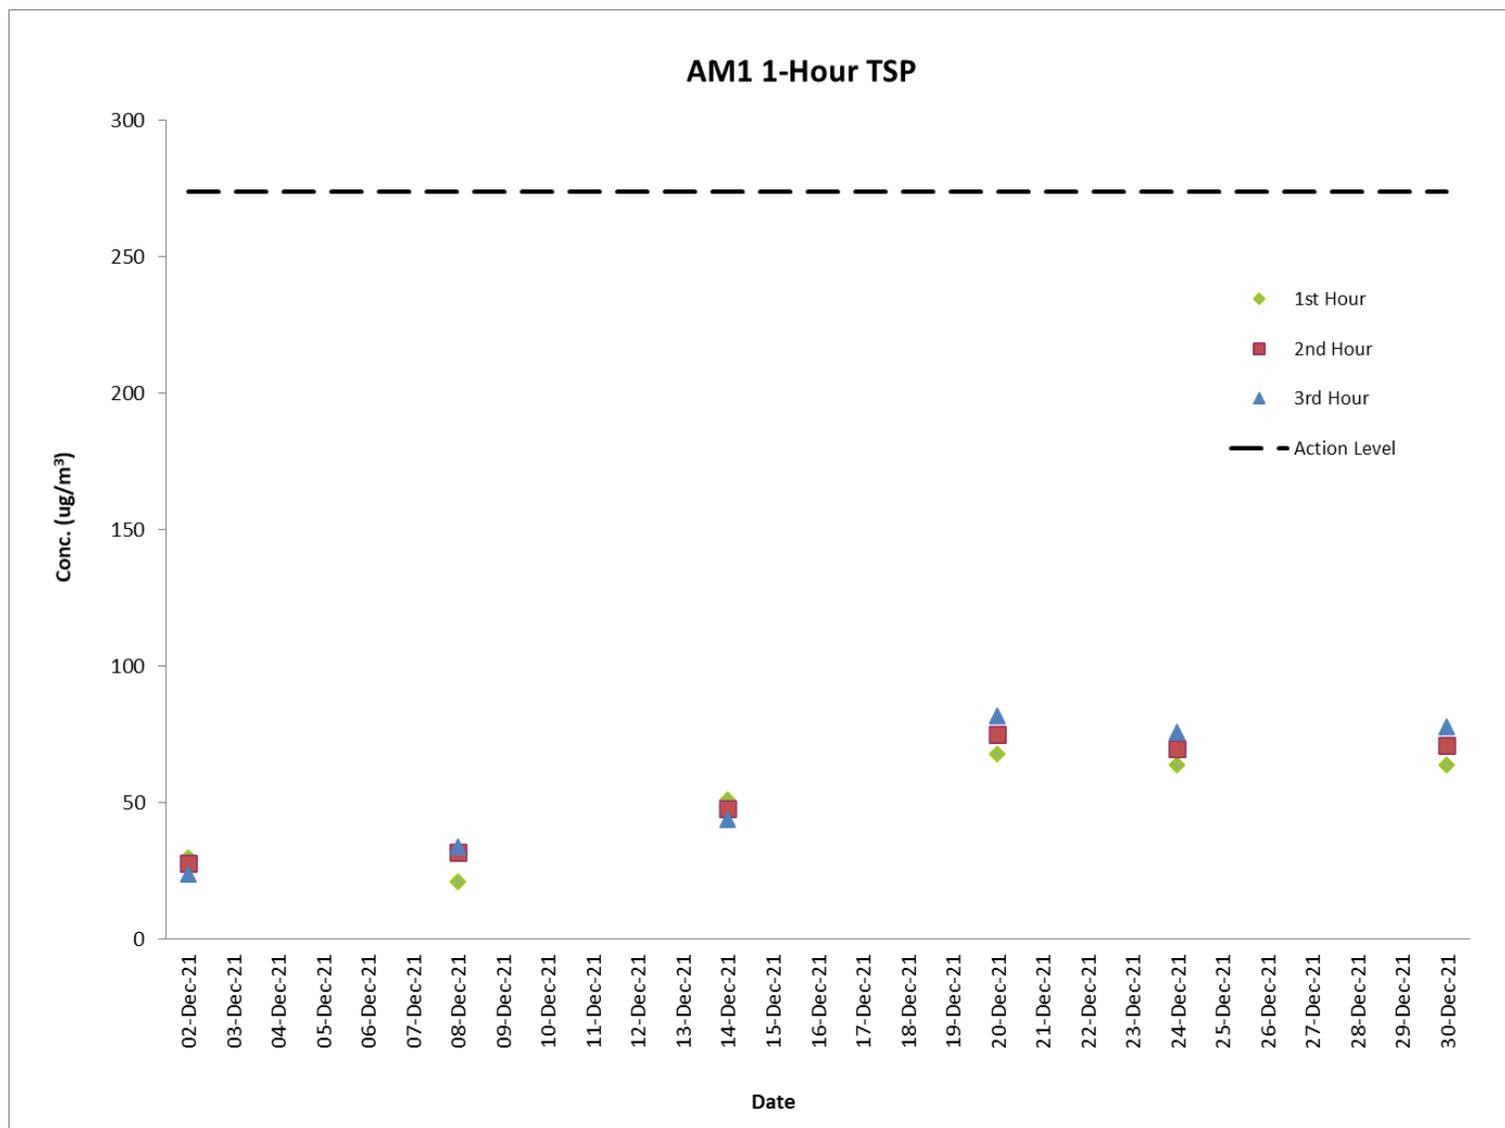
### Graphical Presentation of Air Quality Monitoring Result at Station AM1 (1-hour TSP)

Date	Weather Condition	Time	Conc. ( $\mu\text{g}/\text{m}^3$ )			Action Level ( $\mu\text{g}/\text{m}^3$ )	Limit Level ( $\mu\text{g}/\text{m}^3$ )
			1 <sup>st</sup> Hour	2 <sup>nd</sup> Hour	3 <sup>rd</sup> Hour		
02-Dec-21	Sunny	8:23 - 11:23	30	28	24	273.7	500
08-Dec-21	Sunny	8:23 - 11:23	21	32	34	273.7	500
14-Dec-21	Cloudy	8:23 - 11:23	51	48	44	273.7	500
20-Dec-21	Cloudy	8:25 - 11:25	68	75	82	273.7	500
24-Dec-21	Cloudy	8:23 - 11:23	64	70	76	273.7	500
30-Dec-21	Sunny	8:25 - 11:25	64	71	78	273.7	500

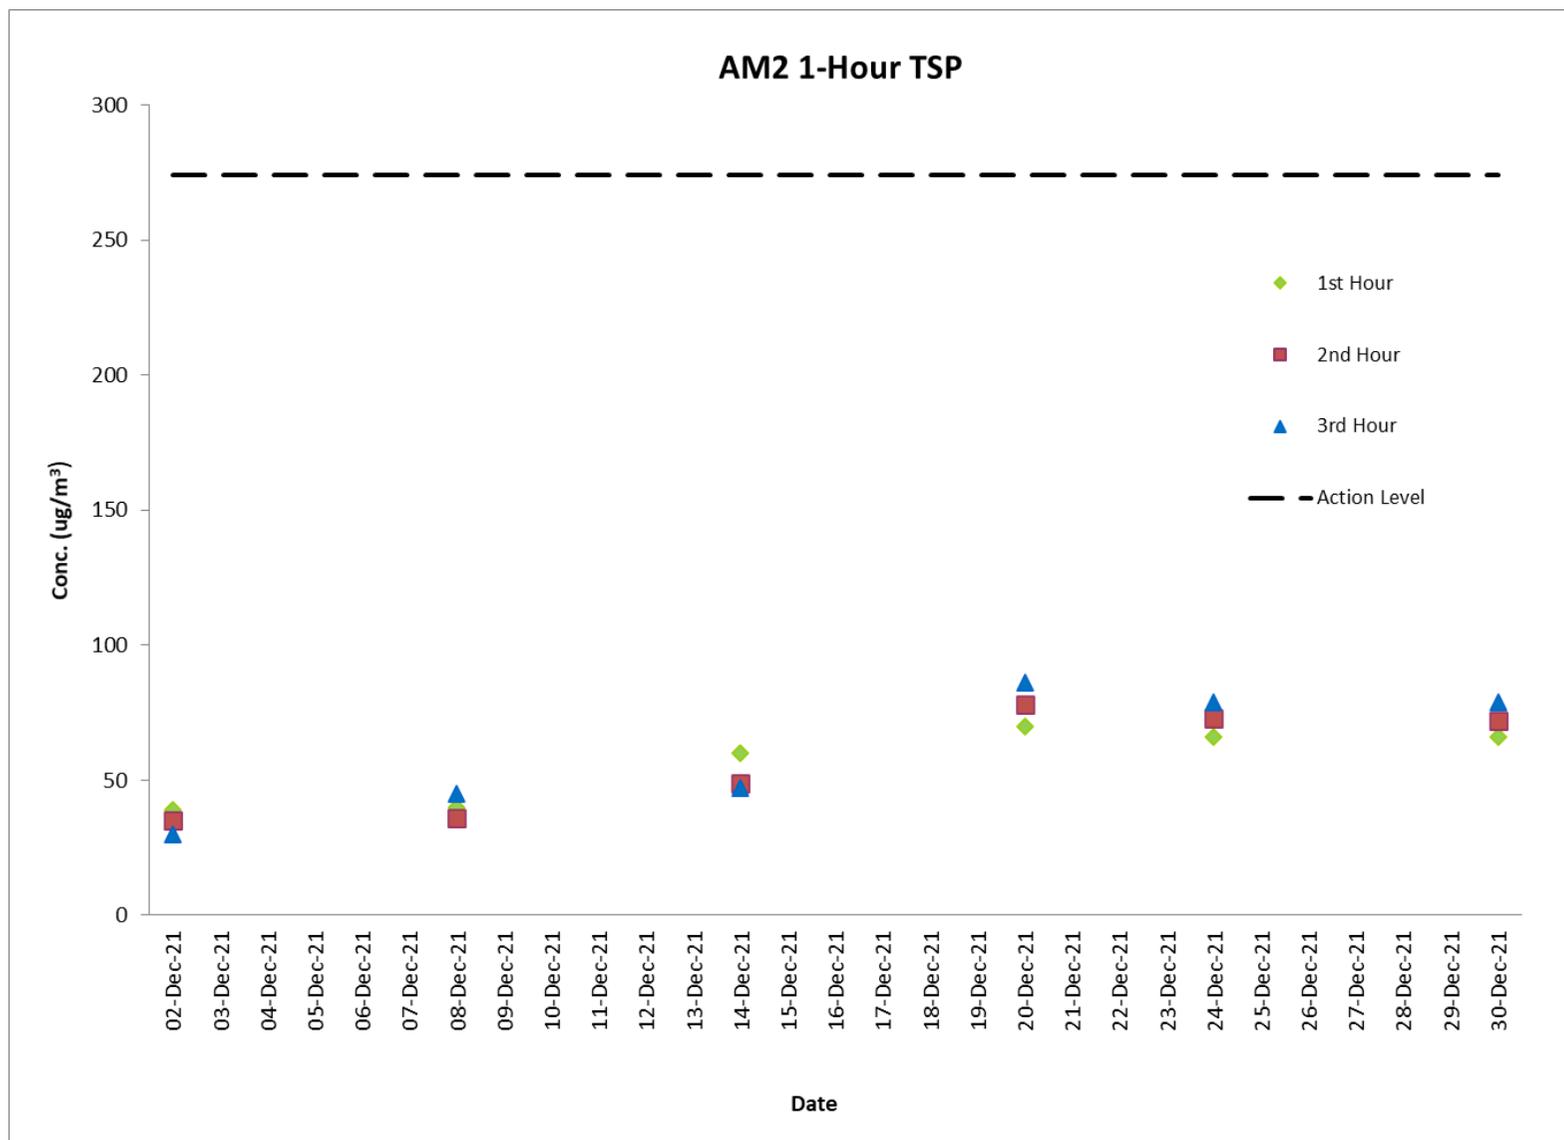
Graphical Presentation of Air Quality Monitoring Result at Station AM2 (1-hour TSP)

Date	Weather Condition	Time	Conc. ( $\mu\text{g}/\text{m}^3$ )			Action Level ( $\mu\text{g}/\text{m}^3$ )	Limit Level ( $\mu\text{g}/\text{m}^3$ )
			1 <sup>st</sup> Hour	2 <sup>nd</sup> Hour	3 <sup>rd</sup> Hour		
02-Dec-21	Sunny	8:38 - 11:38	39	35	30	274.2	500
08-Dec-21	Sunny	8:37 - 11:37	40	36	45	274.2	500
14-Dec-21	Cloudy	8:39 - 11:39	60	49	47	274.2	500
20-Dec-21	Cloudy	8:39 - 11:39	70	78	86	274.2	500
24-Dec-21	Cloudy	8:38 - 11:38	66	73	79	274.2	500
30-Dec-21	Sunny	8:40 - 11:40	66	72	79	274.2	500

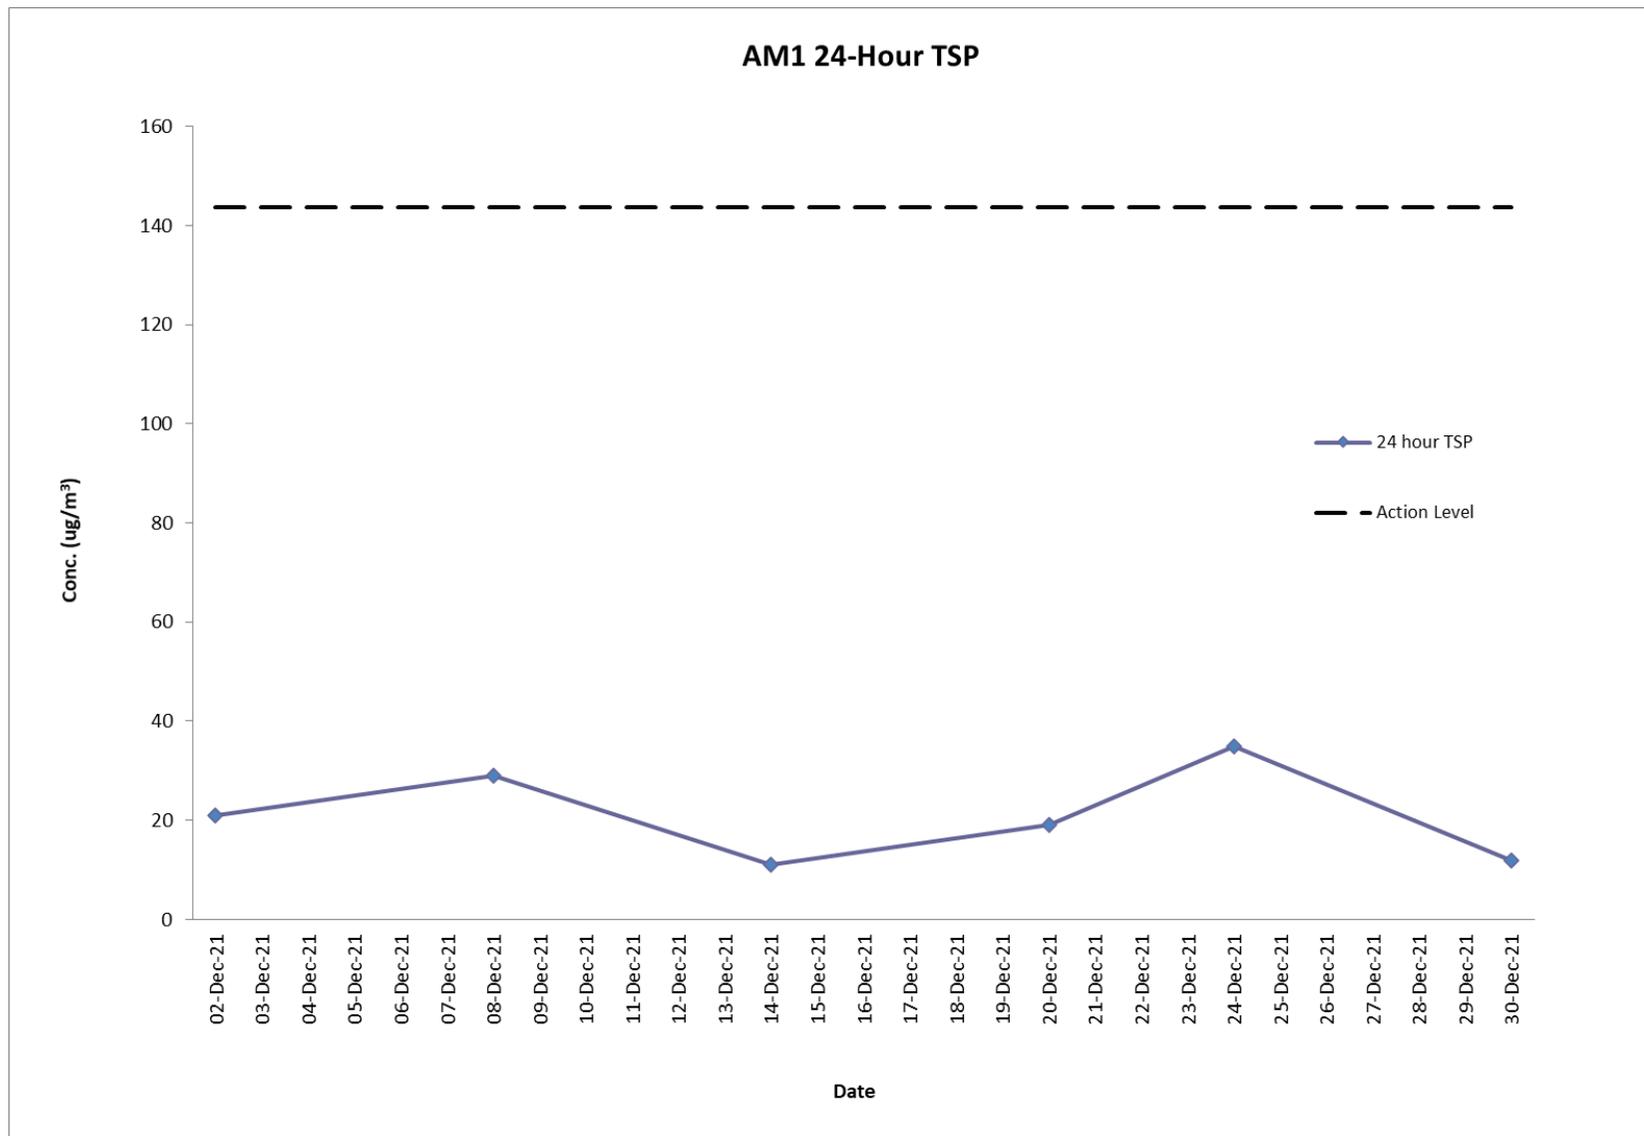
### Graphical Presentation of Air Quality Monitoring Result at Station AM1 (24-hour TSP)

Start		Finish		Filter Weight (g)		Elapsed Time Reading		Sampling Time (hrs)	Flow Rate (m <sup>3</sup> /min)			Conc. (µg/m <sup>3</sup> )	Weather Condition	Action Level	Limit Level
Date	Time	Date	Time	Initial	Final	Initial	Final		Initial	Final	Average				
02-Dec-21	08:20	03-Dec-21	08:20	2.7347	2.7726	24224.38	24248.38	24	1.26	1.26	1.26	21	Sunny	143.6	260
08-Dec-21	08:20	09-Dec-21	08:20	2.7220	2.7755	24248.38	24272.38	24	1.26	1.26	1.26	29	Sunny	143.6	260
14-Dec-21	08:20	15-Dec-21	08:20	2.7354	2.7556	24272.38	24296.38	24	1.26	1.26	1.26	11	Cloudy	143.6	260
20-Dec-21	08:22	21-Dec-21	08:22	2.7742	2.8079	24296.38	24320.38	24	1.26	1.26	1.26	19	Cloudy	143.6	260
24-Dec-21	08:20	25-Dec-21	08:20	2.8172	2.8806	24320.38	24344.38	24	1.26	1.26	1.26	35	Cloudy	143.6	260
30-Dec-21	08:22	31-Dec-21	08:22	2.8188	2.8410	24344.38	24368.38	24	1.26	1.26	1.26	12	Sunny	143.6	260

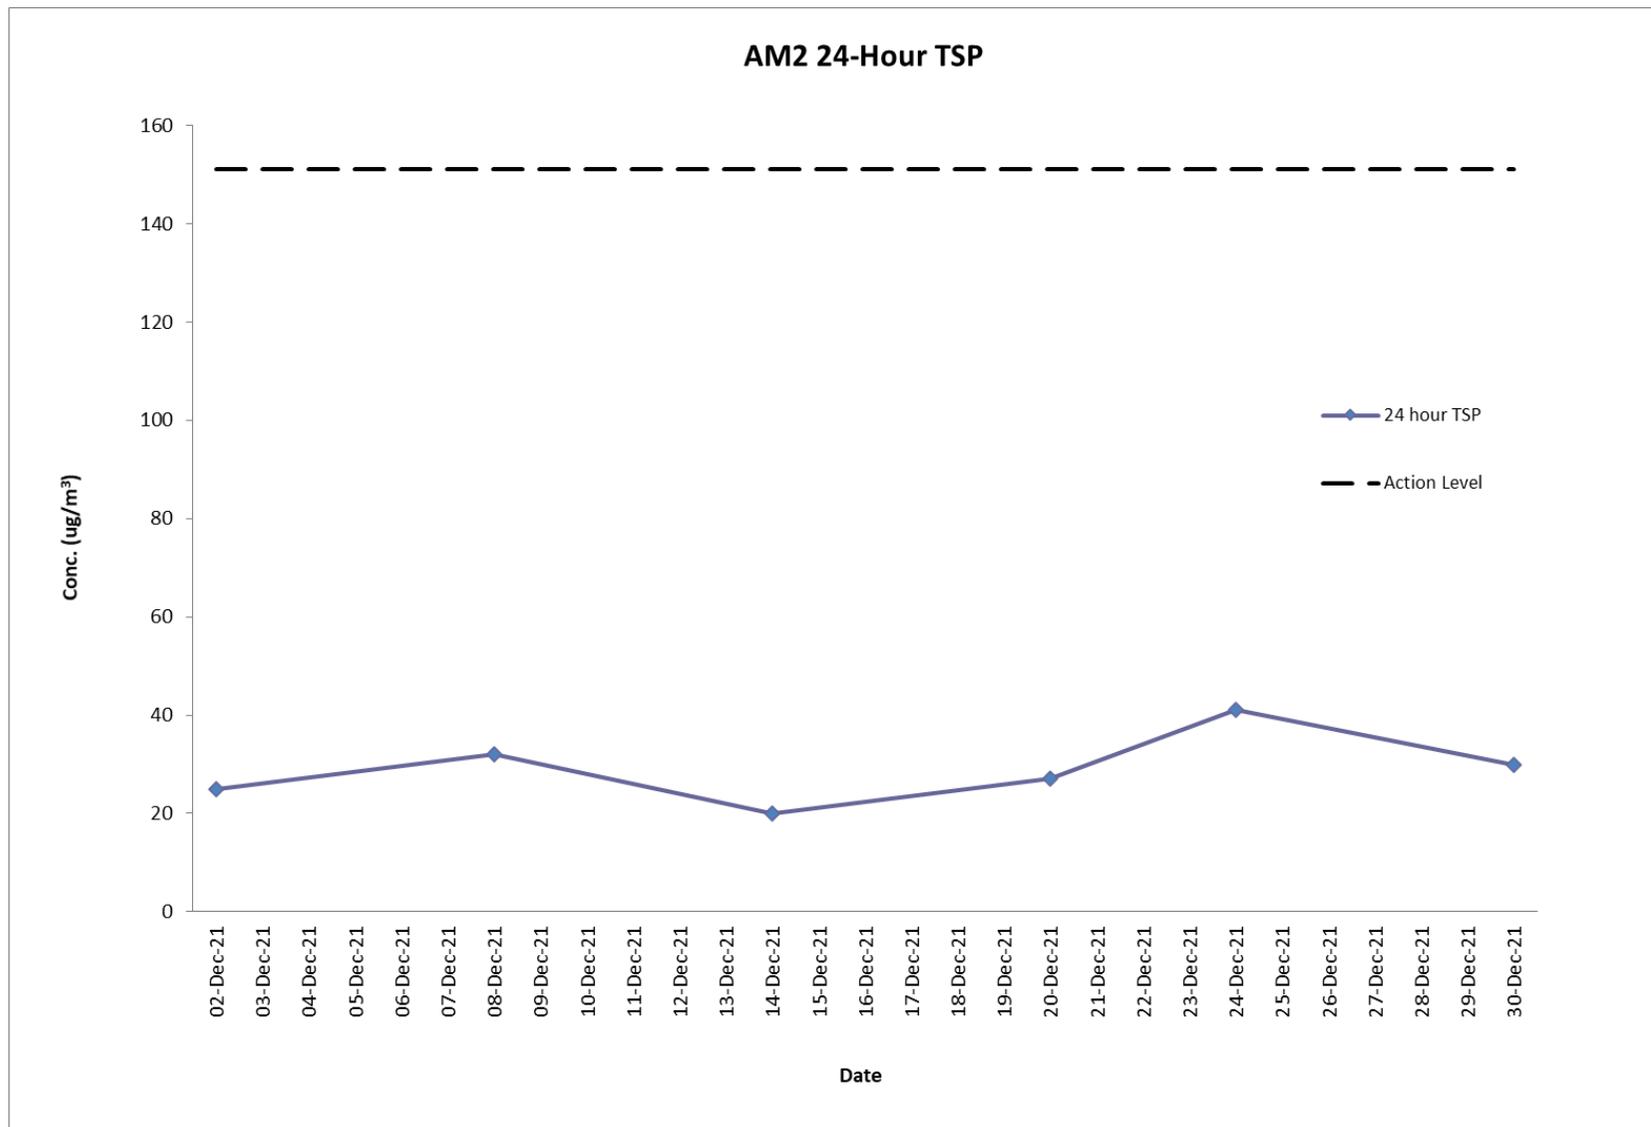
### Graphical Presentation of Air Quality Monitoring Result at Station AM2 (24-hour TSP)

Start		Finish		Sampling Time (hrs)	Conc. ( $\mu\text{g}/\text{m}^3$ )	Weather Condition	Action Level	Limit Level
Date	Time	Date	Time					
02-Dec-21	08:35	03-Dec-21	08:35	24	25	Sunny	151.1	260
08-Dec-21	08:34	09-Dec-21	08:34	24	32	Sunny	151.1	260
14-Dec-21	08:35	15-Dec-21	08:35	24	20	Cloudy	151.1	260
20-Dec-21	08:36	21-Dec-21	08:36	24	27	Cloudy	151.1	260
24-Dec-21	08:35	25-Dec-21	08:35	24	41	Cloudy	151.1	260
30-Dec-21	08:37	31-Dec-21	08:37	24	30	Sunny	151.1	260

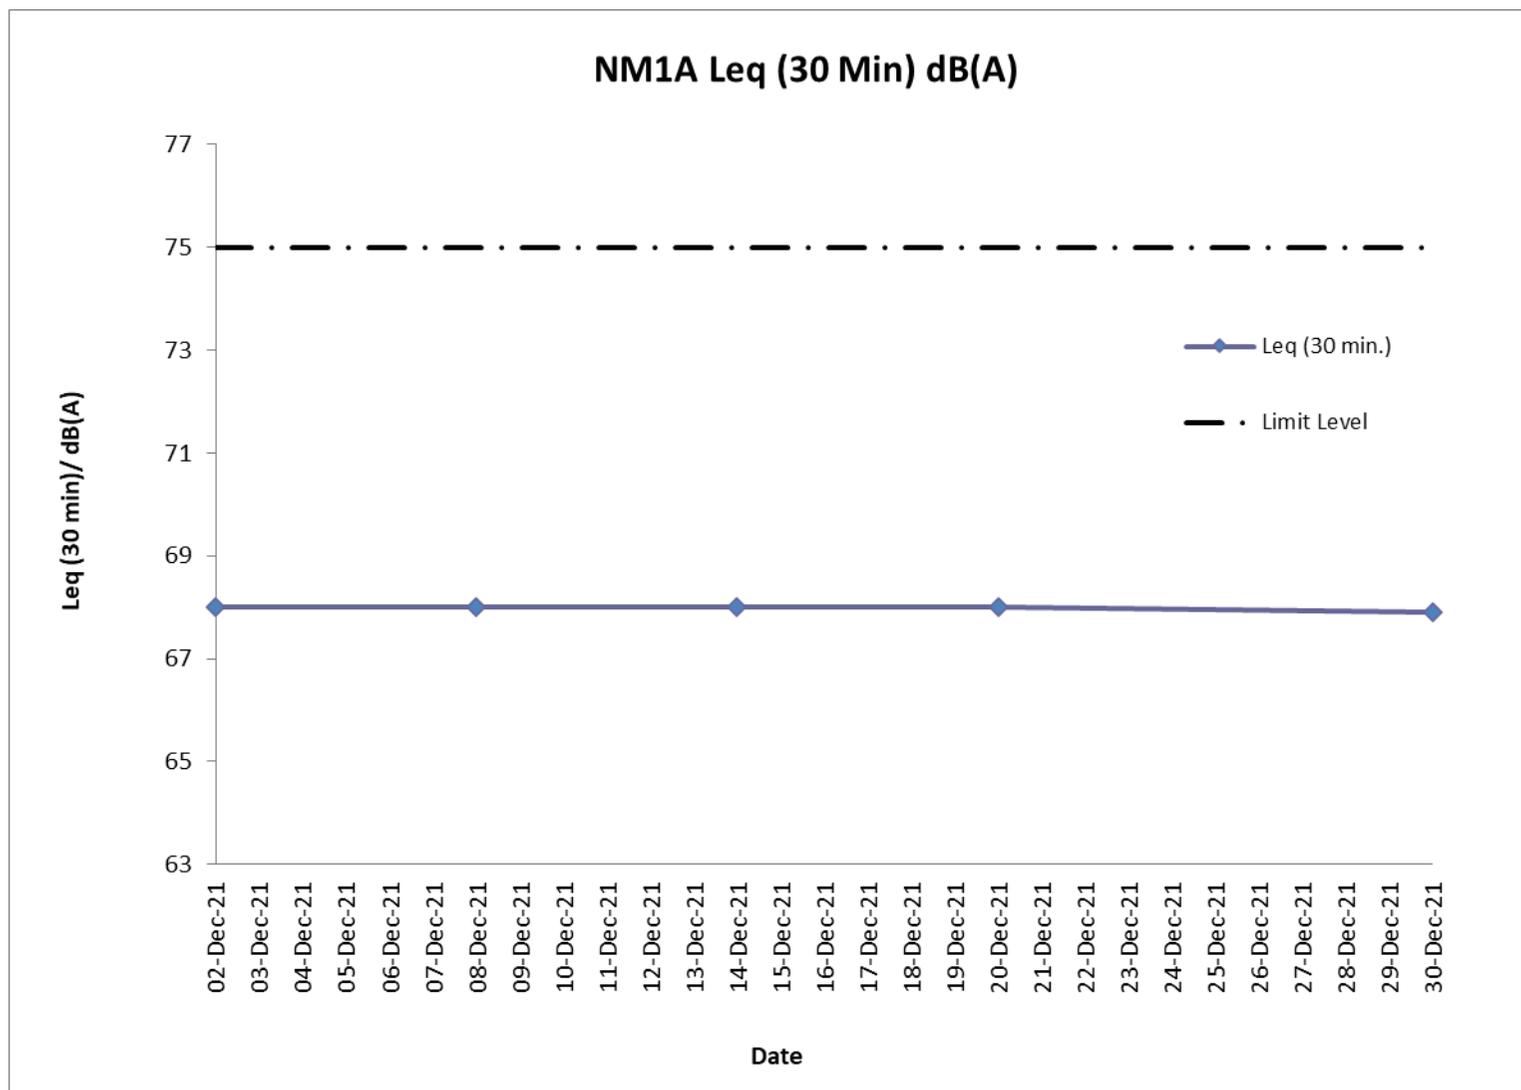
### Graphical Presentation Noise Monitoring Result at Station NM1A

Date	Time	Measured L <sub>10</sub> , dB(A)	Measured L <sub>90</sub> , dB(A)	L <sub>eq</sub> (30 min.)*, dB(A)
02-Dec-21	09:21	66.0	62.8	68
02-Dec-21	09:26	67.2	63.4	
02-Dec-21	09:31	68.6	64.5	
02-Dec-21	09:36	66.3	62.5	
02-Dec-21	09:41	66.1	62.8	
02-Dec-21	09:46	67.6	63.3	
08-Dec-21	09:22	66.0	62.1	68
08-Dec-21	09:27	67.8	63.9	
08-Dec-21	09:32	66.2	62.4	
08-Dec-21	09:37	67.7	63.6	
08-Dec-21	09:42	68.4	64.2	
08-Dec-21	09:47	67.0	63.3	
14-Dec-21	09:23	66.7	62.0	68
14-Dec-21	09:28	67.1	63.3	
14-Dec-21	09:33	67.6	63.5	
14-Dec-21	09:38	66.3	62.1	
14-Dec-21	09:43	68.7	64.8	
14-Dec-21	09:48	67.6	63.5	
20-Dec-21	09:23	67.0	63.4	68
20-Dec-21	09:28	66.8	62.1	
20-Dec-21	09:33	66.2	62.6	
20-Dec-21	09:38	68.7	64.1	
20-Dec-21	09:43	66.4	62.5	
20-Dec-21	09:48	67.6	63.4	
30-Dec-21	09:25	66.4	62.0	68
30-Dec-21	09:30	67.1	63.5	
30-Dec-21	09:35	66.3	62.4	
30-Dec-21	09:40	66.5	62.4	
30-Dec-21	09:45	67.7	63.8	
30-Dec-21	09:50	67.6	63.9

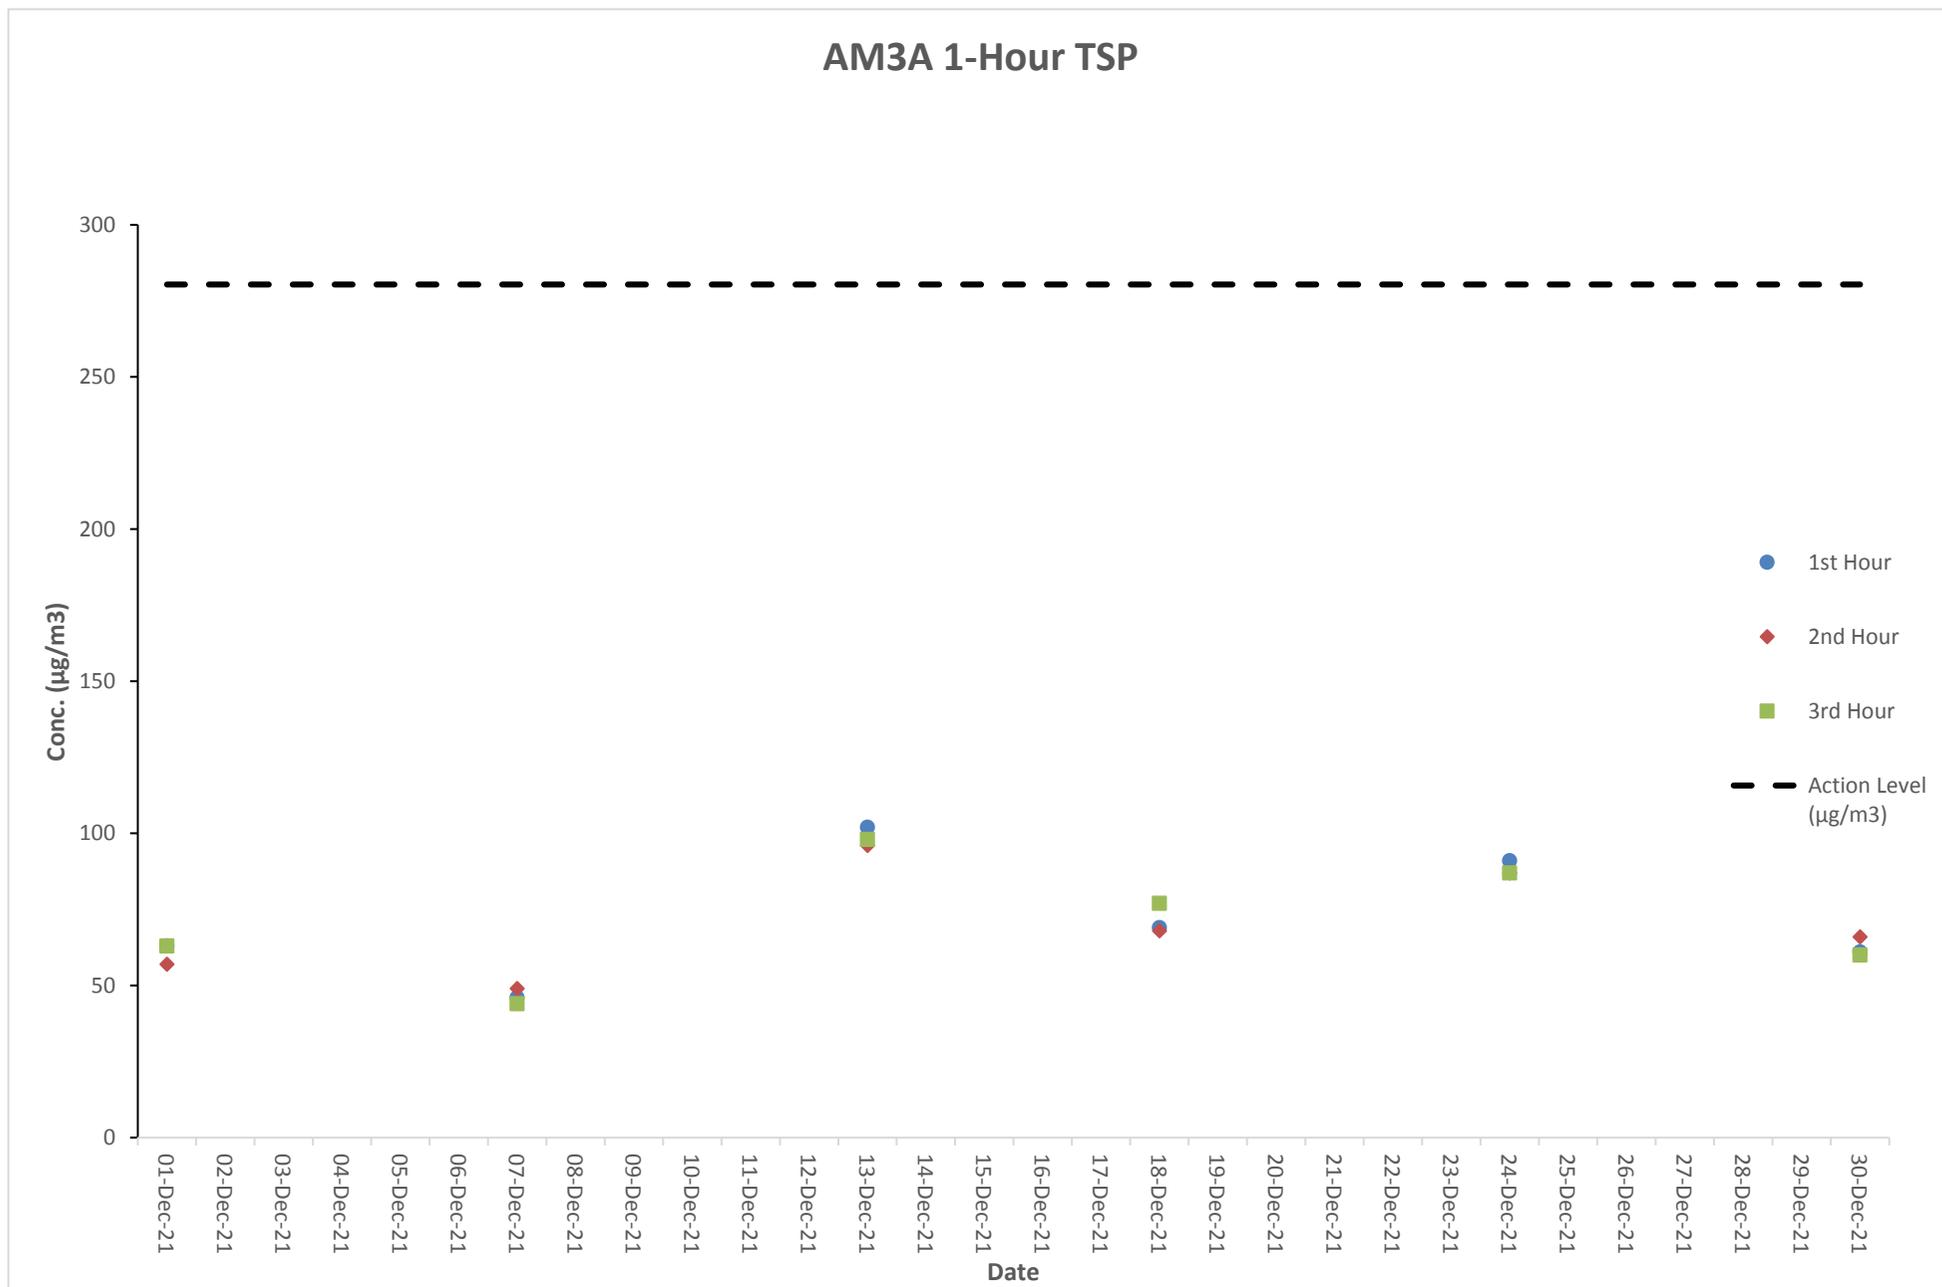
# Graphical Presentation of Air Quality Monitoring Result at Station AM3A (1-hour TSP)

Date	Weather Condition	Time		Conc. ( $\mu\text{g}/\text{m}^3$ )			Action Level	Limit Level
		Start	Finish	1st Hour	2nd Hour	3rd Hour		
01-Dec-21	Fine	8:03	11:03	63	57	63	280.4	500
07-Dec-21	Fine	14:06	17:06	46	49	44	280.4	500
13-Dec-21	Fine	8:01	11:01	102	96	98	280.4	500
18-Dec-21	Fine	14:11	17:11	69	68	77	280.4	500
24-Dec-21	Cloudy	8:16	11:16	91	87	87	280.4	500
30-Dec-21	Fine	14:09	17:09	61	66	60	280.4	500

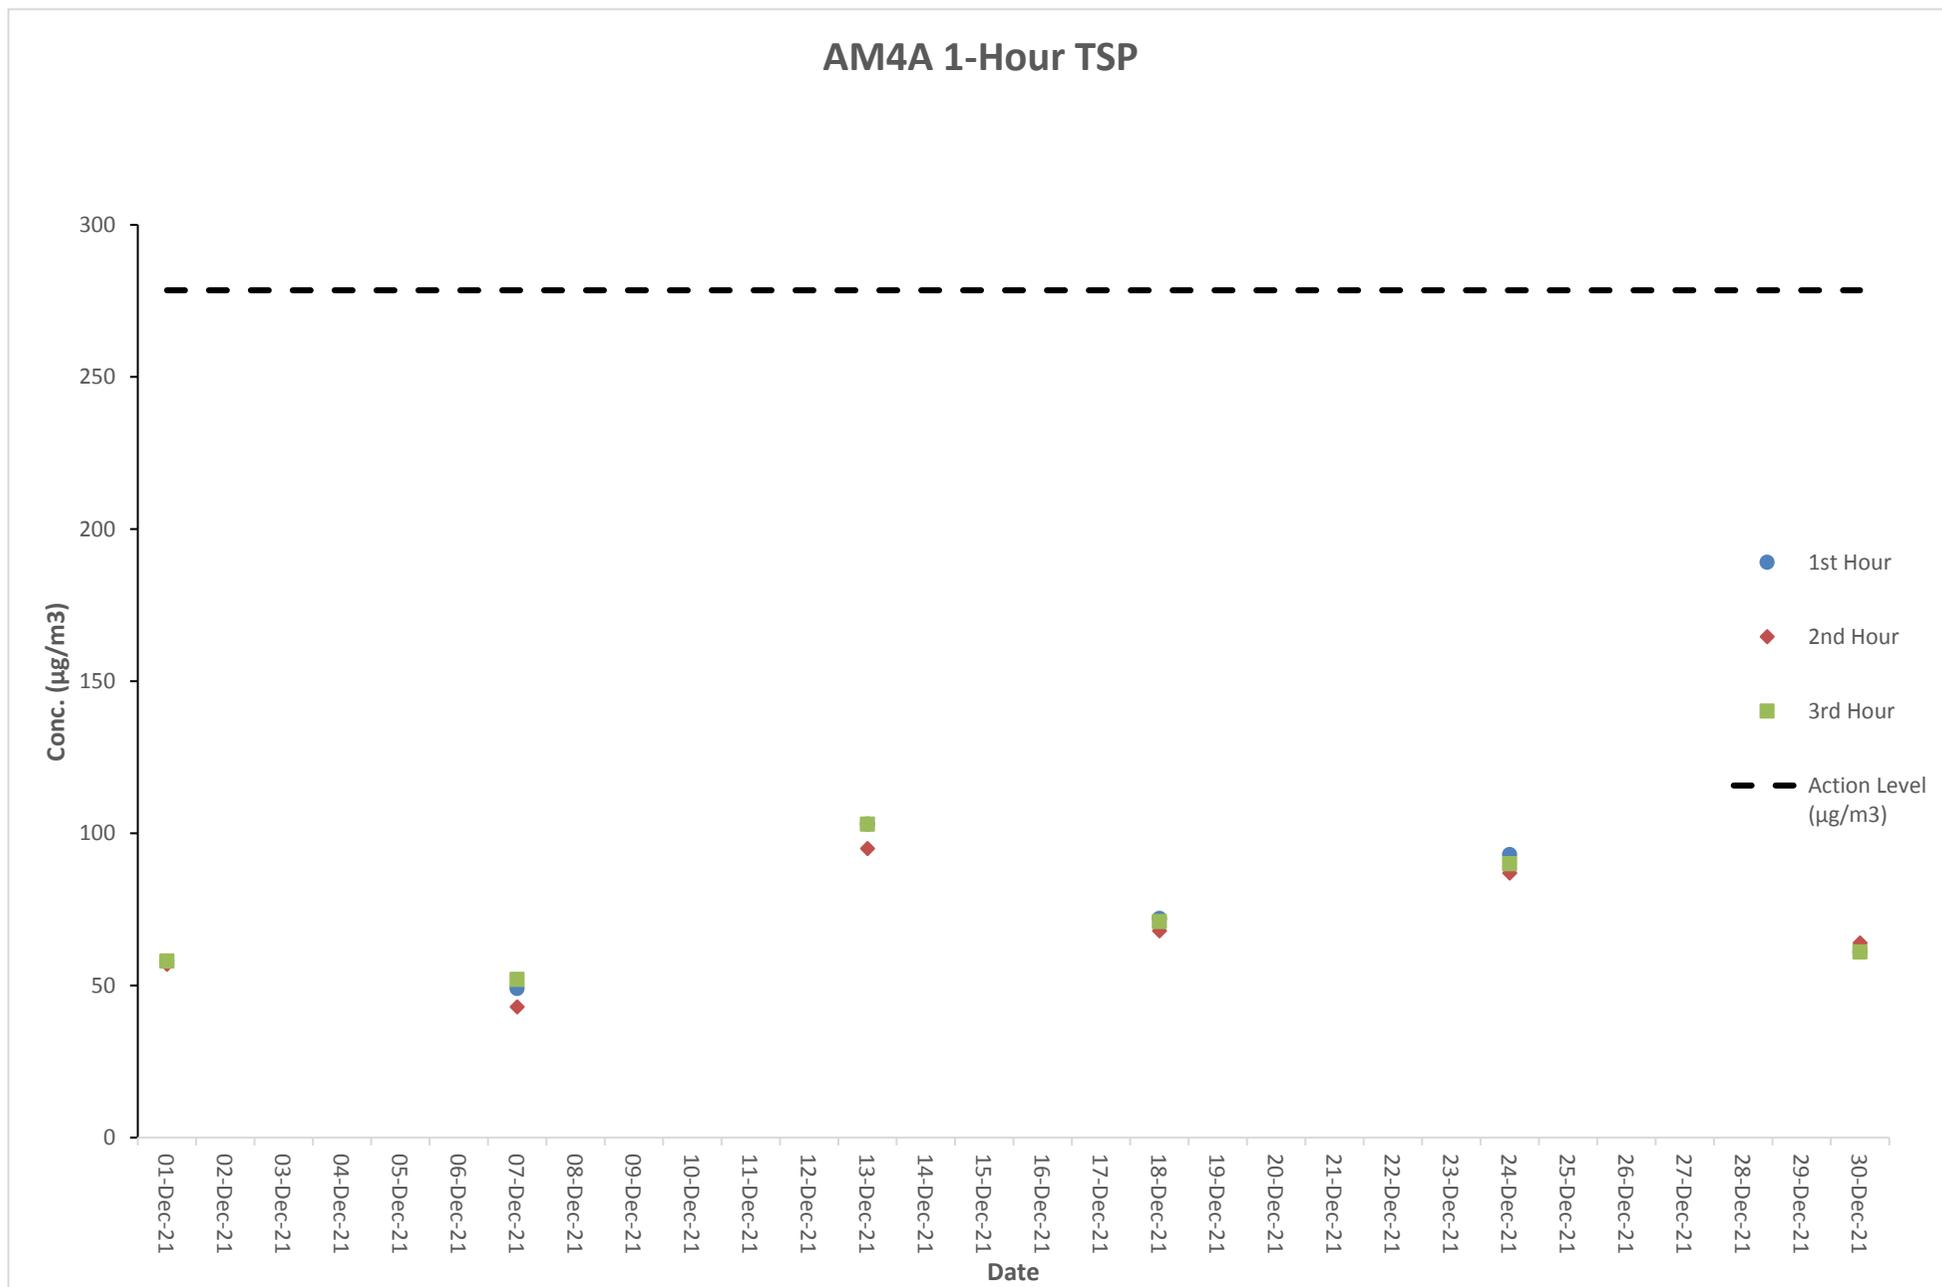
# Graphical Presentation of Air Quality Monitoring Result at Station AM4A (1-hour TSP)

Date	Weather Condition	Time		Conc. ( $\mu\text{g}/\text{m}^3$ )			Action Level	Limit Level
		Start	Finish	1st Hour	2nd Hour	3rd Hour		
01-Dec-21	Fine	8:11	11:11	58	57	58	278.5	500
07-Dec-21	Fine	14:14	17:14	49	43	52	278.5	500
13-Dec-21	Fine	8:09	11:09	103	95	103	278.5	500
18-Dec-21	Fine	14:19	17:19	72	68	71	278.5	500
24-Dec-21	Cloudy	8:24	11:24	93	87	90	278.5	500
30-Dec-21	Fine	14:17	17:17	61	64	61	278.5	500

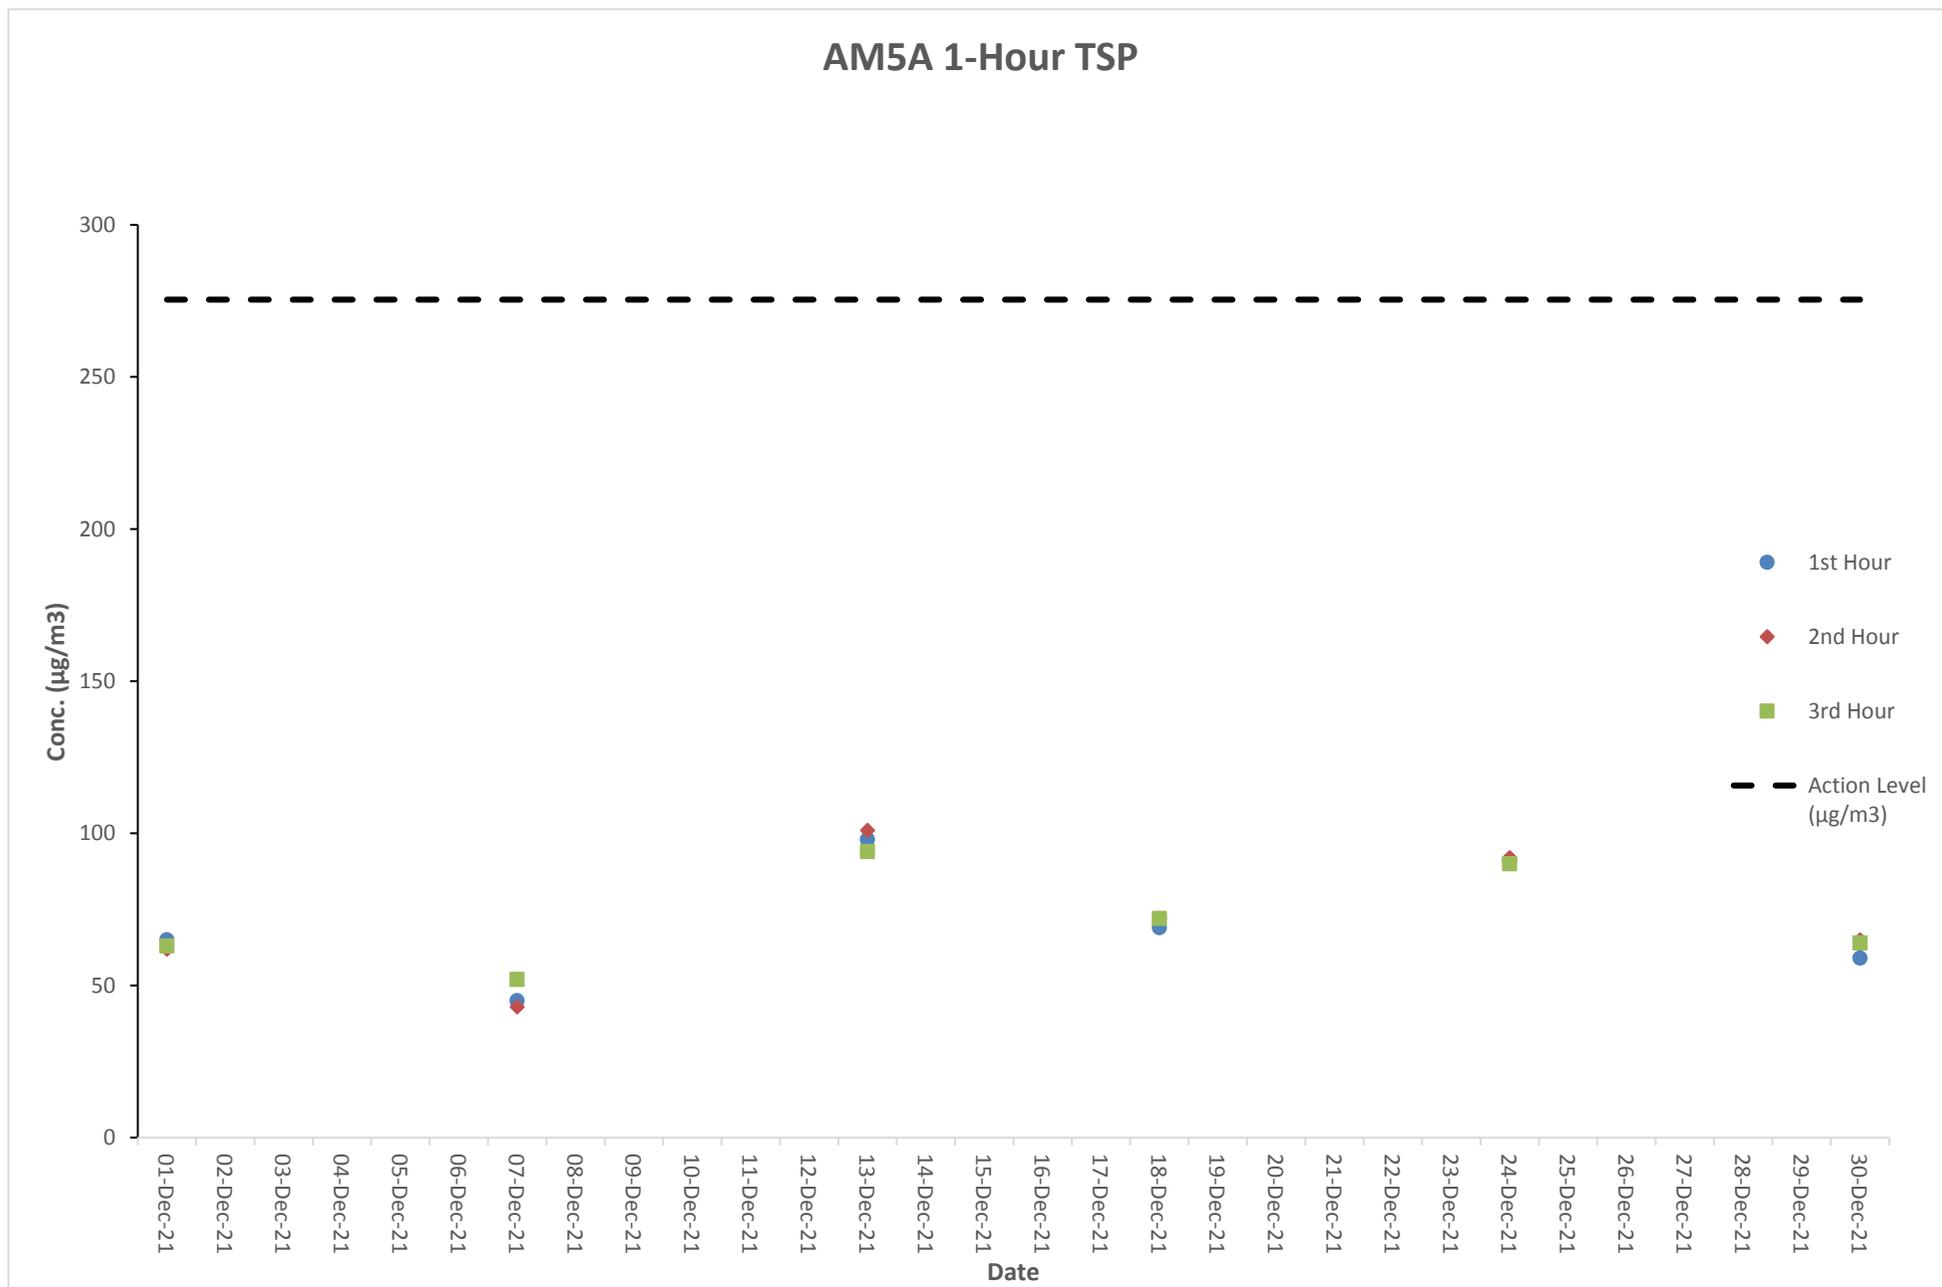
# Graphical Presentation of Air Quality Monitoring Result at Station AM5A (1-hour TSP)

Date	Weather Condition	Time		Conc. ( $\mu\text{g}/\text{m}^3$ )			Action Level	Limit Level
		Start	Finish	1st Hour	2nd Hour	3rd Hour		
01-Dec-21	Fine	8:26	11:26	65	62	63	275.4	500
07-Dec-21	Fine	14:31	17:31	45	43	52	275.4	500
13-Dec-21	Fine	8:24	11:24	98	101	94	275.4	500
18-Dec-21	Fine	14:36	17:36	69	72	72	275.4	500
24-Dec-21	Cloudy	8:39	11:39	91	92	90	275.4	500
30-Dec-21	Fine	14:25	17:25	59	65	64	275.4	500

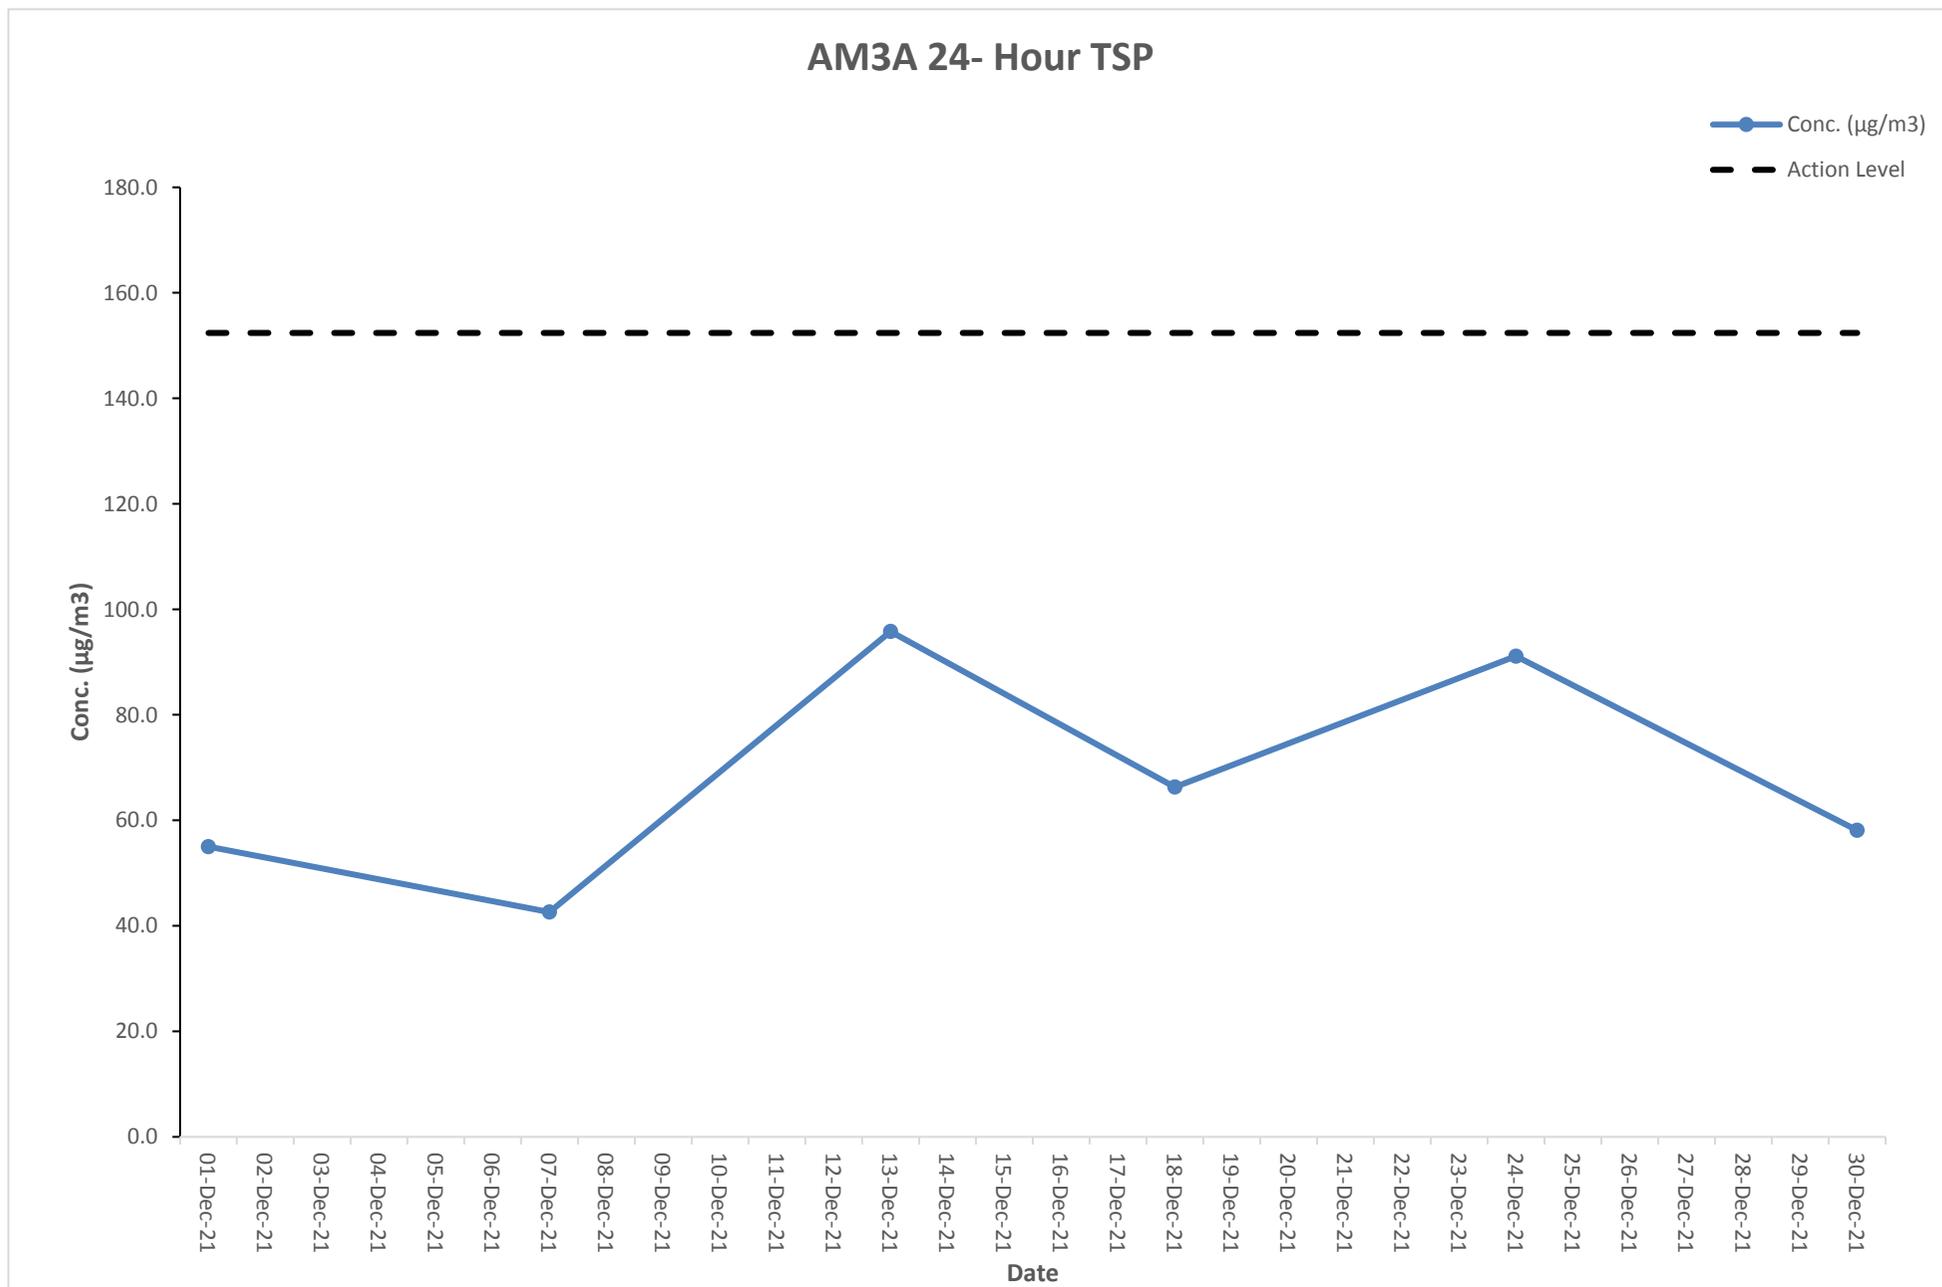
# Graphical Presentation of Air Quality Monitoring Result at Station AM3A (24-hour TSP)

Start		Finish		Filter Weight (g)		Elapsed Time Reading		Sampling Time (hrs)	Flow Rate (m <sup>3</sup> /min)			Conc. (µg/m <sup>3</sup> )	Weather Condition	Action Level	Limit Level
Date	Time	Date	Time	Initial	Final	Initial	Final		Initial	Final	Average				
01-Dec-21	10:00AM	02-Dec-21	10:00AM	2.8015	2.8901	2854.8	2878.8	24	1.12	1.12	1.12	55.0	Fine	152.4	260
07-Dec-21	10:00AM	08-Dec-21	10:00AM	2.8083	2.8768	2878.8	2902.8	24	1.12	1.12	1.12	42.6	Fine	152.4	260
13-Dec-21	10:00AM	14-Dec-21	10:00AM	2.8019	2.9561	2902.8	2926.8	24	1.12	1.12	1.12	95.8	Sunny	152.4	260
18-Dec-21	10:00AM	19-Dec-21	10:00AM	2.8079	2.9146	2926.8	2950.8	24	1.12	1.12	1.12	66.3	Sunny	152.4	260
24-Dec-21	10:00AM	25-Dec-21	10:00AM	2.8060	2.9527	2950.8	2974.8	24	1.12	1.12	1.12	91.1	Cloudy	152.4	260
30-Dec-21	10:00AM	31-Dec-21	10:00AM	2.8041	2.8976	2974.8	2998.8	24	1.12	1.12	1.12	58.1	Fine	152.4	260
