# Development at West Kowloon Cultural District

Monthly Environmental Monitoring and Audit (EM&A) Report  
for December 2021

# Part-1: EM&A at Lyric Theatre Complex

# Lyric Theatre Complex

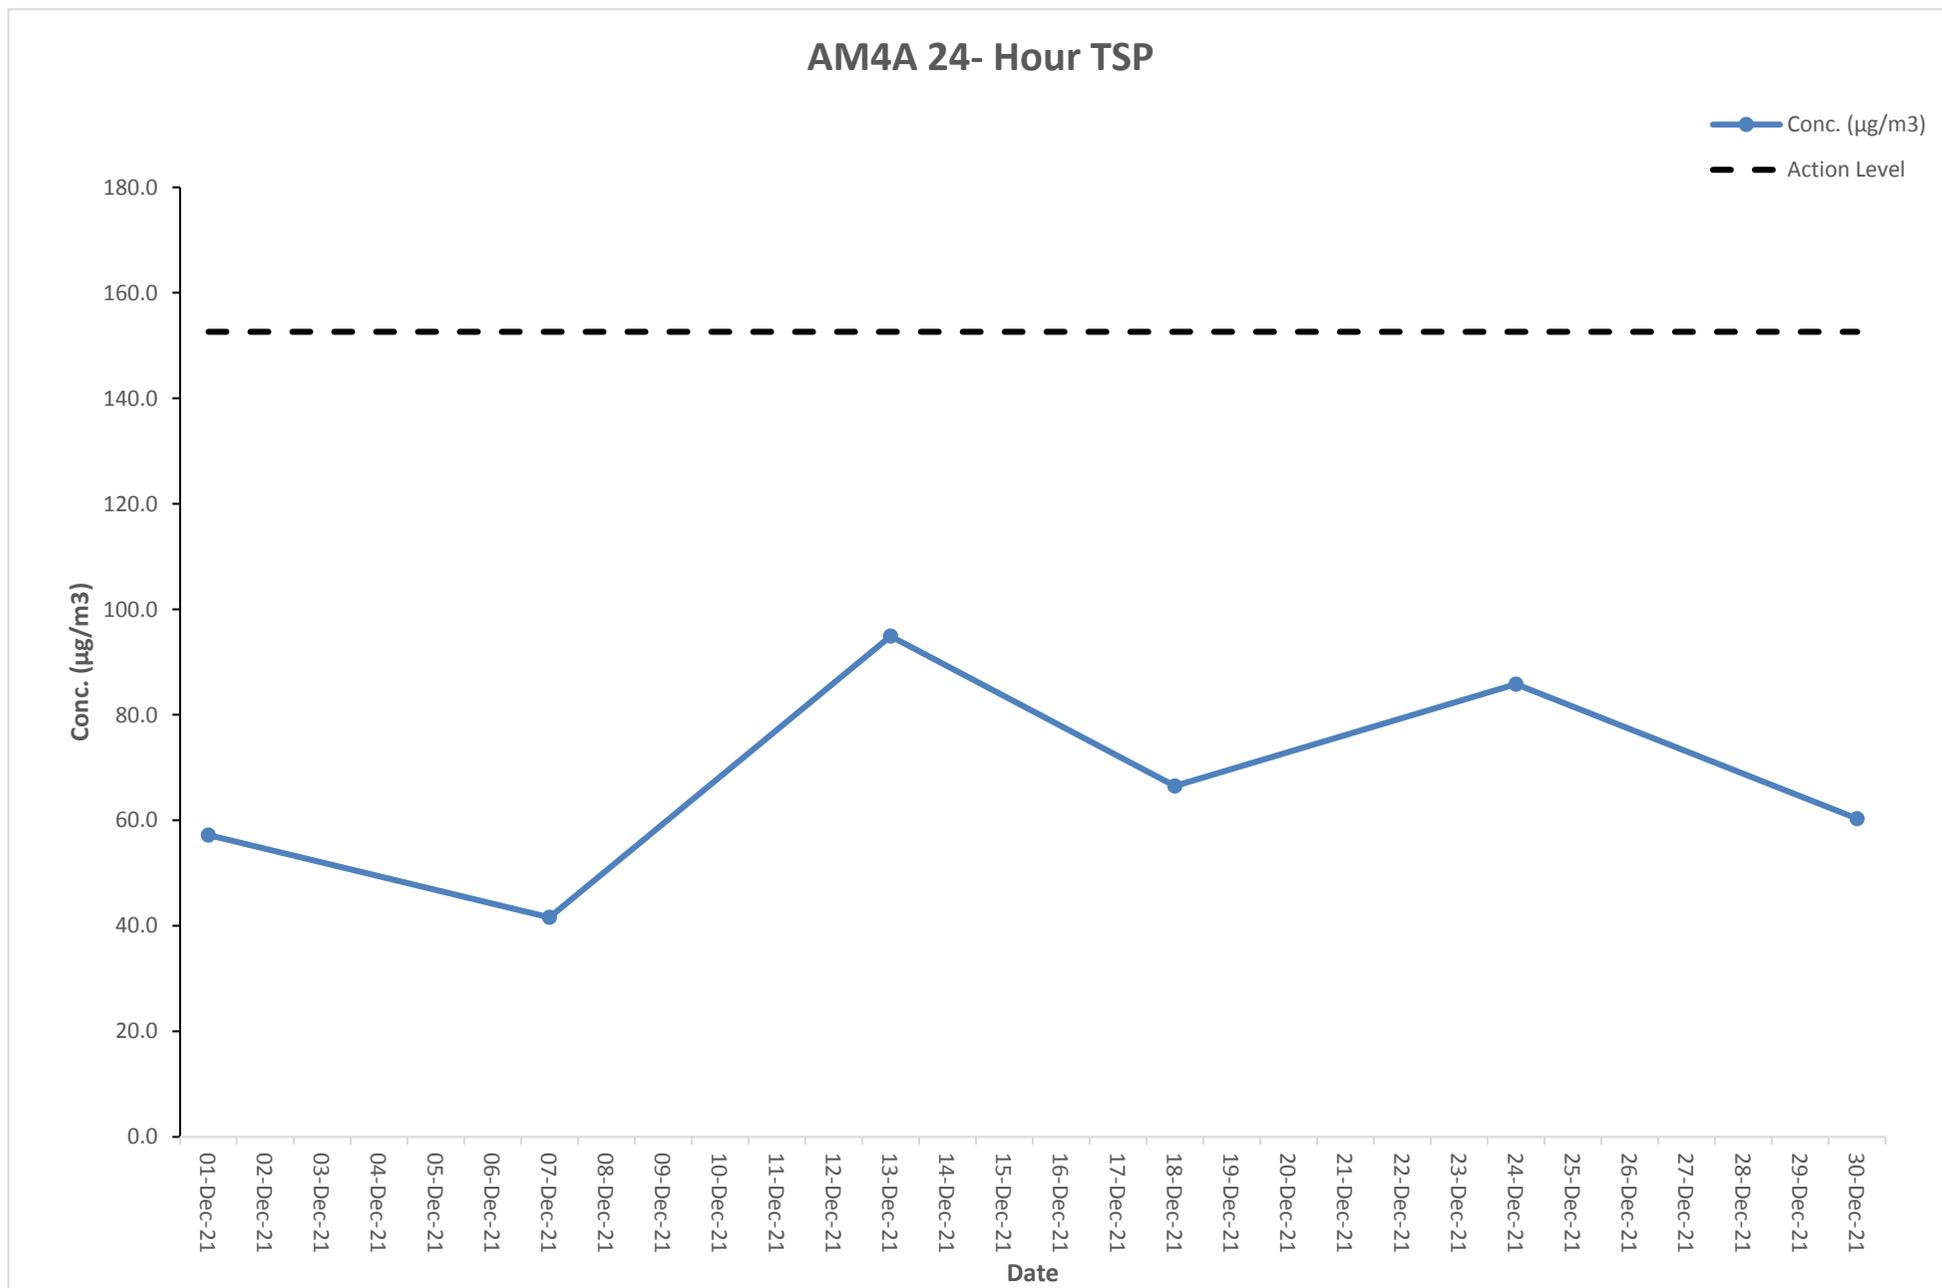
# Graphical Presentation of Air Quality Monitoring Result at Station AM4A (24-hour TSP)

Start		Finish		Filter Weight (g)		Elapsed Time Reading		Sampling Time (hrs)	Flow Rate (m <sup>3</sup> /min)			Conc. (µg/m <sup>3</sup> )	Weather Condition	Action Level	Limit Level
Date	Time	Date	Time	Initial	Final	Initial	Final		Initial	Final	Average				
01-Dec-21	10:00AM	02-Dec-21	10:00AM	2.8073	2.8993	3274.4	3298.4	24	1.12	1.12	1.12	57.2	Fine	152.6	260
07-Dec-21	10:00AM	08-Dec-21	10:00AM	2.8049	2.8718	3298.4	3322.4	24	1.12	1.12	1.12	41.6	Fine	152.6	260
13-Dec-21	10:00AM	14-Dec-21	10:00AM	2.8073	2.9601	3322.4	3346.4	24	1.12	1.12	1.12	94.9	Sunny	152.6	260
18-Dec-21	10:00AM	19-Dec-21	10:00AM	2.8033	2.9104	3346.4	3370.4	24	1.12	1.12	1.12	66.5	Sunny	152.6	260
24-Dec-21	10:00AM	25-Dec-21	10:00AM	2.8089	2.9469	3370.4	3394.4	24	1.12	1.12	1.12	85.8	Cloudy	152.6	260
30-Dec-21	10:00AM	31-Dec-21	10:00AM	2.8080	2.9050	3394.4	3418.4	24	1.12	1.12	1.12	60.3	Fine	152.6	260

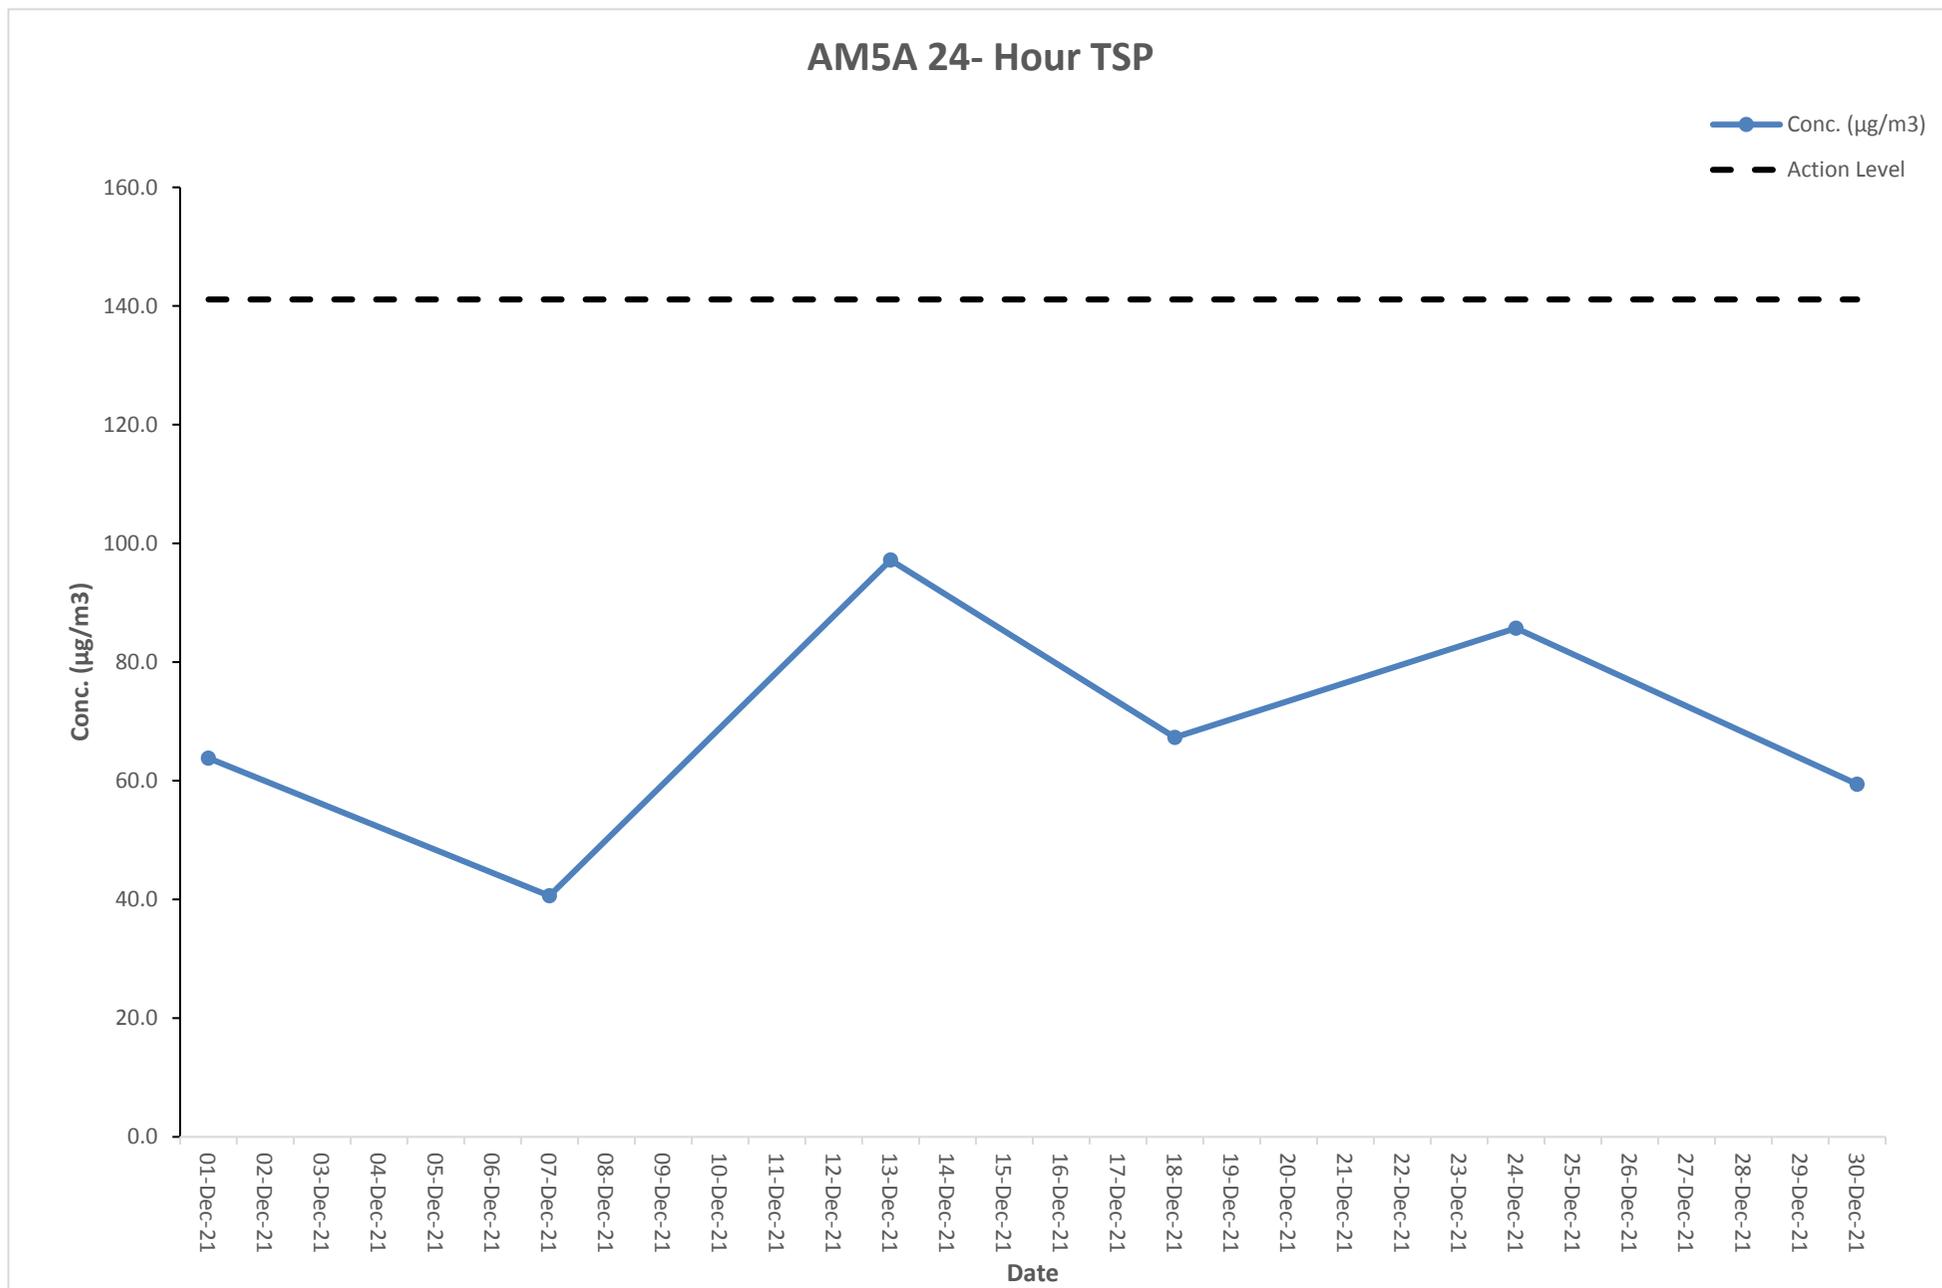
# Graphical Presentation of Air Quality Monitoring Result at Station AM5A (24-hour TSP)

Start		Finish		Filter Weight (g)		Elapsed Time Reading		Sampling Time (hrs)	Flow Rate (m <sup>3</sup> /min)			Conc. (µg/m <sup>3</sup> )	Weather Condition	Action Level	Limit Level
Date	Time	Date	Time	Initial	Final	Initial	Final		Initial	Final	Average				
01-Dec-21	10:00AM	02-Dec-21	10:00AM	2.8068	2.9096	3414.6	3438.6	24	1.12	1.12	1.12	63.8	Fine	141.1	260
07-Dec-21	10:00AM	08-Dec-21	10:00AM	2.8042	2.8697	3438.6	3462.6	24	1.12	1.12	1.12	40.6	Fine	141.1	260
13-Dec-21	10:00AM	14-Dec-21	10:00AM	2.8011	2.9576	3462.6	3486.6	24	1.12	1.12	1.12	97.2	Sunny	141.1	260
18-Dec-21	10:00AM	19-Dec-21	10:00AM	2.8042	2.9126	3486.6	3510.6	24	1.12	1.12	1.12	67.3	Sunny	141.1	260
24-Dec-21	10:00AM	25-Dec-21	10:00AM	2.8089	2.9468	3510.6	3534.6	24	1.12	1.12	1.12	85.7	Cloudy	141.1	260
30-Dec-21	10:00AM	31-Dec-21	10:00AM	2.8042	2.8999	3534.6	3558.6	24	1.12	1.12	1.12	59.4	Fine	141.1	260

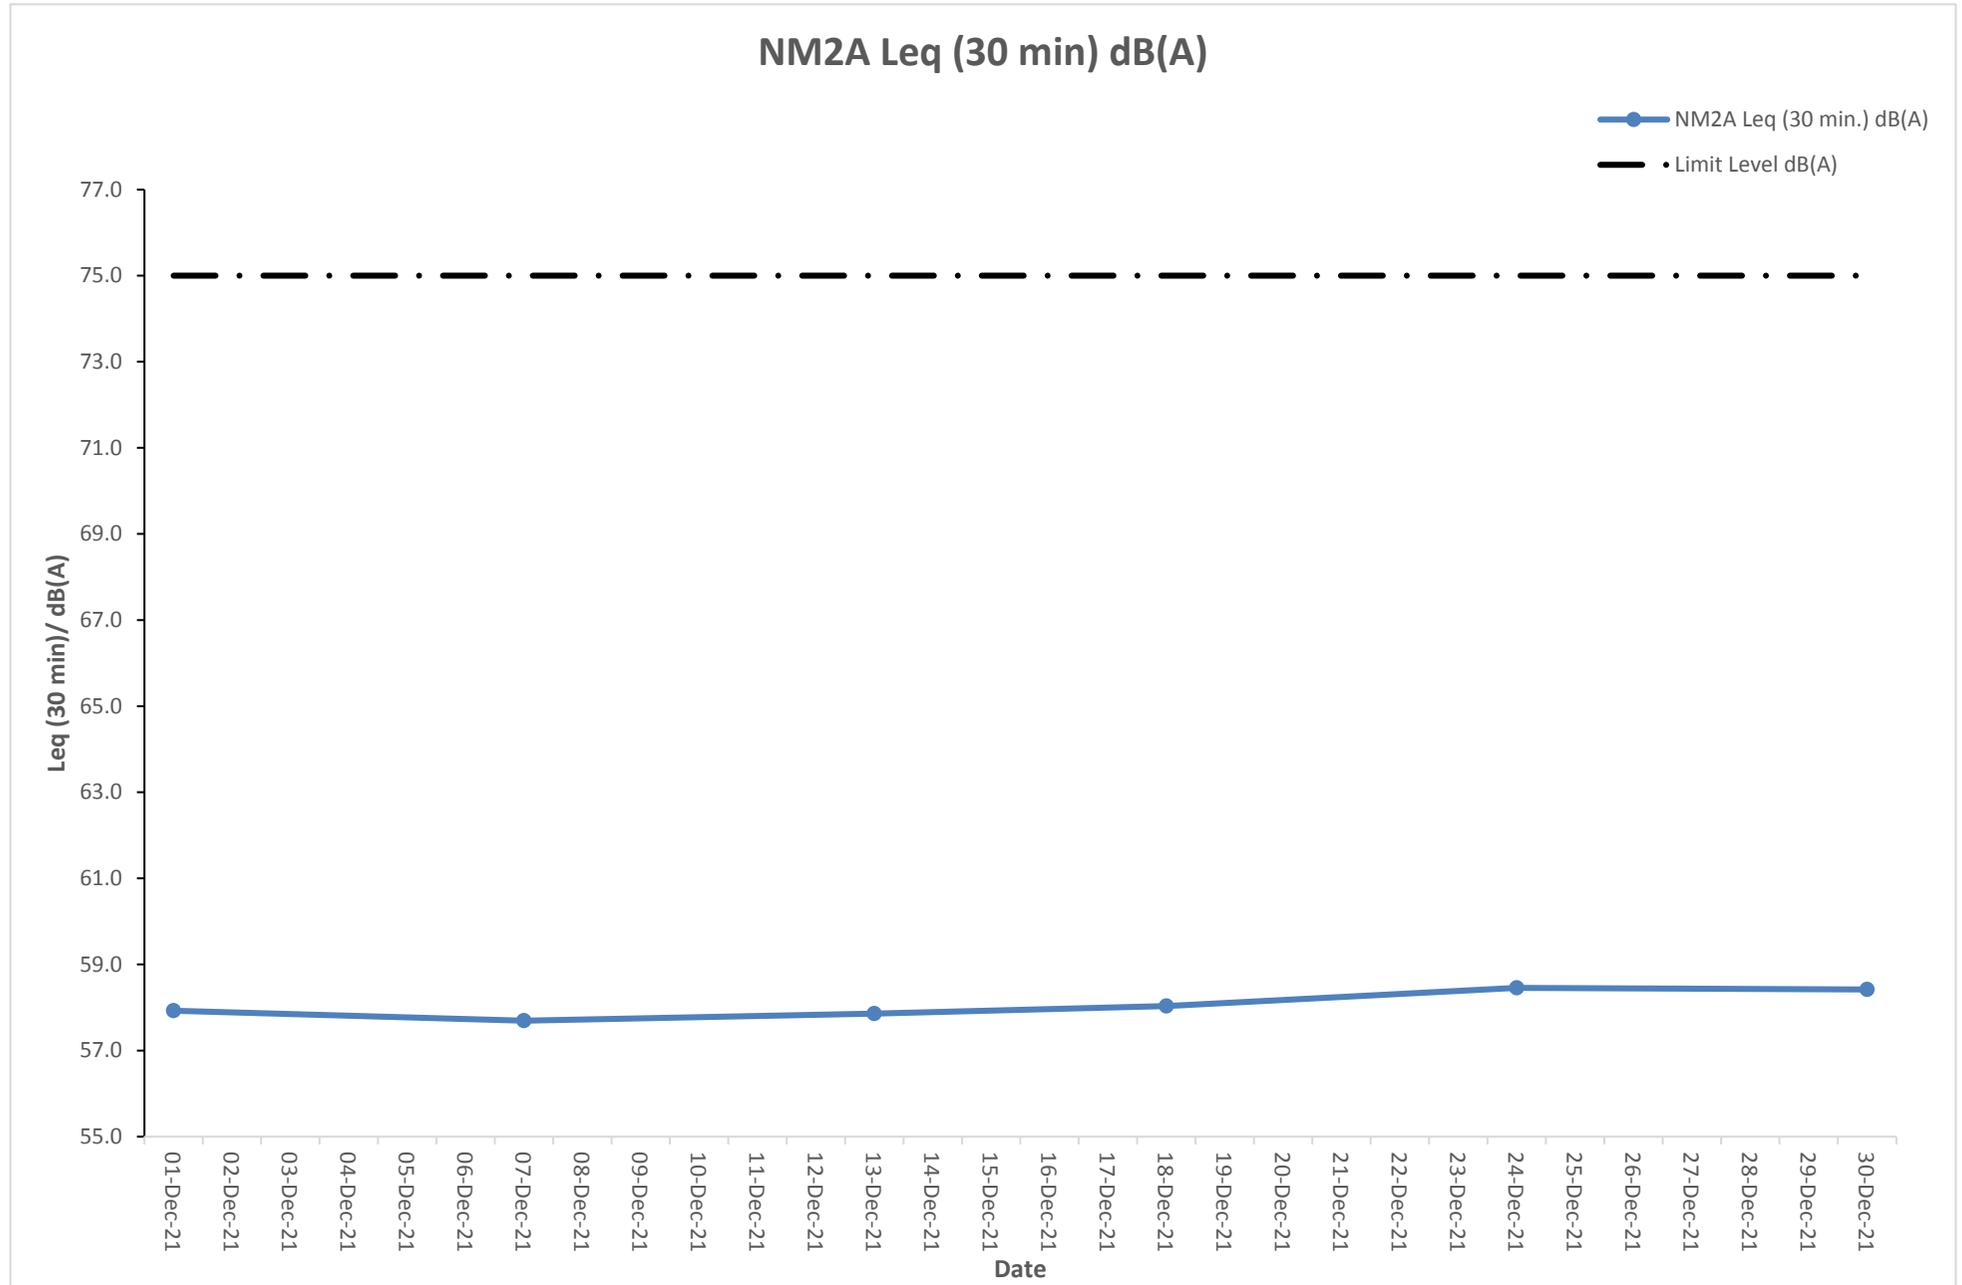
# Graphical Presentation of Noise Monitoring Result at Station NM2A

Date	Time	Measured L10 dB(A)	Measured L90 dB(A)	Leq (30 min.) dB(A)
01-Dec-21	8:33	64.4	55.5	57.9
01-Dec-21	8:38	63.7	55.7	
01-Dec-21	8:43	63.1	54.1	
01-Dec-21	8:48	65.0	55.9	
01-Dec-21	8:53	65.9	54.3	
01-Dec-21	8:58	64.9	55.1	
07-Dec-21	14:36	64.3	55.1	57.7
07-Dec-21	14:41	65.6	54.4	
07-Dec-21	14:46	65.8	54.6	
07-Dec-21	14:51	63.1	55.2	
07-Dec-21	14:56	64.3	54.6	
07-Dec-21	15:01	64.0	55.1	
13-Dec-21	8:31	65.6	54.1	57.9
13-Dec-21	8:36	64.3	55.2	
13-Dec-21	8:41	65.5	55.2	
13-Dec-21	8:46	63.1	54.1	
13-Dec-21	8:51	64.5	54.4	
13-Dec-21	8:56	65.2	55.3	
18-Dec-21	14:41	65.9	56.0	58.0
18-Dec-21	14:46	63.9	54.3	
18-Dec-21	14:51	64.6	54.3	
18-Dec-21	14:56	64.9	55.4	
18-Dec-21	15:01	64.3	54.9	
18-Dec-21	15:06	63.4	54.2	
24-Dec-21	8:46	63.4	54.3	58.5
24-Dec-21	8:51	63.2	56.0	
24-Dec-21	8:56	64.8	55.9	
24-Dec-21	9:01	63.1	55.5	
24-Dec-21	9:06	64.0	54.7	
24-Dec-21	9:11	64.6	55.2	
30-Dec-21	14:09	64.7	55.9	58.4
30-Dec-21	14:14	64.8	55.5

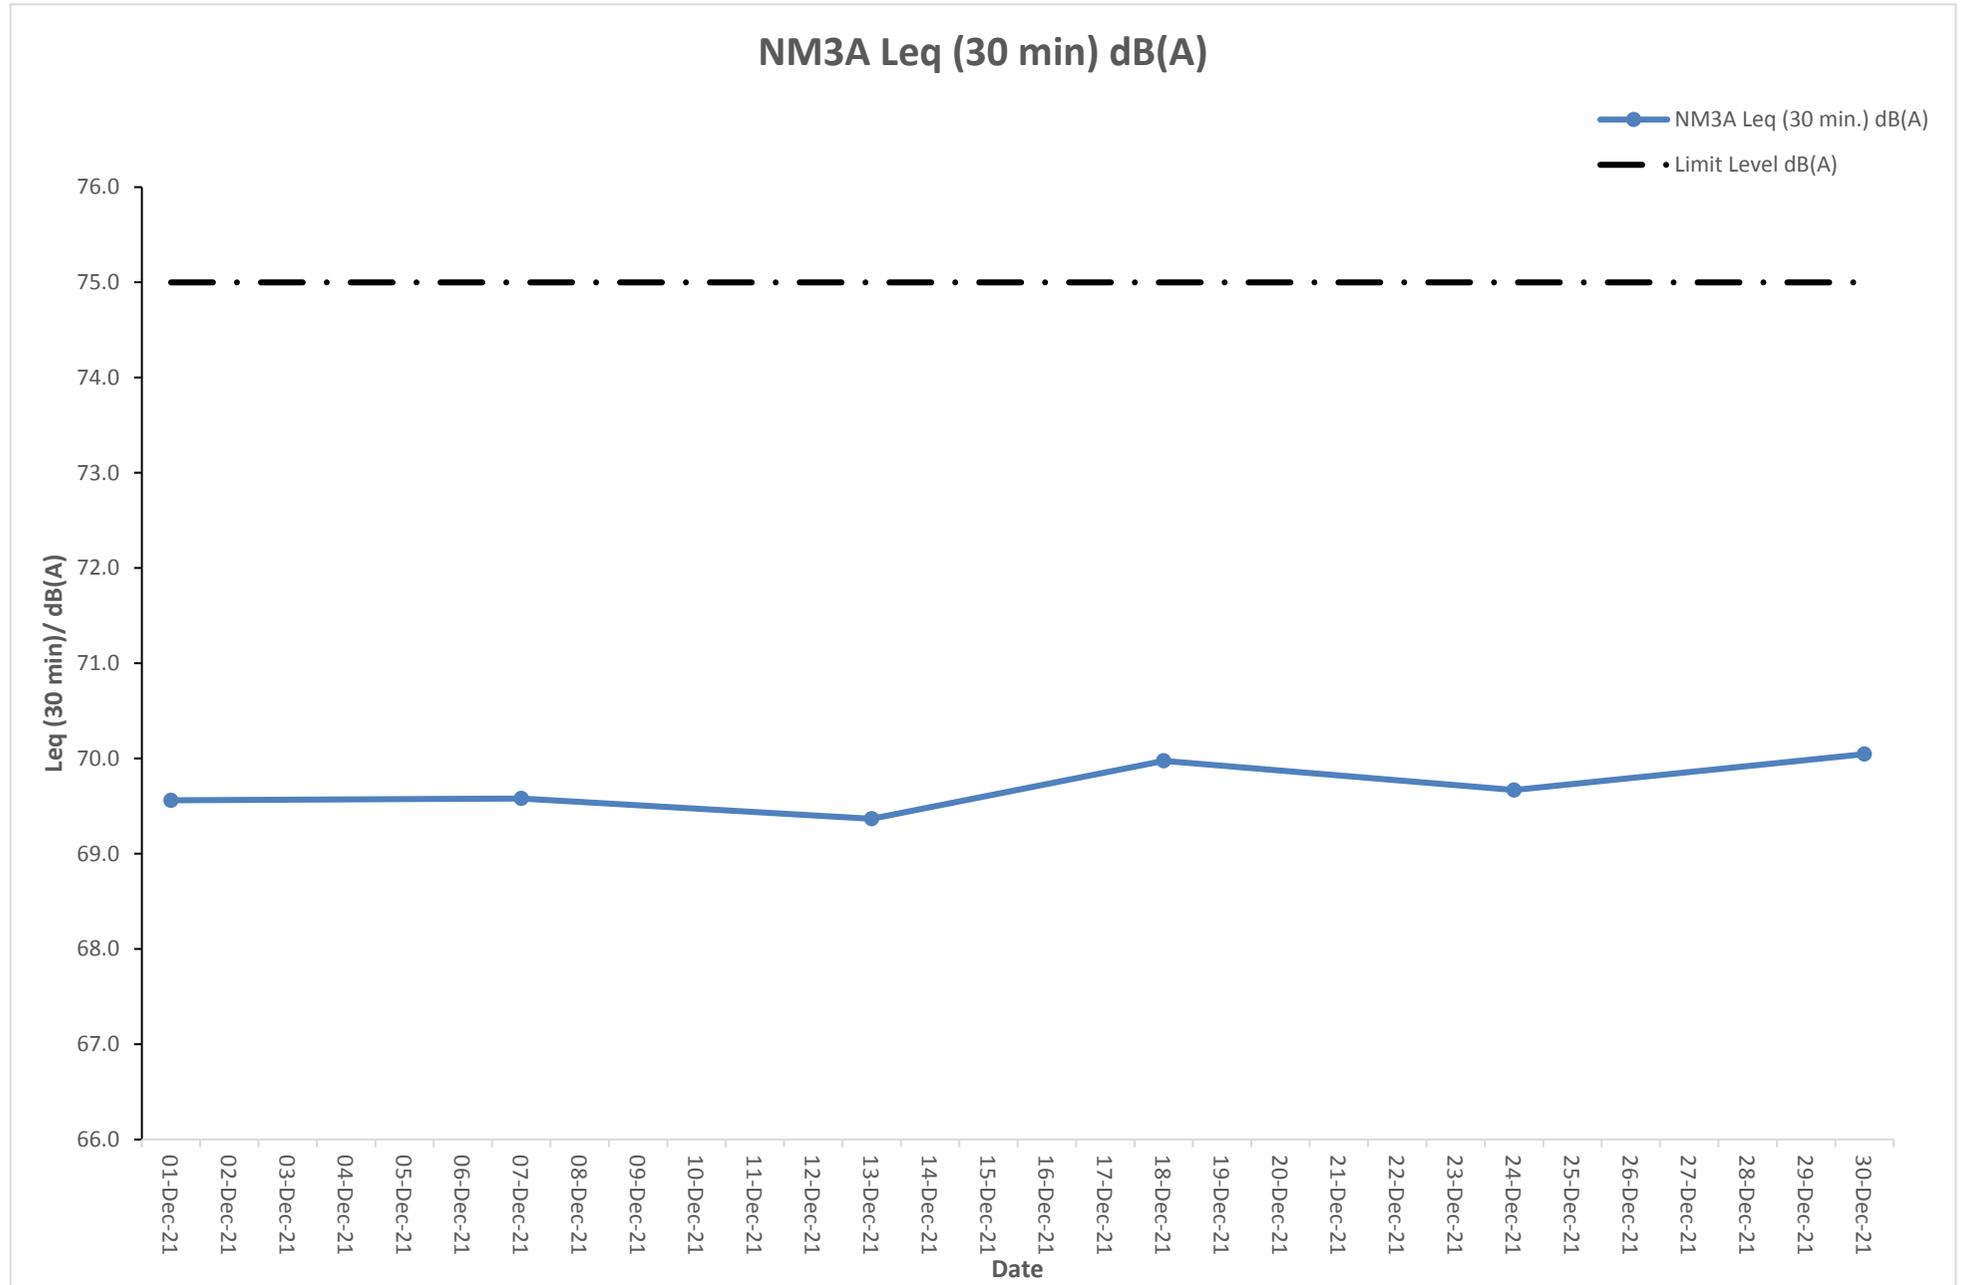
# Graphical Presentation of Noise Monitoring Result at Station NM3A

Date	Time	Measured L10 dB(A)	Measured L90 dB(A)	Leq (30 min.) dB(A)
01-Dec-21	10:03	73.6	64.6	69.6
01-Dec-21	10:08	73.9	66.0	
01-Dec-21	10:13	73.1	66.1	
01-Dec-21	10:18	73.1	65.9	
01-Dec-21	10:23	73.0	65.1	
01-Dec-21	10:28	74.5	66.4	
07-Dec-21	16:09	72.8	66.8	69.6
07-Dec-21	16:14	73.2	65.8	
07-Dec-21	16:19	74.3	64.5	
07-Dec-21	16:24	73.1	65.2	
07-Dec-21	16:29	74.2	64.5	
07-Dec-21	16:34	73.2	66.1	69.4
13-Dec-21	10:01	73.0	64.3	
13-Dec-21	10:06	73.8	66.8	
13-Dec-21	10:11	74.5	64.4	
13-Dec-21	10:16	73.2	64.9	
13-Dec-21	10:21	73.6	65.0	
13-Dec-21	10:26	73.6	64.7	70.0
18-Dec-21	16:14	74.2	64.5	
18-Dec-21	16:19	74.0	64.8	
18-Dec-21	16:24	72.8	65.7	
18-Dec-21	16:29	73.6	66.0	
18-Dec-21	16:34	73.5	65.5	
18-Dec-21	16:39	74.5	66.7	69.7
24-Dec-21	10:16	73.7	66.1	
24-Dec-21	10:21	73.5	64.2	
24-Dec-21	10:26	74.3	65.4	
24-Dec-21	10:31	73.8	65.9	
24-Dec-21	10:36	72.9	64.7	
24-Dec-21	10:41	73.5	66.4	70.0
30-Dec-21	15:51	74.5	64.7	
30-Dec-21	15:56	73.5	64.3

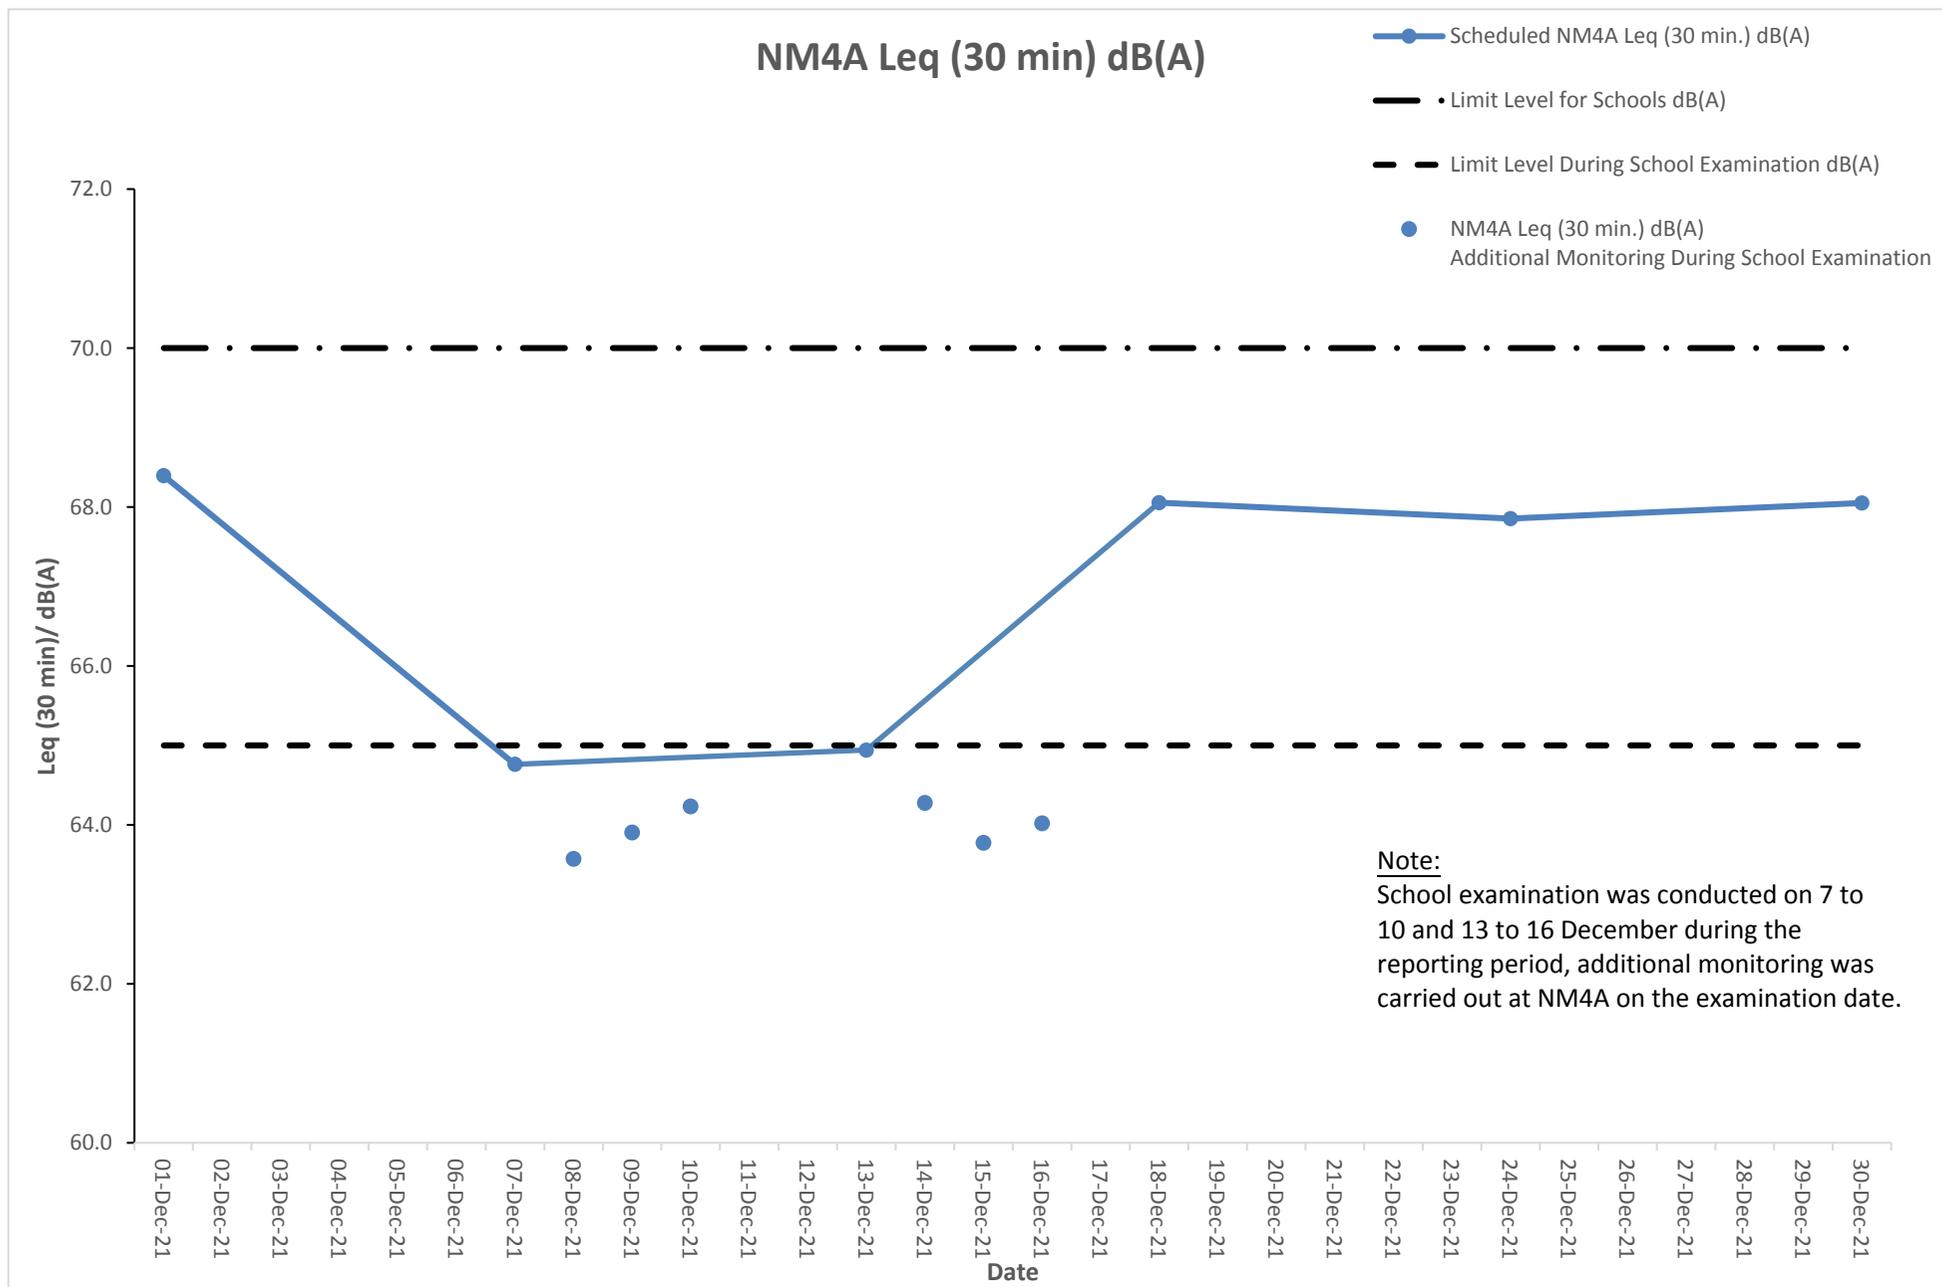
# Graphical Presentation of Noise Monitoring Result at Station NM4A

Date	Time	Measured L10 dB(A)	Measured L90 dB(A)	Leq (30 min.) dB(A)
01-Dec-21	10:38	69.5	65.2	68.4
01-Dec-21	10:43	71.0	63.2	
01-Dec-21	10:48	70.5	63.9	
01-Dec-21	10:53	70.8	64.9	
01-Dec-21	10:58	69.1	64.7	
01-Dec-21	11:03	70.7	64.5	
07-Dec-21	16:44	67.8	62.6	64.8
07-Dec-21	16:49	69.0	62.9	
07-Dec-21	16:54	68.4	60.3	
07-Dec-21	16:59	66.1	60.1	
07-Dec-21	17:04	68.9	61.9	
07-Dec-21	17:09	68.9	61.0	
13-Dec-21	10:36	67.7	62.3	64.9
13-Dec-21	10:41	66.5	62.3	
13-Dec-21	10:46	66.7	62.7	
13-Dec-21	10:51	68.0	61.9	
13-Dec-21	10:56	67.1	60.6	
13-Dec-21	11:01	68.8	61.0	
18-Dec-21	16:49	69.6	64.6	68.1
18-Dec-21	16:54	70.1	65.3	
18-Dec-21	16:59	70.2	65.4	
18-Dec-21	17:04	70.3	63.8	
18-Dec-21	17:09	70.2	65.2	
18-Dec-21	17:14	71.9	63.6	
24-Dec-21	10:51	69.2	65.0	67.9
24-Dec-21	10:56	69.4	65.8	
24-Dec-21	11:01	71.0	65.3	
24-Dec-21	11:06	71.9	63.8	
24-Dec-21	11:11	69.3	64.3	
24-Dec-21	11:16	71.8	65.5	
30-Dec-21	16:26	71.8	63.6	68.0
30-Dec-21	16:31	70.0	65.6

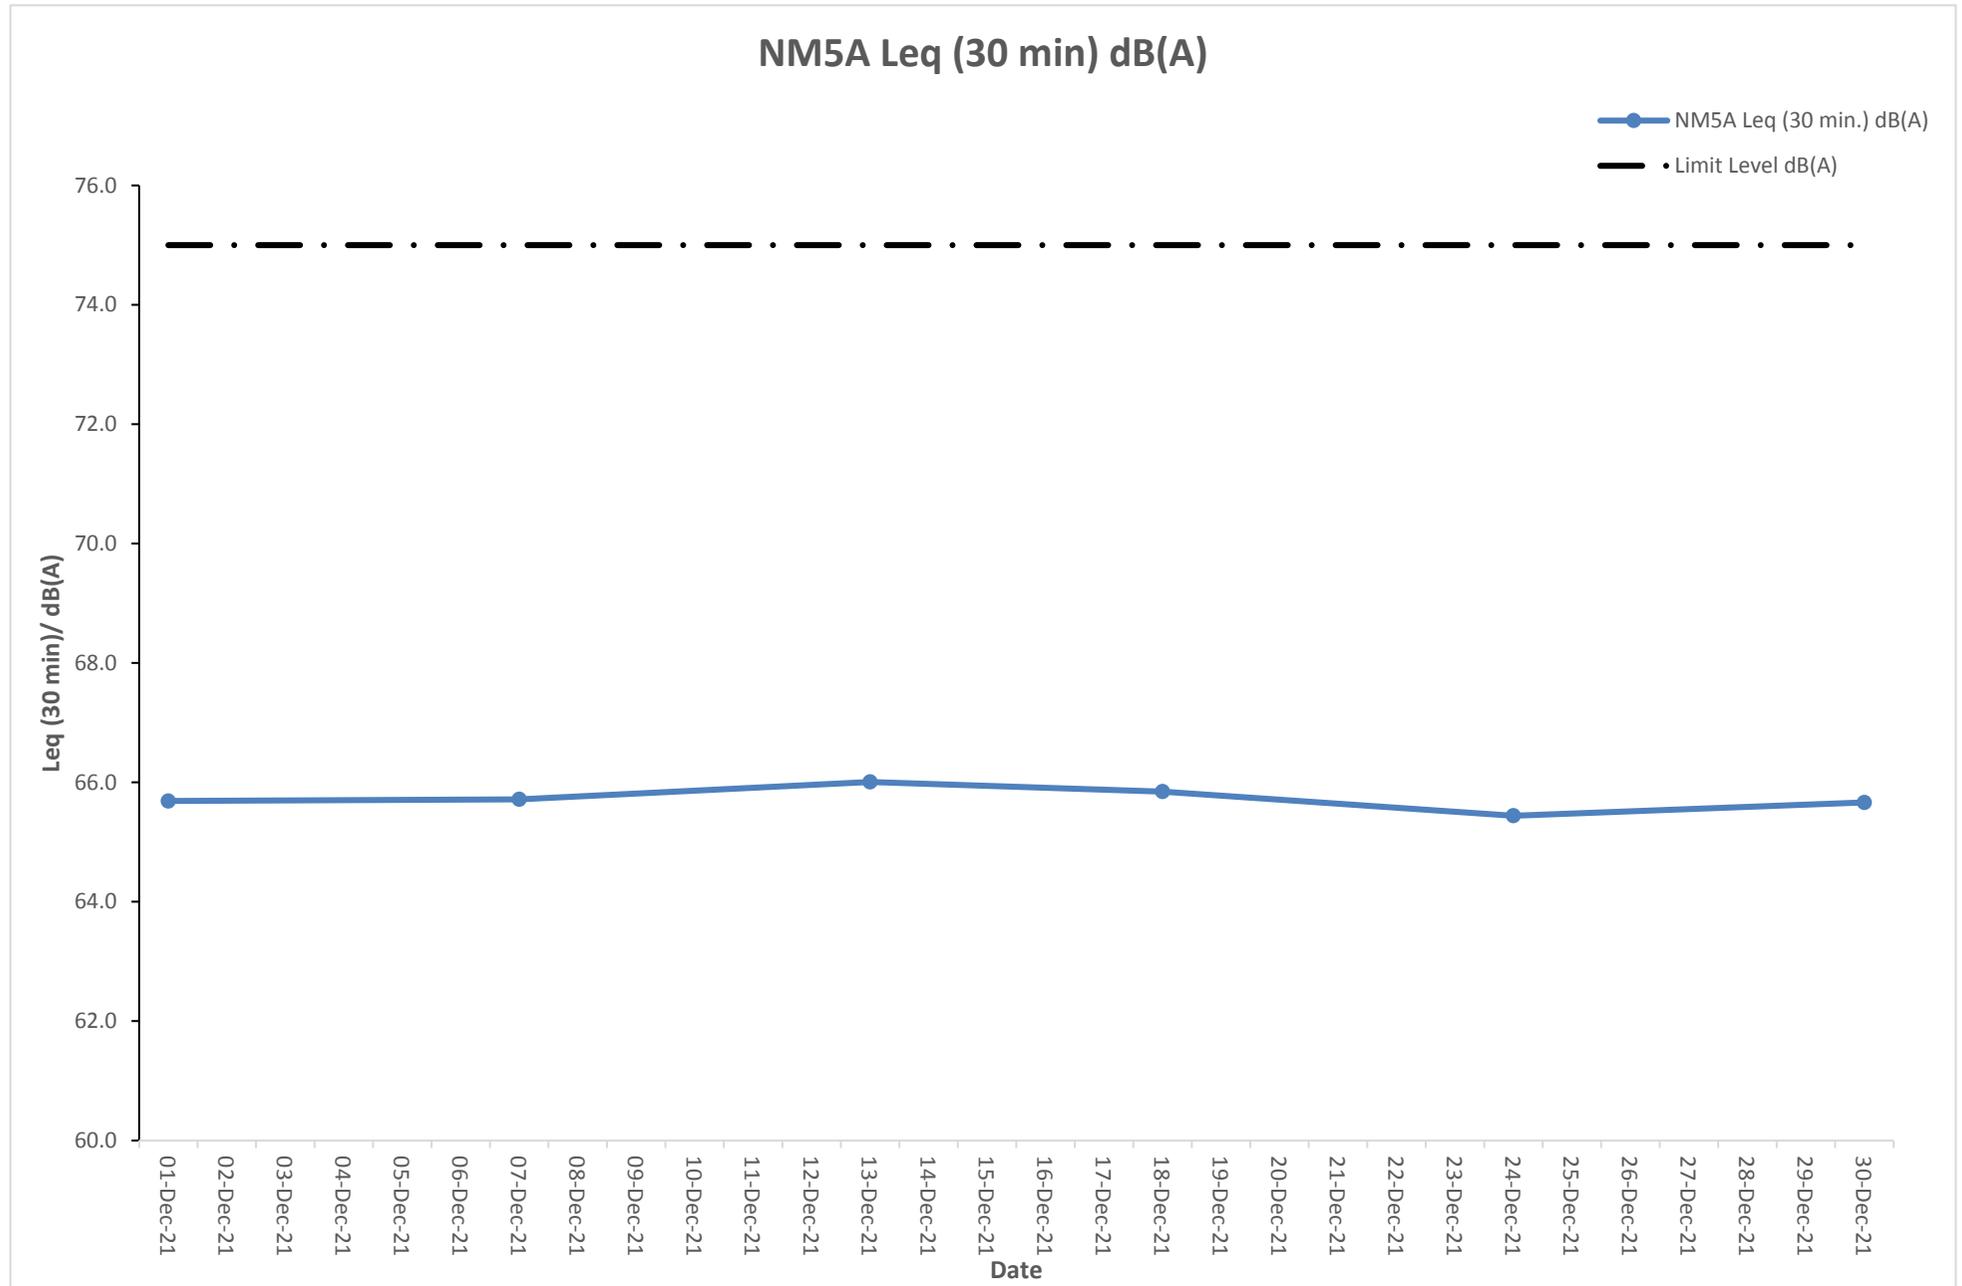
# Graphical Presentation of Noise Monitoring Result at Station NM5A

Date	Time	Measured L10 dB(A)	Measured L90 dB(A)	Leq (30 min.) dB(A)	Leq (30 min.) +3 dB(A)
01-Dec-21	9:23	66.2	58.6	62.7	65.7
01-Dec-21	9:28	65.2	57.0		
01-Dec-21	9:33	65.3	56.1		
01-Dec-21	9:38	66.4	58.6		
01-Dec-21	9:43	65.9	58.9		
01-Dec-21	9:48	65.2	57.8		
07-Dec-21	15:28	65.1	57.0	62.7	65.7
07-Dec-21	15:33	66.4	56.6		
07-Dec-21	15:38	64.4	57.0		
07-Dec-21	15:43	66.6	57.2		
07-Dec-21	15:48	66.1	56.2		
07-Dec-21	15:53	65.6	56.9		
13-Dec-21	9:21	64.3	57.2	63.0	66.0
13-Dec-21	9:26	67.0	58.1		
13-Dec-21	9:31	64.5	58.3		
13-Dec-21	9:36	64.9	56.5		
13-Dec-21	9:41	66.5	56.3		
13-Dec-21	9:46	65.8	58.4		
18-Dec-21	15:33	66.6	56.7	62.8	65.8
18-Dec-21	15:38	65.5	57.7		
18-Dec-21	15:43	65.7	56.6		
18-Dec-21	15:48	65.2	56.2		
18-Dec-21	15:53	64.5	56.3		
18-Dec-21	15:58	66.8	57.1		
24-Dec-21	9:36	66.4	58.2	62.4	65.4
24-Dec-21	9:41	65.6	57.3		
24-Dec-21	9:46	64.4	57.2		
24-Dec-21	9:51	64.4	57.2		
24-Dec-21	9:56	66.5	57.1		
24-Dec-21	10:01	66.0	56.8
