Development at West Kowloon Cultural District

Monthly Environmental Monitoring and Audit (EM&A) Report for February 2023

Part-1: EM&A at Lyric Theatre Complex

Part-2: EM&A for Foundation and ELS Works in Zones 2A, 2B & 2C

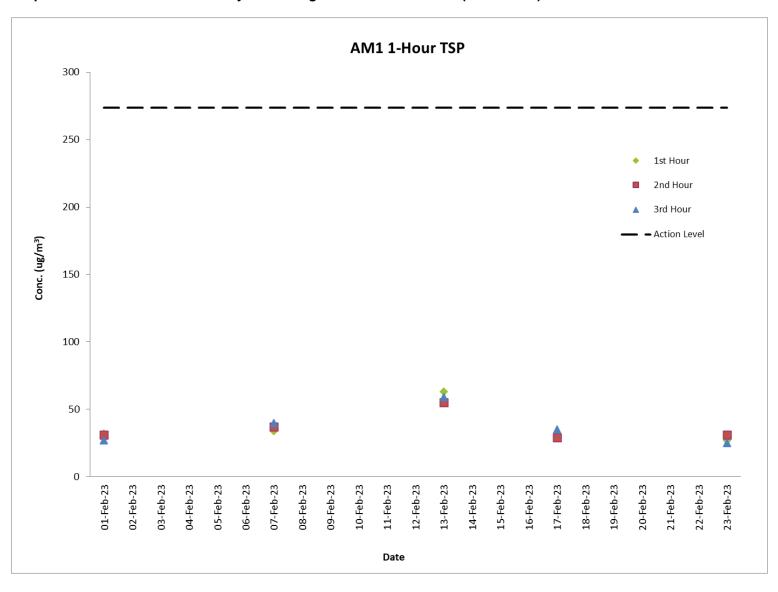
Graphical Presentation of Air Quality Monitoring Result at Station AM1 (1-hour TSP)

Weather			Conc. (μg/m³)	Action Level	Limit Level
Date	Condition	Time	1 st Hour	2 nd Hour	3 rd Hour	(μg/m³)	(µg/m³)
01-Feb-23	Sunny	8:28 - 11:28	32	31	27	273.7	500
07-Feb-23	Cloudy	8:22 - 11:22	34	37	40	273.7	500
13-Feb-23	Cloudy	8:28 - 11:28	63	55	59	273.7	500
17-Feb-23	Sunny	8:28 - 11:28	30	29	35	273.7	500
23-Feb-23	Sunny	8:23 - 11:23	27	31	25	273.7	500

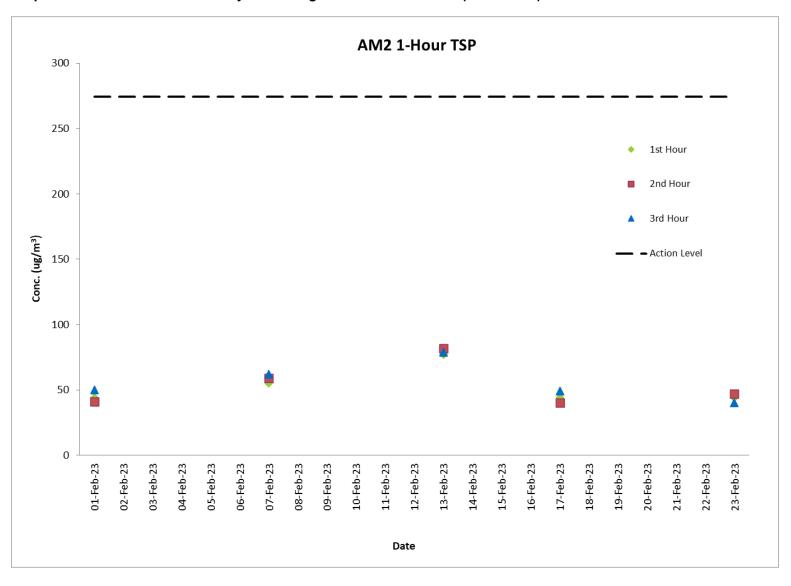
Graphical Presentation of Air Quality Monitoring Result at Station AM2 (1-hour TSP)

Weather			Conc. (µg/m³)	Action Level	Limit Level
Date	Condition	Time	1 st Hour	2 nd Hour	3 rd Hour	(μg/m³)	(μg/m³)
01-Feb-23	Sunny	8:43 - 11:43	44	41	50	274.2	500
07-Feb-23	Cloudy	8:37 - 11:37	55	59	62	274.2	500
13-Feb-23	Cloudy	8:43 - 11:43	77	82	79	274.2	500
17-Feb-23	Sunny	8:43 - 11:43	44	40	49	274.2	500
23-Feb-23	Sunny	8:38 - 11:38	44	47	40	274.2	500

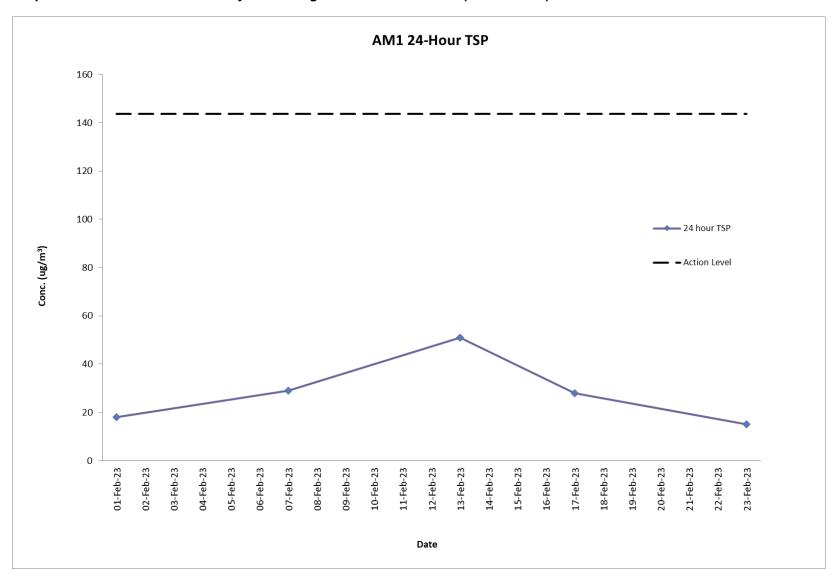
Graphical Presentation of Air Quality Monitoring Result at Station AM1 (24-hour TSP)

Sta	rt	Finis	sh	Filter W	eight (g)	Elapse Rea	d Time ding	Sampling Flow Rate (m ³ /min)		Conc.	Weather	Action	Limit		
Date	Time	Date	Time	Initial	Final	Initial	Final	Time (hrs)	Initial	Final	Average	(µg/m ³)	Condition	Level	Level
01-Feb-23	08:25	02-Feb-23	08:25	2.6901	2.7183	26072.38	26096.38	24	1.1	1.1	1.1	18	Sunny	143.6	260
07-Feb-23	08:20	08-Feb-23	08:20	2.6945	2.7397	26092.38	26116.38	24	1.1	1.1	1.1	29	Cloudy	143.6	260
13-Feb-23	08:25	14-Feb-23	08:25	2.6889	2.7695	26116.38	26140.38	24	1.1	1.1	1.1	51	Cloudy	143.6	260
17-Feb-23	08:25	18-Feb-23	08:25	2.7130	2.7580	26140.38	26164.38	24	1.1	1.1	1.1	28	Sunny	143.6	260
23-Feb-23	08:20	24-Feb-23	08:20	2.7094	2.7332	26164.38	26188.38	24	1.1	1.1	1.1	15	Sunny	143.6	260

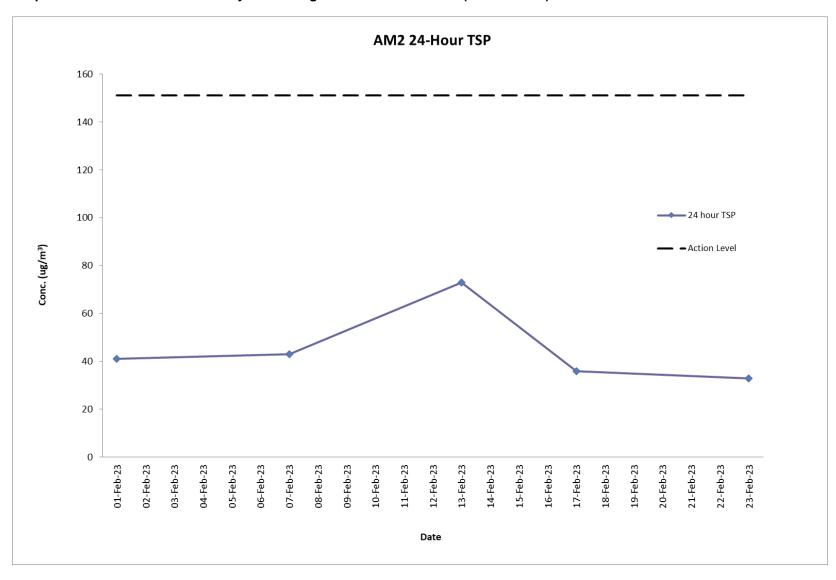
Graphical Presentation of Air Quality Monitoring Result at Station AM2 (24-hour TSP)

Sta	rt	Finis	sh	Sampling	Conc.	Weather	Action	
Date	Time	Date	Time	Time (hrs)	(µg/m³)	Condition	Level	Limit Level
01-Feb-23	08:40	02-Feb-23	08:40	24	41	Sunny	151.1	260
07-Feb-23	08:34	08-Feb-23	08:34	24	43	Cloudy	151.1	260
13-Feb-23	08:40	14-Feb-23	08:40	24	73	Cloudy	151.1	260
17-Feb-23	08:40	18-Feb-23	08:40	24	36	Sunny	151.1	260
23-Feb-23	08:35	24-Feb-23	08:35	24	33	Sunny	151.1	260

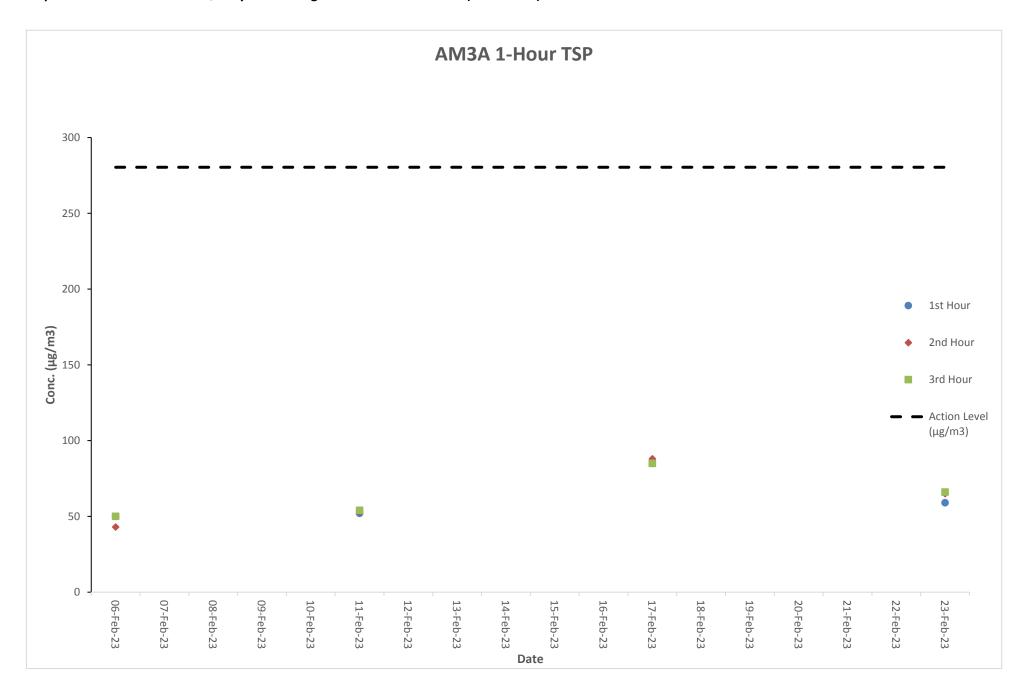
Air Quality Monitoring Result at Station AM3A (1-hour TSP)

Date	Weather	Time		Conc. (µg/m3)			Action	Limit
Date	Condition	Start	Finish	1st Hour	2nd Hour	3rd Hour	Level	Level
06-Feb-23	Cloudy	14:05	17:05	50	43	50	280.4	500
11-Feb-23	Cloudy	8:01	11:01	52	53	54	280.4	500
17-Feb-23	Fine	14:09	17:09	85	88	85	280.4	500
23-Feb-23	Fine	8:07	11:07	59	65	66	280.4	500

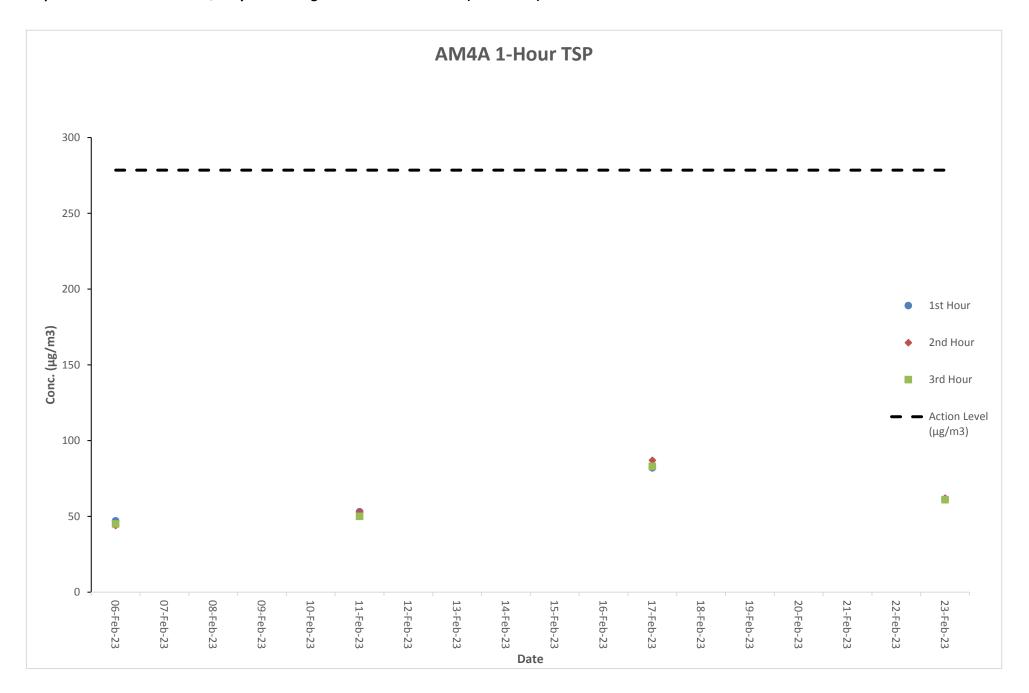
Air Quality Monitoring Result at Station AM4A (1-hour TSP)

Date	Weather	Time		Conc. (µg/m3)			Action	Limit
Date	Condition	Start	Finish	1st Hour	2nd Hour	3rd Hour	Level	Level
06-Feb-23	Cloudy	14:13	17:13	47	44	45	278.5	500
11-Feb-23	Cloudy	8:09	11:09	53	53	50	278.5	500
17-Feb-23	Fine	14:17	17:17	82	87	83	278.5	500
23-Feb-23	Fine	8:15	11:15	61	62	61	278.5	500

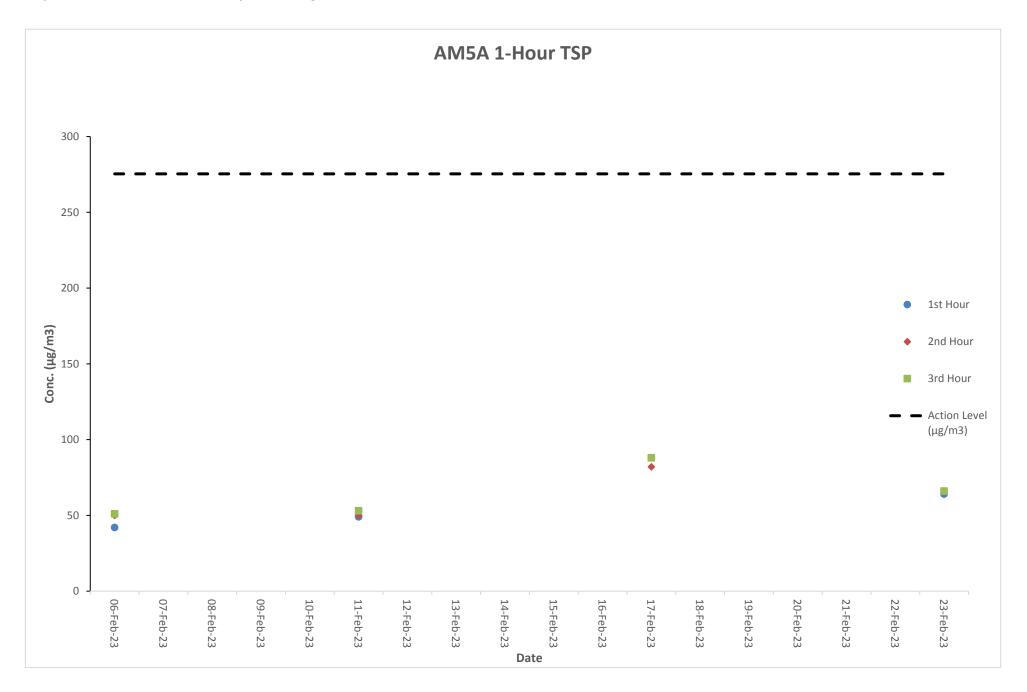
Air Quality Monitoring Result at Station AM5A (1-hour TSP)

Date	Weather	Tir	ne	C	onc. (µg/m3	3)	Action	Limit
Date	Condition	Start Finish		1st Hour	2nd Hour	3rd Hour	Level	Level
06-Feb-23	Cloudy	14:28	17:28	42	50	51	275.4	500
11-Feb-23	Cloudy	8:26	11:26	49	50	53	275.4	500
17-Feb-23	Fine	14:32	17:32	88	82	88	275.4	500
23-Feb-23	Fine	8:32	11:32	64	66	66	275.4	500

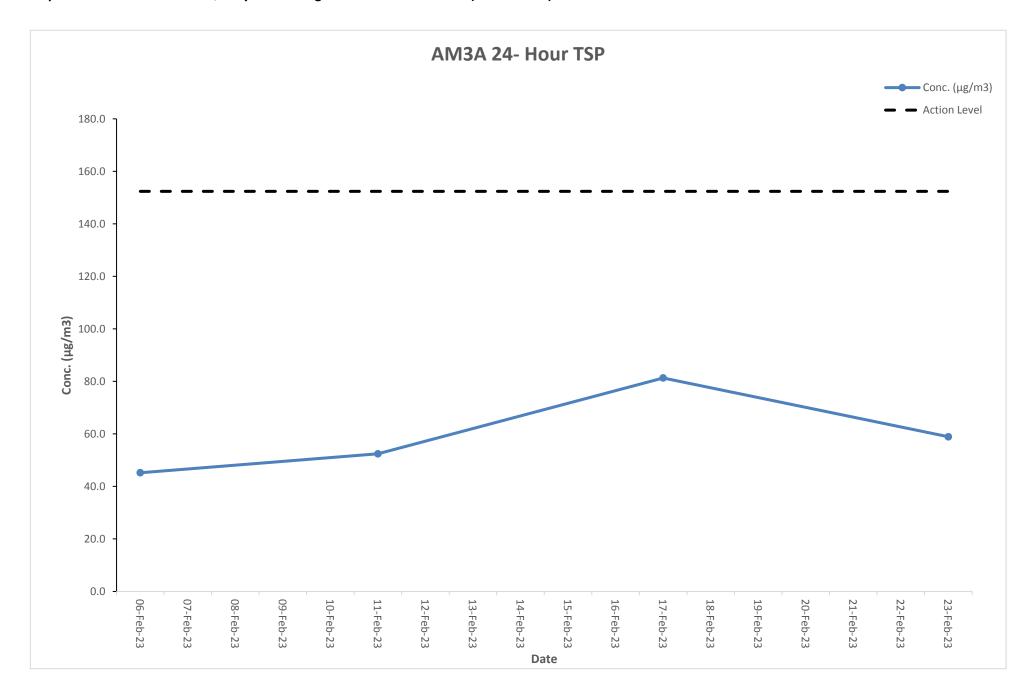
Air Quality Monitoring Result at Station AM3A (24-hour TSP)

Sta	rt	Fini	sh	Filter W	eight (g)	Elapsed Tir	me Reading	Sampling	Flov	v Rate (m	n³/min)	Conc.	Weather	Action	Limit
Date	Time	Date	Time	Initial	Final	Initial	Final	Time (hrs)	Initial	Final	Average	(µg/m3)	Condition	Level	Level
06-Feb-23	10:00AM	07-Feb-23	10:00AM	2.8044	2.8771	4758.8	4782.8	24	1.12	1.12	1.12	45.2	Cloudy	152.4	260
11-Feb-23	10:00AM	12-Feb-23	10:00AM	2.8086	2.8929	4782.8	4806.8	24	1.12	1.12	1.12	52.4	Cloudy	152.4	260
17-Feb-23	10:00AM	18-Feb-23	10:00AM	2.8062	2.9369	4806.8	4830.8	24	1.12	1.12	1.12	81.3	Sunny	152.4	260
23-Feb-23	10:00AM	24-Feb-23	10:00AM	2.8053	2.9001	4830.8	4854.8	24	1.12	1.12	1.12	58.9	Sunny	152.4	260

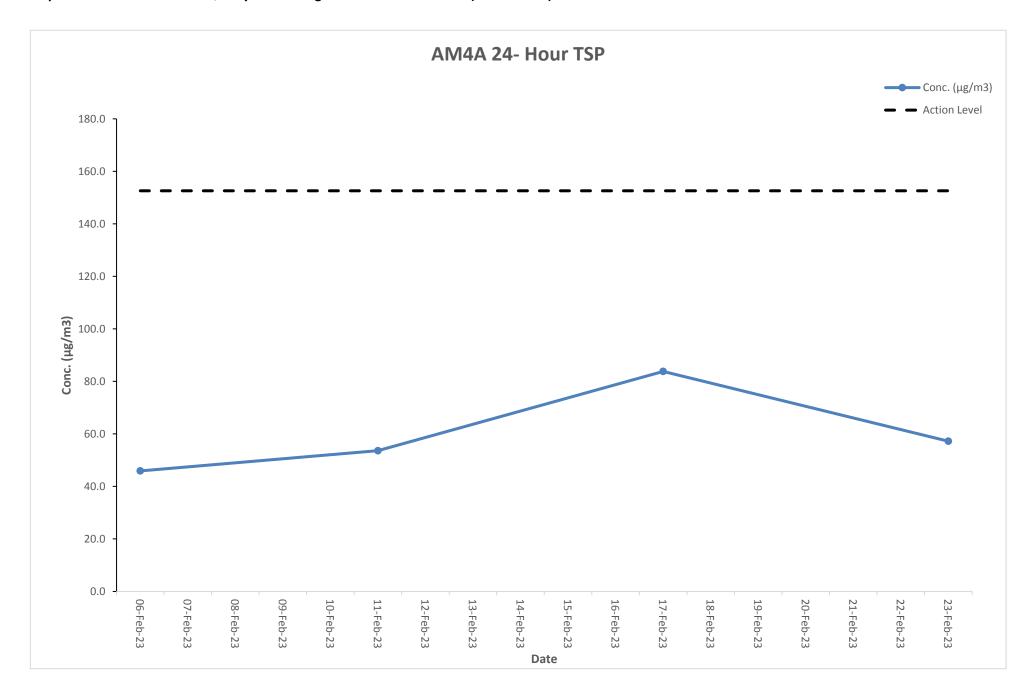
Air Quality Monitoring Result at Station AM4A (24-hour TSP)

Sta	rt	Fini	sh	Filter W	eight (g)	Elapsed Tir	me Reading	Sampling	Flov	v Rate (m	n³/min)	Conc.	Weather	Action	Limit
Date	Time	Date	Time	Initial	Final	Initial	Final	Time (hrs)	Initial	Final	Average	(µg/m3)	Condition	Level	Level
06-Feb-23	10:00AM	07-Feb-23	10:00AM	2.8088	2.8826	5178.4	5202.4	24	1.12	1.12	1.12	45.9	Cloudy	152.6	260
11-Feb-23	10:00AM	12-Feb-23	10:00AM	2.8059	2.8922	5202.4	5226.4	24	1.12	1.12	1.12	53.6	Cloudy	152.6	260
17-Feb-23	10:00AM	18-Feb-23	10:00AM	2.8027	2.9376	5226.4	5250.4	24	1.12	1.12	1.12	83.8	Sunny	152.6	260
23-Feb-23	10:00AM	24-Feb-23	10:00AM	2.8078	2.8998	5250.4	5274.4	24	1.12	1.12	1.12	57.2	Sunny	152.6	260

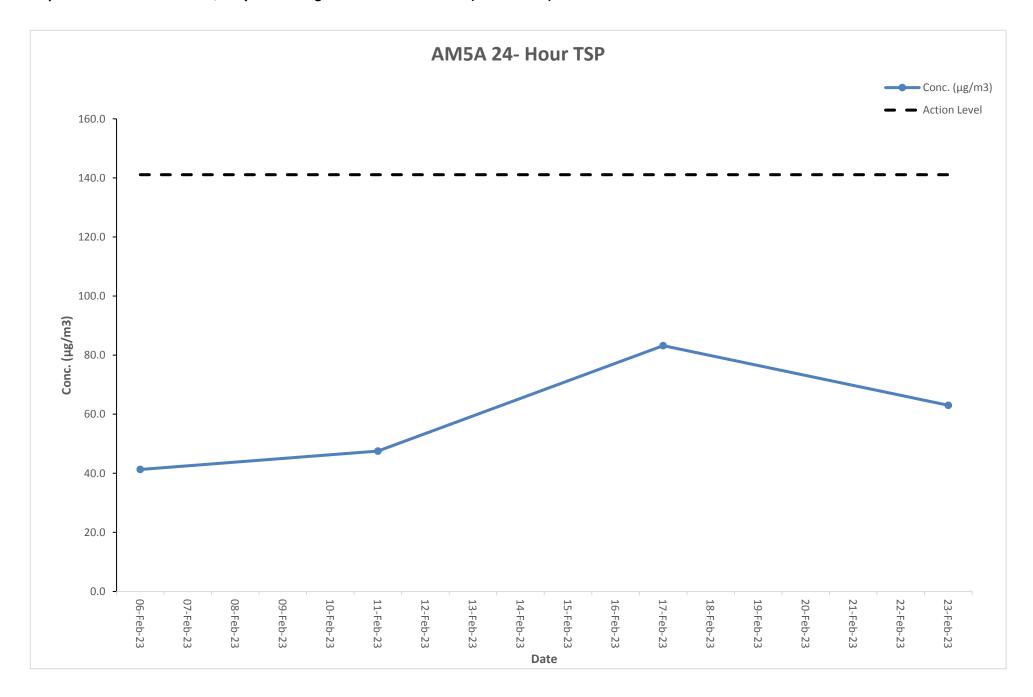
Air Quality Monitoring Result at Station AM5A (24-hour TSP)

Sta	rt	Fini	sh	Filter W	eight (g)	Elapsed Tir	me Reading	Sampling	Flov	v Rate (m	n³/min)	Conc.	Weather	Action	Limit
Date	Time	Date	Time	Initial	Final	Initial	Final	Time (hrs)	Initial	Final	Average	(µg/m3)	Condition	Level	Level
06-Feb-23	10:00AM	07-Feb-23	10:00AM	2.8050	2.8714	5318.6	5342.6	24	1.12	1.12	1.12	41.3	Cloudy	141.1	260
11-Feb-23	10:00AM	12-Feb-23	10:00AM	2.8049	2.8813	5342.6	5366.6	24	1.12	1.12	1.12	47.5	Cloudy	141.1	260
17-Feb-23	10:00AM	18-Feb-23	10:00AM	2.8029	2.9369	5366.6	5390.6	24	1.12	1.12	1.12	83.2	Sunny	141.1	260
23-Feb-23	10:00AM	24-Feb-23	10:00AM	2.8056	2.9070	5390.6	5414.6	24	1.12	1.12	1.12	63.0	Sunny	141.1	260

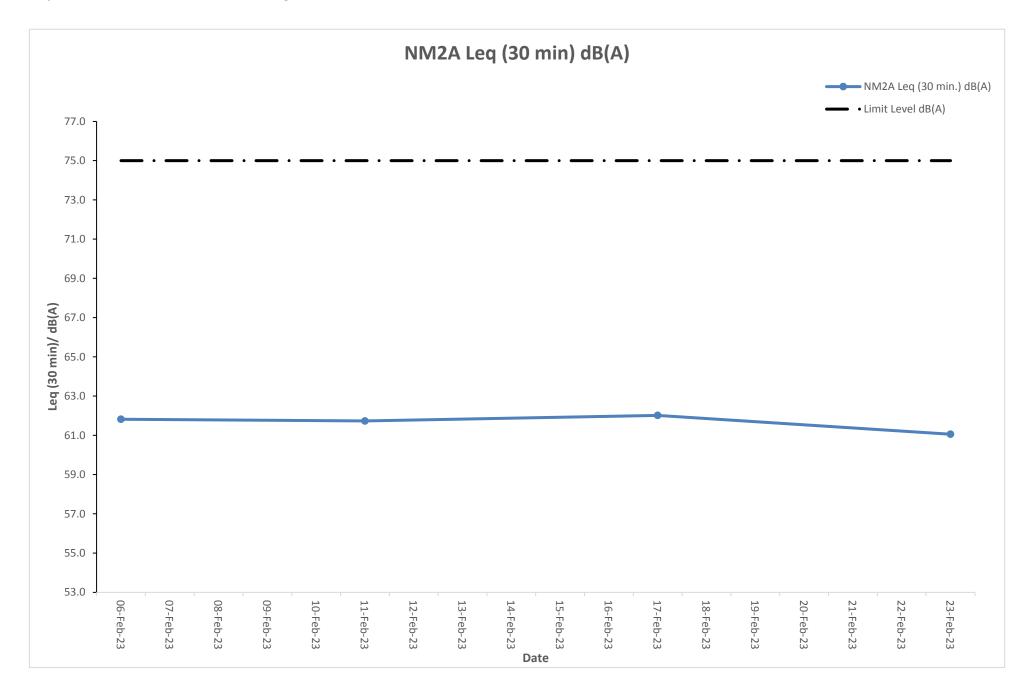
The station set-up of a façade measurement at station NM2A.

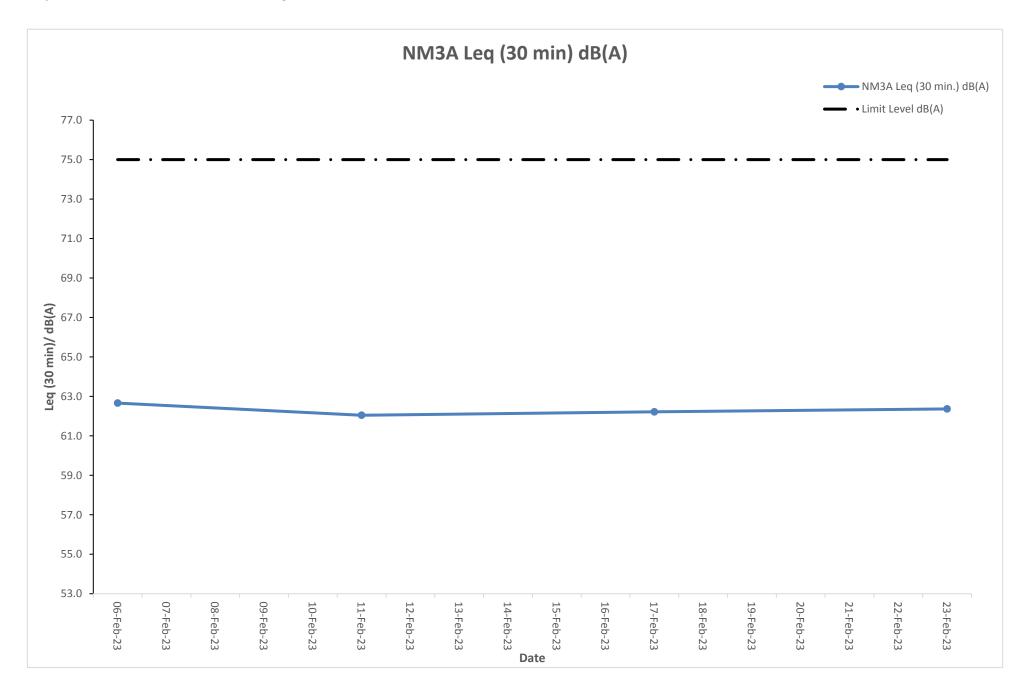
The station set-up of a façade measurement at station NM3A.

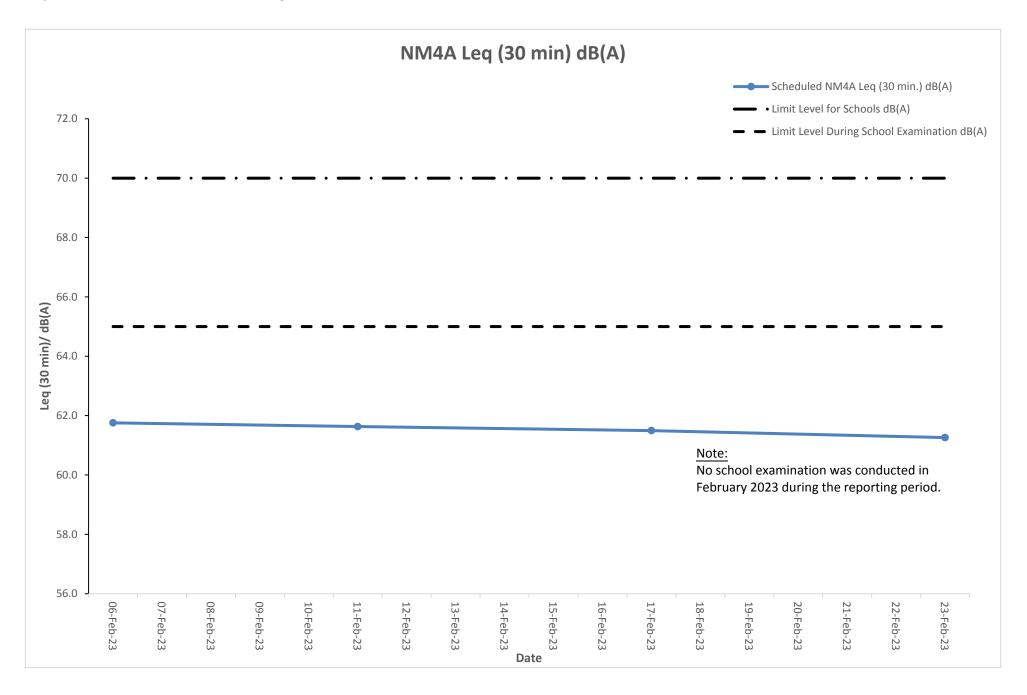
The station set-up of a façade measurement at station NM4A.

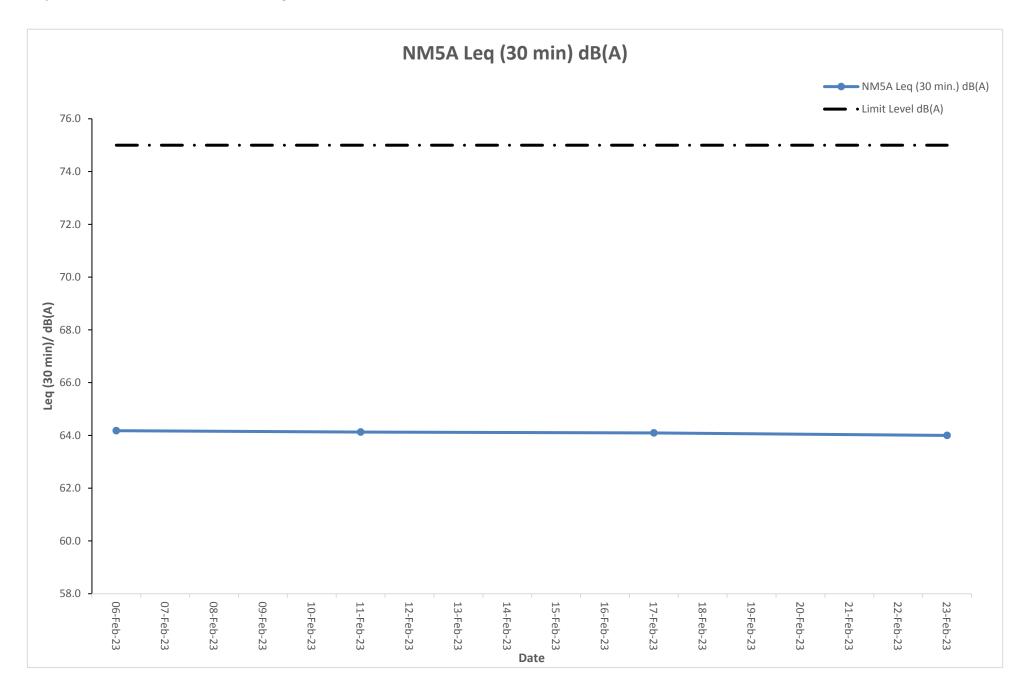
The station set-up of a free-field measurement at station NM5A.
