### Development at West Kowloon Cultural District

Monthly Environmental Monitoring and Audit (EM&A) Report

for June 2023

# Part-2: EM&A for Foundation Works in Zone 2B & 2C

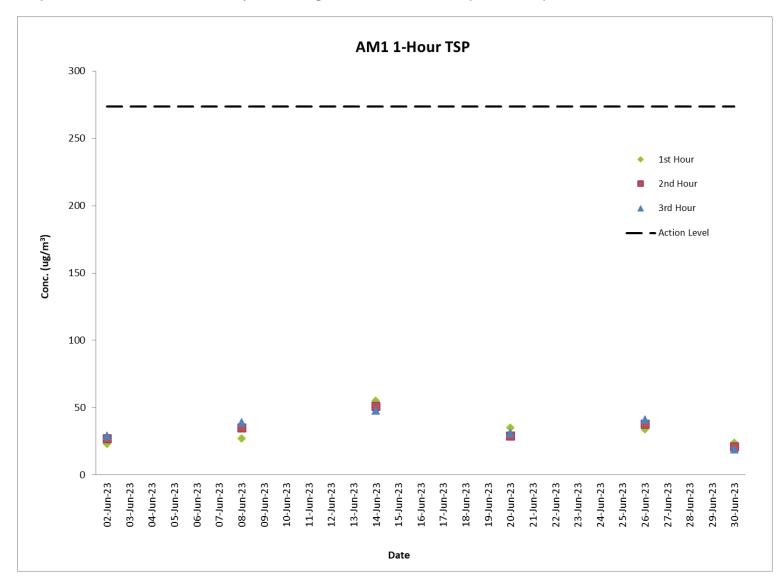
Air Quality Monitoring Result at Station AM1 (1-hour TSP)

Graphical Presentation of Air Quality Monitoring Result at Station AM1 (1-hour TSP)

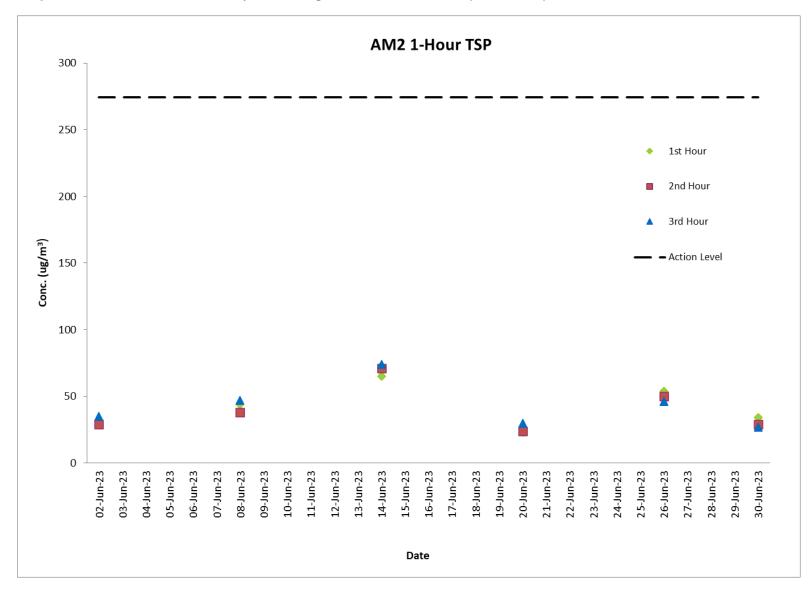
Air Quality Monitoring Result at Station AM2 (1-hour TSP)

Graphical Presentation of Air Quality Monitoring Result at Station AM2 (1-hour TSP)

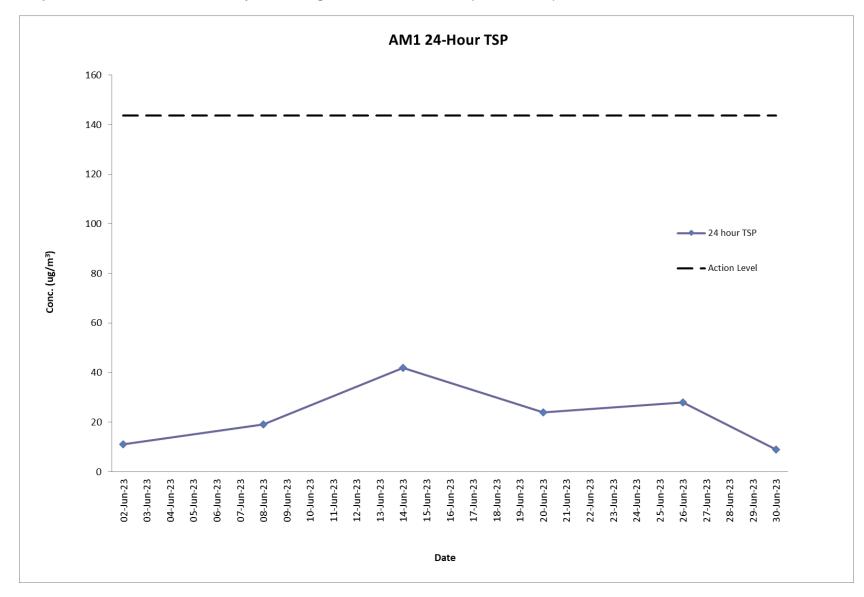
Air Quality Monitoring I	Result at Station AM	1 (24-hour TSP)
--------------------------	----------------------	-----------------

Graphical Presentation of Air Quality Monitoring Result at Station AM1 (24-hour TSP)

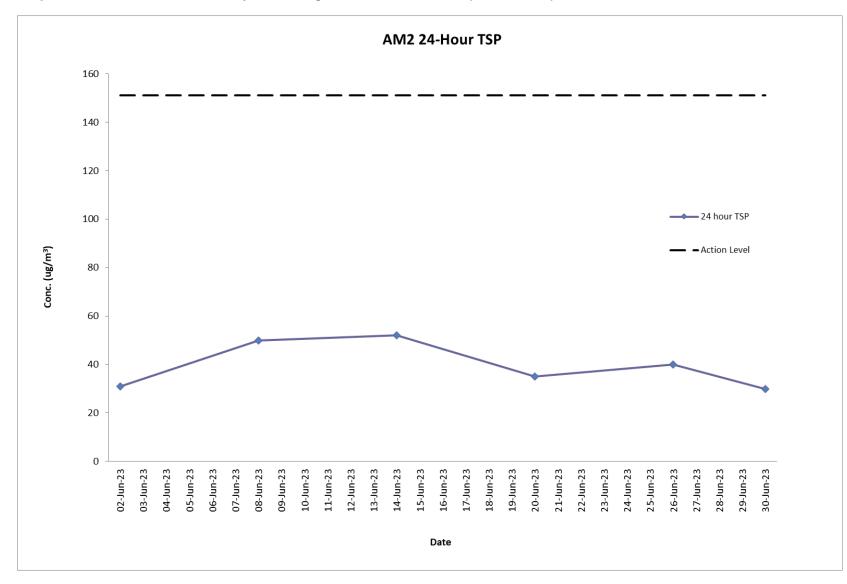
Air Quality Monitoring Result at Station AM2 (24-hour TSP)

Graphical Presentation of Air Quality Monitoring Result at Station AM2 (24-hour TSP)

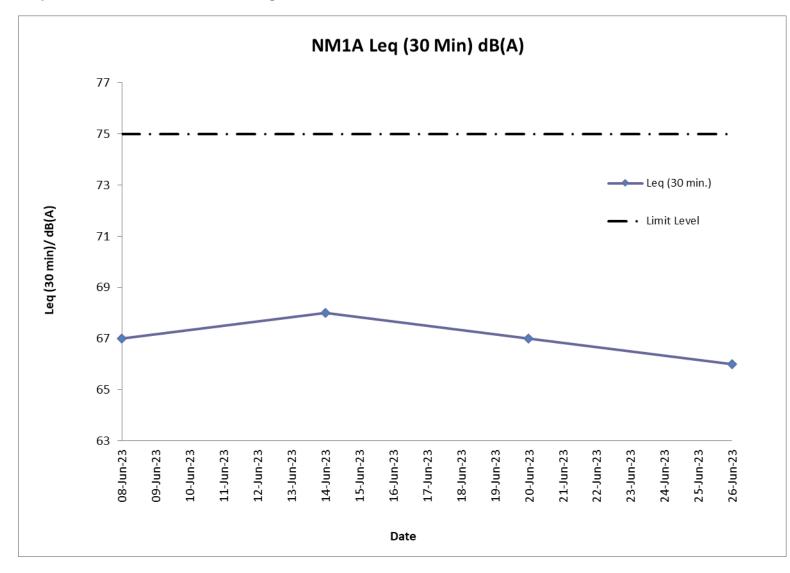
The station set-up of a free-field measurement at Station NM1A.

Graphical Presentation Noise Monitoring Result at Station NM1A

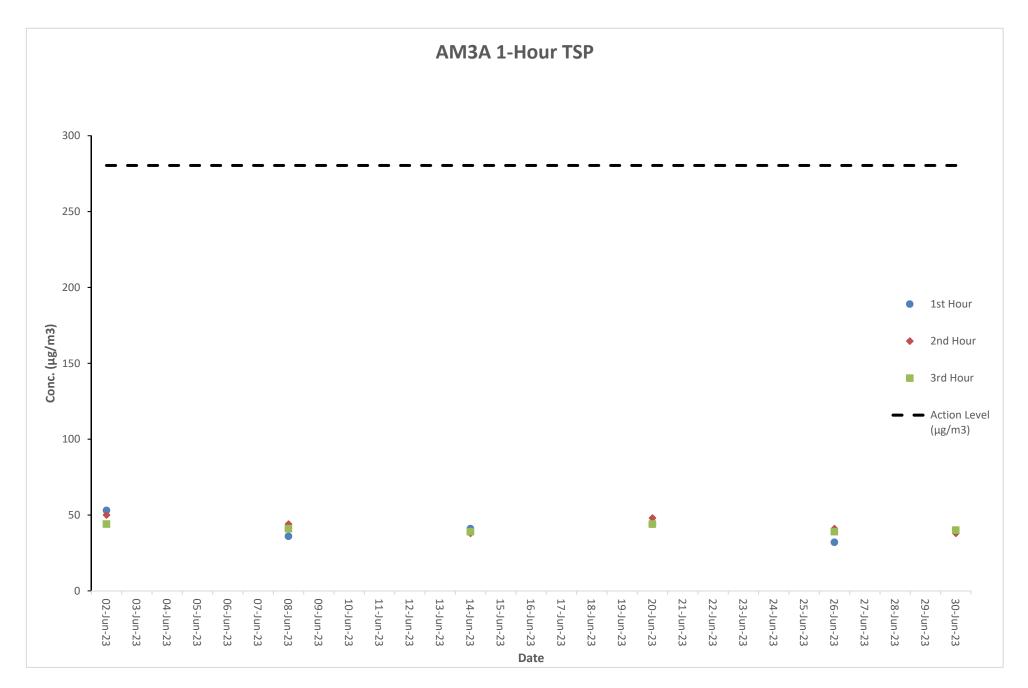
#### Air Quality Monitoring Result at Station AM3A (1-hour TSP)

Date	Weather	Tir	ne	C	onc. (µg/m3	3)	Action	Limit
Date	Condition	Start Finish		1st Hour	1st Hour 2nd Hour		Level	Level
02-Jun-23	Fine	8:09	11:09	53	50	44	280.4	500
08-Jun-23	Fine	14:07	17:07	36	44	41	280.4	500
14-Jun-23	Cloudy	8:05	11:05	41	38	39	280.4	500
20-Jun-23	Cloudy	14:01	17:01	44	48	44	280.4	500
26-Jun-23	Cloudy	8:06	11:06	32	41	39	280.4	500
30-Jun-23	Fine	14:09	17:09	40	38	40	280.4	500

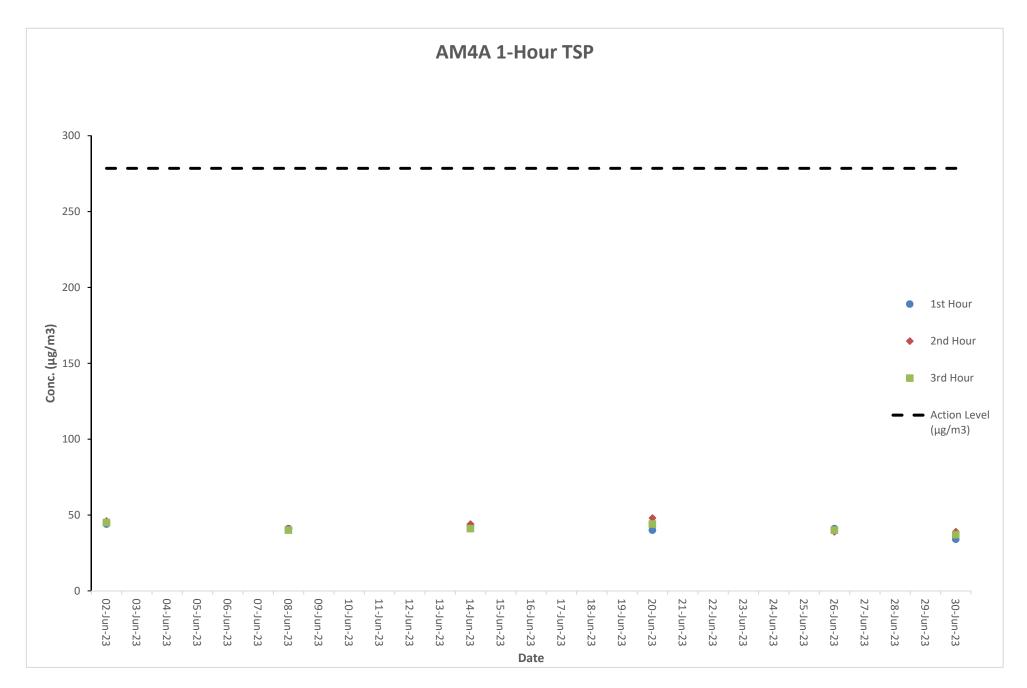
#### Air Quality Monitoring Result at Station AM4A (1-hour TSP)

Date	Weather	Tir	ne	C	onc. (µg/m3	3)	Action	Limit
Date	Condition	Start Finish		1st Hour 2nd Hour		3rd Hour	Level	Level
02-Jun-23	Fine	8:17	11:17	44	46	45	278.5	500
08-Jun-23	Fine	14:15	17:15	41	41	40	278.5	500
14-Jun-23	Cloudy	8:13	11:13	43	44	41	278.5	500
20-Jun-23	Cloudy	14:09	17:09	40	48	44	278.5	500
26-Jun-23	Cloudy	8:14	11:14	41	39	40	278.5	500
30-Jun-23	Fine	14:17	17:17	34	39	37	278.5	500

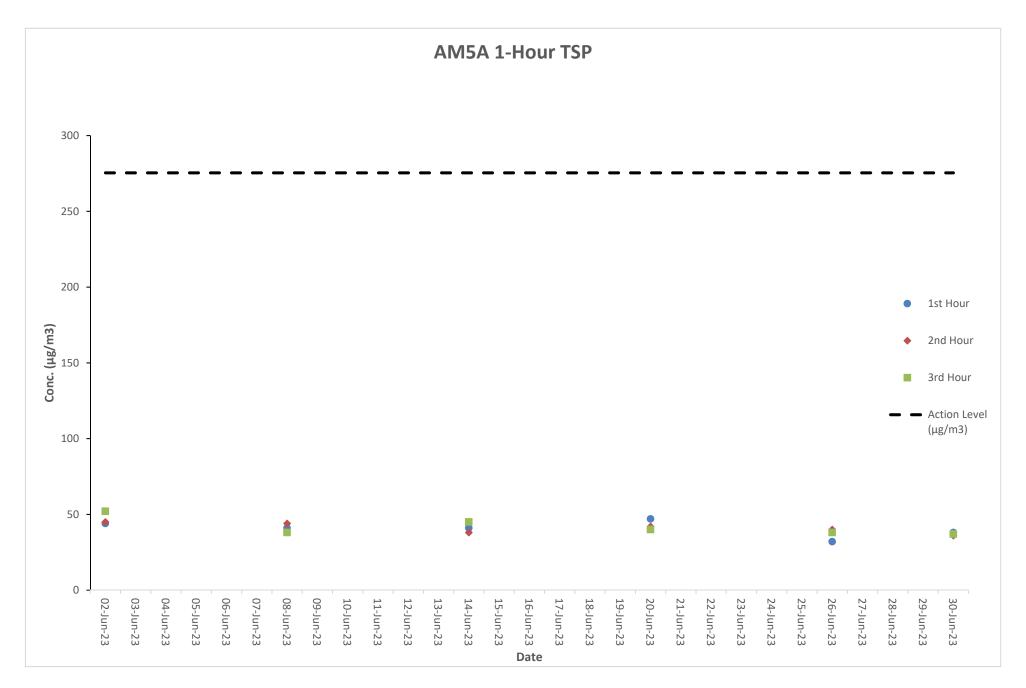
#### Air Quality Monitoring Result at Station AM5A (1-hour TSP)

Date	Weather	Tir	ne	C	onc. (µg/m3	3)	Action	Limit
Date	Condition	Start	Finish	1st Hour	2nd Hour	3rd Hour	Level	Level
02-Jun-23	Fine	8:32	11:32	44	45	52	275.4	500
08-Jun-23	Fine	14:32	17:32	41	44	38	275.4	500
14-Jun-23	Cloudy	8:28	11:28	41	38	45	275.4	500
20-Jun-23	Cloudy	14:26	17:26	47	42	40	275.4	500
26-Jun-23	Cloudy	8:29	11:29	32	40	38	275.4	500
30-Jun-23	Fine	14:34	17:34	38	36	37	275.4	500

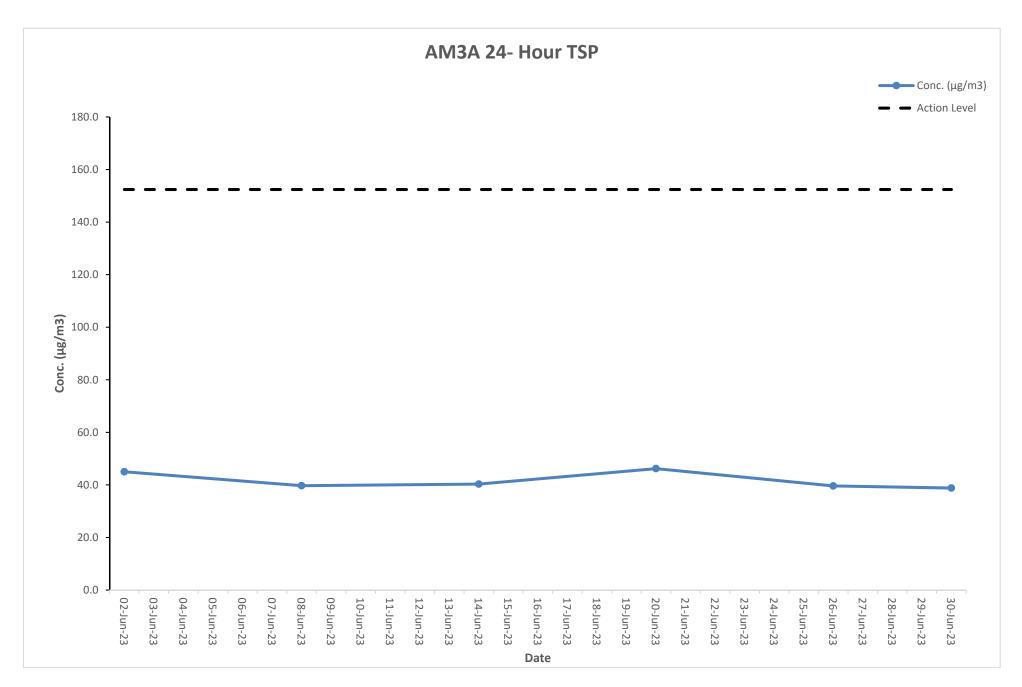
#### Air Quality Monitoring Result at Station AM3A (24-hour TSP)

Sta	irt	Fini	sh	Filter W	eight (g)	Elapsed Time Reading		Sampling	Flow Rate (m <sup>3</sup> /min)		Conc.	Weather	Action	Limit	
Date	Time	Date	Time	Initial	Final	Initial	Final	Time (hrs)	Initial	Final	Average	(µg/m3)	Condition	Level	Level
02-Jun-23	10:00AM	03-Jun-23	10:00AM	2.8017	2.8742	5264.8	5288.8	24	1.12	1.12	1.12	45.0	Sunny	152.4	260
08-Jun-23	10:00AM	09-Jun-23	10:00AM	2.8055	2.8694	5288.8	5312.8	24	1.12	1.12	1.12	39.7	Rainy	152.4	260
14-Jun-23	10:00AM	15-Jun-23	10:00AM	2.8023	2.8672	5312.8	5336.8	24	1.12	1.12	1.12	40.3	Rainy	152.4	260
20-Jun-23	10:00AM	21-Jun-23	10:00AM	2.8062	2.8806	5336.8	5360.8	24	1.12	1.12	1.12	46.2	Rainy	152.4	260
26-Jun-23	10:00AM	27-Jun-23	10:00AM	2.8018	2.8656	5360.8	5384.8	24	1.12	1.12	1.12	39.6	Rainy	152.4	260
30-Jun-23	10:00AM	01-Jul-23	10:00AM	2.8018	2.8642	5384.8	5408.8	24	1.12	1.12	1.12	38.8	Rainy	152.4	260

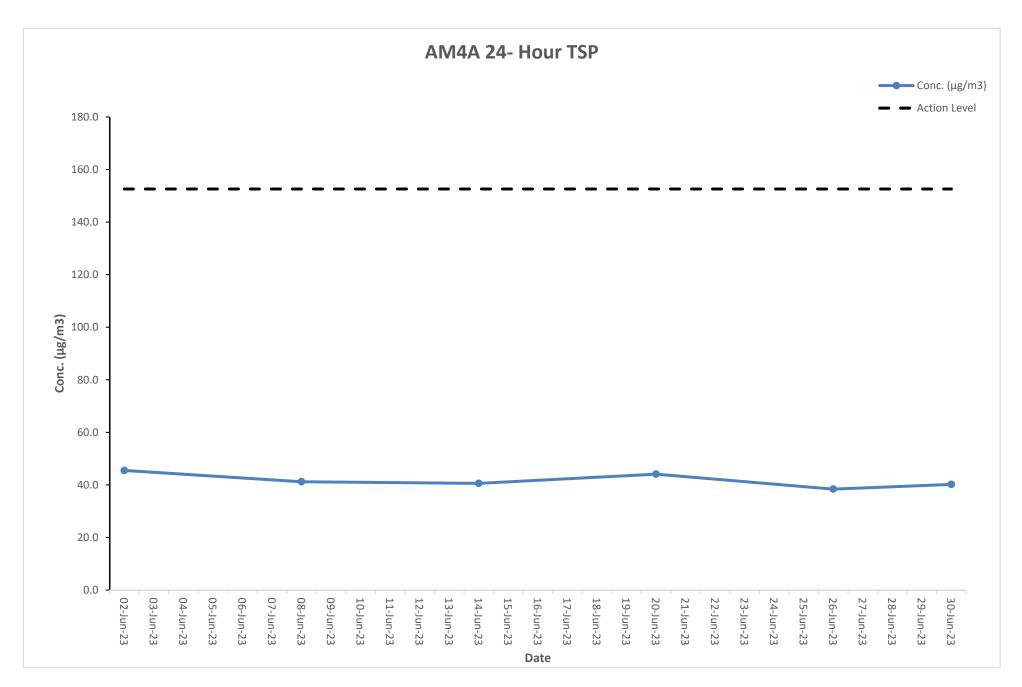
#### Air Quality Monitoring Result at Station AM4A (24-hour TSP)

Sta	rt	Fini	sh	Filter W	eight (g)	Elapsed Time Reading		Sampling	Flow Rate (m <sup>3</sup> /min)		Conc.	Weather	Action	Limit	
Date	Time	Date	Time	Initial	Final	Initial	Final	Time (hrs)	Initial	Final	Average	(µg/m3)	Condition	Level	Level
02-Jun-23	10:00AM	03-Jun-23	10:00AM	2.8059	2.8791	5684.4	5708.4	24	1.12	1.12	1.12	45.5	Sunny	152.6	260
08-Jun-23	10:00AM	09-Jun-23	10:00AM	2.8028	2.8691	5708.4	5732.4	24	1.12	1.12	1.12	41.2	Rainy	152.6	260
14-Jun-23	10:00AM	15-Jun-23	10:00AM	2.8031	2.8685	5732.4	5756.4	24	1.12	1.12	1.12	40.6	Rainy	152.6	260
20-Jun-23	10:00AM	21-Jun-23	10:00AM	2.8059	2.8769	5756.4	5780.4	24	1.12	1.12	1.12	44.1	Rainy	152.6	260
26-Jun-23	10:00AM	27-Jun-23	10:00AM	2.8052	2.8670	5780.4	5804.4	24	1.12	1.12	1.12	38.4	Rainy	152.6	260
30-Jun-23	10:00AM	01-Jul-23	10:00AM	2.8068	2.8715	5804.4	5828.4	24	1.12	1.12	1.12	40.2	Rainy	152.6	260

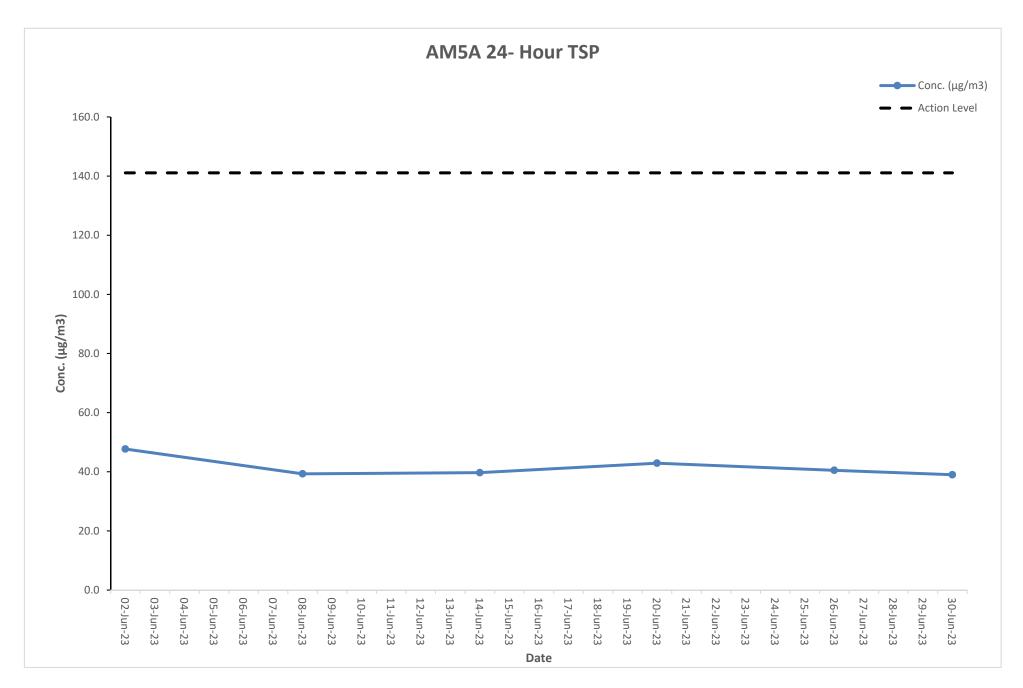
#### Air Quality Monitoring Result at Station AM5A (24-hour TSP)

Sta	rt	Fini	sh	Filter W	eight (g)		ed Time Iding Sampling Flow Rate (m <sup>3</sup> /min)		Conc.	Weather	Action	Limit			
Date	Time	Date	Time	Initial	Final	Initial	Final	Time (hrs)	Initial	Final	Average	(µg/m3)	Condition	Level	Level
02-Jun-23	10:00AM	03-Jun-23	10:00AM	2.8019	2.8788	5824.6	5848.6	24	1.12	1.12	1.12	47.7	Sunny	141.1	260
08-Jun-23	10:00AM	09-Jun-23	10:00AM	2.8082	2.8714	5848.6	5872.6	24	1.12	1.12	1.12	39.3	Rainy	141.1	260
14-Jun-23	10:00AM	15-Jun-23	10:00AM	2.8066	2.8705	5872.6	5896.6	24	1.12	1.12	1.12	39.7	Rainy	141.1	260
20-Jun-23	10:00AM	21-Jun-23	10:00AM	2.8051	2.8742	5896.6	5920.6	24	1.12	1.12	1.12	42.9	Rainy	141.1	260
26-Jun-23	10:00AM	27-Jun-23	10:00AM	2.8016	2.8668	5920.6	5944.6	24	1.12	1.12	1.12	40.5	Rainy	141.1	260
30-Jun-23	10:00AM	01-Jul-23	10:00AM	2.8044	2.8672	5944.6	5968.6	24	1.12	1.12	1.12	39.0	Rainy	141.1	260

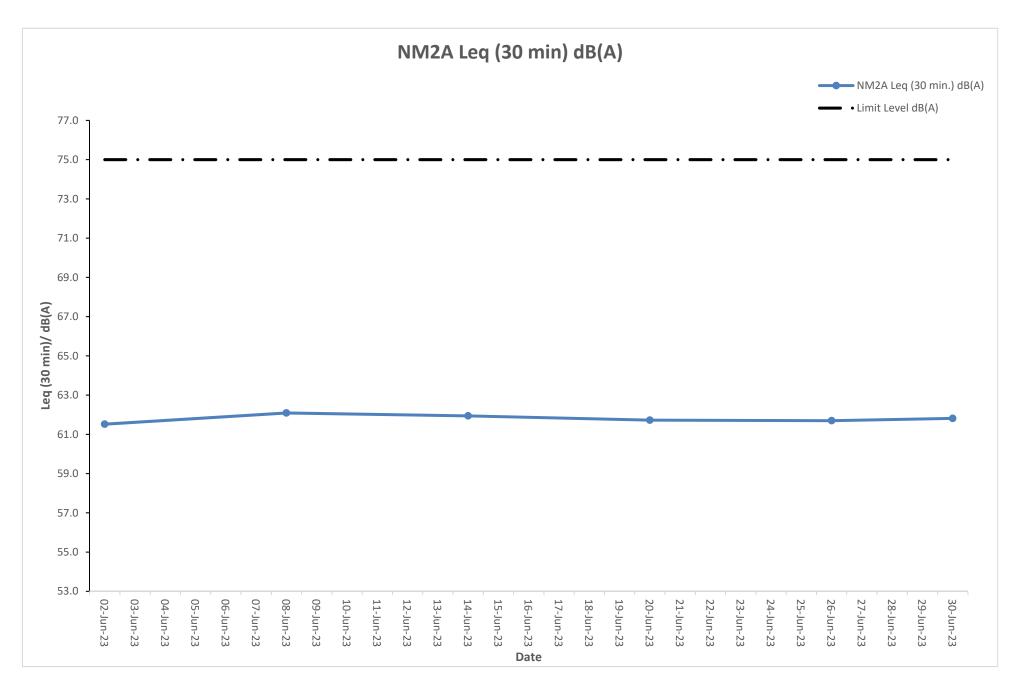
#### Noise Monitoring Result at Station NM2A

The station set-up of a façade measurement at station NM2A.

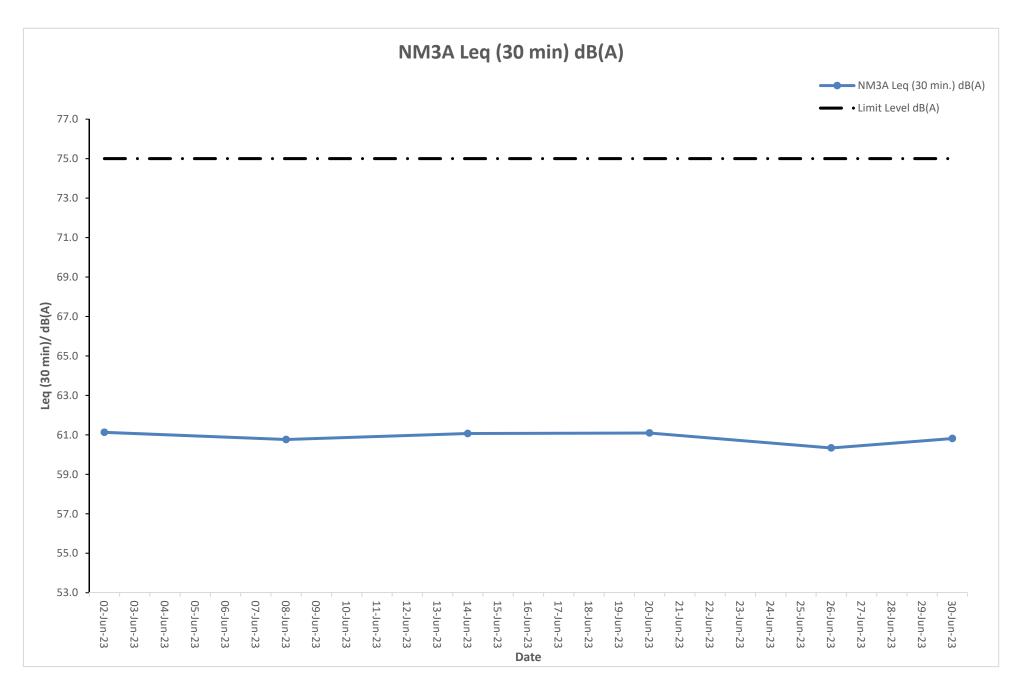
#### Noise Monitoring Result at Station NM3A

The station set-up of a façade measurement at station NM3A.

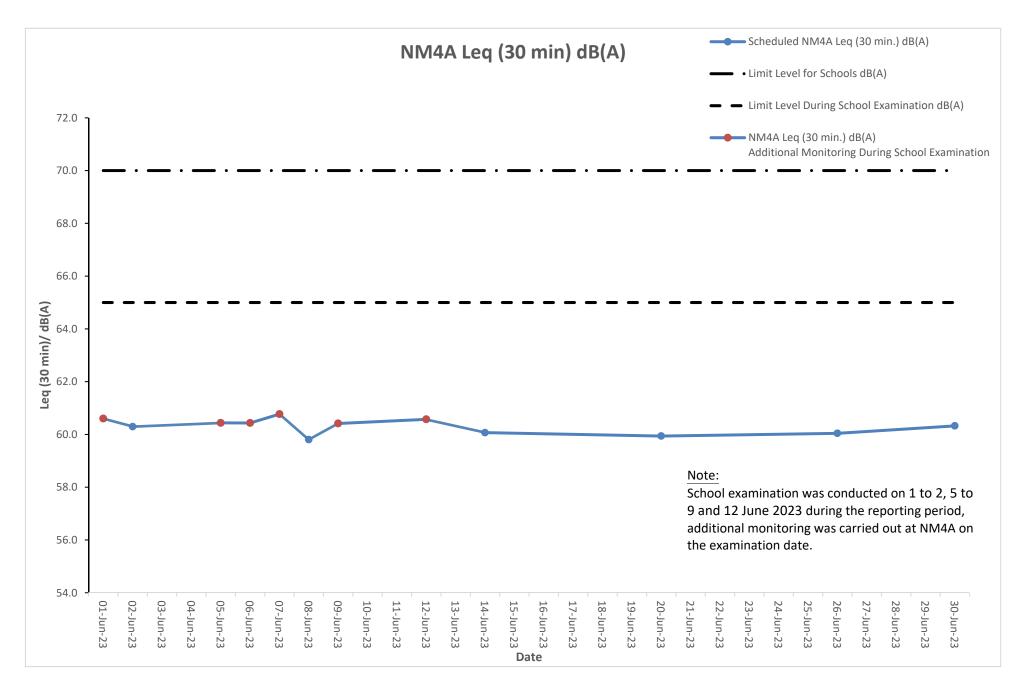
#### Noise Monitoring Result at Station NM4A

The station set-up of a façade measurement at station NM4A.

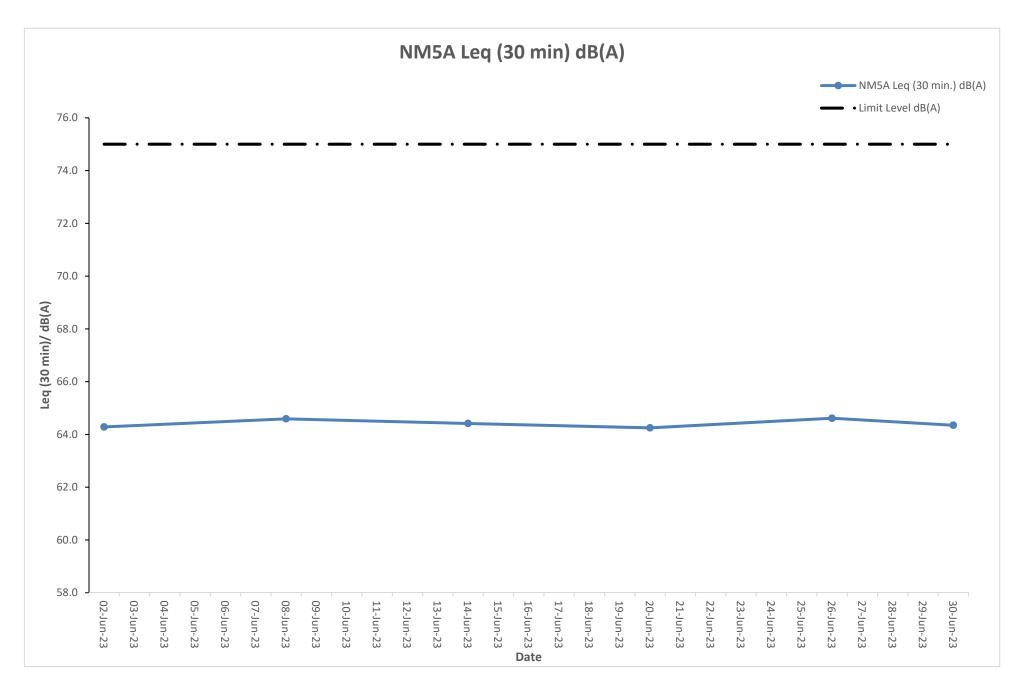
#### Noise Monitoring Result at Station NM5A

The station set-up of a free-field measurement at station NM5A.
