Development at West Kowloon Cultural District

Monthly Environmental Monitoring and Audit (EM&A) Report

for July 2023

Part-2: EM&A for Foundation Works in Zone 2B & 2C

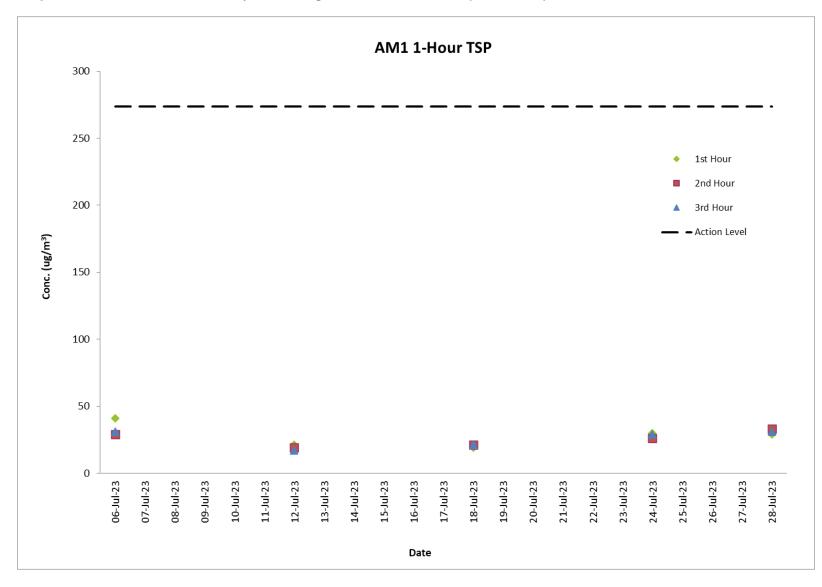
Graphical Presentation of Air Quality Monitoring Result at Station AM1 (1-hour TSP)

Air Quality Monitoring Result at Station AM1 (1-hour TSP)

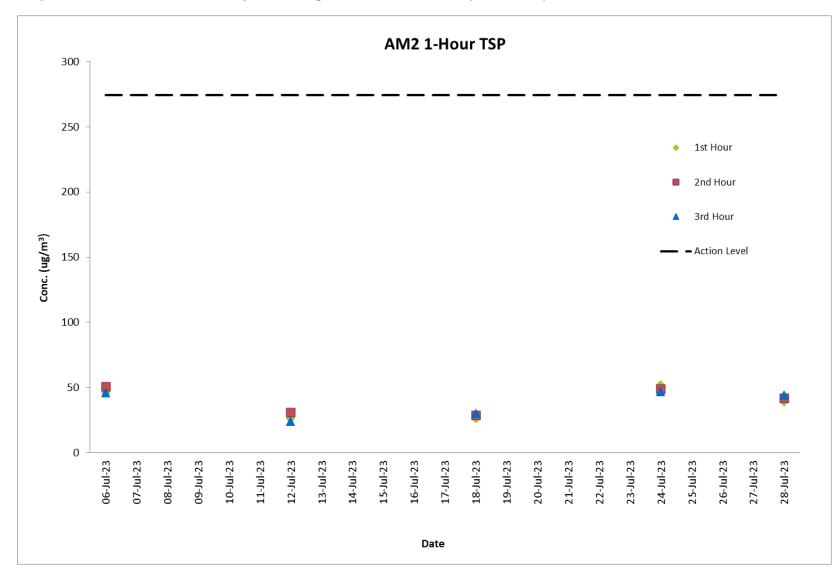
Graphical Presentation of Air Quality Monitoring Result at Station AM2 (1-hour TSP)

Air Quality Monitoring Result at Station AM2 (1-hour TSP)

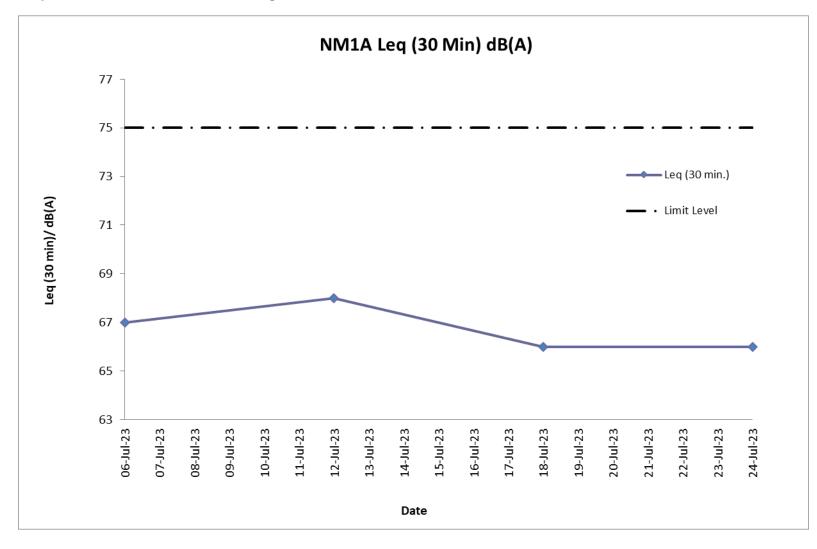
Graphical Presentation Noise Monitoring Result at Station NM1A

The station set-up of a free-field measurement at Station NM1A.
