# Development at West Kowloon Cultural District

Monthly Environmental Monitoring and Audit (EM&A) Report  
for January 2024

**Part-1: EM&A at Lyric Theatre Complex**

**Part-2: EM&A for Foundation Works in  
Zone 2B & 2C**

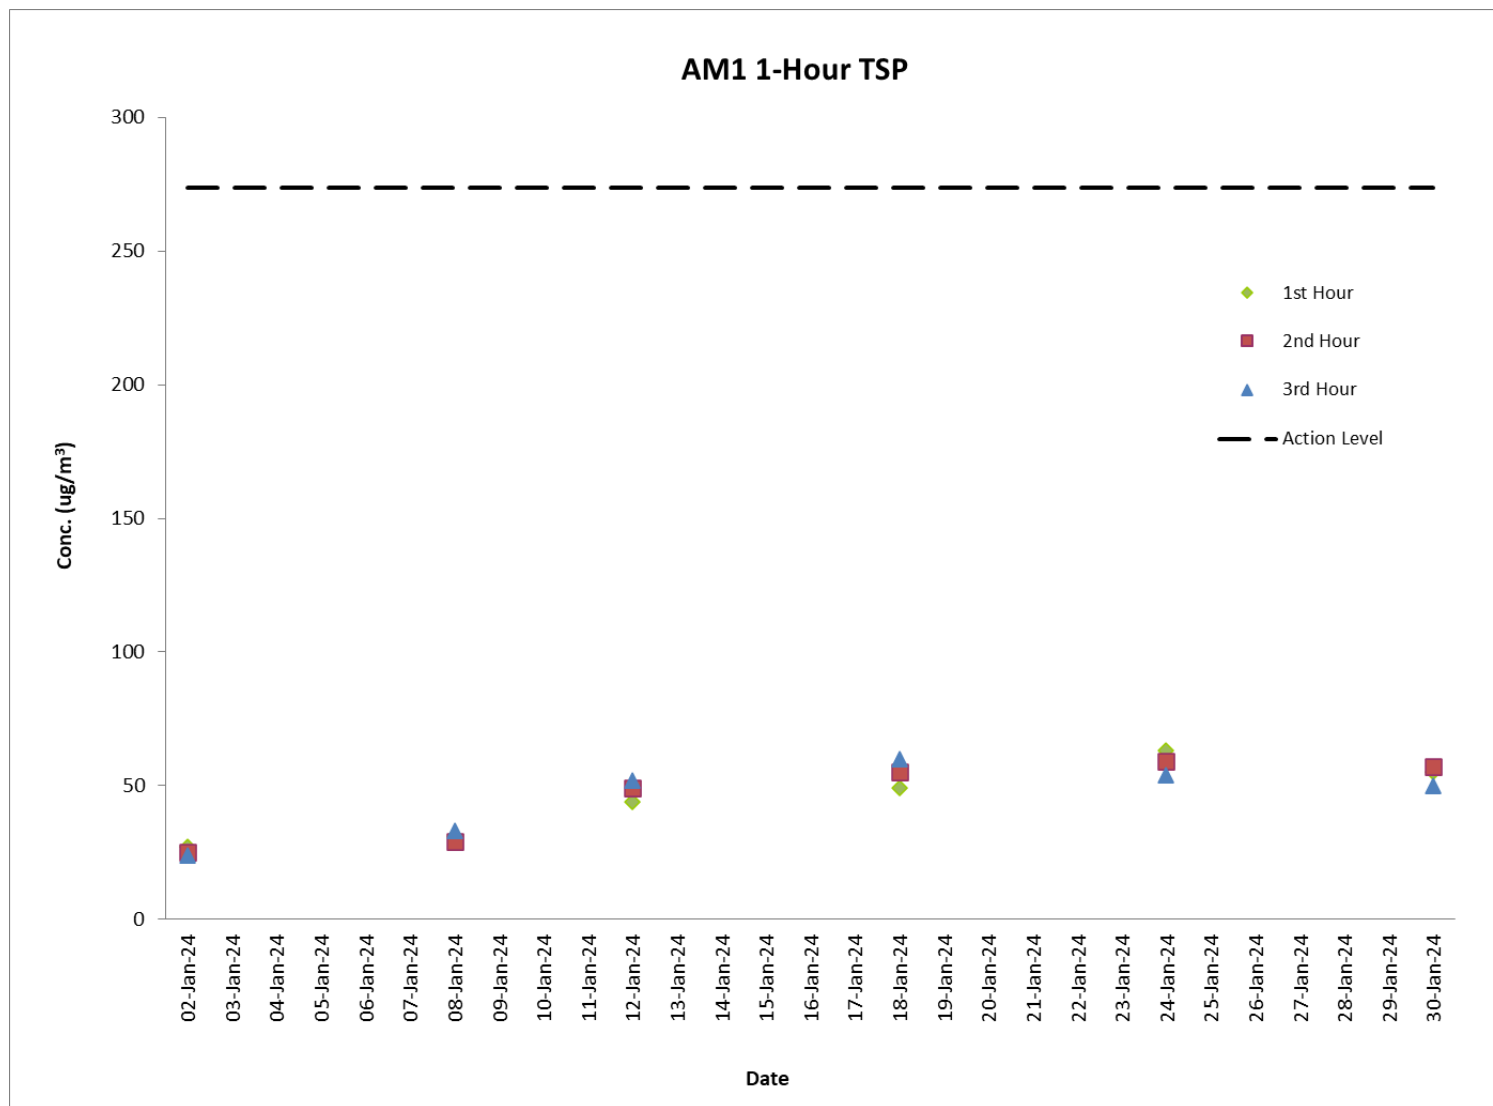
### Graphical Presentation of Air Quality Monitoring Result at Station AM1 (1-hour TSP)

Date	Weather Condition	Time	Conc. ( $\mu\text{g}/\text{m}^3$ )			Action Level ( $\mu\text{g}/\text{m}^3$ )	Limit Level ( $\mu\text{g}/\text{m}^3$ )
			1 <sup>st</sup> Hour	2 <sup>nd</sup> Hour	3 <sup>rd</sup> Hour		
02-Jan-24	Cloudy	8:31 - 11:31	27	25	24	273.7	500
08-Jan-24	Fine	8:32 - 11:32	31	29	33	273.7	500
12-Jan-24	Cloudy	8:28 - 11:28	44	49	52	273.7	500
18-Jan-24	Fine	8:33 - 11:33	49	55	60	273.7	500
24-Jan-24	Cloudy	8:23 - 11:23	63	59	54	273.7	500
30-Jan-24	Cloudy	8:28 - 11:28	55	57	50	273.7	500

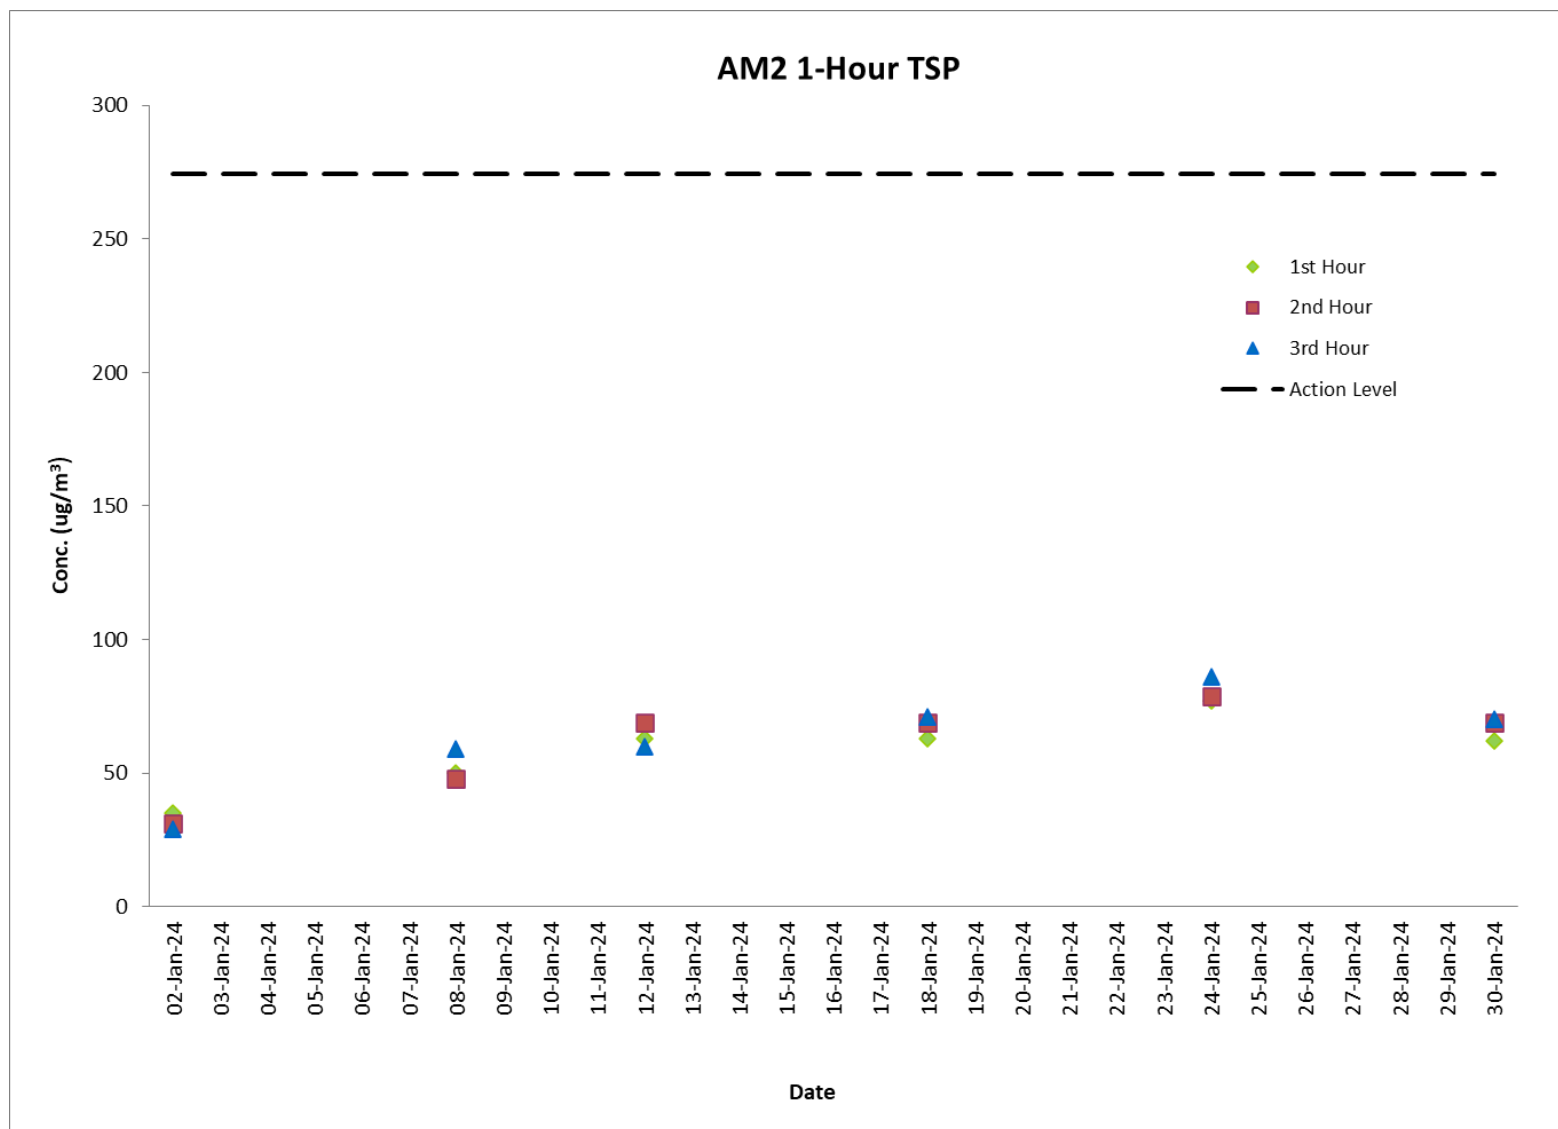
### Graphical Presentation of Air Quality Monitoring Result at Station AM2 (1-hour TSP)

Date	Weather Condition	Time	Conc. ( $\mu\text{g}/\text{m}^3$ )			Action Level ( $\mu\text{g}/\text{m}^3$ )	Limit Level ( $\mu\text{g}/\text{m}^3$ )
			1 <sup>st</sup> Hour	2 <sup>nd</sup> Hour	3 <sup>rd</sup> Hour		
02-Jan-24	Cloudy	8:46 - 11:46	35	31	29	274.2	500
08-Jan-24	Fine	8:47 - 11:47	50	48	59	274.2	500
12-Jan-24	Cloudy	8:43 - 11:43	63	69	60	274.2	500
18-Jan-24	Fine	8:48 - 11:48	63	69	71	274.2	500
24-Jan-24	Cloudy	8:38 - 11:38	77	79	86	274.2	500
30-Jan-24	Cloudy	8:43 - 11:43	62	69	70	274.2	500

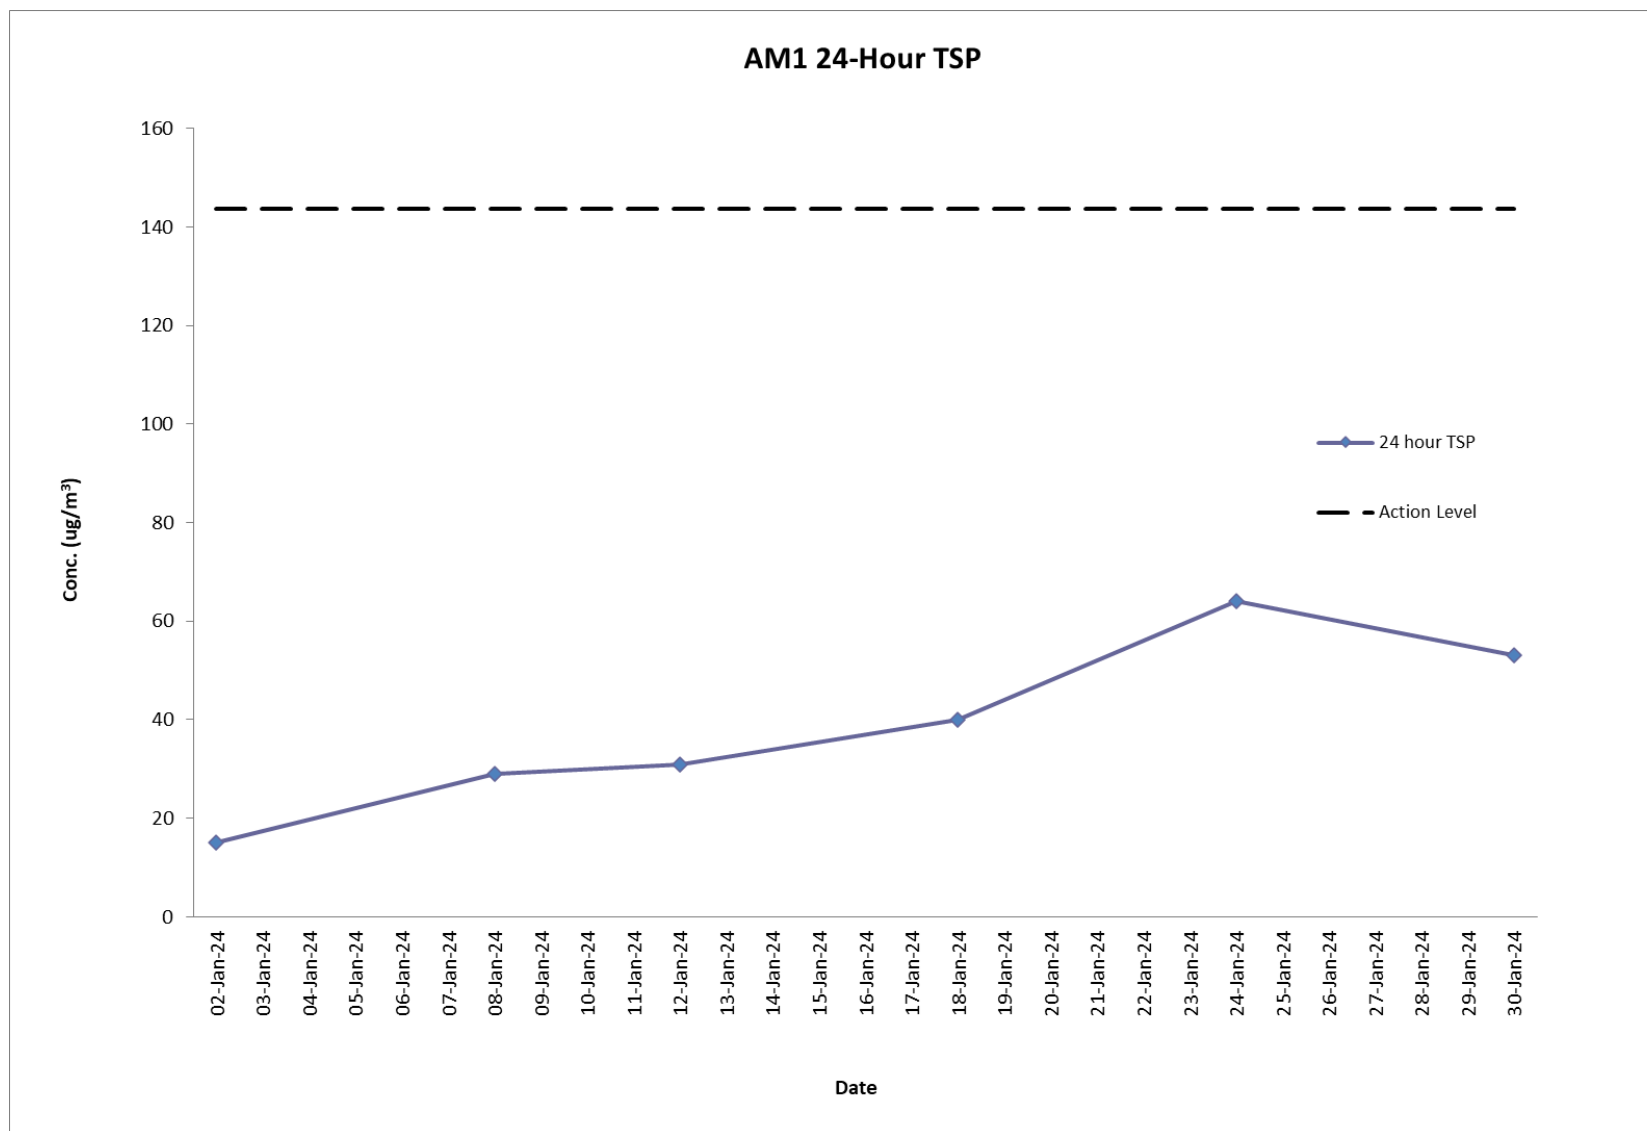
### Graphical Presentation of Air Quality Monitoring Result at Station AM1 (24-hour TSP)

Start		Finish		Filter Weight (g)		Elapsed Time Reading		Sampling Time (hrs)	Flow Rate (m <sup>3</sup> /min)			Conc. (µg/m <sup>3</sup> )	Weather Condition	Action Level	Limit Level
Date	Time	Date	Time	Initial	Final	Initial	Final		Initial	Final	Average				
02-Jan-24	08:29	03-Jan-24	08:29	2.8108	2.8354	27532.38	27556.38	24	1.16	1.16	1.16	15	Cloudy	143.6	260
08-Jan-24	08:30	09-Jan-24	08:30	2.8249	2.8731	27556.38	27580.38	24	1.16	1.16	1.16	29	Fine	143.6	260
12-Jan-24	08:25	13-Jan-24	08:25	2.8106	2.8677	27580.38	27604.38	24	1.26	1.26	1.26	31	Cloudy	143.6	260
18-Jan-24	08:30	19-Jan-24	08:30	2.8136	2.8868	27604.38	27628.38	24	1.26	1.26	1.26	40	Fine	143.6	260
24-Jan-24	08:20	25-Jan-24	08:20	2.8283	2.9451	27628.38	27652.38	24	1.26	1.26	1.26	64	Cloudy	143.6	260
30-Jan-24	08:25	31-Jan-24	08:25	2.8092	2.9060	27652.38	27676.38	24	1.26	1.26	1.26	53	Cloudy	143.6	260

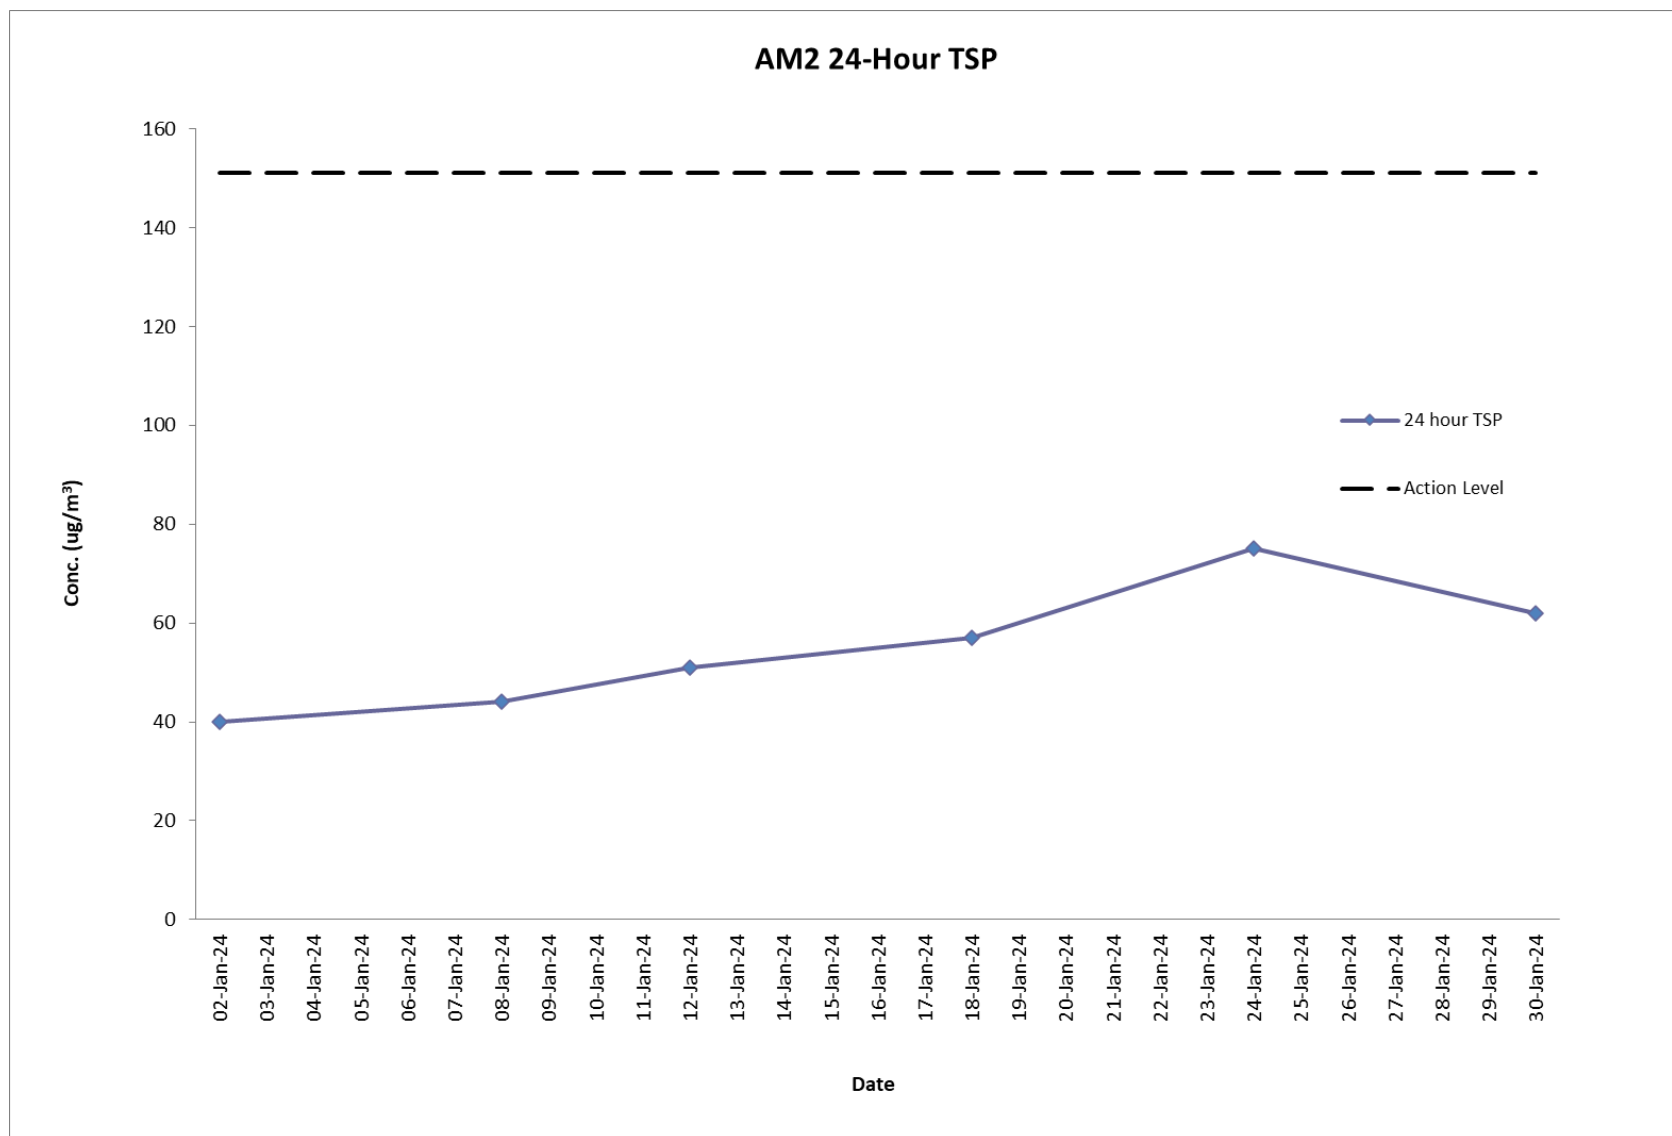
Graphical Presentation of Air Quality Monitoring Result at Station AM2 (24-hour TSP)

Start		Finish		Sampling Time (hrs)	Conc. ( $\mu\text{g}/\text{m}^3$ )	Weather Condition	Action Level	Limit Level
Date	Time	Date	Time					
02-Jan-24	08:43	03-Jan-24	08:43	24	40	Cloudy	151.1	260
08-Jan-24	08:44	09-Jan-24	08:44	24	44	Fine	151.1	260
12-Jan-24	08:40	13-Jan-24	08:40	24	51	Cloudy	151.1	260
18-Jan-24	08:45	19-Jan-24	08:45	24	57	Fine	151.1	260
24-Jan-24	08:35	25-Jan-24	08:35	24	75	Cloudy	151.1	260
30-Jan-24	08:40	31-Jan-24	08:40	24	62	Cloudy	151.1	260

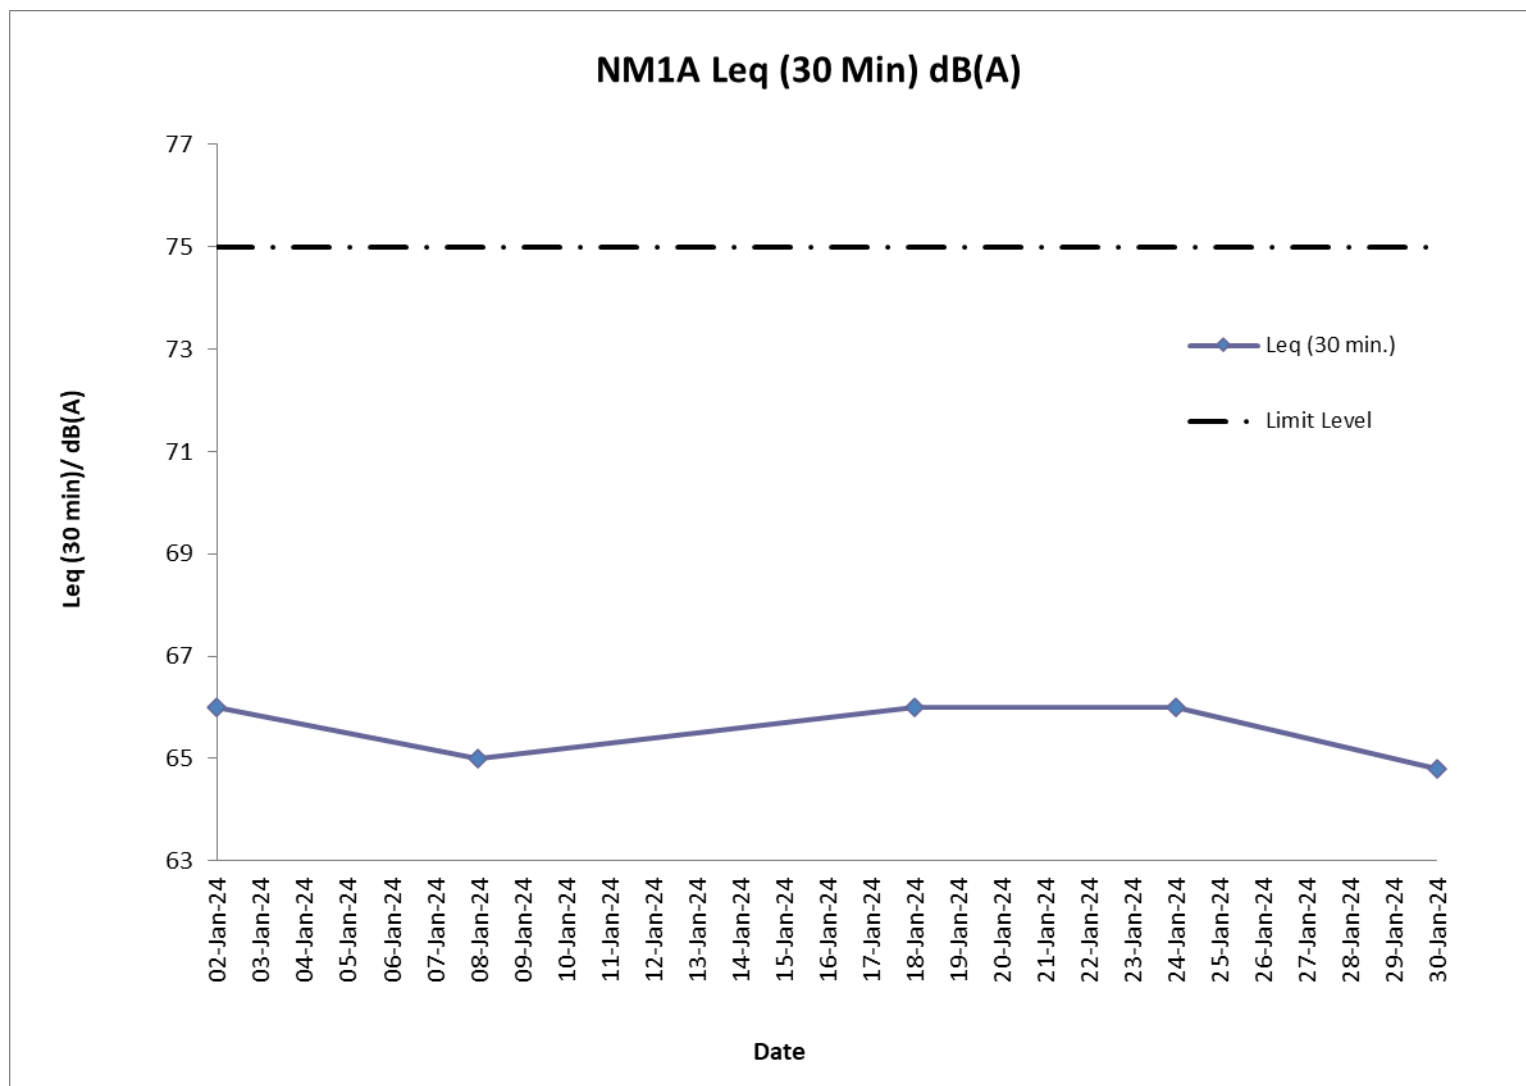
### Graphical Presentation Noise Monitoring Result at Station NM1A

Date	Time	Measured L <sub>10</sub> , dB(A)	Measured L <sub>90</sub> , dB(A)	L <sub>eq</sub> (30 min.)*, dB(A)
02-Jan-24	09:30	65.7	61.8	66
02-Jan-24	09:35	64.5	60.4	
02-Jan-24	09:40	65.3	61.7	
02-Jan-24	09:45	64.2	60.5	
02-Jan-24	09:50	64.0	60.4	
02-Jan-24	09:55	64.9	60.0	
08-Jan-24	09:30	64.9	60.9	65
08-Jan-24	09:35	63.7	59.6	
08-Jan-24	09:40	64.4	60.5	
08-Jan-24	09:45	65.2	61.4	
08-Jan-24	09:50	63.0	59.3	
08-Jan-24	09:55	64.4	60.0	
18-Jan-24	09:31	65.7	61.8	66
18-Jan-24	09:36	64.9	60.7	
18-Jan-24	09:41	64.4	60.3	
18-Jan-24	09:46	65.2	61.5	
18-Jan-24	09:51	64.0	60.4	
18-Jan-24	09:56	64.6	60.0	
24-Jan-24	09:21	64.8	60.9	66
24-Jan-24	09:26	65.6	61.5	
24-Jan-24	09:31	64.4	60.7	
24-Jan-24	09:36	64.2	60.2	
24-Jan-24	09:41	63.0	59.4	
24-Jan-24	09:46	64.7	60.0	
30-Jan-24	09:26	64.6	60.5	65
30-Jan-24	09:31	63.4	59.8	
30-Jan-24	09:36	64.8	58.9	
30-Jan-24	09:41	62.2	58.6	
30-Jan-24	09:46	63.0	59.4	
30-Jan-24	09:51	64.7	60.0

The station set-up of a free-field measurement at Station NM1A.

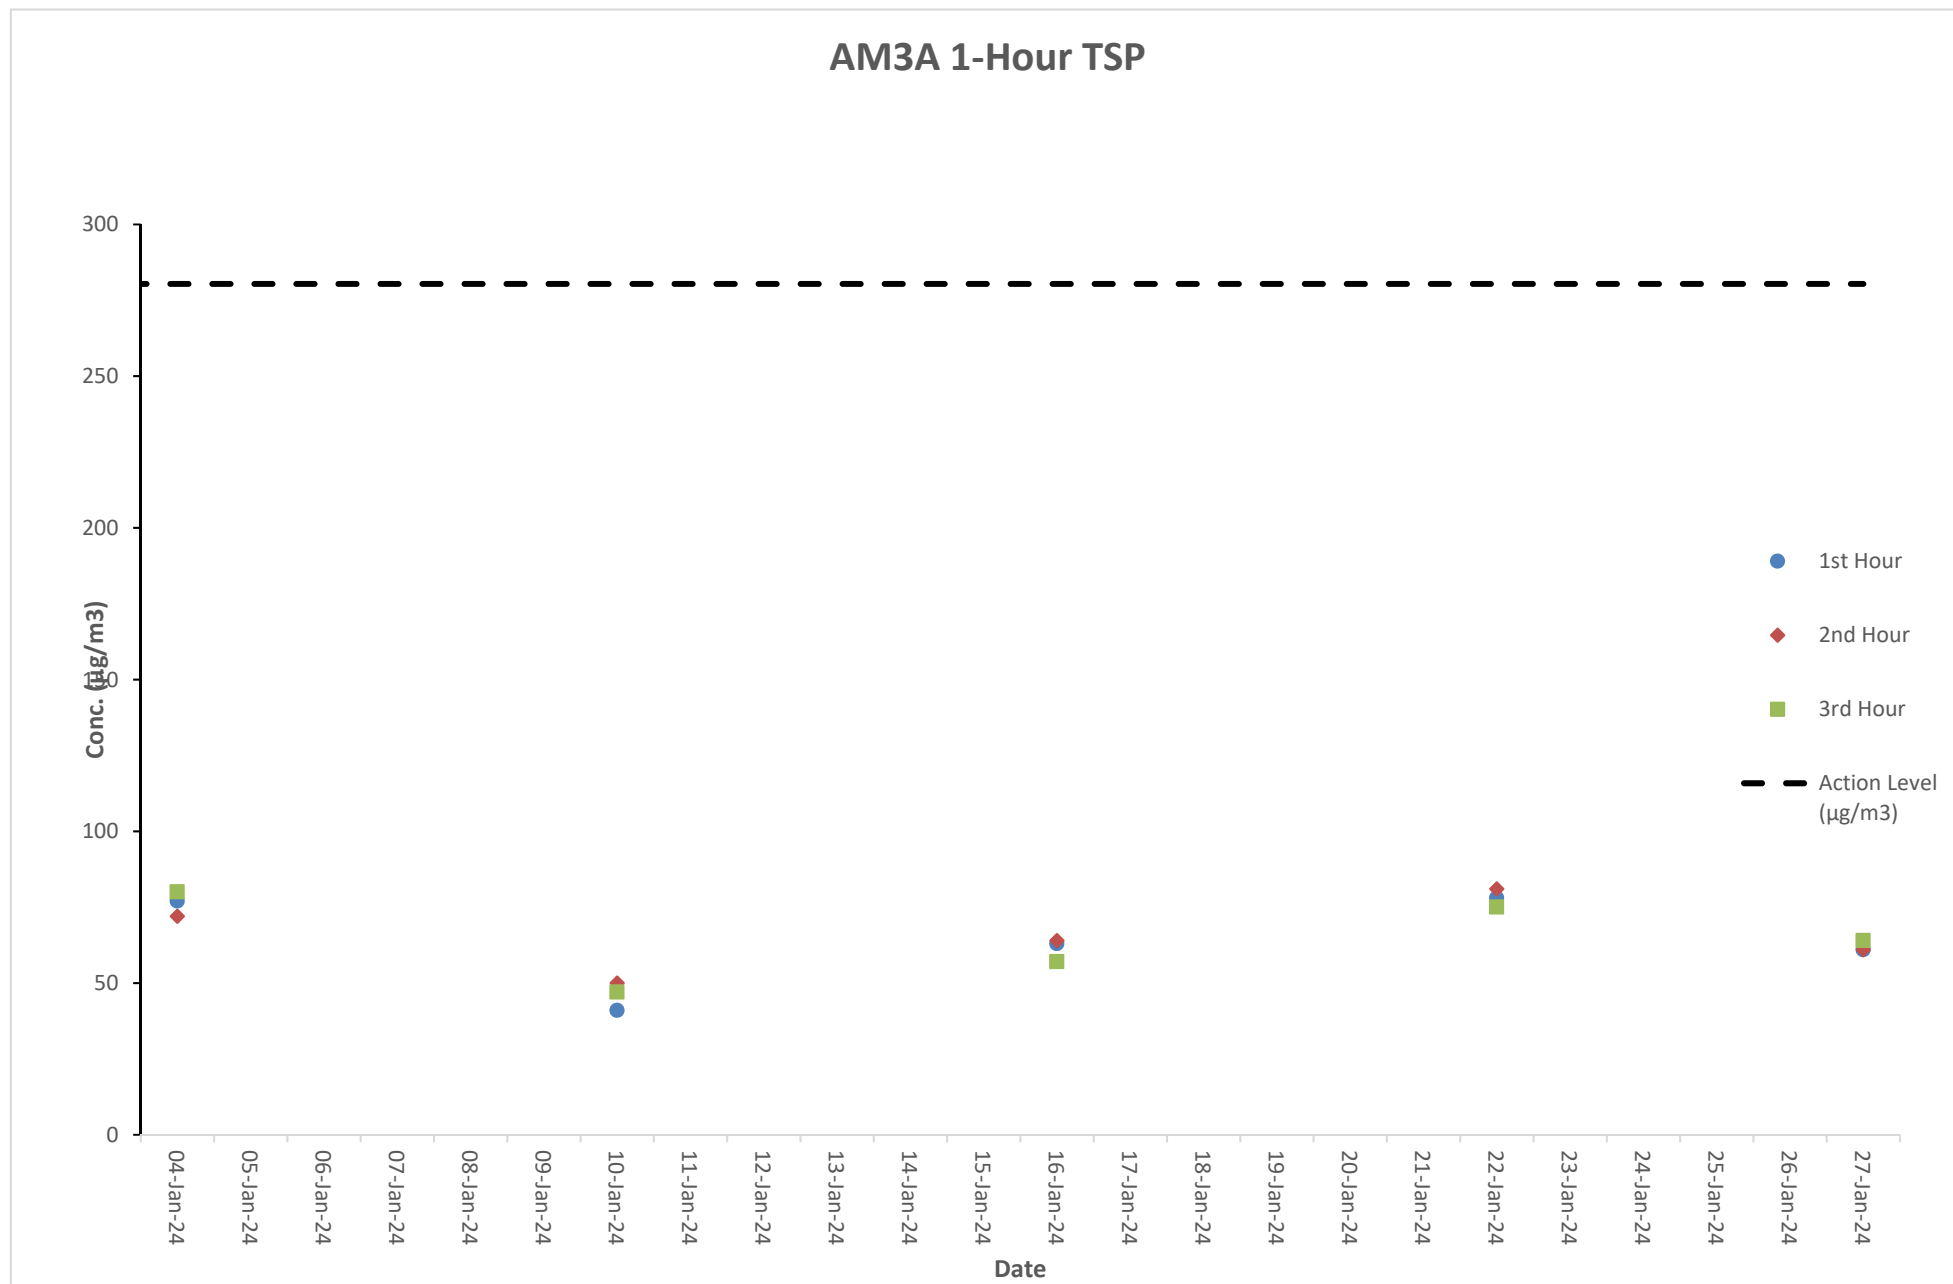
# Graphical Presentation of Air Quality Monitoring Result at Station AM3A (1-hour TSP)

Date	Weather Condition	Time		Conc. ( $\mu\text{g}/\text{m}^3$ )			Action Level	Limit Level
		Start	Finish	1st Hour	2nd Hour	3rd Hour		
04-Jan-24	Fine	14:09	17:09	77	72	80	280.4	500
10-Jan-24	Fine	8:01	11:01	41	50	47	280.4	500
16-Jan-24	Fine	14:06	17:06	63	64	57	280.4	500
22-Jan-24	Cloudy	8:03	11:03	78	81	75	280.4	500
27-Jan-24	Cloudy	14:01	17:01	61	61	64	280.4	500

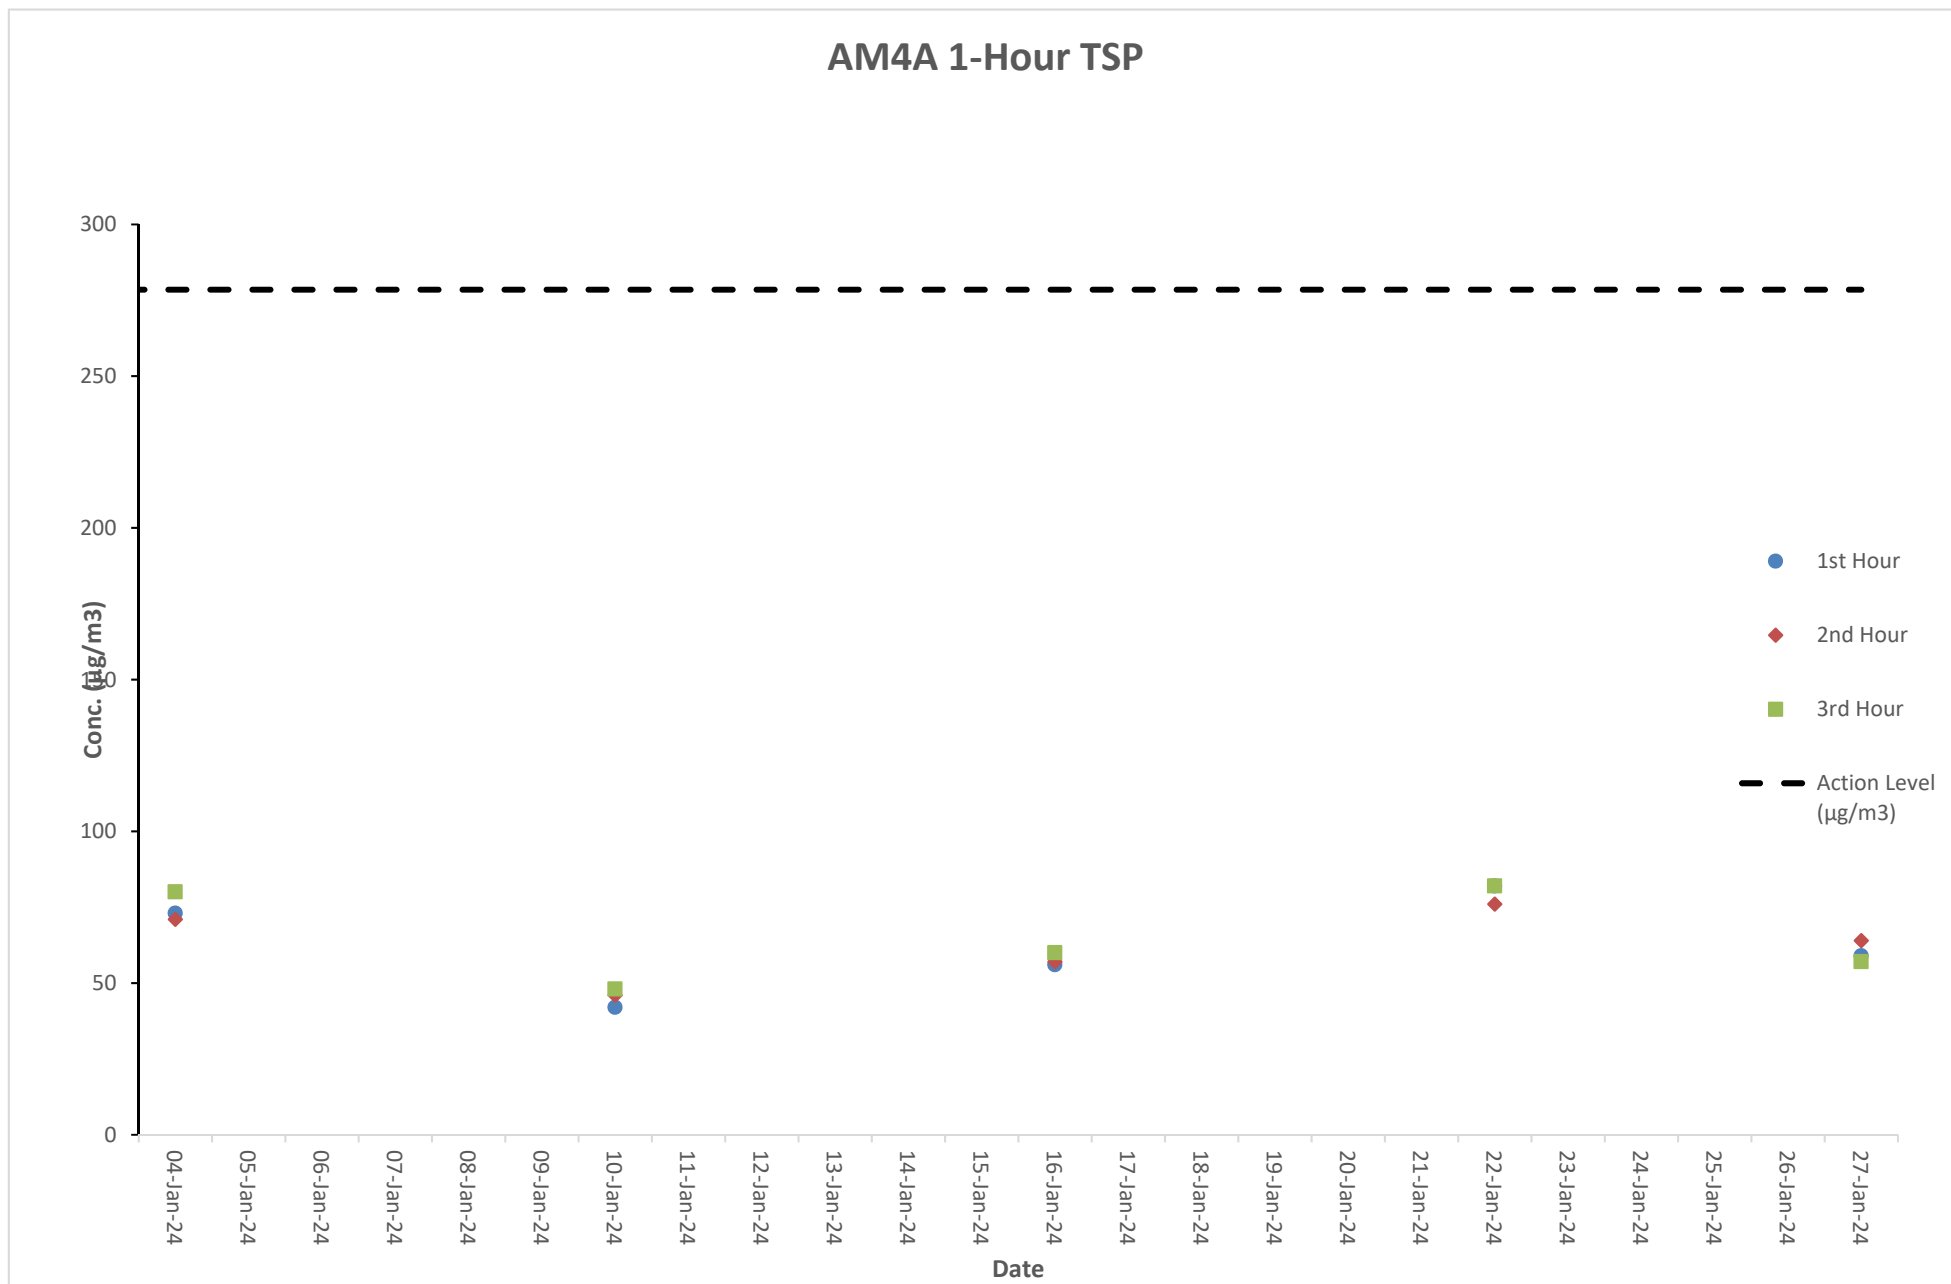
# Graphical Presentation of Air Quality Monitoring Result at Station AM4A (1-hour TSP)

Date	Weather Condition	Time		Conc. ( $\mu\text{g}/\text{m}^3$ )			Action Level	Limit Level
		Start	Finish	1st Hour	2nd Hour	3rd Hour		
04-Jan-24	Fine	14:17	17:17	73	71	80	278.5	500
10-Jan-24	Fine	8:09	11:09	42	46	48	278.5	500
16-Jan-24	Fine	14:14	17:14	56	57	60	278.5	500
22-Jan-24	Cloudy	8:11	11:11	82	76	82	278.5	500
27-Jan-24	Cloudy	14:09	17:09	59	64	57	278.5	500

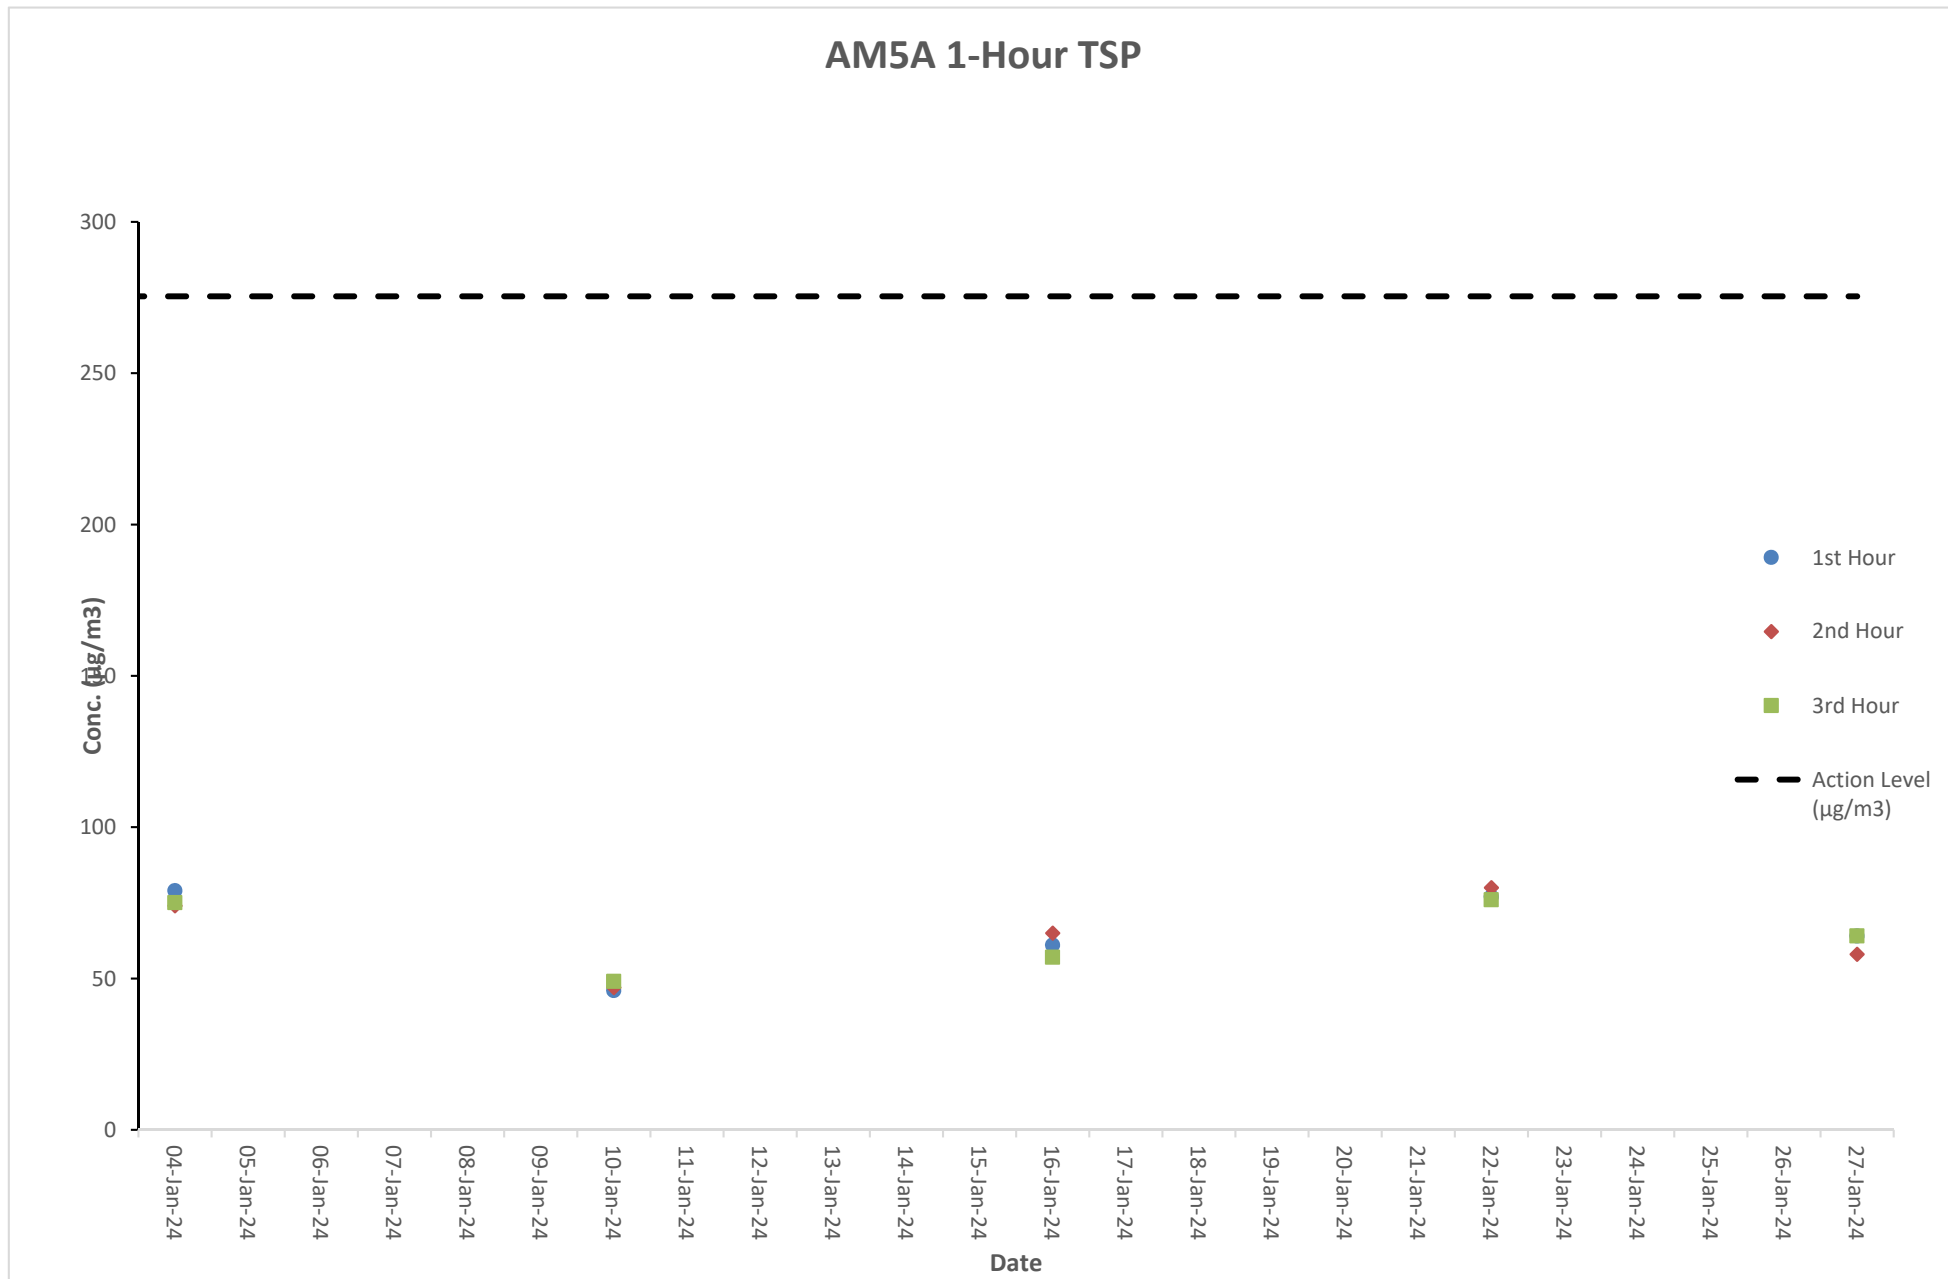
# Graphical Presentation of Air Quality Monitoring Result at Station AM5A (1-hour TSP)

Date	Weather Condition	Time		Conc. ( $\mu\text{g}/\text{m}^3$ )			Action Level	Limit Level
		Start	Finish	1st Hour	2nd Hour	3rd Hour		
04-Jan-24	Fine	14:32	17:32	79	74	75	275.4	500
10-Jan-24	Fine	8:26	11:26	46	47	49	275.4	500
16-Jan-24	Fine	14:29	17:29	61	65	57	275.4	500
22-Jan-24	Cloudy	8:28	11:28	77	80	76	275.4	500
27-Jan-24	Cloudy	14:24	17:24	64	58	64	275.4	500

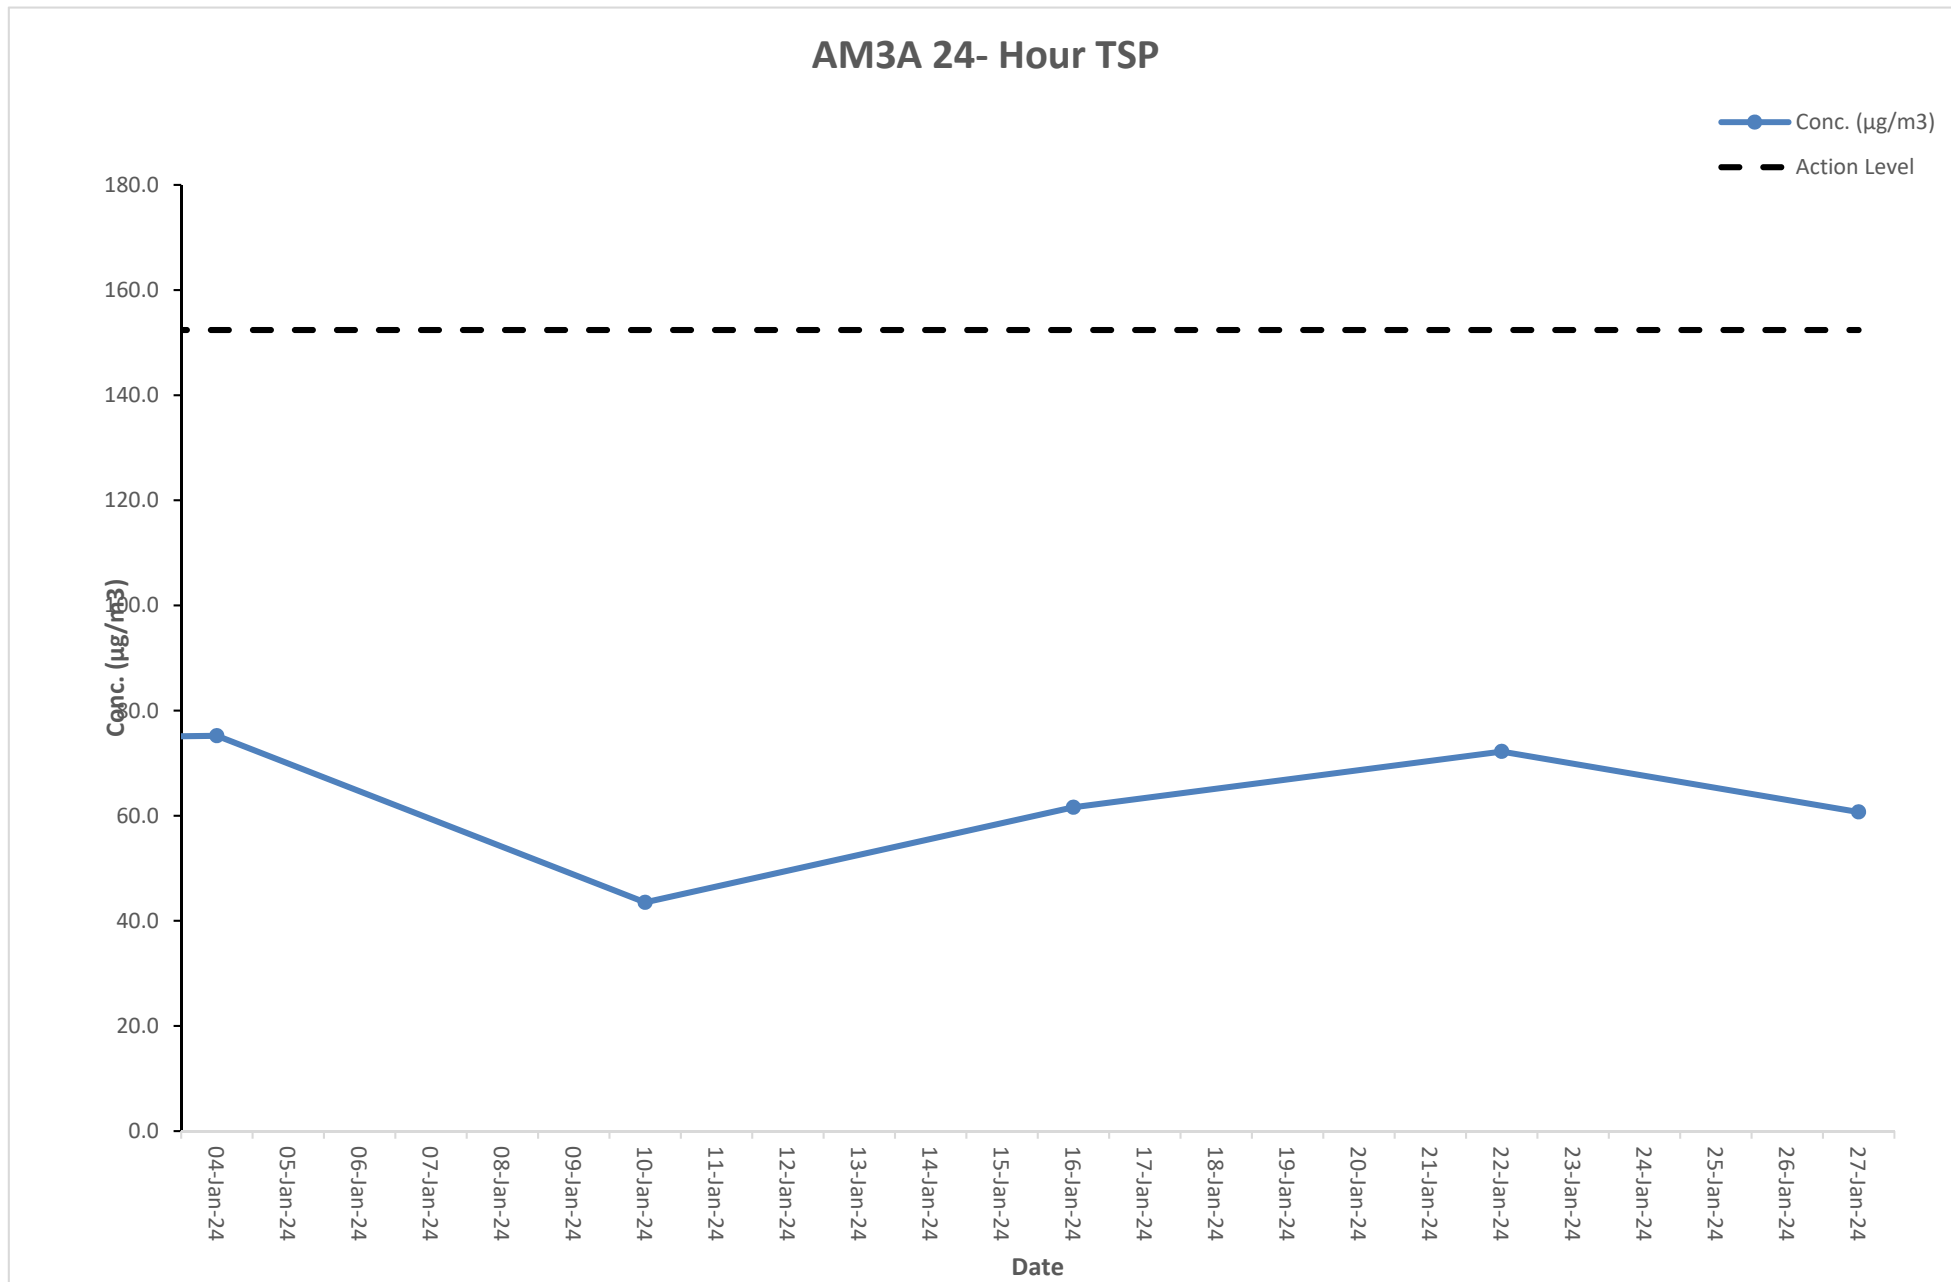
# Graphical Presentation of Air Quality Monitoring Result at Station AM3A (24-hour TSP)

Start		Finish		Filter Weight (g)		Elapsed Time Reading		Sampling Time (hrs)	Flow Rate (m <sup>3</sup> /min)			Conc. (µg/m <sup>3</sup> )	Weather Condition	Action Level	Limit Level
Date	Time	Date	Time	Initial	Final	Initial	Final		Initial	Final	Average				
04-Jan-24	10:00AM	05-Jan-24	10:00AM	2.8012	2.9223	6180.8	6204.8	24	1.12	1.12	1.12	75.2	Sunny	152.4	260
10-Jan-24	10:00AM	11-Jan-24	10:00AM	2.8027	2.8728	6204.8	6228.8	24	1.12	1.12	1.12	43.5	Sunny	152.4	260
16-Jan-24	10:00AM	17-Jan-24	10:00AM	2.8013	2.9004	6228.8	6252.8	24	1.12	1.12	1.12	61.6	Cloudy	152.4	260
22-Jan-24	10:00AM	23-Jan-24	10:00AM	2.8042	2.9205	6252.8	6276.8	24	1.12	1.12	1.12	72.2	Rainy	152.4	260
27-Jan-24	10:00AM	28-Jan-24	10:00AM	2.8027	2.9004	6276.8	6300.8	24	1.12	1.12	1.12	60.7	Rainy	152.4	260
