# Development at West Kowloon Cultural District

Monthly Environmental Monitoring and Audit (EM&A) Report  
for January 2024

**Part-1: EM&A at Lyric Theatre Complex**

**Part-2: EM&A for Foundation Works in  
Zone 2B & 2C**

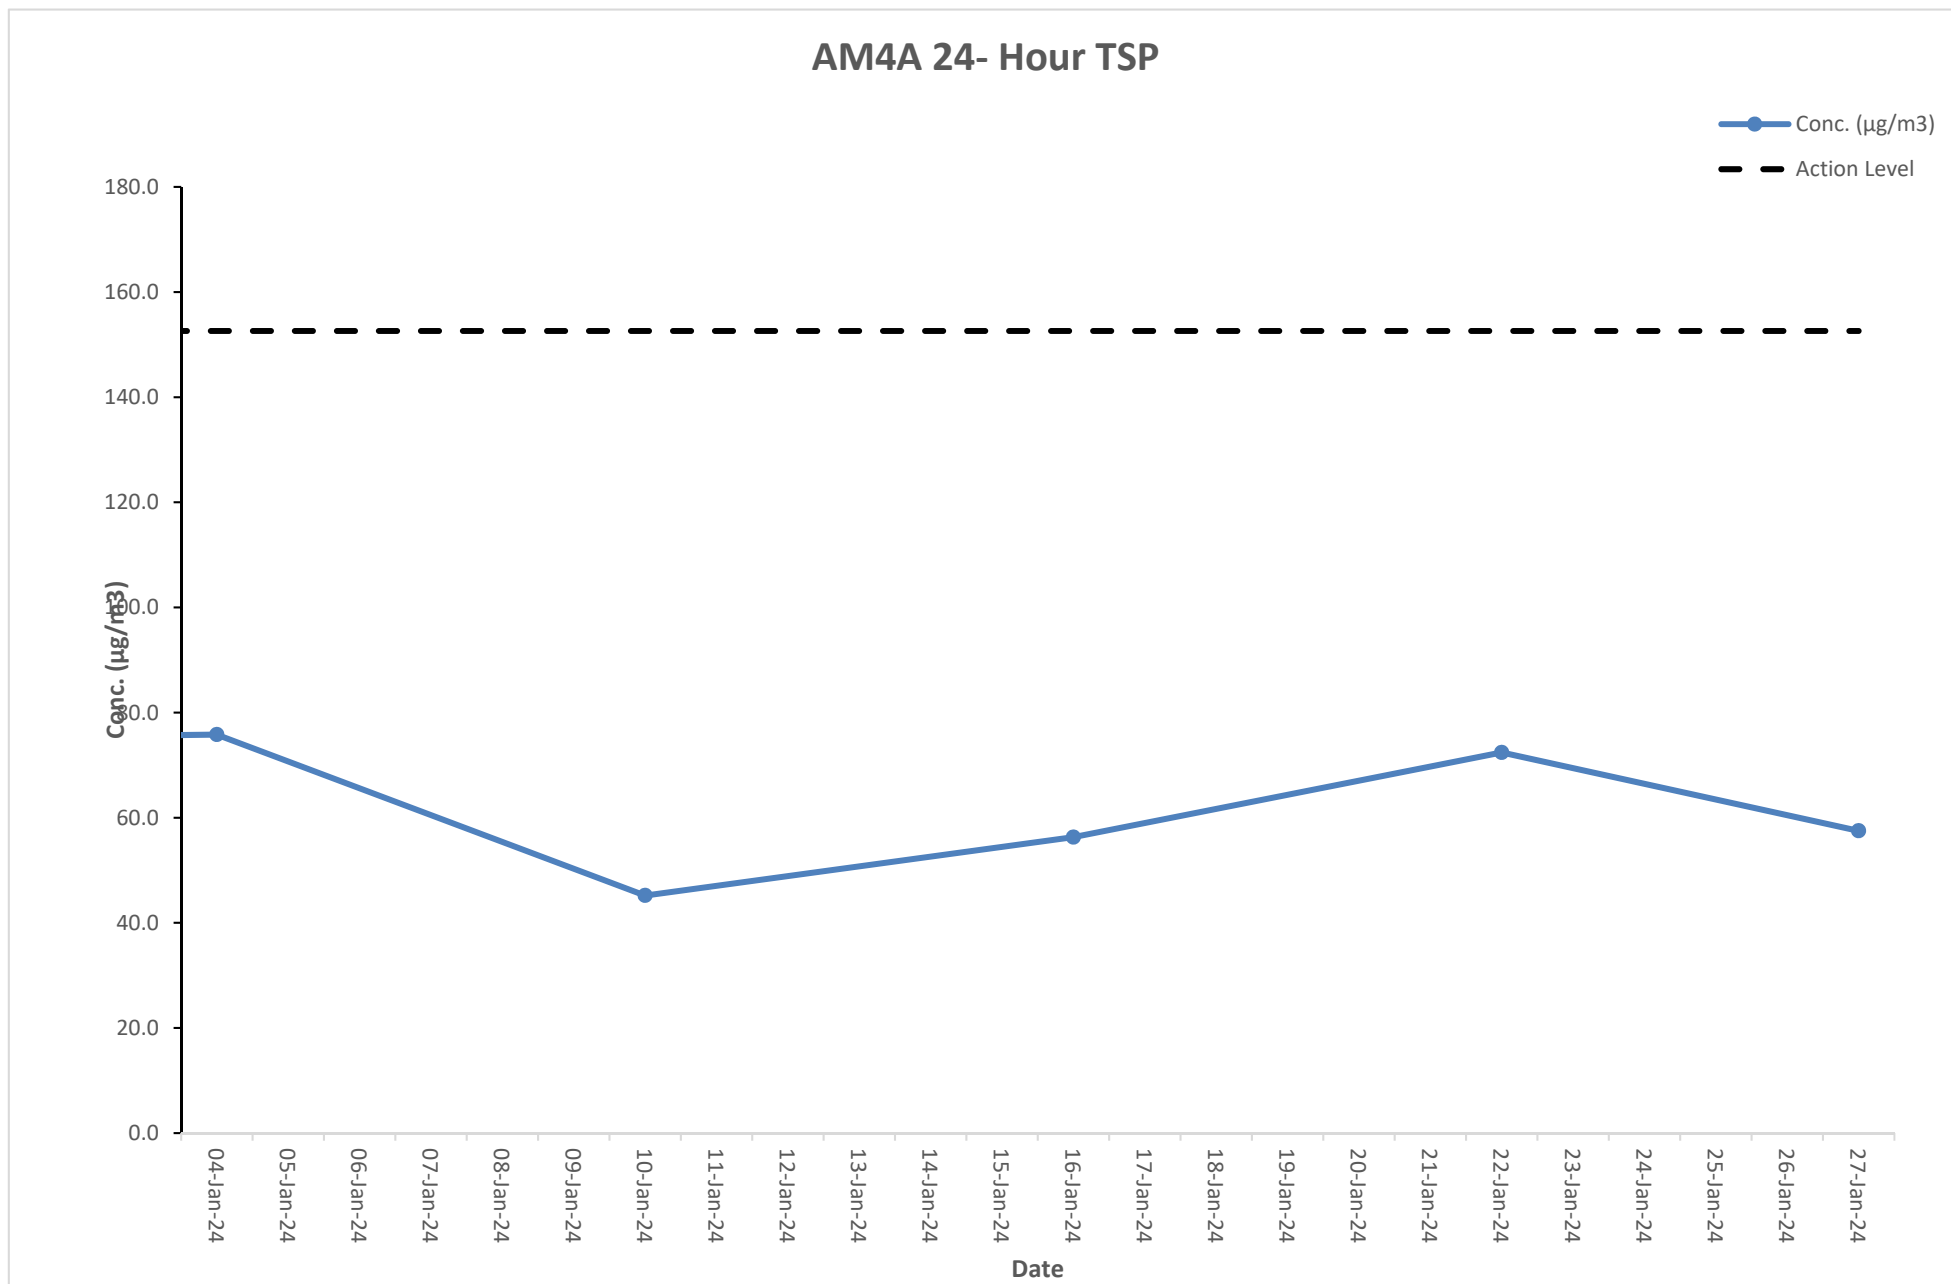
# Graphical Presentation of Air Quality Monitoring Result at Station AM4A (24-hour TSP)

Start		Finish		Filter Weight (g)		Elapsed Time Reading		Sampling Time (hrs)	Flow Rate (m <sup>3</sup> /min)			Conc. (µg/m3)	Weather Condition	Action Level	Limit Level
Date	Time	Date	Time	Initial	Final	Initial	Final		Initial	Final	Average				
04-Jan-24	10:00AM	05-Jan-24	10:00AM	2.8012	2.9233	6600.4	6624.4	24	1.12	1.12	1.12	75.8	Sunny	152.6	260
10-Jan-24	10:00AM	11-Jan-24	10:00AM	2.8028	2.8756	6624.4	6648.4	24	1.12	1.12	1.12	45.2	Sunny	152.6	260
16-Jan-24	10:00AM	17-Jan-24	10:00AM	2.8060	2.8965	6648.4	6672.4	24	1.12	1.12	1.12	56.3	Cloudy	152.6	260
22-Jan-24	10:00AM	23-Jan-24	10:00AM	2.8081	2.9246	6672.4	6696.4	24	1.12	1.12	1.12	72.4	Rainy	152.6	260
27-Jan-24	10:00AM	28-Jan-24	10:00AM	2.8034	2.8959	6696.4	6720.4	24	1.12	1.12	1.12	57.5	Rainy	152.6	260

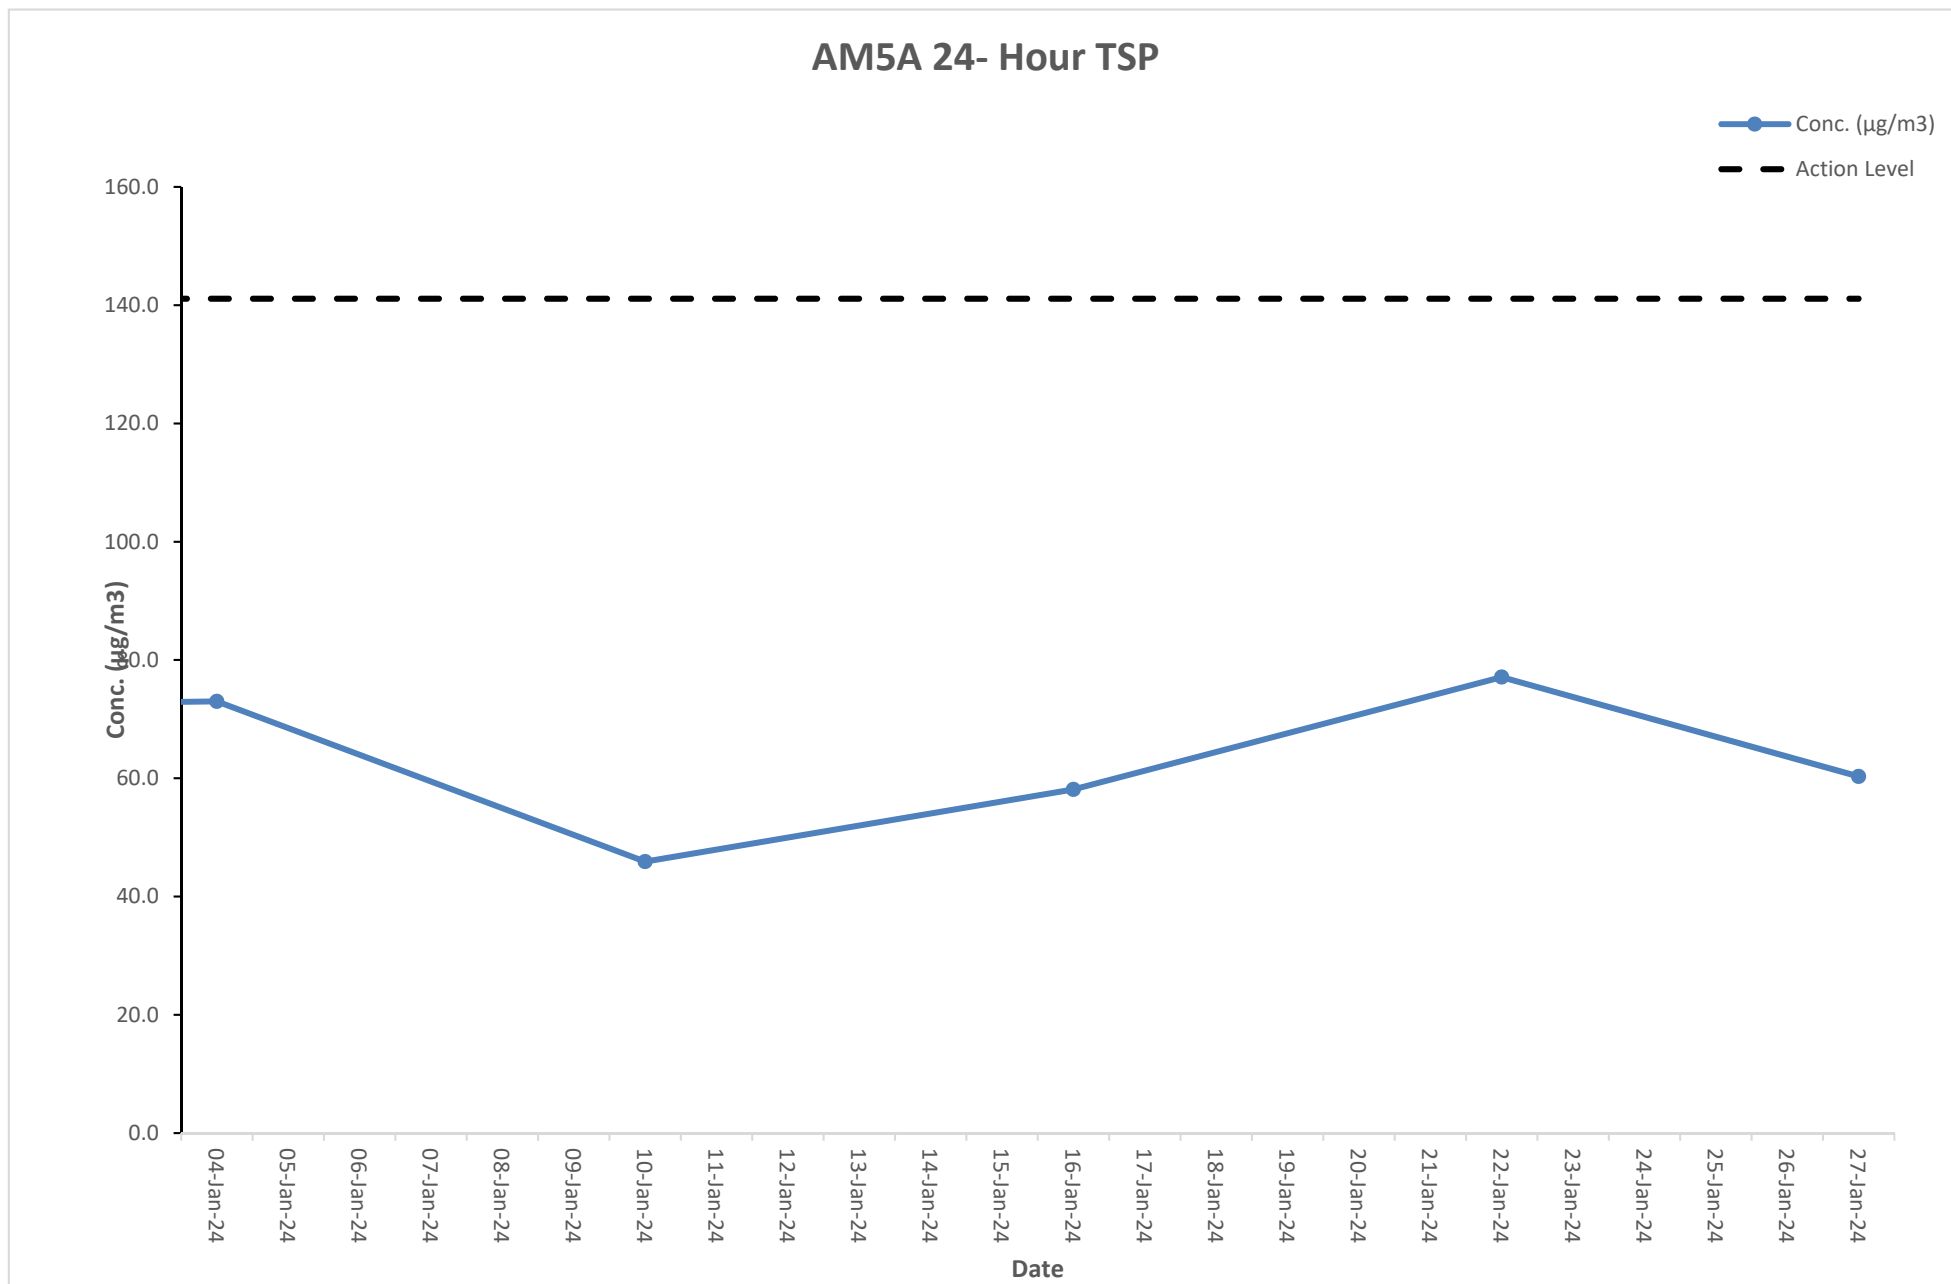
# Graphical Presentation of Air Quality Monitoring Result at Station AM5A (24-hour TSP)

Start		Finish		Filter Weight (g)		Elapsed Time Reading		Sampling Time (hrs)	Flow Rate (m <sup>3</sup> /min)			Conc. (µg/m <sup>3</sup> )	Weather Condition	Action Level	Limit Level
Date	Time	Date	Time	Initial	Final	Initial	Final		Initial	Final	Average				
04-Jan-24	10:00AM	05-Jan-24	10:00AM	2.8076	2.9250	6738.6	6762.6	24	1.12	1.12	1.12	73.0	Sunny	141.1	260
10-Jan-24	10:00AM	11-Jan-24	10:00AM	2.8020	2.8758	6762.6	6786.6	24	1.12	1.12	1.12	45.9	Sunny	141.1	260
16-Jan-24	10:00AM	17-Jan-24	10:00AM	2.8017	2.8952	6786.6	6810.6	24	1.12	1.12	1.12	58.1	Cloudy	141.1	260
22-Jan-24	10:00AM	23-Jan-24	10:00AM	2.8065	2.9306	6810.6	6834.6	24	1.12	1.12	1.12	77.1	Rainy	141.1	260
27-Jan-24	10:00AM	28-Jan-24	10:00AM	2.8069	2.9040	6834.6	6858.6	24	1.12	1.12	1.12	60.3	Rainy	141.1	260

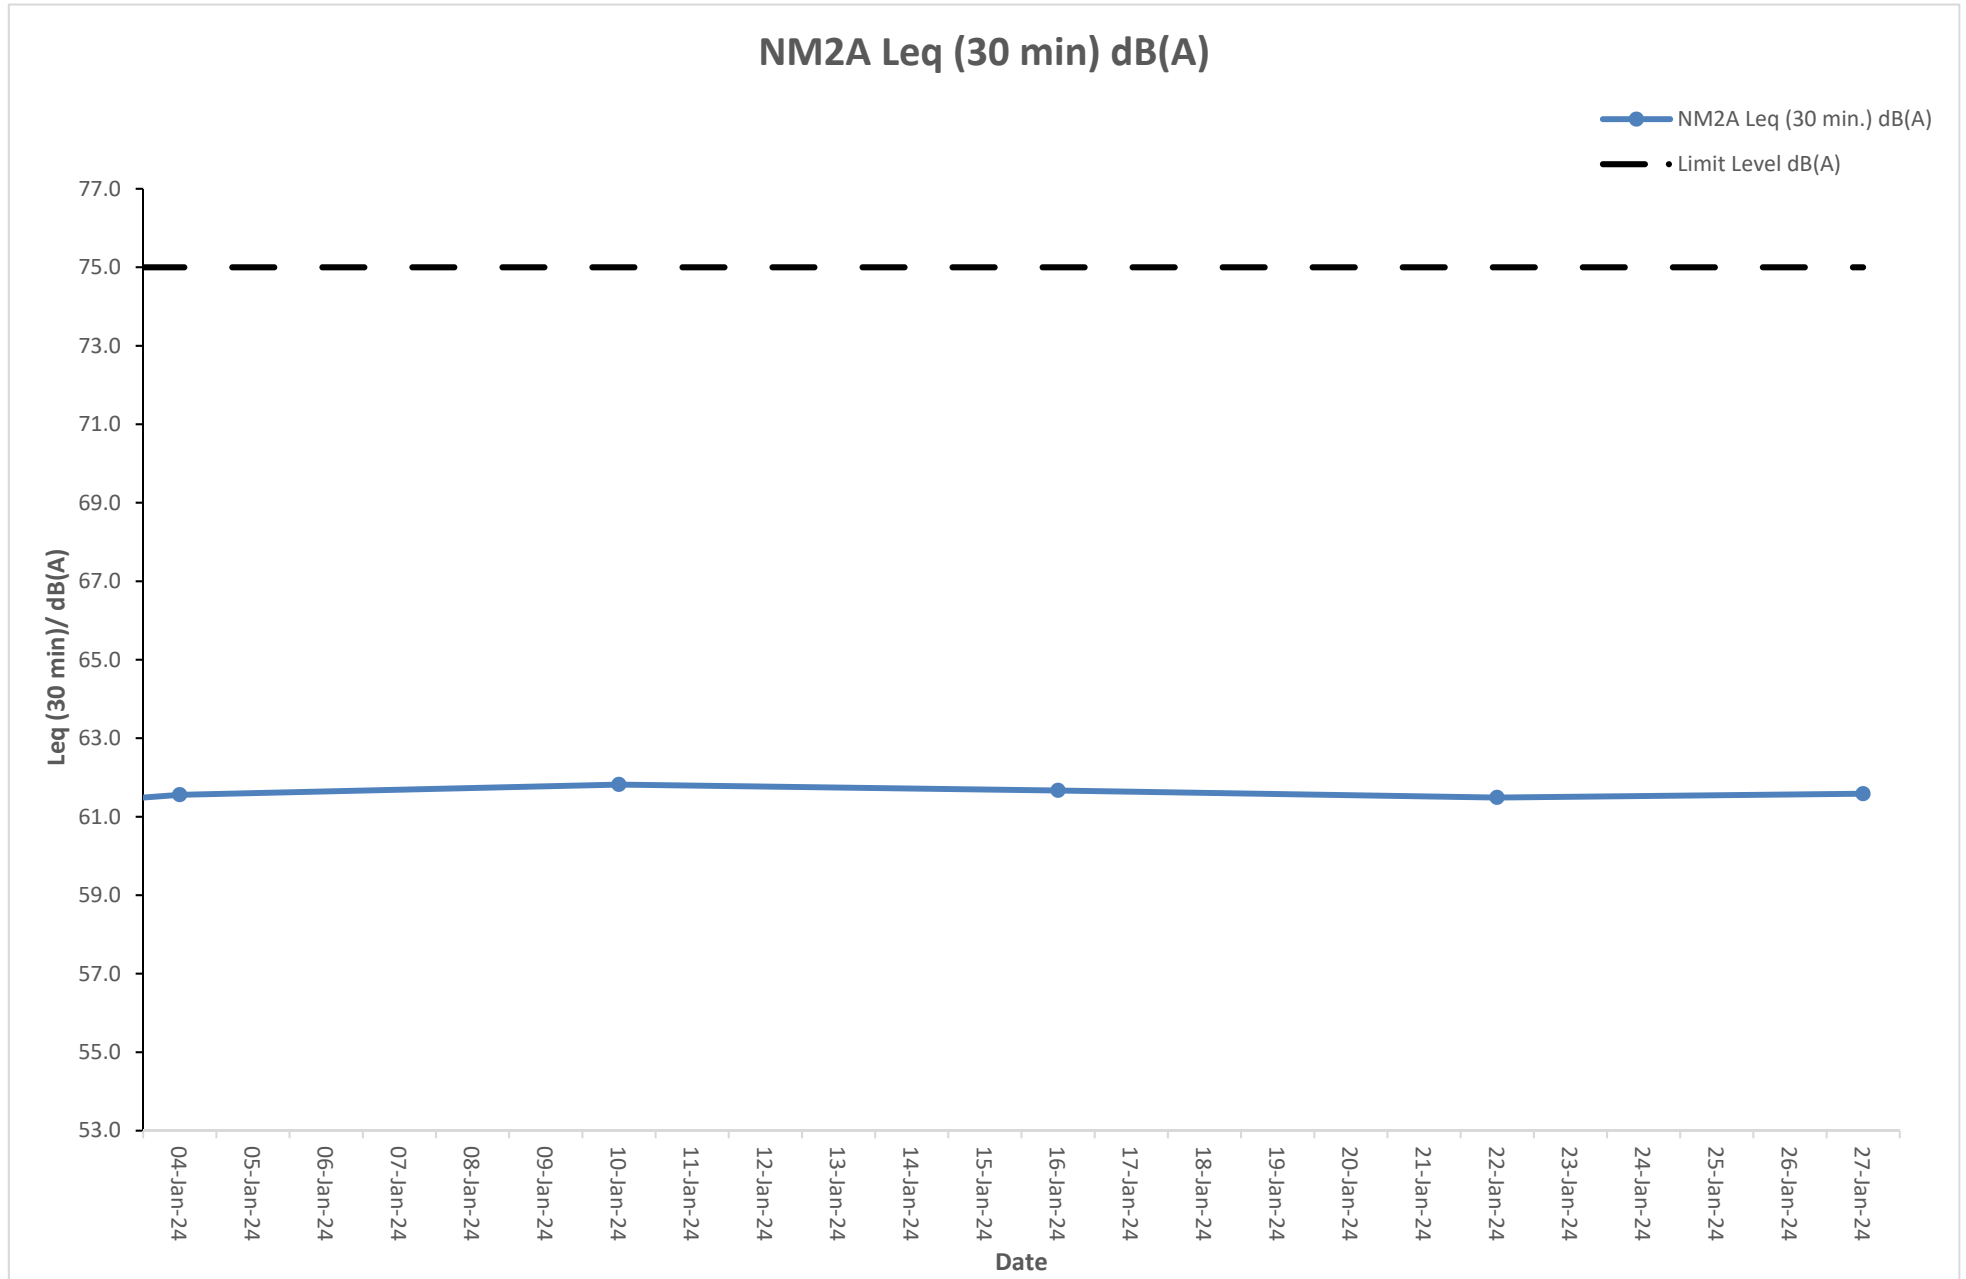
# Graphical Presentation of Noise Monitoring Result at Station NM2A

Date	Time	Measured L10 dB(A)	Measured L90 dB(A)	Leq (30 min.) dB(A)
04-Jan-24	14:39	62.6	60.1	61.6
04-Jan-24	14:44	62.8	59.4	
04-Jan-24	14:49	62.8	59.4	
04-Jan-24	14:54	63.5	60.1	
04-Jan-24	14:59	63.2	59.5	
04-Jan-24	15:04	62.8	60.2	
10-Jan-24	8:31	63.7	59.6	61.8
10-Jan-24	8:36	63.2	59.3	
10-Jan-24	8:41	63.5	60.0	
10-Jan-24	8:46	62.6	60.0	
10-Jan-24	8:51	63.6	59.4	
10-Jan-24	8:56	63.5	59.7	
16-Jan-24	14:36	62.7	60.6	61.7
16-Jan-24	14:41	64.0	60.2	
16-Jan-24	14:46	62.7	60.2	
16-Jan-24	14:51	63.1	59.9	
16-Jan-24	14:56	63.1	60.2	
16-Jan-24	15:01	63.1	59.8	
22-Jan-24	8:33	63.0	59.6	61.5
22-Jan-24	8:38	62.6	60.4	
22-Jan-24	8:43	63.8	59.2	
22-Jan-24	8:48	63.3	60.2	
22-Jan-24	8:53	63.0	60.2	
22-Jan-24	8:58	63.2	60.6	
27-Jan-24	14:31	62.7	59.4	61.6
27-Jan-24	14:36	62.8	60.0	
27-Jan-24	14:41	63.2	59.4	
27-Jan-24	14:46	64.0	59.4	
27-Jan-24	14:51	63.4	59.3	
27-Jan-24	14:56	64.0	60.3

The station set-up of a façade measurement at station NM2A.

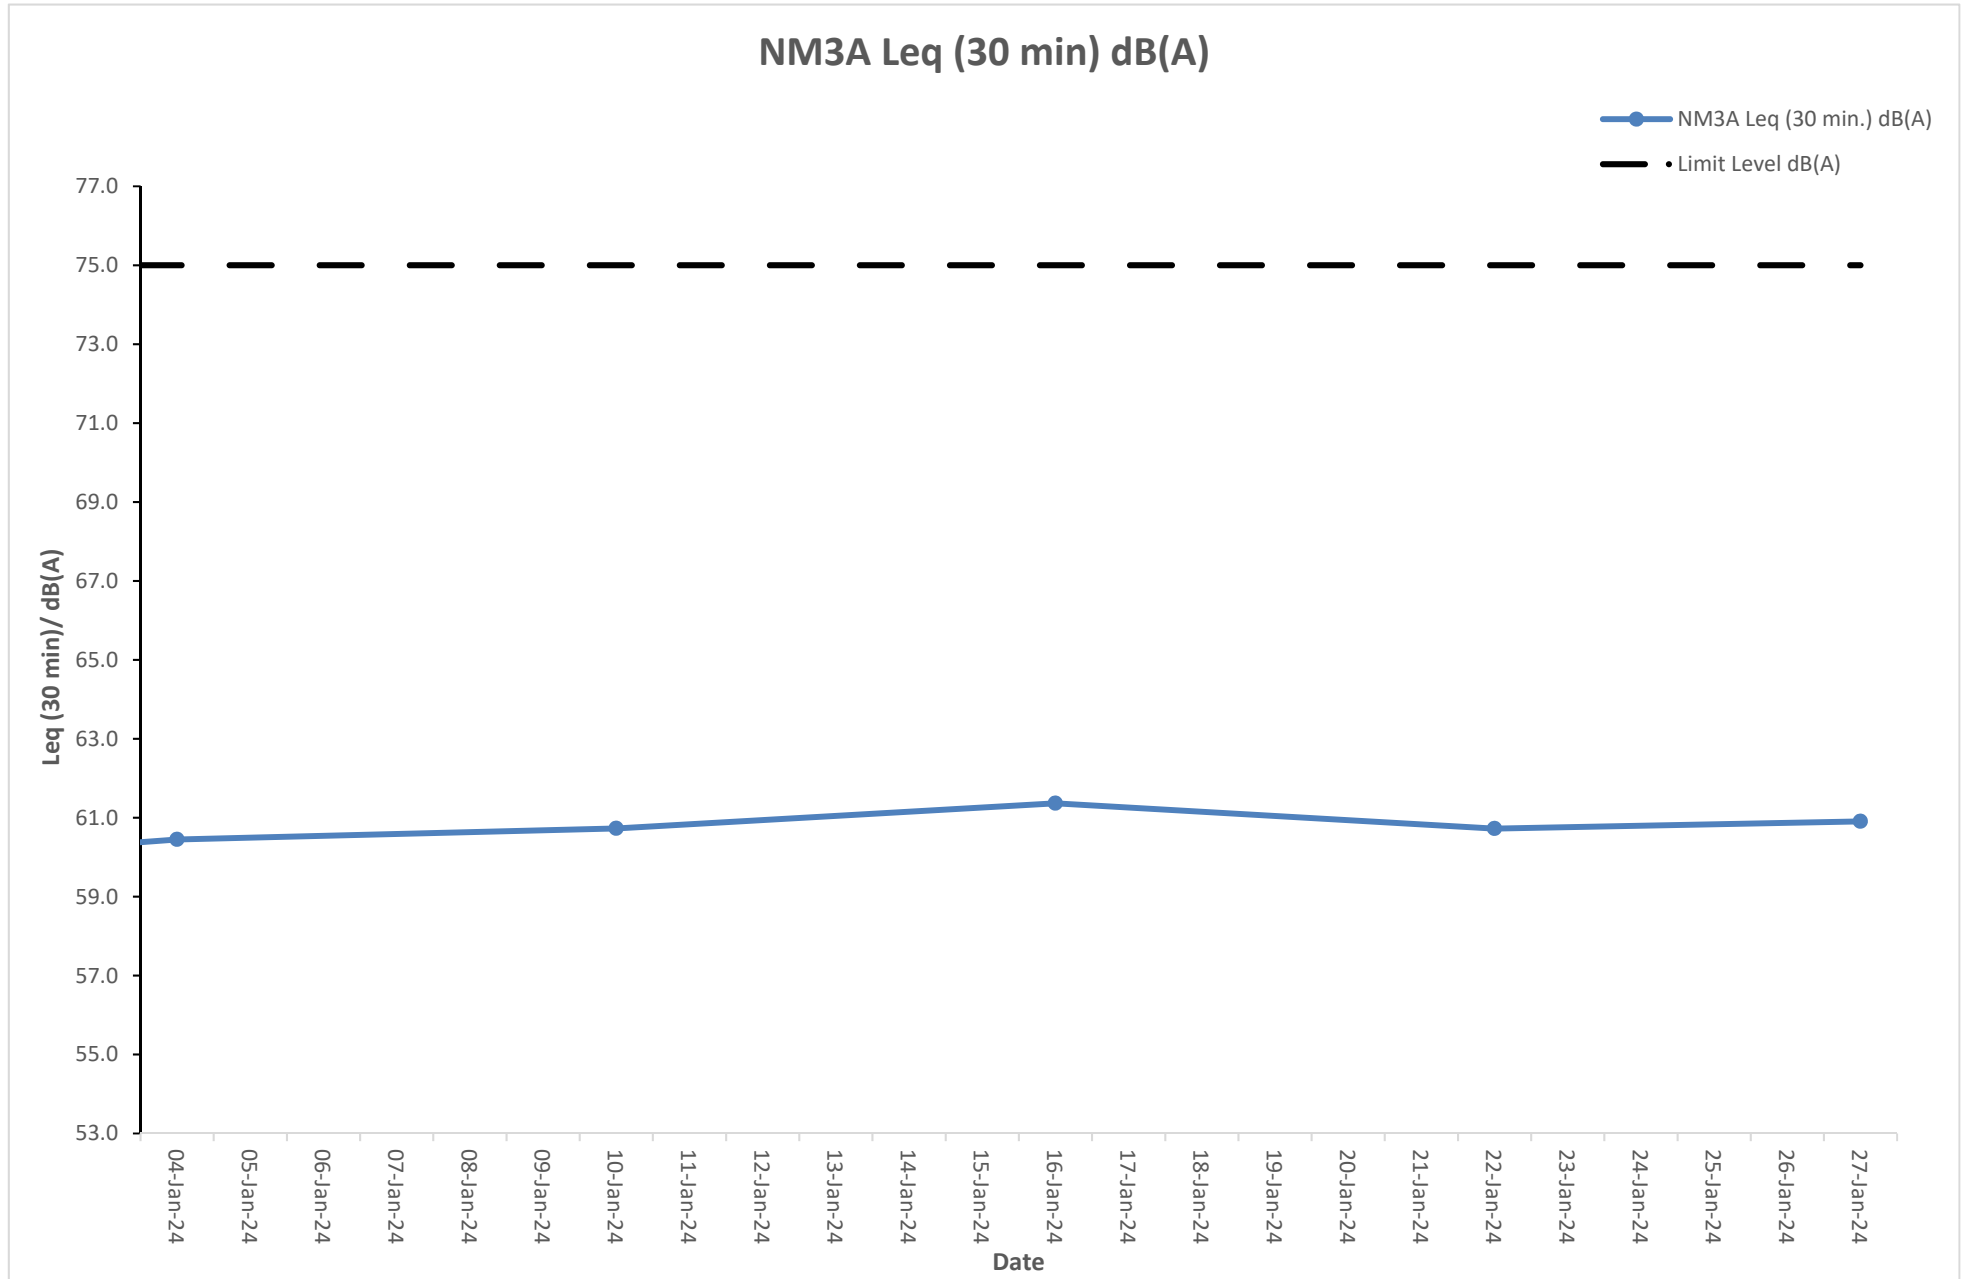
# Graphical Presentation of Noise Monitoring Result at Station NM3A

Date	Time	Measured L10 dB(A)	Measured L90 dB(A)	Leq (30 min.) dB(A)
04-Jan-24	16:09	62.2	57.8	60.5
04-Jan-24	16:14	62.5	56.3	
04-Jan-24	16:19	62.5	56.7	
04-Jan-24	16:24	62.8	56.6	
04-Jan-24	16:29	63.4	55.9	
04-Jan-24	16:34	61.9	56.1	
10-Jan-24	10:04	63.5	56.1	60.7
10-Jan-24	10:09	62.8	56.2	
10-Jan-24	10:14	62.6	57.2	
10-Jan-24	10:19	63.2	56.8	
10-Jan-24	10:24	61.9	55.9	
10-Jan-24	10:29	63.8	57.5	
16-Jan-24	16:06	63.8	57.2	61.4
16-Jan-24	16:11	63.7	56.5	
16-Jan-24	16:16	63.2	56.9	
16-Jan-24	16:21	63.7	57.8	
16-Jan-24	16:26	62.0	57.0	
16-Jan-24	16:31	63.4	56.1	
22-Jan-24	10:06	62.3	56.3	60.7
22-Jan-24	10:11	63.7	56.6	
22-Jan-24	10:16	63.6	57.5	
22-Jan-24	10:21	63.6	55.9	
22-Jan-24	10:26	62.3	56.4	
22-Jan-24	10:31	63.7	56.7	
27-Jan-24	16:01	63.0	57.1	60.9
27-Jan-24	16:06	62.6	57.6	
27-Jan-24	16:11	62.8	57.7	
27-Jan-24	16:16	62.1	56.0	
27-Jan-24	16:21	63.6	56.9	
27-Jan-24	16:26	62.6	57.0

The station set-up of a façade measurement at station NM3A.

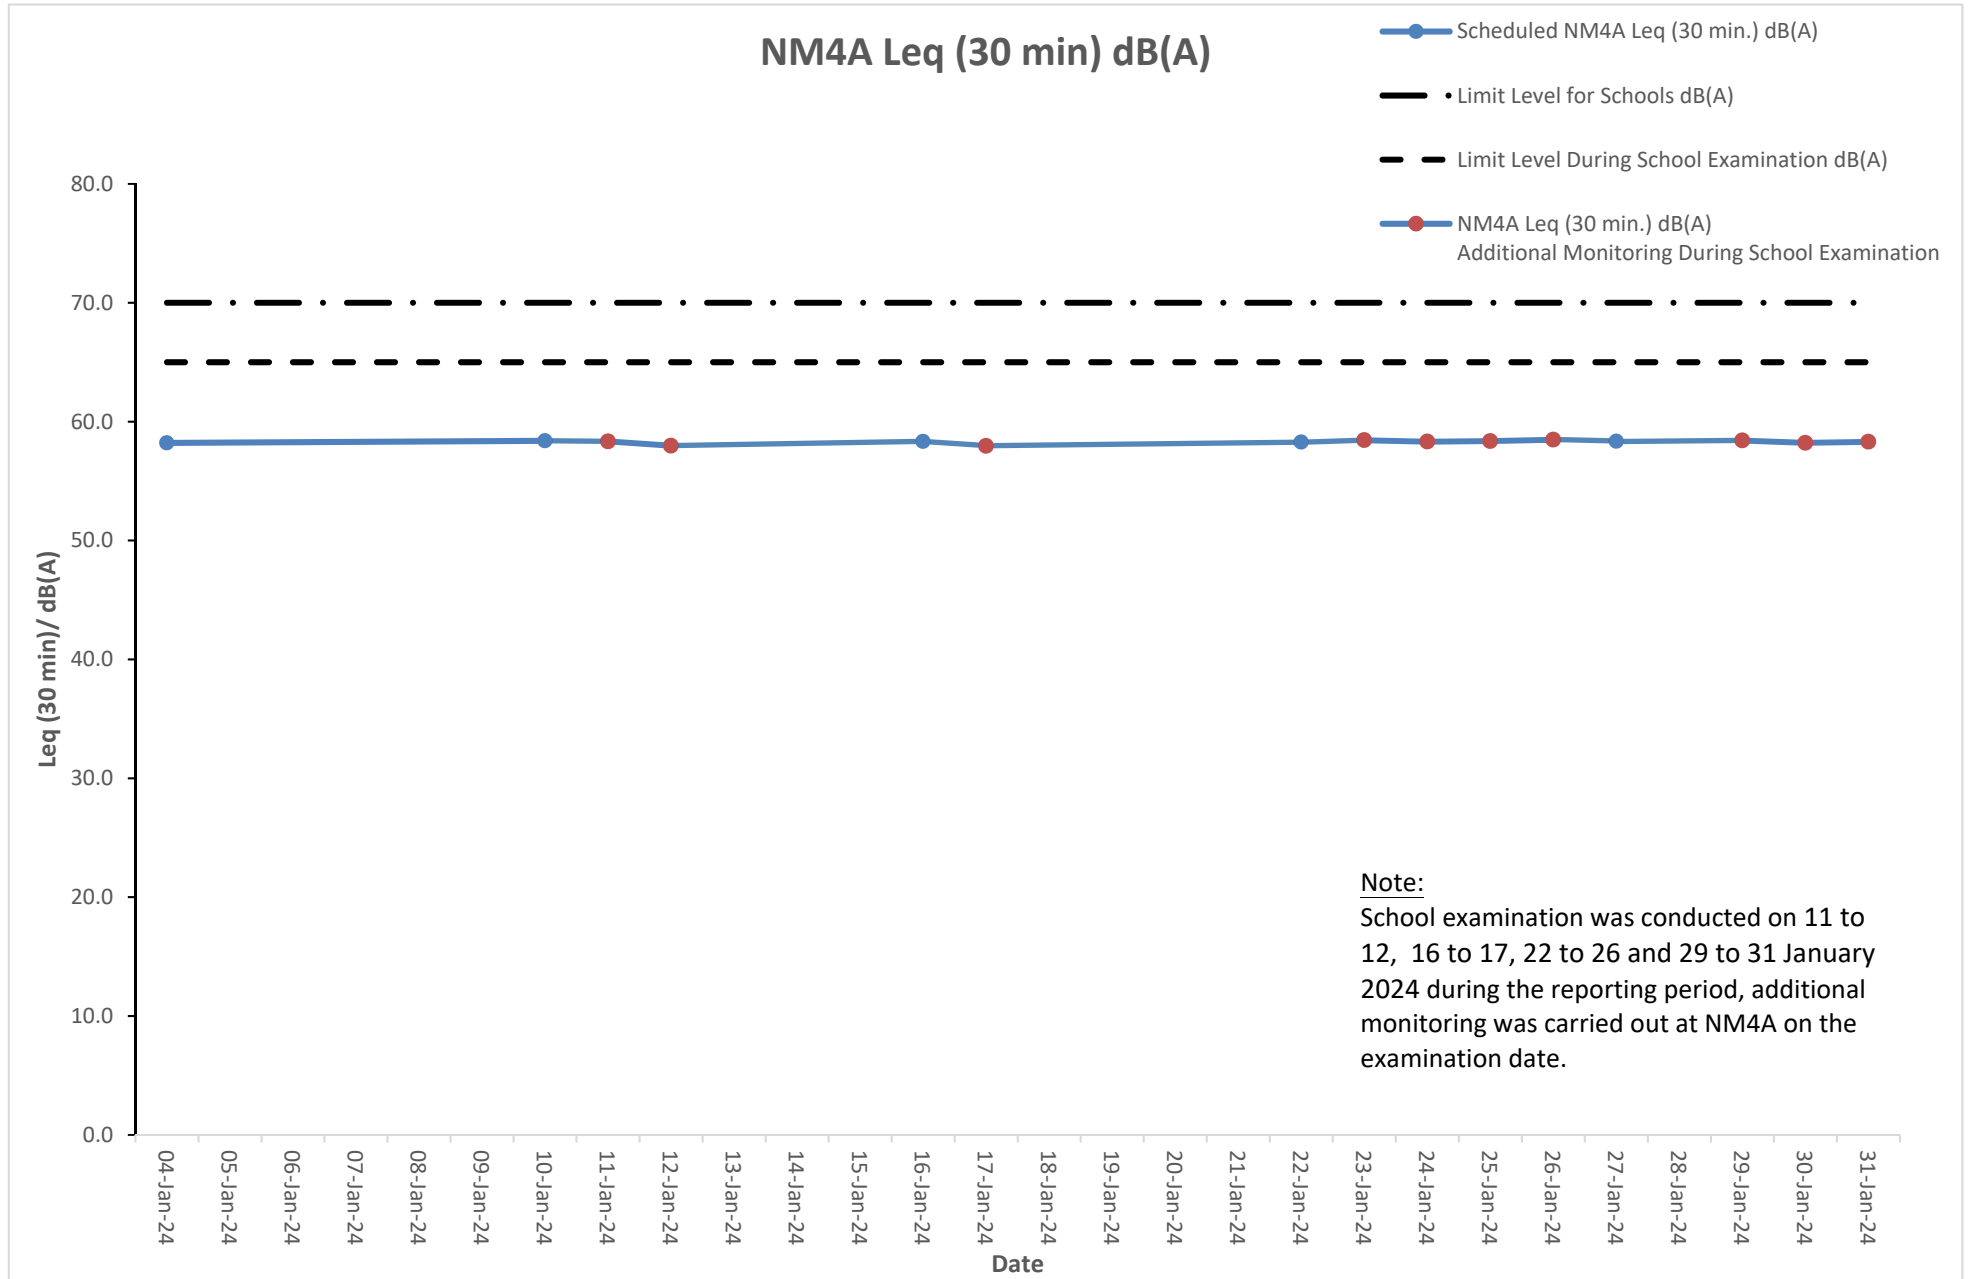
# Graphical Presentation of Noise Monitoring Result at Station NM4A

Date	Time	Measured L10 dB(A)	Measured L90 dB(A)	Leq (30 min.) dB(A)
04-Jan-24	16:44	59.9	55.8	58.2
04-Jan-24	16:49	59.5	56.1	
04-Jan-24	16:54	59.9	56.4	
04-Jan-24	16:59	59.5	56.8	
04-Jan-24	17:04	59.4	55.7	
04-Jan-24	17:09	60.1	56.0	
10-Jan-24	10:39	60.0	57.1	58.4
10-Jan-24	10:44	59.2	57.0	
10-Jan-24	10:49	60.6	55.7	
10-Jan-24	10:54	59.7	57.0	
10-Jan-24	10:59	59.6	56.5	
10-Jan-24	11:04	59.2	56.0	
16-Jan-24	16:41	59.2	55.7	58.3
16-Jan-24	16:46	59.7	56.3	
16-Jan-24	16:51	60.5	56.7	
16-Jan-24	16:56	60.6	56.0	
16-Jan-24	17:01	60.6	56.3	
16-Jan-24	17:06	59.2	57.1	
22-Jan-24	10:41	59.5	56.6	58.3
22-Jan-24	10:46	59.8	56.4	
22-Jan-24	10:51	59.8	56.8	
22-Jan-24	10:56	60.6	56.4	
22-Jan-24	11:01	60.3	57.1	
22-Jan-24	11:06	59.3	57.1	
27-Jan-24	16:36	59.7	56.0	58.3
27-Jan-24	16:41	59.6	55.8	
27-Jan-24	16:46	59.4	56.1	
27-Jan-24	16:51	59.3	55.9	
27-Jan-24	16:56	59.9	55.7	
27-Jan-24	17:01	59.9	56.0

The station set-up of a façade measurement at station NM4A.

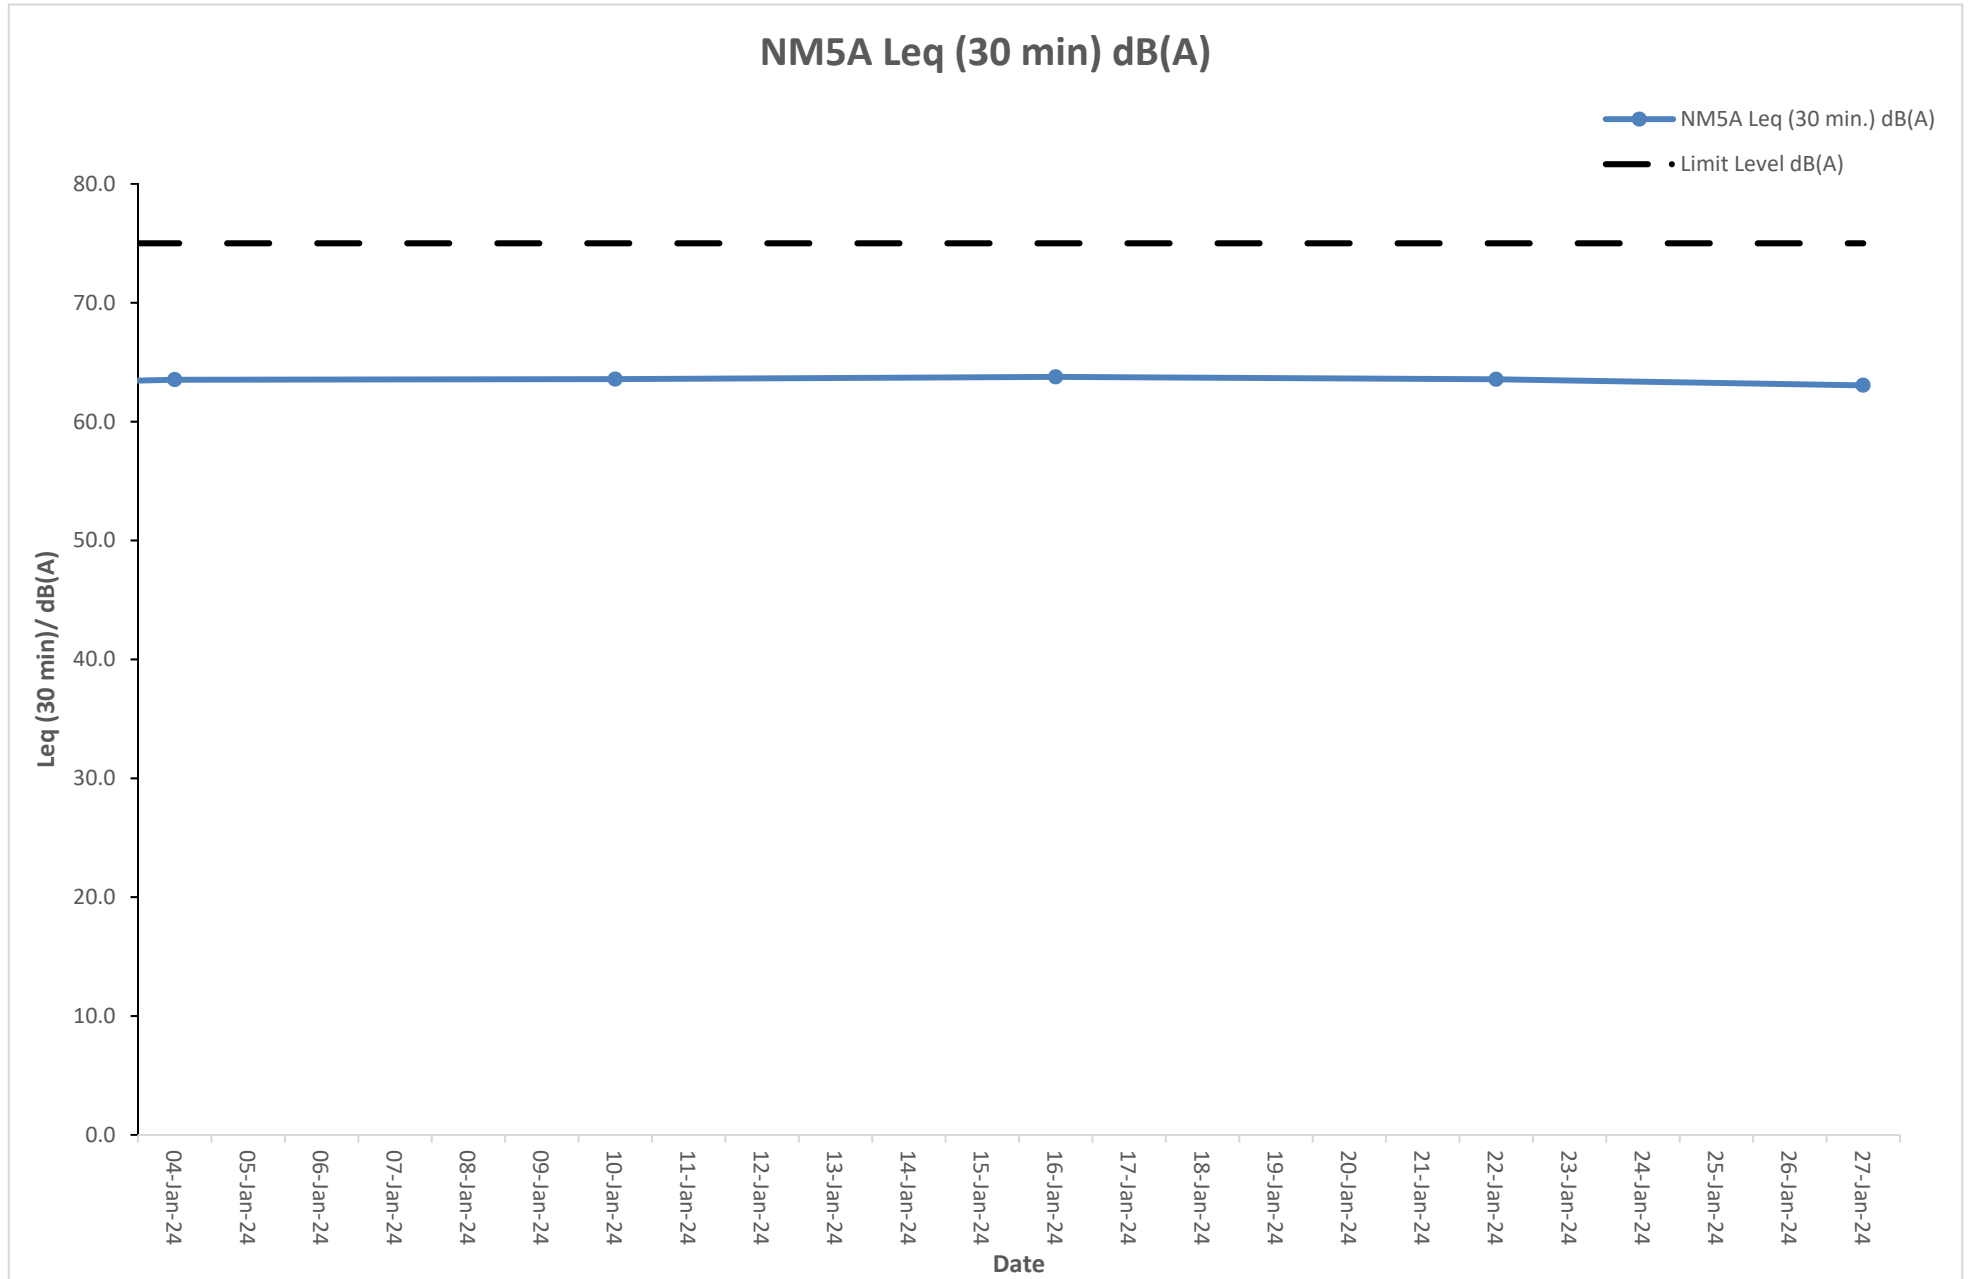
# Graphical Presentation of Noise Monitoring Result at Station NM5A

Date	Time	Measured L10 dB(A)	Measured L90 dB(A)	Leq (30 min.) dB(A)	Leq (30 min.) +3 dB(A)
04-Jan-24	15:29	61.7	57.8	60.5	63.5
04-Jan-24	15:34	62.8	58.5		
04-Jan-24	15:39	61.4	59.1		
04-Jan-24	15:44	61.5	58.5		
04-Jan-24	15:49	61.7	57.5		
04-Jan-24	15:54	62.6	59.2		
10-Jan-24	9:23	61.7	58.6	60.6	63.6
10-Jan-24	9:28	62.1	58.0		
10-Jan-24	9:33	62.7	58.3		
10-Jan-24	9:38	61.5	58.5		
10-Jan-24	9:43	61.9	58.5		
10-Jan-24	9:48	62.5	58.6		
16-Jan-24	15:26	61.4	58.8	60.8	63.8
16-Jan-24	15:31	61.5	57.4		
16-Jan-24	15:36	61.4	58.7		
16-Jan-24	15:41	62.1	58.1		
16-Jan-24	15:46	62.1	58.8		
16-Jan-24	15:51	62.2	57.7		
22-Jan-24	9:25	62.2	57.4	60.6	63.6
22-Jan-24	9:30	62.2	57.4		
22-Jan-24	9:35	62.4	57.5		
22-Jan-24	9:40	62.8	58.2		
22-Jan-24	9:45	62.6	59.1		
22-Jan-24	9:50	61.6	58.3		
27-Jan-24	15:21	61.8	59.2	60.1	63.1
27-Jan-24	15:26	62.6	58.5		
27-Jan-24	15:31	62.7	58.6		
27-Jan-24	15:36	62.4	58.6		
27-Jan-24	15:41	62.6	59.1

The station set-up of a free-field measurement at station NM5A.
