Development at West Kowloon Cultural District

Monthly Environmental Monitoring and Audit (EM&A) Report
for February 2024

Part-1: EM&A at Lyric Theatre Complex

**Part-2: EM&A for Foundation Works in
Zone 2B & 2C**

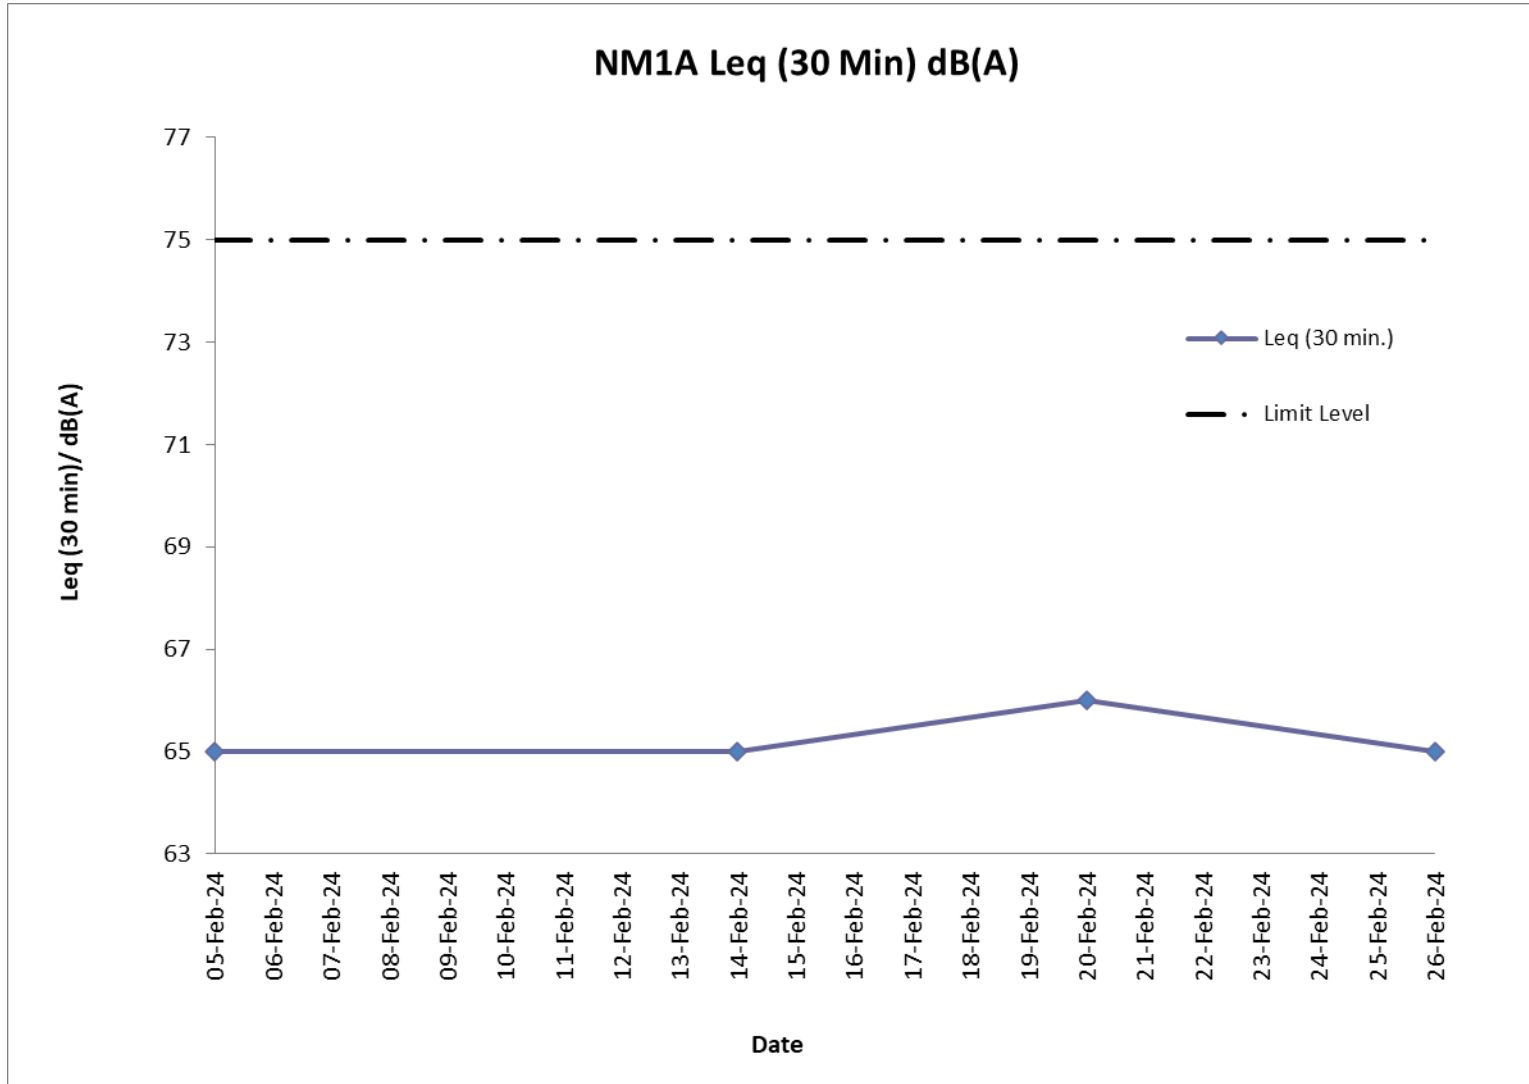
Graphical Presentation Noise Monitoring Result at Station NM1A

The station set-up of a free-field measurement at Station NM1A.
