Development at West Kowloon Cultural District

Monthly Environmental Monitoring and Audit (EM&A) Report for May 2025

Part-1: EM&A at Lyric Theatre Complex

Part-2: EM&A for ELS Works for The Integrated Basement and Underground Road in Zones 2A, 2B & 2C

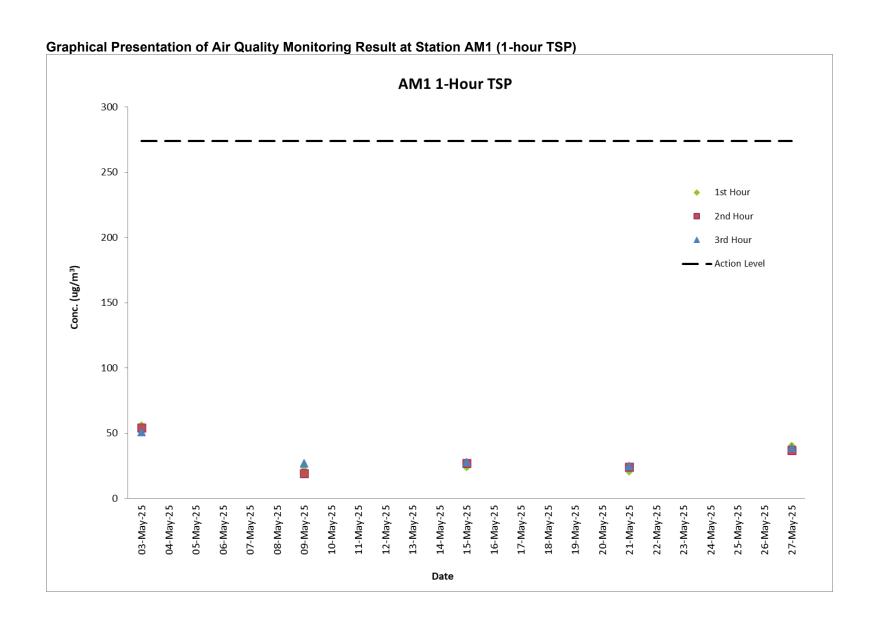
Air Quality Monitoring Result at Station AM1 (1-hour TSP)

Weather			Conc. (μg/m³)			Limit Level
Date	Condition	Time	1 st Hour	2 nd Hour	3 rd Hour	(µg/m³)	(μg/m ³)
03-May-25	Cloudy	8:33 - 11:33	56	54	51	273.7	500
09-May-25	Cloudy	8:28 - 11:28	24	19	27	273.7	500
15-May-25	Cloudy	8:29 - 11:29	24	27	28	273.7	500
21-May-25	Fine	8:38 - 11:38	21	24	25	273.7	500
27-May-25	Fine	8:34 - 11:34	40	37	39	273.7	500

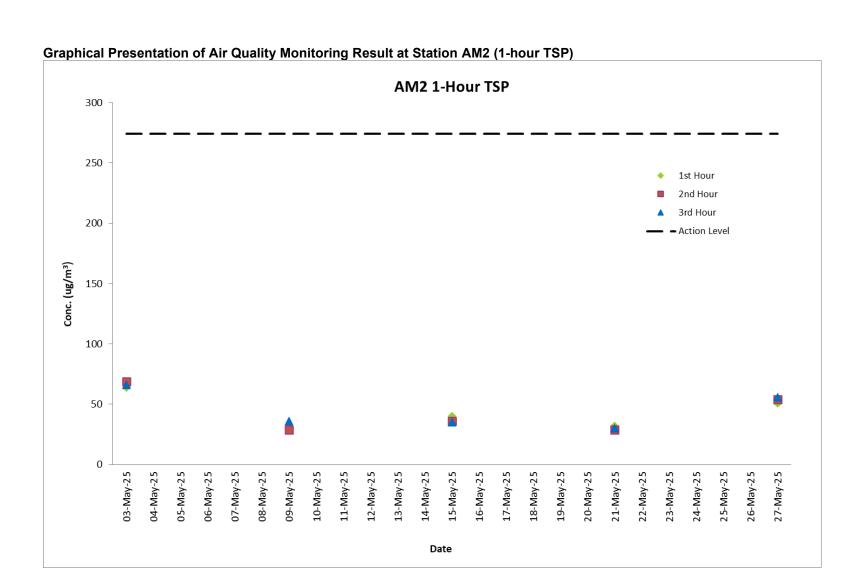
Air Quality Monitoring Result at Station AM2 (1-hour TSP)

Weather			Conc. (μg/m³)		Action Level	Limit Level
Date	Condition	Time	1 st Hour	2 nd Hour	3 rd Hour	(µg/m³)	$(\mu g/m^3)$
03-May-25	Cloudy	8:49 - 11:49	64	69	66	274.2	500
09-May-25	Cloudy	8:43 - 11:43	33	29	36	274.2	500
15-May-25	Cloudy	8:45 - 11:45	40	36	35	274.2	500
21-May-25	Fine	8:43 - 11:43	32	29	30	274.2	500
27-May-25	Fine	8:50 - 11:50	51	54	56	274.2	500

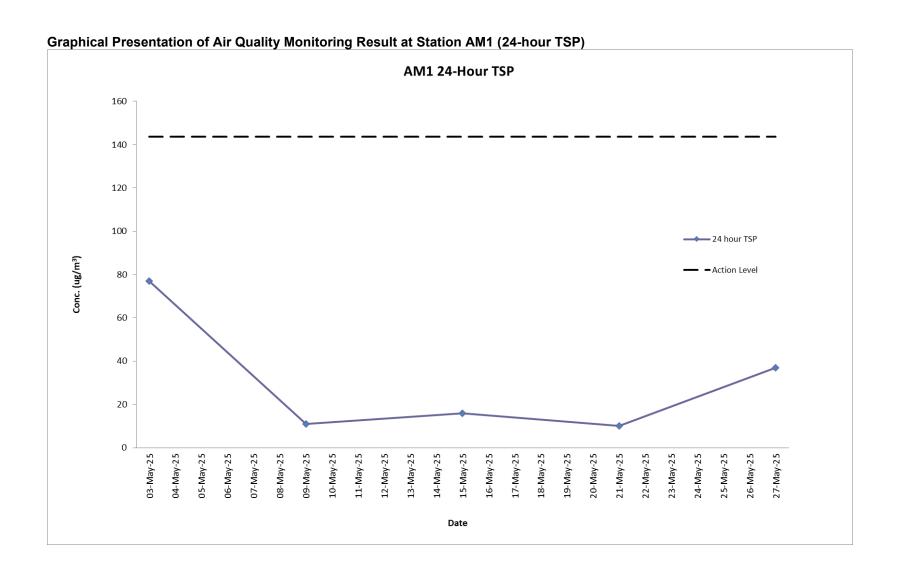
Air Quality Monitoring Result at Station AM1 (24-hour TSP)

Star	t	Finis	sh	Filter We	eight (g)		Elapsed Time Reading		Flow Rate (m ³ /min)		ng Flow Rate (m³/min)		Conc.	Weather	Action	Limit
Date	Time	Date	Time	Initial	Final	Initial	Final	Time (hrs)	Initial	Final	Average	(µg/m ³)	Condition	Level	Level	
03-May-25	08:30	04-May-25	08:30	2.8173	2.9545	29644.38	29668.38	24	1.24	1.24	1.24	77	Cloudy	143.6	260	
09-May-25	08:25	10-May-25	08:25	2.8291	2.8485	29668.38	29692.38	24	1.18	1.18	1.18	11	Cloudy	143.6	260	
15-May-25	08:26	16-May-25	08:26	2.8110	2.8380	29692.38	29716.38	24	1.18	1.18	1.18	16	Cloudy	143.6	260	
21-May-25	08:35	22-May-25	08:35	2.8166	2.8338	29716.38	29740.38	24	1.18	1.18	1.18	10	Fine	143.6	260	
27-May-25	08:31	28-May-25	08:31	2.8170	2.8806	29740.38	29764.38	24	1.18	1.18	1.18	37	Fine	143.6	260

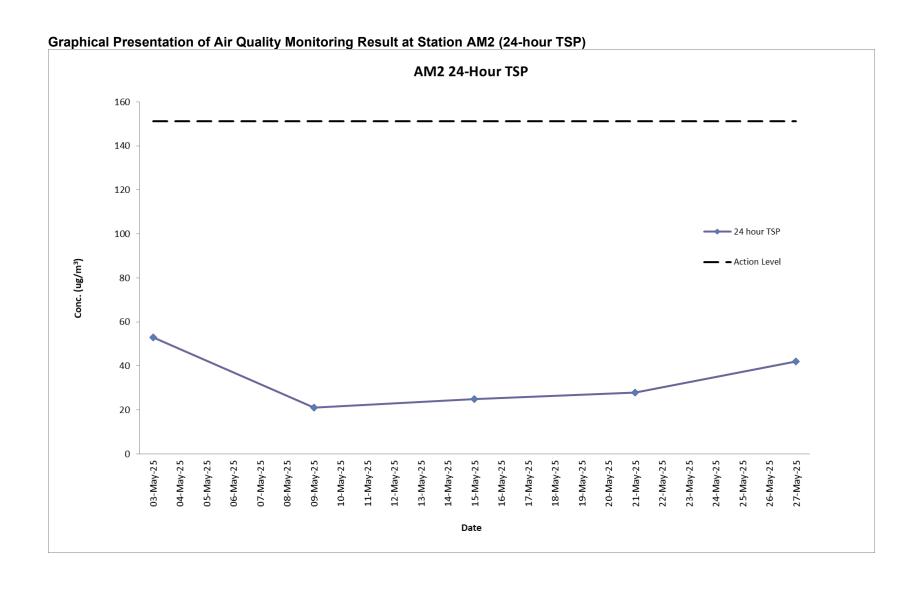
Air Quality Monitoring Result at Station AM2 (24-hour TSP)

Sta	rt	Finis	sh	Sampling	Conc.	Weather	Action	
Date	Time	Date	Time	Time (hrs)	(µg/m³)	Condition	Level	Limit Level
03-May-25	08:46	04-May-25	08:46	24	53	Cloudy	151.1	260
09-May-25	08:40	10-May-25	08:40	24	21	Cloudy	151.1	260
15-May-25	08:42	16-May-25	08:42	24	25	Cloudy	151.1	260
21-May-25	08:41	22-May-25	08:41	24	28	Fine	151.1	260
27-May-25	08:47	28-May-25	08:47	24	42	Fine	151.1	260

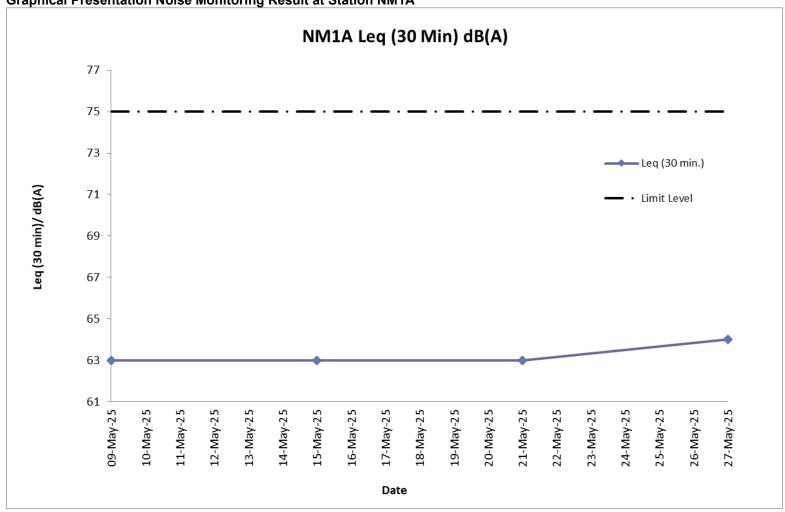
The station set-up of a free-field measurement at Station NM1A.

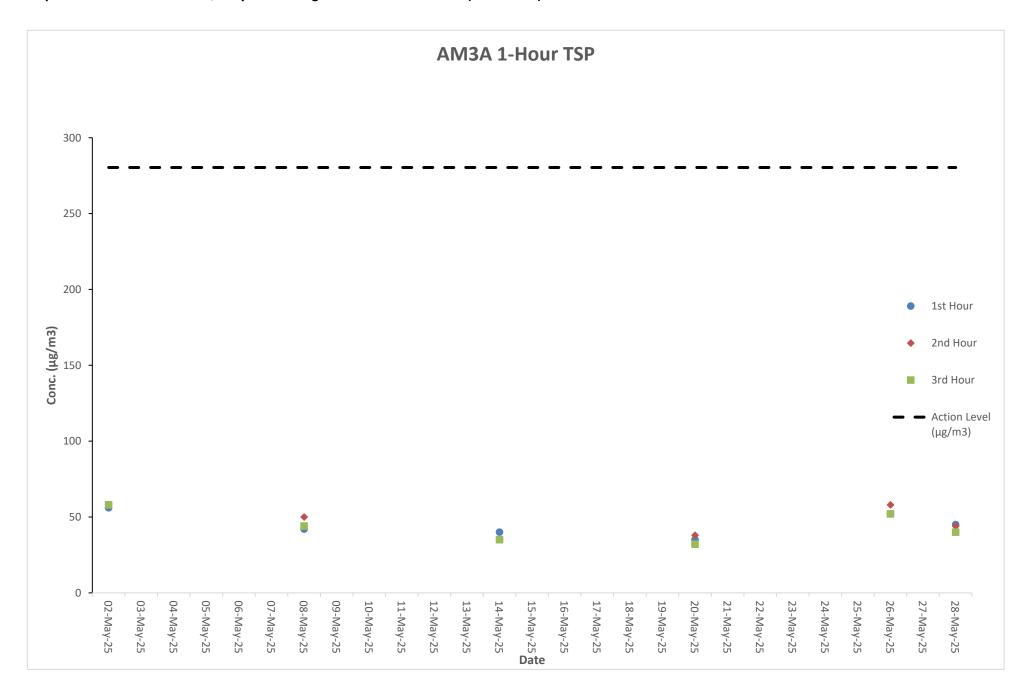
Air Quality Monitoring Result at Station AM3A (1-hour TSP)

Date	Weather	Time		C	onc. (µg/m3	3)	Action	Limit
Date	Condition	Start	Finish	1st Hour	2nd Hour	3rd Hour	Level	Level
02-May-25	Fine	08:01	11:01	56	58	58	280.4	500
08-May-25	Cloudy	14:03	17:03	42	50	44	280.4	500
14-May-25	Cloudy	08:00	11:00	40	35	35	280.4	500
20-May-25	Fine	14:05	17:05	35	38	32	280.4	500
26-May-25	Fine	08:07	11:07	52	58	52	280.4	500
28-May-25	Cloudy	14:09	17:09	45	44	40	280.4	500

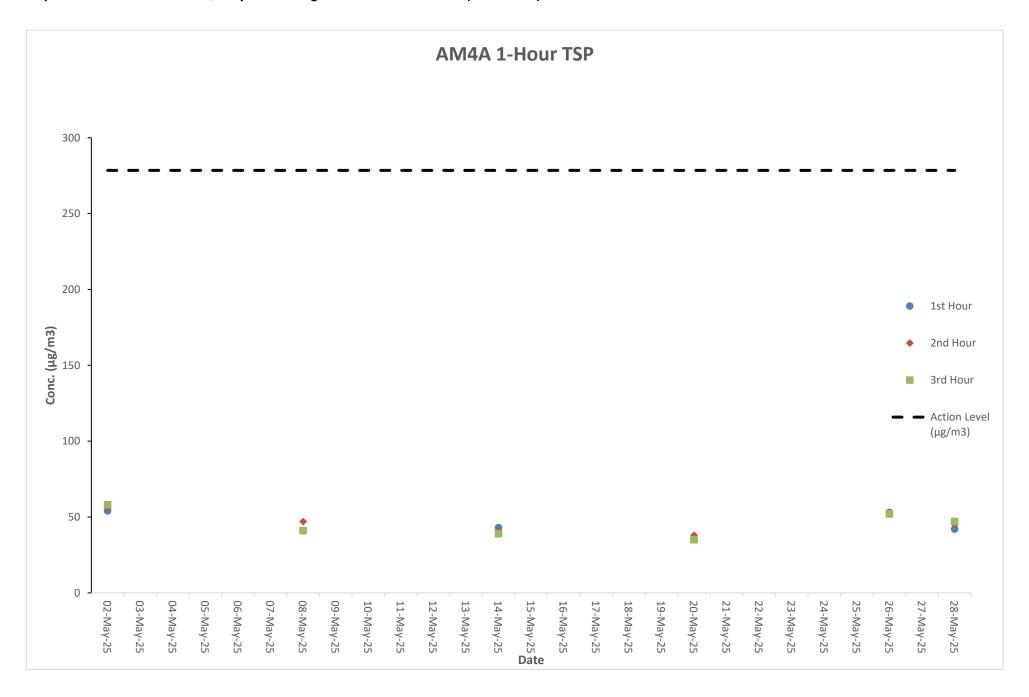
Air Quality Monitoring Result at Station AM4A (1-hour TSP)

Date	Weather	Time		C	onc. (µg/m3	3)	Action	Limit
Date	Condition	Start	Finish	1st Hour	2nd Hour	3rd Hour	Level	Level
02-May-25	Fine	08:09	11:09	54	56	58	278.5	500
08-May-25	Cloudy	14:11	17:11	41	47	41	278.5	500
14-May-25	Cloudy	80:80	11:08	43	41	39	278.5	500
20-May-25	Fine	14:13	17:13	35	38	35	278.5	500
26-May-25	Fine	08:15	11:15	53	52	52	278.5	500
28-May-25	Cloudy	14:17	17:17	42	45	47	278.5	500

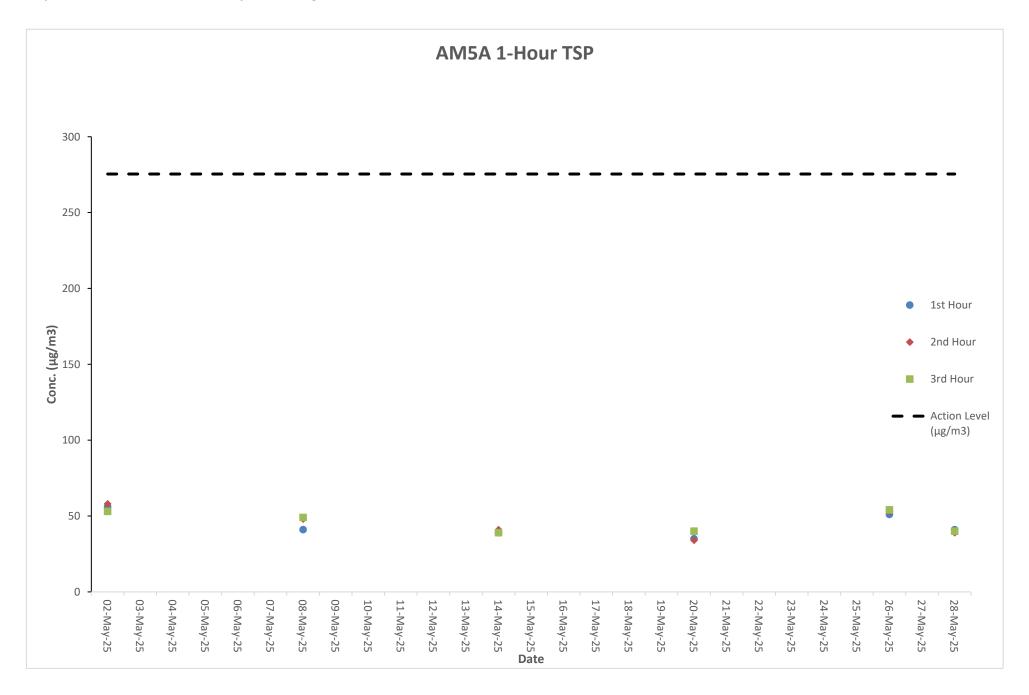
Air Quality Monitoring Result at Station AM5A (1-hour TSP)

Date	Weather	Time		C	onc. (µg/m3	3)	Action	Limit
Date	Condition	Start	Finish	1st Hour	2nd Hour	3rd Hour	Level	Level
02-May-25	Fine	08:24	11:24	56	58	53	275.4	500
08-May-25	Cloudy	14:28	17:28	41	48	49	275.4	500
14-May-25	Cloudy	08:23	11:23	39	41	39	275.4	500
20-May-25	Fine	14:30	17:30	35	34	40	275.4	500
26-May-25	Fine	08:30	11:30	51	53	54	275.4	500
28-May-25	Cloudy	14:34	17:34	41	39	40	275.4	500

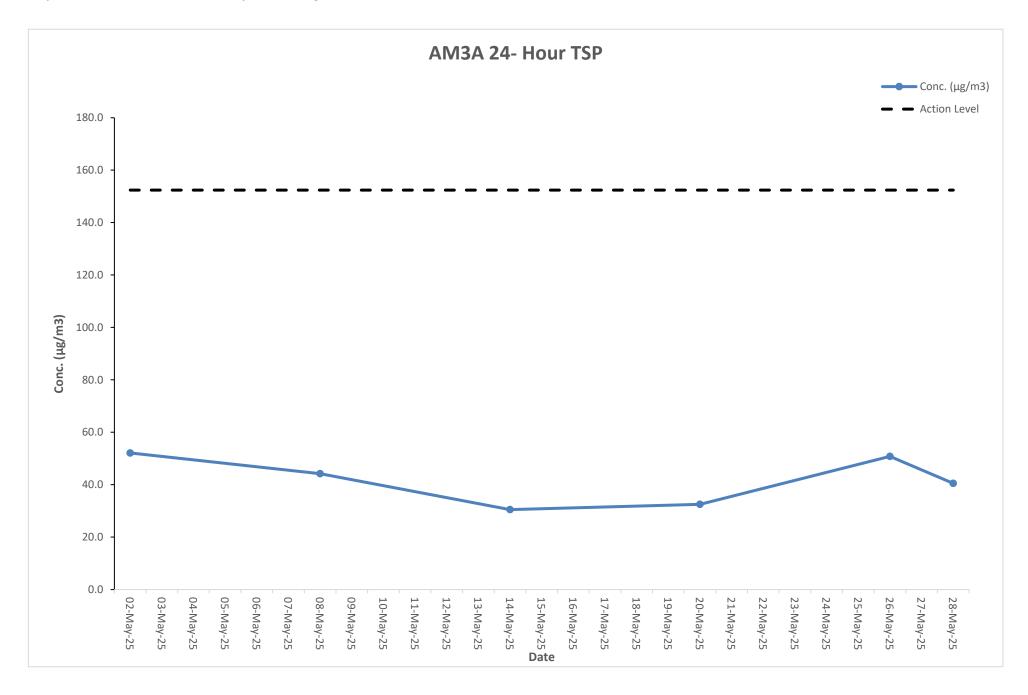
Air Quality Monitoring Result at Station AM3A (24-hour TSP)

Star	rt	Finis	h	Filtor W	Elapsed Time Filter Weight (g) Reading		Compline	Flow Rate (m³/min)			Conc.	Weather	Action	Limit	
Date	Time	Date	Time	Initial	Final	Initial	Final	Sampling Time (hrs)	Initial	Final	Average	(µg/m3)	Condition	Level	Level
02-May-25	10:00AM	03-May-25	10:00AM	2.8066	2.8904	8301.8	8325.8	24	1.12	1.12	1.12	52.1	Cloudy	152.4	260
08-May-25	10:00AM	09-May-25	10:00AM	2.8089	2.8801	8325.8	8349.8	24	1.12	1.12	1.12	44.2	Rainy	152.4	260
14-May-25	10:00AM	15-May-25	10:00AM	2.8012	2.8502	8349.8	8373.8	24	1.12	1.12	1.12	30.5	Cloudy	152.4	260
20-May-25	10:00AM	21-May-25	10:00AM	2.8035	2.8558	8373.8	8397.8	24	1.12	1.12	1.12	32.5	Cloudy	152.4	260
26-May-25	10:00AM	27-May-25	10:00AM	2.8073	2.8891	8397.8	8421.8	24	1.12	1.12	1.12	50.8	Sunny	152.4	260
28-May-25	10:00AM	29-May-25	10:00AM	2.8043	2.8695	8421.8	8445.8	24	1.12	1.12	1.12	40.5	Cloudy	152.4	260

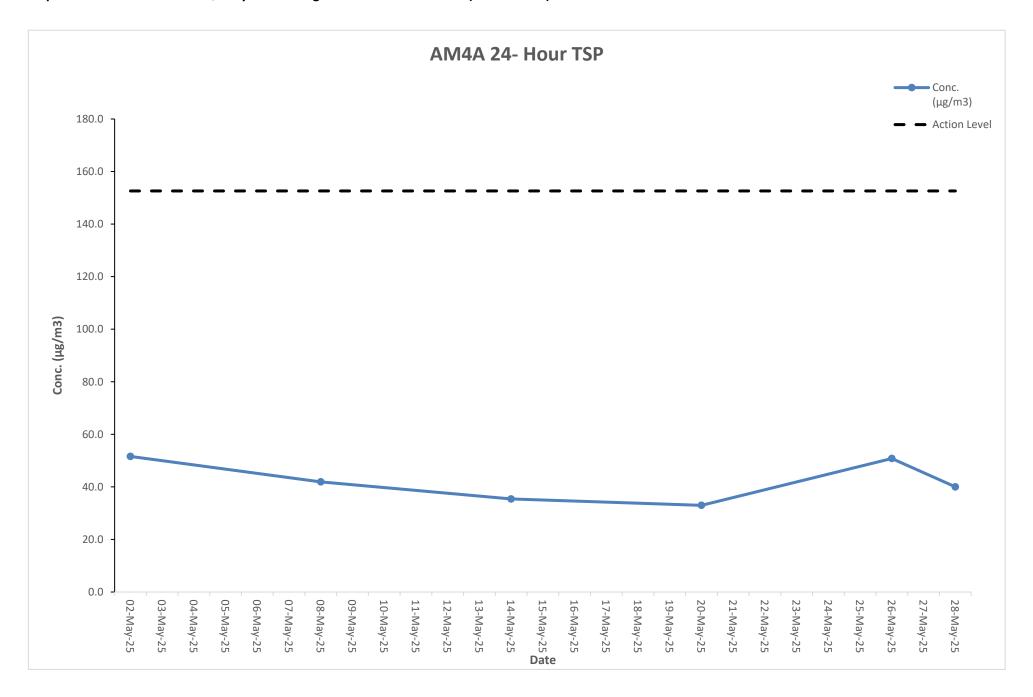
Air Quality Monitoring Result at Station AM4A (24-hour TSP)

Star	-4	Finis	h	Filtor W	eight (g)		d Time ding	Committee	Elev	v Rate (m	o ³ /min)	0	Ma adla au	A adia n	Limais
Date	Time	Date	Time	Initial	Final	Initial	Final	Sampling Time (hrs)	Initial	Final	Average	Conc. (µg/m3)	Weather Condition	Action Level	Limit Level
02-May-25	10:00AM	03-May-25	10:00AM	2.8050	2.8881	8721.4	8745.4	24	1.12	1.12	1.12	51.6	Cloudy	152.6	260
08-May-25	10:00AM	09-May-25	10:00AM	2.8070	2.8743	8745.4	8769.4	24	1.12	1.12	1.12	41.9	Rainy	152.6	260
14-May-25	10:00AM	15-May-25	10:00AM	2.8018	2.8587	8769.4	8793.4	24	1.12	1.12	1.12	35.4	Cloudy	152.6	260
20-May-25	10:00AM	21-May-25	10:00AM	2.8063	2.8595	8793.4	8817.4	24	1.12	1.12	1.12	33.0	Cloudy	152.6	260
26-May-25	10:00AM	27-May-25	10:00AM	2.8037	2.8855	8817.4	8841.4	24	1.12	1.12	1.12	50.8	Sunny	152.6	260
28-May-25	10:00AM	29-May-25	10:00AM	2.8033	2.8677	8841.4	8865.4	24	1.12	1.12	1.12	40.0	Cloudy	152.6	260

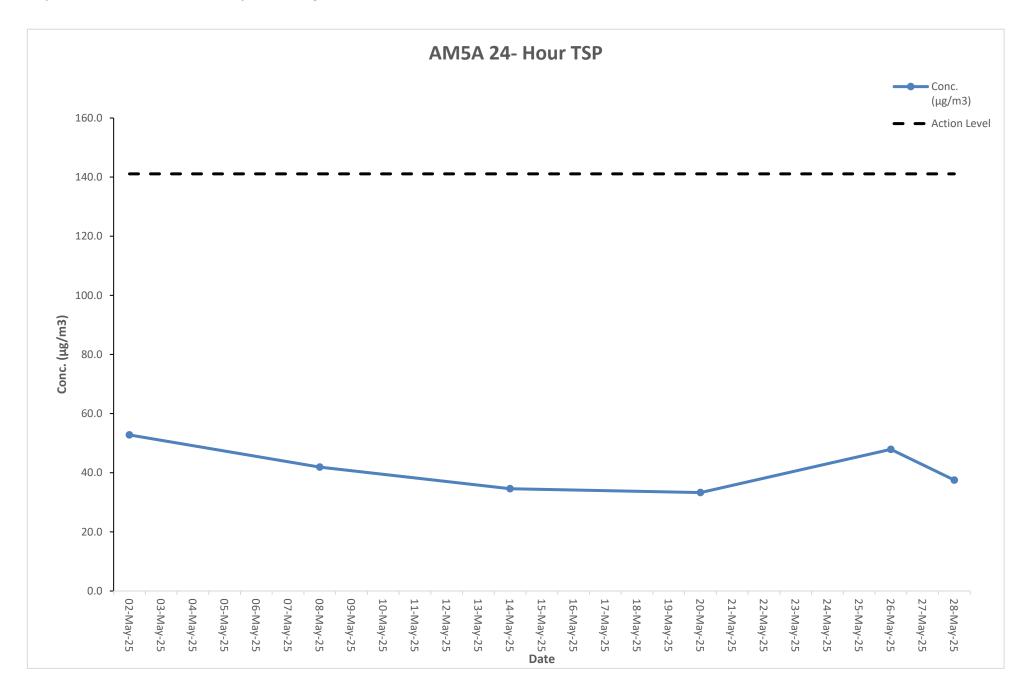
Air Quality Monitoring Result at Station AM5A (24-hour TSP)

Elapse	d Time								
Star	rt	Finis	h	Filter W	eight (g)	Rea	ding	Sampling	Flow Rate (m ³ /min)		Conc.	Weather	Action	Limit	
Date	Time	Date	Time	Initial	Final	Initial	Final	Time (hrs)	Initial	Final	Average	(µg/m3)	Condition	Level	Level
02-May-25	10:00AM	03-May-25	10:00AM	2.8075	2.8925	8859.6	8883.6	24	1.12	1.12	1.12	52.8	Cloudy	141.1	260
08-May-25	10:00AM	09-May-25	10:00AM	2.8046	2.8721	8883.6	8907.6	24	1.12	1.12	1.12	41.9	Rainy	141.1	260
14-May-25	10:00AM	15-May-25	10:00AM	2.8060	2.8616	8907.6	8931.6	24	1.12	1.12	1.12	34.6	Cloudy	141.1	260
20-May-25	10:00AM	21-May-25	10:00AM	2.8040	2.8576	8931.6	8955.6	24	1.12	1.12	1.12	33.3	Cloudy	141.1	260
26-May-25	10:00AM	27-May-25	10:00AM	2.8077	2.8847	8955.6	8979.6	24	1.12	1.12	1.12	47.9	Sunny	141.1	260
28-May-25	10:00AM	29-May-25	10:00AM	2.8022	2.8626	8979.6	9003.6	24	1.12	1.12	1.12	37.5	Cloudy	141.1	260

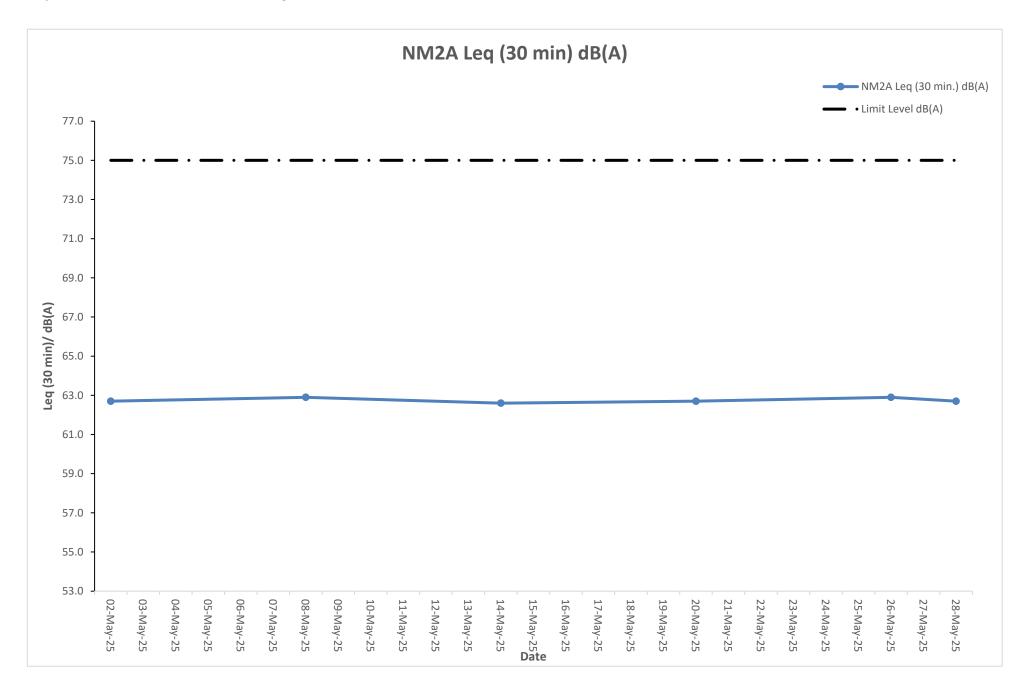
The station set-up of a façade measurement at station NM2A.

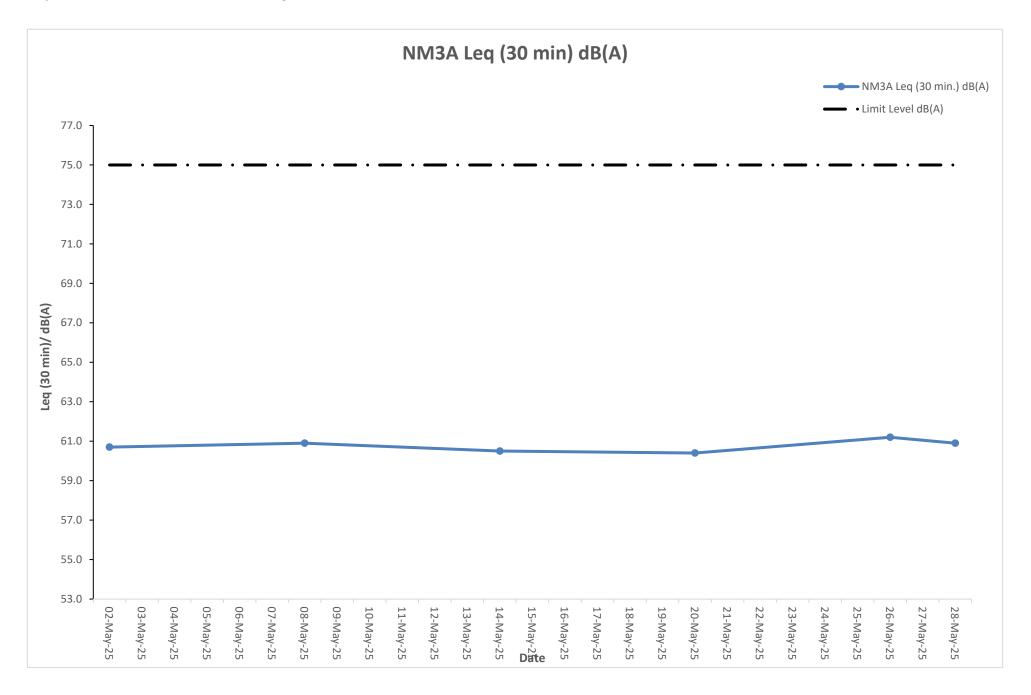
The station set-up of a façade measurement at station NM3A.

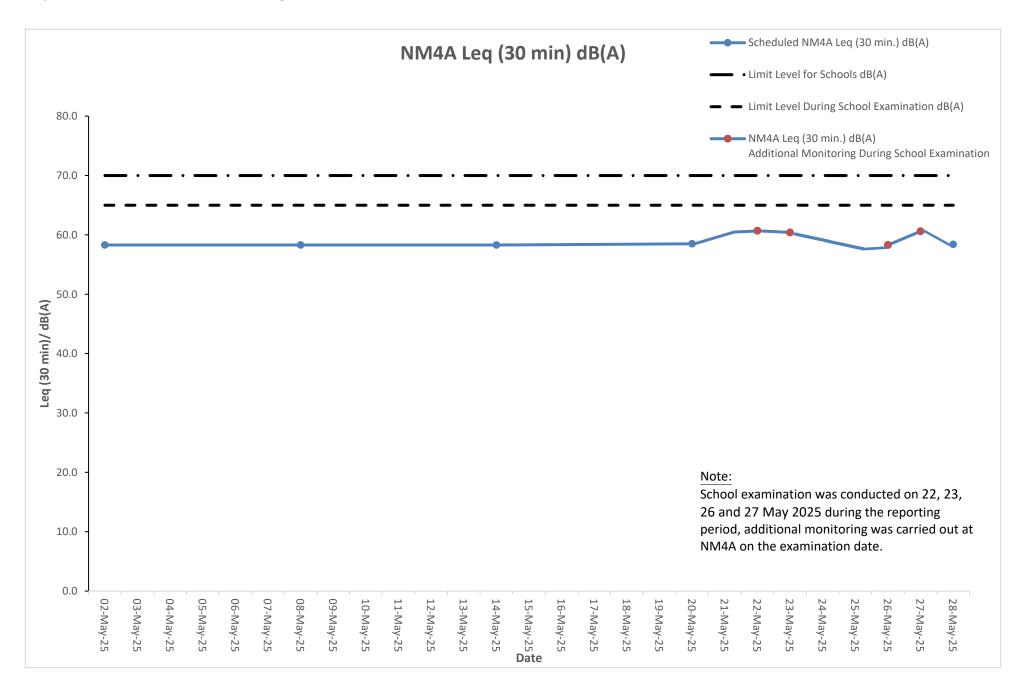
The station set-up of a façade measurement at station NM4A.

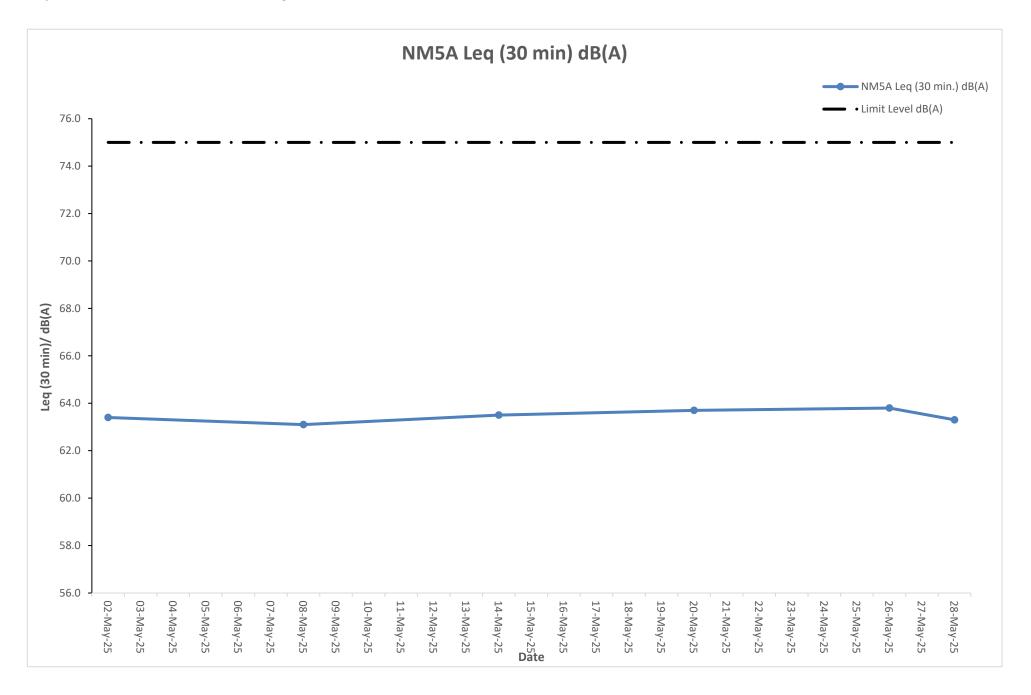
The station set-up of a free-field measurement at station NM5A.
