Development at West Kowloon Cultural District

**Monthly Environmental Monitoring and Audit (EM&A) Report
for December 2025**

**Part-2: EM&A for ELS Works for The
Integrated Basement and
Underground Road in Zones 2A, 2B
& 2C**

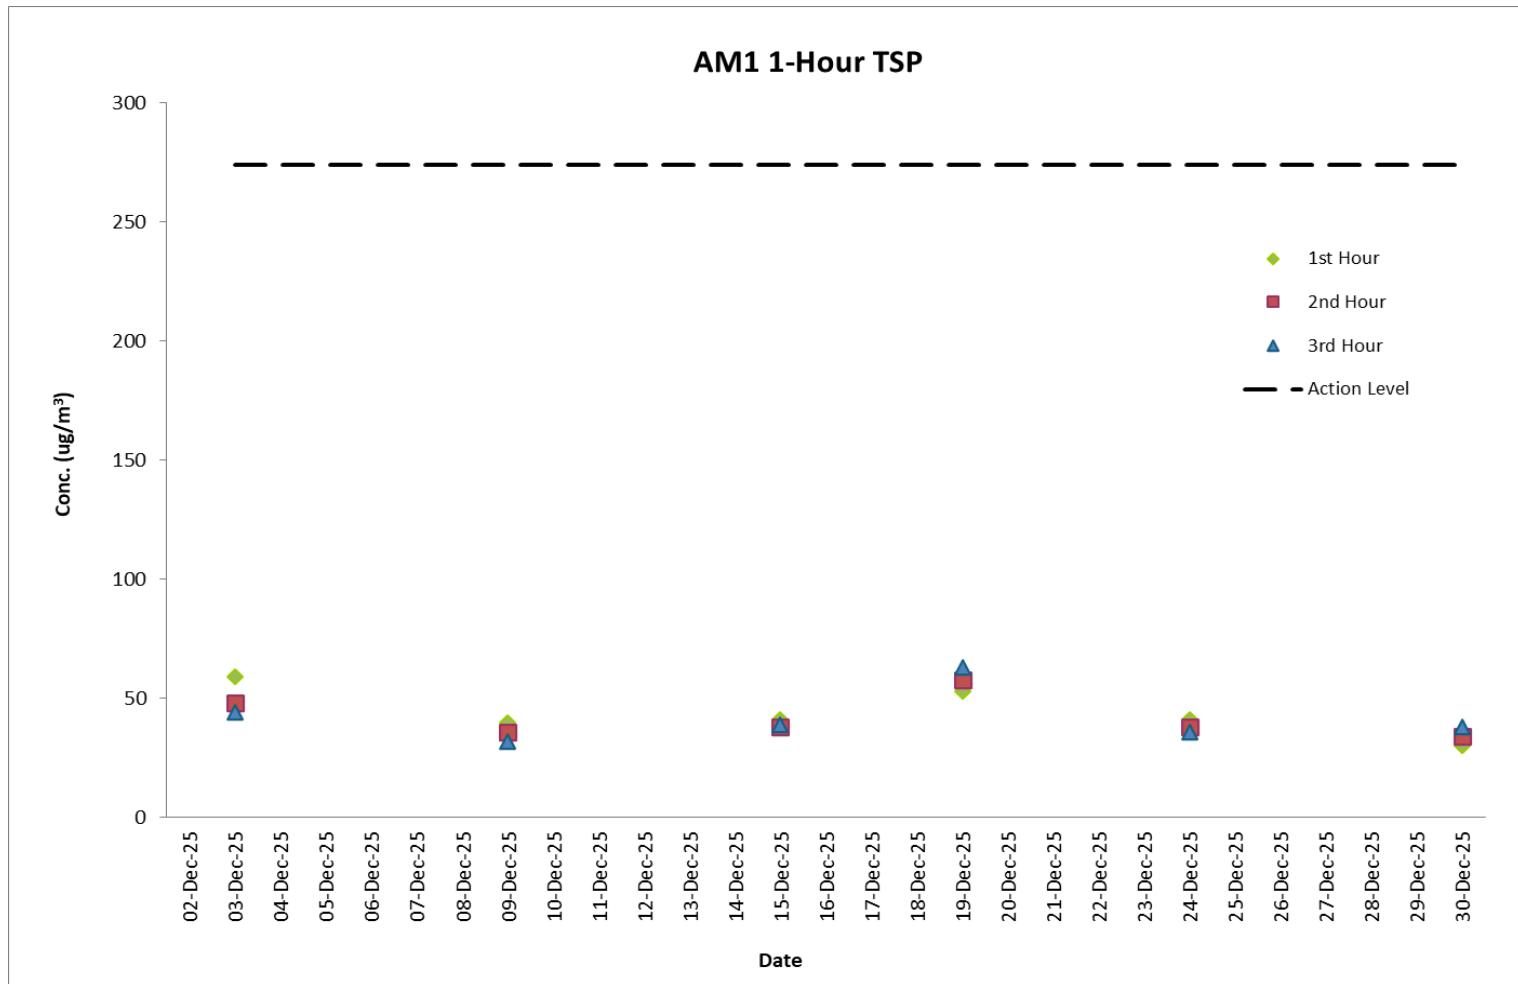
Graphical Presentation of Air Quality Monitoring Result at Station AM1 (1-hour TSP)

Date	Weather Condition	Time		Conc. (µg/m ³)			Action Level (µg/m ³)	Limit Level (µg/m ³)	Min	Max
				1 st Hour	2 nd Hour	3 rd Hour				
03-Dec-25	Cloudy	8:30	-	59	48	44	273.7	500	30	63
09-Dec-25	Sunny	8:29	-	40	36	32	273.7	500		
15-Dec-25	Sunny	8:28	-	41	38	39	273.7	500		
19-Dec-25	Fine	8:34	-	53	58	63	273.7	500		
24-Dec-25	Fine	8:32	-	41	38	36	273.7	500		
30-Dec-25	Fine	8:33	-	30	34	38	273.7	500

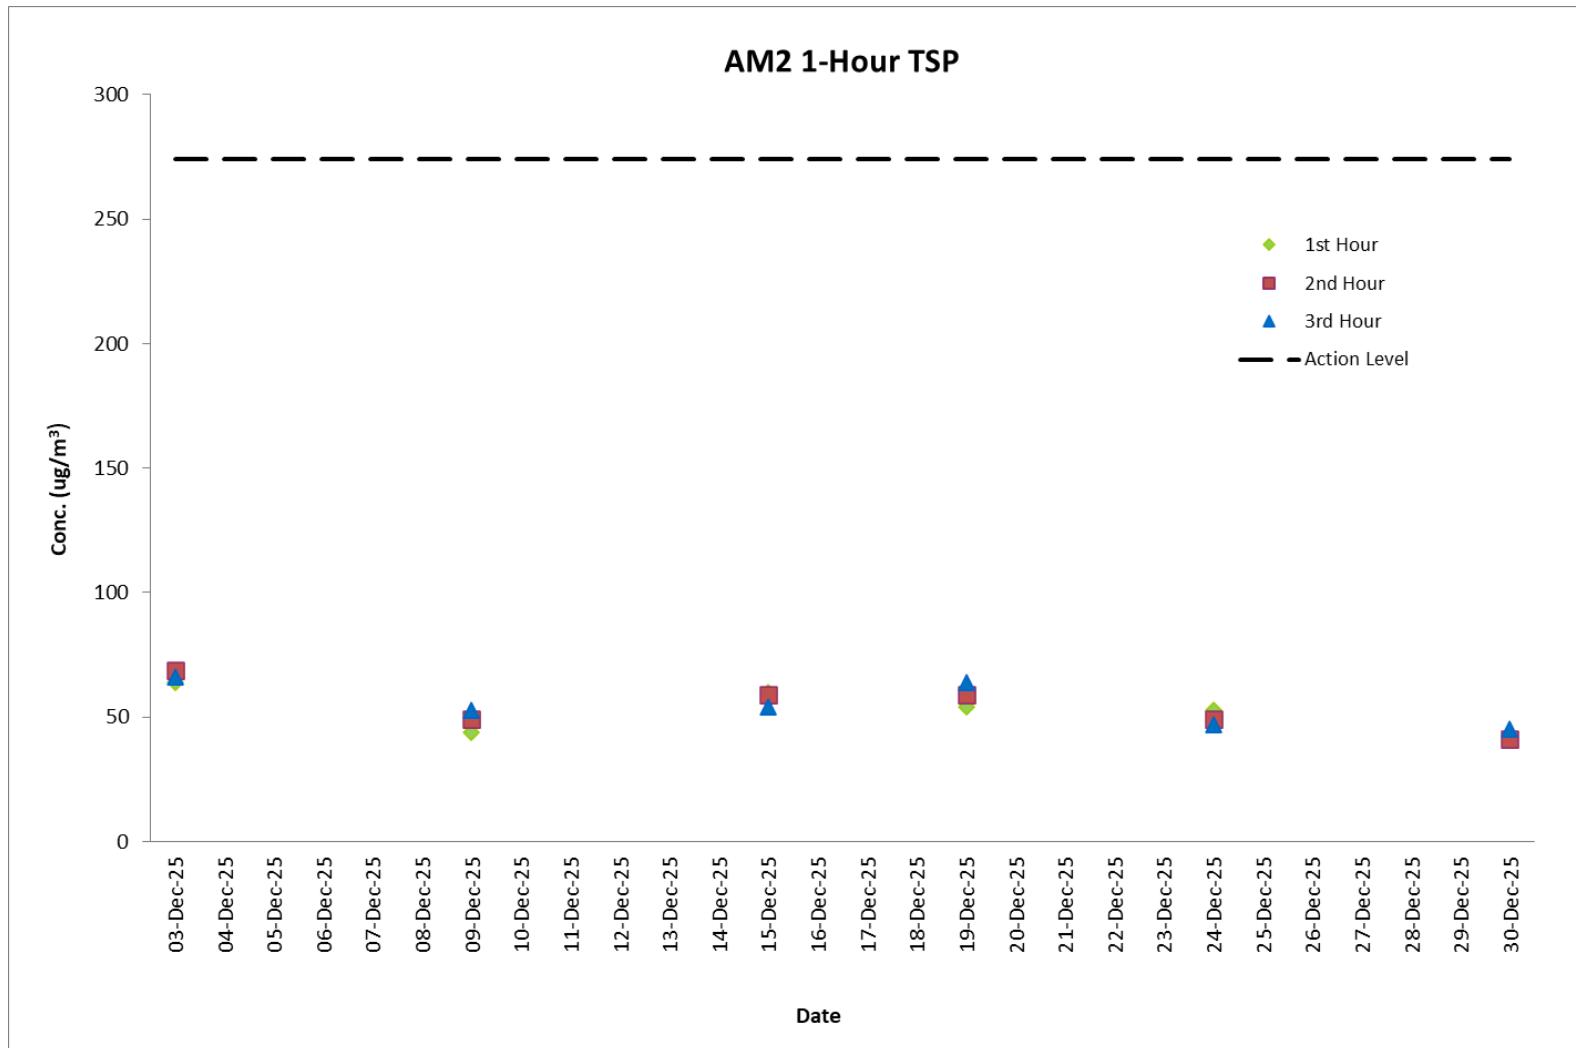
Graphical Presentation of Air Quality Monitoring Result at Station AM2 (1-hour TSP)

Date	Weather Condition	Time	Conc. ($\mu\text{g}/\text{m}^3$)			Action Level ($\mu\text{g}/\text{m}^3$)	Limit Level ($\mu\text{g}/\text{m}^3$)	Min	Max
			1 st Hour	2 nd Hour	3 rd Hour				
03-Dec-25	Cloudy	8:47 - 11:47	64	69	66	274.2	500	41	69
09-Dec-25	Sunny	8:45 - 11:45	44	49	53	274.2	500		
15-Dec-25	Sunny	8:44 - 11:44	60	59	54	274.2	500		
19-Dec-25	Fine	8:50 - 11:50	54	59	64	274.2	500		
24-Dec-25	Fine	8:47 - 11:47	53	49	47	274.2	500		
30-Dec-25	Fine	8:50 - 11:50	43	41	45	274.2	500

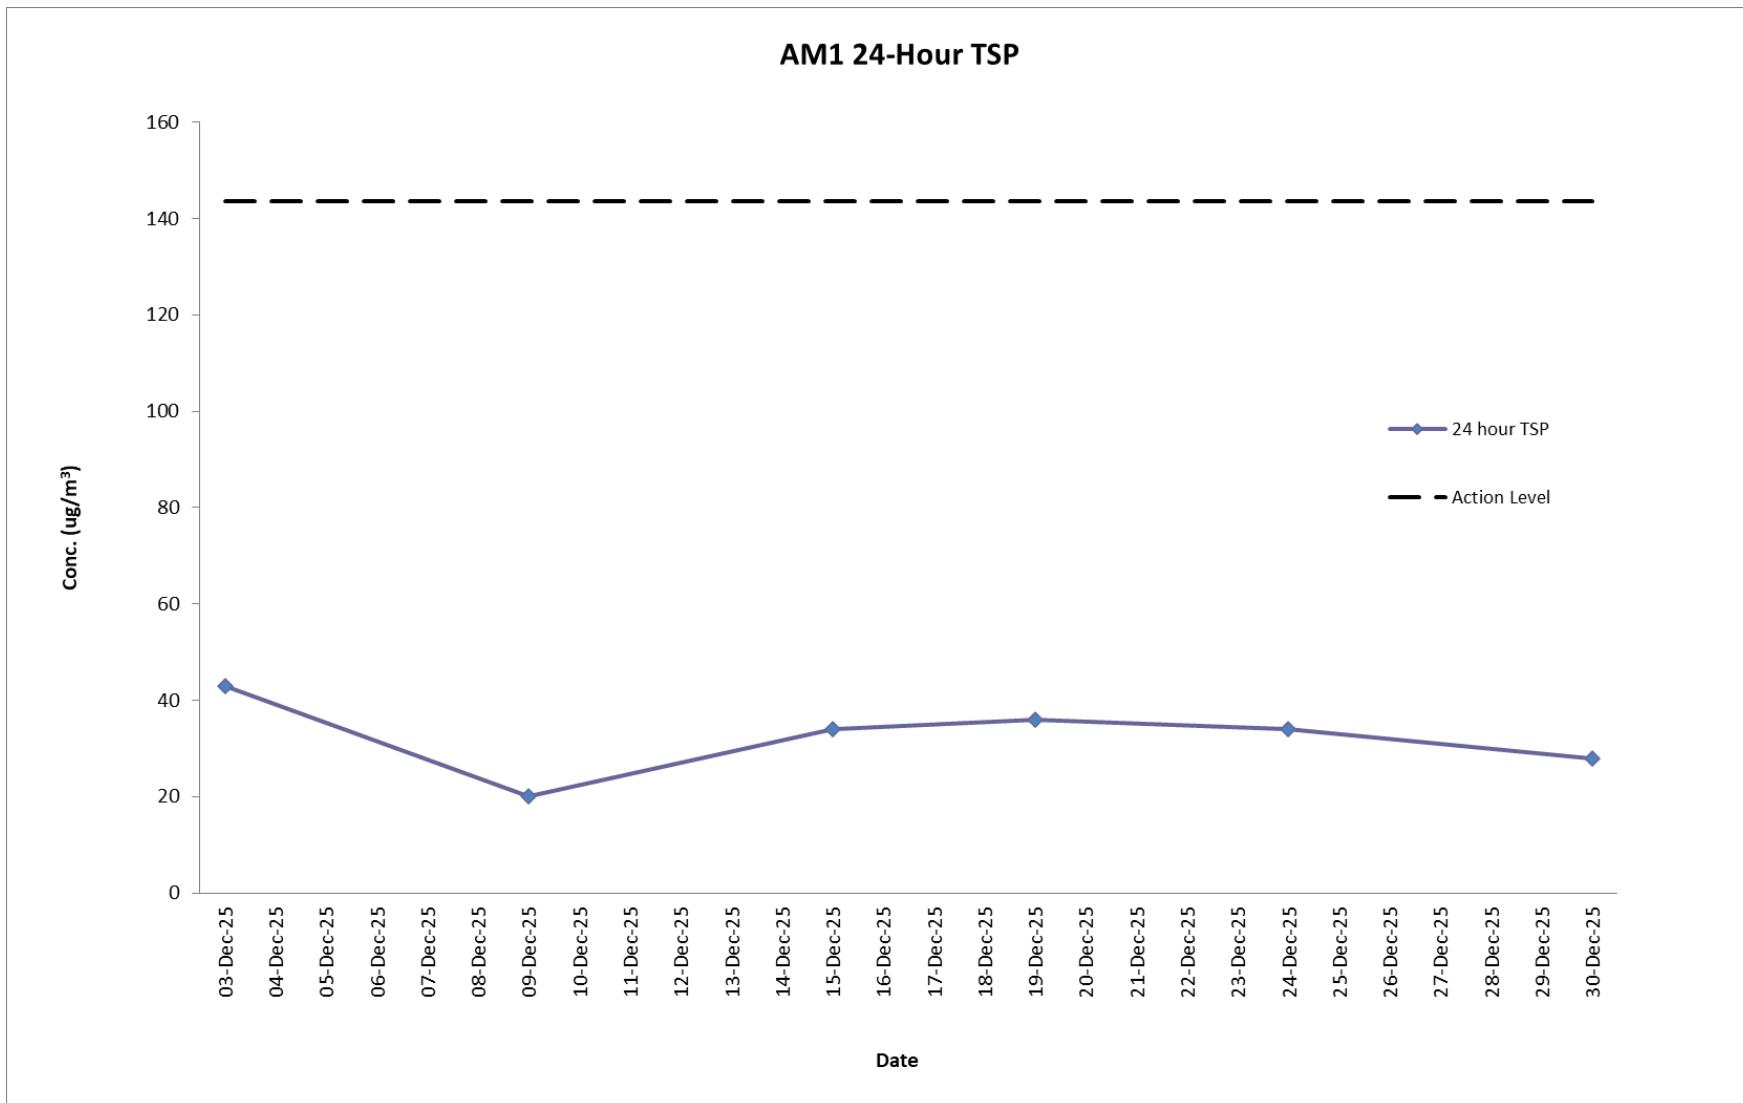
Graphical Presentation of Air Quality Monitoring Result at Station AM1 (24-hour TSP)

Start		Finish		Filter Weight (g)		Elapsed Time Reading		Sampling Time (hrs)	Flow Rate (m ³ /min)			Conc. (µg/m ³)	Weather Condition	Action Level	Limit Level
Date	Time	Date	Time	Initial	Final	Initial	Final		Initial	Final	Average				
03-Dec-25	08:28	04-Dec-25	08:28	2.7582	2.8354	30556.38	30580.38	24	1.24	1.24	1.24	43	Cloudy	143.6	260
09-Dec-25	08:26	10-Dec-25	08:26	2.7581	2.7943	30580.38	30604.38	24	1.24	1.24	1.24	20	Sunny	143.6	260
15-Dec-25	08:26	16-Dec-25	08:26	2.7439	2.8040	30604.38	30628.38	24	1.24	1.24	1.24	34	Sunny	143.6	260
19-Dec-25	08:32	20-Dec-25	08:32	2.7427	2.8070	30628.38	30652.38	24	1.24	1.24	1.24	36	Fine	143.6	260
24-Dec-25	08:30	25-Dec-25	08:30	2.7494	2.8098	30652.38	30676.38	24	1.24	1.24	1.24	34	Fine	143.6	260
30-Dec-25	08:31	31-Dec-25	08:31	2.7499	2.8003	30676.38	30700.38	24	1.26	1.26	1.26	28	Fine	143.6	260

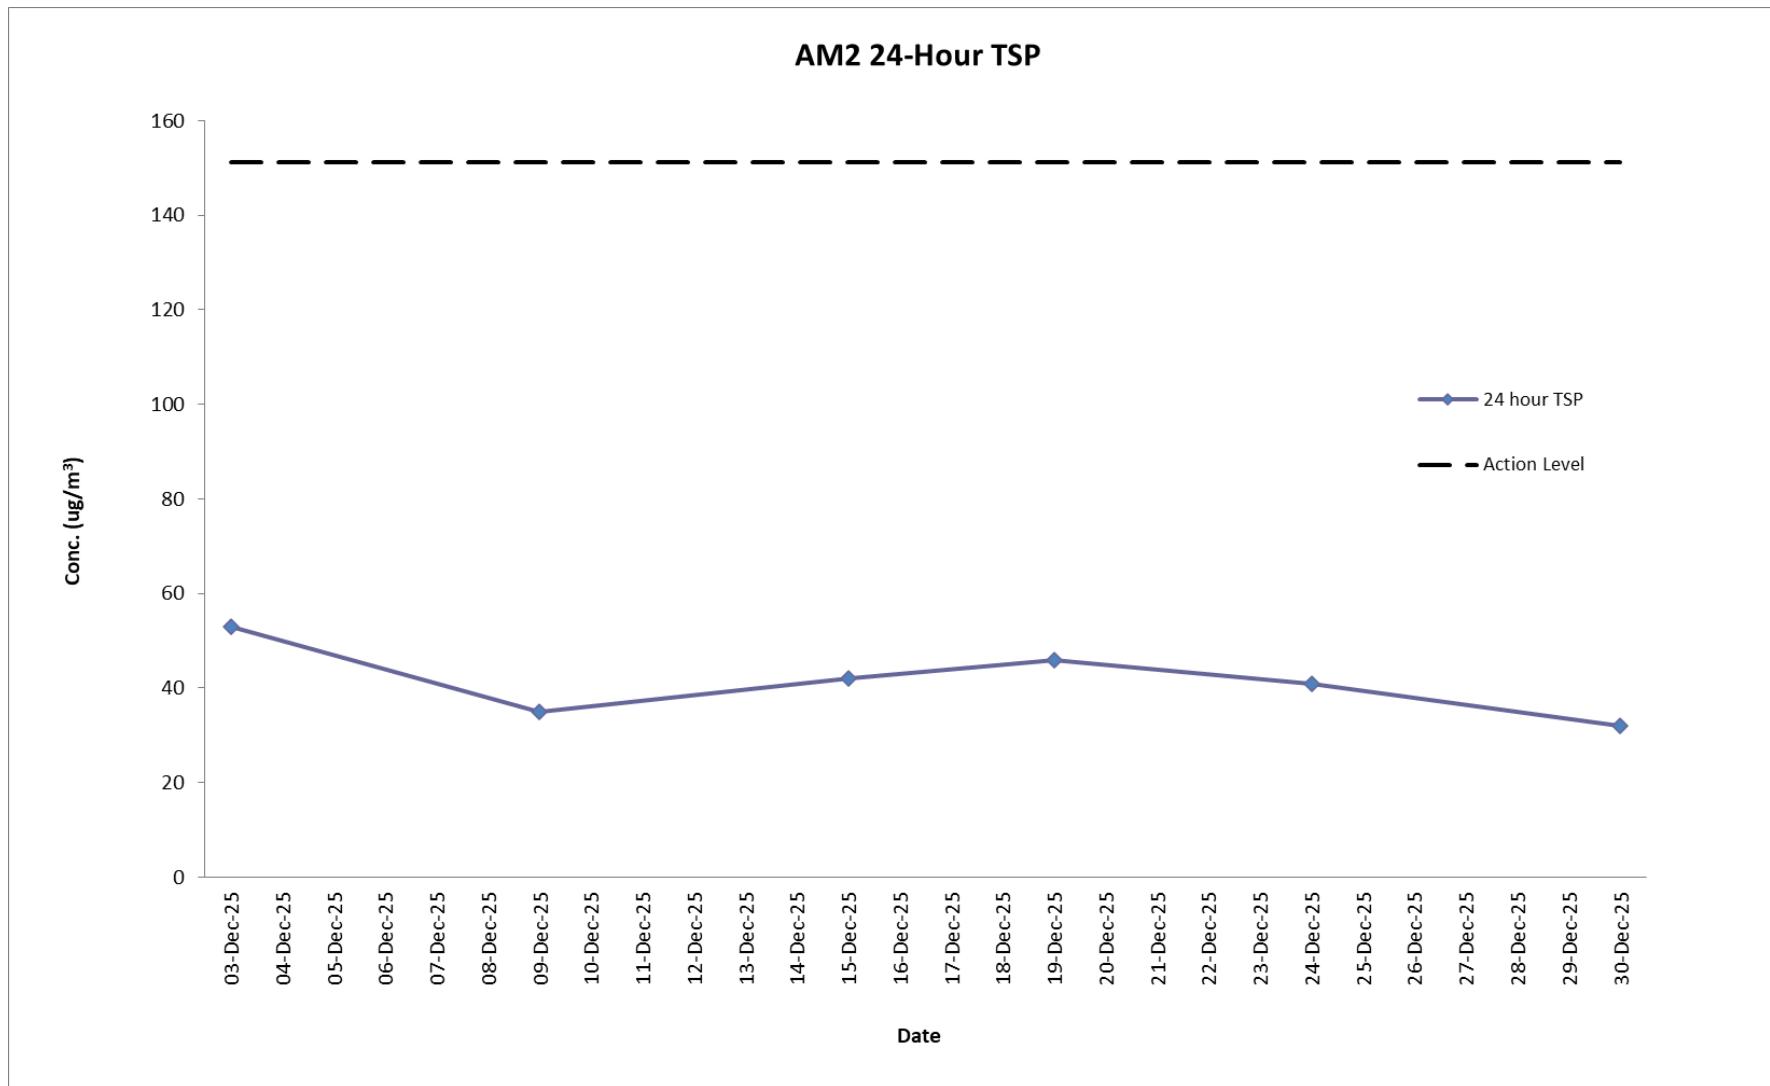
Graphical Presentation of Air Quality Monitoring Result at Station AM2 (24-hour TSP)

Start		Finish		Sampling Time (hrs)	Conc. ($\mu\text{g}/\text{m}^3$)	Weather Condition	Action Level	Limit Level
Date	Time	Date	Time					
03-Dec-25	08:45	04-Dec-25	08:45	24	53	Cloudy	151.1	260
09-Dec-25	08:43	10-Dec-25	08:43	24	35	Sunny	151.1	260
15-Dec-25	08:42	16-Dec-25	08:42	24	42	Sunny	151.1	260
19-Dec-25	08:48	20-Dec-25	08:48	24	46	Fine	151.1	260
24-Dec-25	08:45	25-Dec-25	08:45	24	41	Fine	151.1	260
30-Dec-25	08:47	31-Dec-25	08:47	24	32	Fine	151.1	260

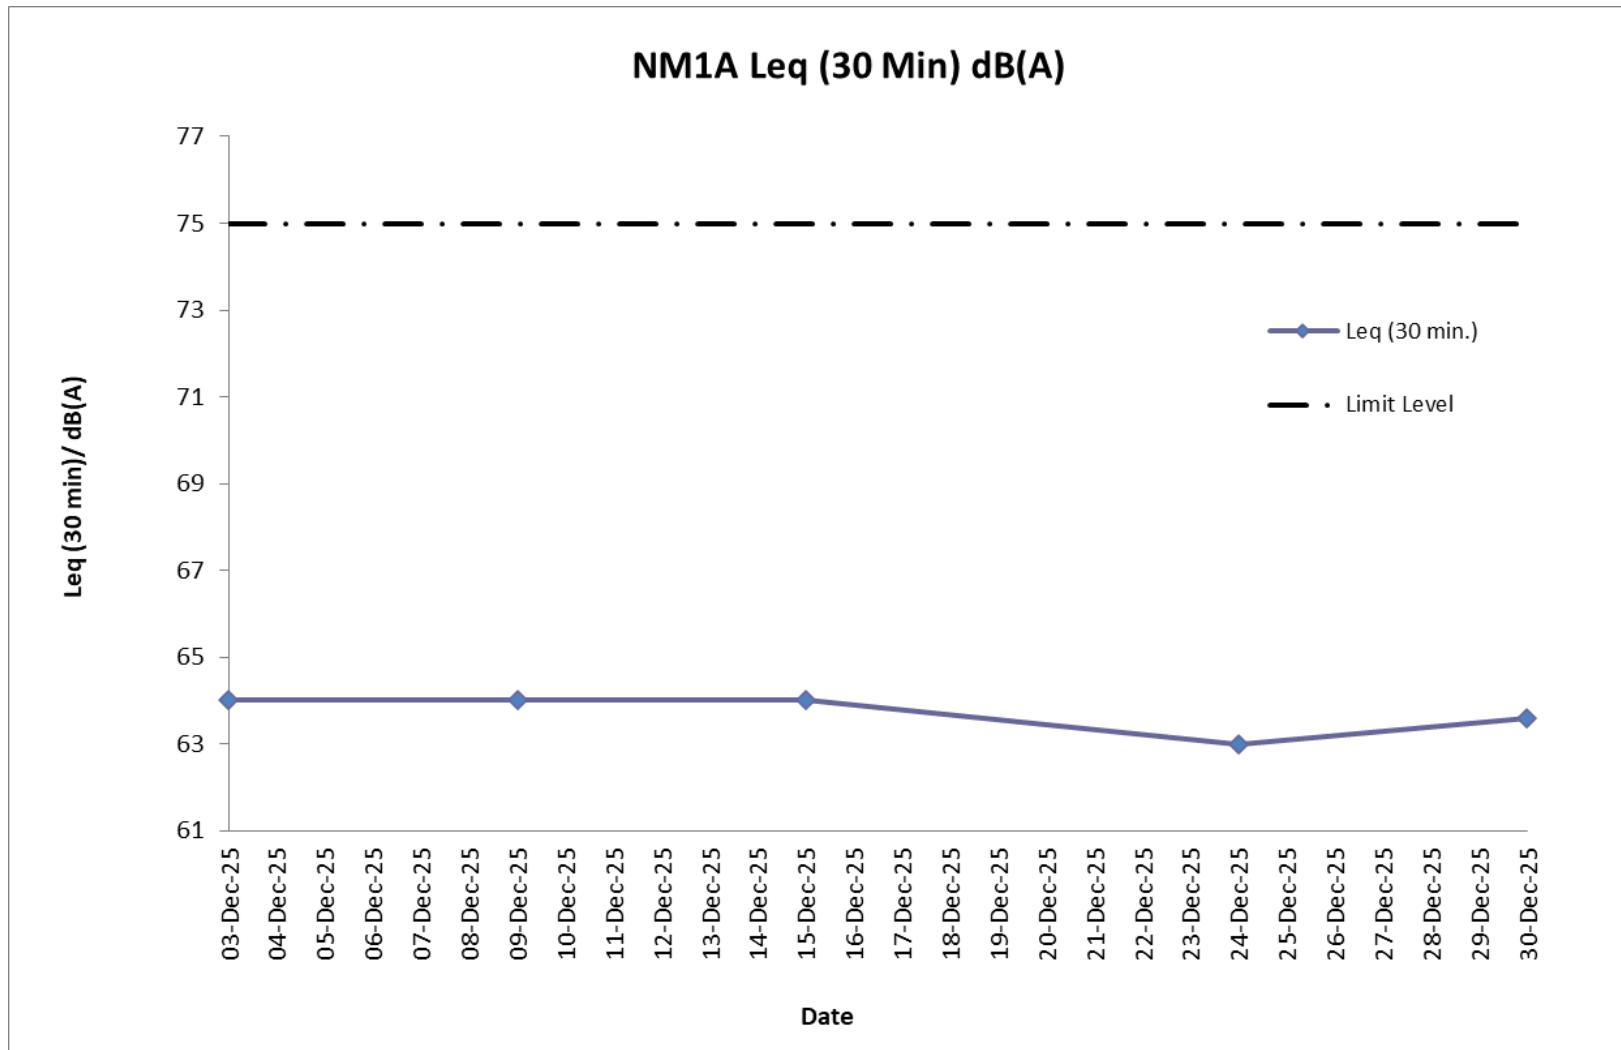
Graphical Presentation Noise Monitoring Result at Station NM1A

Date	Time	Measured L ₁₀ , dB(A)	Measured L ₉₀ , dB(A)	L _{eq} (30 min.)*, dB(A)
3-Dec-25	9:34	61.5	57.7	64
3-Dec-25	9:39	62.2	58.3	
3-Dec-25	9:44	63.8	59.0	
3-Dec-25	9:49	63.0	59.6	
3-Dec-25	9:54	62.9	58.9	
3-Dec-25	9:59	64.7	60.6	
9-Dec-25	9:31	62.9	58.3	64
9-Dec-25	9:36	61.2	57.9	
9-Dec-25	9:41	63.5	59.0	
9-Dec-25	9:46	62.8	58.6	
9-Dec-25	9:51	63.0	59.7	
9-Dec-25	9:56	62.7	58.4	
15-Dec-25	9:30	61.5	57.3	64
15-Dec-25	9:35	62.2	58.6	
15-Dec-25	9:40	62.8	58.0	
15-Dec-25	9:45	63.9	59.9	
15-Dec-25	9:50	62.0	58.7	
15-Dec-25	9:55	62.7	58.4	
24-Dec-25	9:35	62.8	58.6	63
24-Dec-25	9:40	61.5	57.3	
24-Dec-25	9:45	63.2	59.0	
24-Dec-25	9:50	62.9	58.9	
24-Dec-25	9:55	61.0	57.7	
24-Dec-25	10:00	62.7	58.4	
30-Dec-25	9:36	62.2	58.3	64
30-Dec-25	9:41	63.9	59.9	
30-Dec-25	9:46	61.8	57.0	
30-Dec-25	9:51	61.5	57.7	
30-Dec-25	9:56	62.0	58.6	
30-Dec-25	10:01	63.7	59.4

The station set-up of a free-field measurement at Station NM1A.

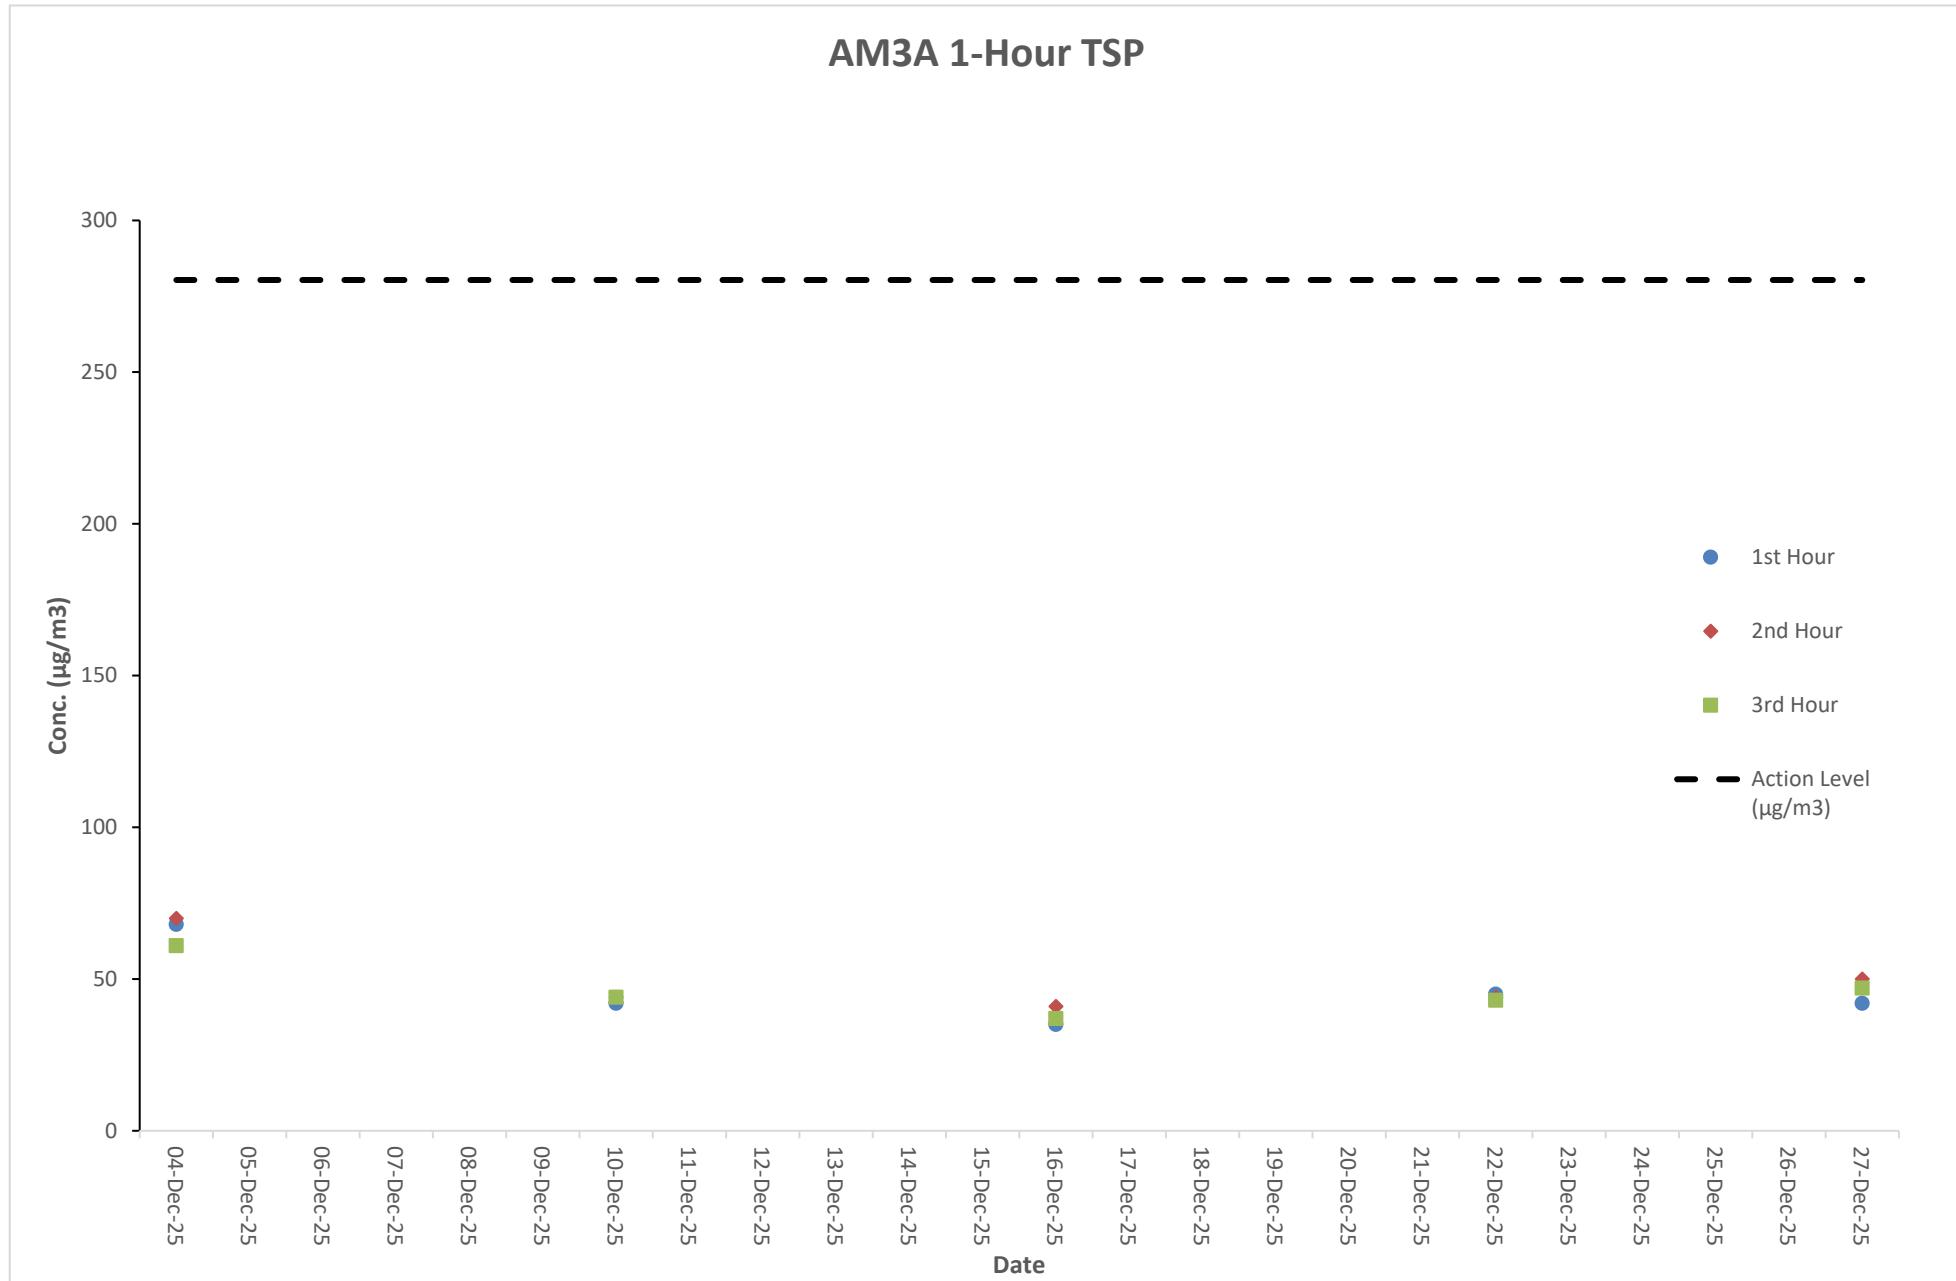
Graphical Presentation of Air Quality Monitoring Result at Station AM3A (1-hour TSP)

Date	Weather Condition	Time		Conc. (µg/m3)			Action Level	Limit Level
		Start	Finish	1st Hour	2nd Hour	3rd Hour		
04-Dec-25	Cloudy	7:00	10:00	68	70	61	280.4	500
10-Dec-25	Cloudy	13:05	16:05	42	44	44	280.4	500
16-Dec-25	Fine	7:09	10:09	35	41	37	280.4	500
22-Dec-25	Cloudy	13:02	16:02	45	44	43	280.4	500
27-Dec-25	Fine	7:02	10:02	42	50	47	280.4	500

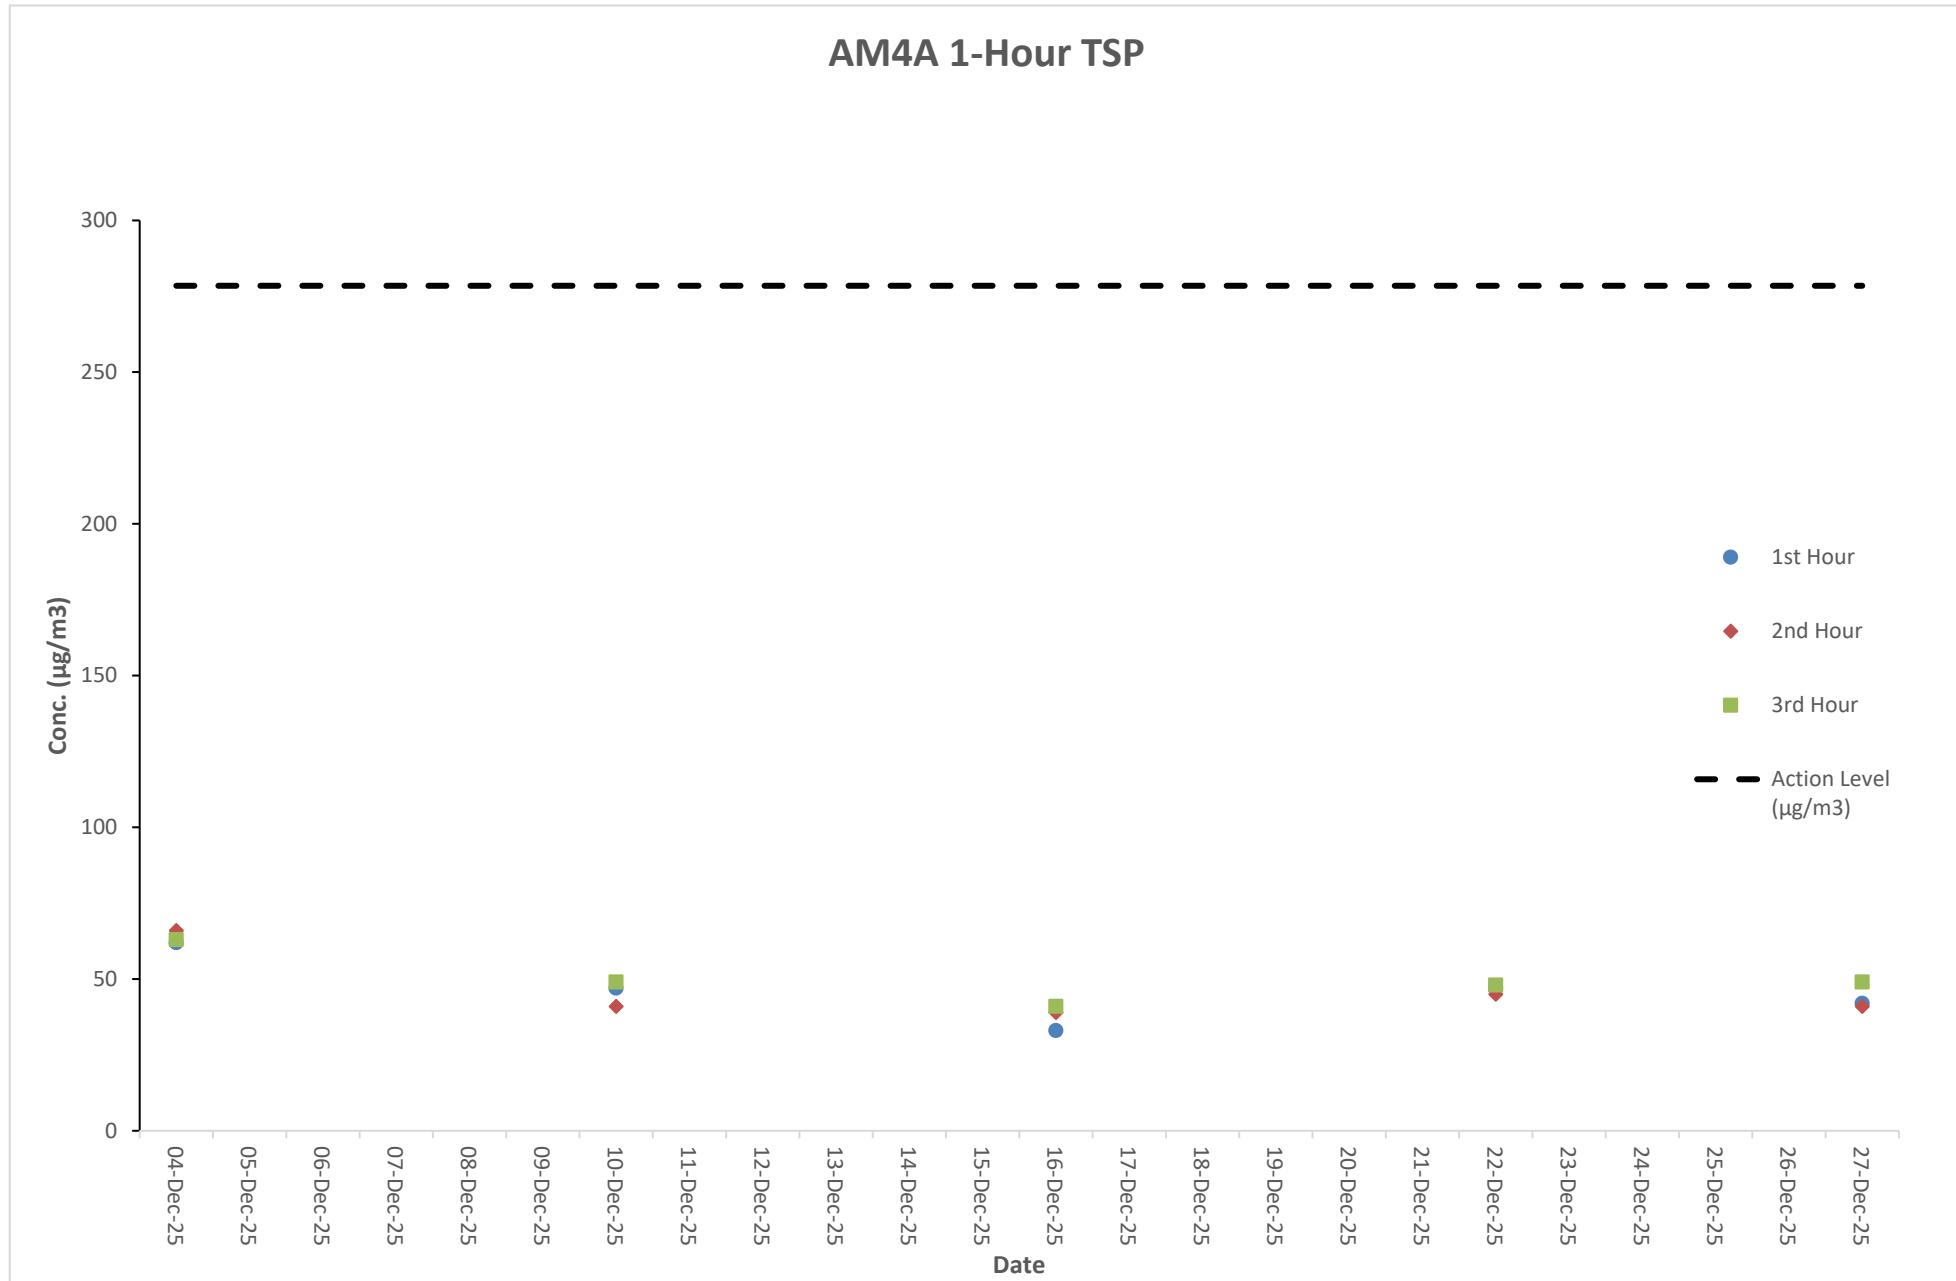
Graphical Presentation of Air Quality Monitoring Result at Station AM4A (1-hour TSP)

Date	Weather Condition	Time		Conc. (µg/m3)			Action Level	Limit Level
		Start	Finish	1st Hour	2nd Hour	3rd Hour		
04-Dec-25	Cloudy	7:08	10:08	62	66	63	278.5	500
10-Dec-25	Cloudy	13:13	16:13	47	41	49	278.5	500
16-Dec-25	Fine	7:17	10:17	33	39	41	278.5	500
22-Dec-25	Cloudy	13:10	16:10	47	45	48	278.5	500
27-Dec-25	Fine	7:10	10:10	42	41	49	278.5	500

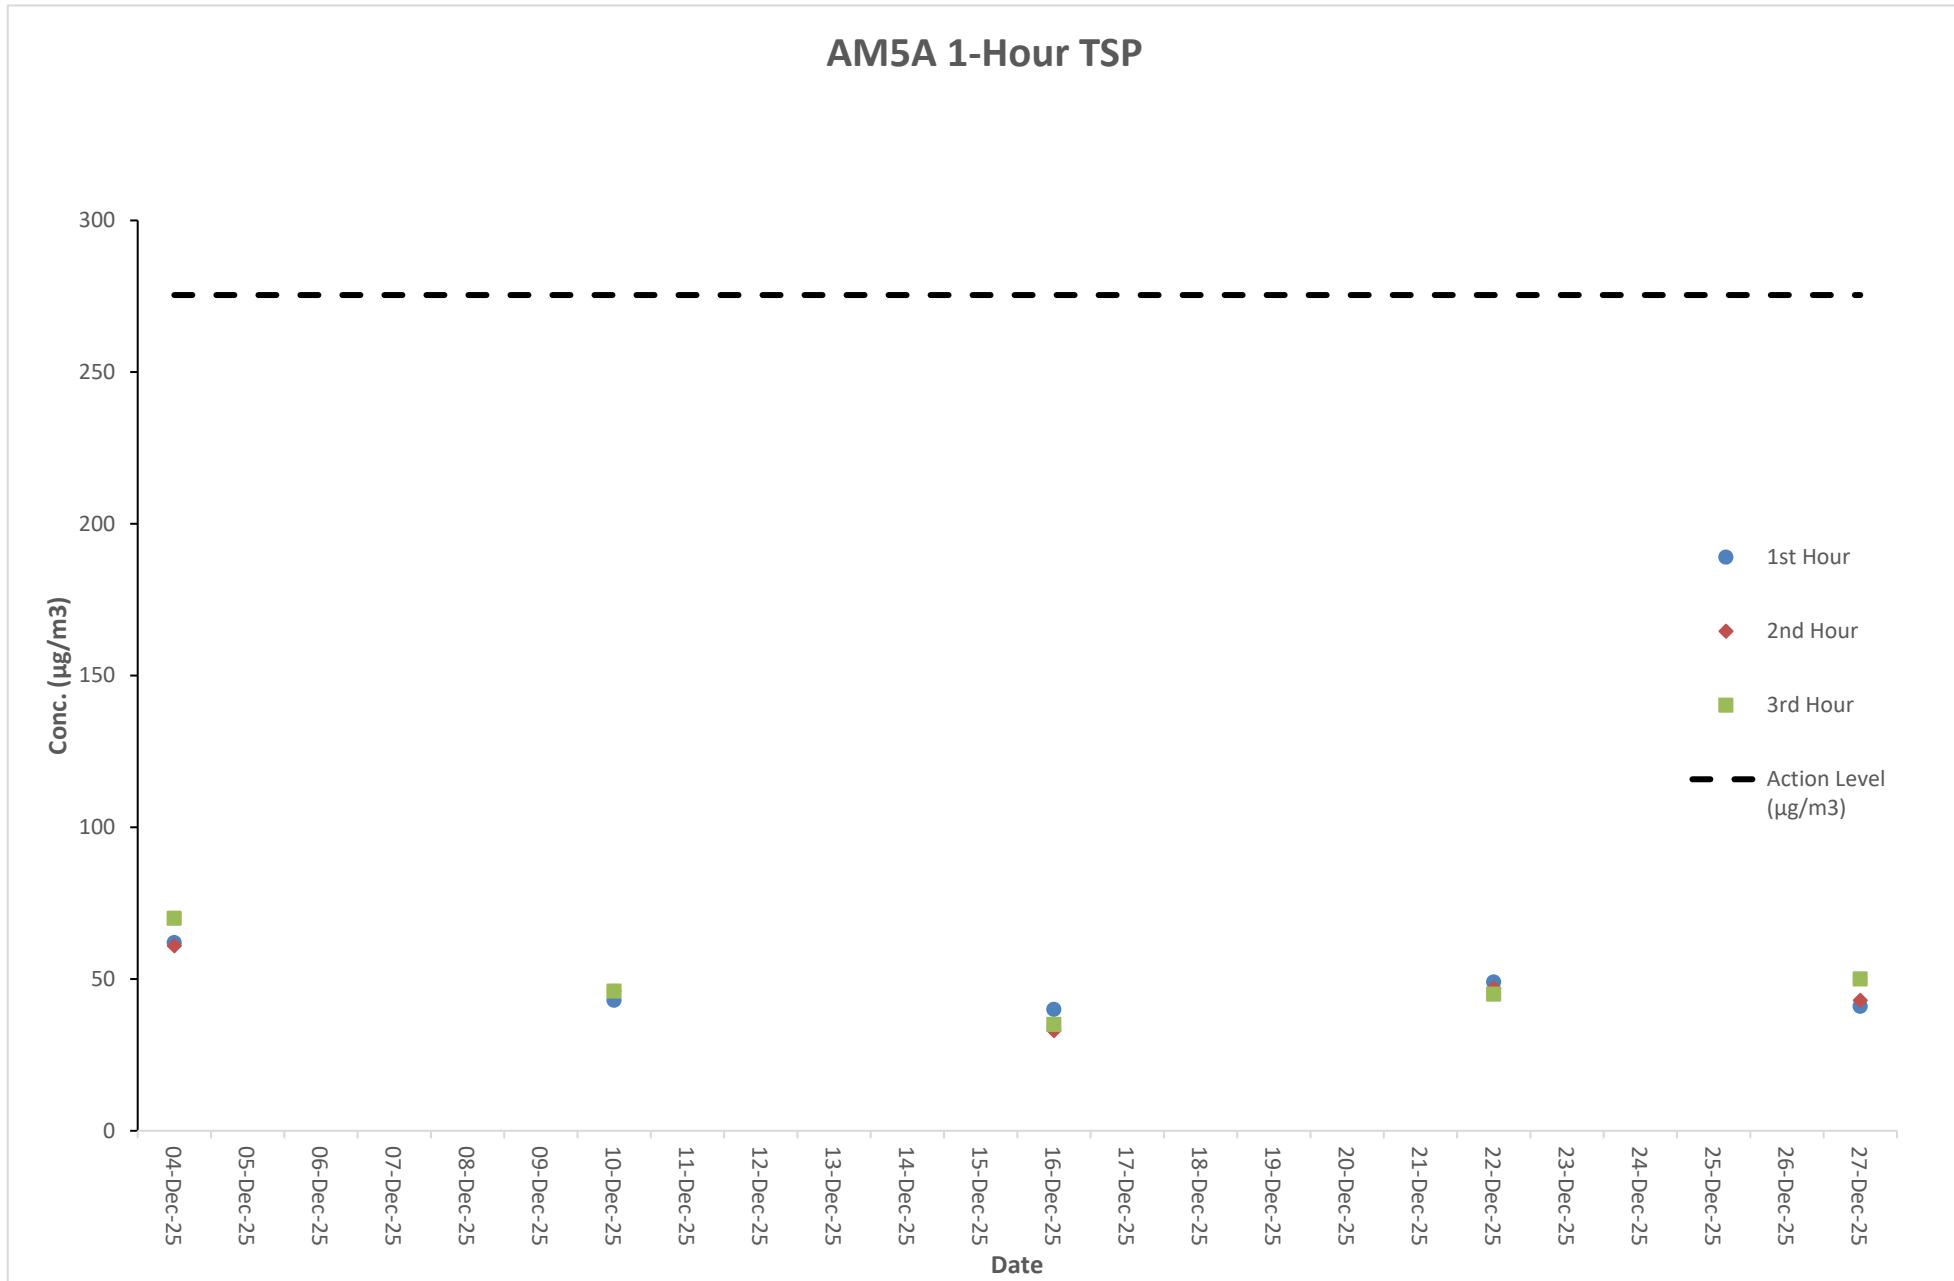
Graphical Presentation of Air Quality Monitoring Result at Station AM5A (1-hour TSP)

Date	Weather Condition	Time		Conc. (µg/m3)			Action Level	Limit Level
		Start	Finish	1st Hour	2nd Hour	3rd Hour		
04-Dec-25	Cloudy	7:23	10:23	62	61	70	275.4	500
10-Dec-25	Cloudy	13:30	16:30	43	46	46	275.4	500
16-Dec-25	Fine	7:32	10:32	40	33	35	275.4	500
22-Dec-25	Cloudy	13:27	16:27	49	47	45	275.4	500
27-Dec-25	Fine	7:25	10:25	41	43	50	275.4	500

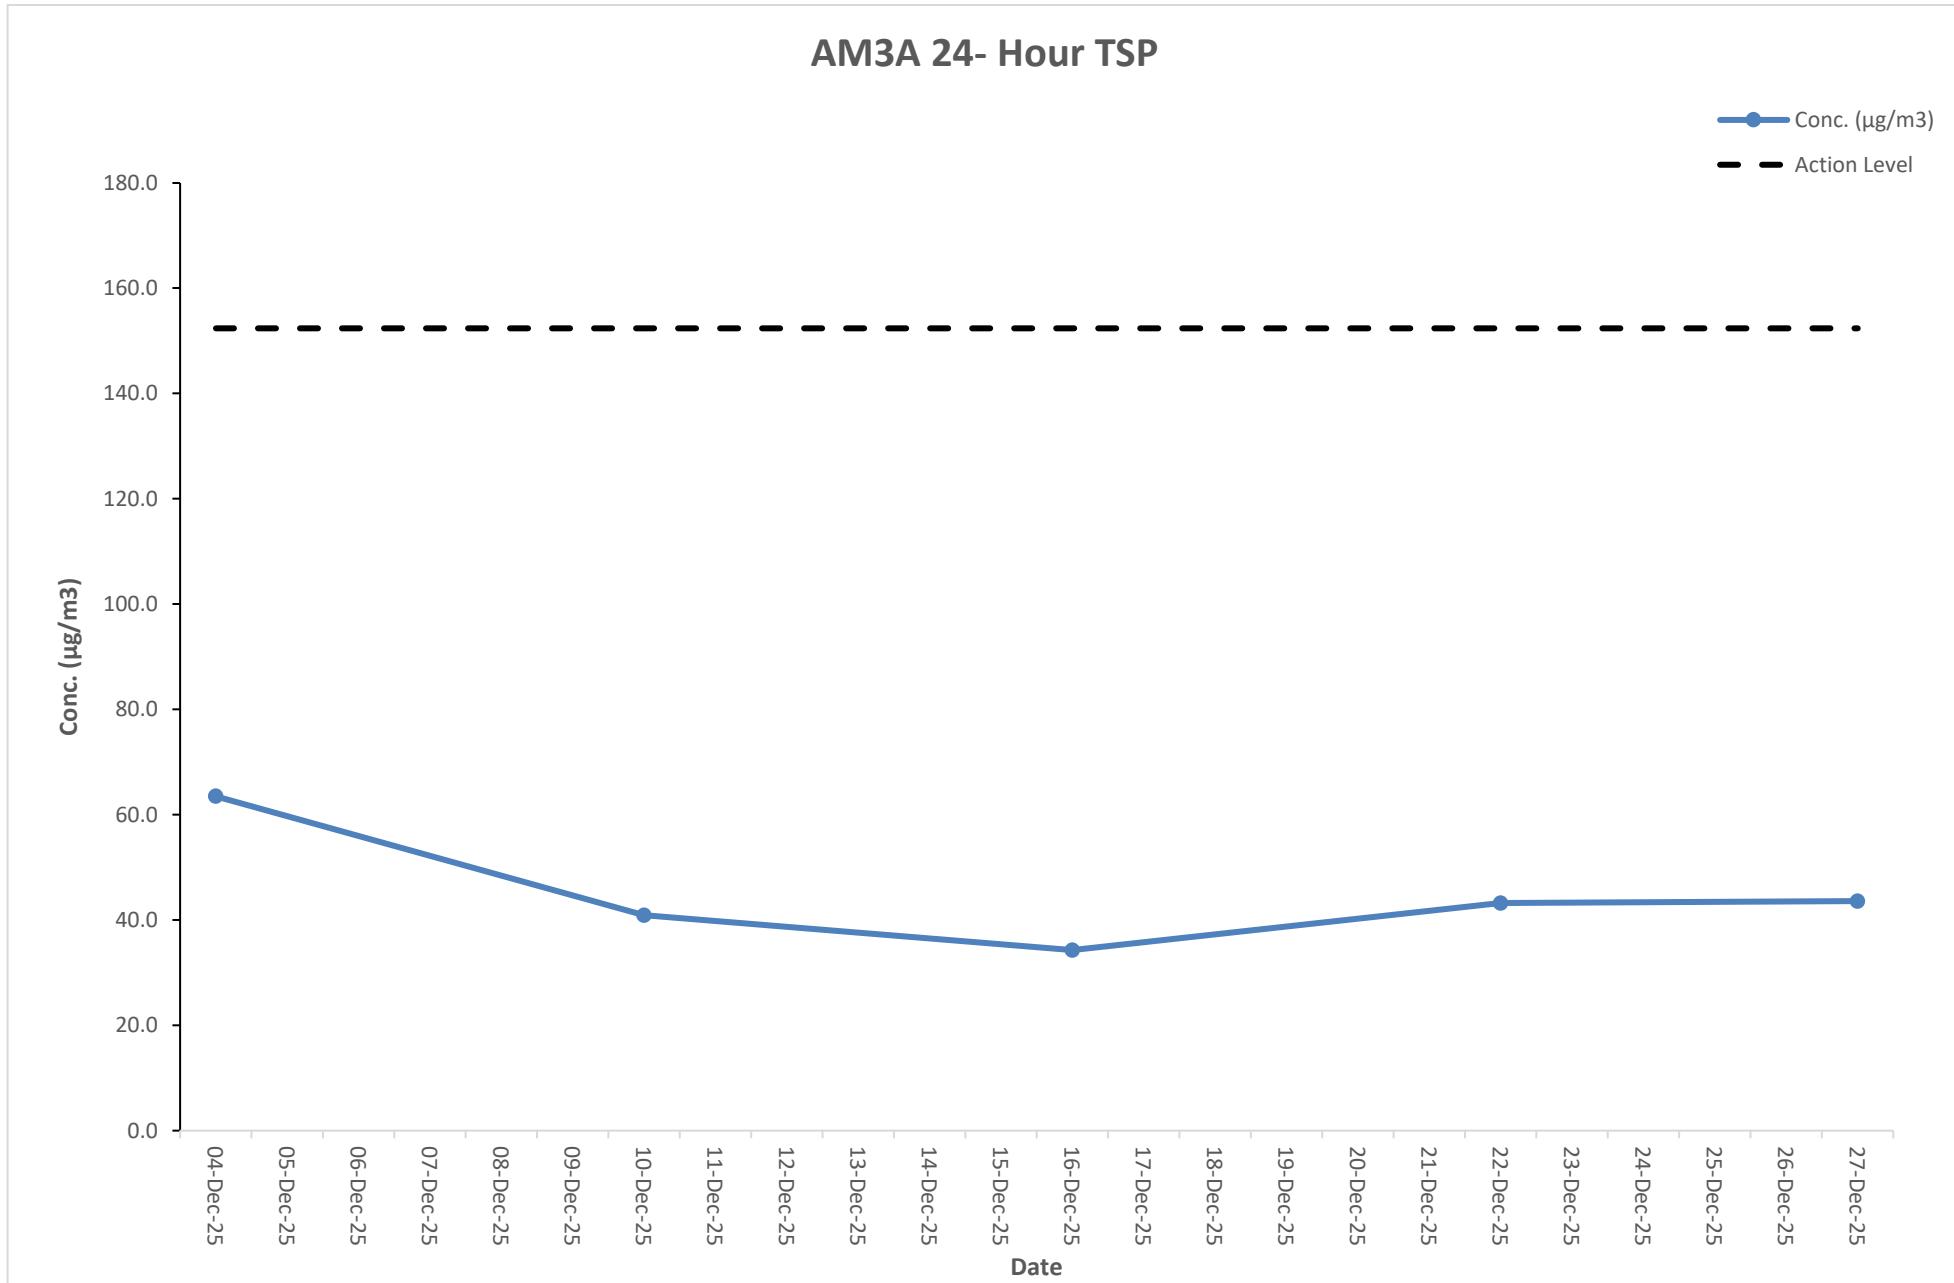
Graphical Presentation of Air Quality Monitoring Result at Station AM3A (24-hour TSP)

Start		Finish		Filter Weight (g)		Elapsed Time Reading		Sampling Time (hrs)	Flow Rate (m ³ /min)			Conc. (µg/m ³)	Weather Condition	Action Level	Limit Level
Date	Time	Date	Time	Initial	Final	Initial	Final		Initial	Final	Average				
4-12-2025	10:00AM	5-12-2025	10:00AM	2.8024	2.9046	9262.8	9286.8	24	1.12	1.12	1.12	63.5	Cloudy	152.4	260
10-12-2025	10:00AM	11-12-2025	10:00AM	2.8080	2.8739	9286.8	9310.8	24	1.12	1.12	1.12	40.9	Cloudy	152.4	260
16-12-2025	10:00AM	17-12-2025	10:00AM	2.8062	2.8614	9310.8	9334.8	24	1.12	1.12	1.12	34.3	Sunny	152.4	260
22-12-2025	10:00AM	23-12-2025	10:00AM	2.8028	2.8724	9334.8	9358.8	24	1.12	1.12	1.12	43.2	Cloudy	152.4	260
27-12-2025	10:00AM	28-12-2025	10:00AM	2.8088	2.8789	9358.8	9382.8	24	1.12	1.12	1.12	43.6	Sunny	152.4	260

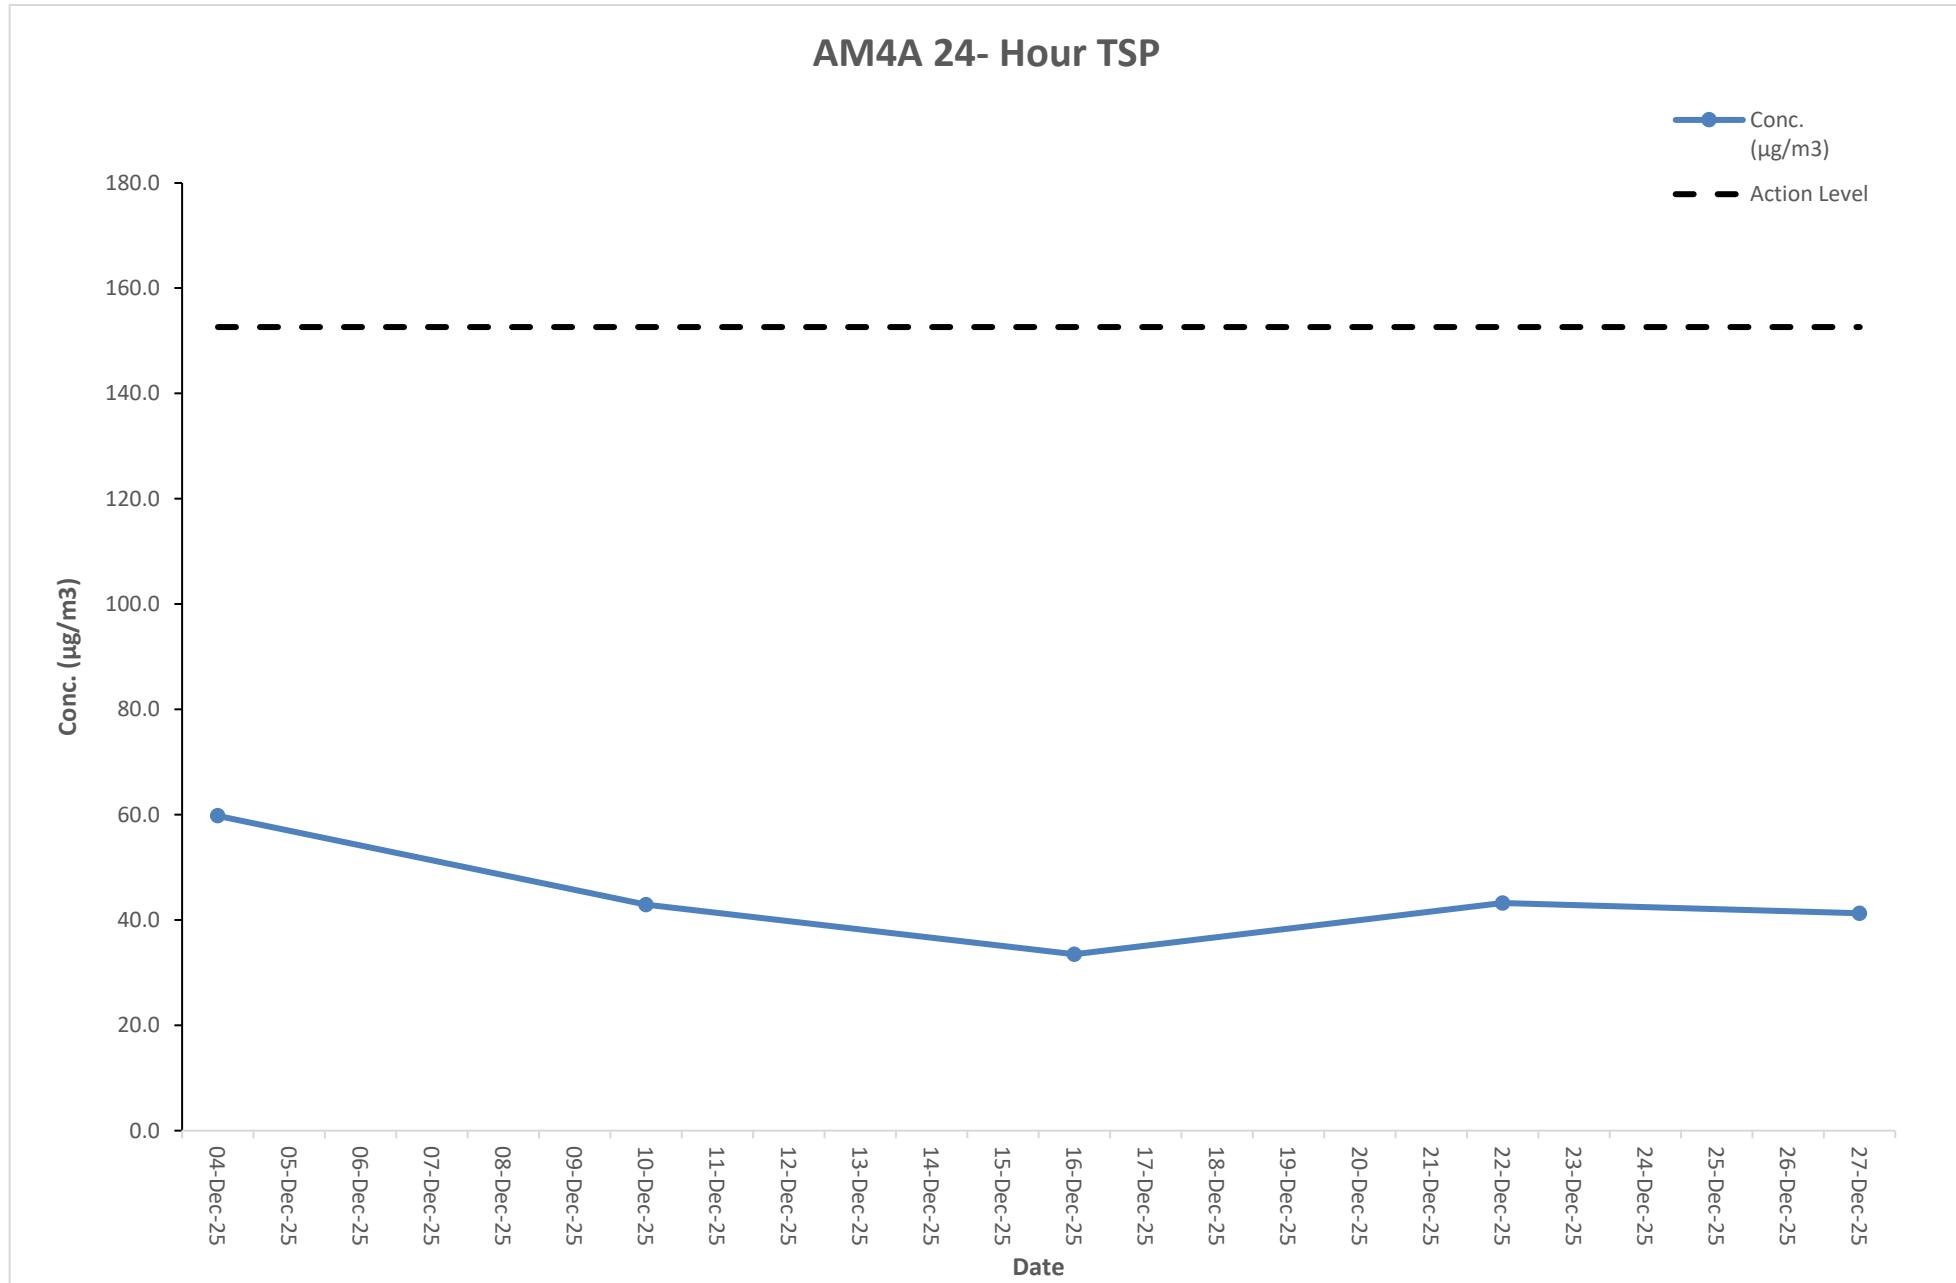
Graphical Presentation of Air Quality Monitoring Result at Station AM4A (24-hour TSP)

Start		Finish		Filter Weight (g)		Elapsed Time Reading		Sampling Time (hrs)	Flow Rate (m ³ /min)			Conc. (µg/m ³)	Weather Condition	Action Level	Limit Level
Date	Time	Date	Time	Initial	Final	Initial	Final		Initial	Final	Average				
4-12-2025	10:00AM	5-12-2025	10:00AM	2.8026	2.8989	9682.4	9706.4	24	1.12	1.12	1.12	59.8	Cloudy	152.6	260
10-12-2025	10:00AM	11-12-2025	10:00AM	2.8066	2.8756	9706.4	9730.4	24	1.12	1.12	1.12	42.9	Cloudy	152.6	260
16-12-2025	10:00AM	17-12-2025	10:00AM	2.8052	2.8592	9730.4	9754.4	24	1.12	1.12	1.12	33.5	Sunny	152.6	260
22-12-2025	10:00AM	23-12-2025	10:00AM	2.8056	2.8751	9754.4	9778.4	24	1.12	1.12	1.12	43.2	Cloudy	152.6	260
27-12-2025	10:00AM	28-12-2025	10:00AM	2.8062	2.8726	9778.4	9802.4	24	1.12	1.12	1.12	41.3	Sunny	152.6	260
