Development at West Kowloon Cultural District

**Monthly Environmental Monitoring and Audit (EM&A) Report
for December 2025**

**Part-2: EM&A for ELS Works for The
Integrated Basement and
Underground Road in Zones 2A, 2B
& 2C**

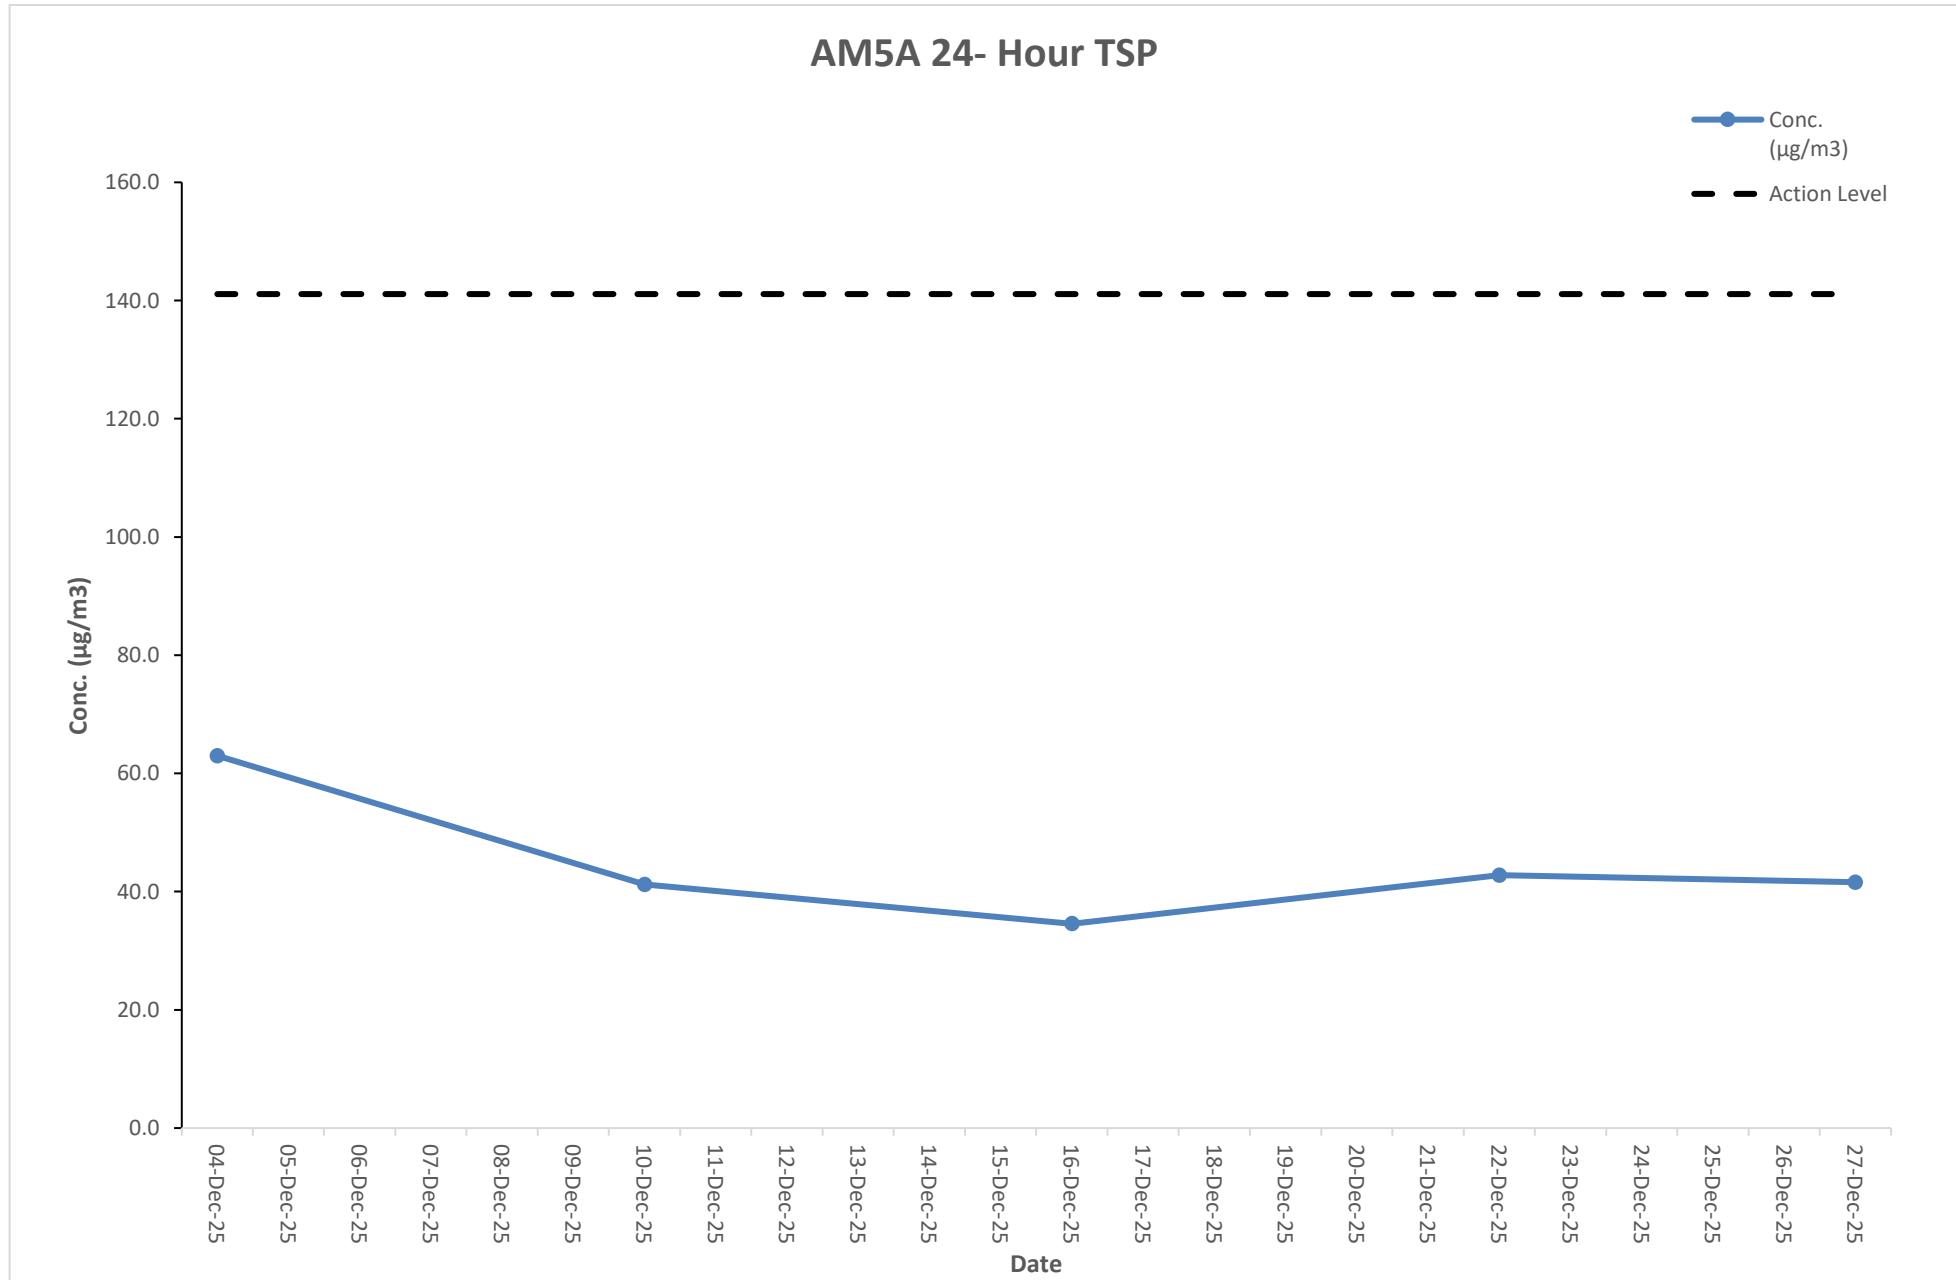
Graphical Presentation of Air Quality Monitoring Result at Station AM5A (24-hour TSP)

Start		Finish		Filter Weight (g)		Elapsed Time Reading		Sampling Time (hrs)	Flow Rate (m ³ /min)			Conc. (µg/m ³)	Weather Condition	Action Level	Limit Level
Date	Time	Date	Time	Initial	Final	Initial	Final		Initial	Final	Average				
4-12-2025	10:00AM	5-12-2025	10:00AM	2.8067	2.9081	9820.6	9844.6	24	1.12	1.12	1.12	63.0	Cloudy	141.1	260
10-12-2025	10:00AM	11-12-2025	10:00AM	2.8071	2.8735	9844.6	9868.6	24	1.12	1.12	1.12	41.2	Cloudy	141.1	260
16-12-2025	10:00AM	17-12-2025	10:00AM	2.8016	2.8573	9868.6	9892.6	24	1.12	1.12	1.12	34.6	Sunny	141.1	260
22-12-2025	10:00AM	23-12-2025	10:00AM	2.8026	2.8716	9892.6	9916.6	24	1.12	1.12	1.12	42.8	Cloudy	141.1	260
27-12-2025	10:00AM	28-12-2025	10:00AM	2.8011	2.8680	9916.6	9940.6	24	1.12	1.12	1.12	41.6	Sunny	141.1	260

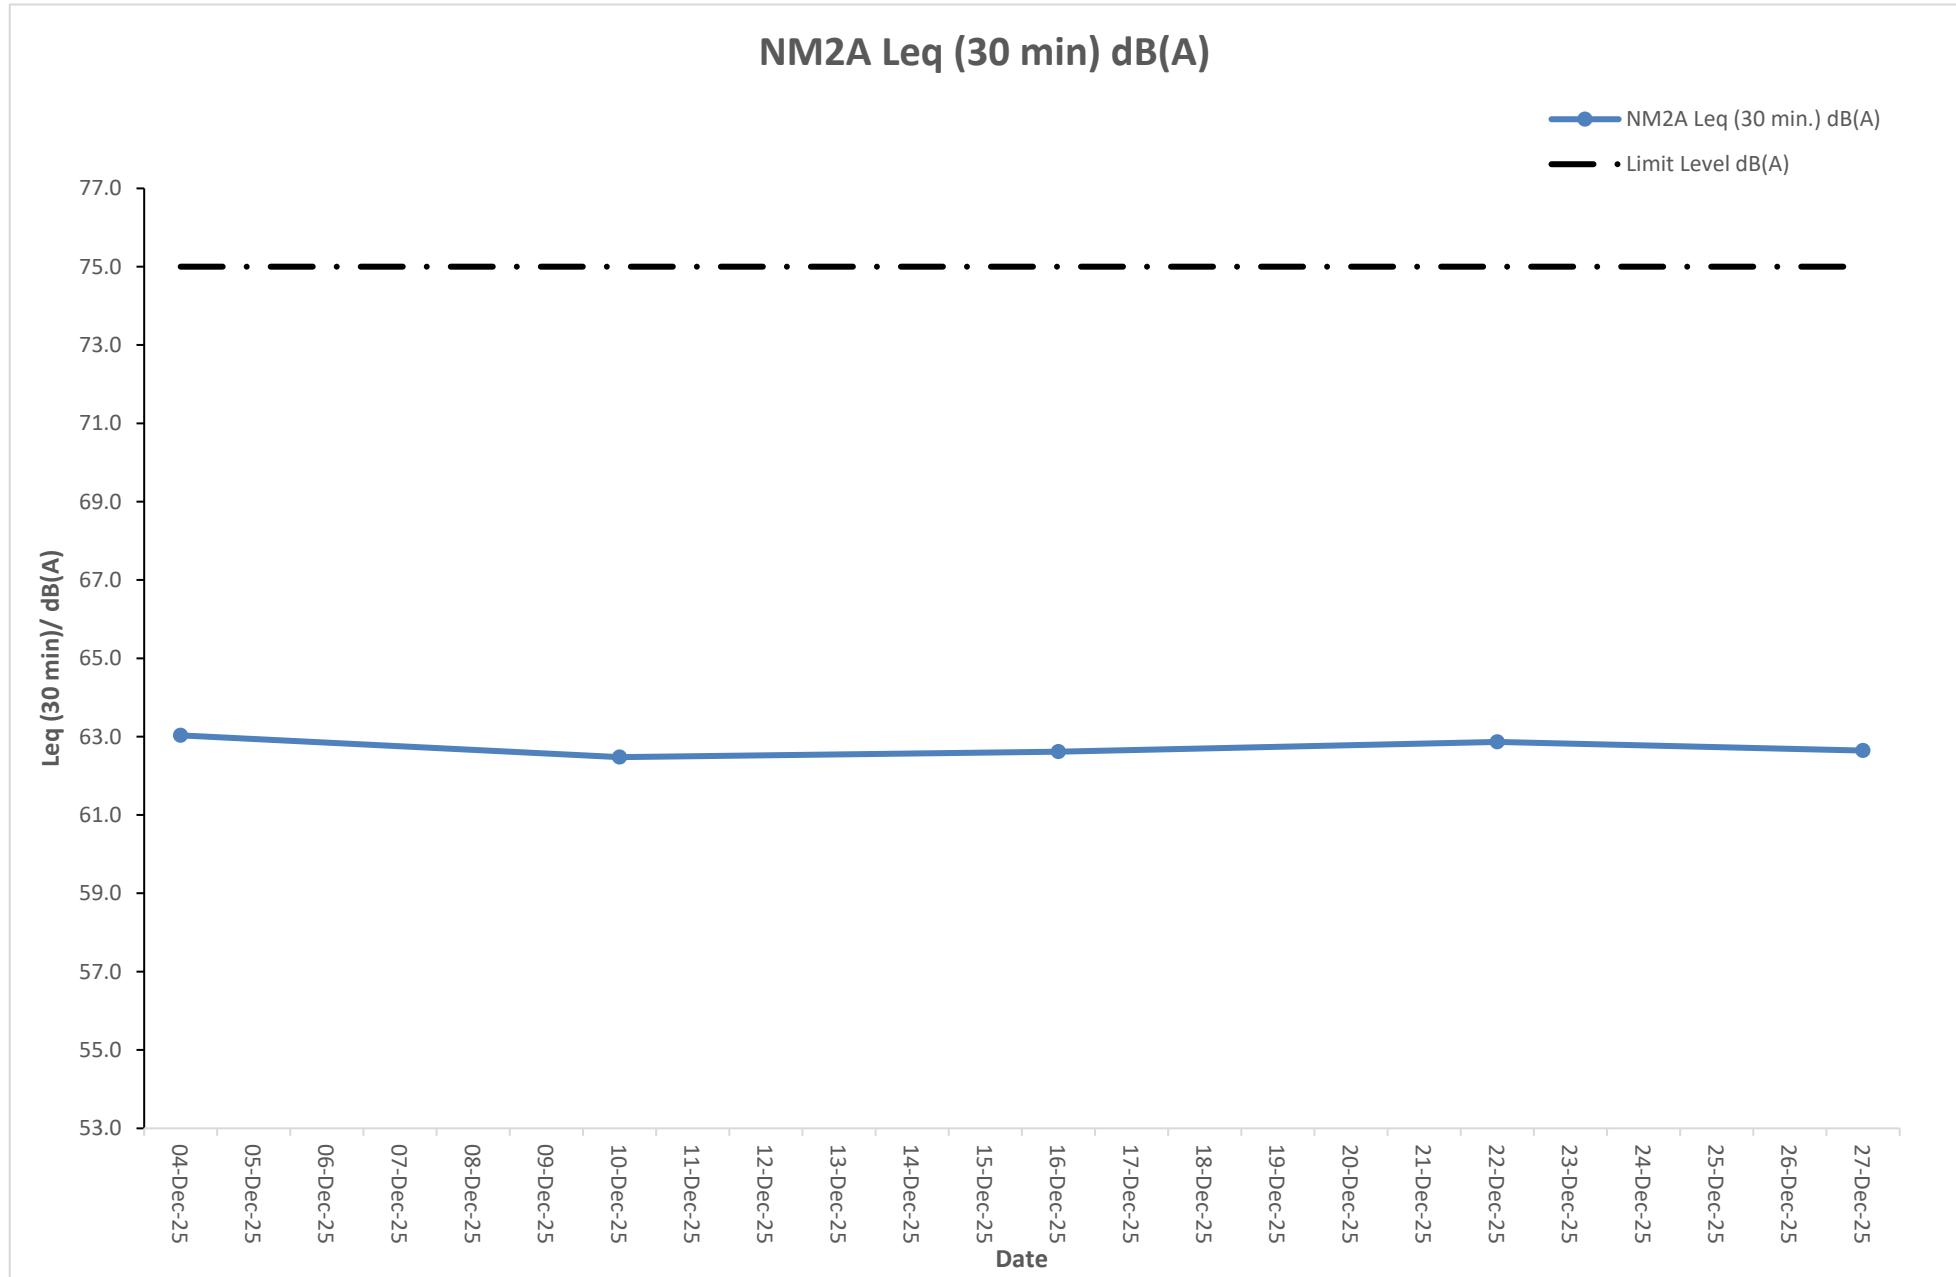
Graphical Presentation of Noise Monitoring Result at Station NM2A

Date	Time	Measured L10 dB(A)	Measured L90 dB(A)	Leq (30 min.) dB(A)
04-Dec-25	7:00	64.3	61.3	63.0
04-Dec-25	7:05	64.5	60.8	
04-Dec-25	7:10	64.1	60.2	
04-Dec-25	7:15	63.9	61.5	
04-Dec-25	7:20	64.9	60.6	
04-Dec-25	7:25	64.6	60.5	
10-Dec-25	13:05	64.1	61.0	62.5
10-Dec-25	13:10	63.8	60.7	
10-Dec-25	13:15	65.0	61.4	
10-Dec-25	13:20	64.3	60.3	
10-Dec-25	13:25	64.4	60.7	
10-Dec-25	13:30	64.1	60.8	
16-Dec-25	7:09	64.8	61.5	62.6
16-Dec-25	7:14	63.8	60.6	
16-Dec-25	7:19	64.4	60.3	
16-Dec-25	7:24	63.6	60.6	
16-Dec-25	7:29	63.8	60.6	
16-Dec-25	7:34	64.8	61.4	
22-Dec-25	13:02	64.5	60.8	62.9
22-Dec-25	13:07	63.7	60.6	
22-Dec-25	13:12	64.4	60.9	
22-Dec-25	13:17	64.0	60.7	
22-Dec-25	13:22	64.2	60.2	
22-Dec-25	13:27	64.2	61.1	
27-Dec-25	7:02	63.6	60.7	62.6
27-Dec-25	7:07	63.6	61.0	
27-Dec-25	7:12	63.6	60.9	
27-Dec-25	7:17	64.2	60.3	
27-Dec-25	7:22	64.0	61.0	
27-Dec-25	7:27	64.1	60.3

The station set-up of a façade measurement at station NM2A.

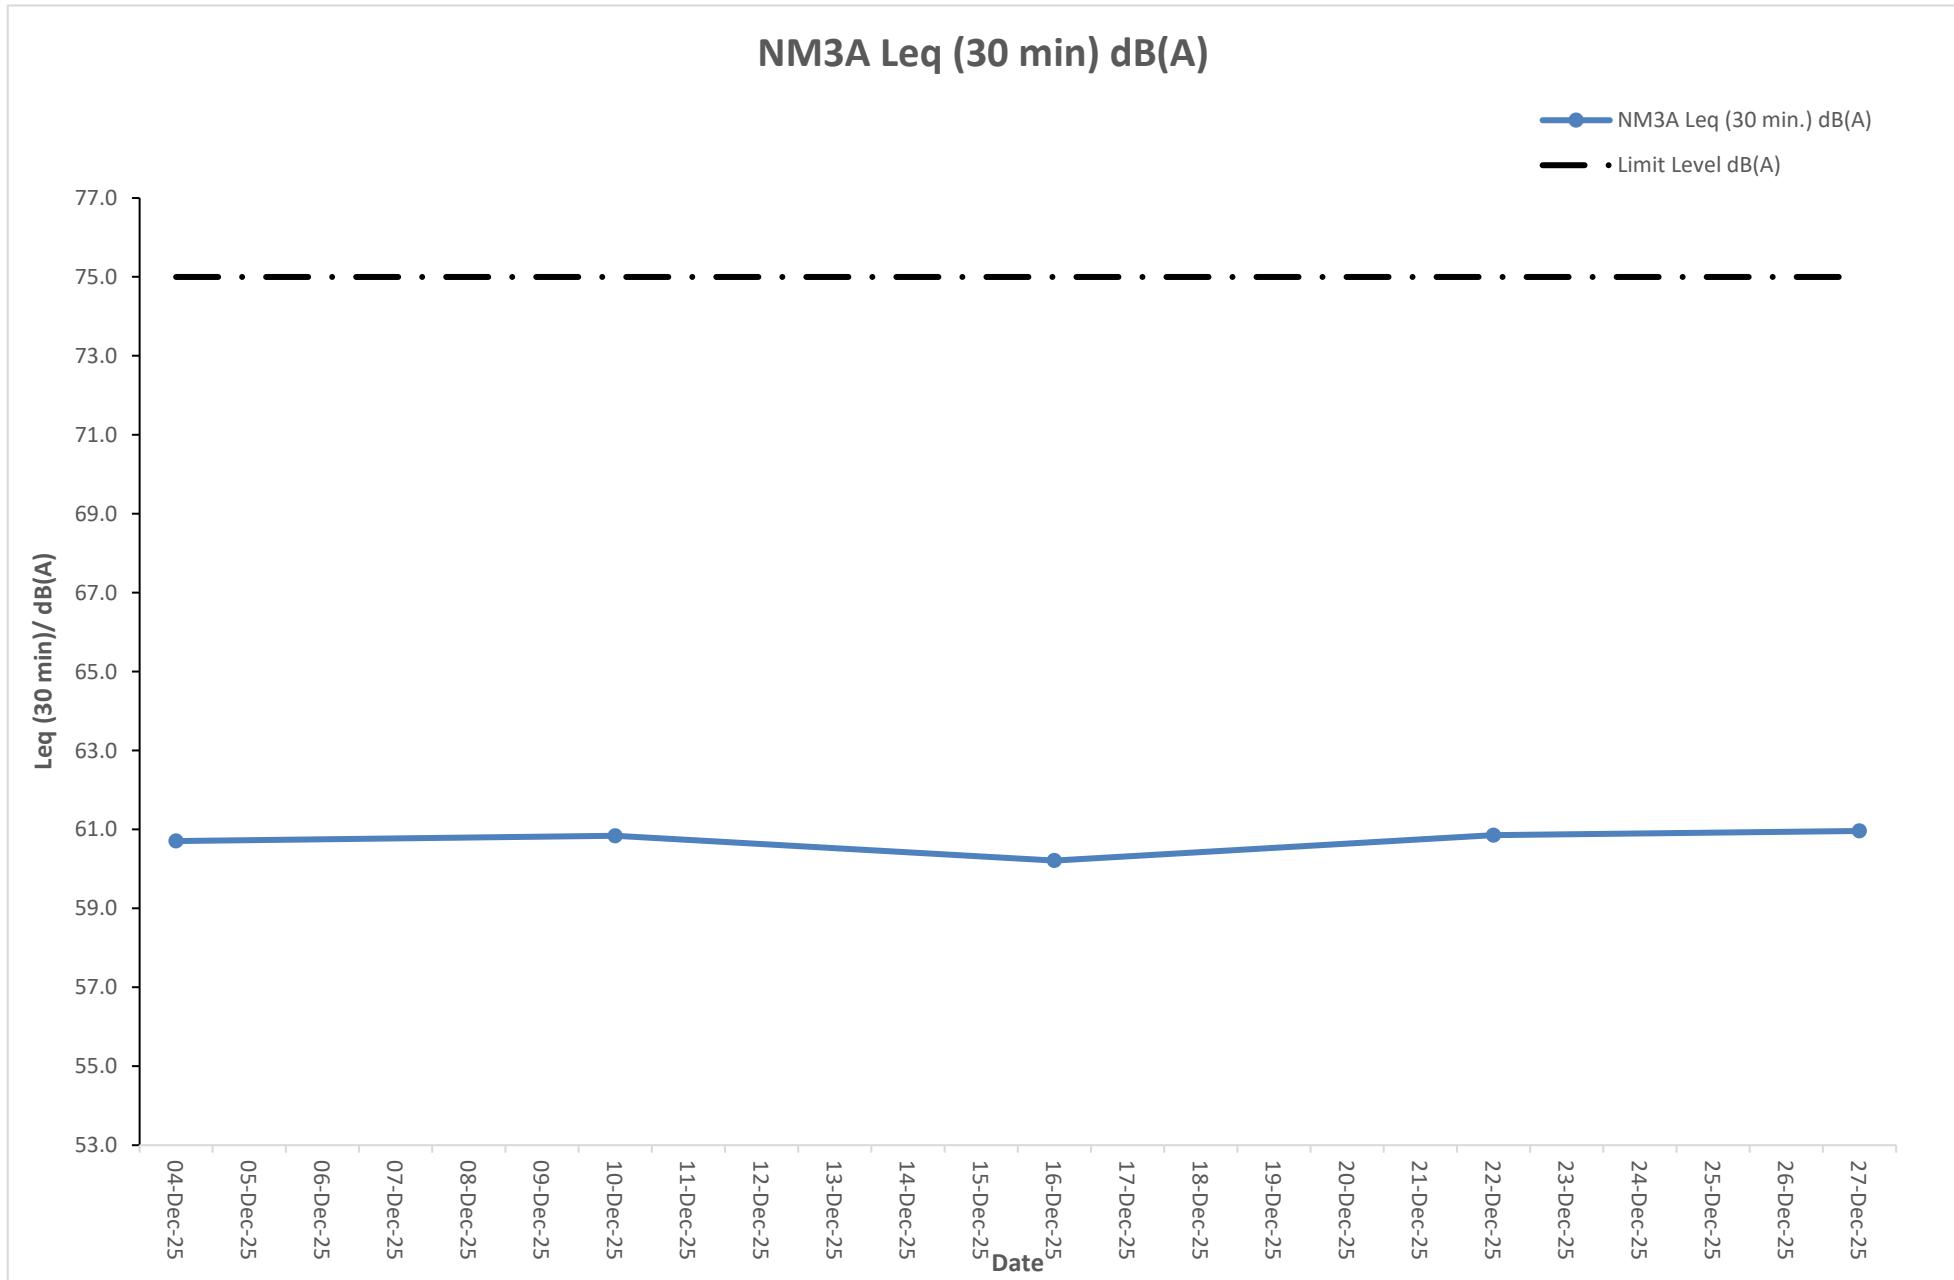
Graphical Presentation of Noise Monitoring Result at Station NM3A

Date	Time	Measured L10 dB(A)	Measured L90 dB(A)	Leq (30 min.) dB(A)
04-Dec-25	8:30	62.6	57.5	60.7
04-Dec-25	8:35	63.8	57.3	
04-Dec-25	8:40	62.1	55.9	
04-Dec-25	8:45	62.3	56.2	
04-Dec-25	8:50	62.3	57.4	
04-Dec-25	8:55	62.5	57.1	
10-Dec-25	14:26	63.2	56.8	60.8
10-Dec-25	14:31	62.5	57.7	
10-Dec-25	14:36	63.4	57.3	
10-Dec-25	14:41	63.5	56.2	
10-Dec-25	14:46	62.6	56.4	
10-Dec-25	14:51	62.7	57.3	
16-Dec-25	8:39	62.4	56.5	60.2
16-Dec-25	8:44	62.7	56.4	
16-Dec-25	8:49	63.6	56.5	
16-Dec-25	8:54	62.9	57.4	
16-Dec-25	8:59	62.1	57.3	
16-Dec-25	9:04	62.3	56.5	
22-Dec-25	14:27	62.6	56.1	60.9
22-Dec-25	14:32	61.9	57.1	
22-Dec-25	14:37	62.2	57.8	
22-Dec-25	14:42	63.6	56.5	
22-Dec-25	14:47	63.6	57.4	
22-Dec-25	14:52	63.2	56.2	
27-Dec-25	8:41	62.7	57.1	61.0
27-Dec-25	8:46	63.5	56.3	
27-Dec-25	8:51	62.6	56.8	
27-Dec-25	8:56	62.4	56.9	
27-Dec-25	9:01	63.5	56.8	
27-Dec-25	9:06	62.1	57.5

The station set-up of a façade measurement at station NM3A.

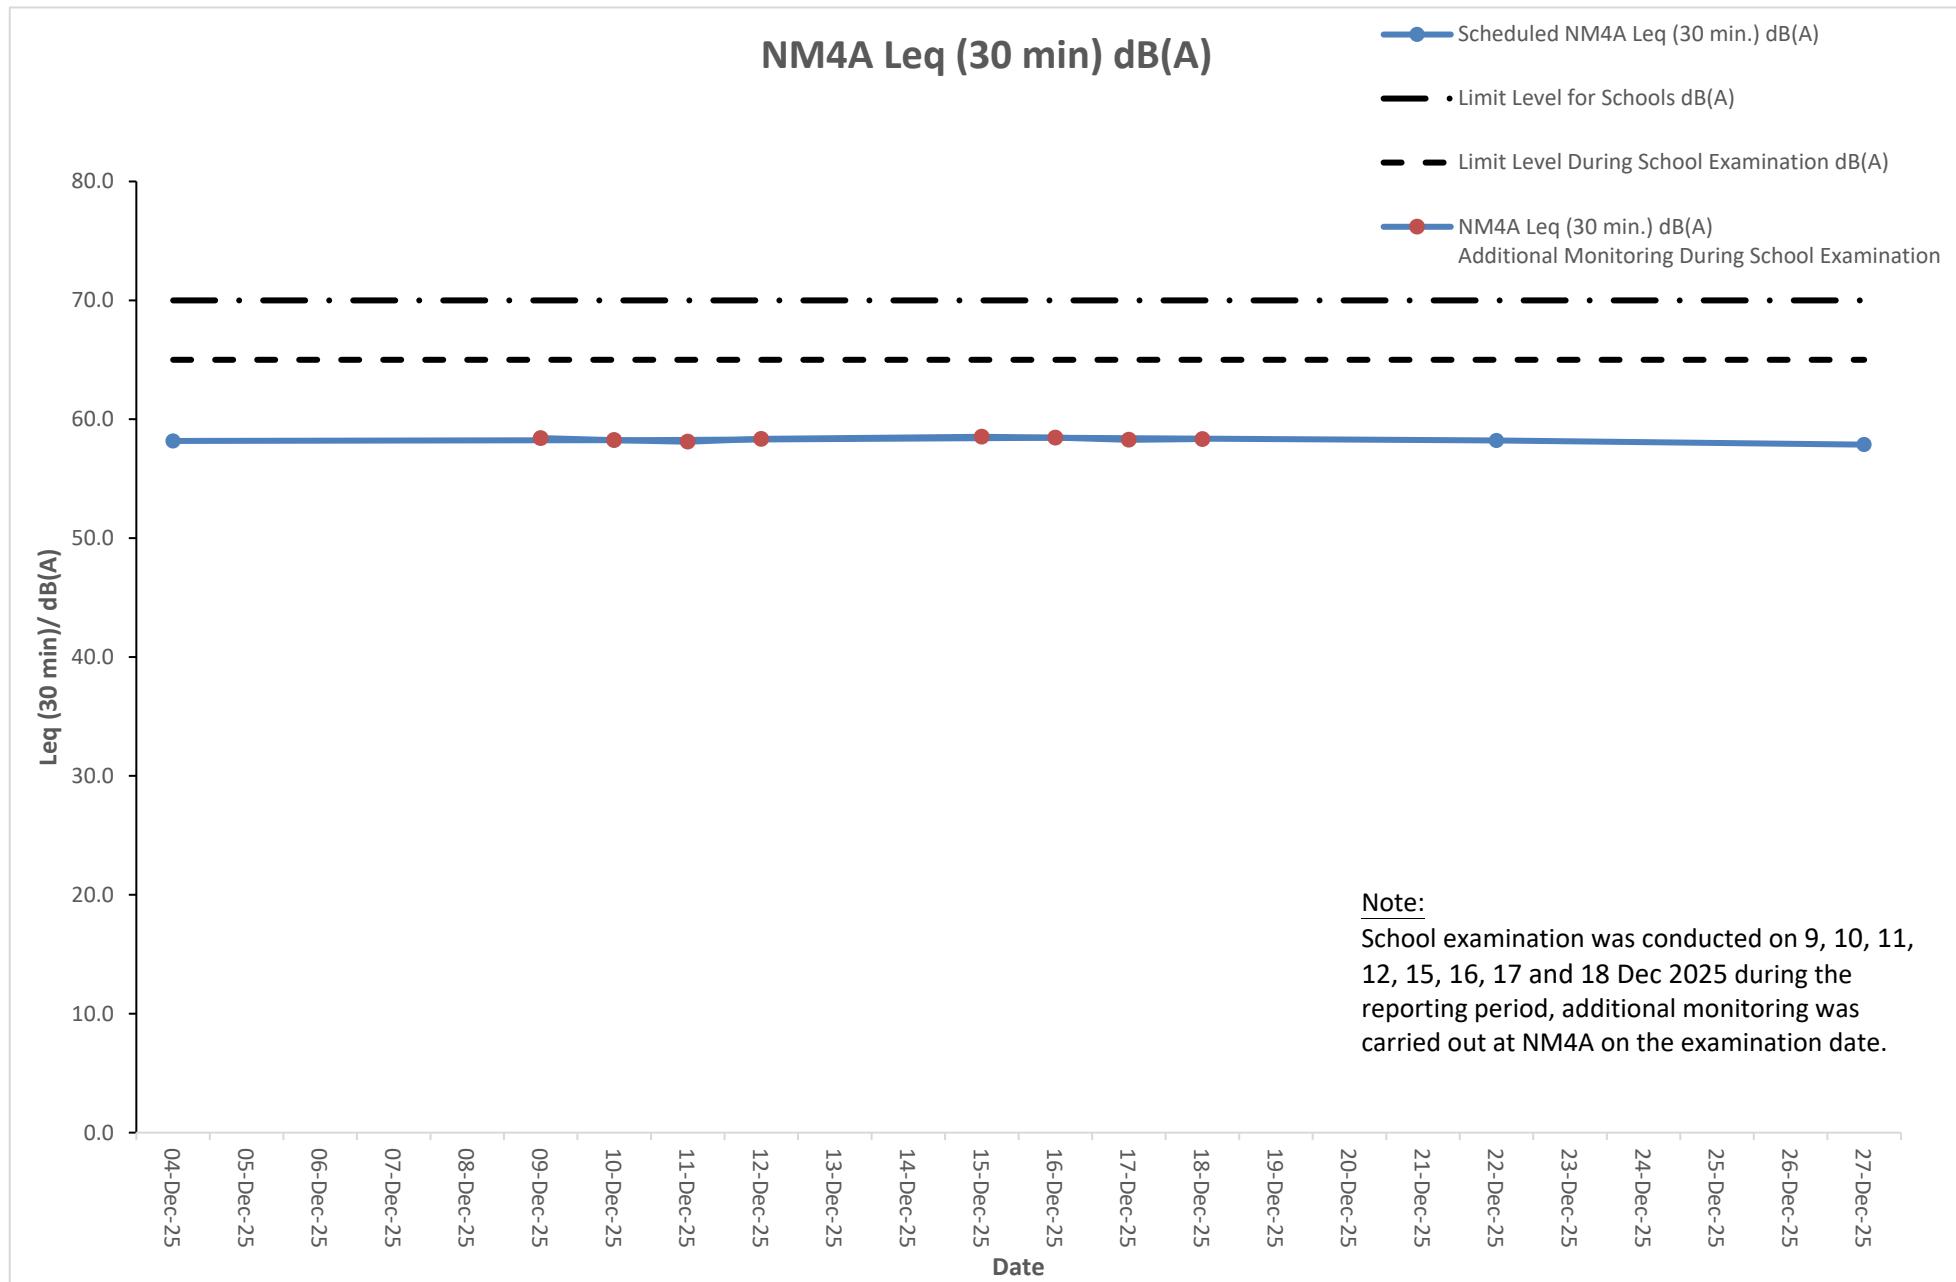
Graphical Presentation of Noise Monitoring Result at Station NM4A

Date	Time	Measured L10 dB(A)	Measured L90 dB(A)	Leq (30 min.) dB(A)
04-Dec-25	10:35	59.7	56.9	58.2
04-Dec-25	10:40	60.2	55.7	
04-Dec-25	10:45	60.6	56.5	
04-Dec-25	10:50	60.3	55.8	
04-Dec-25	10:55	59.6	56.5	
04-Dec-25	11:00	59.5	56.6	
10-Dec-25	15:01	59.4	56.9	58.2
10-Dec-25	15:06	60.5	56.1	
10-Dec-25	15:11	59.9	56.2	
10-Dec-25	15:16	60.3	56.8	
10-Dec-25	15:21	59.4	56.8	
10-Dec-25	15:26	59.3	56.4	
16-Dec-25	10:44	60.2	57.0	58.5
16-Dec-25	10:49	59.5	56.3	
16-Dec-25	10:54	59.5	56.3	
16-Dec-25	10:59	59.6	56.0	
16-Dec-25	11:04	59.7	56.6	
16-Dec-25	11:09	60.4	55.9	
22-Dec-25	15:02	59.4	56.2	58.2
22-Dec-25	15:07	60.3	56.2	
22-Dec-25	15:12	59.8	56.9	
22-Dec-25	15:17	59.6	56.6	
22-Dec-25	15:22	59.8	56.4	
22-Dec-25	15:27	60.0	57.0	
27-Dec-25	10:46	59.3	55.8	57.9
27-Dec-25	10:51	59.5	56.8	
27-Dec-25	10:56	60.2	57.1	
27-Dec-25	11:01	59.6	57.0	
27-Dec-25	11:06	59.7	56.9	
27-Dec-25	11:11	59.8	56.0

The station set-up of a façade measurement at station NM4A.

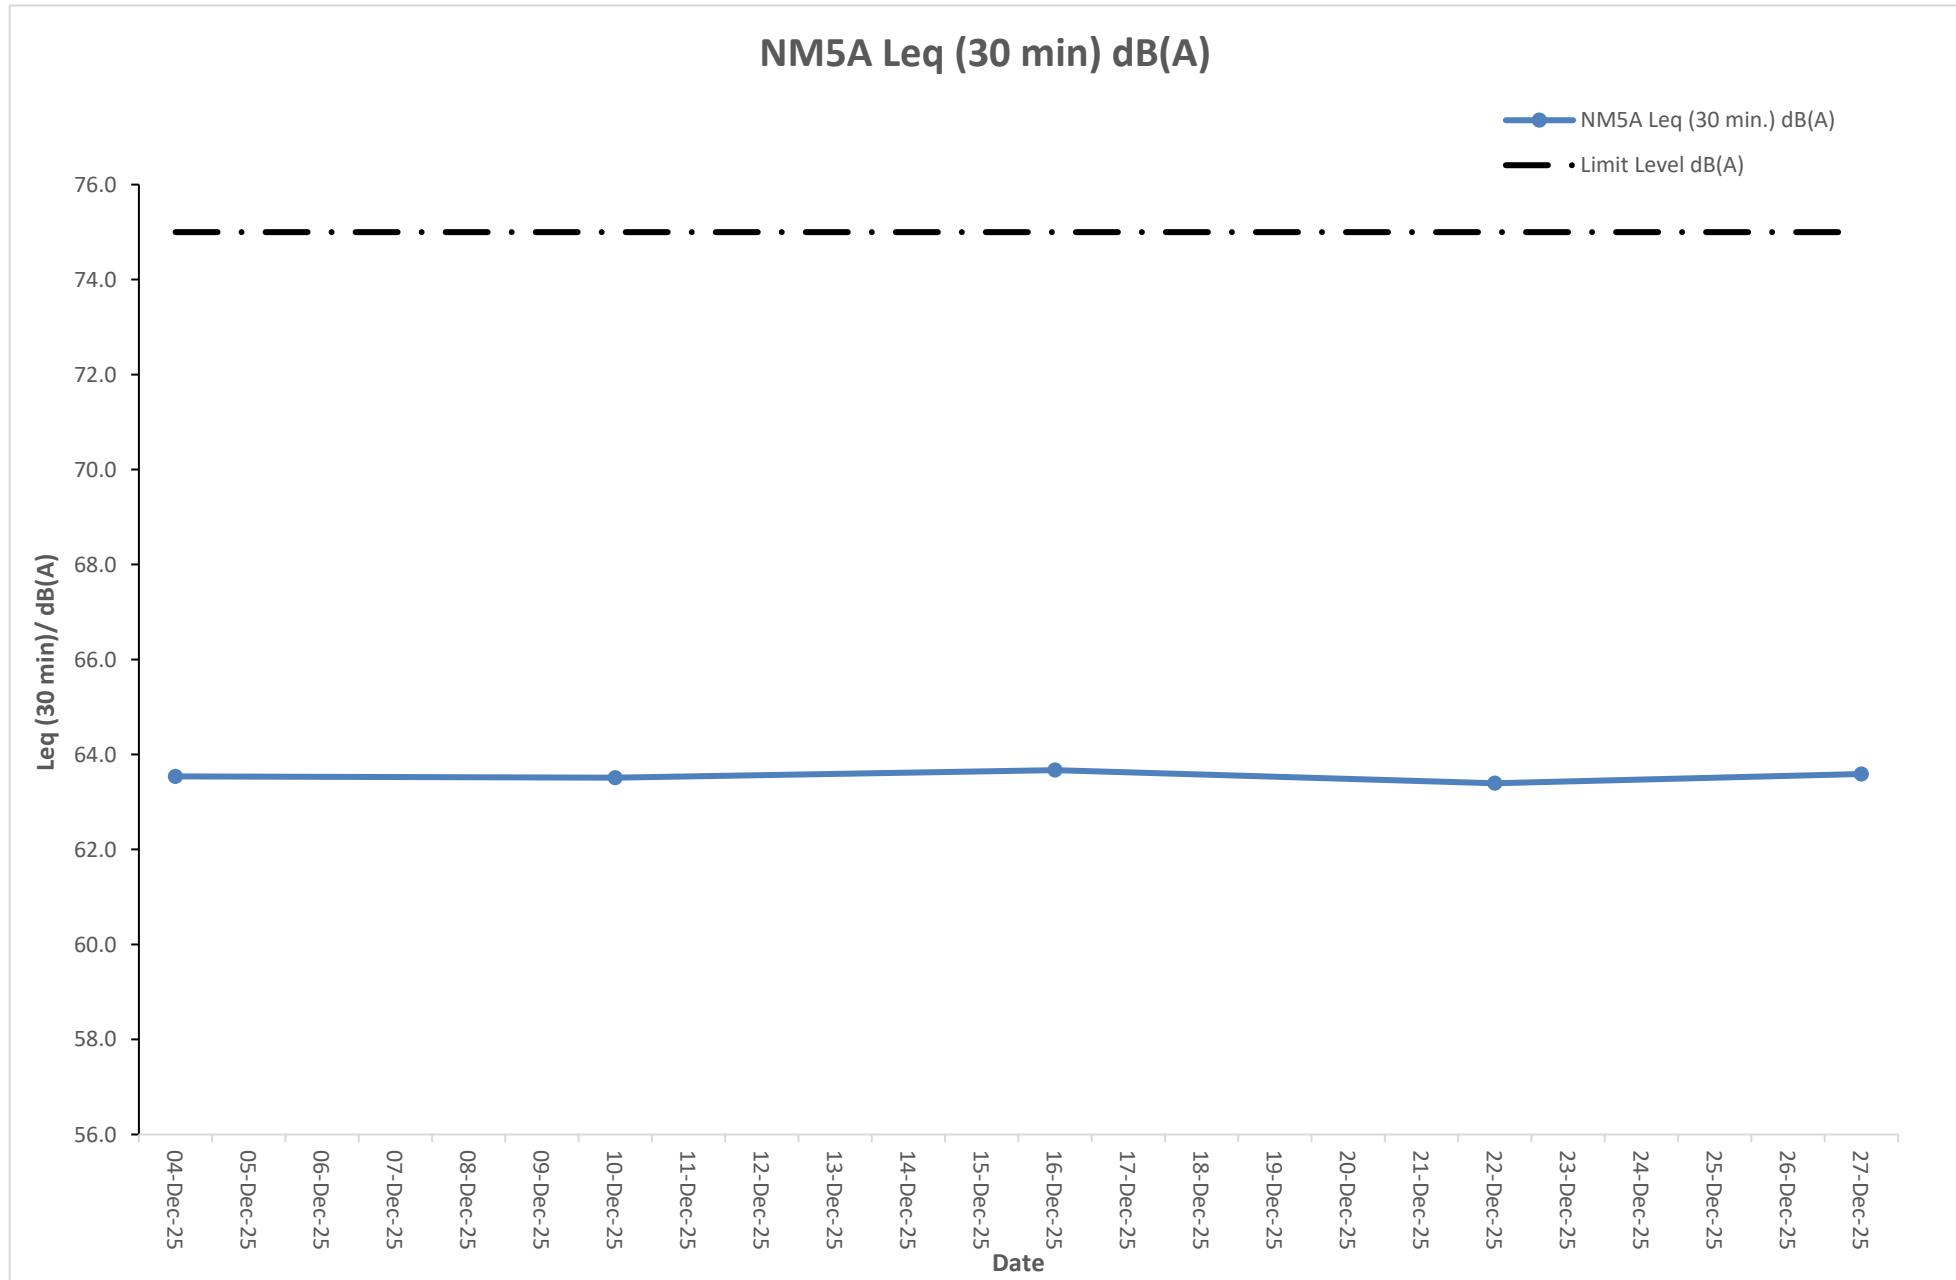
Graphical Presentation of Noise Monitoring Result at Station NM5A

Date	Time	Measured L10 dB(A)	Measured L90 dB(A)	Leq (30 min.) dB(A)	Leq (30 min.) +3 dB(A)
04-Dec-25	7:50	62.0	57.9	60.5	63.5
04-Dec-25	7:55	62.2	58.7		
04-Dec-25	8:00	62.5	58.6		
04-Dec-25	8:05	61.5	58.8		
04-Dec-25	8:10	61.5	58.0		
04-Dec-25	8:15	61.6	57.8		
10-Dec-25	13:45	62.1	58.8	60.5	63.5
10-Dec-25	13:50	62.1	58.9		
10-Dec-25	13:55	62.8	57.4		
10-Dec-25	14:00	62.5	58.9		
10-Dec-25	14:05	61.9	58.1		
10-Dec-25	14:10	61.9	57.6		
16-Dec-25	7:59	61.8	59.0	60.7	63.7
16-Dec-25	8:04	62.7	58.3		
16-Dec-25	8:09	62.8	58.2		
16-Dec-25	8:14	61.8	58.9		
16-Dec-25	8:19	62.0	59.1		
16-Dec-25	8:24	62.7	58.1		
22-Dec-25	13:40	62.4	58.2	60.4	63.4
22-Dec-25	13:54	61.9	58.9		
22-Dec-25	13:59	61.4	59.3		
22-Dec-25	14:04	62.3	57.8		
22-Dec-25	14:09	62.3	59.2		
22-Dec-25	14:14	62.5	57.7		
27-Dec-25	7:52	62.6	57.8	60.6	63.6
27-Dec-25	8:06	62.8	59.0		
27-Dec-25	8:11	61.4	58.1		
27-Dec-25	8:16	62.3	59.1		
27-Dec-25	8:21	61.7	57.5		
27-Dec-25	8:26	61.5	58.6

The station set-up of a free-field measurement at station NM5A.
