Development at West Kowloon Cultural District

Monthly Environmental Monitoring and Audit
(EM&A) Report for April 2016

May 2016

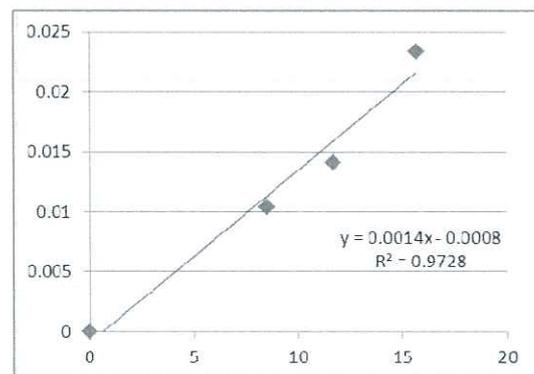
Correlation Coefficient 0.9863

- Strong** Correlation ($R > 0.8$)
 - Factor 0.0014 should be apply for TSP monitoring
- *If $R < 0.5$, repair or re-verification is required for the equipment

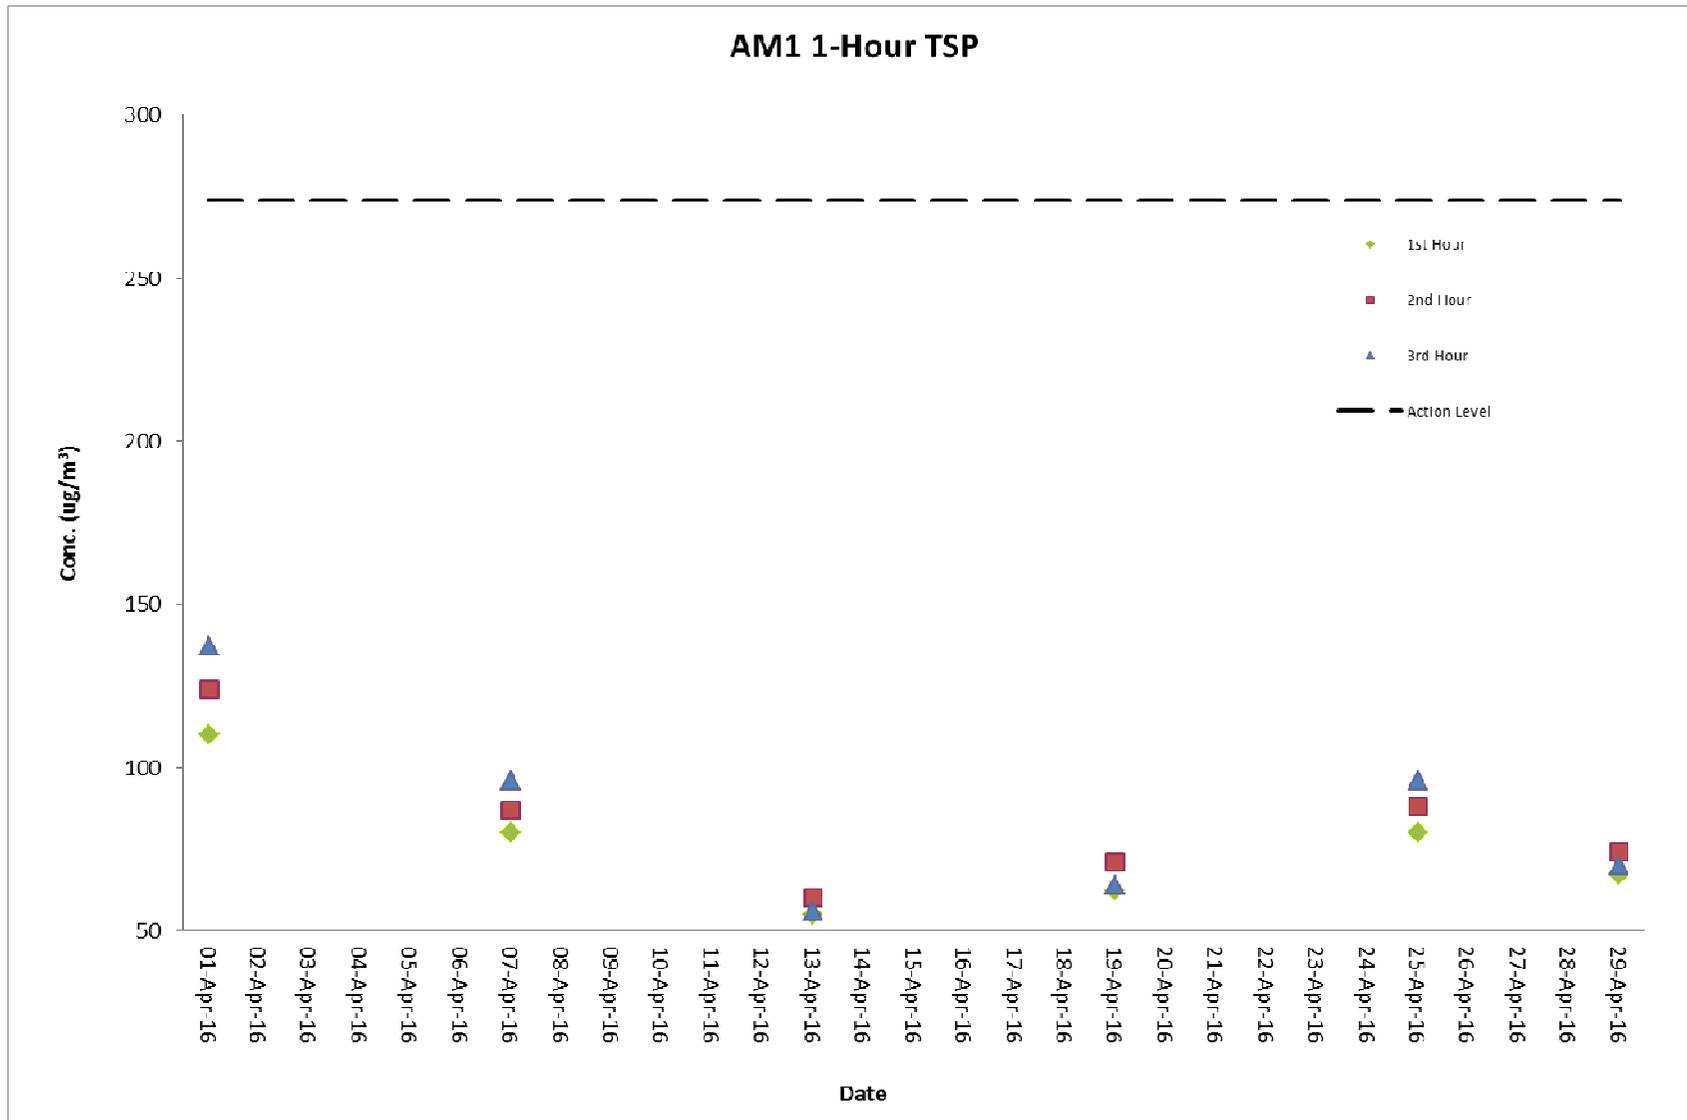
Graphical Presentation of Air Quality Monitoring Result at Station AM1 (1-hour TSP)

Date	Weather Condition	Time	Conc. ($\mu\text{g}/\text{m}^3$)			Action Level ($\mu\text{g}/\text{m}^3$)	Limit Level ($\mu\text{g}/\text{m}^3$)	Min	Max
			1 st Hour	2 nd Hour	3 rd Hour				
01-Apr-16	Cloudy	8:02 - 11:02	110	124	137	273.7	500	55	137
07-Apr-16	Cloudy	10:50 - 16:00	80	87	96	273.7	500		
13-Apr-16	Cloudy	14:00 - 17:00	55	60	56	273.7	500		
19-Apr-16	Cloudy	10:50 - 16:00	62	71	64	273.7	500		
25-Apr-16	Fine	10:42 - 16:00	80	88	96	273.7	500		
29-Apr-16	Cloudy	8:02 - 11:02	67	74	70	273.7	500

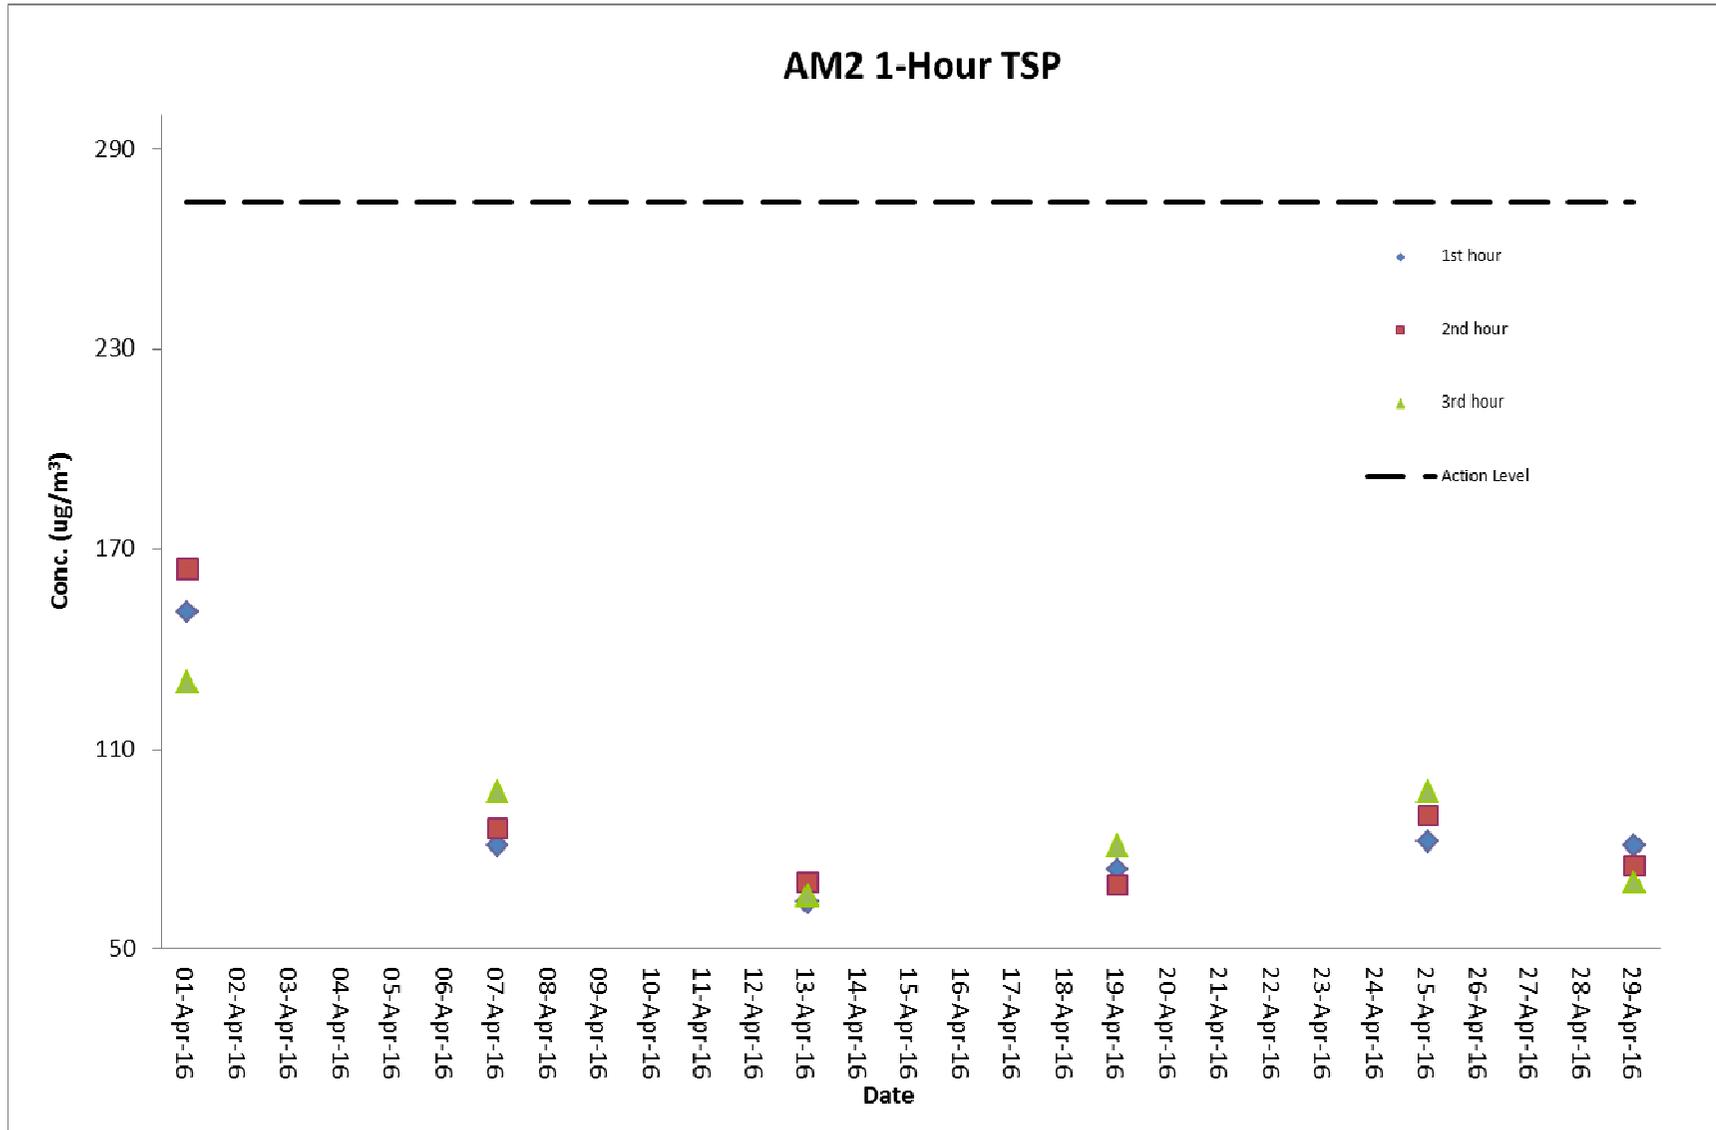
Graphical Presentation of Air Quality Monitoring Result at Station AM2 (1-hour TSP)

Date	Weather Condition	Time	Conc. ($\mu\text{g}/\text{m}^3$)			Action Level ($\mu\text{g}/\text{m}^3$)	Limit Level ($\mu\text{g}/\text{m}^3$)	Min	Max
			1 st Hour	2 nd Hour	3 rd Hour				
01-Apr-16	Cloudy	8:15 - 11:15	151	164	130	274.2	500	64	164
07-Apr-16	Cloudy	11:00 - 16:10	81	86	97	274.2	500		
13-Apr-16	Cloudy	14:10 - 17:10	64	70	66	274.2	500		
19-Apr-16	Cloudy	11:00 - 16:10	74	69	81	274.2	500		
25-Apr-16	Fine	10:52 - 16:10	82	90	97	274.2	500		
29-Apr-16	Cloudy	8:10 - 11:10	81	75	70	274.2	500

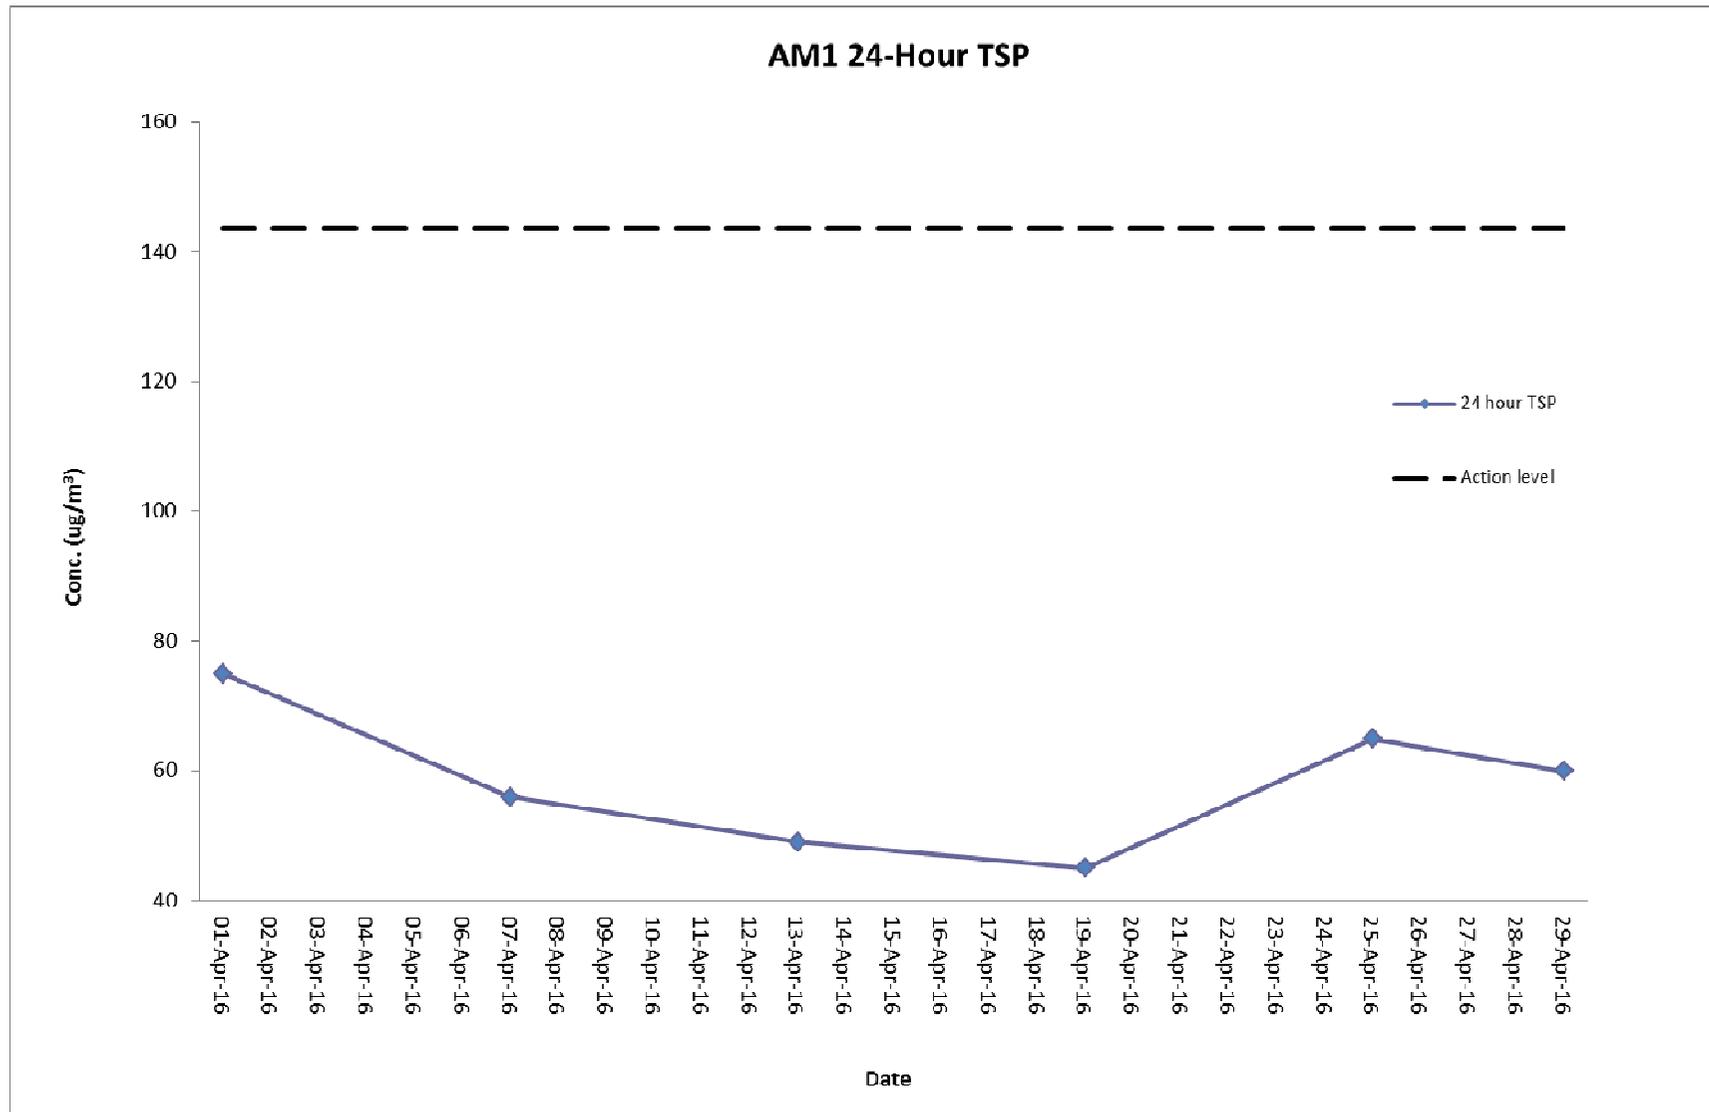
Graphical Presentation of Air Quality Monitoring Result at Station AM1 (24-hour TSP)

Start		Finish		Filter Weight (g)		Elapsed Time Reading		Sampling Time (hrs)	Flow Rate (m ³ /min)			Conc. (µg/m ³)	Weather Condition	Action Level	Limit Level
Date	Time	Date	Time	Initial	Final	Initial	Final		Initial	Final	Average				
01-Apr-16	08:00	02-Apr-16	08:00	2.7801	2.9142	19296.38	19320.38	24	1.25	1.25	1.25	75	Cloudy	143.6	260
07-Apr-16	10:48	08-Apr-16	10:48	2.7732	2.8738	19320.38	19344.38	24	1.25	1.25	1.25	56	Cloudy	143.6	260
13-Apr-16	14:02	14-Apr-16	14:02	2.812	2.9009	19344.38	19368.38	24	1.25	1.25	1.25	49	Rainy	143.6	260
19-Apr-16	10:47	20-Apr-16	10:47	2.8023	2.88	19368.38	19392.38	24	1.2	1.2	1.2	45	Cloudy	143.6	260
25-Apr-16	10:40	26-Apr-16	10:40	2.7879	2.9	19392.38	19416.38	24	1.2	1.2	1.2	65	Fine	143.6	260
29-Apr-16	08:00	30-Apr-16	08:00	2.8072	2.911	19416.38	19440.38	24	1.2	1.2	1.2	60	Cloudy	143.6	260

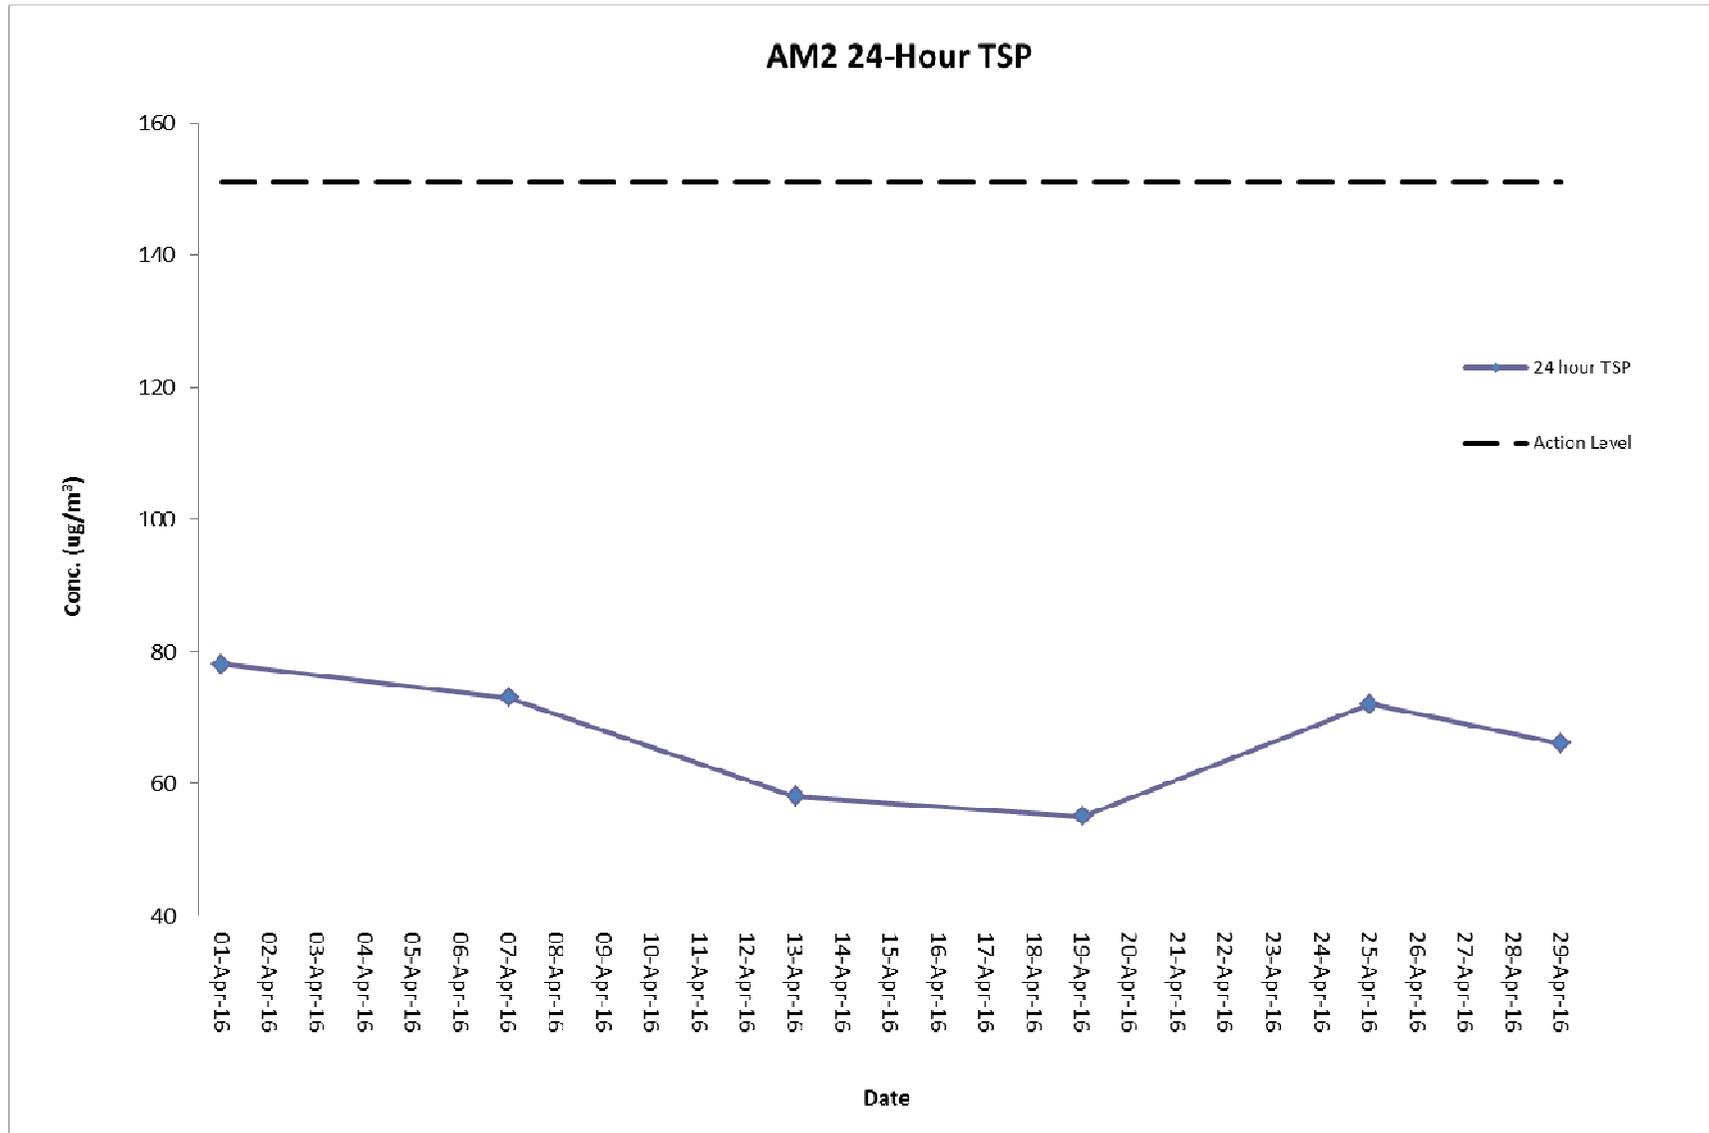
Graphical Presentation of Air Quality Monitoring Result at Station AM2 (24-hour TSP)

Start		Finish		Filter Weight (g)		Elapsed Time Reading		Sampling Time (hrs)	Flow Rate (m ³ /min)			Conc. (µg/m ³)	Weather Condition	Action Level	Limit Level
Date	Time	Date	Time	Initial	Final	Initial	Final		Initial	Final	Average				
01-Apr-16	08:12	02-Apr-16	08:12	2.7811	2.9159	14999.59	15023.59	24	1.2	1.2	1.2	78	Cloudy	151.1	260
07-Apr-16	11:02	08-Apr-16	11:02	2.8063	2.9329	15023.59	15047.59	24	1.2	1.2	1.2	73	Cloudy	151.1	260
13-Apr-16	14:12	14-Apr-16	14:12	2.7986	2.8991	15047.59	15071.59	24	1.2	1.2	1.2	58	Rainy	151.1	260
19-Apr-16	11:05	20-Apr-16	11:05	2.8127	2.911	15071.59	15095.59	24	1.25	1.25	1.25	55	Cloudy	151.1	260
25-Apr-16	10:54	26-Apr-16	10:54	2.7999	2.9287	15095.59	15119.59	24	1.25	1.25	1.25	72	Fine	151.1	260
29-Apr-16	08:07	30-Apr-16	08:07	2.8101	2.9292	15119.59	15143.59	24	1.25	1.25	1.25	66	Cloudy	151.1	260

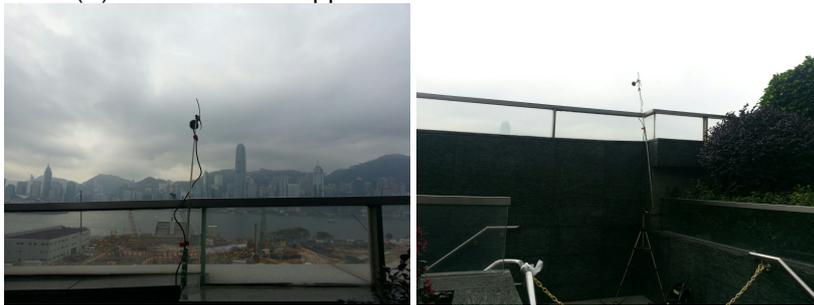
+3dB (A) correction was applied to free-field measurement.

The station set-up of a free-field measurement at Station NM1A.

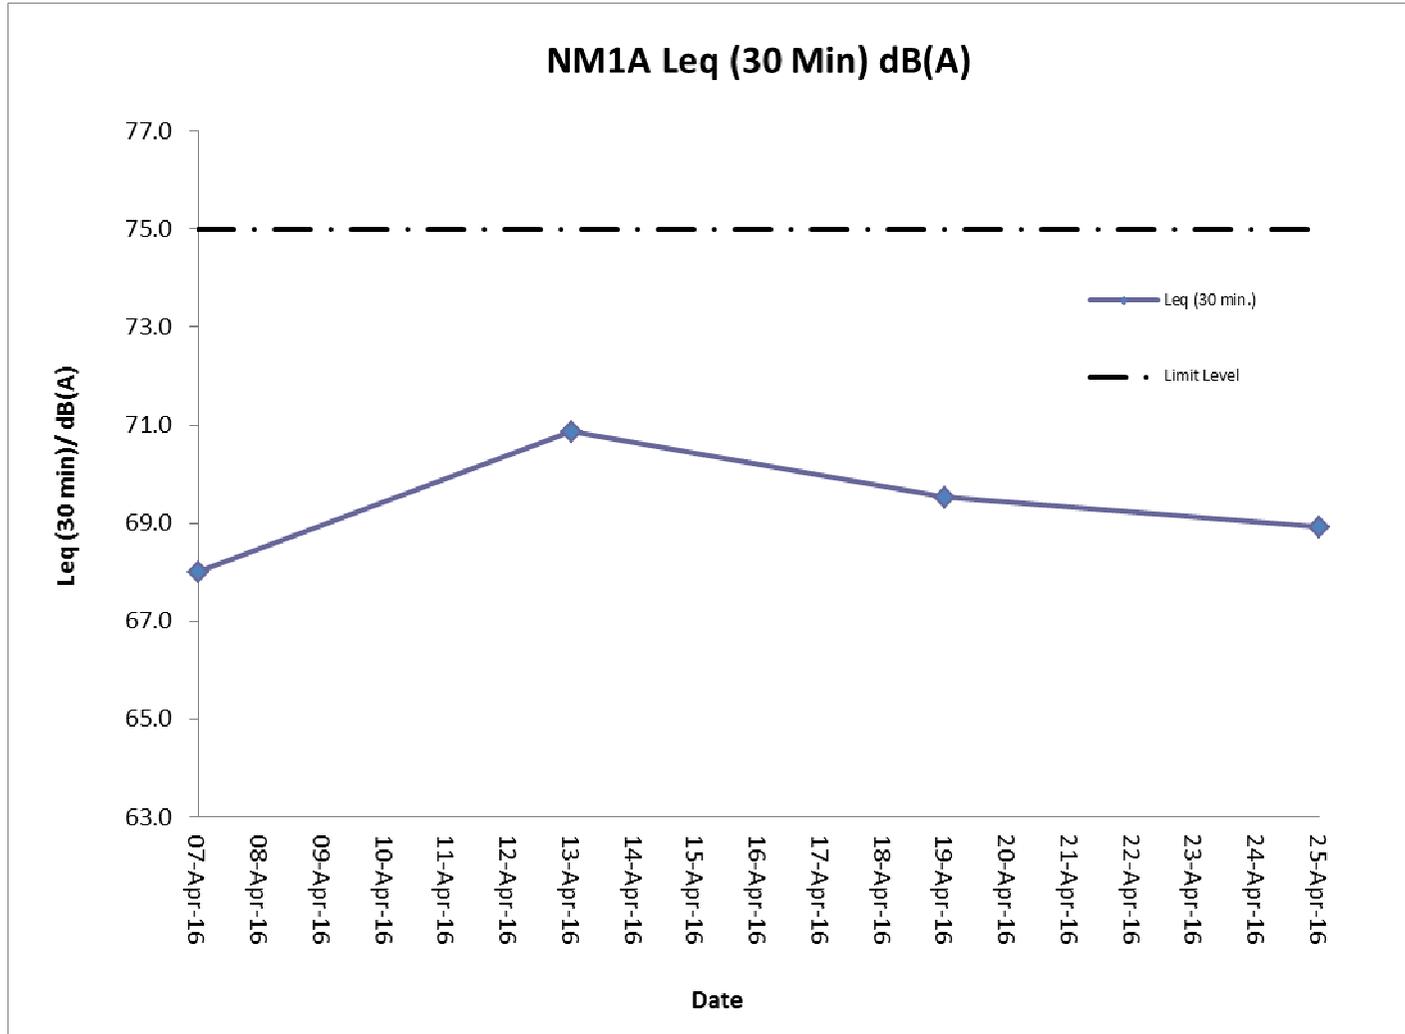
Graphical Presentation Noise Monitoring Result at Station NM1A

Date	Time	Measured L ₁₀ dB(A)	Measured L ₉₀ dB(A)	L _{eq} (30 min.) dB(A)
07-Apr-16	14:00	66.0	62.1	68.0
07-Apr-16	14:05	67.0	63.0	
07-Apr-16	14:10	66.2	61.9	
07-Apr-16	14:15	66.5	62.7	
07-Apr-16	14:20	67.8	63.1	
07-Apr-16	14:25	67.5	63.3	
13-Apr-16	14:45	69.8	65.8	70.9
13-Apr-16	14:50	71.7	66.0	
13-Apr-16	14:55	69.1	65.5	
13-Apr-16	15:00	69.6	65.6	
13-Apr-16	15:05	68.8	65.8	
13-Apr-16	15:10	68.7	65.8	
19-Apr-16	14:00	66.9	62.7	69.5
19-Apr-16	14:05	68.0	64.1	
19-Apr-16	14:10	67.7	63.7	
19-Apr-16	14:15	69.0	65.0	
19-Apr-16	14:20	68.8	64.2	
19-Apr-16	14:25	69.7	65.7	
25-Apr-16	14:00	68.9	64.7	68.9
25-Apr-16	14:05	67.7	63.4	
25-Apr-16	14:10	66.4	62.8	
25-Apr-16	14:15	68.0	64.1	
25-Apr-16	14:20	67.9	63.4	
25-Apr-16	14:25	67.9	63.7
