Development at West Kowloon Cultural District

Monthly Environmental Monitoring and Audit
(EM&A) Report for November 2016

December 2016

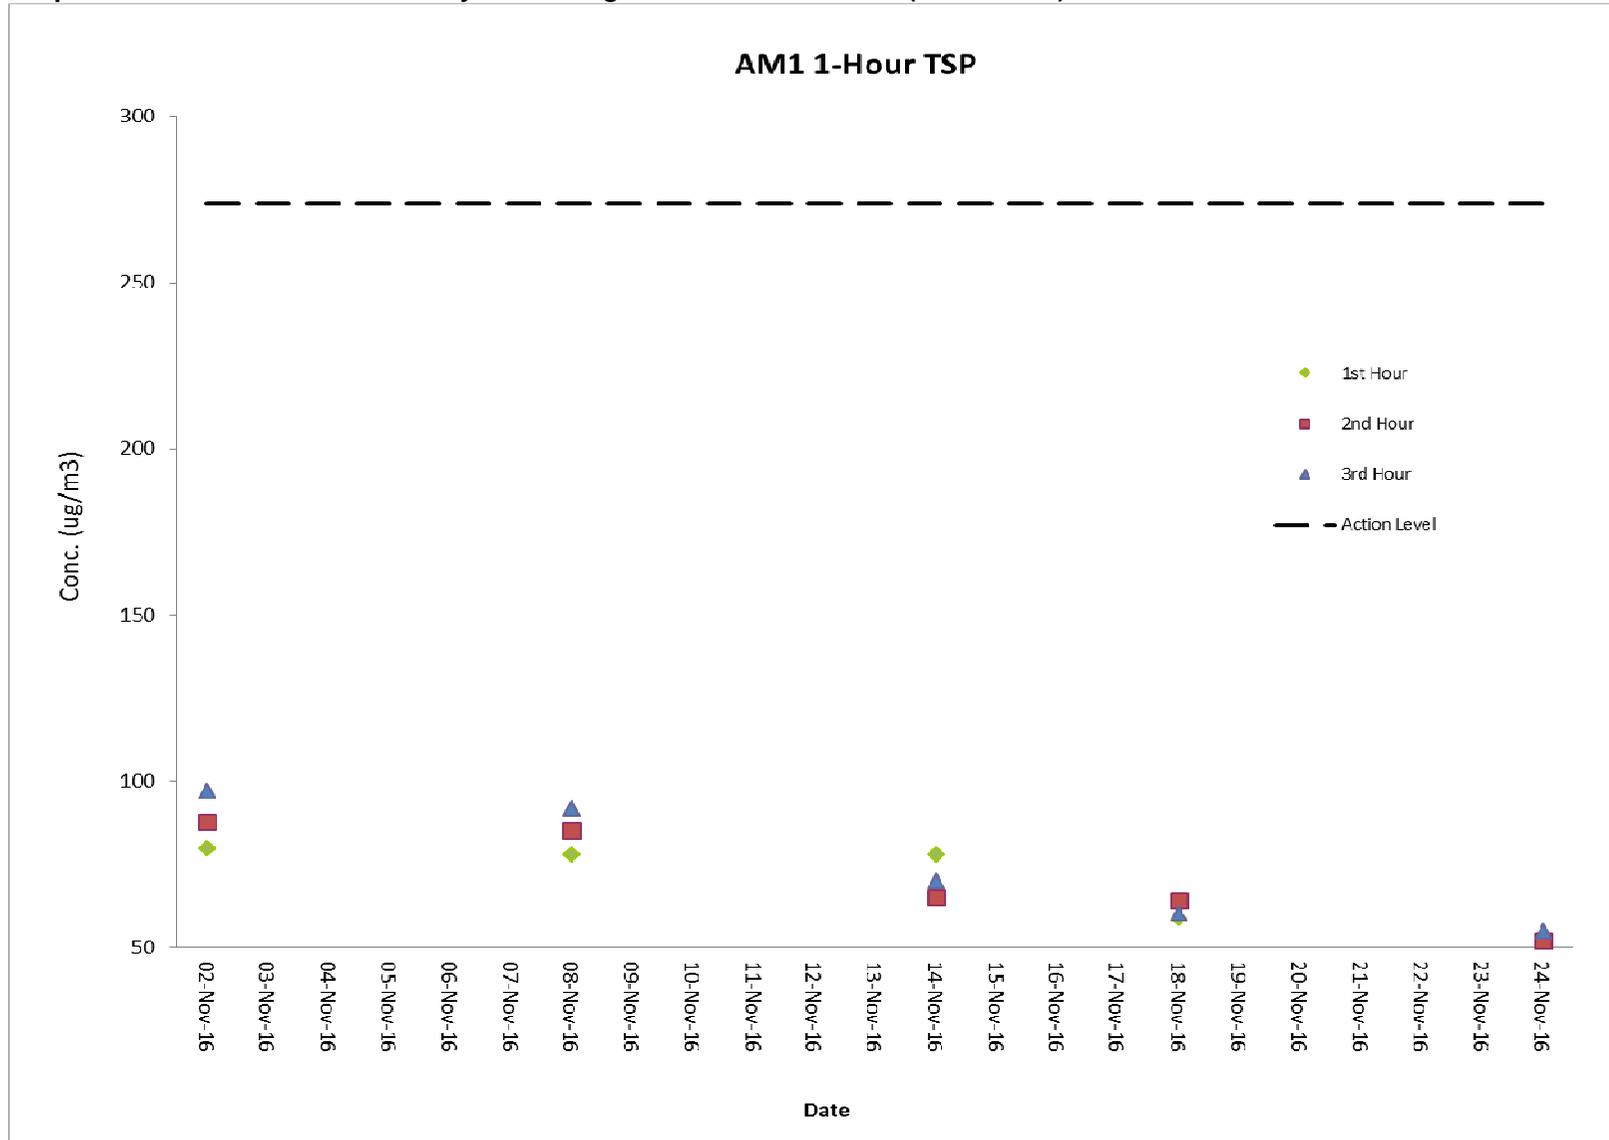
Graphical Presentation of Air Quality Monitoring Result at Station AM1 (1-hour TSP)

Date	Weather Condition	Time	Conc. ($\mu\text{g}/\text{m}^3$)			Action Level ($\mu\text{g}/\text{m}^3$)	Limit Level ($\mu\text{g}/\text{m}^3$)
			1 st Hour	2 nd Hour	3 rd Hour		
02-Nov-16	Sunny	10:40 - 16:00	80	88	97	273.7	500
08-Nov-16	Sunny	10:48 - 16:00	78	85	92	273.7	500
14-Nov-16	Sunny	10:42 - 16:00	78	65	70	273.7	500
18-Nov-16	Cloudy	8:00 - 11:00	59	64	60	273.7	500
24-Nov-16	Cloudy	10:40 - 16:00	49	52	55	273.7	500
30-Nov-16	Sunny	10:42 - 16:00	49	53	56	273.7	500

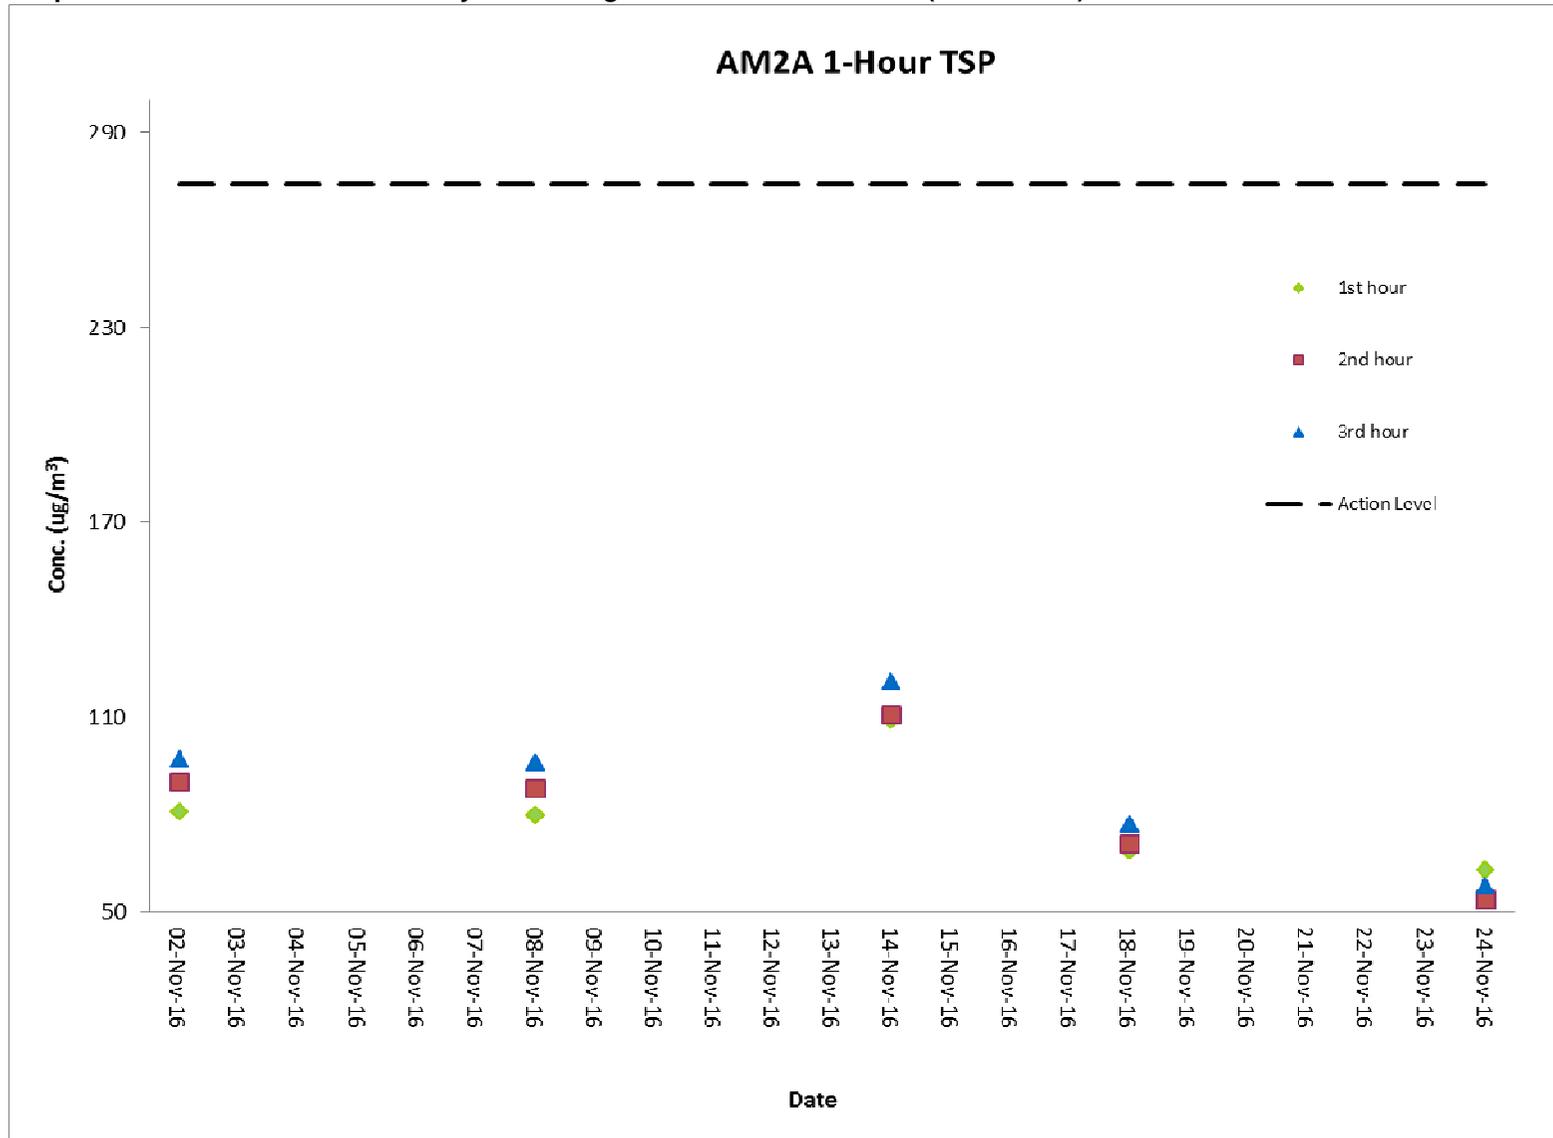
Graphical Presentation of Air Quality Monitoring Result at Station AM2A (1-hour TSP)

Date	Weather Condition	Time	Conc. ($\mu\text{g}/\text{m}^3$)			Action Level ($\mu\text{g}/\text{m}^3$)	Limit Level ($\mu\text{g}/\text{m}^3$)
			1 st Hour	2 nd Hour	3 rd Hour		
02-Nov-16	Sunny	10:52 - 16:10	81	90	97	274.2	500
08-Nov-16	Sunny	11:00 - 16:10	80	88	96	274.2	500
14-Nov-16	Sunny	10:54 - 16:10	109	111	121	274.2	500
18-Nov-16	Cloudy	8:14 - 11:14	69	71	77	274.2	500
24-Nov-16	Cloudy	10:52 - 16:10	63	54	58	274.2	500
30-Nov-16	Sunny	10:54 - 16:10	60	58	59	274.2	500

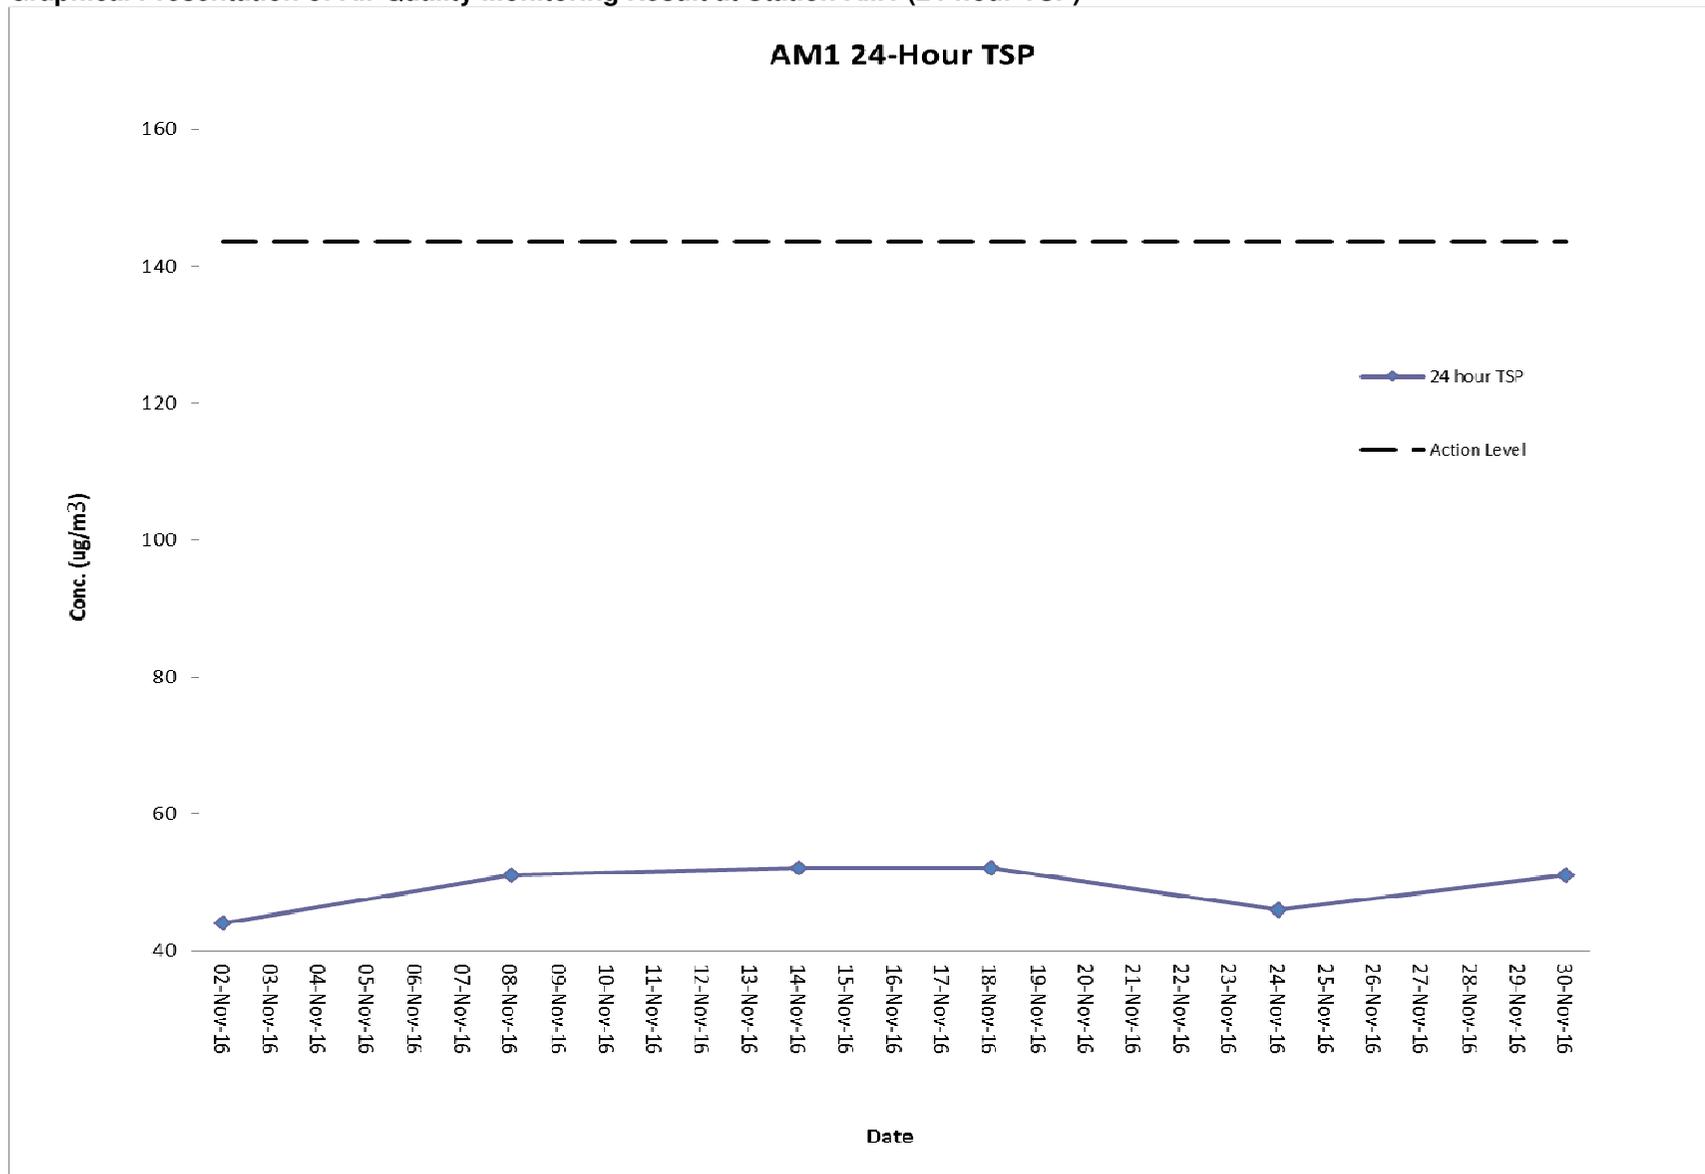
Graphical Presentation of Air Quality Monitoring Result at Station AM1 (24-hour TSP)

Start		Finish		Filter Weight (g)		Elapsed Time Reading		Sampling Time (hrs)	Flow Rate (m ³ /min)			Conc. (µg/m ³)	Weather Condition	Action Level	Limit Level
Date	Time	Date	Time	Initial	Final	Initial	Final		Initial	Final	Average				
02-Nov-16	10:42	03-Nov-16	10:42	2.7984	2.877	20208.38	20232.38	24	1.23	1.23	1.23	44	Sunny	143.6	260
08-Nov-16	10:50	09-Nov-16	10:50	2.7901	2.88	20232.38	20256.38	24	1.23	1.23	1.23	51	Sunny	143.6	260
14-Nov-16	10:40	15-Nov-16	10:40	2.7656	2.8575	20256.38	20280.38	24	1.23	1.23	1.23	52	Sunny	143.6	260
18-Nov-16	08:02	19-Nov-16	08:02	2.7589	2.8506	20280.38	20304.38	24	1.23	1.23	1.23	52	Cloudy	143.6	260
24-Nov-16	10:42	25-Nov-16	10:42	2.748	2.8295	20304.38	20328.38	24	1.23	1.23	1.23	46	Cloudy	143.6	260
30-Nov-16	10:40	01-Dec-16	10:40	2.75	2.84	20328.38	20352.38	24	1.23	1.23	1.23	51	Sunny	143.6	260

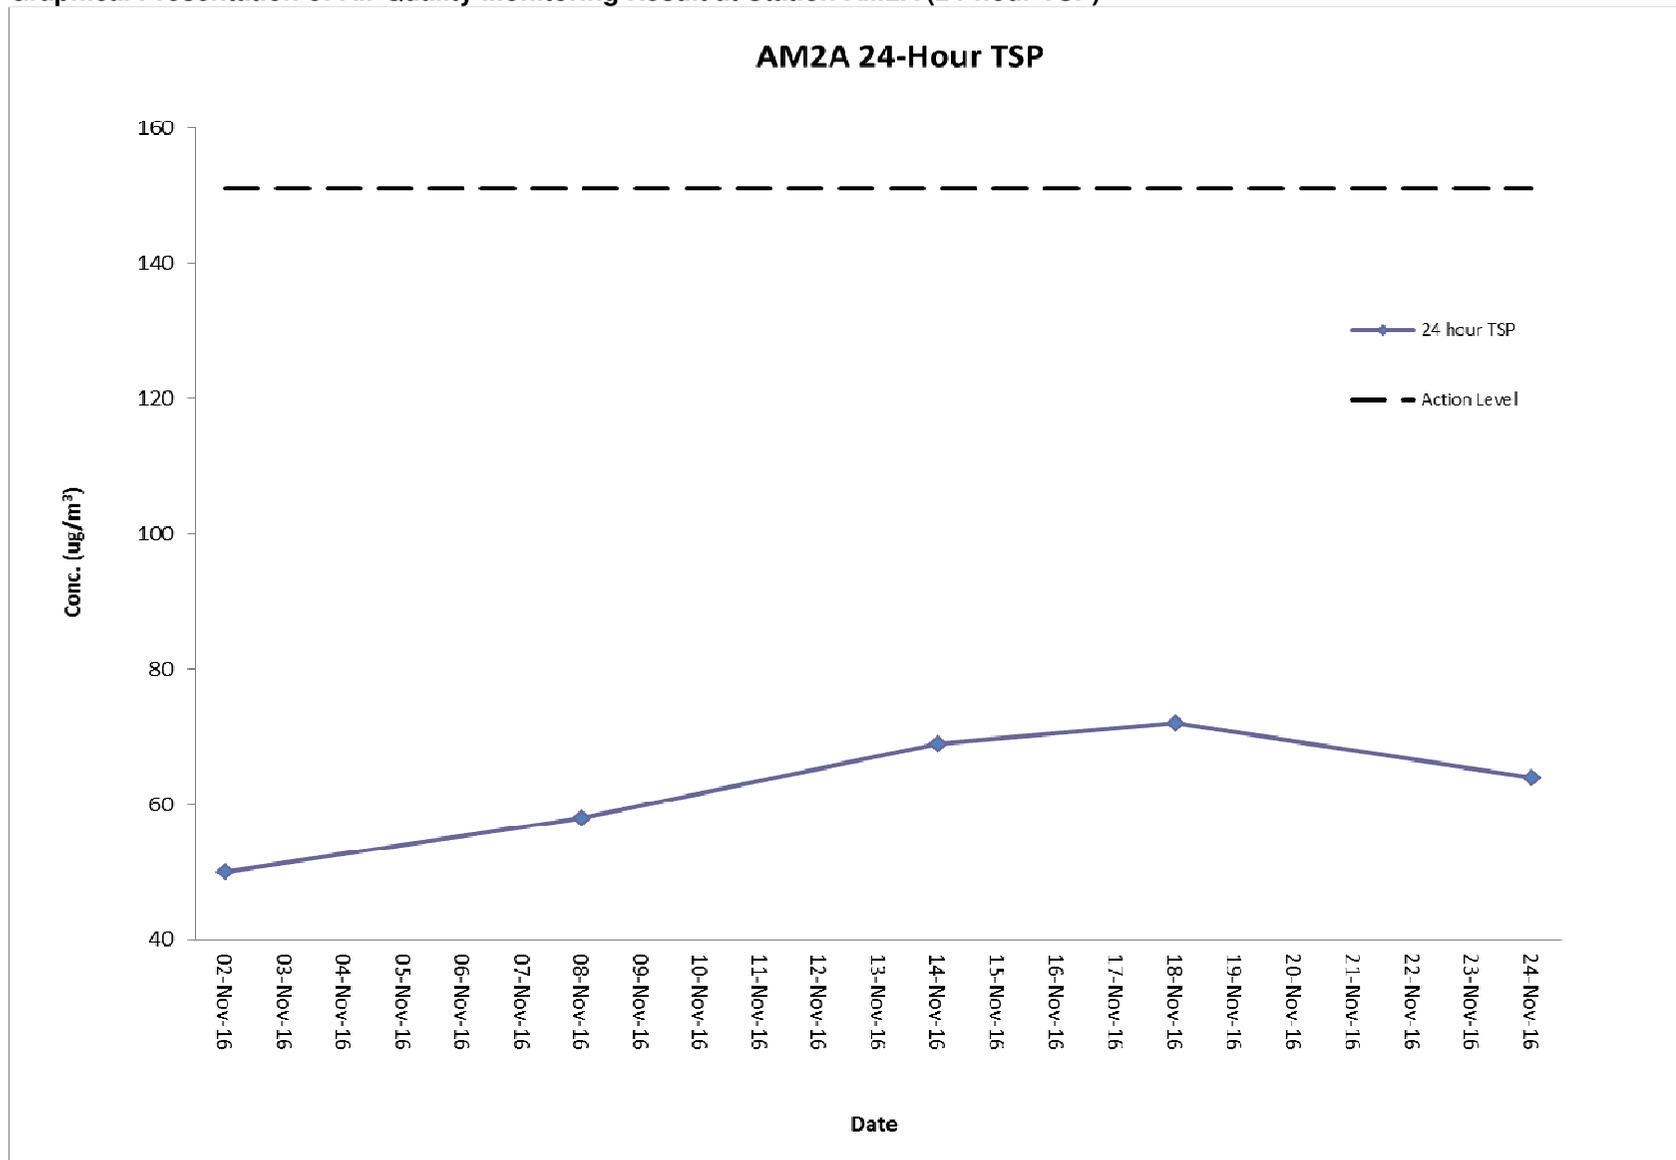
Graphical Presentation of Air Quality Monitoring Result at Station AM2A (24-hour TSP)

Start		Finish		Filter Weight (g)		Elapsed Time Reading		Sampling Time (hrs)	Flow Rate (m ³ /min)			Conc. (µg/m ³)	Weather Condition	Action Level	Limit Level
Date	Time	Date	Time	Initial	Final	Initial	Final		Initial	Final	Average				
02-Nov-16	10:55	03-Nov-16	10:55	2.7816	2.8722	15863.59	15887.59	24	1.25	1.25	1.25	50	Sunny	151.1	260
08-Nov-16	11:02	09-Nov-16	11:02	2.7846	2.8882	15887.59	15911.59	24	1.25	1.25	1.25	58	Sunny	151.1	260
14-Nov-16	10:52	15-Nov-16	10:52	2.7633	2.8866	15911.59	15935.59	24	1.25	1.25	1.25	69	Sunny	151.1	260
18-Nov-16	08:12	19-Nov-16	08:12	2.7714	2.9009	15935.59	15959.59	24	1.25	1.25	1.25	72	Cloudy	151.1	260
24-Nov-16	10:54	25-Nov-16	10:54	2.7421	2.8575	15959.59	15983.59	24	1.25	1.25	1.25	64	Cloudy	151.1	260
30-Nov-16	10:52	01-Dec-16	10:52	2.7452	2.8511	15983.59	16007.59	24	1.25	1.25	1.25	59	Sunny	151.1	260

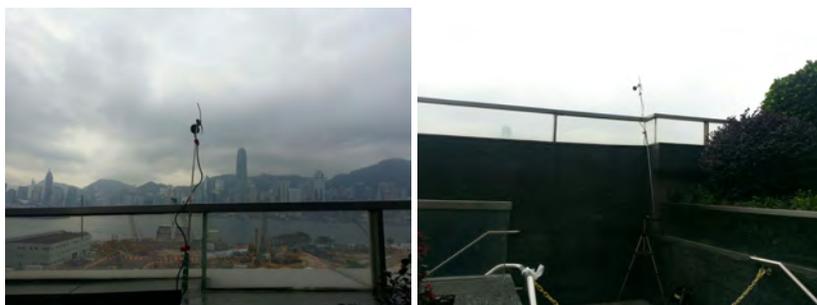
+3dB (A) correction was applied to free-field measurement.

The station set-up of a free-field measurement at Station NM1A.

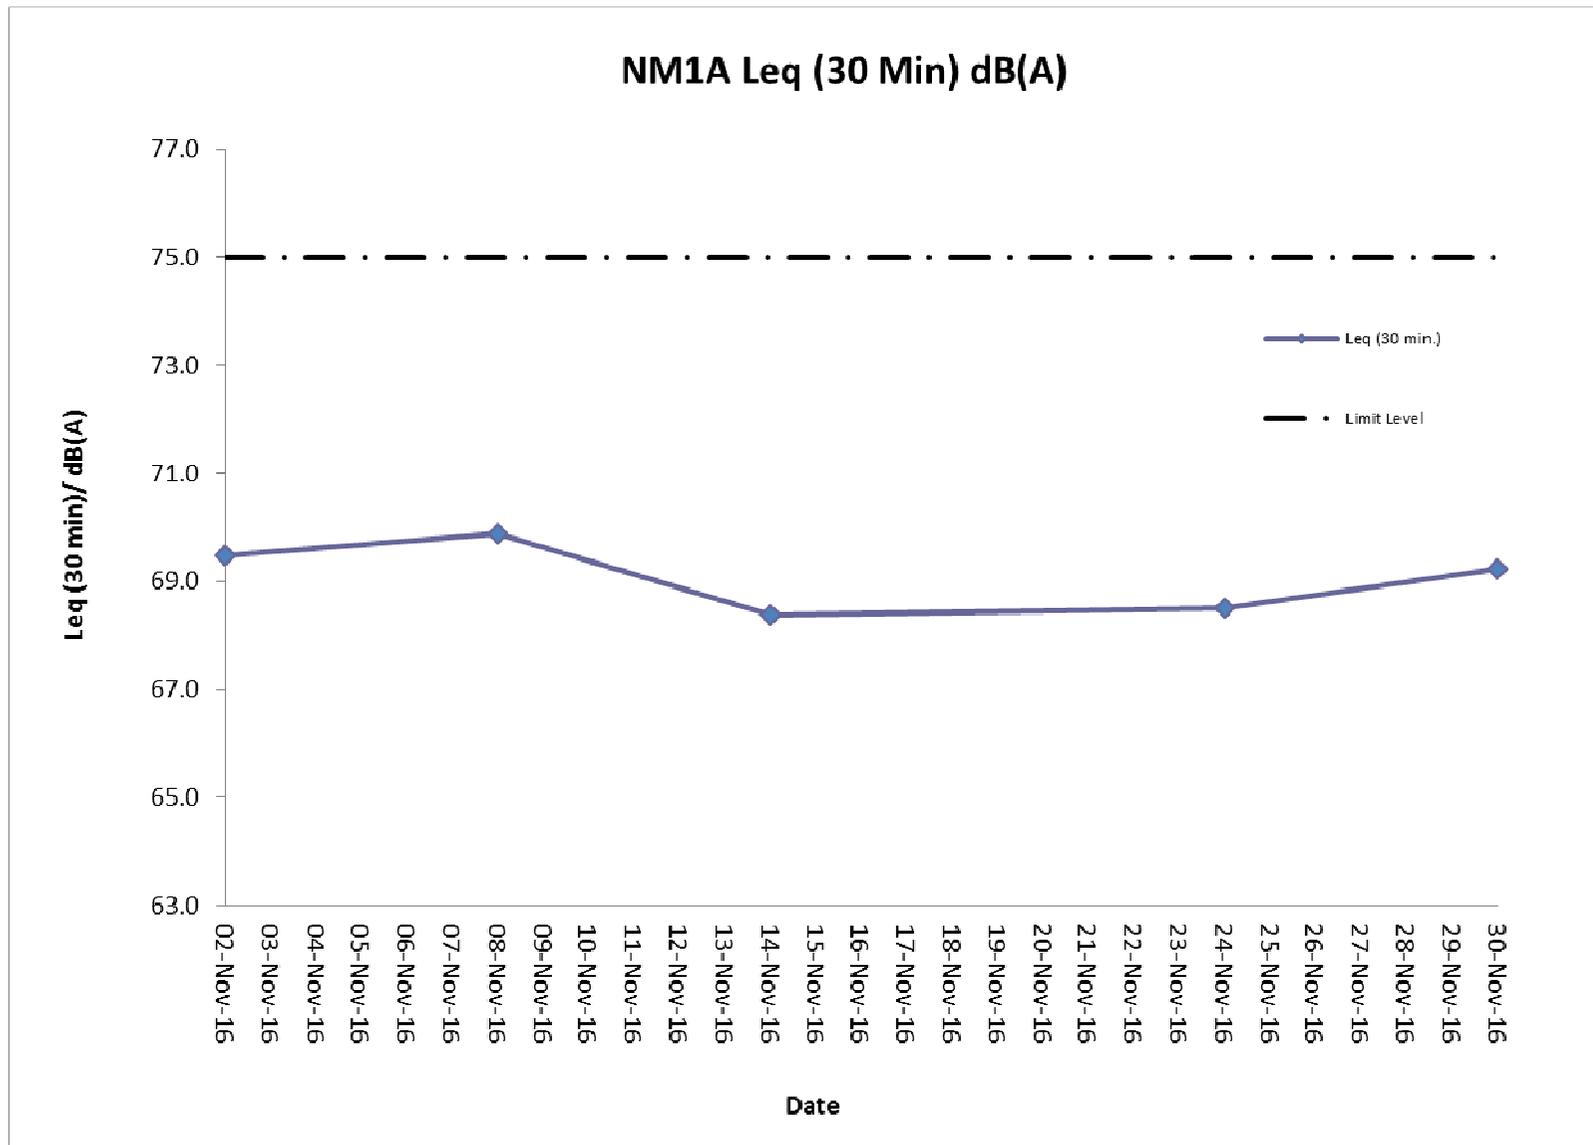
Graphical Presentation Noise Monitoring Result at Station NM1A

Date	Time	Measured L ₁₀ dB(A)	Measured L ₉₀ dB(A)	L _{eq} (30 min.) dB(A)
2-Nov-16	14:00	68.0	63.9	69.5
2-Nov-16	14:05	67.9	63.7	
2-Nov-16	14:10	69.0	64.0	
2-Nov-16	14:15	69.4	64.1	
2-Nov-16	14:20	67.9	63.8	
2-Nov-16	14:25	68.4	64.2	
8-Nov-16	14:00	68.0	63.7	69.9
8-Nov-16	14:05	67.9	62.7	
8-Nov-16	14:10	69.0	64.1	
8-Nov-16	14:15	70.0	63.9	
8-Nov-16	14:20	68.2	62.8	
8-Nov-16	14:25	70.2	63.8	
14-Nov-16	14:00	66.7	62.7	68.4
14-Nov-16	14:05	67.0	63.1	
14-Nov-16	14:10	67.9	63.4	
14-Nov-16	14:15	66.8	62.7	
14-Nov-16	14:20	67.7	63.7	
14-Nov-16	14:25	68.4	64.0	
24-Nov-16	14:00	67.1	63.2	68.5
24-Nov-16	14:05	66.8	62.4	
24-Nov-16	14:10	68.0	64.0	
24-Nov-16	14:15	67.8	63.7	
24-Nov-16	14:20	66.9	62.9	
24-Nov-16	14:25	68.8	64.1	
30-Nov-16	14:00	67.7	63.1	69.2
30-Nov-16	14:05	68.4	64.2	
30-Nov-16	14:10	68.8	64.1	
30-Nov-16	14:15	66.7	63.9	
30-Nov-16	14:20	68.7	64.1	
30-Nov-16	14:25	68.9	64.5
