Development at West Kowloon Cultural District

Monthly Environmental Monitoring and Audit (EM&A) Report for March 2025

Part-1: EM&A at Lyric Theatre Complex

Part-2: EM&A for ELS Works for The Integrated Basement and Underground Road in Zones 2A, 2B & 2C

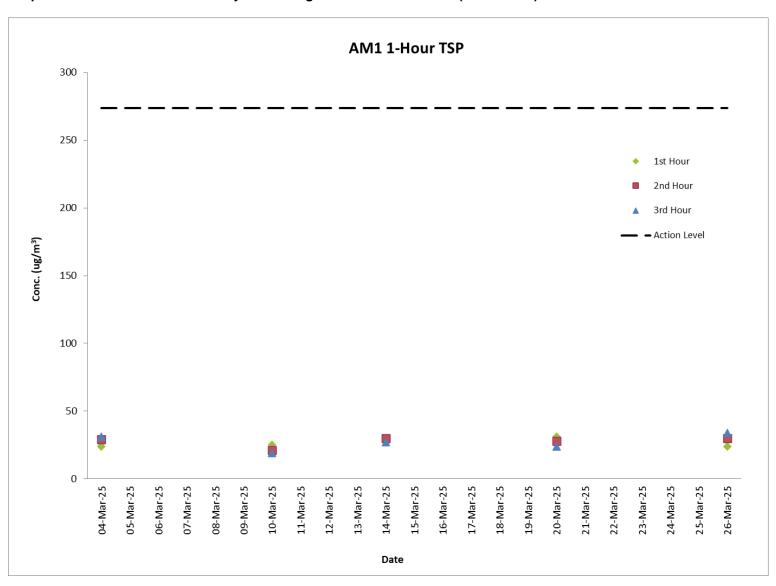
Graphical Presentation of Air Quality Monitoring Result at Station AM1 (1-hour TSP)

Weather		Conc. (µg/m³)			Action Level	Limit Level
Date	Condition	Time	1 st Hour	2 nd Hour	3 rd Hour	(μg/m³)	(µg/m³)
4-Mar-25	Cloudy	8:40 - 11:40	24	29	31	273.7	500
10-Mar-25	Fine	8:23 - 11:23	25	21	19	273.7	500
14-Mar-25	Cloudy	8:29 - 11:29	29	30	27	273.7	500
20-Mar-25	Sunny	8:28 - 11:28	31	28	24	273.7	500
26-Mar-25	Fine	8:31 - 11:31	24	30	34	273.7	500

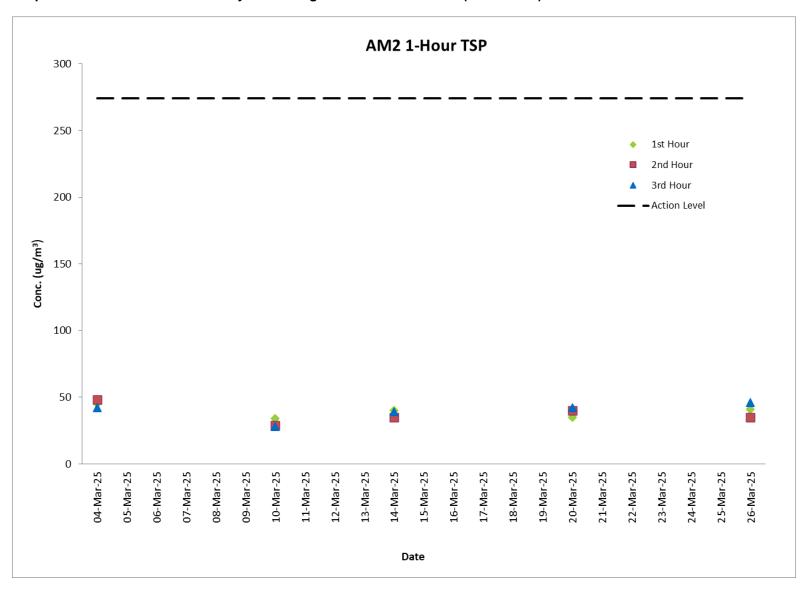
Graphical Presentation of Air Quality Monitoring Result at Station AM2 (1-hour TSP)

Weather			Conc. (μg/m³)	Action Level	Limit Level
Date	Condition	Time	1 st Hour	2 nd Hour	3 rd Hour	(μg/m³)	(µg/m³)
4-Mar-25	Cloudy	8:55 - 11:55	45	48	42	274.2	500
10-Mar-25	Fine	8:39 - 11:39	34	29	28	274.2	500
14-Mar-25	Cloudy	8:45 - 11:45	40	35	39	274.2	500
20-Mar-25	Sunny	8:43 - 11:43	35	40	42	274.2	500
26-Mar-25	Fine	8:46 - 11:46	41	35	46	274.2	500

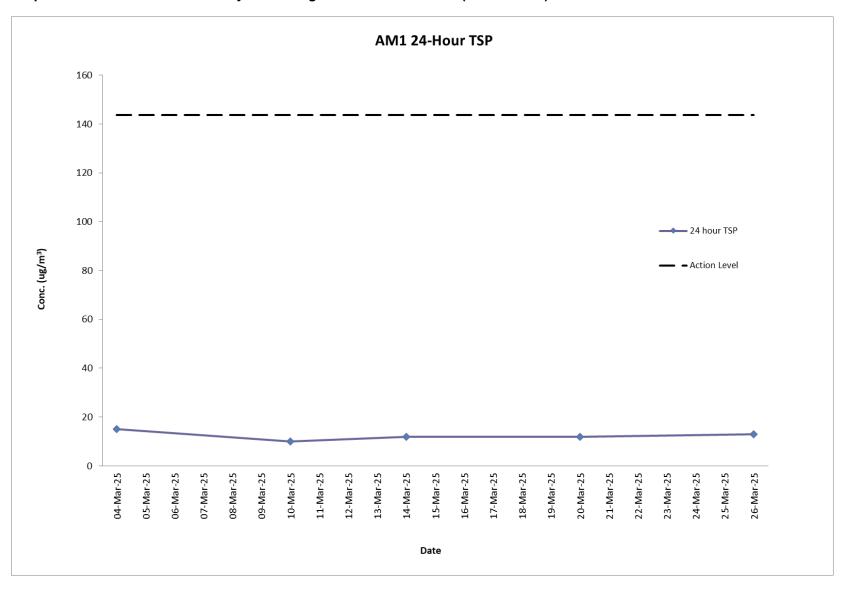
Graphical Presentation of Air Quality Monitoring Result at Station AM1 (24-hour TSP)

Sta	rt	Finis	sh	Filter W	eight (g)	Elapse Rea	d Time ding	Sampling Flow Rate (m ³ /min)		Conc.	Weather	Action	Limit		
Date	Time	Date	Time	Initial	Final	Initial	Final	Time (hrs)	Initial	Final	Average	(µg/m ³)	Condition	Level	Level
4-Mar-25	8:37	5-Mar-25	8:37	2.8051	2.8277	29380.38	29404.38	24	1.02	1.02	1.02	15	Cloudy	143.6	260
10-Mar-25	8:20	11-Mar-25	8:20	2.8063	2.8242	29404.38	29428.38	24	1.24	1.24	1.24	10	Fine	143.6	260
14-Mar-25	8:26	15-Mar-25	8:26	2.8111	2.8318	29428.38	29452.38	24	1.24	1.24	1.24	12	Cloudy	143.6	260
20-Mar-25	8:25	21-Mar-25	8:25	2.8129	2.8350	29452.38	29476.38	24	1.24	1.24	1.24	12	Sunny	143.6	260
26-Mar-25	8:28	27-Mar-25	8:28	2.8187	2.8420	29476.38	29500.38	24	1.24	1.24	1.24	13	Fine	143.6	260

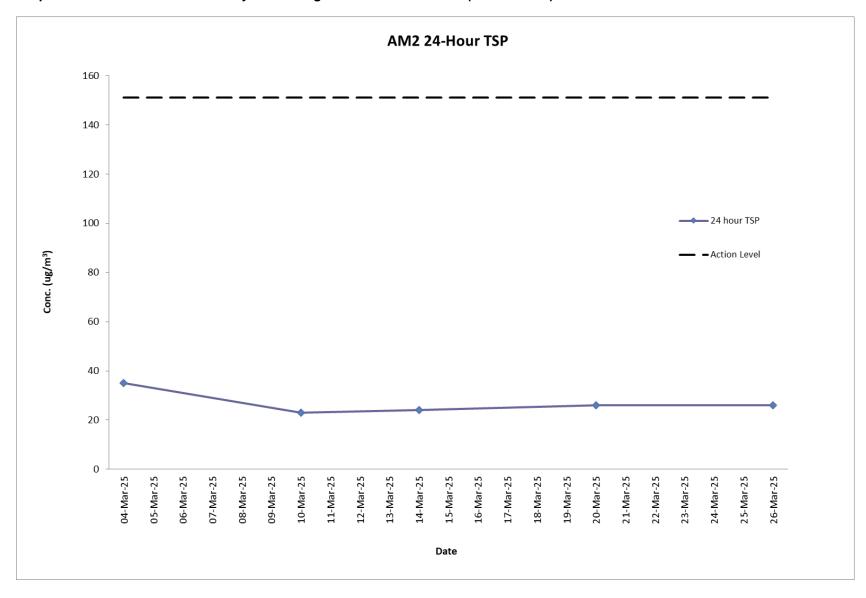
Graphical Presentation of Air Quality Monitoring Result at Station AM2 (24-hour TSP)

Sta	rt	Finis	sh	Sampling	Conc.	Weather	Action	
Date	Time	Date	Time	Time (hrs)	(µg/m³)	Condition	Level	Limit Level
4-Mar-25	8:52	5-Mar-25	8:52	24	35	Cloudy	151.1	260
10-Mar-25	8:36	11-Mar-25	8:36	24	23	Fine	151.1	260
14-Mar-25	8:42	15-Mar-25	8:42	24	24	Cloudy	151.1	260
20-Mar-25	8:41	21-Mar-25	8:41	24	26	Sunny	151.1	260
26-Mar-25	8:44	27-Mar-25	8:44	24	26	Fine	151.1	260

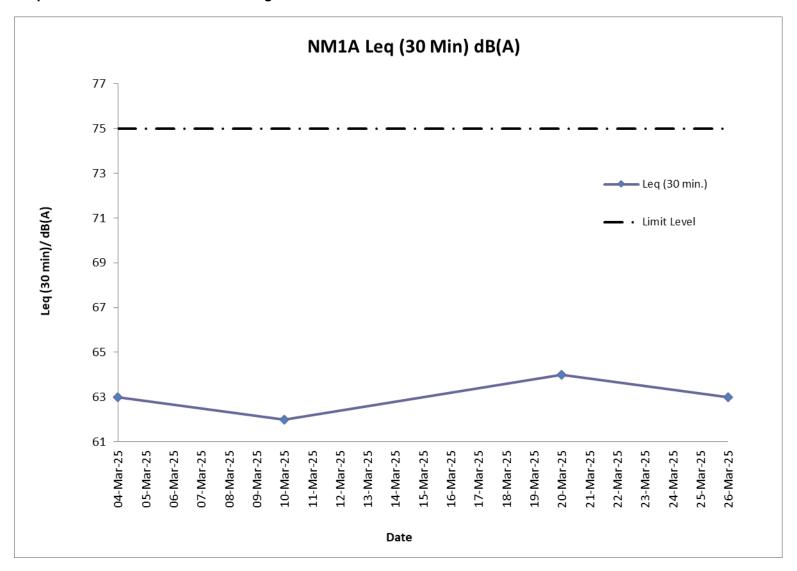
The station set-up of a free-field measurement at Station NM1A.

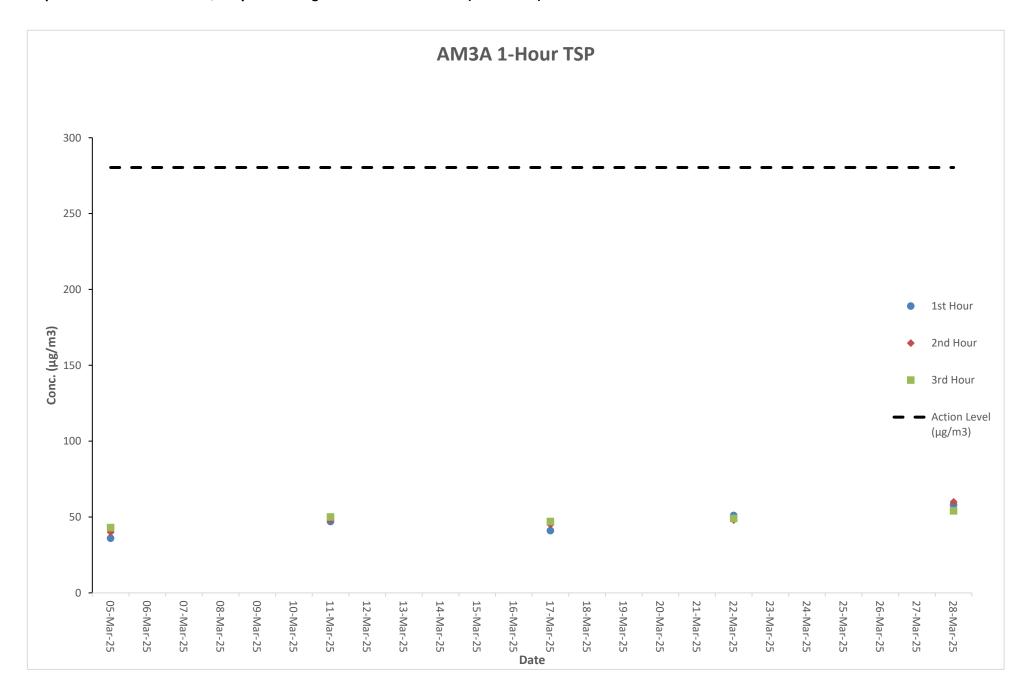
Air Quality Monitoring Result at Station AM3A (1-hour TSP)

Date	Weather	Tir	ne	C	onc. (µg/m3	Action	Limit	
Date	Condition	Start	Finish	1st Hour	2nd Hour	3rd Hour	Level	Level
05-Mar-25	Cloudy	14:02	17:02	36	40	43	280.4	500
11-Mar-25	Fine	08:04	11:04	47	48	50	280.4	500
17-Mar-25	Cloudy	14:09	17:09	41	45	47	280.4	500
22-Mar-25	Fine	08:05	11:05	51	48	49	280.4	500
28-Mar-25	Fine	14:02	17:02	58	60	54	280.4	500

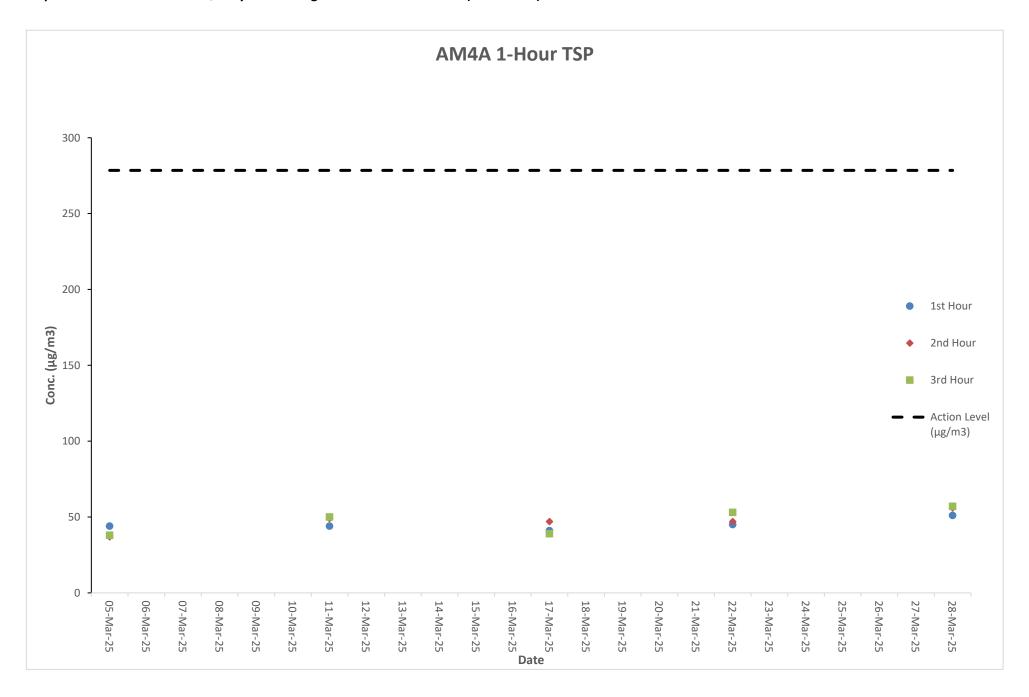
Air Quality Monitoring Result at Station AM4A (1-hour TSP)

Date	Weather	Tir	ne	C	onc. (µg/m3	Action	Limit	
Date	Condition	Start	Finish	1st Hour	2nd Hour	3rd Hour	Level	Level
05-Mar-25	Cloudy	14:10	17:10	44	37	38	278.5	500
11-Mar-25	Fine	08:12	11:12	44	49	50	278.5	500
17-Mar-25	Cloudy	14:17	17:17	41	47	39	278.5	500
22-Mar-25	Fine	08:13	11:13	45	47	53	278.5	500
28-Mar-25	Fine	14:10	17:10	51	56	57	278.5	500

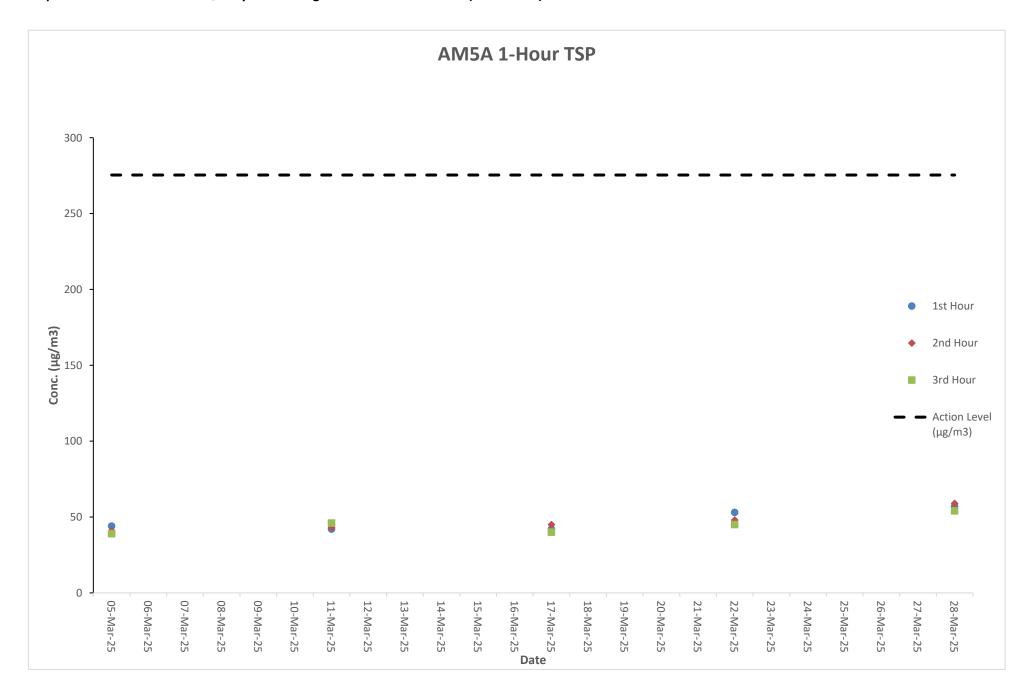
Air Quality Monitoring Result at Station AM5A (1-hour TSP)

Date Weathe		Tir	ne	C	onc. (µg/m3	Action	Limit	
Date	Condition	Start	Finish	1st Hour	2nd Hour	3rd Hour	Level	Level
05-Mar-25	Cloudy	14:25	17:25	44	41	39	275.4	500
11-Mar-25	Fine	08:29	11:29	42	43	46	275.4	500
17-Mar-25	Cloudy	14:32	17:32	42	45	40	275.4	500
22-Mar-25	Fine	08:30	11:30	53	48	45	275.4	500
28-Mar-25	Fine	14:25	17:25	57	59	54	275.4	500

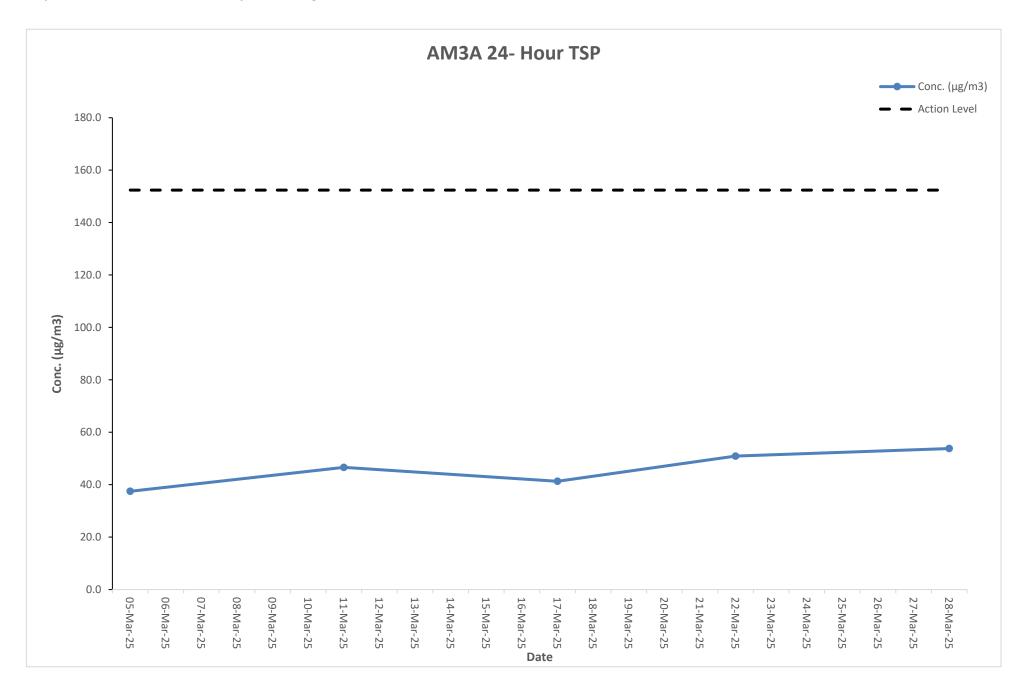
Air Quality Monitoring Result at Station AM3A (24-hour TSP)

Elapsed Time									
Star	rt	Finis	sh	Filter Weight (g)		Rea	Reading		Flov	w Rate (m	າ ³ /min)	Conc.	Weather	Action	Limit
Date	Time	Date	Time	Initial	Final	Initial	Final	Time (hrs)	Initial	Final	Average	(µg/m3)	Condition	Level	Level
05-Mar-25	10:00AM	06-Mar-25	10:00AM	2.8055	2.8659	8036.8	8060.8	24	1.12	1.12	1.12	37.5	Rainy	152.4	260
11-Mar-25	10:00AM	12-Mar-25	10:00AM	2.8086	2.8835	8.060.8	8084.8	24	1.12	1.12	1.12	46.6	Cloudy	152.4	260
17-Mar-25	10:00AM	18-Mar-25	10:00AM	2.8072	2.8736	8084.8	8108.8	24	1.12	1.12	1.12	41.3	Sunny	152.4	260
22-Mar-25	10:00AM	23-Mar-25	10:00AM	2.8018	2.8837	8108.8	8132.8	24	1.12	1.12	1.12	50.9	Sunny	152.4	260
28-Mar-25	10:00AM	29-Mar-25	10:00AM	2.8062	2.8928	8132.8	8156.8	24	1.12	1.12	1.12	53.8	Rainy	152.4	260

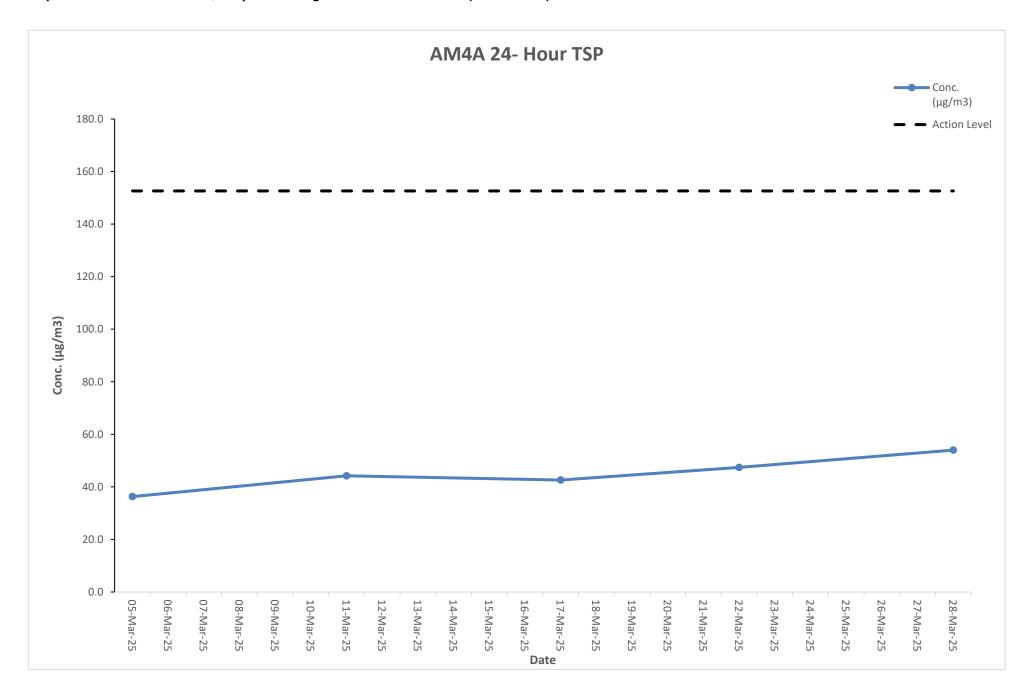
Air Quality Monitoring Result at Station AM4A (24-hour TSP)

Start		Finish		Elapsed Time Filter Weight (g) Reading		Sampling	Flov	v Rate (n	n ³ /min)	Conc.	Weather	Action	Limit		
Date	Time	Date	Time	Initial	Final	Initial	Final	Time (hrs)	Initial	Final	Average	(µg/m3)	Condition	Level	Level
05-Mar-25	10:00AM	06-Mar-25	10:00AM	2.8066	2.8649	8456.4	8480.4	24	1.12	1.12	1.12	36.3	Rainy	152.6	260
11-Mar-25	10:00AM	12-Mar-25	10:00AM	2.8082	2.8793	8480.4	8504.4	24	1.12	1.12	1.12	44.2	Cloudy	152.6	260
17-Mar-25	10:00AM	18-Mar-25	10:00AM	2.8054	2.8739	8504.4	8528.4	24	1.12	1.12	1.12	42.6	Sunny	152.6	260
22-Mar-25	10:00AM	23-Mar-25	10:00AM	2.8036	2.8798	8528.4	8552.4	24	1.12	1.12	1.12	47.4	Sunny	152.6	260
28-Mar-25	10:00AM	29-Mar-25	10:00AM	2.8062	2.8931	8552.4	8576.4	24	1.12	1.12	1.12	54.0	Rainy	152.6	260

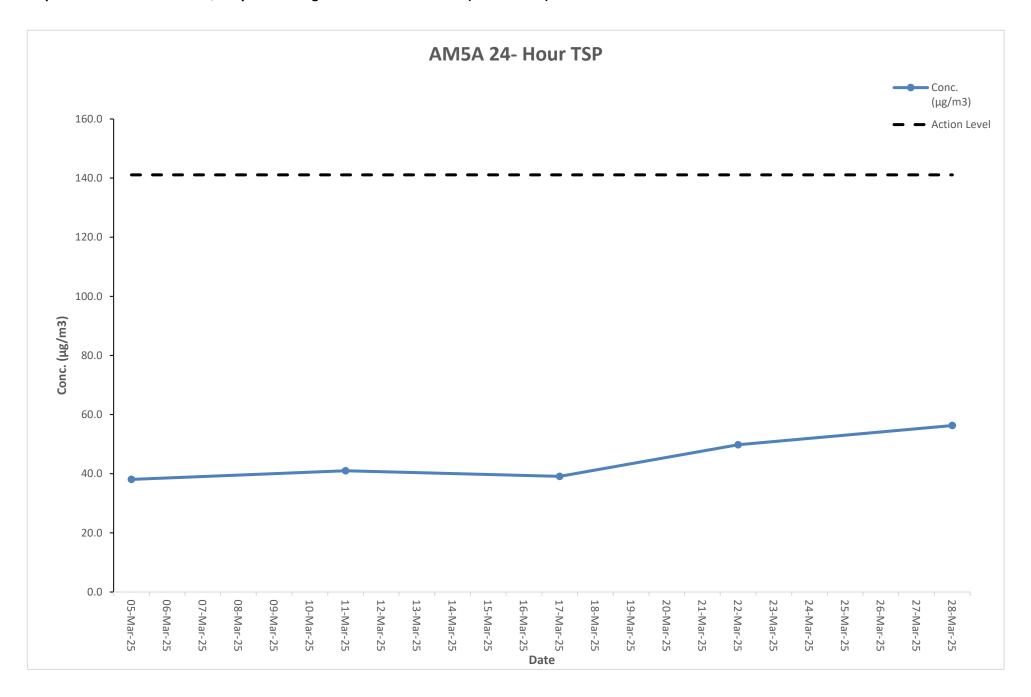
Air Quality Monitoring Result at Station AM5A (24-hour TSP)

Star	rt	Finis	sh	Filter W	eight (g)		d Time ding	Sampling	Flov	w Rate (n	n³/min)	Conc.	Weather	Action	Limit
Date	Time	Date	Time	Initial	Final	Initial	Final	Time (hrs)	Initial	Final	Average	(µg/m3)	Condition	Level	Level
05-Mar-25	10:00AM	06-Mar-25	10:00AM	2.8074	2.8688	8594.6	8618.6	24	1.12	1.12	1.12	38.1	Rainy	141.1	260
11-Mar-25	10:00AM	12-Mar-25	10:00AM	2.8076	2.8735	8618.6	8642.6	24	1.12	1.12	1.12	41.0	Cloudy	141.1	260
17-Mar-25	10:00AM	18-Mar-25	10:00AM	2.8056	2.8685	8642.6	8666.6	24	1.12	1.12	1.12	39.1	Sunny	141.1	260
22-Mar-25	10:00AM	23-Mar-25	10:00AM	2.8049	2.8850	8666.6	8690.6	24	1.12	1.12	1.12	49.8	Sunny	141.1	260
28-Mar-25	10:00AM	29-Mar-25	10:00AM	2.8069	2.8976	8690.6	8714.6	24	1.12	1.12	1.12	56.3	Rainy	141.1	260

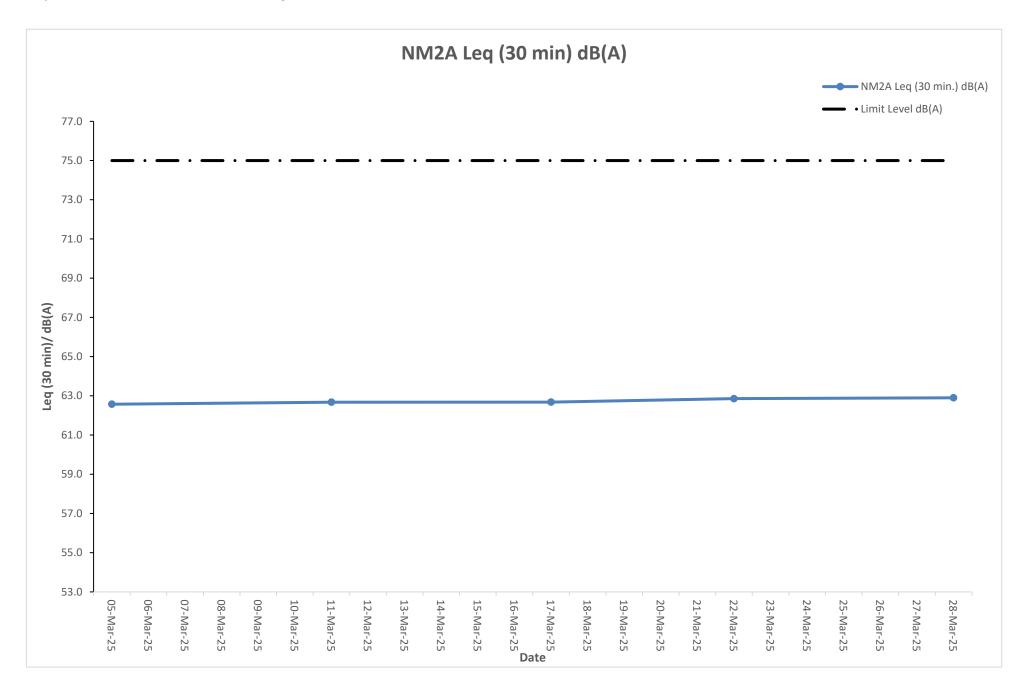
The station set-up of a façade measurement at station NM2A.

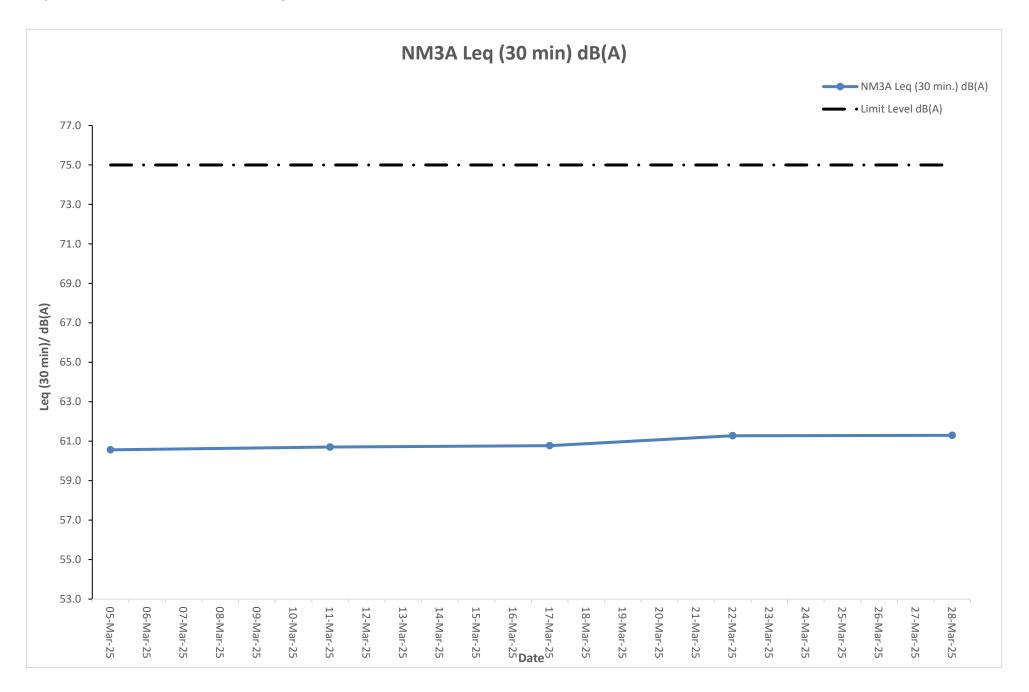
The station set-up of a façade measurement at station NM3A.

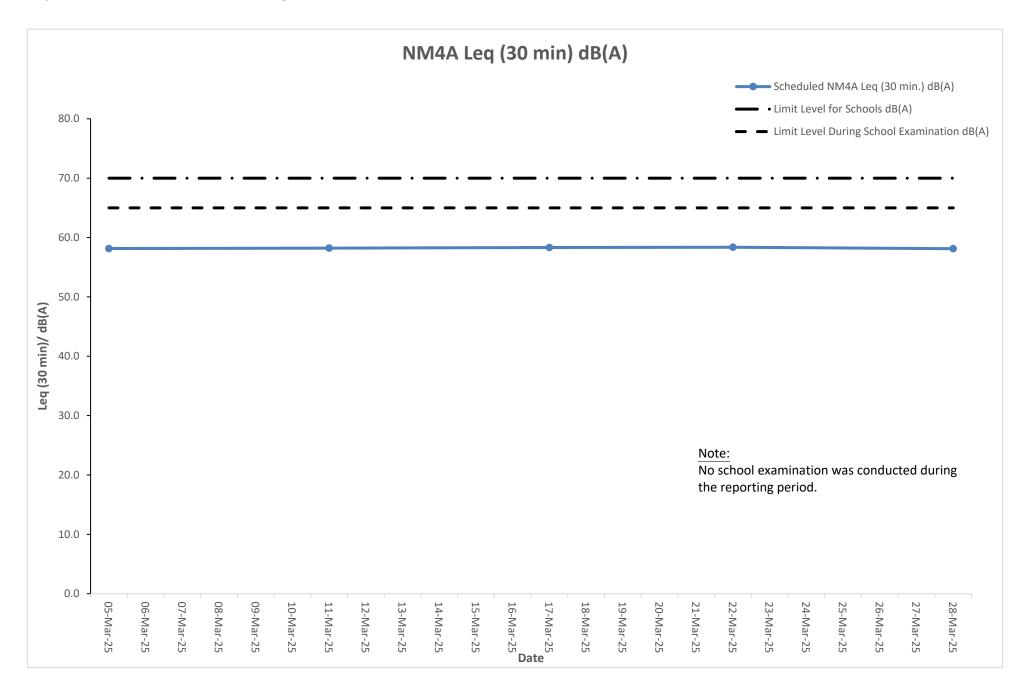
The station set-up of a façade measurement at station NM4A.

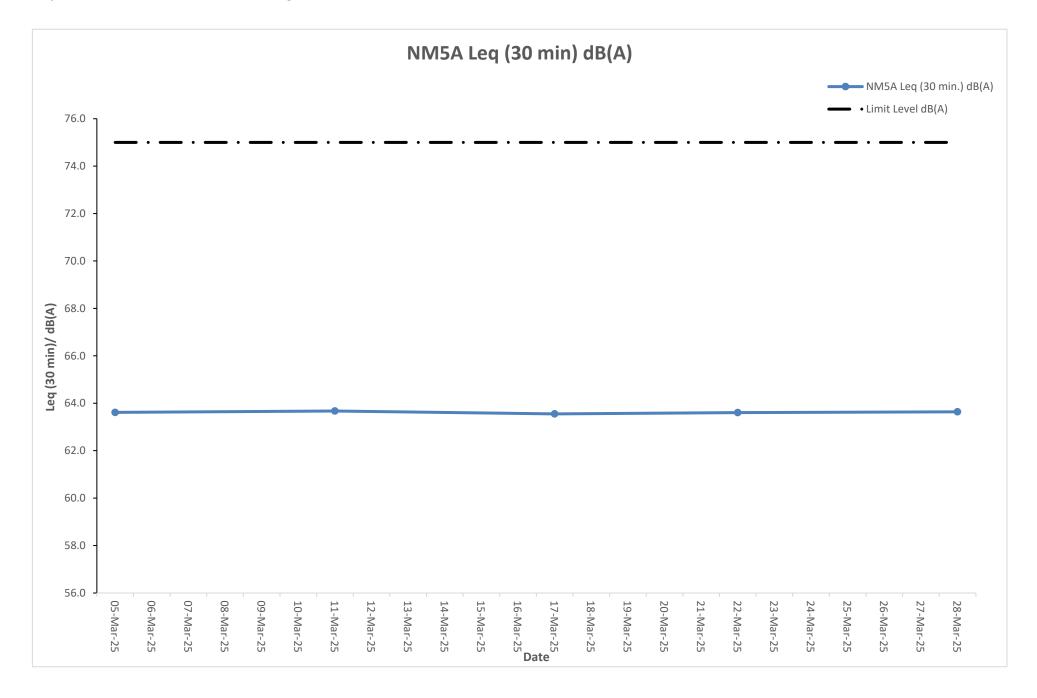
The station set-up of a free-field measurement at station NM5A.
