# Development at West Kowloon Cultural District

Monthly Environmental Monitoring and Audit (EM&A) Report  
for July 2025

13 August 2025

**Part-2: EM&A for ELS Works for The  
Integrated Basement and  
Underground Road in Zones 2A, 2B  
& 2C**

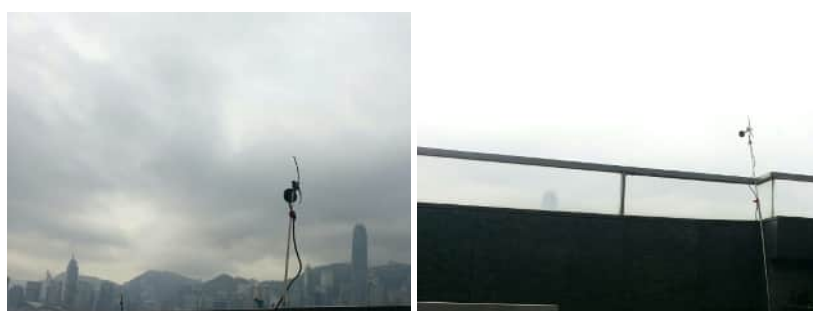
Graphical Presentation Noise Monitoring Result at Station NM1A

The station set-up of a free-field measurement at Station NM1A.

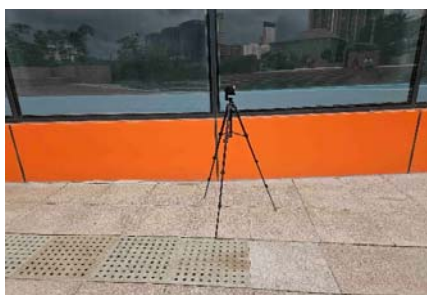
Graphical Presentation of Noise Monitoring Result at Station NM2A

The station set-up of a façade measurement at station NM2A.

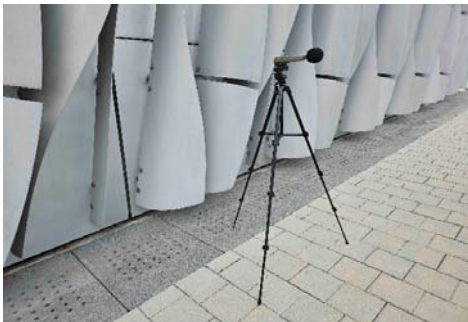
Graphical Presentation of Noise Monitoring Result at Station NM3A

The station set-up of a façade measurement at station NM3A.

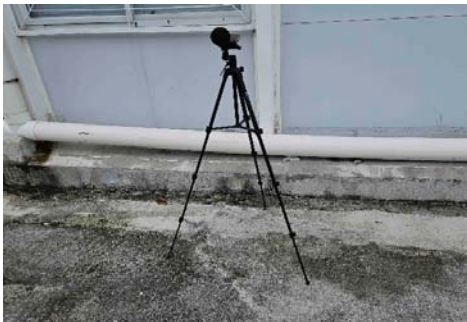
Graphical Presentation of Noise Monitoring Result at Station NM4A

The station set-up of a façade measurement at station NM4A.

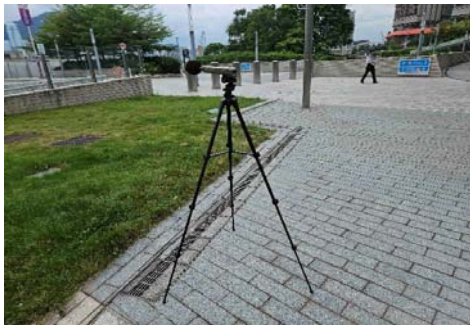
Graphical Presentation of Noise Monitoring Result at Station NM5A

The station set-up of a free-field measurement at station NM5A.
