Development at West Kowloon Cultural District

**Monthly Environmental Monitoring and Audit (EM&A) Report
for September 2025**

**Part-2: EM&A for ELS Works for The
Integrated Basement and
Underground Road in Zones 2A, 2B
& 2C**

Part-1: EM&A at Lyric Theatre Complex

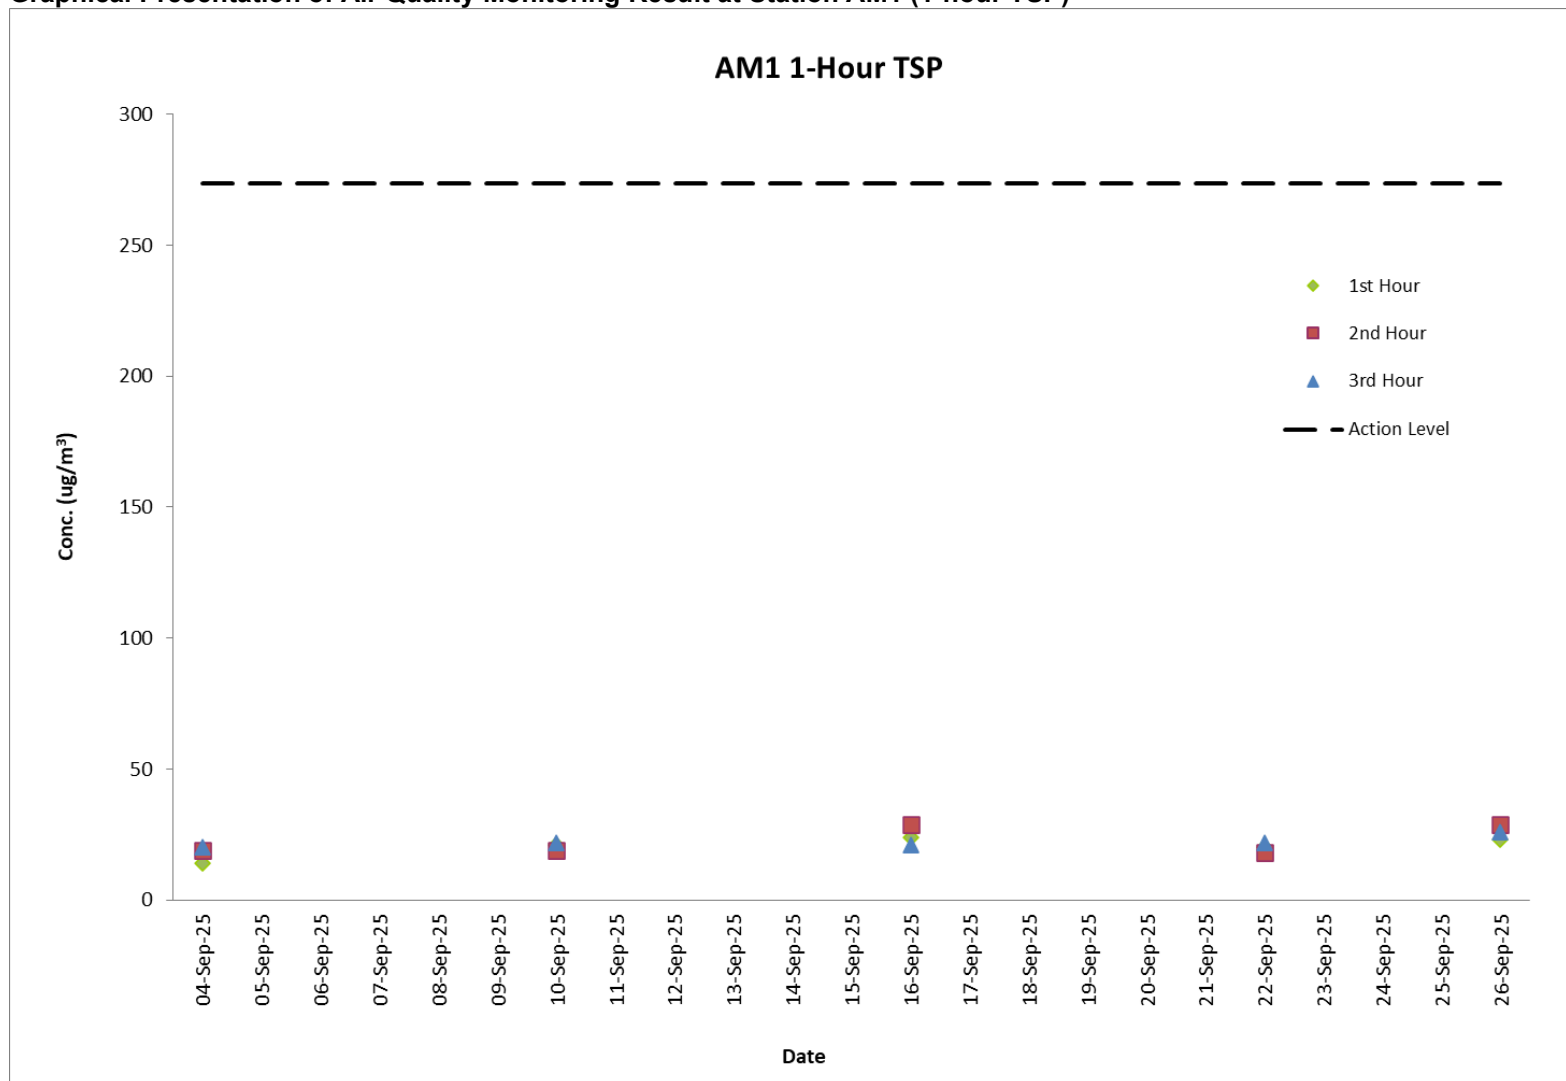
Graphical Presentation of Air Quality Monitoring Result at Station AM1 (1-hour TSP)

Date	Weather Condition	Time	Conc. ($\mu\text{g}/\text{m}^3$)			Action Level ($\mu\text{g}/\text{m}^3$)	Limit Level ($\mu\text{g}/\text{m}^3$)
			1 st Hour	2 nd Hour	3 rd Hour		
04-Sep-25	Fine	8:22 - 11:22	14	19	20	273.7	500
10-Sep-25	Fine	8:33 - 11:33	21	19	22	273.7	500
16-Sep-25	Fine	8:38 - 11:38	24	29	21	273.7	500
22-Sep-25	Fine	8:33 - 11:33	20	18	22	273.7	500
26-Sep-25	Fine	8:32 - 11:32	23	29	26	273.7	500
