Development at West Kowloon Cultural District

**Monthly Environmental Monitoring and Audit (EM&A) Report
for February 2026**

**Part-2: EM&A for ELS Works for The
Integrated Basement and
Underground Road in Zones 2A, 2B
& 2C**

The Monthly EM&A Report is prepared in accordance with the Condition 3.4 of the Environmental Permit No. EP-453/2013/B. This Monthly EM&A Report presents the monitoring works at Lyric Theatre Complex (L2 Contract) from 1 February to 28 February 2026. The purpose of this report is to summarise the findings in the EM&A of the project over the reporting period.

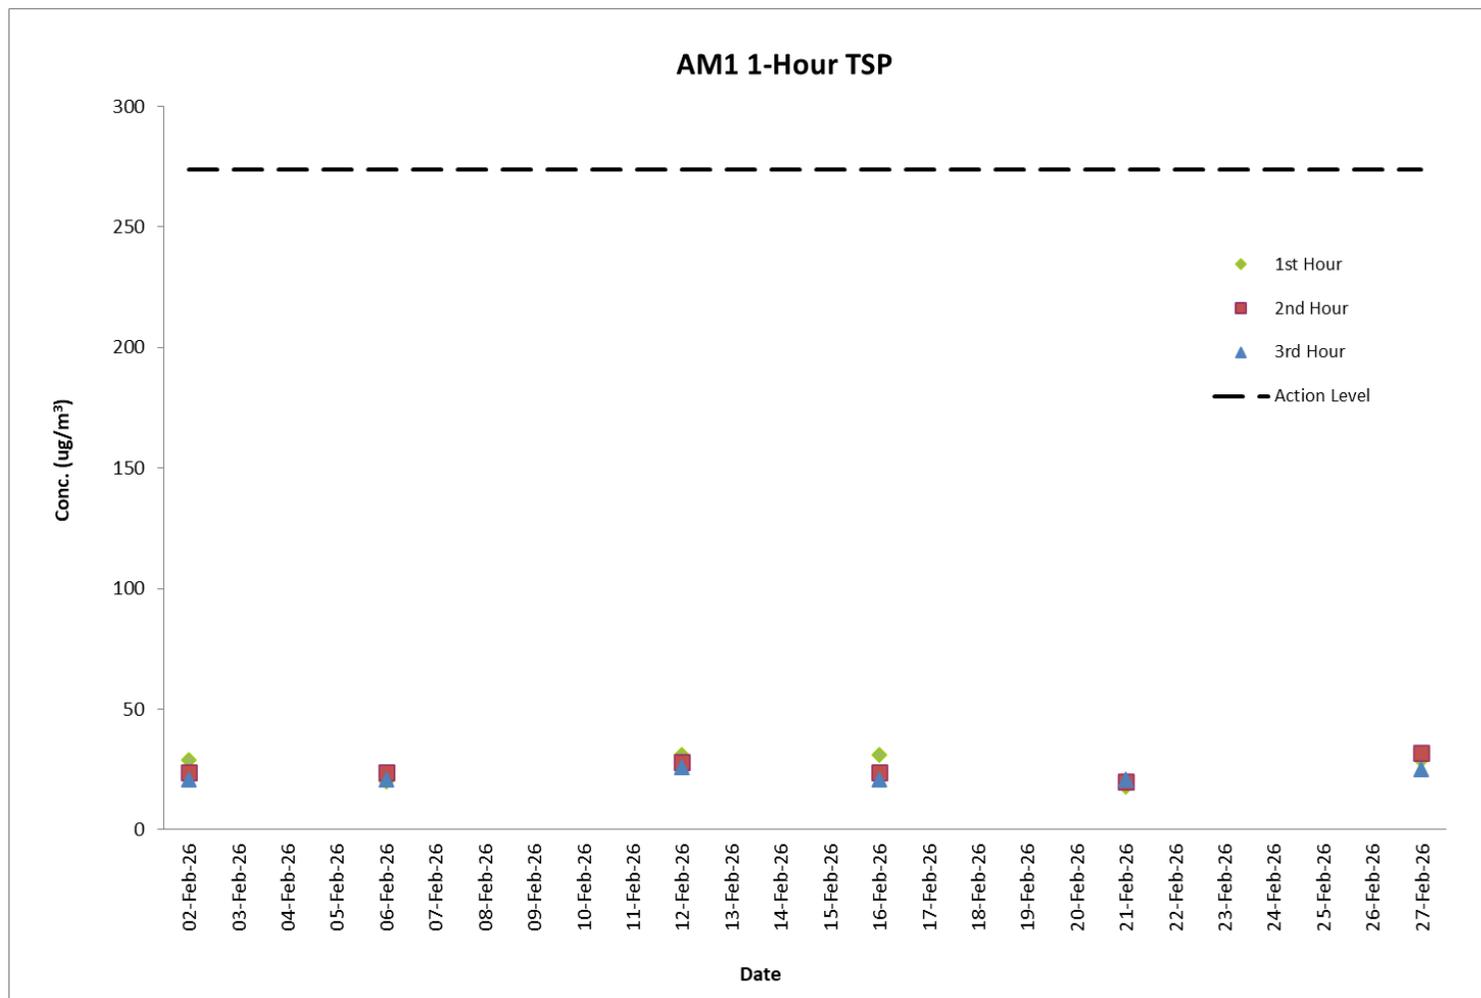
Graphical Presentation of Air Quality Monitoring Result at Station AM1 (1-hour TSP)

Date	Weather Condition	Time	Conc. ($\mu\text{g}/\text{m}^3$)			Action Level ($\mu\text{g}/\text{m}^3$)	Limit Level ($\mu\text{g}/\text{m}^3$)	Min	Max
			1 st Hour	2 nd Hour	3 rd Hour				
02-Feb-26	Cloudy	8:23 - 11:23	29	24	21	273.7	500	18	32
06-Feb-26	Fine	8:32 - 11:32	20	24	21	273.7	500		
12-Feb-26	Cloudy	8:33 - 11:33	31	28	26	273.7	500		
16-Feb-26	Fine	8:33 - 11:33	31	24	21	273.7	500		
21-Feb-26	Fine	8:27 - 11:27	18	20	21	273.7	500		
27-Feb-26	Fine	8:28 - 11:28	29	32	25	273.7	500

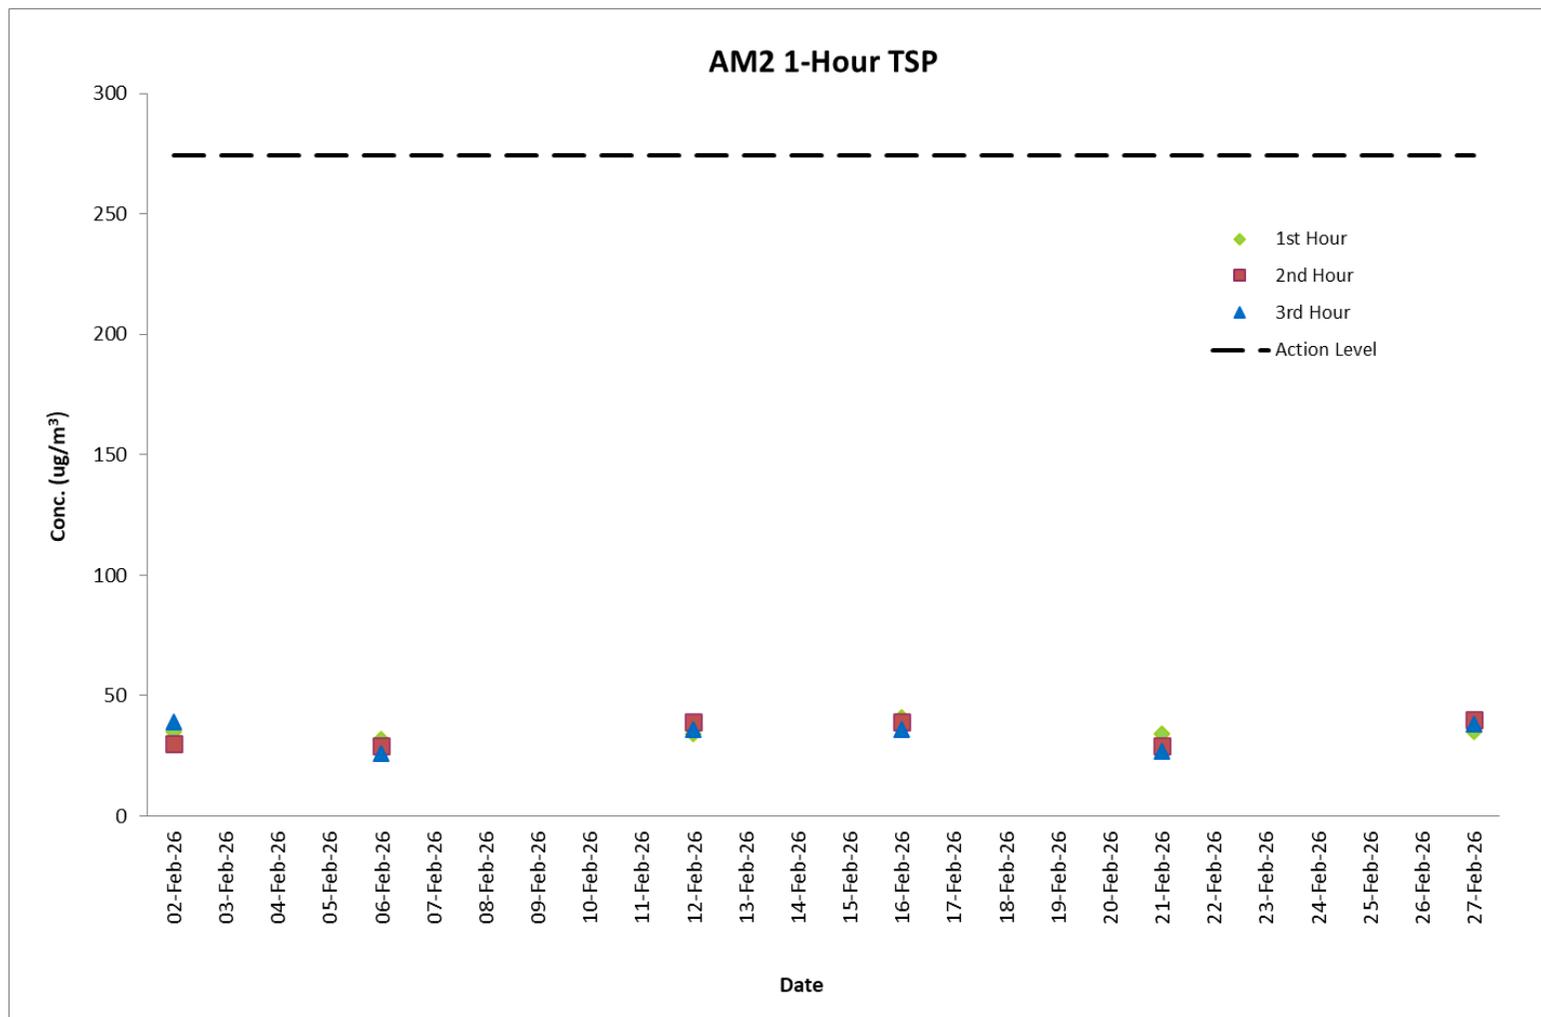
Graphical Presentation of Air Quality Monitoring Result at Station AM2 (1-hour TSP)

Date	Weather Condition	Time		Conc. ($\mu\text{g}/\text{m}^3$)			Action Level ($\mu\text{g}/\text{m}^3$)	Limit Level ($\mu\text{g}/\text{m}^3$)	Min	Max
				1 st Hour	2 nd Hour	3 rd Hour				
02-Feb-26	Cloudy	8:42	- 11:42	35	30	39	274.2	500	26	41
06-Feb-26	Fine	8:48	- 11:48	32	29	26	274.2	500		
12-Feb-26	Cloudy	8:50	- 11:50	34	39	36	274.2	500		
16-Feb-26	Fine	8:50	- 11:50	41	39	36	274.2	500		
21-Feb-26	Fine	8:42	- 11:42	34	29	27	274.2	500		
27-Feb-26	Cloudy	8:45	- 11:45	35	40	38	274.2	500

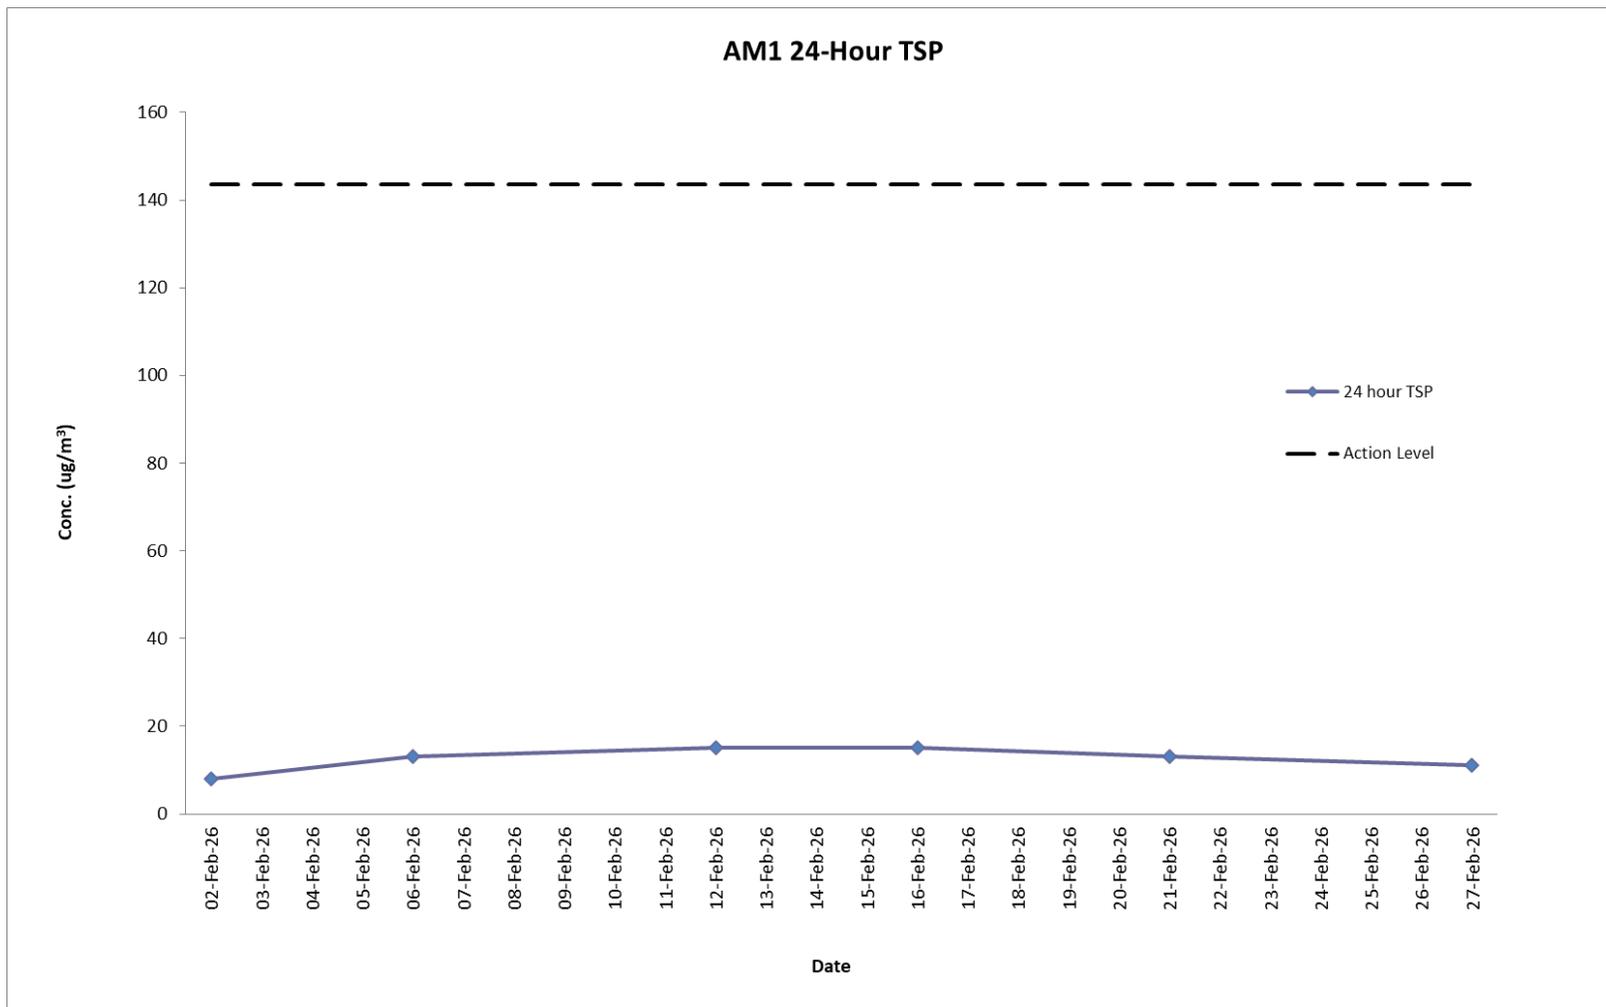
Graphical Presentation of Air Quality Monitoring Result at Station AM1 (24-hour TSP)

Start		Finish		Filter Weight (g)		Elapsed Time Reading		Sampling Time (hrs)	Flow Rate (m ³ /min)			Conc. (µg/m ³)	Weather Condition	Action Level	Limit Level
Date	Time	Date	Time	Initial	Final	Initial	Final		Initial	Final	Average				
02-Feb-26	08:21	03-Feb-26	08:21	2.7689	2.7831	30820.38	30844.38	24	1.26	1.26	1.26	8	Cloudy	143.6	260
06-Feb-26	08:30	07-Feb-26	08:30	2.7735	2.7963	30844.38	30868.38	24	1.26	1.26	1.26	13	Fine	143.6	260
12-Feb-26	08:31	13-Feb-26	08:31	2.7653	2.7925	30868.38	30892.38	24	1.26	1.26	1.26	15	Cloudy	143.6	260
16-Feb-26	08:31	17-Feb-26	08:31	2.7691	2.7968	30892.38	30916.38	24	1.26	1.26	1.26	15	Fine	143.6	260
21-Feb-26	08:25	22-Feb-26	08:25	2.7705	2.7946	30916.38	30940.38	24	1.26	1.26	1.26	13	Fine	143.6	260
27-Feb-26	08:26	28-Feb-26	08:26	2.7688	2.7893	30940.38	30964.38	24	1.26	1.26	1.26	11	Cloudy	143.6	260

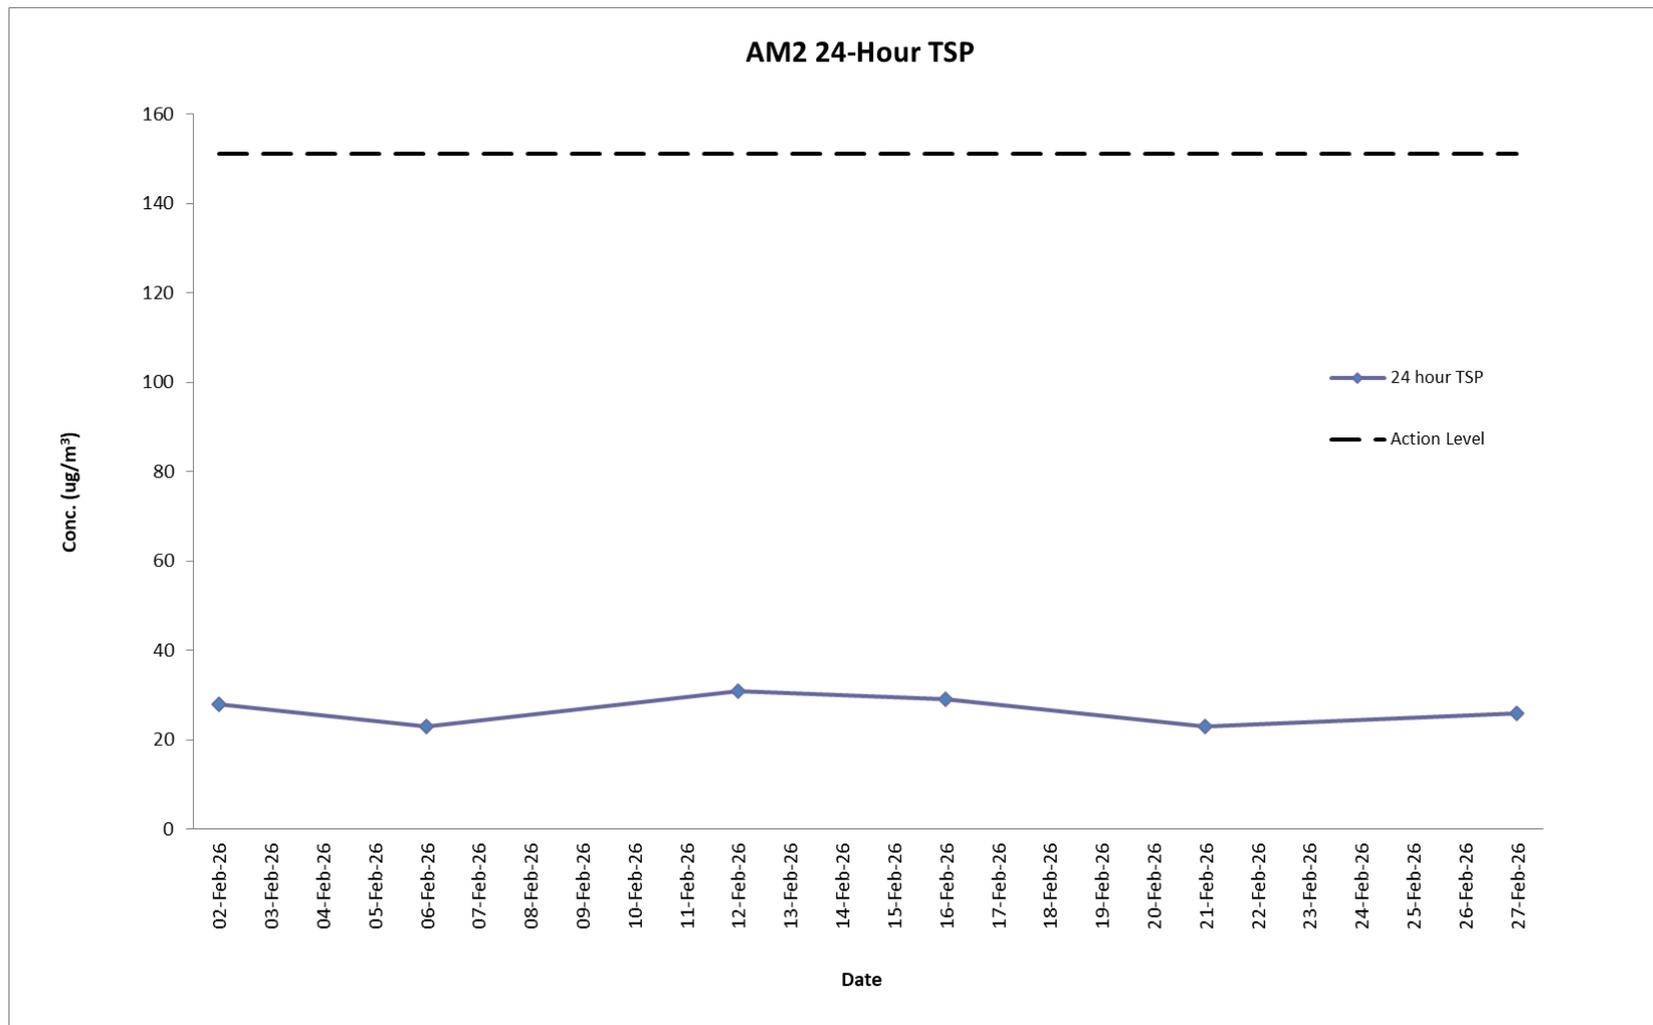
Graphical Presentation of Air Quality Monitoring Result at Station AM2 (24-hour TSP)

Start		Finish		Sampling Time (hrs)	Conc. ($\mu\text{g}/\text{m}^3$)	Weather Condition	Action Level	Limit Level
Date	Time	Date	Time					
02-Feb-26	08:40	03-Feb-26	08:40	24	28	Cloudy	151.1	260
06-Feb-26	08:46	07-Feb-26	08:46	24	23	Fine	151.1	260
12-Feb-26	08:48	13-Feb-26	08:48	24	31	Cloudy	151.1	260
16-Feb-26	08:48	17-Feb-26	08:48	24	29	Fine	151.1	260
21-Feb-26	08:40	22-Feb-26	08:40	24	23	Fine	151.1	260
27-Feb-26	08:43	28-Feb-26	08:43	24	26	Cloudy	151.1	260

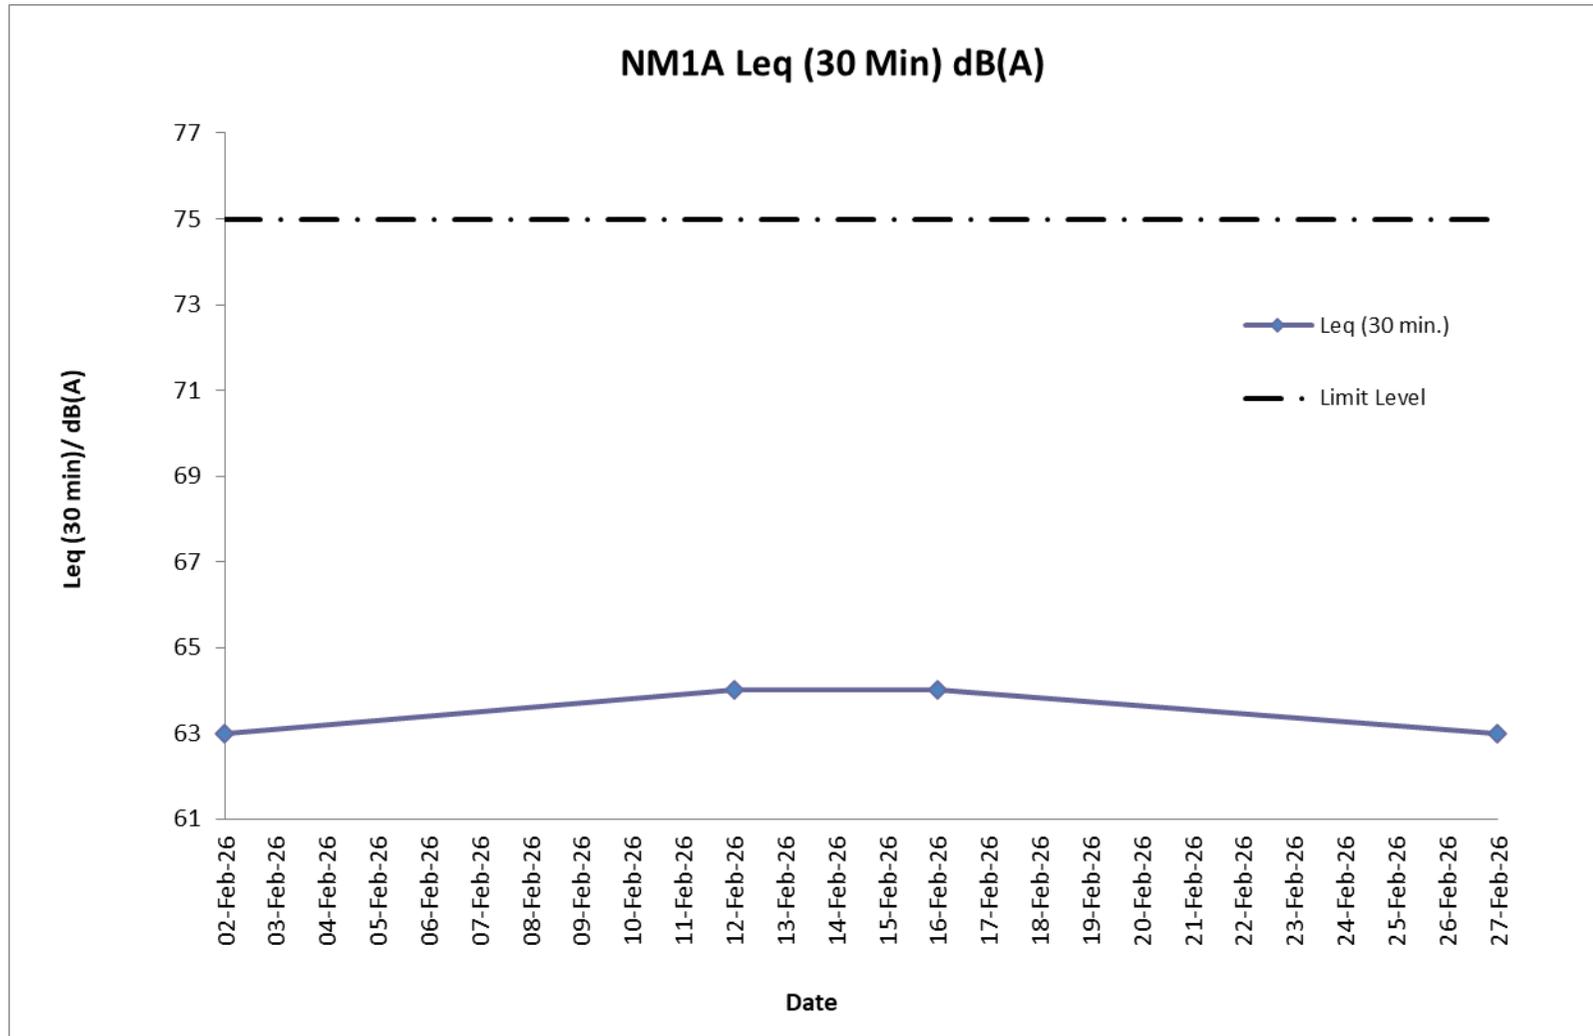
Graphical Presentation Noise Monitoring Result at Station NM1A

Date	Time	Measured L ₁₀ , dB(A)	Measured L ₉₀ , dB(A)	L _{eq} (30 min.)*, dB(A)
02-Feb-26	09:30	61.7	57.6	63
02-Feb-26	09:35	62.2	58.0	
02-Feb-26	09:40	62.5	58.3	
02-Feb-26	09:45	63.0	59.6	
02-Feb-26	09:50	62.8	58.7	
02-Feb-26	09:55	61.9	57.9	
12-Feb-26	09:35	62.8	58.7	64
12-Feb-26	09:40	61.2	57.0	
12-Feb-26	09:45	63.7	59.3	
12-Feb-26	09:50	63.5	59.9	
12-Feb-26	09:55	62.0	58.6	
12-Feb-26	10:00	63.9	59.8	
16-Feb-26	09:37	62.2	58.9	64
16-Feb-26	09:42	63.9	59.0	
16-Feb-26	09:47	61.8	57.3	
16-Feb-26	09:52	61.0	57.7	
16-Feb-26	09:57	63.7	59.6	
16-Feb-26	10:02	63.5	59.8	
27-Feb-26	09:42	62.2	58.9	63
27-Feb-26	09:47	62.7	58.0	
27-Feb-26	09:52	63.8	59.3	
27-Feb-26	09:57	61.5	57.6	
27-Feb-26	10:02	61.0	57.7	
27-Feb-26	10:07	62.9	58.6

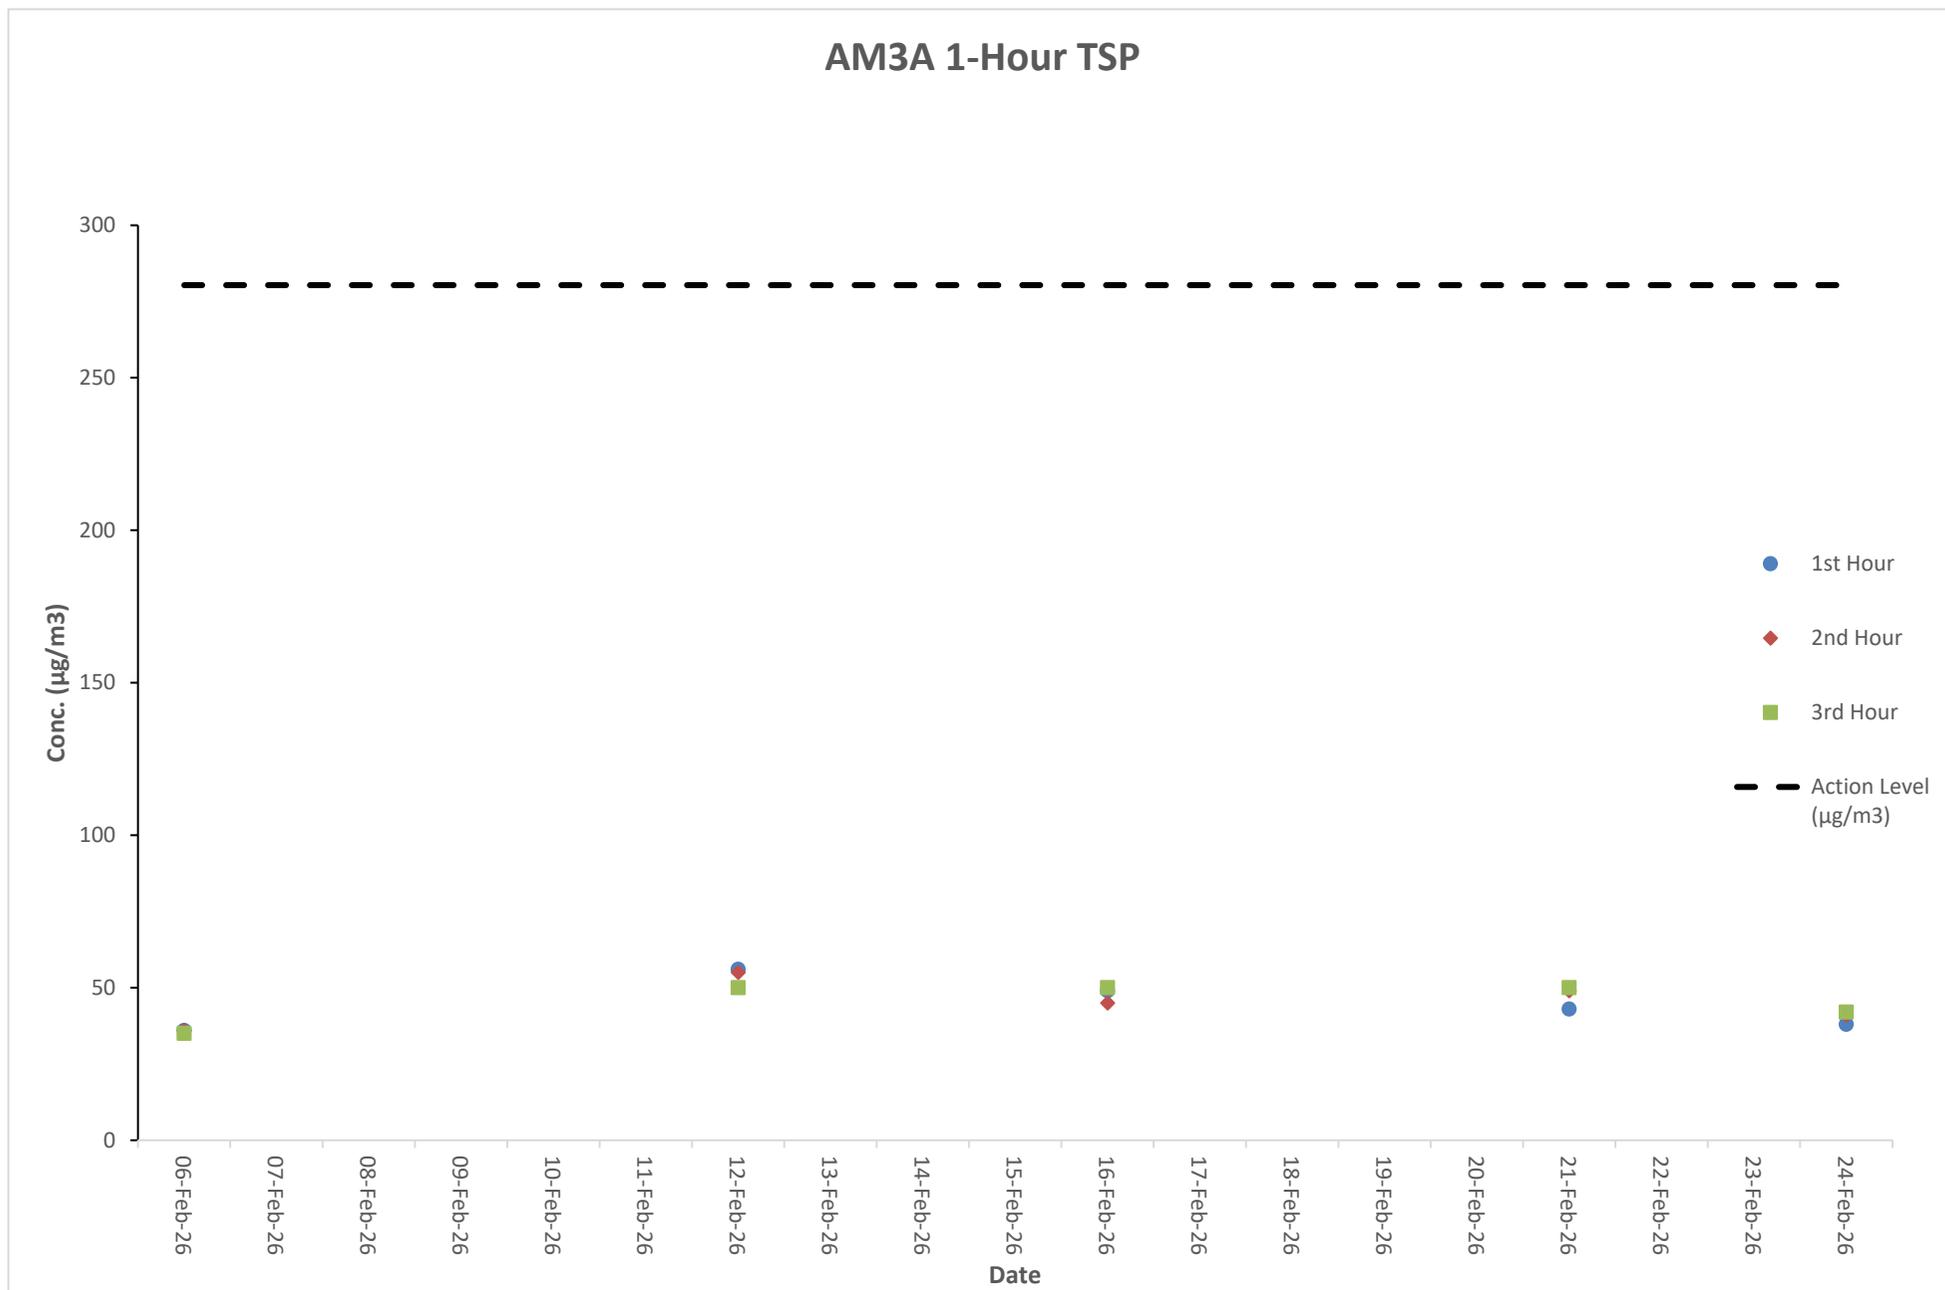
Graphical Presentation of Air Quality Monitoring Result at Station AM3A (1-hour TSP)

Date	Weather Condition	Time		Conc. ($\mu\text{g}/\text{m}^3$)			Action Level	Limit Level
		Start	Finish	1st Hour	2nd Hour	3rd Hour		
06-Feb-26	Fine	13:02	16:02	36	36	35	280.4	500
12-Feb-26	Cloudy	7:01	10:01	56	55	50	280.4	500
16-Feb-26	Fine	13:04	16:04	49	45	50	280.4	500
21-Feb-26	Fine	7:09	10:09	43	49	50	280.4	500
24-Feb-26	Cloudy	13:02	16:02	38	41	42	280.4	500

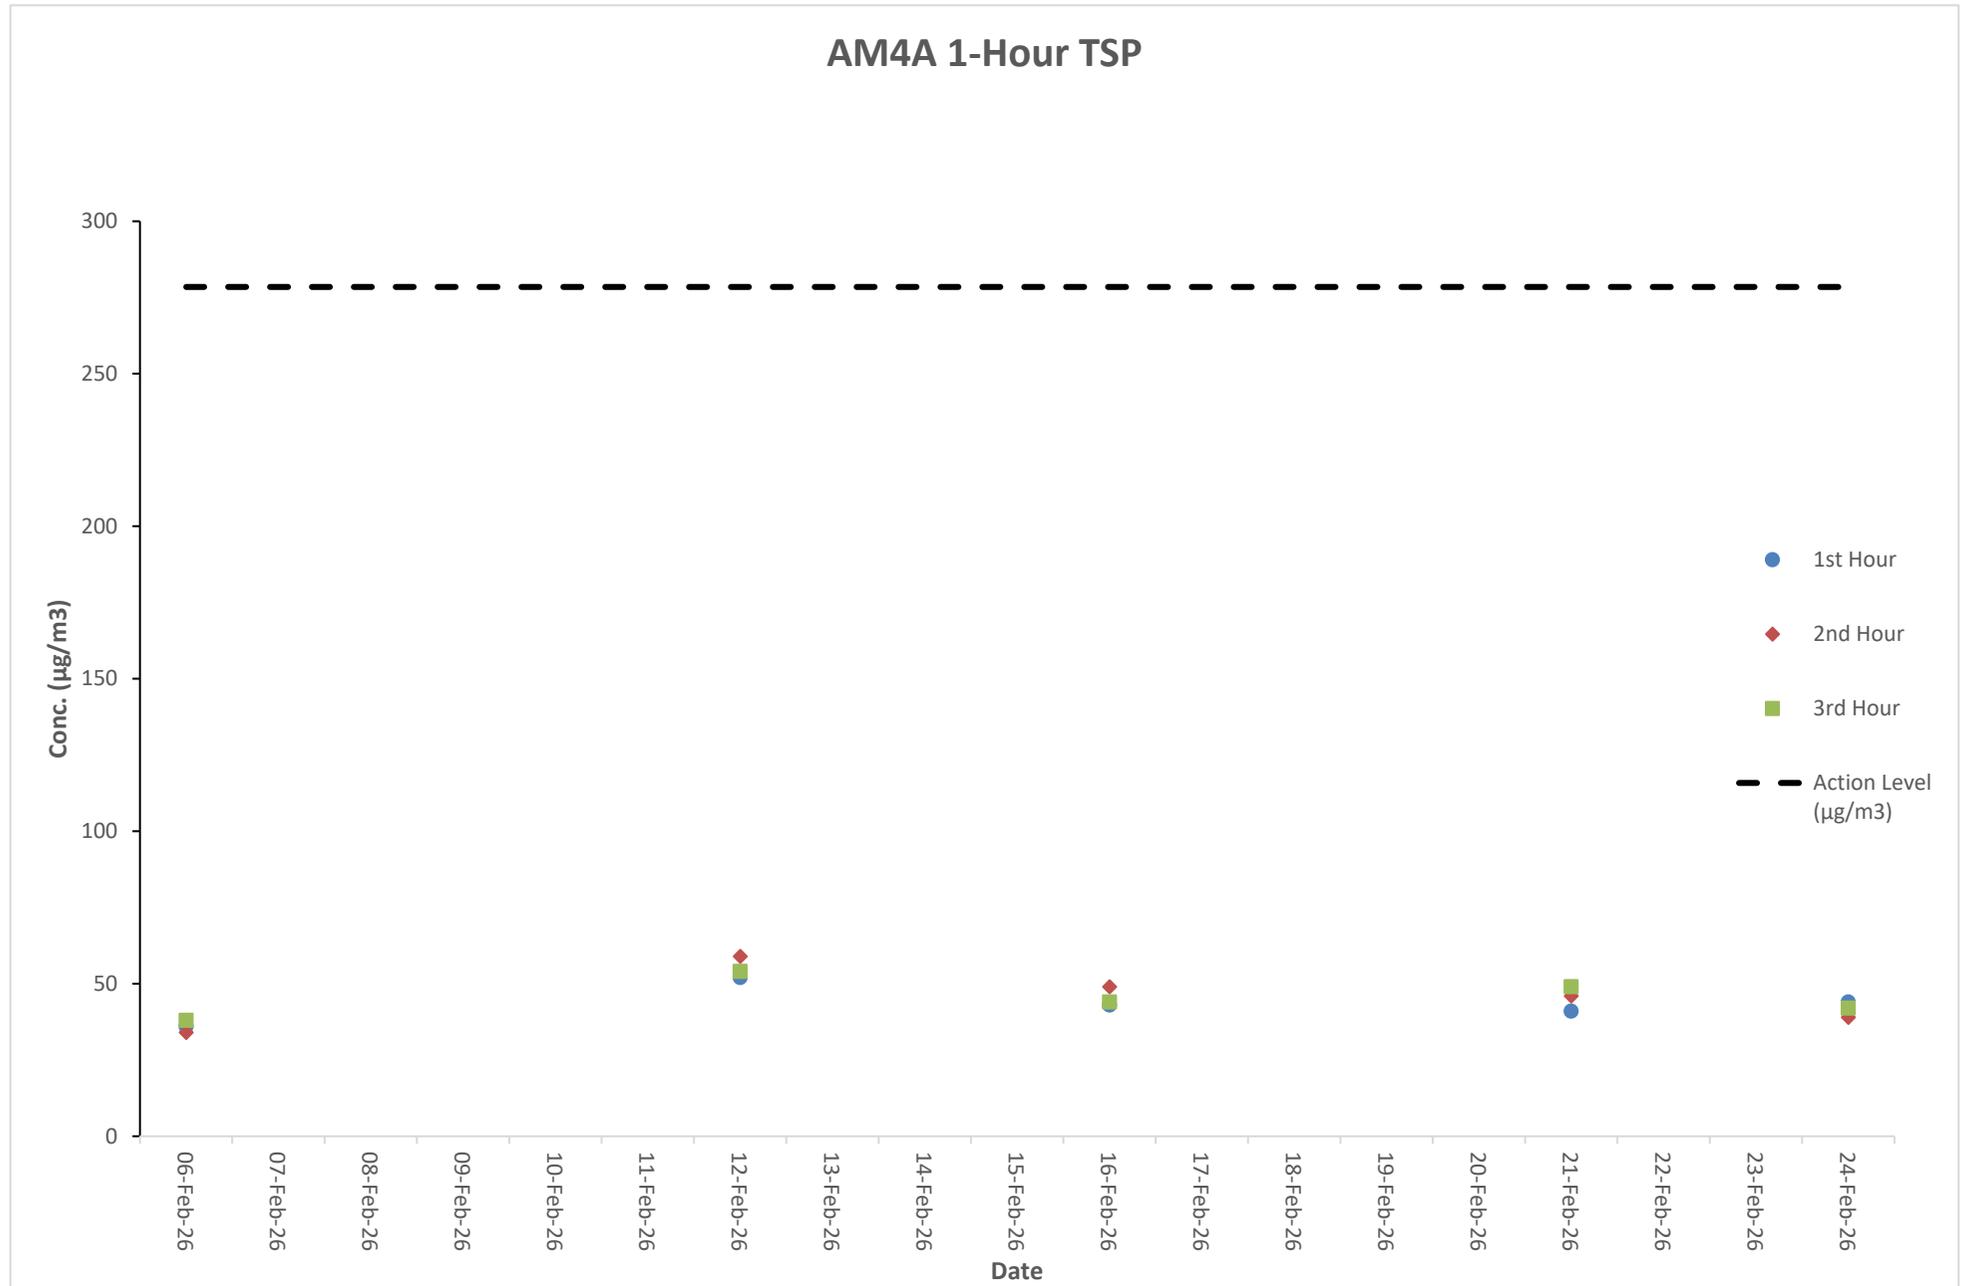
Graphical Presentation of Air Quality Monitoring Result at Station AM4A (1-hour TSP)

Date	Weather Condition	Time		Conc. ($\mu\text{g}/\text{m}^3$)			Action Level	Limit Level
		Start	Finish	1st Hour	2nd Hour	3rd Hour		
06-Feb-26	Fine	13:10	16:10	36	34	38	278.5	500
12-Feb-26	Cloudy	7:09	10:09	52	59	54	278.5	500
16-Feb-26	Fine	13:12	16:12	43	49	44	278.5	500
21-Feb-26	Fine	7:17	10:17	41	46	49	278.5	500
24-Feb-26	Cloudy	13:10	16:10	44	39	42	278.5	500

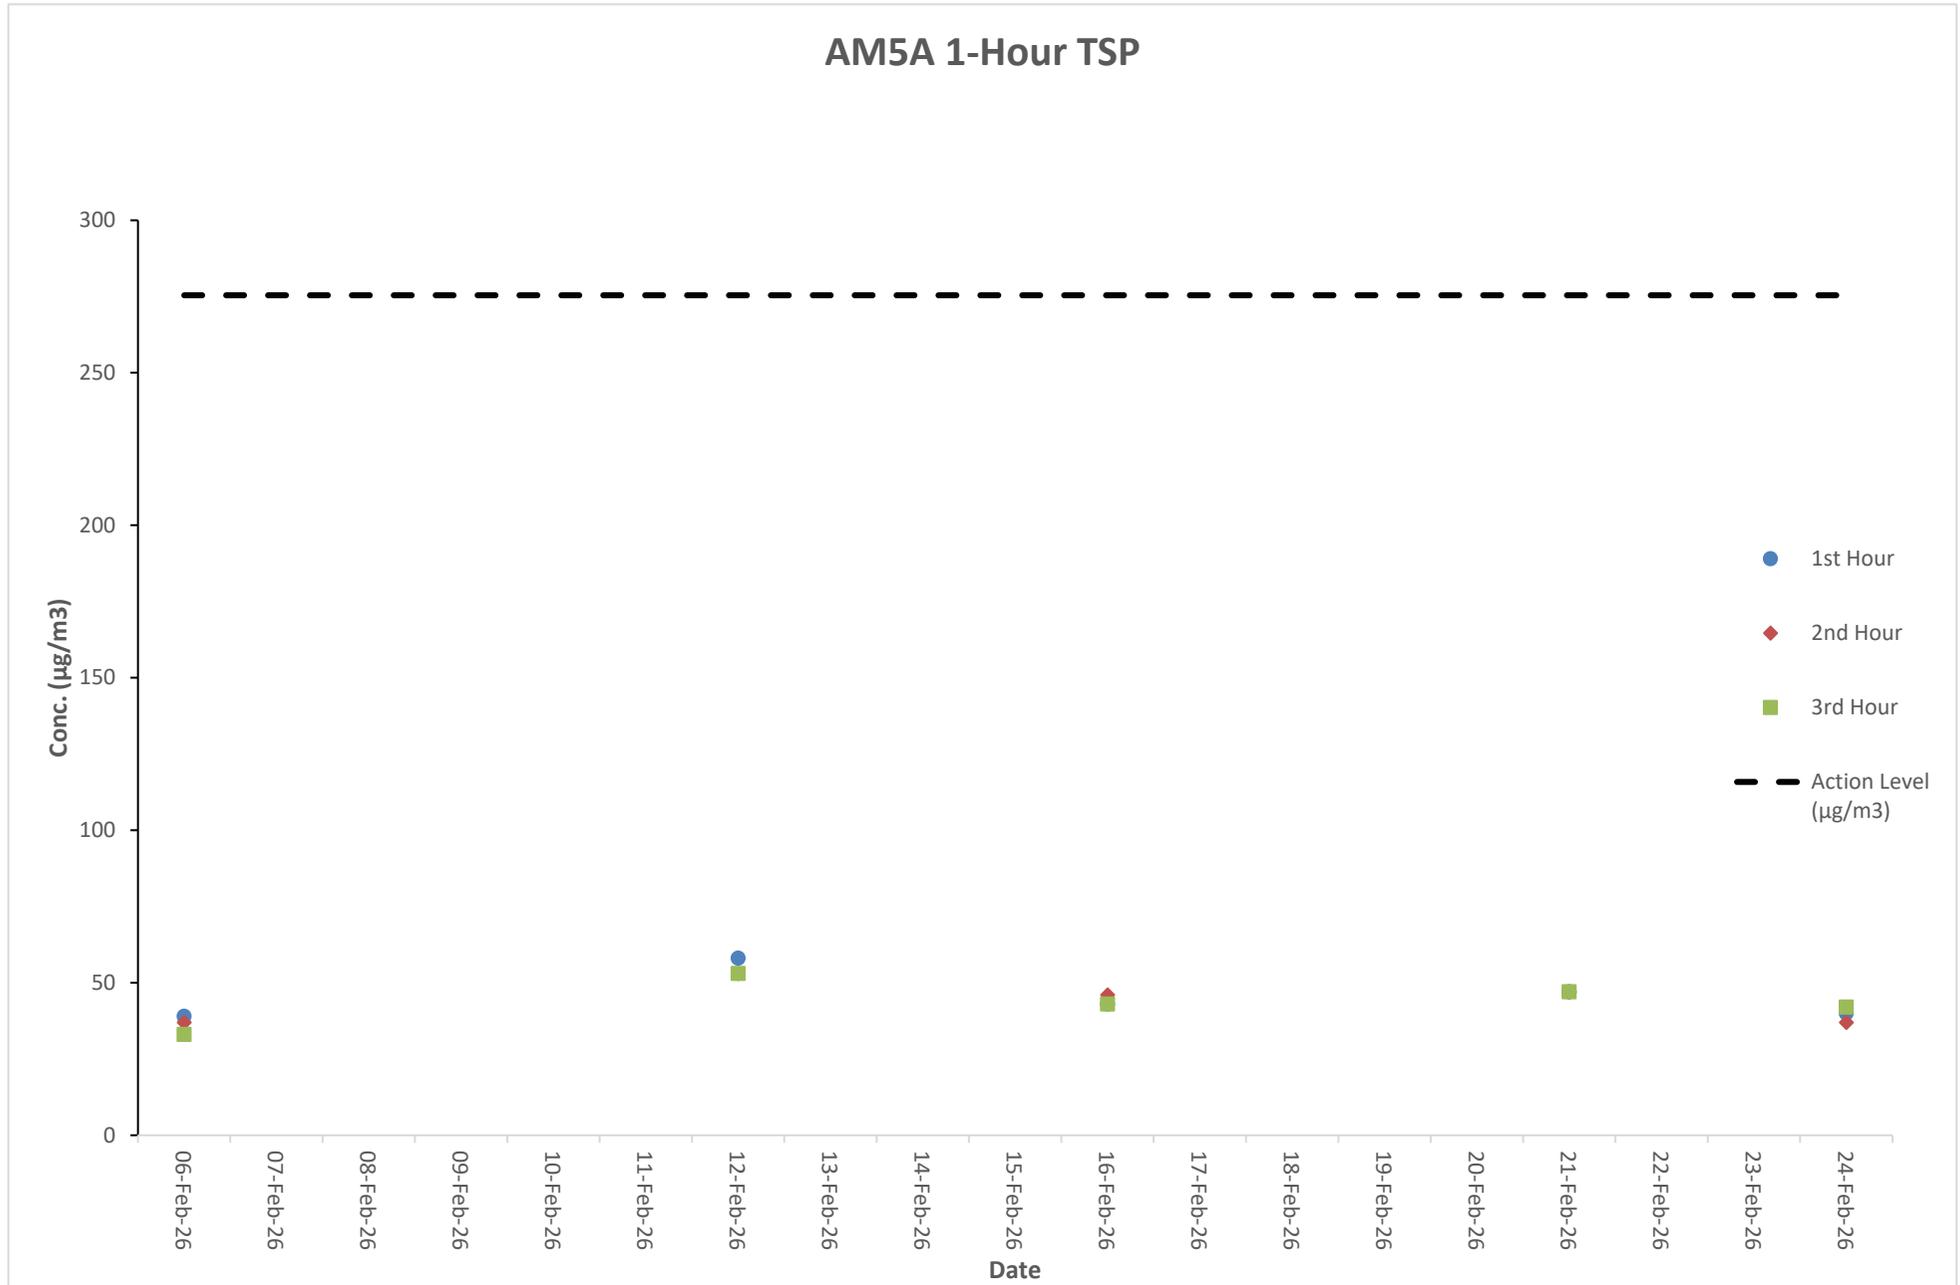
Graphical Presentation of Air Quality Monitoring Result at Station AM5A (1-hour TSP)

Date	Weather Condition	Time		Conc. ($\mu\text{g}/\text{m}^3$)			Action Level	Limit Level
		Start	Finish	1st Hour	2nd Hour	3rd Hour		
06-Feb-26	Fine	13:25	16:25	39	37	33	275.4	500
12-Feb-26	Cloudy	7:26	10:26	58	53	53	275.4	500
16-Feb-26	Fine	13:27	16:27	43	46	43	275.4	500
21-Feb-26	Fine	7:34	10:34	47	47	47	275.4	500
24-Feb-26	Cloudy	13:25	16:25	40	37	42	275.4	500

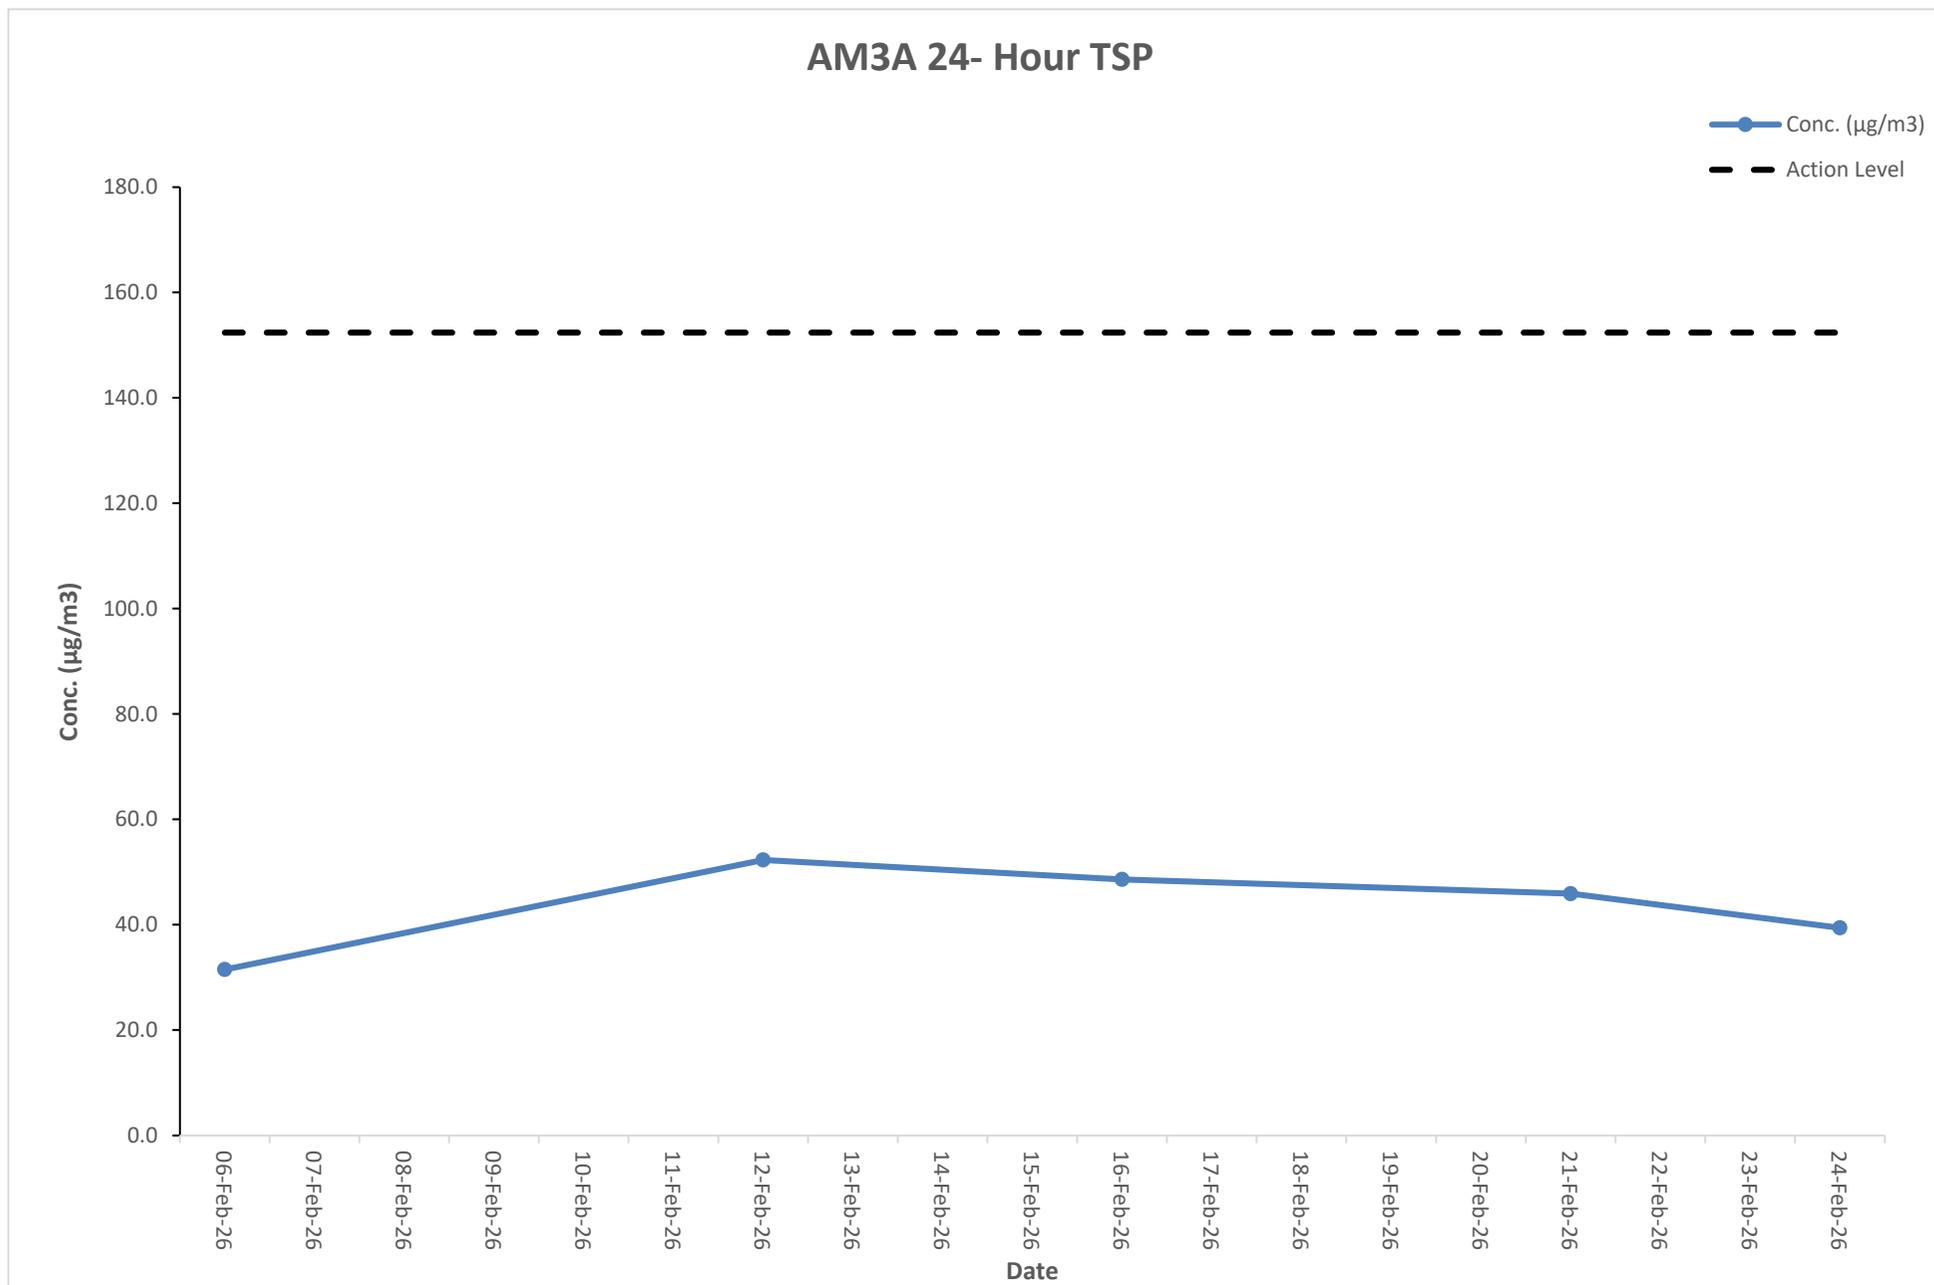
Graphical Presentation of Air Quality Monitoring Result at Station AM3A (24-hour TSP)

Start		Finish		Filter Weight (g)		Elapsed Time Reading		Sampling Time (hrs)	Flow Rate (m ³ /min)			Conc. (µg/m ³)	Weather Condition	Action Level	Limit Level
Date	Time	Date	Time	Initial	Final	Initial	Final		Initial	Final	Average				
06-Feb-26	10:00AM	07-Feb-26	10:00AM	2.8021	2.8528	9527.8	9551.8	24	1.12	1.12	1.12	31.5	Sunny	152.4	260
12-Feb-26	10:00AM	13-Feb-26	10:00AM	2.8062	2.8903	9551.8	9575.8	24	1.12	1.12	1.12	52.3	Cloudy	152.4	260
16-Feb-26	10:00AM	17-Feb-26	10:00AM	2.8049	2.8832	9575.8	9599.8	24	1.12	1.12	1.12	48.6	Sunny	152.4	260
21-Feb-26	10:00AM	22-Feb-26	10:00AM	2.8029	2.8768	9599.8	9623.8	24	1.12	1.12	1.12	45.9	Sunny	152.4	260
24-Feb-26	10:00AM	25-Feb-26	10:00AM	2.8083	2.8717	9623.8	9647.8	24	1.12	1.12	1.12	39.4	Rainy	152.4	260

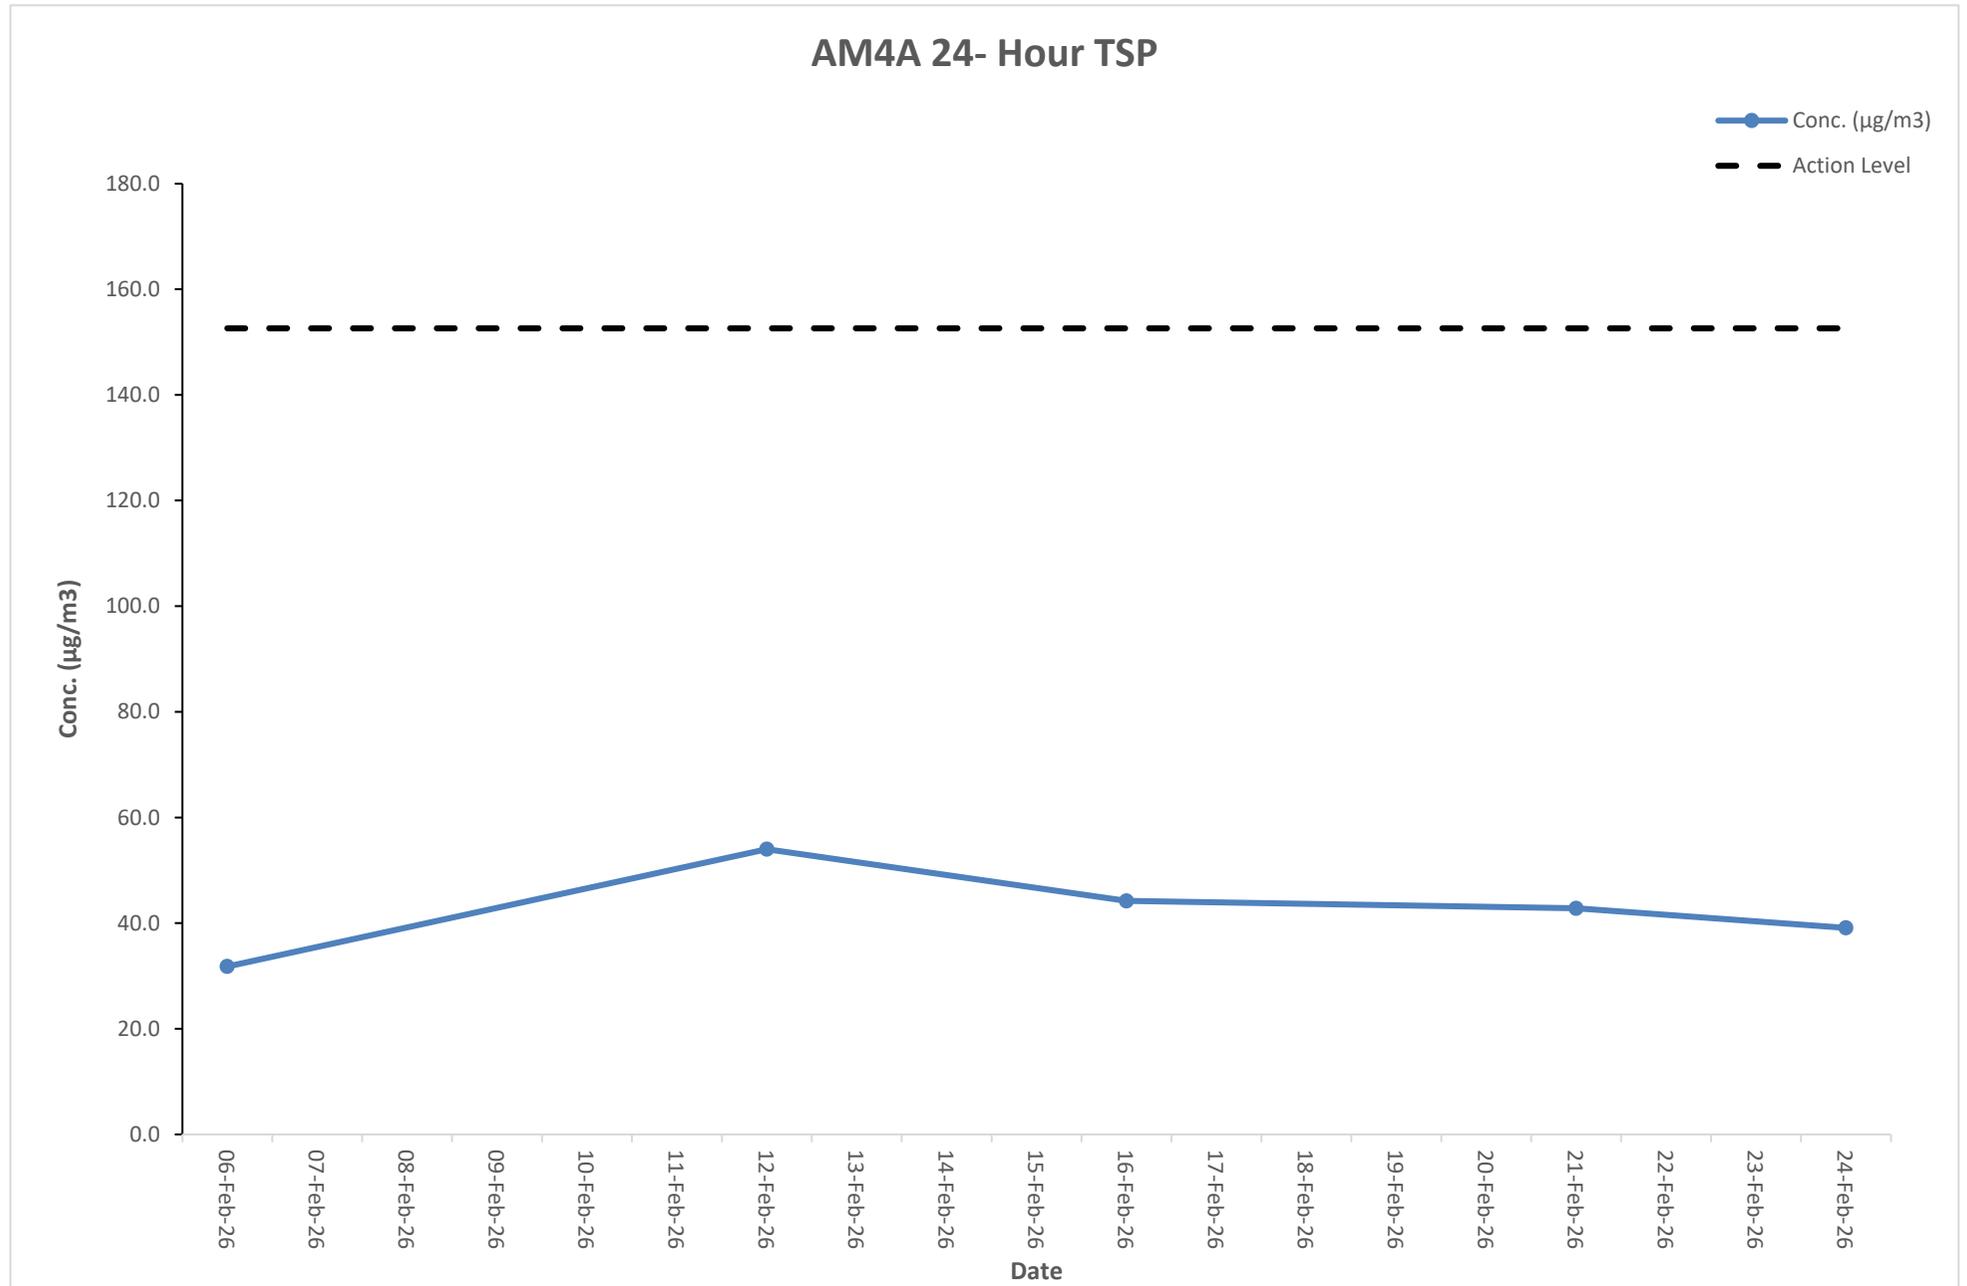
Graphical Presentation of Air Quality Monitoring Result at Station AM4A (24-hour TSP)

Start		Finish		Filter Weight (g)		Elapsed Time Reading		Sampling Time (hrs)	Flow Rate (m ³ /min)			Conc. (µg/m ³)	Weather Condition	Action Level	Limit Level
Date	Time	Date	Time	Initial	Final	Initial	Final		Initial	Final	Average				
06-Feb-26	10:00AM	07-Feb-26	10:00AM	2.8064	2.8576	9947.4	9971.4	24	1.12	1.12	1.12	31.8	Sunny	152.6	260
12-Feb-26	10:00AM	13-Feb-26	10:00AM	2.8044	2.8914	9971.4	9995.4	24	1.12	1.12	1.12	54.0	Cloudy	152.6	260
16-Feb-26	10:00AM	17-Feb-26	10:00AM	2.8084	2.8795	9995.4	10019.4	24	1.12	1.12	1.12	44.2	Sunny	152.6	260
21-Feb-26	10:00AM	22-Feb-26	10:00AM	2.8060	2.8750	10019.4	10043.4	24	1.12	1.12	1.12	42.8	Sunny	152.6	260
24-Feb-26	10:00AM	25-Feb-26	10:00AM	2.8056	2.8684	10043.4	10067.4	24	1.12	1.12	1.12	39.1	Rainy	152.6	260
