Development at West Kowloon Cultural District

**Monthly Environmental Monitoring and Audit (EM&A) Report
for February 2026**

**Part-2: EM&A for ELS Works for The
Integrated Basement and
Underground Road in Zones 2A, 2B
& 2C**

The Monthly EM&A Report is prepared in accordance with the Condition 3.4 of the Environmental Permit No. EP-453/2013/B. This Monthly EM&A Report presents the monitoring works at Lyric Theatre Complex (L2 Contract) from 1 February to 28 February 2026. The purpose of this report is to summarise the findings in the EM&A of the project over the reporting period.

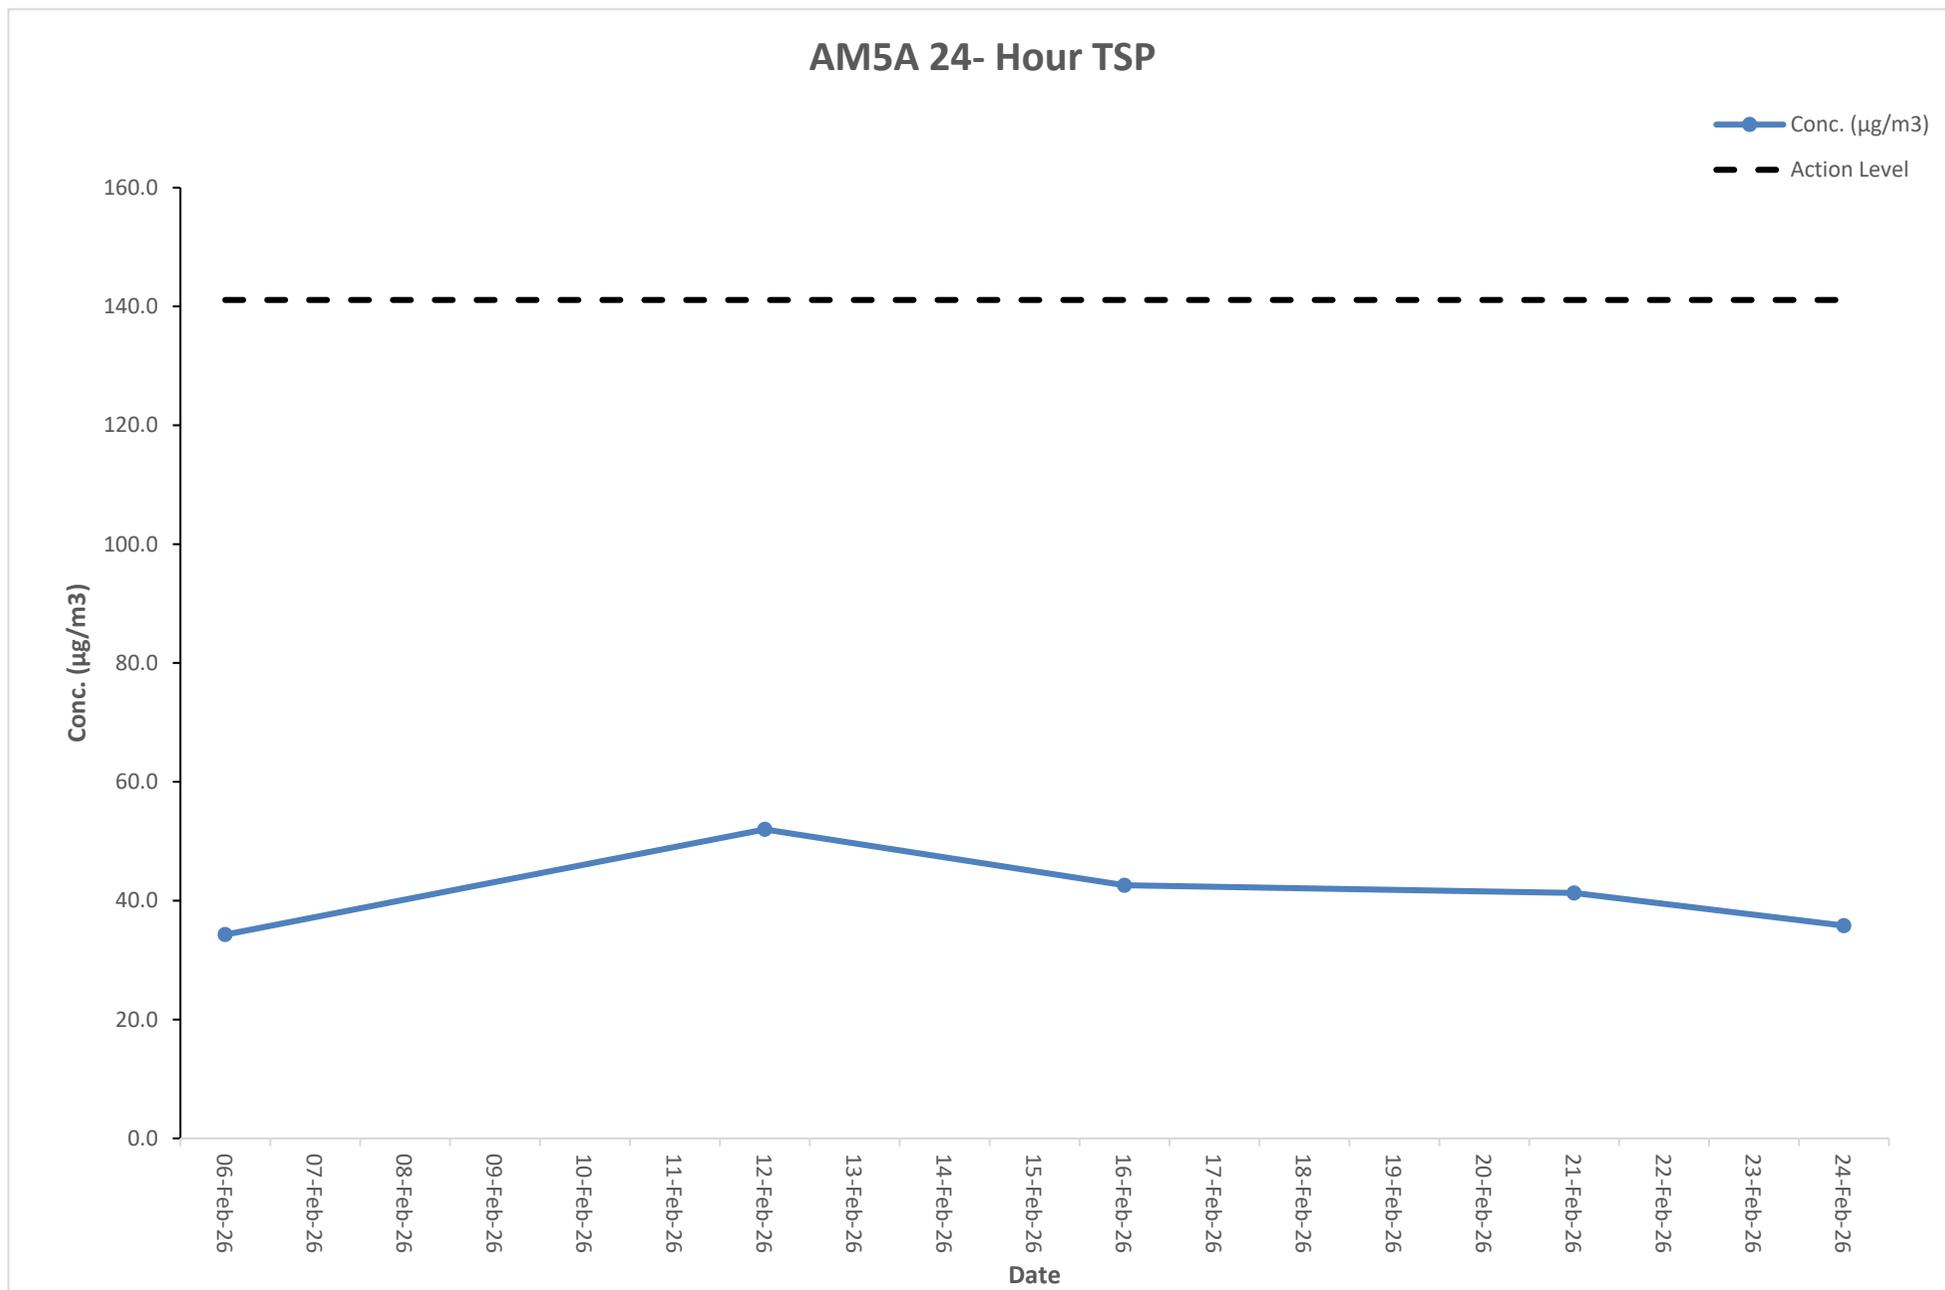
Graphical Presentation of Air Quality Monitoring Result at Station AM5A (24-hour TSP)

Start		Finish		Filter Weight (g)		Elapsed Time Reading		Sampling Time (hrs)	Flow Rate (m ³ /min)			Conc. (µg/m ³)	Weather Condition	Action Level	Limit Level
Date	Time	Date	Time	Initial	Final	Initial	Final		Initial	Final	Average				
06-Feb-26	10:00AM	07-Feb-26	10:00AM	2.8041	2.8594	10085.6	10109.6	24	1.12	1.12	1.12	34.3	Sunny	141.1	260
12-Feb-26	10:00AM	13-Feb-26	10:00AM	2.8035	2.8872	10109.6	10133.6	24	1.12	1.12	1.12	52.0	Cloudy	141.1	260
16-Feb-26	10:00AM	17-Feb-26	10:00AM	2.8012	2.8697	10133.6	10157.6	24	1.12	1.12	1.12	42.6	Sunny	141.1	260
21-Feb-26	10:00AM	22-Feb-26	10:00AM	2.8031	2.8696	10157.6	10181.6	24	1.12	1.12	1.12	41.3	Sunny	141.1	260
24-Feb-26	10:00AM	25-Feb-26	10:00AM	2.8047	2.8624	10181.6	10205.6	24	1.12	1.12	1.12	35.8	Rainy	141.1	260

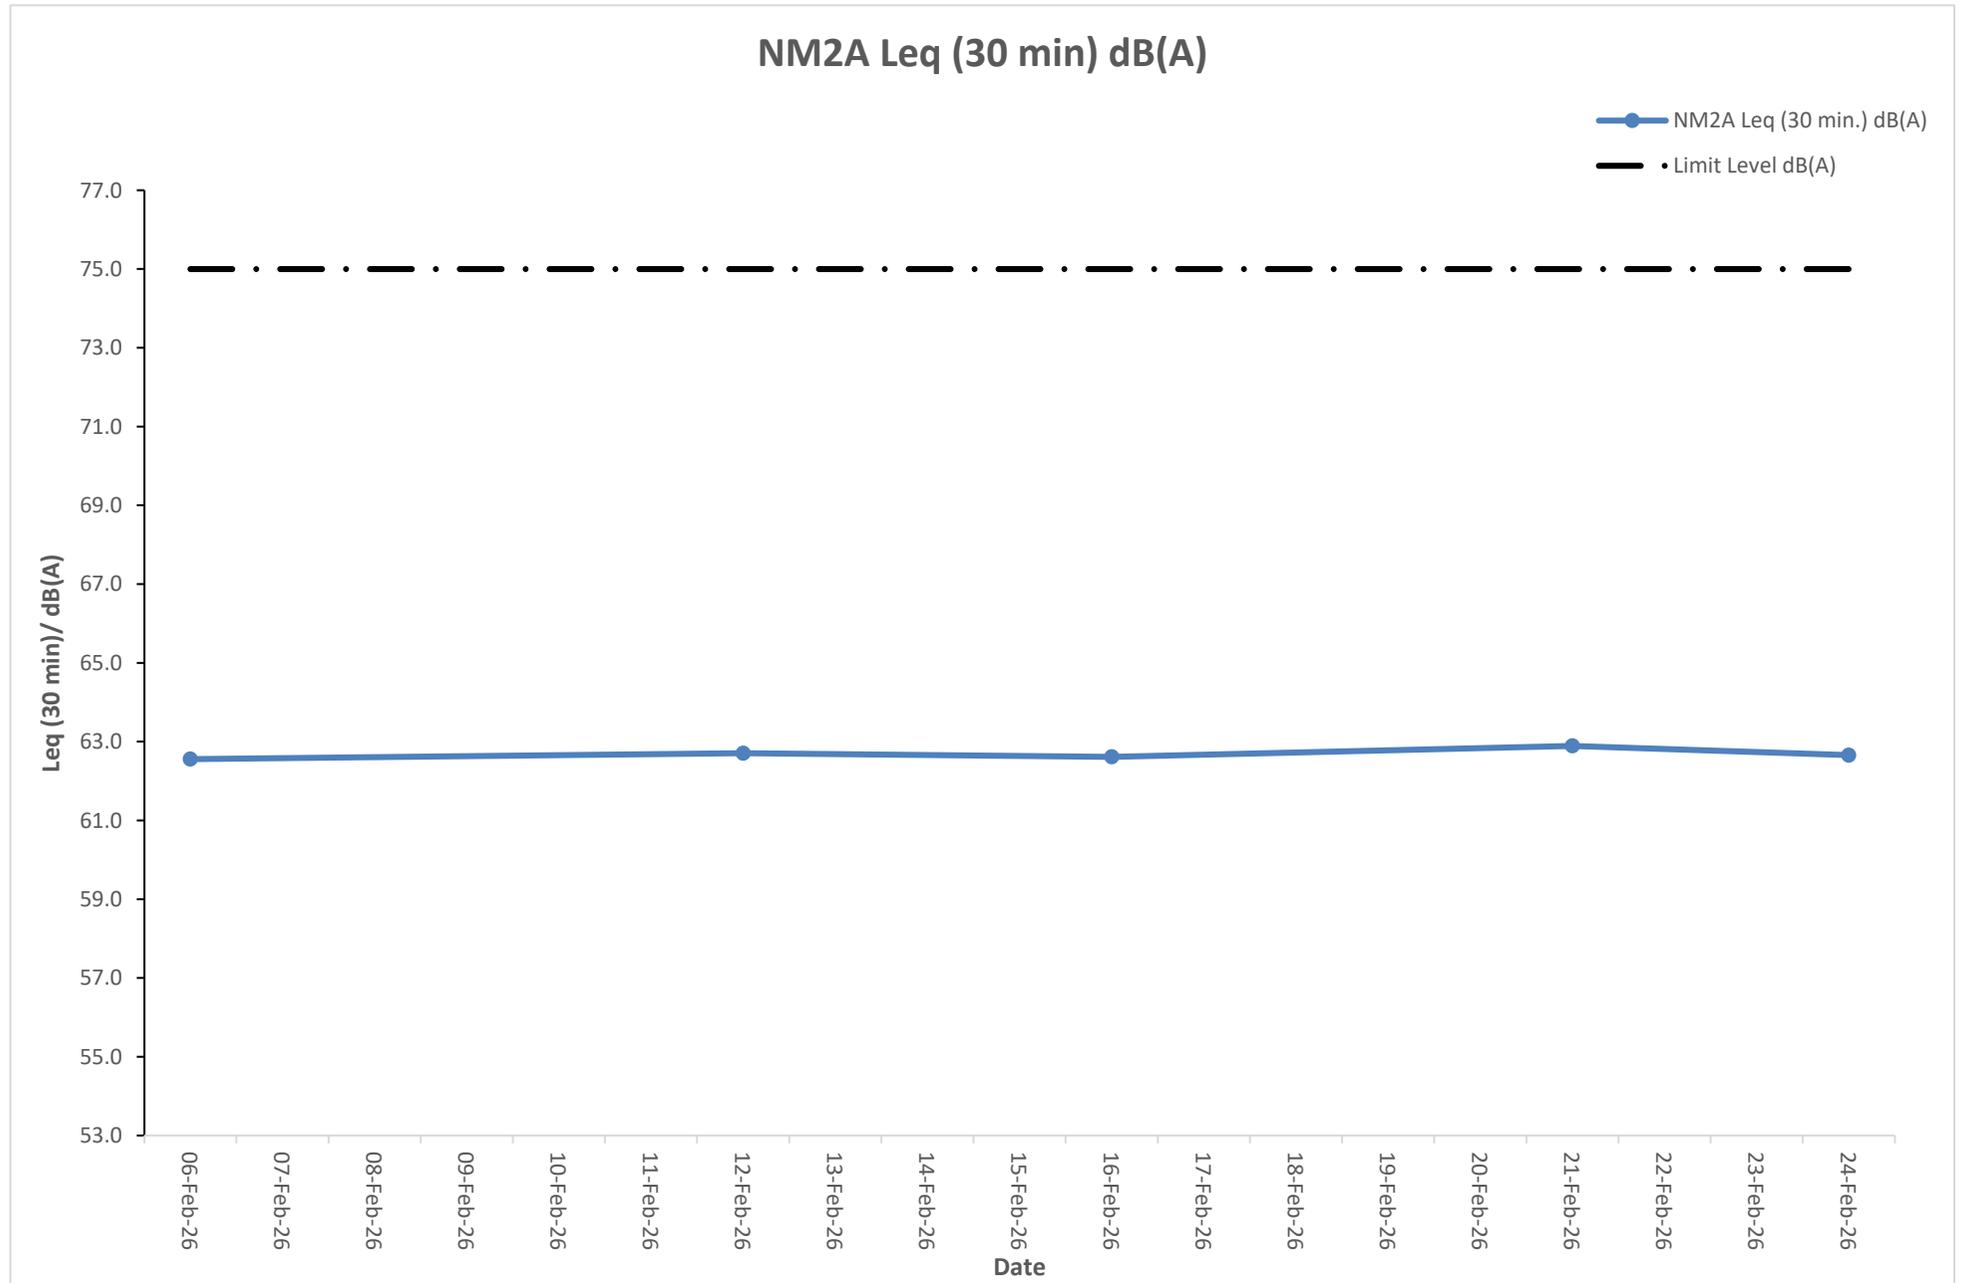
Graphical Presentation of Noise Monitoring Result at Station NM2A

Date	Time	Measured L10 dB(A)	Measured L90 dB(A)	Leq (30 min.) dB(A)
06-Feb-26	13:02	63.7	60.9	62.6
06-Feb-26	13:07	64.2	60.3	
06-Feb-26	13:12	64.2	61.1	
06-Feb-26	13:17	65.0	60.6	
06-Feb-26	13:22	64.7	60.8	
06-Feb-26	13:27	64.4	61.1	
12-Feb-26	7:01	64.2	61.0	62.7
12-Feb-26	7:06	64.1	60.7	
12-Feb-26	7:11	64.8	60.6	
12-Feb-26	7:16	64.0	61.0	
12-Feb-26	7:21	63.6	61.6	
12-Feb-26	7:26	64.3	61.1	
16-Feb-26	13:04	64.9	61.6	62.6
16-Feb-26	13:09	63.6	61.2	
16-Feb-26	13:14	63.7	60.5	
16-Feb-26	13:19	63.9	60.6	
16-Feb-26	13:24	64.9	60.2	
16-Feb-26	13:29	64.6	60.9	
21-Feb-26	7:09	65.0	60.3	62.9
21-Feb-26	7:14	63.8	61.2	
21-Feb-26	7:19	64.9	60.3	
21-Feb-26	7:24	64.4	61.5	
21-Feb-26	7:29	64.9	60.9	
21-Feb-26	7:34	64.8	60.2	
24-Feb-26	13:02	63.9	61.3	62.7
24-Feb-26	13:07	64.4	60.2	
24-Feb-26	13:12	64.2	61.6	
24-Feb-26	13:17	63.8	60.2	
24-Feb-26	13:22	64.4	60.8	
24-Feb-26	13:27	64.0	60.4

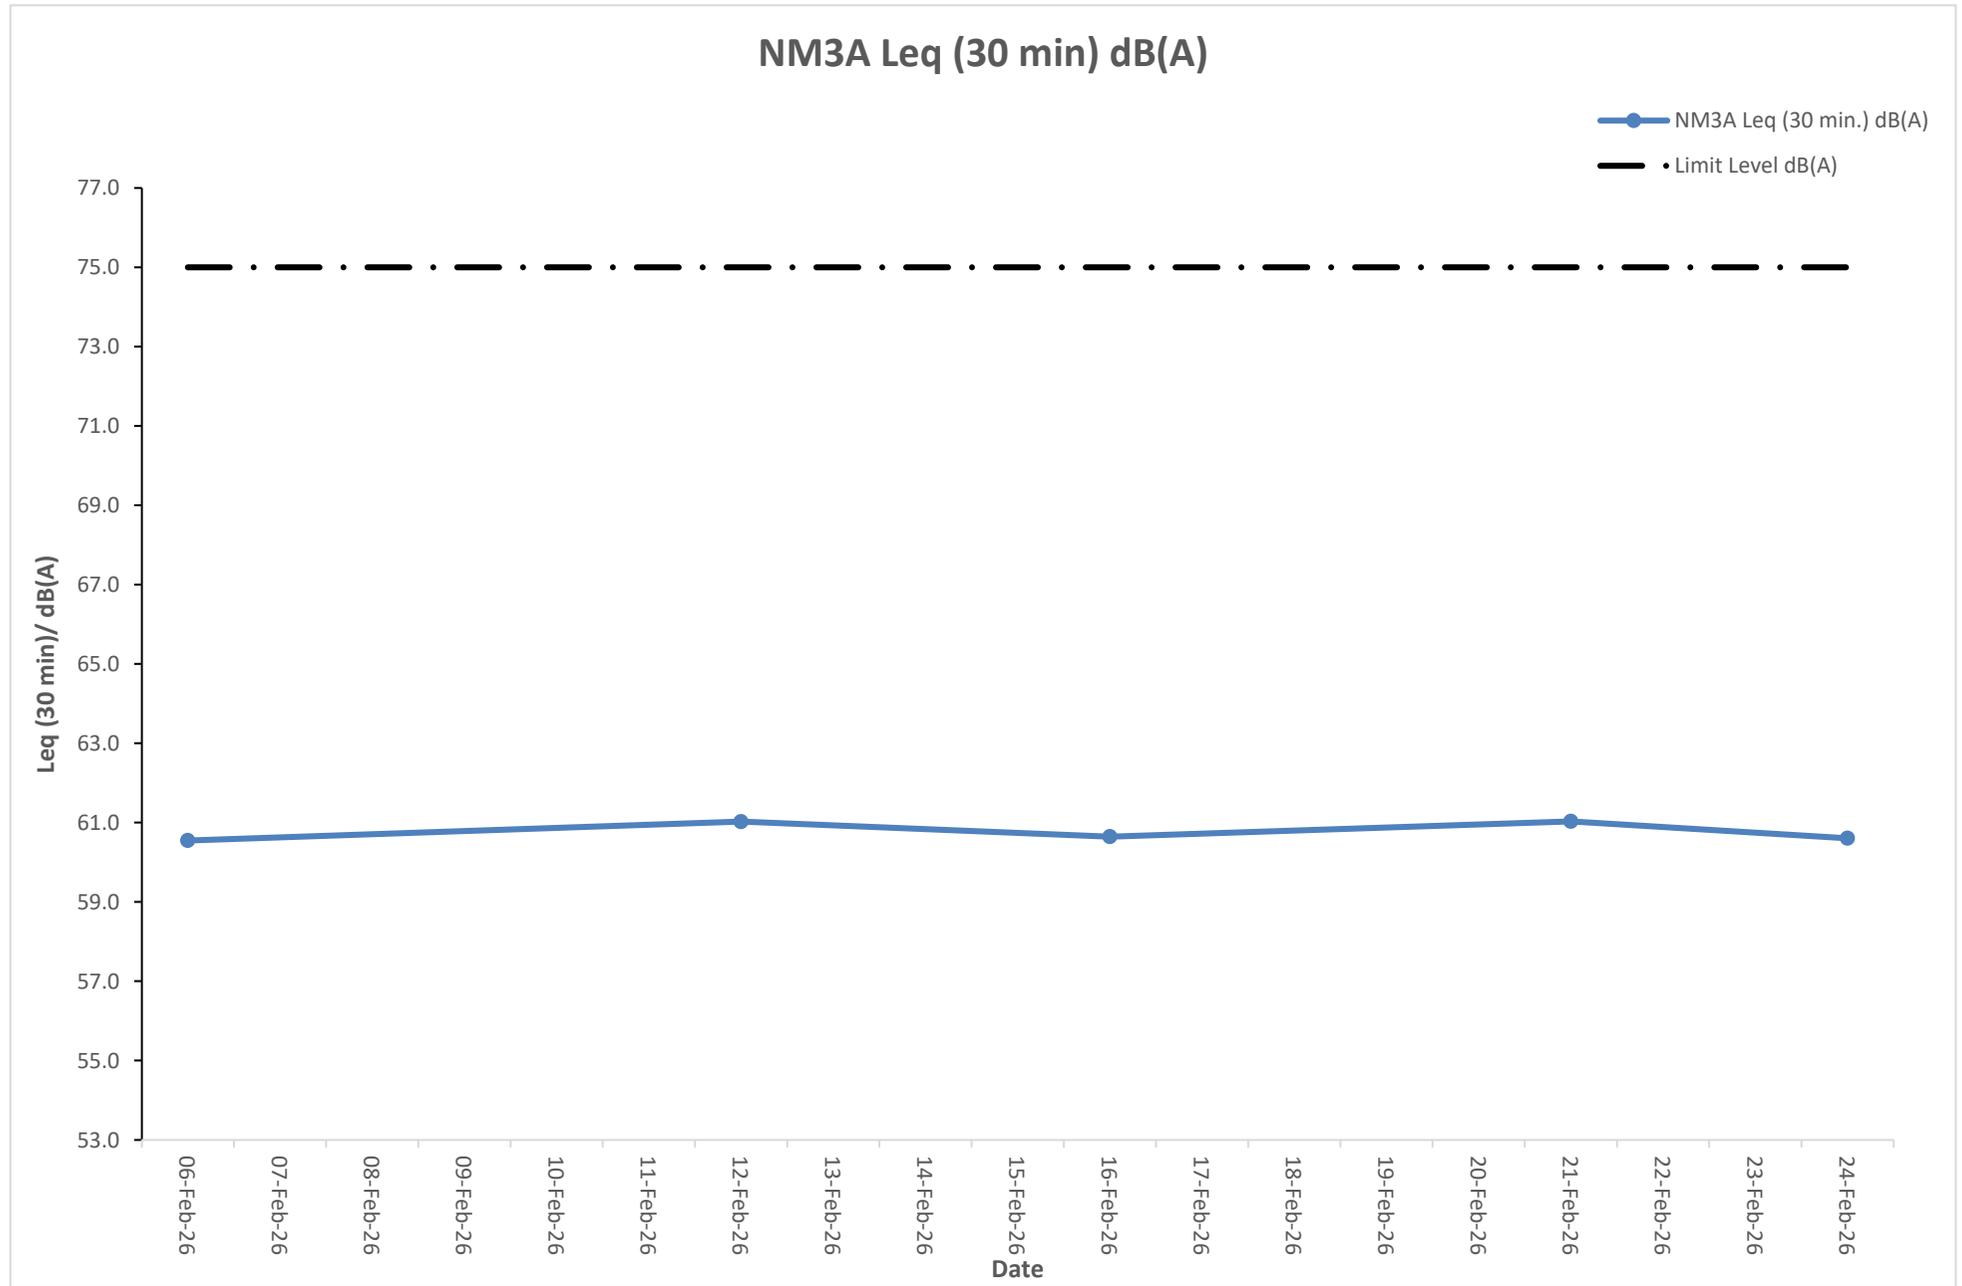
Graphical Presentation of Noise Monitoring Result at Station NM3A

Date	Time	Measured L10 dB(A)	Measured L90 dB(A)	Leq (30 min.) dB(A)
06-Feb-26	14:32	62.0	56.9	60.5
06-Feb-26	14:37	63.5	56.0	
06-Feb-26	14:42	61.9	57.7	
06-Feb-26	14:47	63.7	56.0	
06-Feb-26	14:52	63.0	56.2	
06-Feb-26	14:57	63.3	56.8	
12-Feb-26	8:22	62.5	56.3	61.0
12-Feb-26	8:27	63.1	57.1	
12-Feb-26	8:32	63.2	56.4	
12-Feb-26	8:37	62.4	56.6	
12-Feb-26	8:42	63.5	57.7	
12-Feb-26	8:47	63.2	56.3	
16-Feb-26	14:34	62.2	56.7	60.6
16-Feb-26	14:39	63.0	57.4	
16-Feb-26	14:44	62.6	57.4	
16-Feb-26	14:49	63.1	56.4	
16-Feb-26	14:54	63.3	56.6	
16-Feb-26	14:59	62.2	57.2	
21-Feb-26	8:25	62.9	57.0	61.0
21-Feb-26	8:30	63.4	55.9	
21-Feb-26	8:35	63.7	57.7	
21-Feb-26	8:40	63.2	57.2	
21-Feb-26	8:45	62.1	57.7	
21-Feb-26	8:50	63.8	56.0	
24-Feb-26	14:32	62.6	56.3	60.6
24-Feb-26	14:37	61.9	57.3	
24-Feb-26	14:42	63.3	56.1	
24-Feb-26	14:47	63.8	57.3	
24-Feb-26	14:52	63.4	56.8	
24-Feb-26	14:57	62.9	57.6

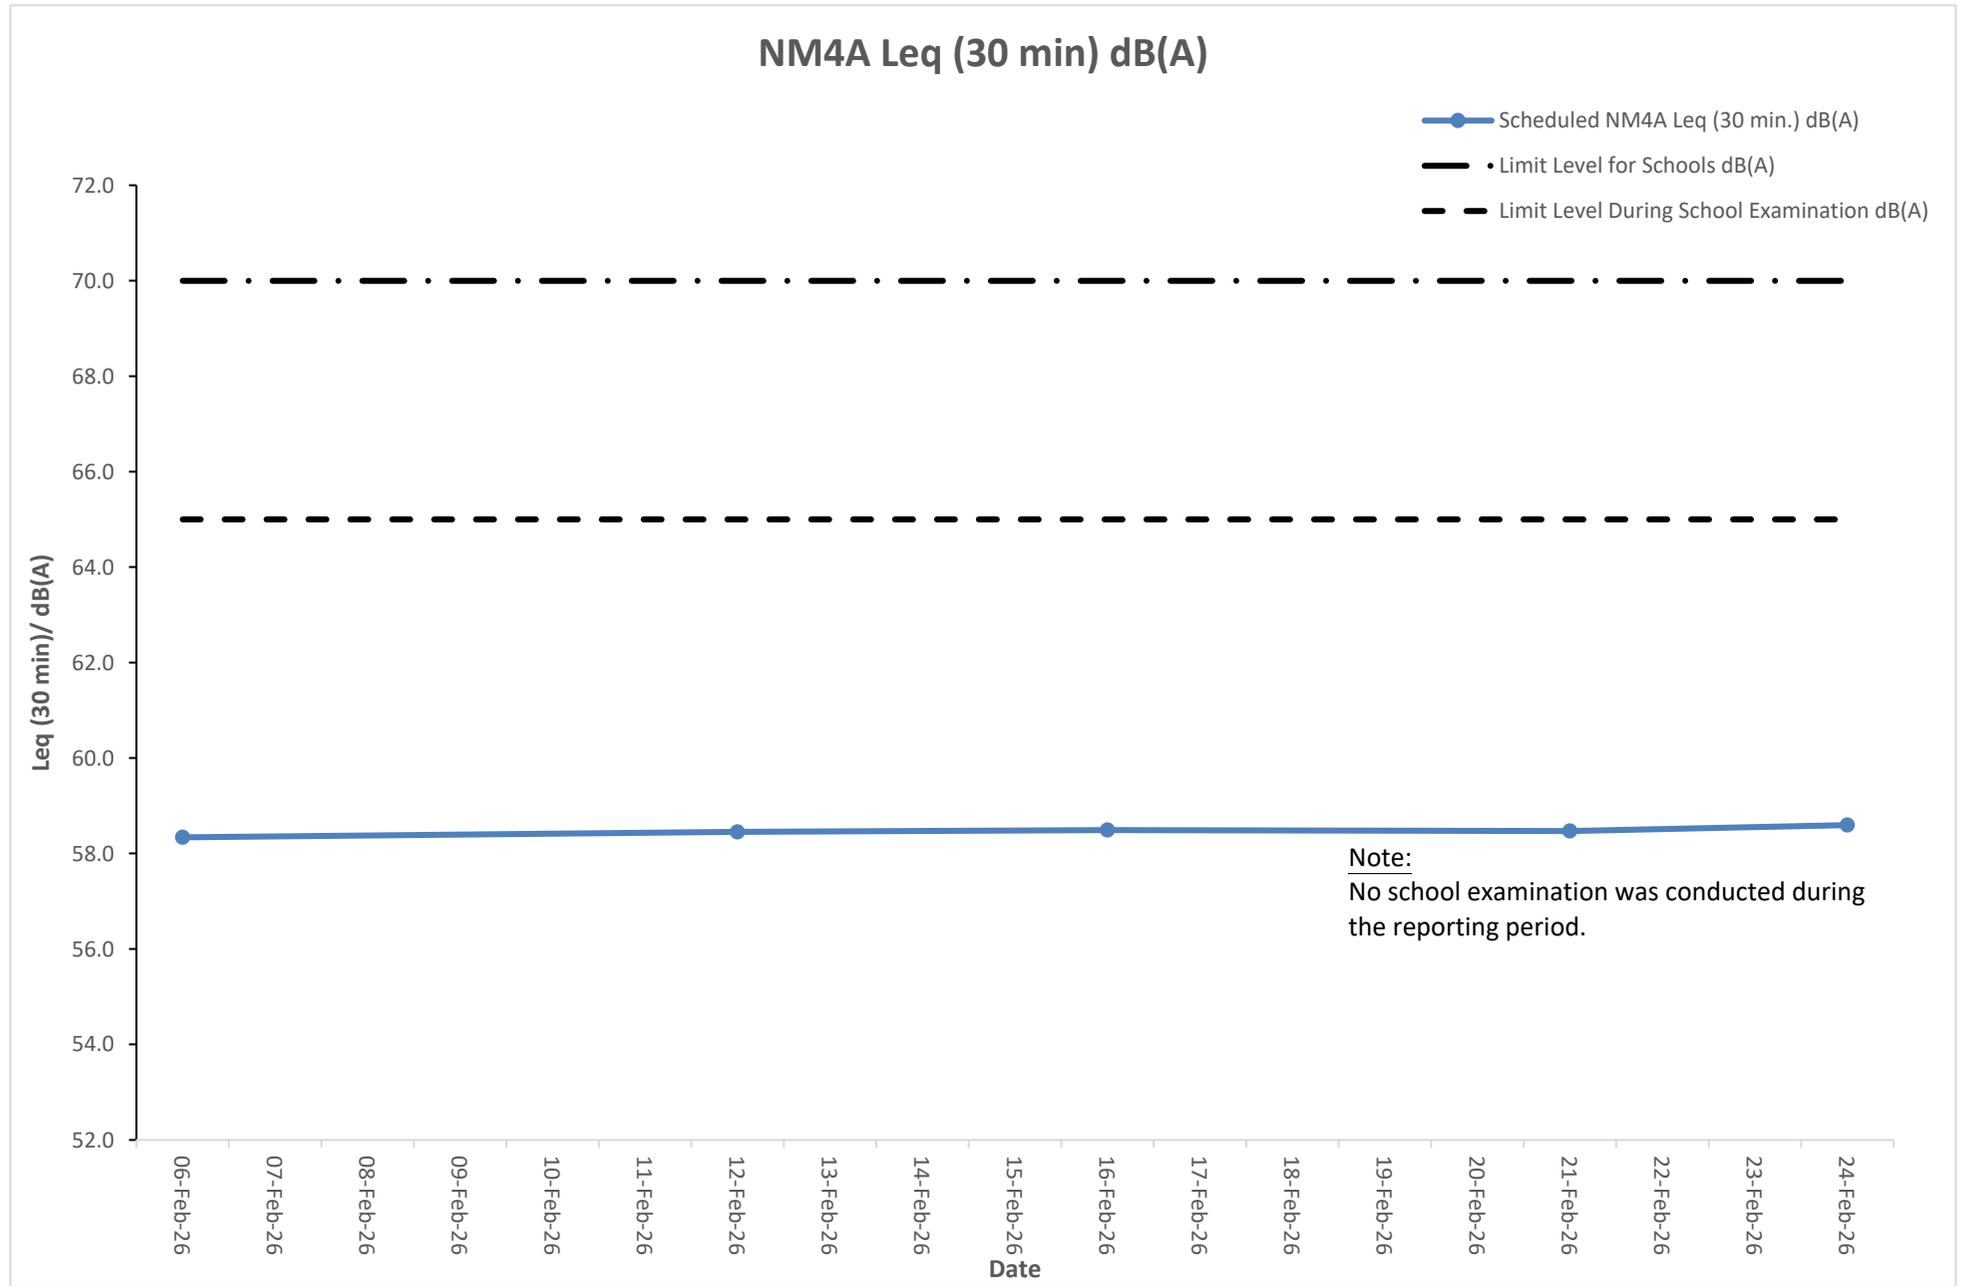
Graphical Presentation of Noise Monitoring Result at Station NM4A

Date	Time	Measured L10 dB(A)	Measured L90 dB(A)	Leq (30 min.) dB(A)
06-Feb-26	16:37	59.4	56.0	58.3
06-Feb-26	16:42	59.4	56.4	
06-Feb-26	16:47	59.2	56.4	
06-Feb-26	16:52	60.4	55.8	
06-Feb-26	16:57	60.1	57.0	
06-Feb-26	17:02	60.3	56.4	
12-Feb-26	8:57	60.6	55.8	58.5
12-Feb-26	9:02	59.7	56.7	
12-Feb-26	9:07	60.3	57.0	
12-Feb-26	9:12	60.3	57.1	
12-Feb-26	9:17	59.2	56.1	
12-Feb-26	9:22	59.3	56.7	
16-Feb-26	16:39	59.5	56.5	58.5
16-Feb-26	16:44	59.4	56.4	
16-Feb-26	16:49	59.3	56.2	
16-Feb-26	16:54	59.4	55.9	
16-Feb-26	16:59	60.0	55.9	
16-Feb-26	17:04	60.1	56.0	
21-Feb-26	9:00	59.8	56.5	58.5
21-Feb-26	9:05	59.2	55.8	
21-Feb-26	9:10	59.4	56.1	
21-Feb-26	9:15	60.0	56.2	
21-Feb-26	9:20	60.5	56.3	
21-Feb-26	9:25	59.9	56.7	
24-Feb-26	16:37	60.5	56.8	58.6
24-Feb-26	16:42	60.4	56.6	
24-Feb-26	16:47	59.3	57.0	
24-Feb-26	16:52	60.4	56.7	
24-Feb-26	16:57	60.5	56.7	
24-Feb-26	17:02	59.8	55.7

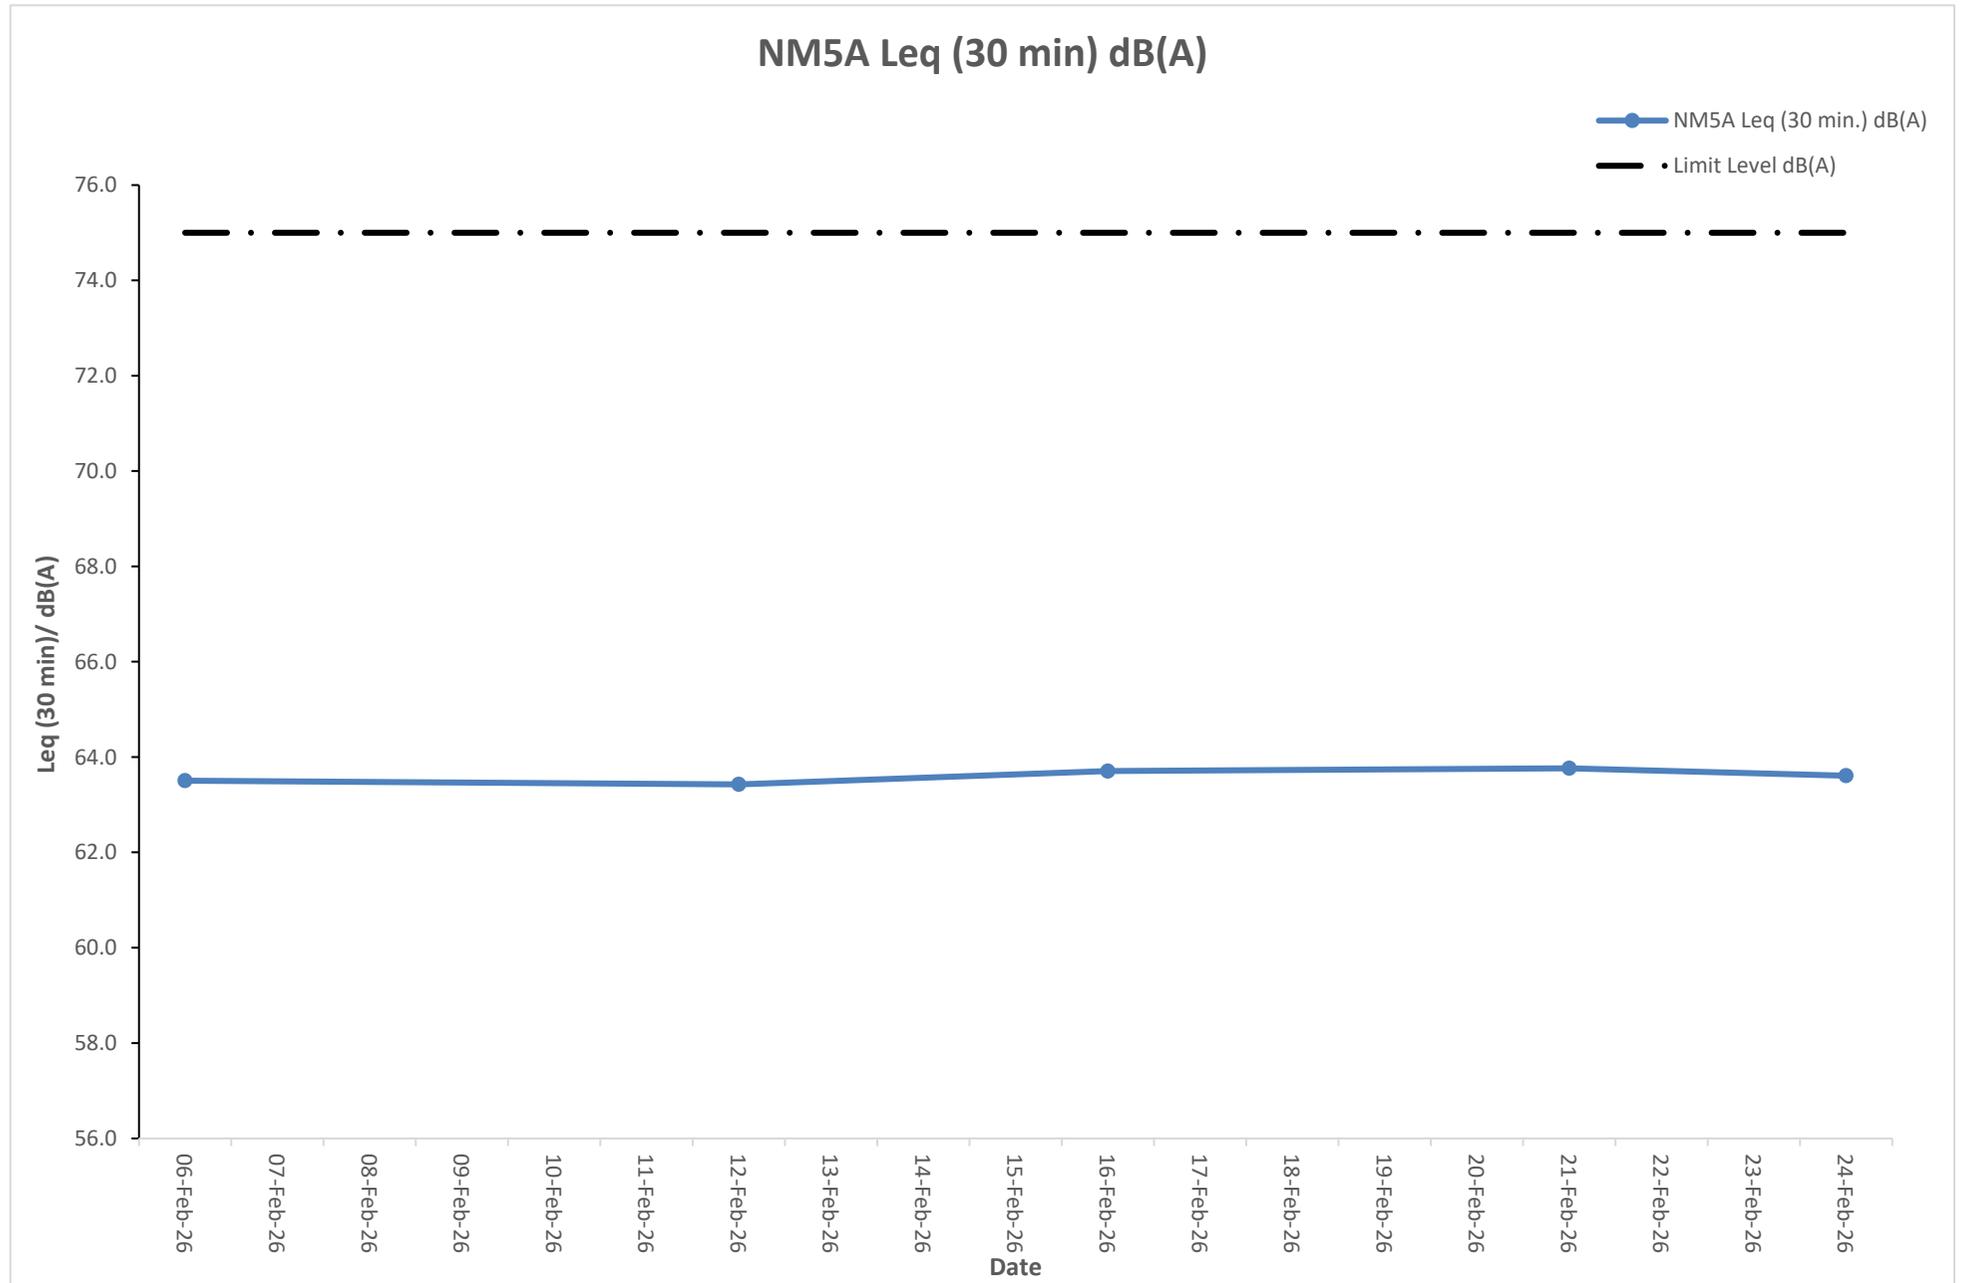
Graphical Presentation of Noise Monitoring Result at Station NM5A

Date	Time	Measured L10 dB(A)	Measured L90 dB(A)	Leq (30 min.) dB(A)	Leq (30 min.) +3 dB(A)
06-Feb-26	13:52	61.6	57.7	60.5	63.5
06-Feb-26	13:57	62.1	57.4		
06-Feb-26	14:02	62.0	59.3		
06-Feb-26	14:07	62.4	58.5		
06-Feb-26	14:12	61.4	59.3		
06-Feb-26	14:17	62.3	59.2		
12-Feb-26	7:41	61.4	59.2	60.4	63.4
12-Feb-26	7:46	62.2	59.2		
12-Feb-26	7:51	61.5	57.4		
12-Feb-26	7:56	61.7	58.9		
12-Feb-26	8:01	61.9	58.6		
12-Feb-26	8:06	62.8	58.3		
16-Feb-26	13:54	62.1	57.6	60.7	63.7
16-Feb-26	13:59	62.8	58.1		
16-Feb-26	14:04	61.5	59.2		
16-Feb-26	14:09	62.7	57.7		
16-Feb-26	14:14	62.7	58.6		
16-Feb-26	14:19	61.9	57.8		
21-Feb-26	7:47	62.6	58.3	60.8	63.8
21-Feb-26	7:52	62.7	58.9		
21-Feb-26	7:57	62.2	58.3		
21-Feb-26	8:02	62.3	58.1		
21-Feb-26	8:07	62.0	58.1		
21-Feb-26	8:12	62.8	58.1		
24-Feb-26	13:52	62.8	58.6	60.6	63.6
24-Feb-26	13:57	62.8	58.8		
24-Feb-26	14:02	62.5	58.7		
24-Feb-26	14:07	61.5	59.2		
24-Feb-26	14:12	61.7	58.0
