# **Development at West Kowloon Cultural District**

**Monthly Environmental Monitoring and Audit (EM&A) Report  
for July 2026**

**13 August 2026**

**Part-2: EM&A for ELS Works for The  
Integrated Basement and  
Underground Road in Zones 2A, 2B  
& 2C**

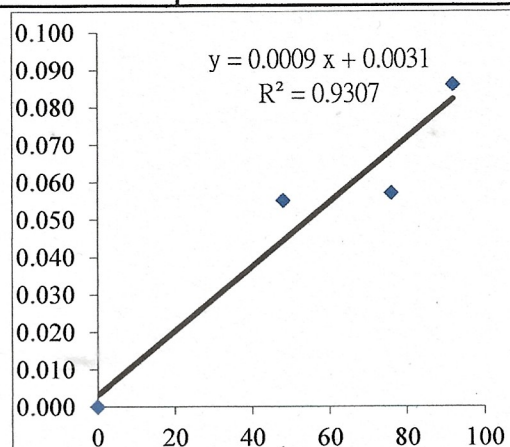
Slope (K-factor): 0.0009(mg)/Count  
Correlation Coefficient (R): 0.9647  
Date of Issue: 4-May-2026

1. Strong Correlation ( $>0.8$ )
2. Factor 0.0009(mg)/Count should be applied for TSP monitoring

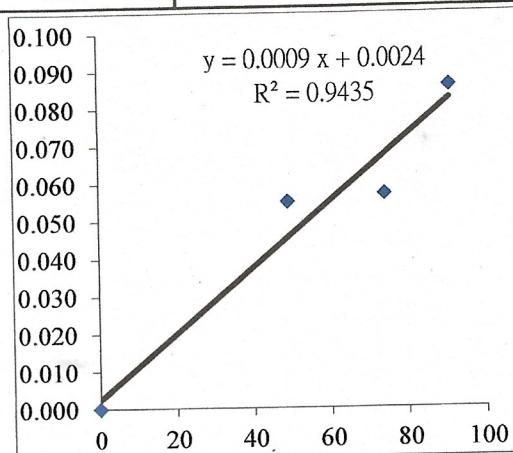
Slope (K-factor): 0.0009(mg)/Count  
Correlation Coefficient (R): 0.9713  
Date of Issue: 4-May-2026

1. Strong Correlation ( $>0.8$ )
2. Factor 0.0009(mg)/Count should be applied for TSP monitoring

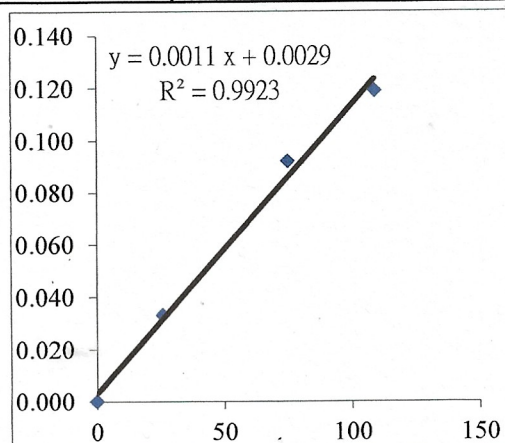
Slope (K-factor):  $0.0011(\text{mg})/\text{Count}$   
Correlation Coefficient (R): 0.9961  
Date of Issue: 24-Dec-2025

1. Strong Correlation ( $>0.8$ )
2. Factor  $0.0011(\text{mg})/\text{Count}$  should be applied for TSP monitoring

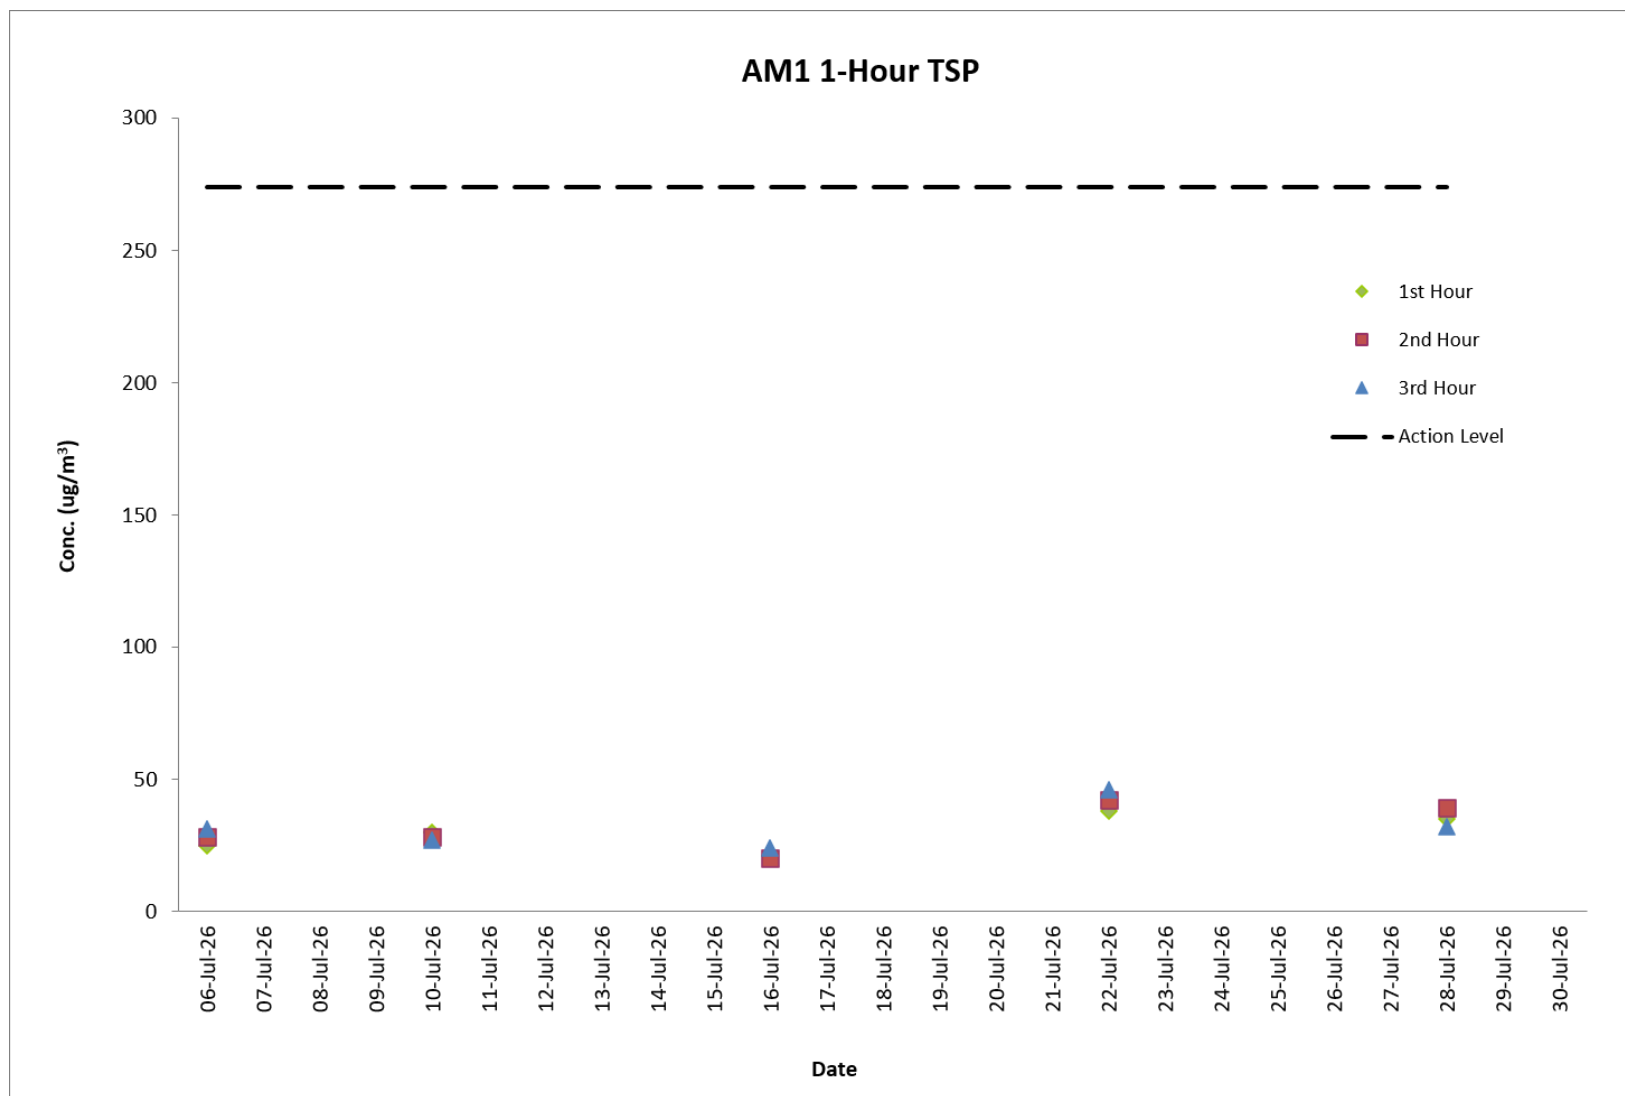
Graphical Presentation of Air Quality Monitoring Result at Station AM1 (1-hour TSP)

| Date | Weather Condition | Time | Conc. ( $\mu\text{g}/\text{m}^3$ ) | | | Action Level ( $\mu\text{g}/\text{m}^3$ ) | Limit Level ( $\mu\text{g}/\text{m}^3$ ) | Min | Max |
|---|---|---|---|---|---|---|---|---|---|
| 28-Jul-26 | Cloudy | 8:32 - 11:32 | 35 | 39 | 32 | 273.7 | 500 | | |

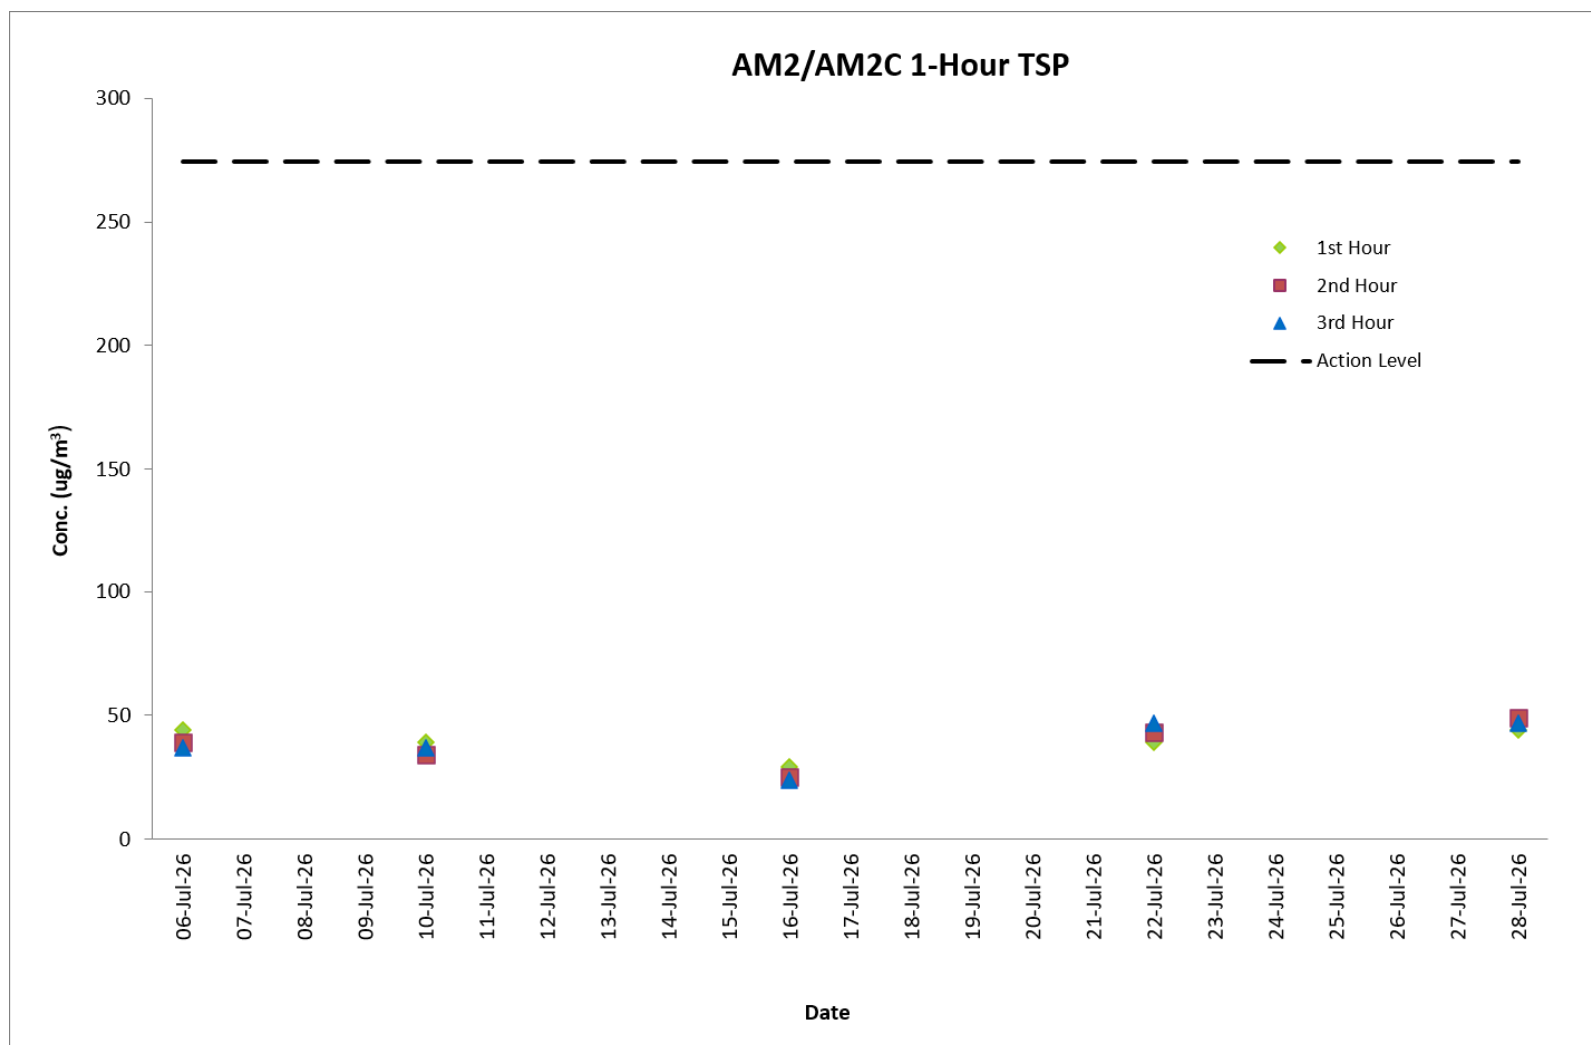
### Graphical Presentation of Air Quality Monitoring Result at Station AM2/AM2C (1-hour TSP)

\*Note: Monitoring has been conducted at AM2C starting from 22 July 2026.

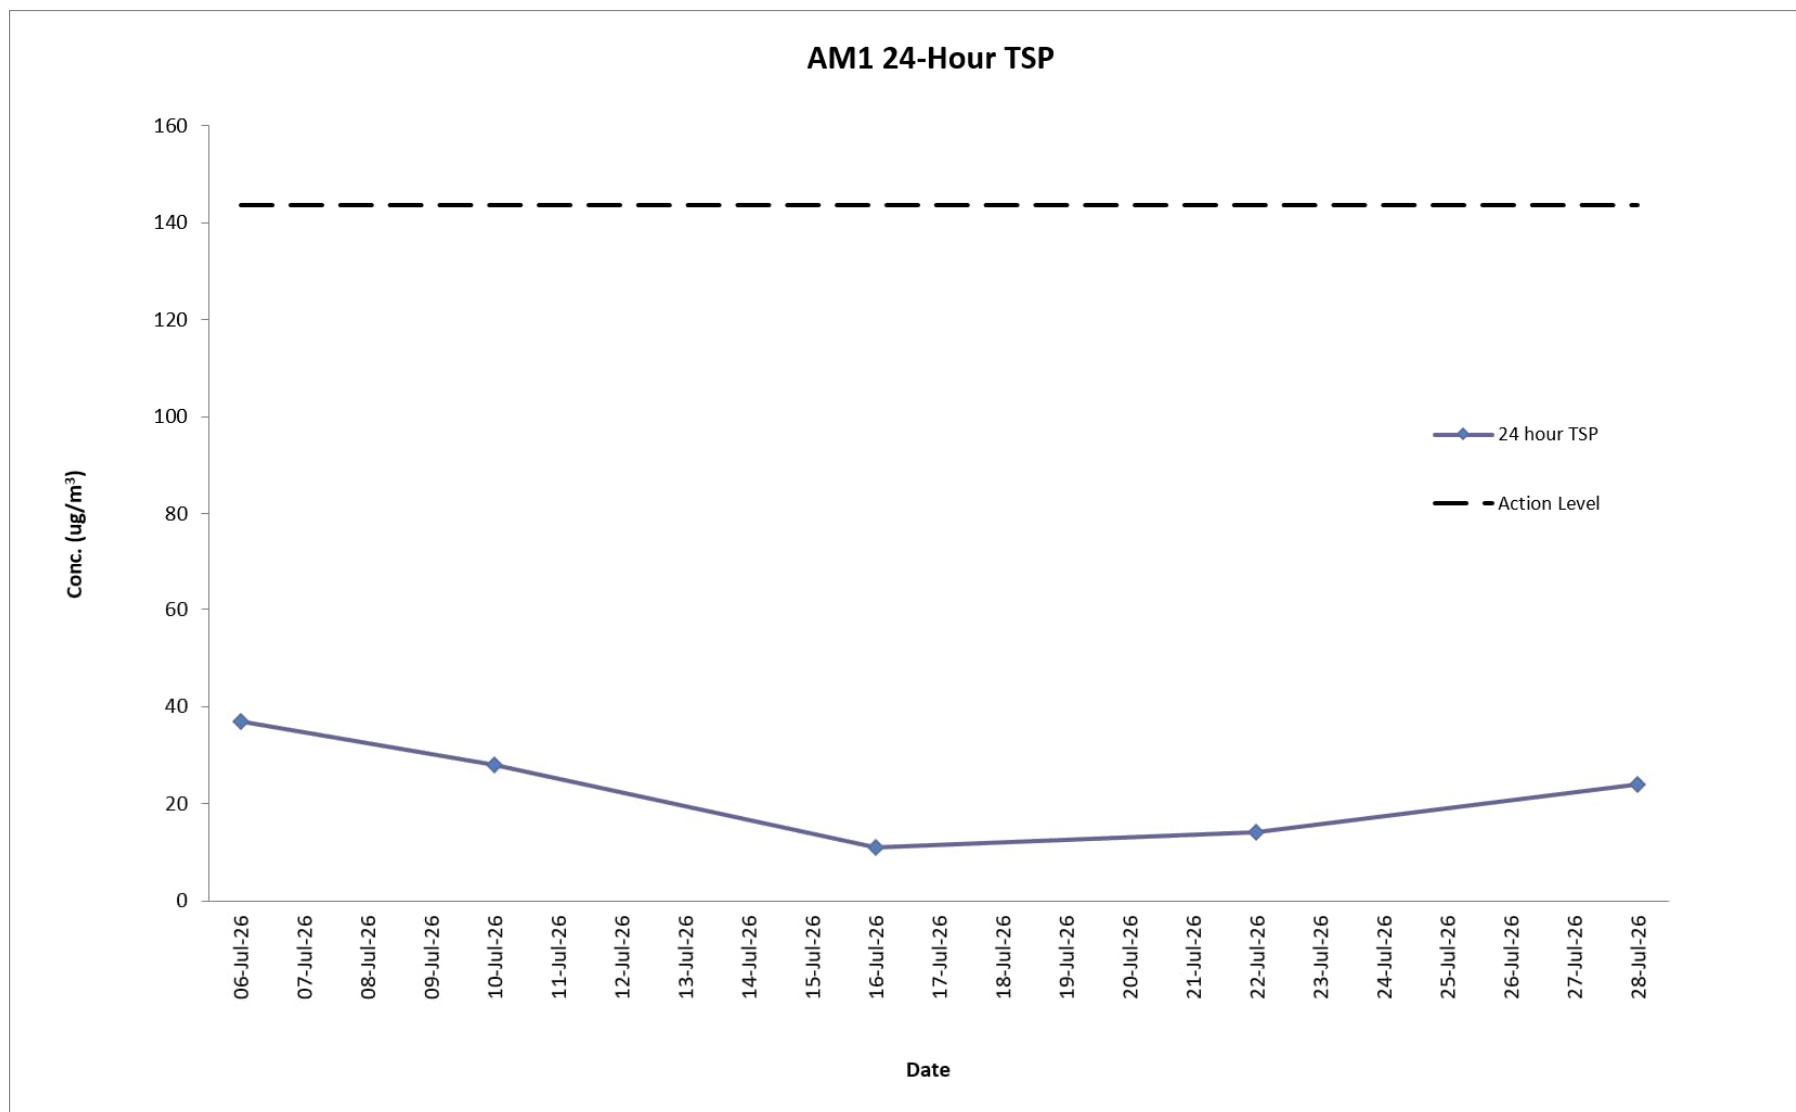
Graphical Presentation of Air Quality Monitoring Result at Station AM1 (24-hour TSP)

| Start | | Finish | | Filter Weight (g) | | Elapsed Time Reading | | Sampling Time (hrs) | Flow Rate (m <sup>3</sup> /min) | | | Conc. (µg/m <sup>3</sup> ) | Weather Condition | Action Level | Limit Level |
|---|---|---|---|---|---|---|---|---|---|---|---|---|---|---|---|
| 28-Jul-26 | 08:30 | 29-Jul-26 | 08:30 | 2.7660 | 2.8060 | 31588.38 | 31612.38 | 24 | 1.17 | 1.17 | 1.17 | 24 | Rainy | 143.6 | 260 |

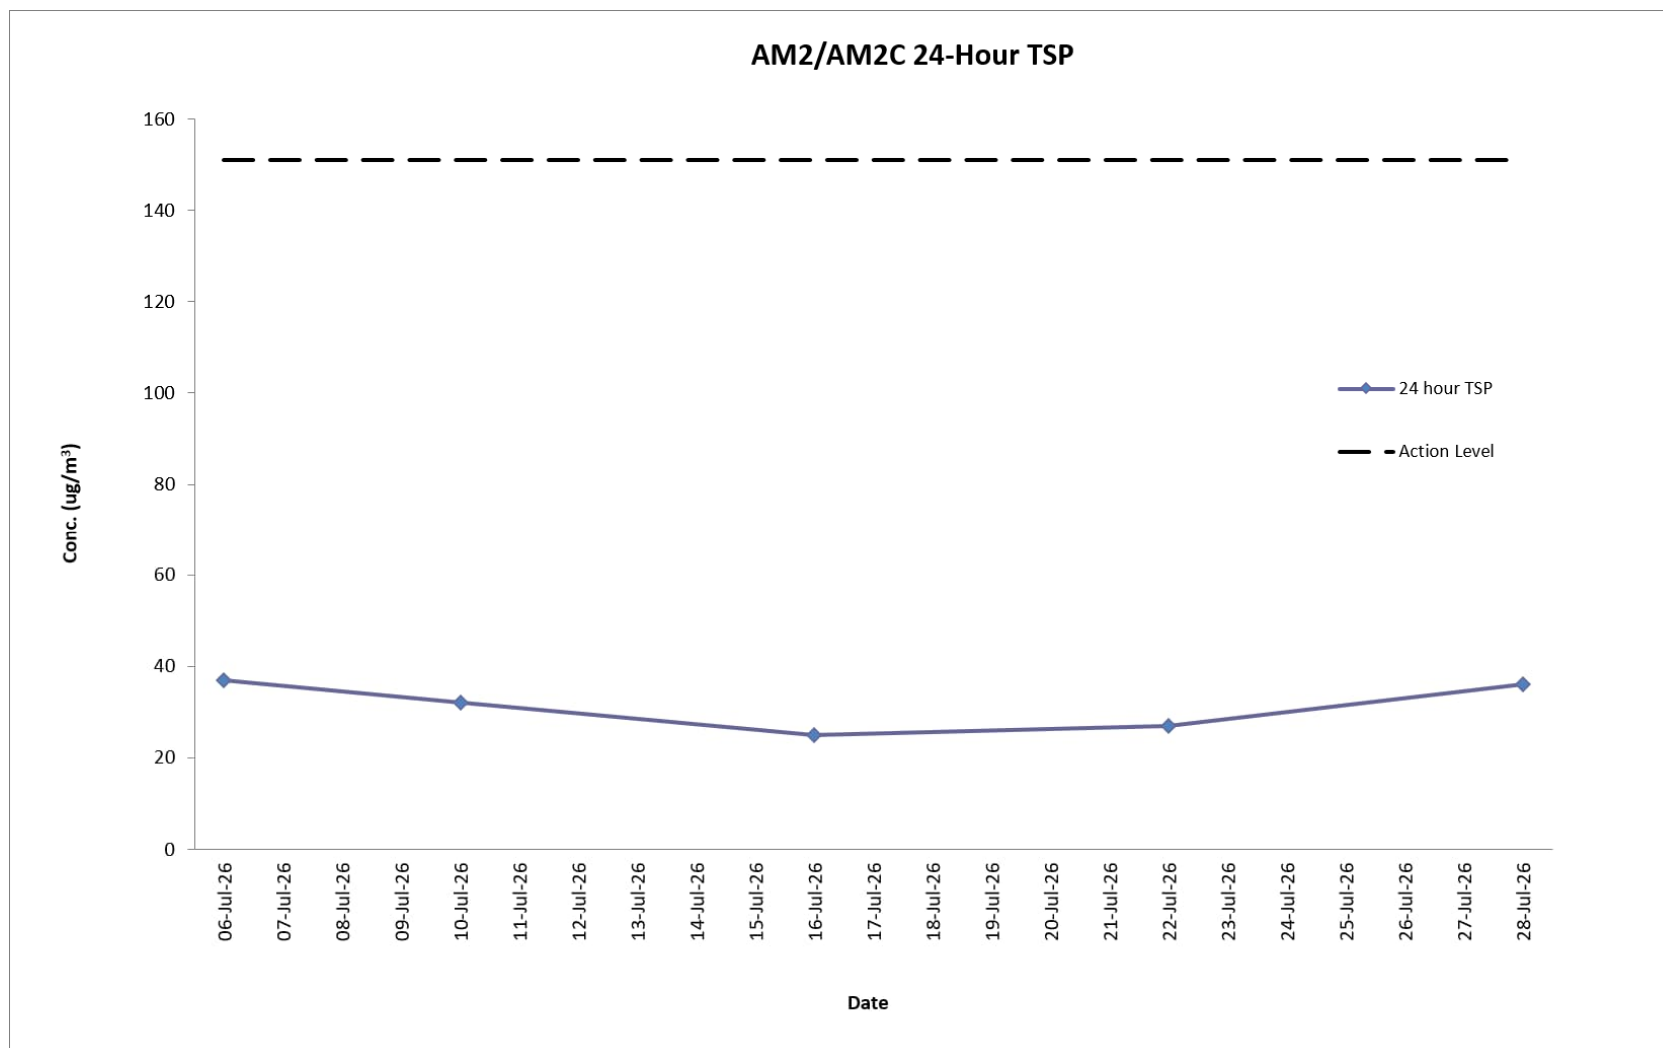
### Graphical Presentation of Air Quality Monitoring Result at Station AM2/AM2C (24-hour TSP)

\*Note: Monitoring has been conducted at AM2C starting from 22 July 2026.

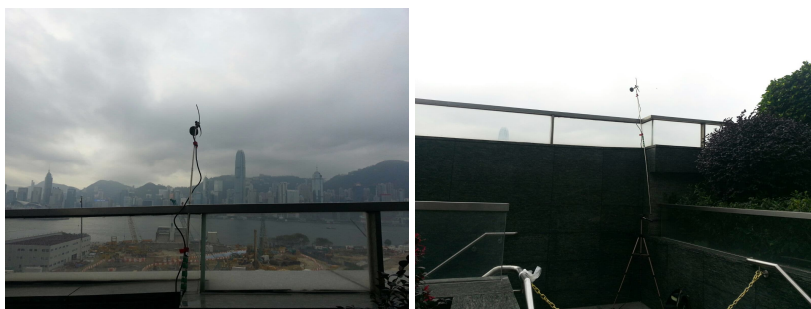
\* +3dB (A) correction was applied to free-field measurement.

The station set-up of a free-field measurement at Station NM1A.

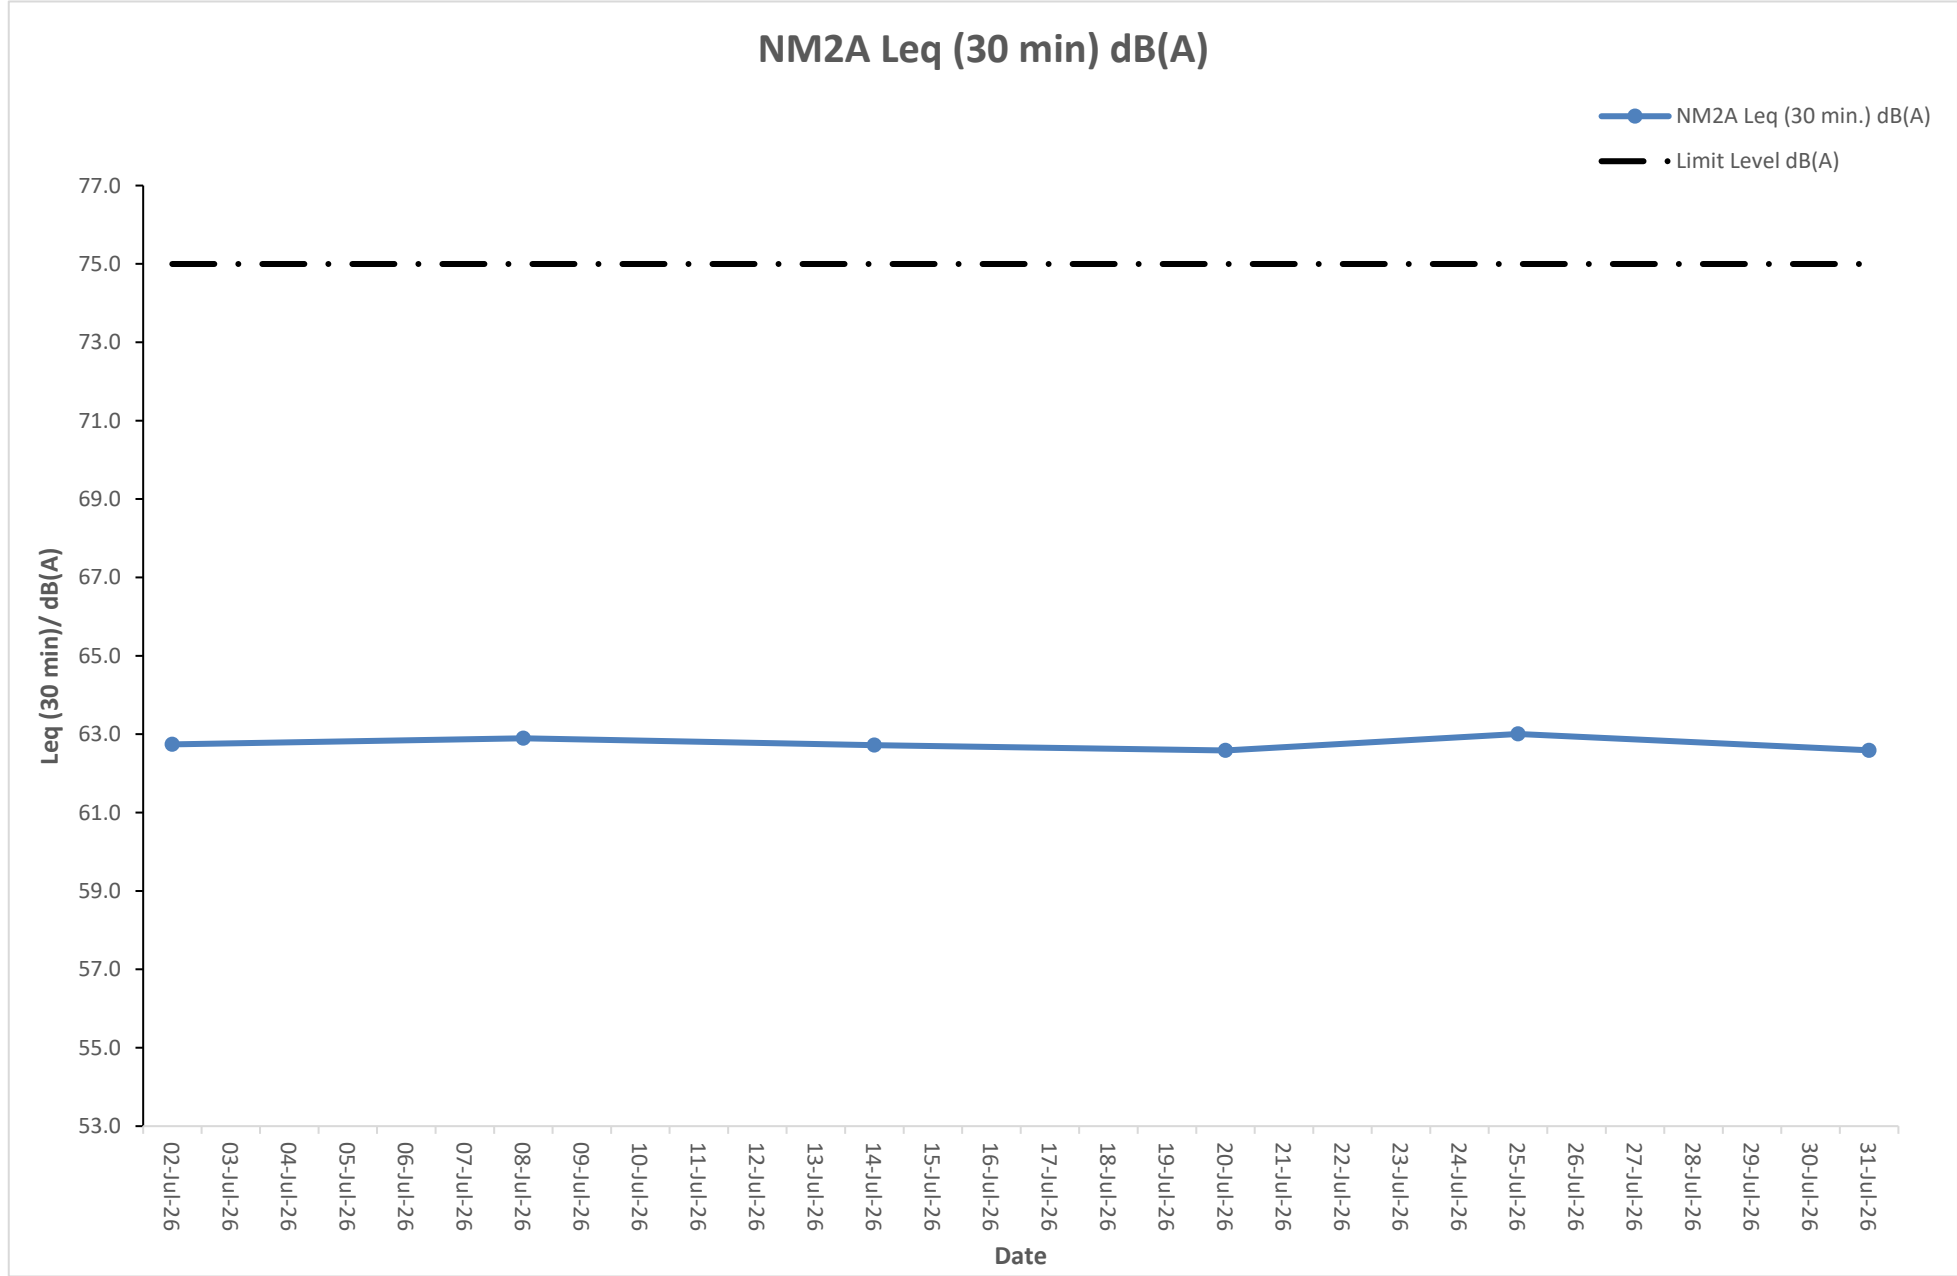
Graphical Presentation of Noise Monitoring Result at Station NM2A

The station set-up of a façade measurement at station NM2A.

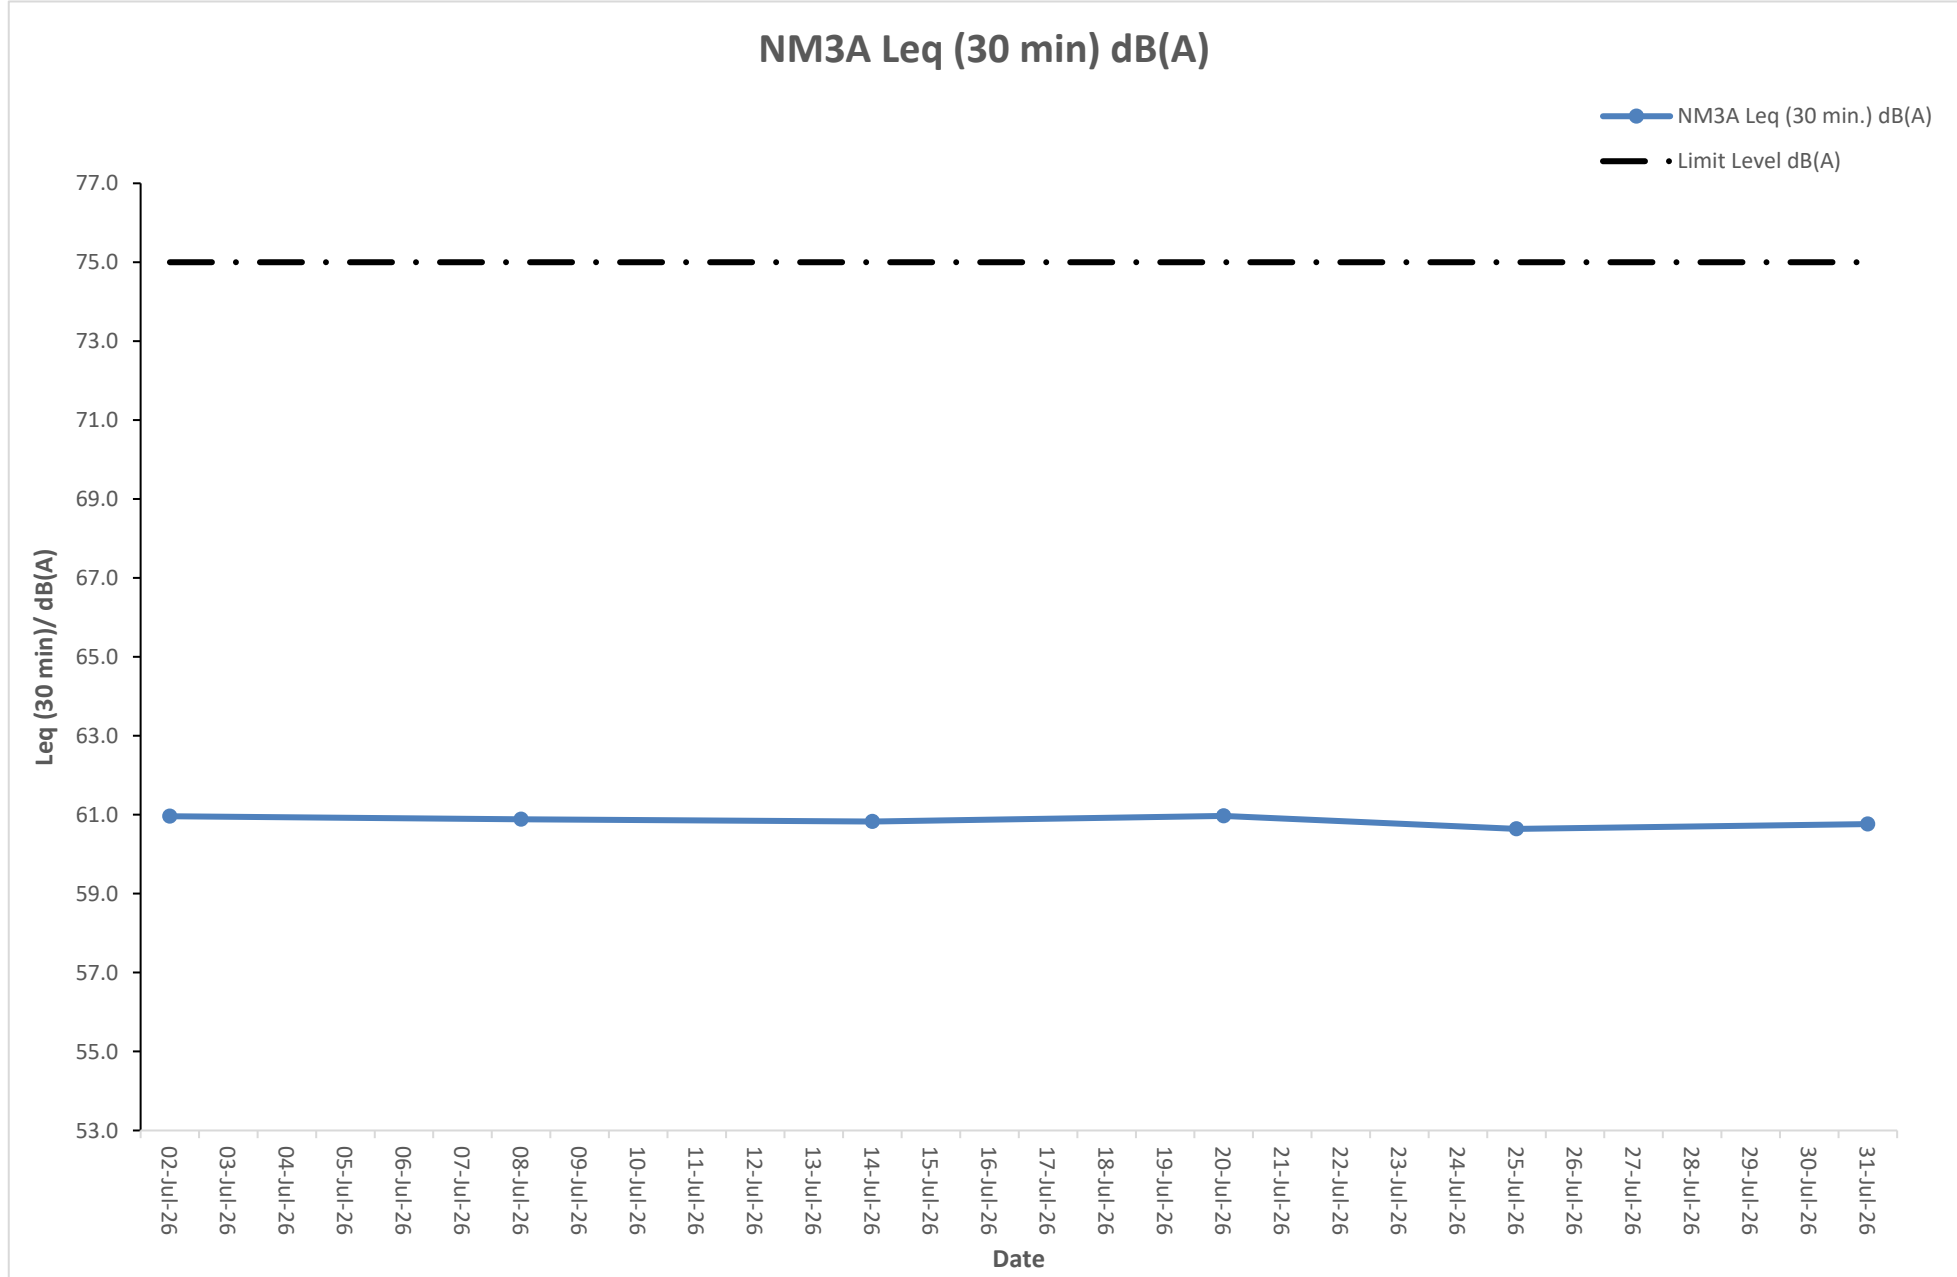
Graphical Presentation of Noise Monitoring Result at Station NM3A

The station set-up of a façade measurement at station NM3A.

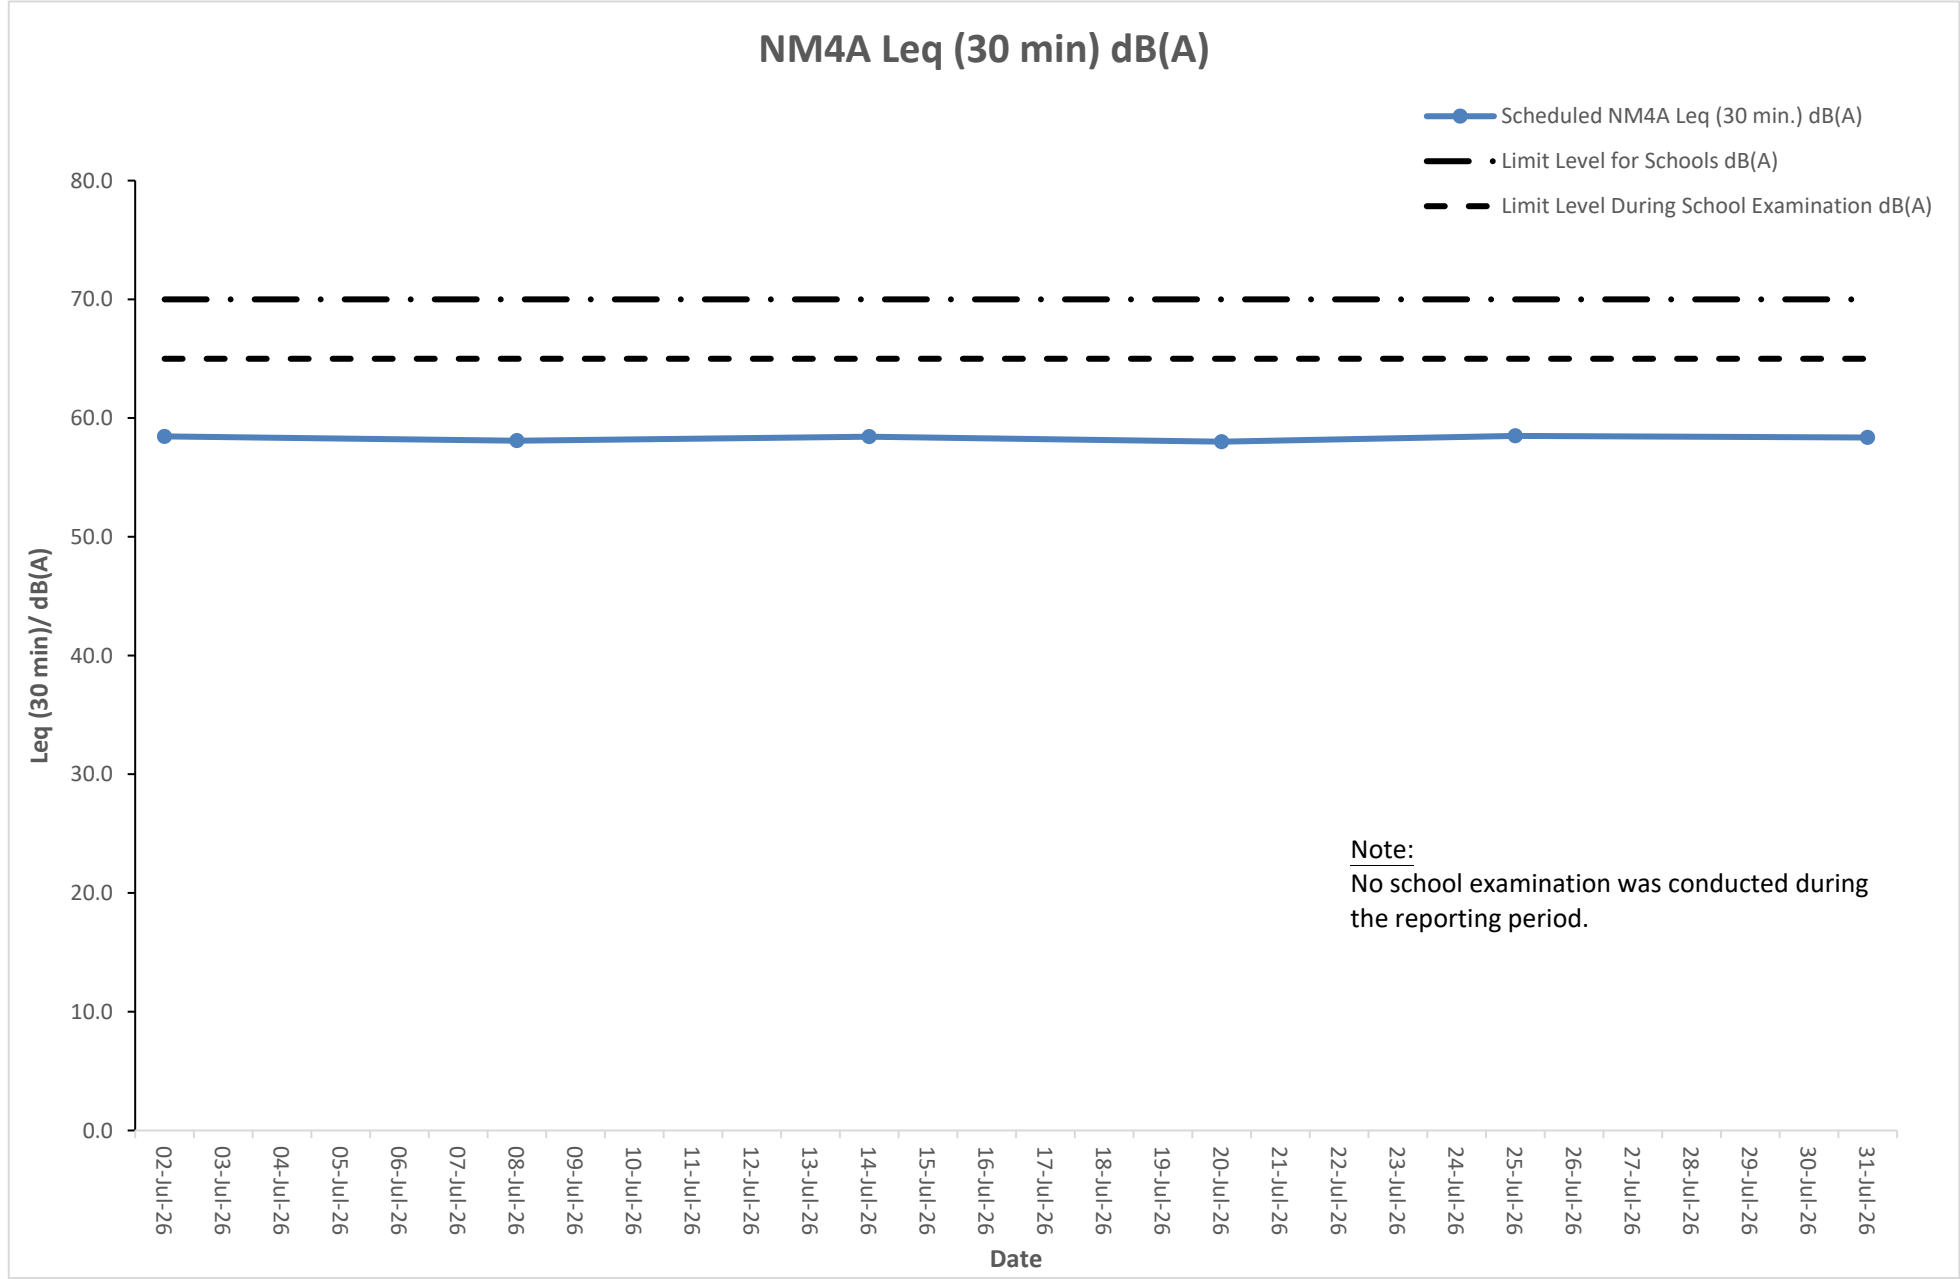
Graphical Presentation of Noise Monitoring Result at Station NM4A

The station set-up of a façade measurement at station NM4A.

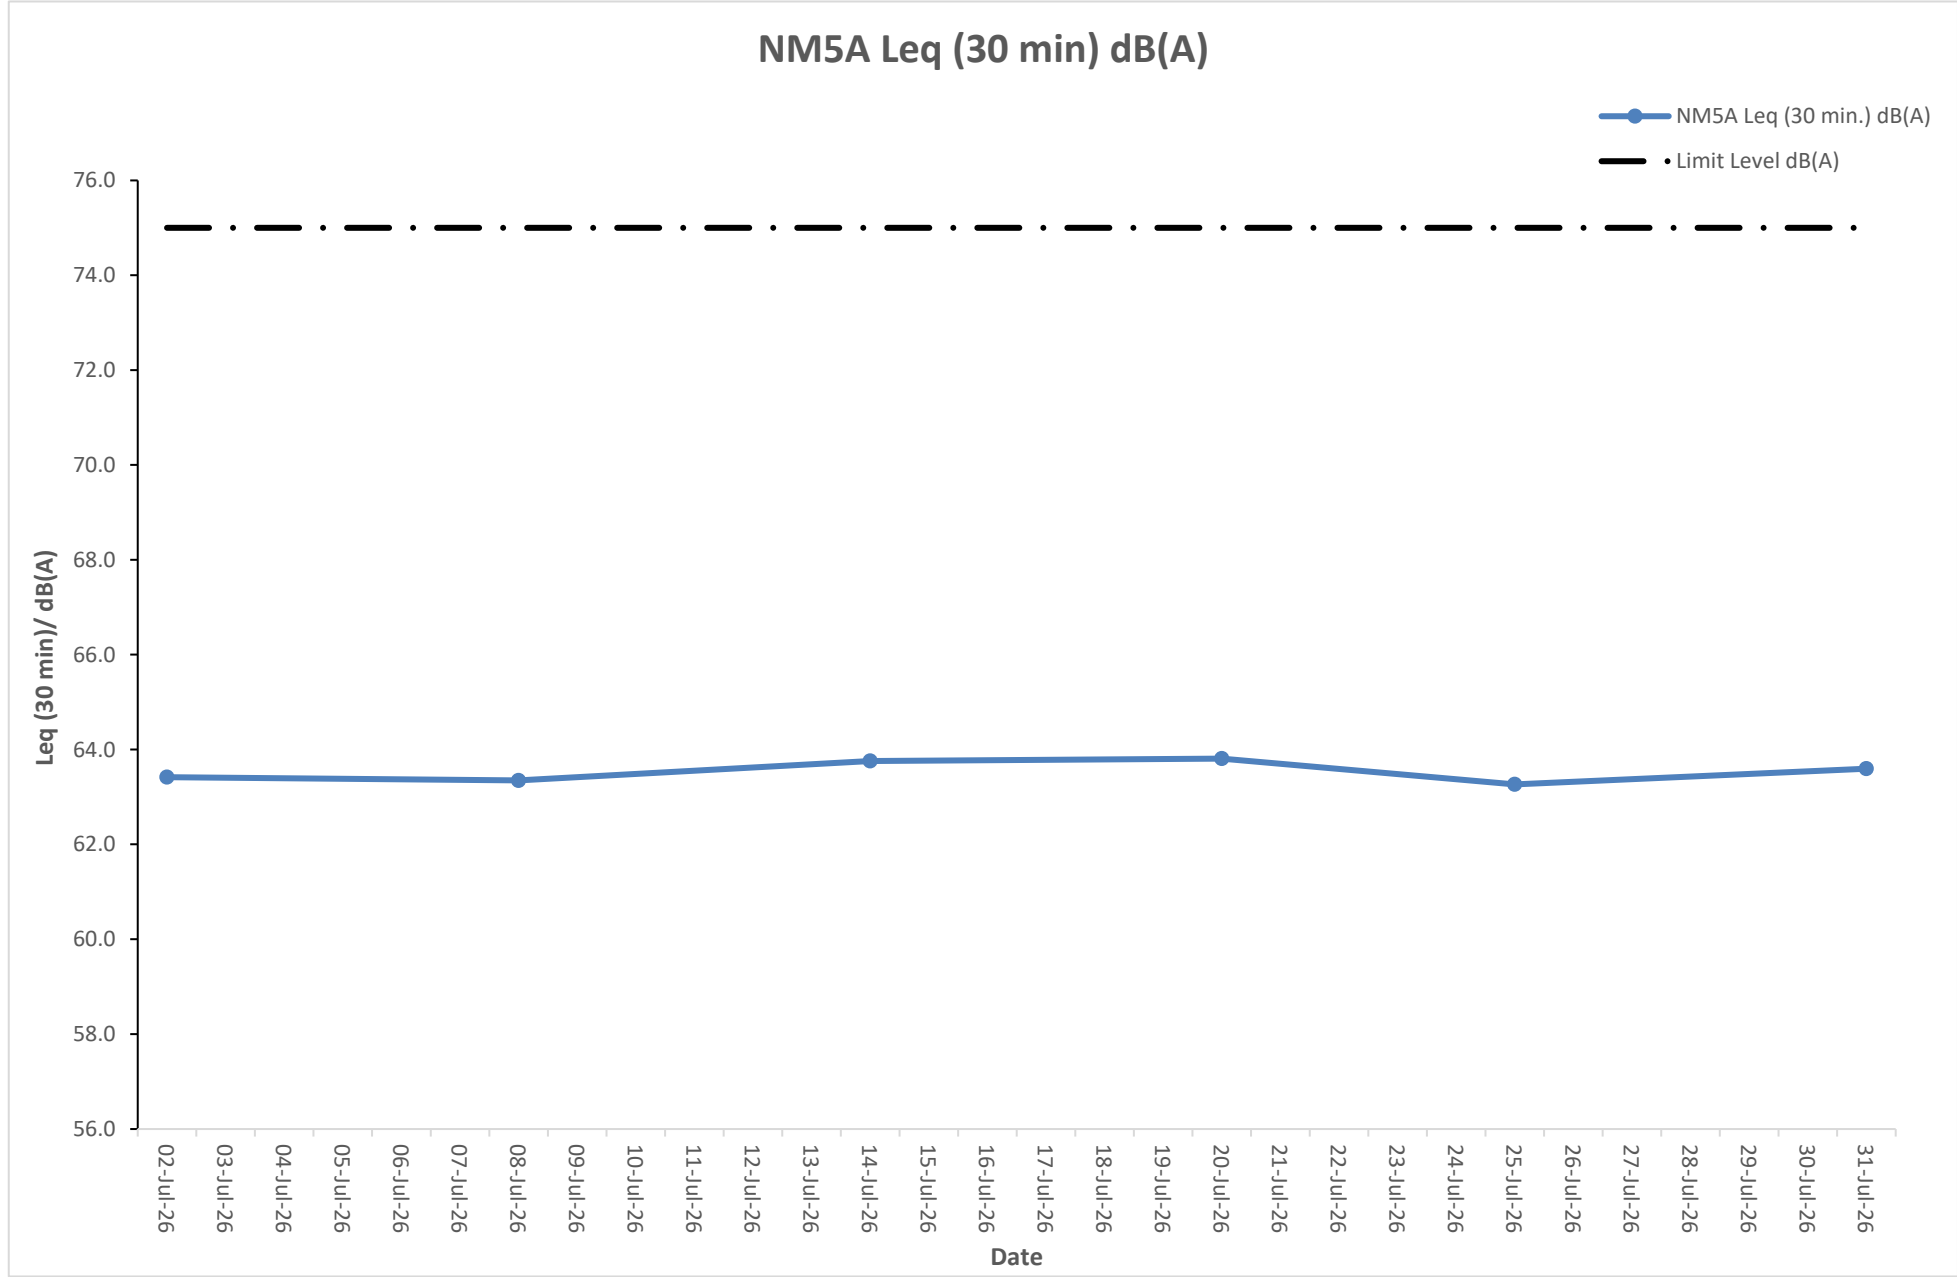
Graphical Presentation of Noise Monitoring Result at Station NM5A

The station set-up of a free-field measurement at station NM5A.
